Expertise

Protocol number: 46859330  
Order No. / Reference: 26759332  
Inspection date: 3 Aug 2026

Manufacturer: Seat

Model: Alhambra 1.4 TSI S&S DSG OPF XCELLENCE

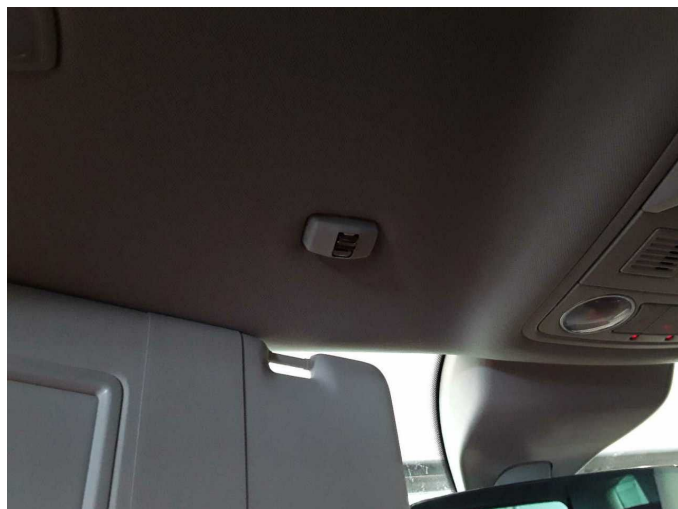
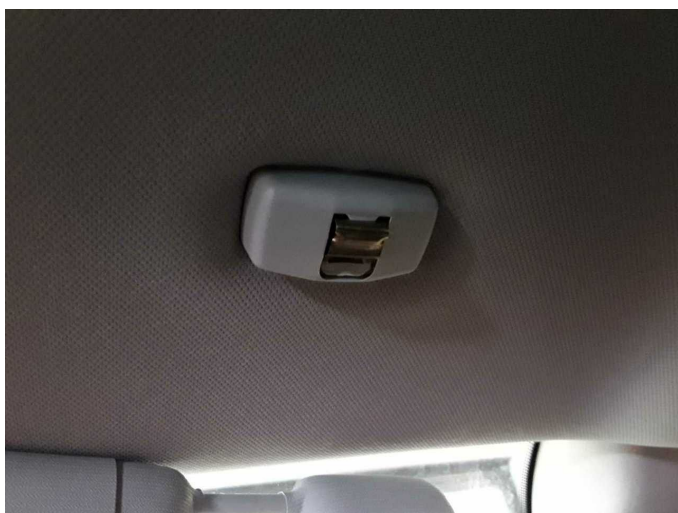
| No. | Component group | Description |
|---|---|---|
| 1 | Interior | Sun visor - left side (Halterung) - Broken / torn - Replace |

**Damage 1:** Interior: Sun visor - left side (Halterung) - Broken / torn - Replace

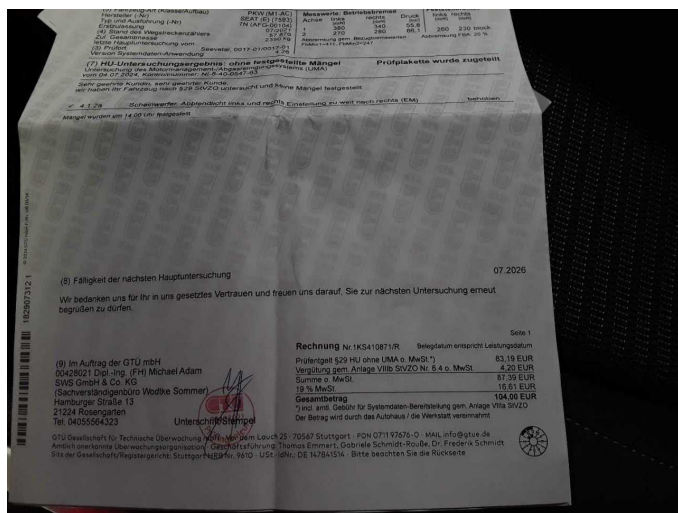
| No. | Component group | Description |
|---|---|---|
| 2 | Misc. | Main inspection - Due - Replace |

**Damage 2: Misc.: Main inspection - Due - Replace**

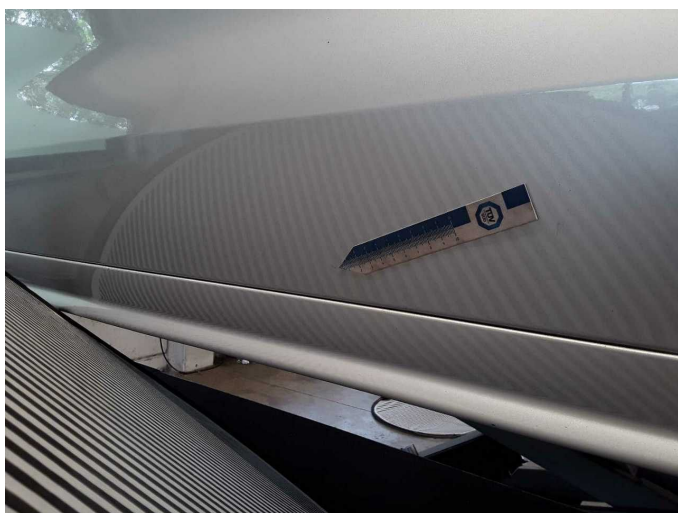
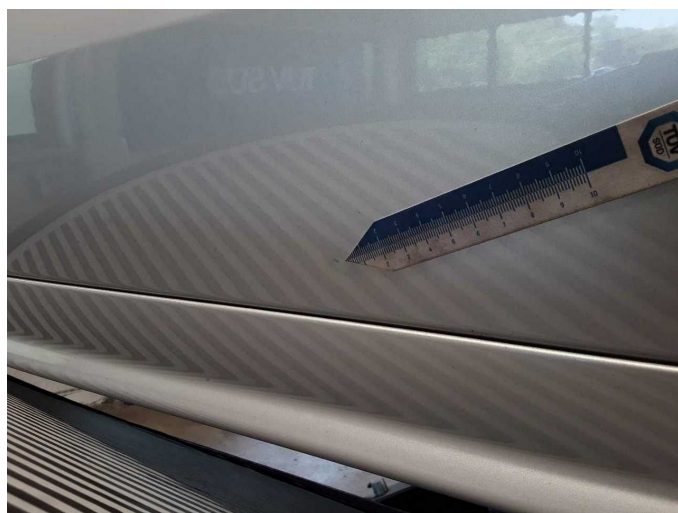
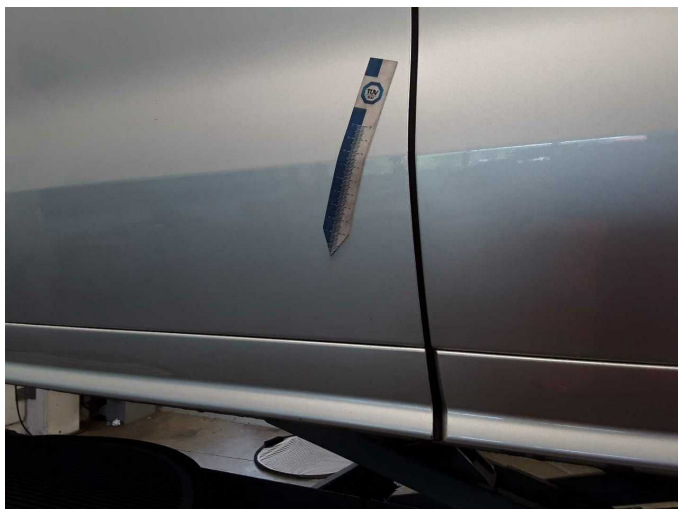
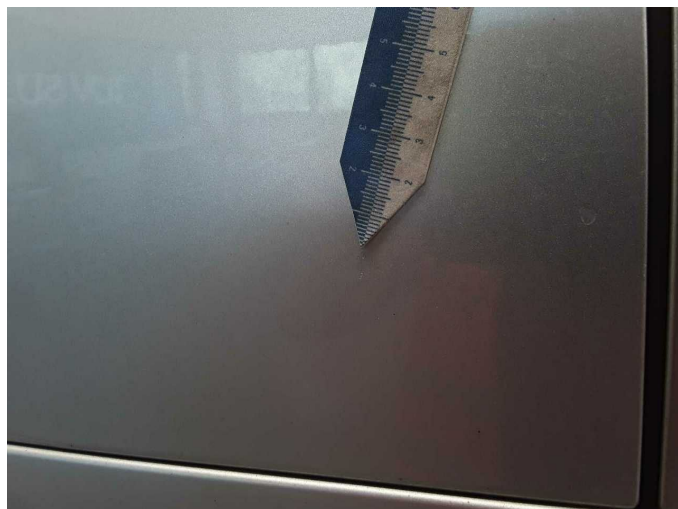
| No. | Component group | Description |
|---|---|---|
| 3 | Door - front left side | Door - Dent / paintcoat damage - Repair and paint |

**Damage 3:** Door - front left side: Door - Dent / paintcoat damage - Repair and paint

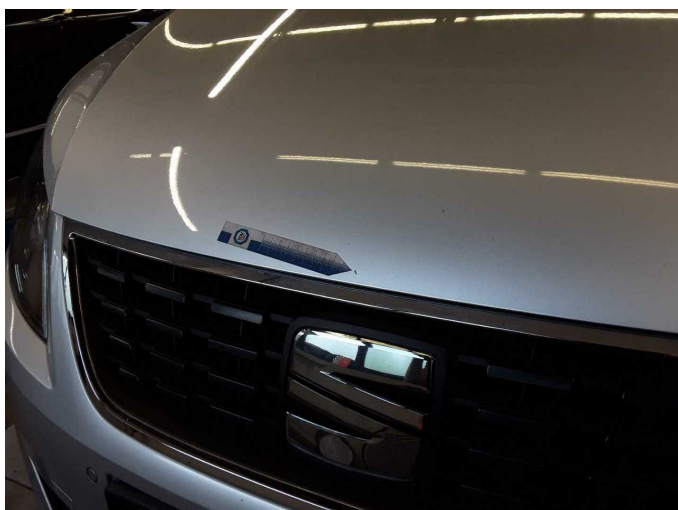
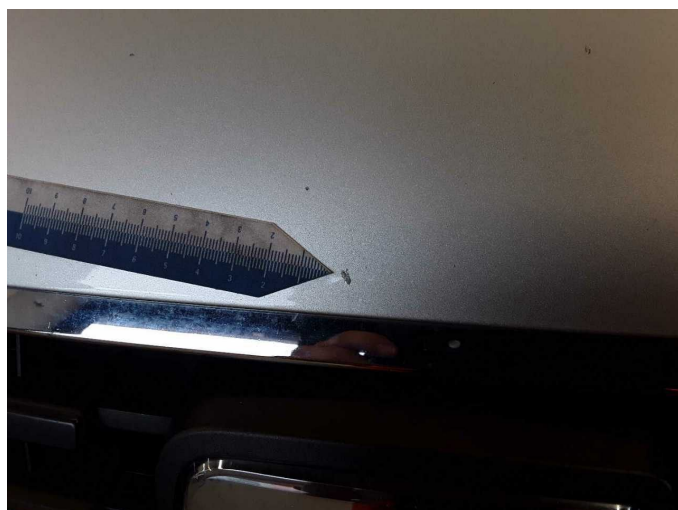
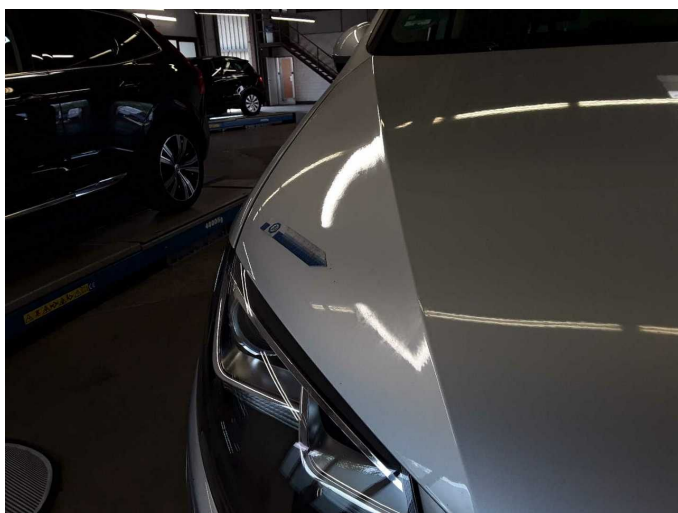
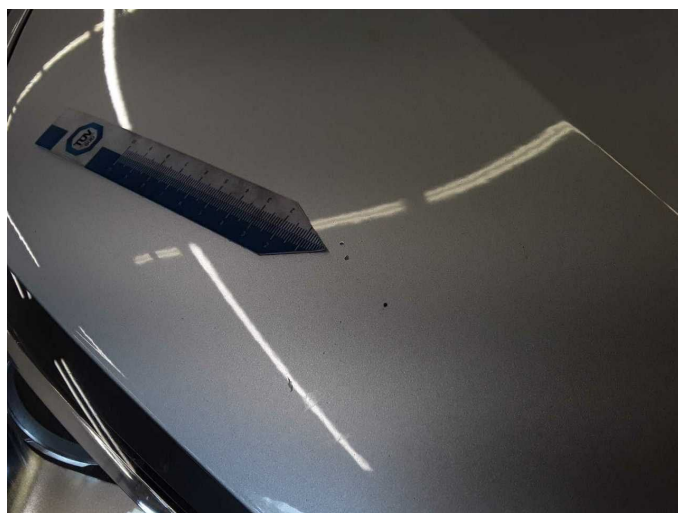
| No. | Component group | Description |
|---|---|---|
| 4 | Bonnet | Bonnet - Stone chips - Paint |

**Damage 4:** Bonnet: Bonnet - Stone chips - Paint

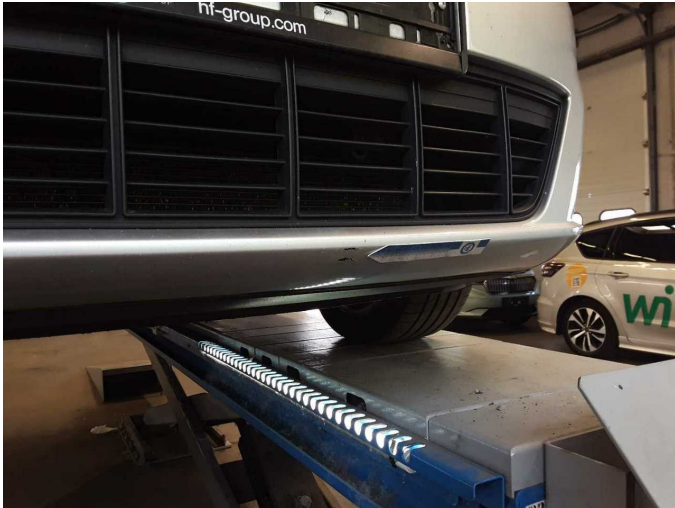
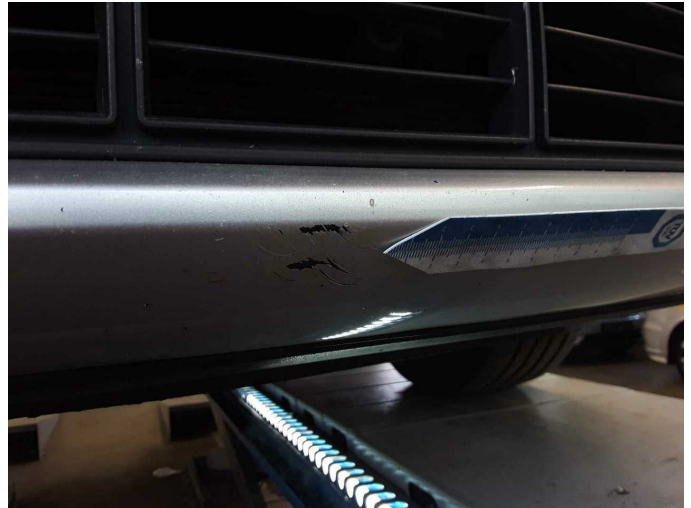
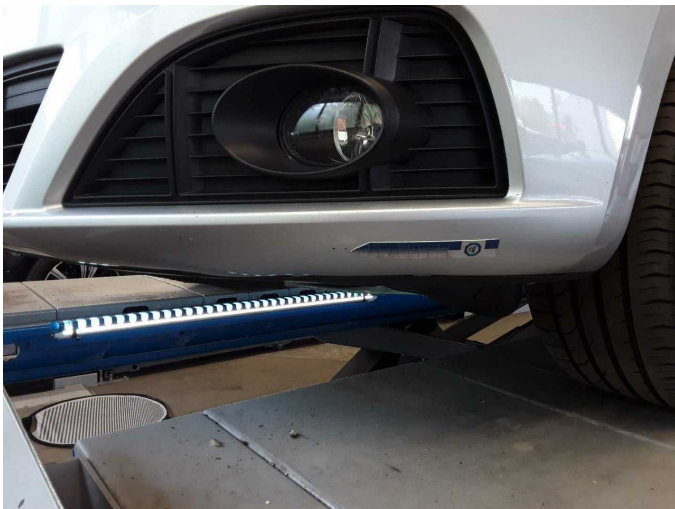
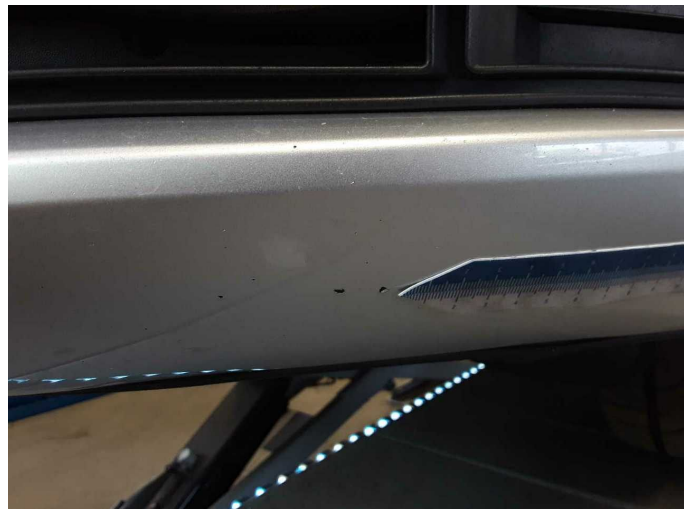
| No. | Component group | Description |
|---|---|---|
| 5 | Front bumper | Front bumper - Scratched - Paint |

**Damage 5:** Front bumper: Front bumper - Scratched - Paint

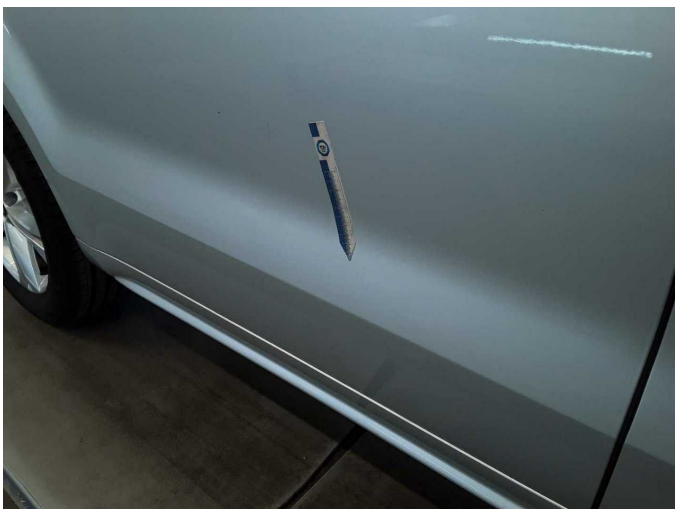
| No. | Component group | Description |
|---|---|---|
| 1 | Sliding door, right | Sliding door - Abrasion - No deduction |

**Wear and tear 1:** Sliding door, right: Sliding door - Abrasion - No deduction

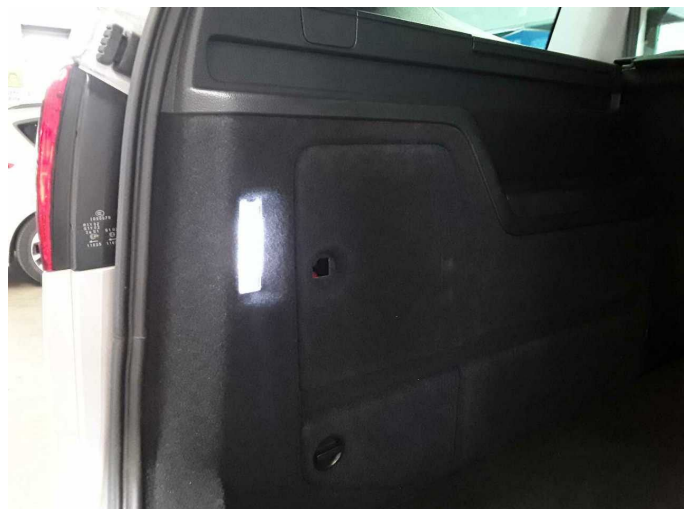
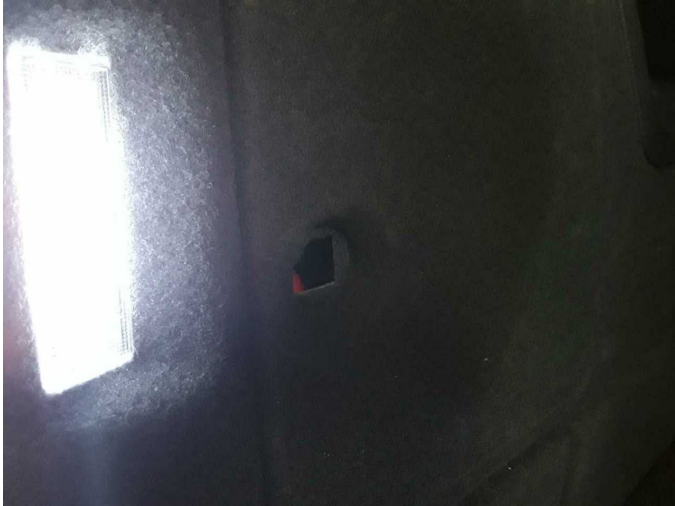
Trim / covers - Cargo area - lining -left side (Halterung erneuern)

**Missing part 2:** Trim / covers: Cargo area - lining -left side (Halterung erneuern) - Missing - Replace

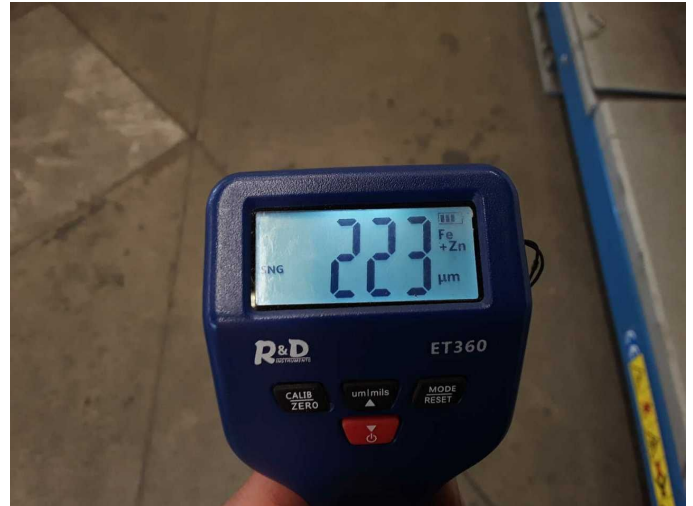
- 1 Roof rail - right side, Side panel - rear right side, Professionally carried out, Invoice of repair done Non-existent

**Roof rail - right side:** 223 µm

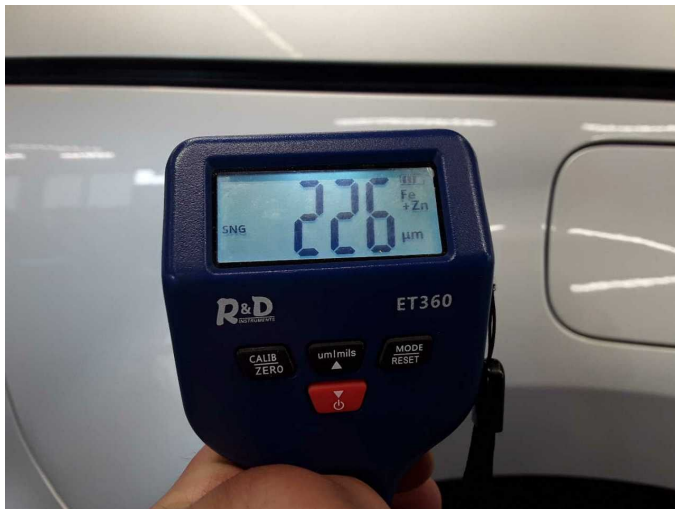
**Side panel - rear right side:** 226 µm
