Expertise

Protocol number: 46872489  
Order No. / Reference: 26754769  
Inspection date: 4 Aug 2026

Manufacturer: Ford

Model: Focus Turnier 2.0 EcoBlue Start-Stopp-System Aut.  
COOL&CONNECT

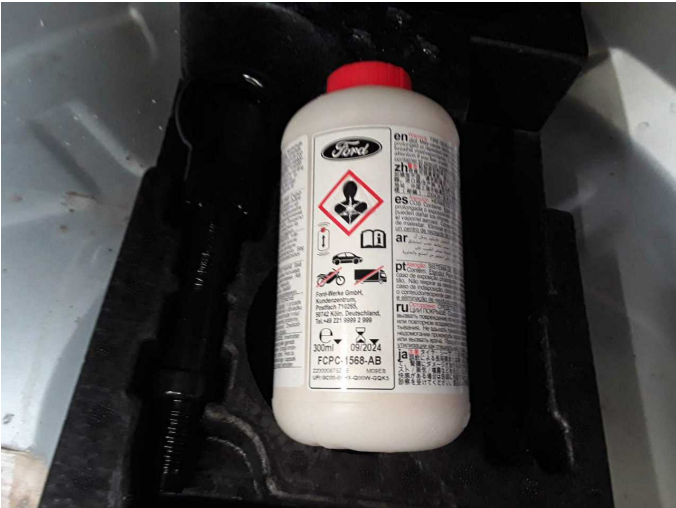
| No. | Component group | Description |
|---|---|---|
| 1 | Equipment | Tirefit filler - Expired - Replace |

Damage 1: Equipment: Tirefit filler - Expired - Replace

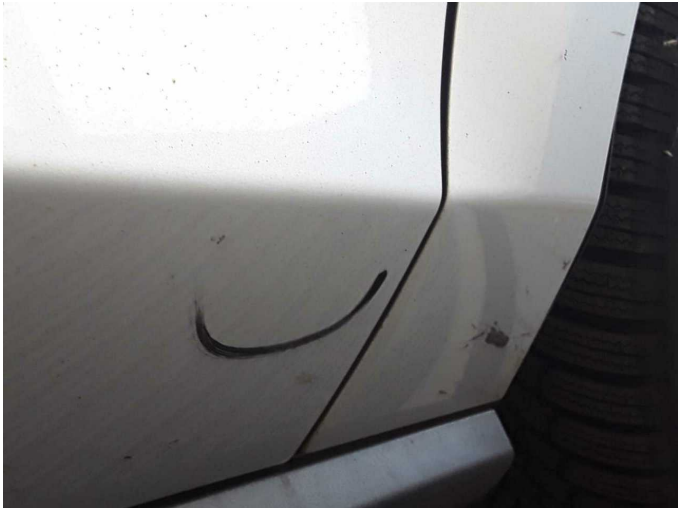
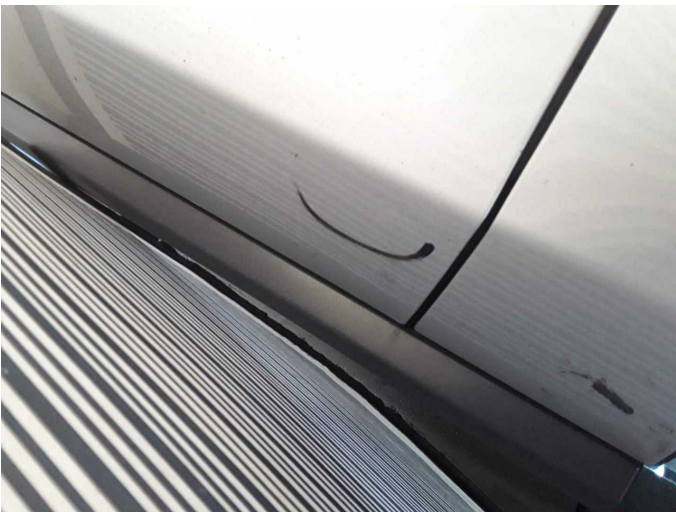
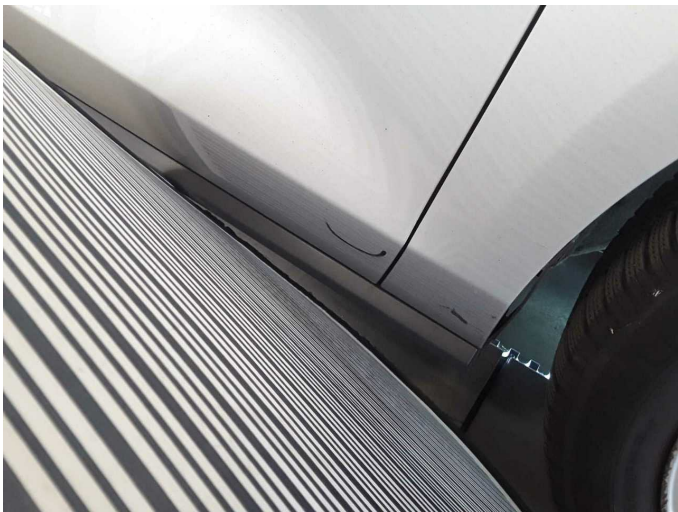
| No. | Component group | Description |
|---|---|---|
| 2 | Door - front right side | Door - dent(s) - Smooth repair work |

Damage 2: Door - front right side: Door - dent(s) - Smooth repair work

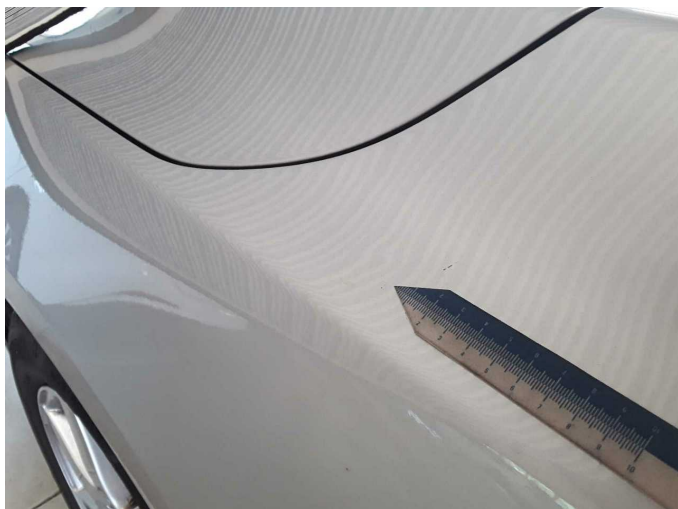
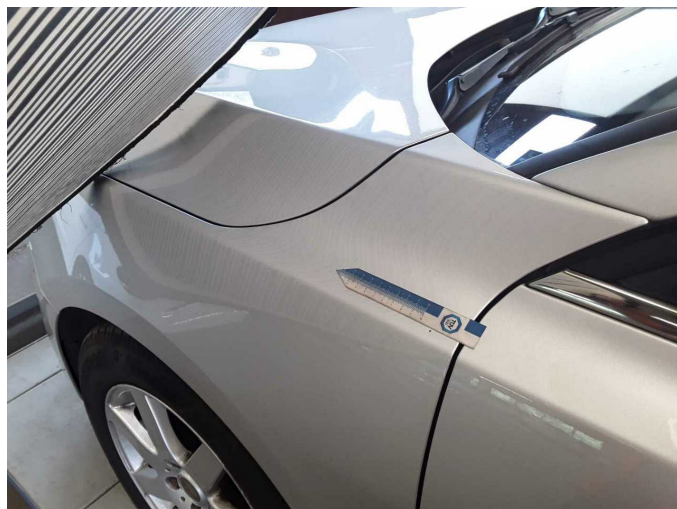
| No. | Component group | Description |
|---|---|---|
| 3 | Mudguard - left side | Mudguard - left side - dent(s) - Smooth repair work |

**Damage 3:** Mudguard - left side: Mudguard - left side - dent(s) - Smooth repair work

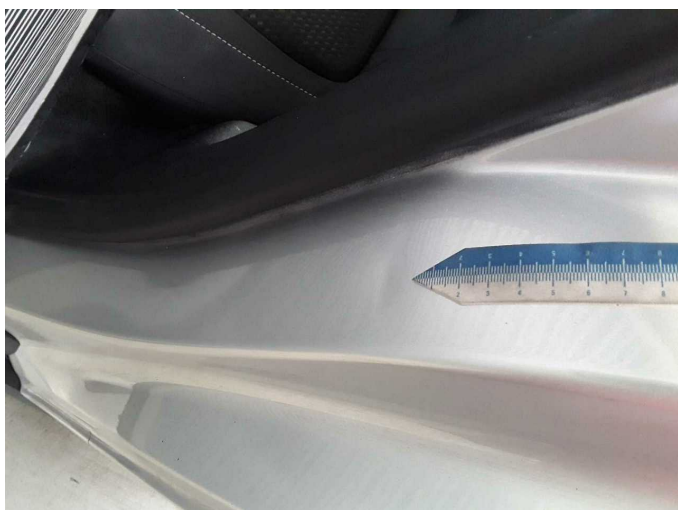
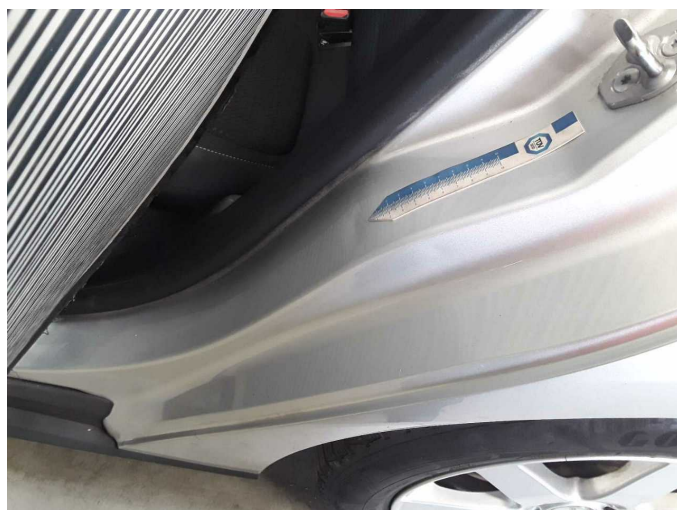
| No. | Component group | Description |
|---|---|---|
| 4 | Side panel - rear left side | Sill - dent(s) - Smart repair |

**Damage 4:** Side panel - rear left side: Sill - dent(s) - Smart repair

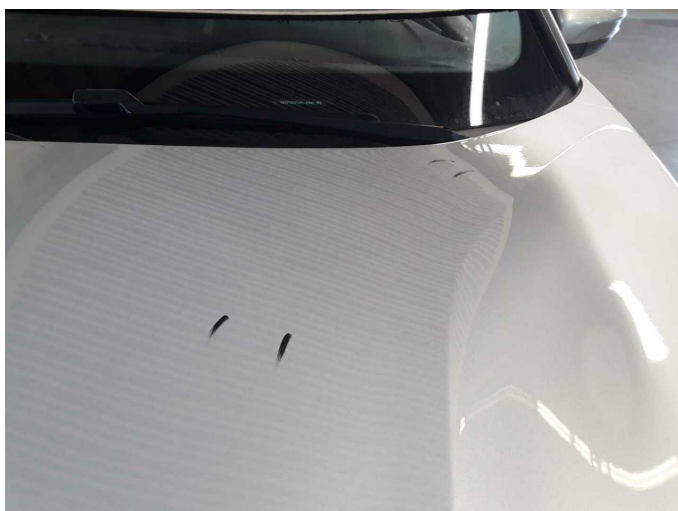
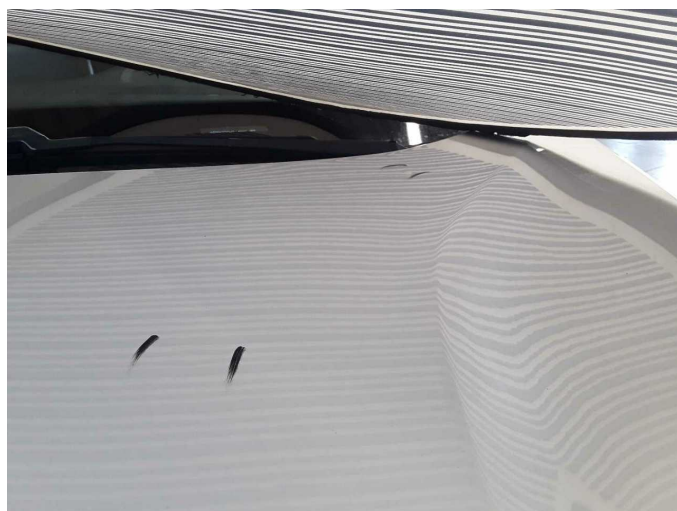
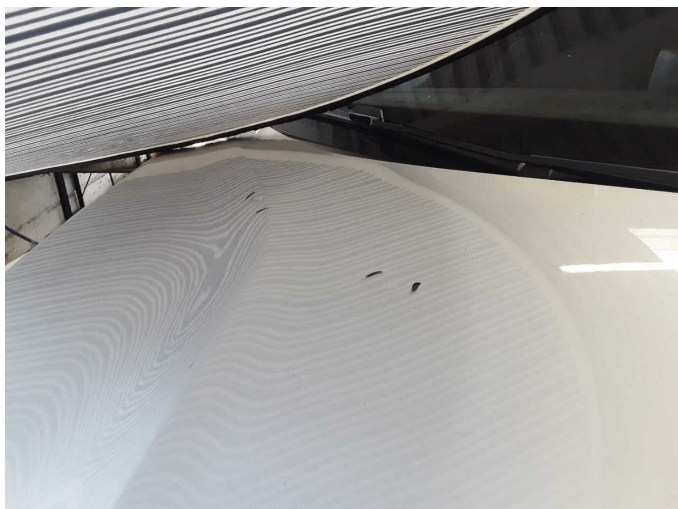
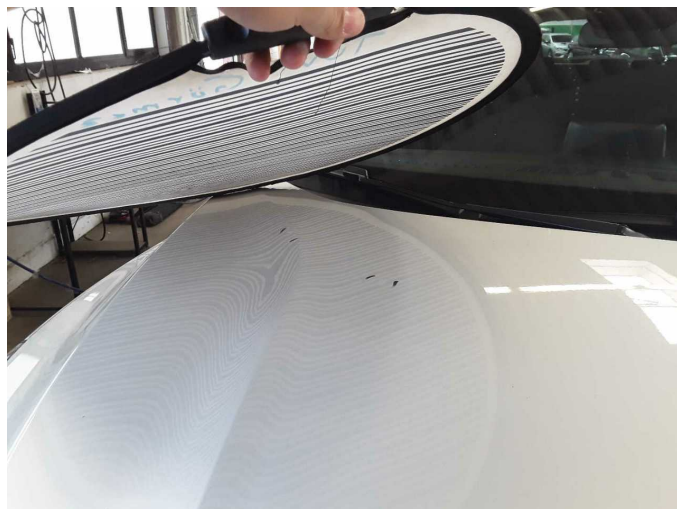
| No. | Component group | Description |
|---|---|---|
| 6 | Bonnet | Bonnet (4 Dellen) - dent(s) - Smooth repair work |

**Damage 6:** Bonnet: Bonnet (4 Dellen) - dent(s) - Smooth repair work

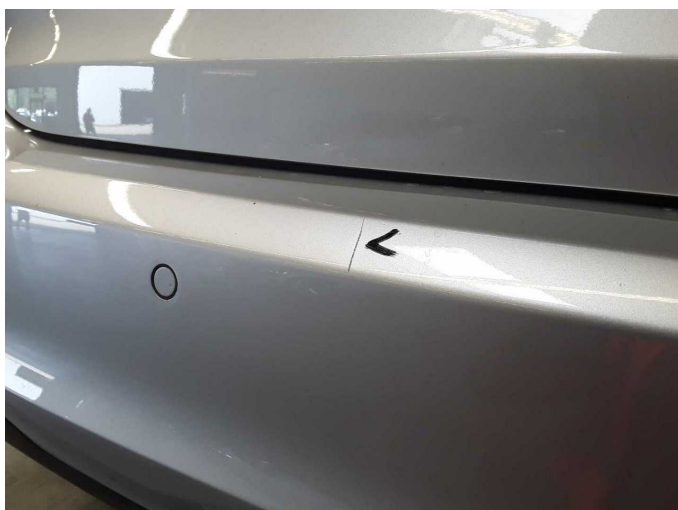
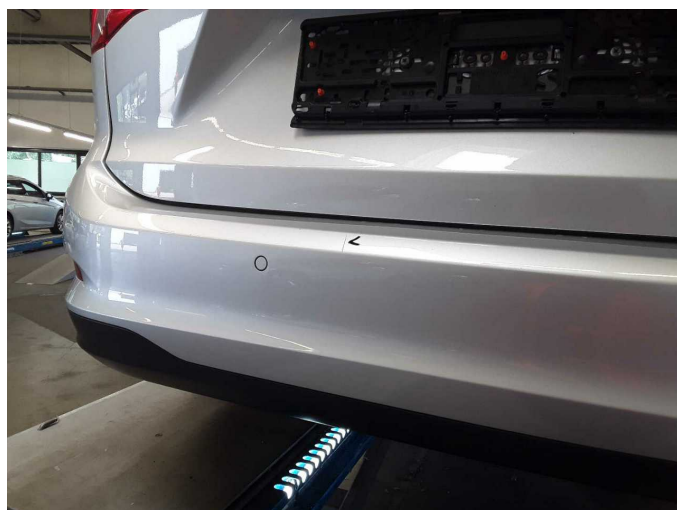
| No. | Component group | Description |
|---|---|---|
| 7 | Rear bumper | Rear bumper - Scratch(es) - Paint |

**Damage 7:** Rear bumper: Rear bumper - Scratch(es) - Paint

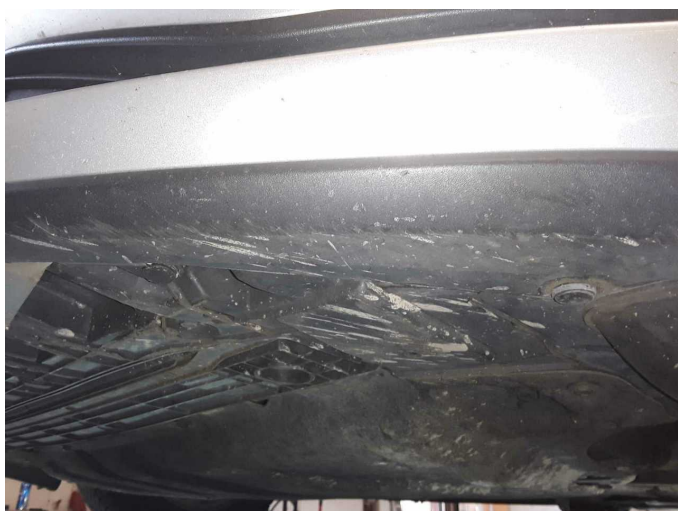
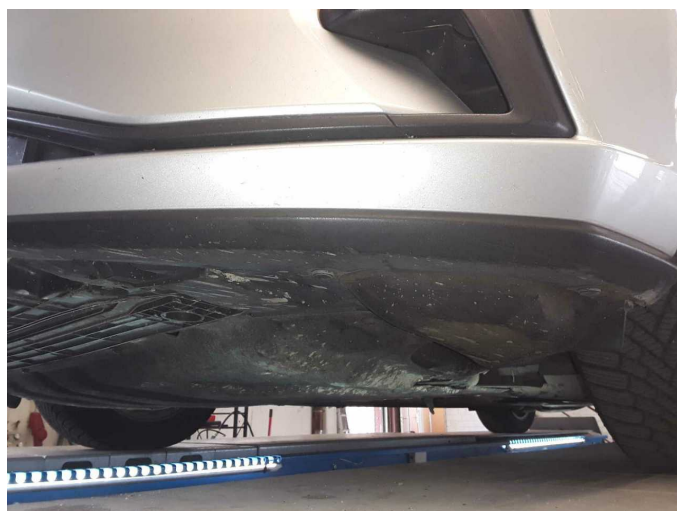
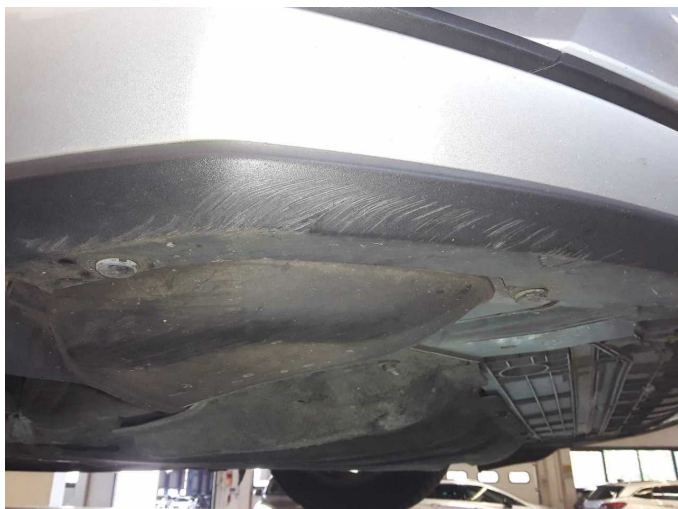
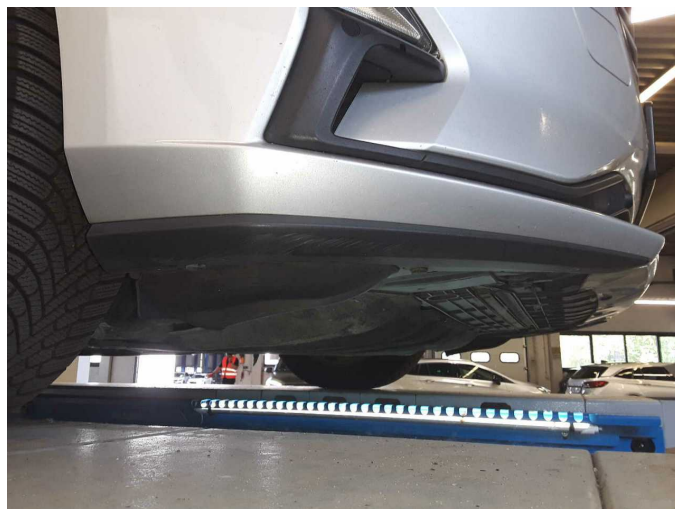
| No. | Component group | Description |
|---|---|---|
| 8 | Front bumper | Spoiler (Linke und rechte seite) - Scratch(es) - Replace |

**Damage 8:** Front bumper: Spoiler (Linke und rechte Seite) - Scratch(es) - Replace

**Damage 8:** Front bumper: Spoiler (Linke und rechte seite) - Scratch(es) - Replace

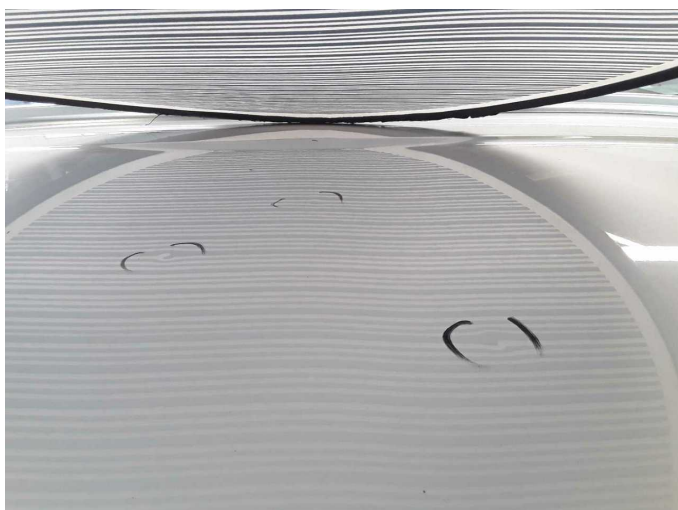
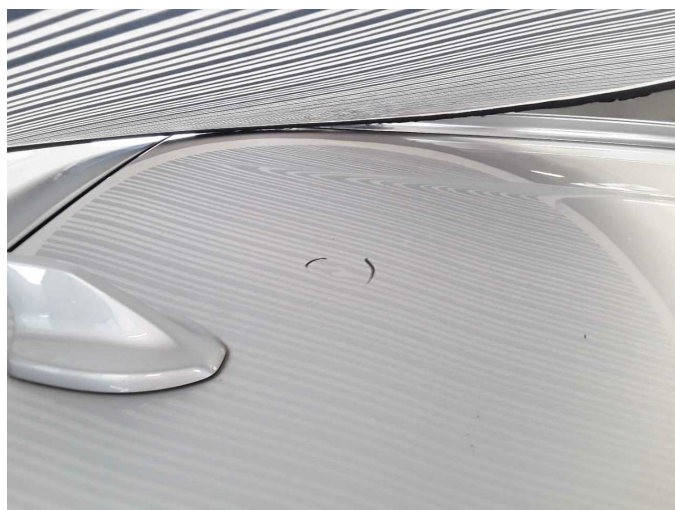
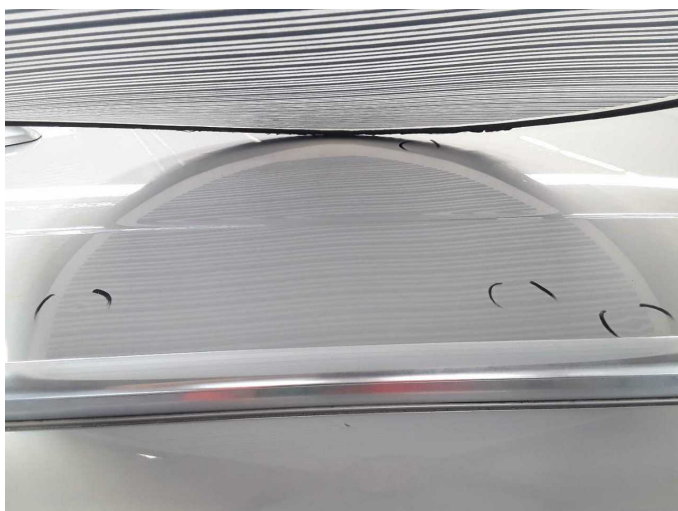
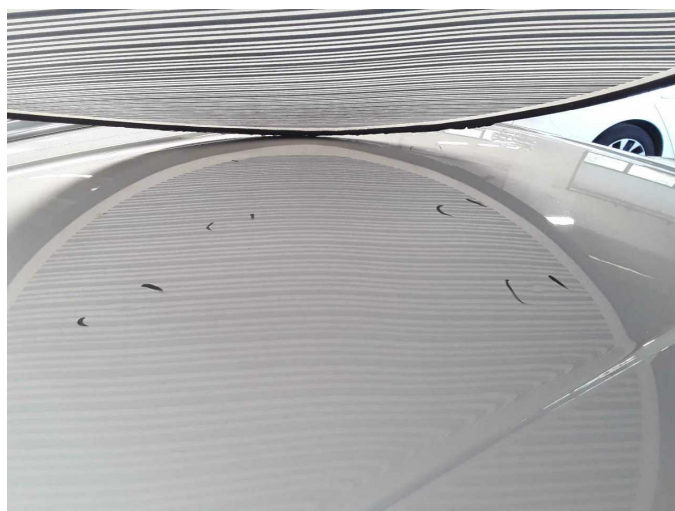
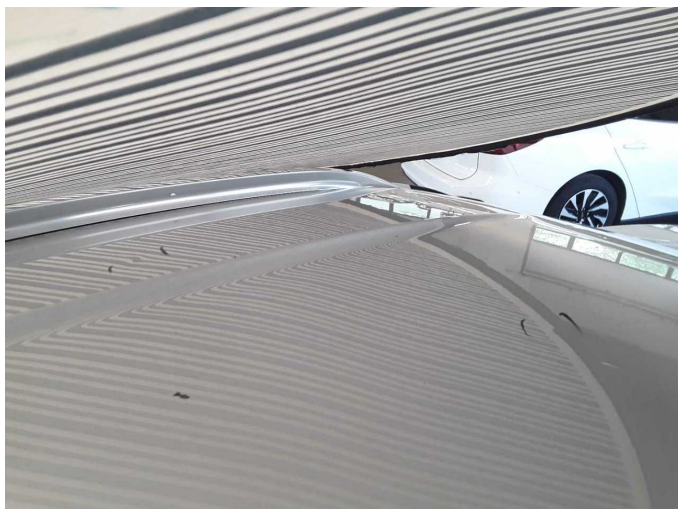
| No. | Component group | Description |
|---|---|---|
| 9 | Roof | Roof - dent(s) - repair according to calculation |

**Damage 9:** Roof: Roof - dent(s) - repair according to calculation

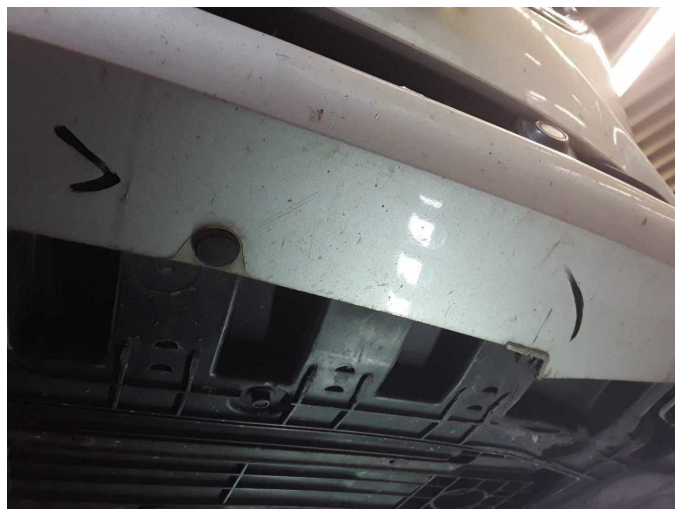
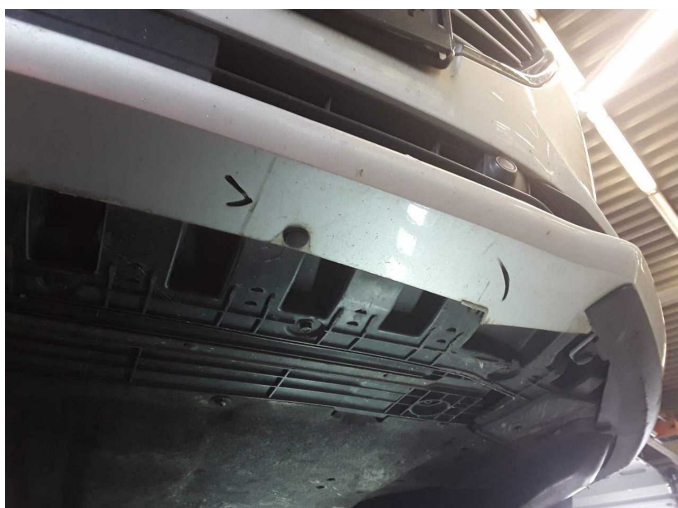
| No. | Component group | Description |
|---|---|---|
| 10 | Front bumper | Front bumper - Scratch(es) - Paint |

**Damage 10:** Front bumper: Front bumper - Scratch(es) - Paint

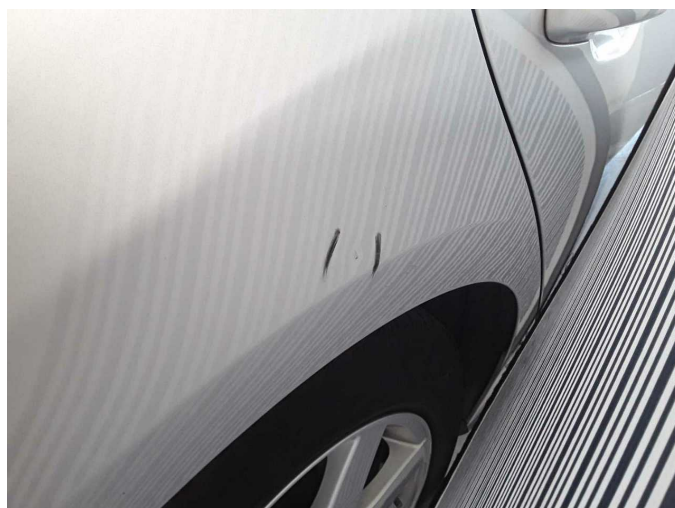
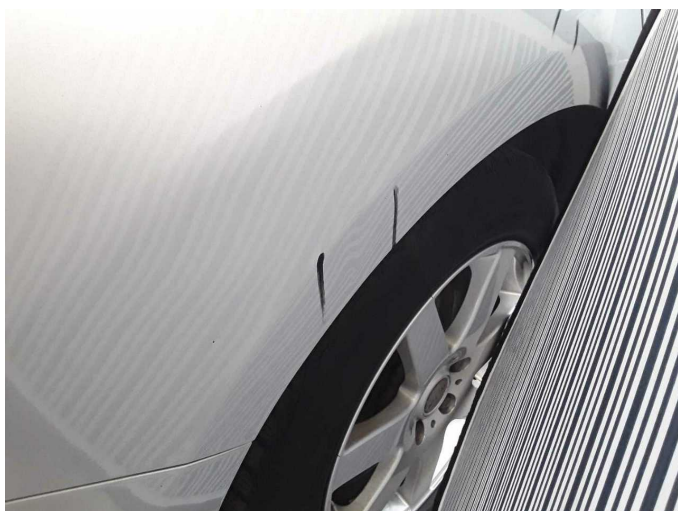
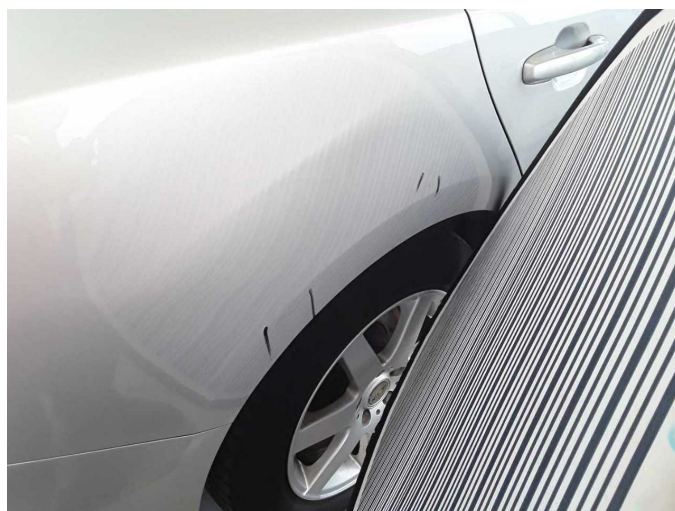
| No. | Component group | Description |
|---|---|---|
| 11 | Door - rear right side | Door - Dent / paintcoat damage - Repair and paint |

**Damage 11:** Door - rear right side: Door - Dent / paintcoat damage - Repair and paint

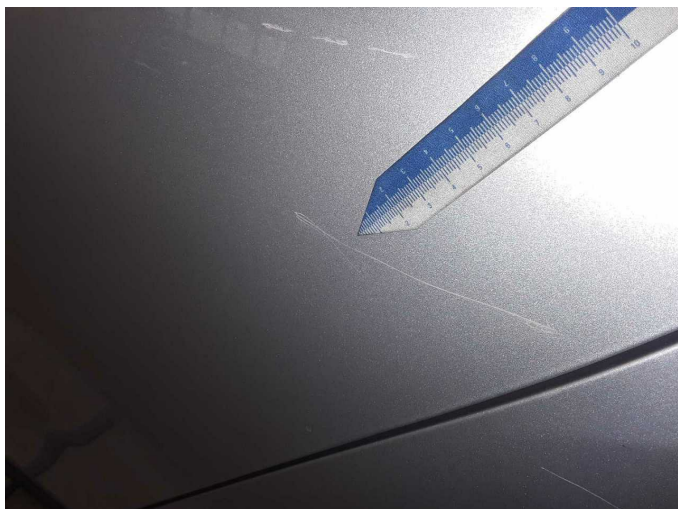
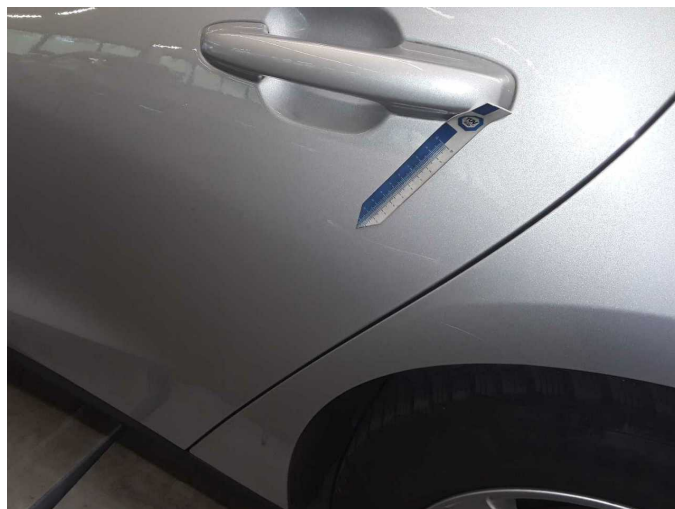
| No. | Component group | Description |
|---|---|---|
| 12 | Door - rear left side | Door - Scratch(es) - Paint |

**Damage 12:** Door - rear left side: Door - Scratch(es) - Paint

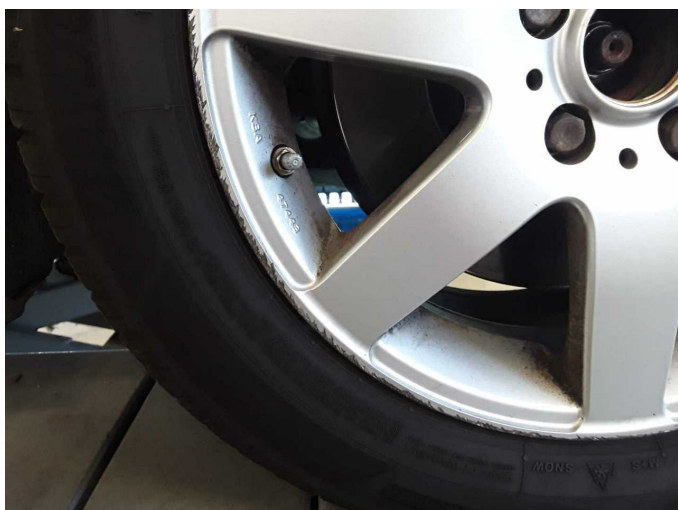
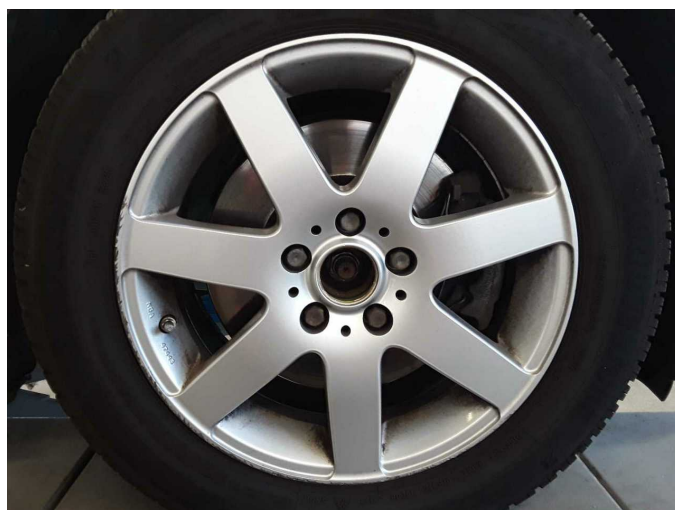
| No. | Component group | Description |
|---|---|---|
| 1 | Wheel / tyres | Alloy rim - front right side - Scratch(es) - No deduction |

**Wear and tear 1:** Wheel / tyres: Alloy rim - front right side - Scratch(es) - No deduction

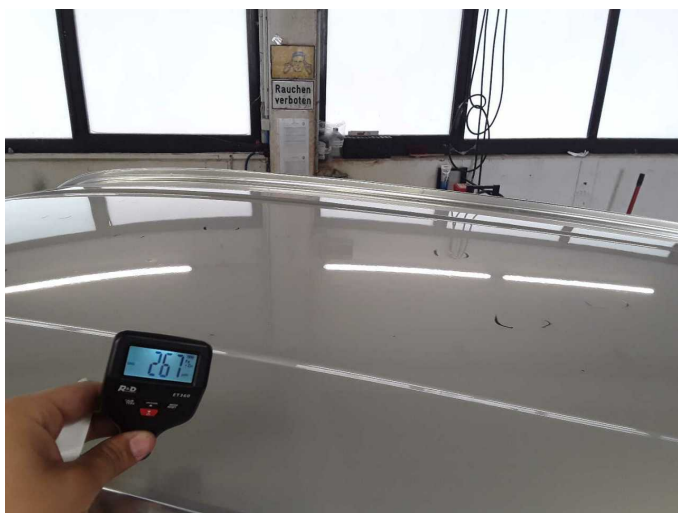
**Roof:** 267 µm

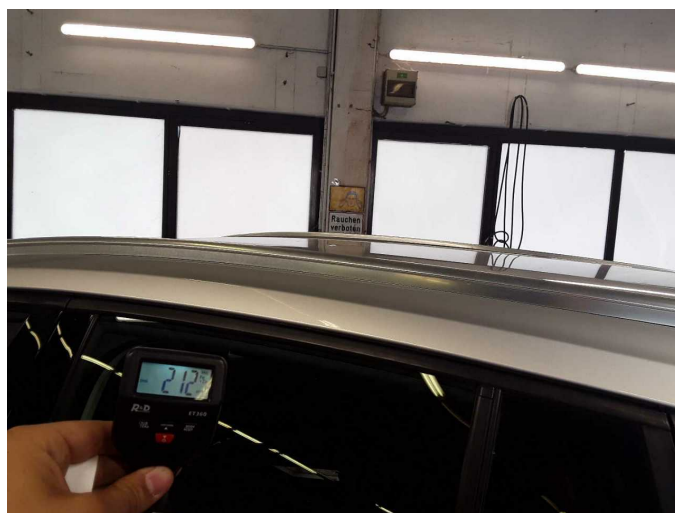
**Roof rail - left side:** 212 µm

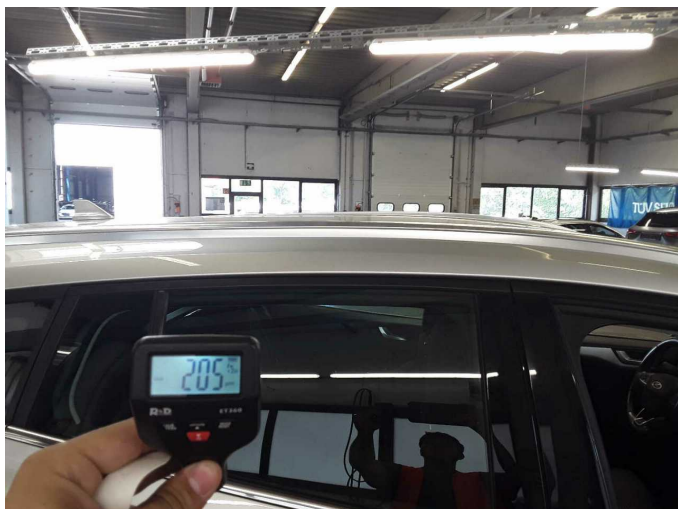
Roof rail - right side: 205 µm

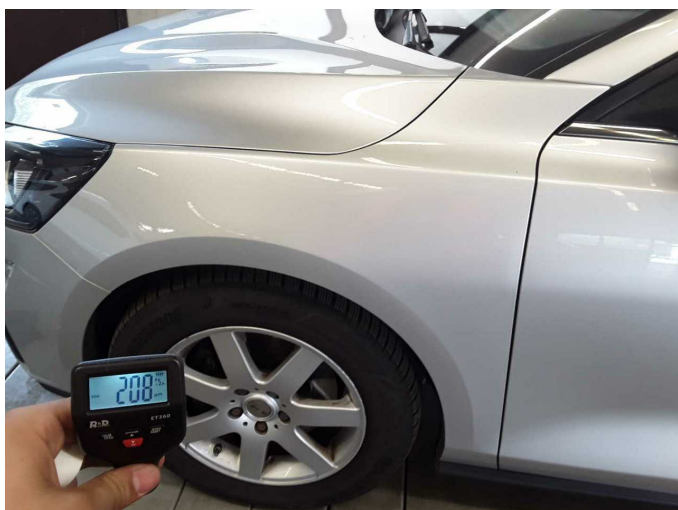
Mudguard - left side: 208 µm

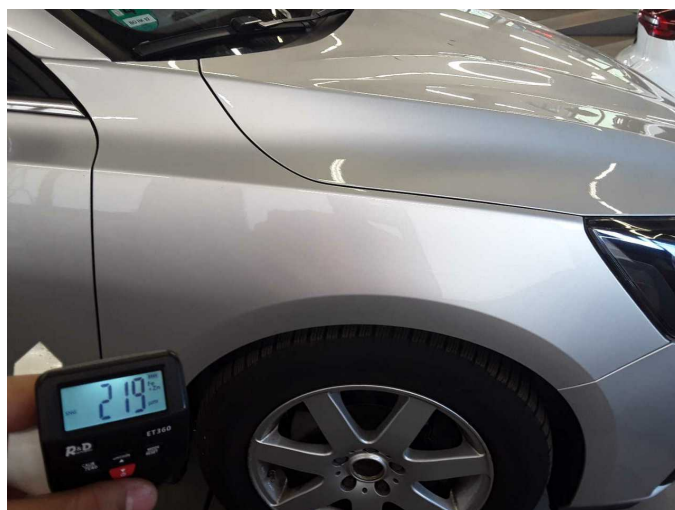
Mudguard - right side: 219 µm

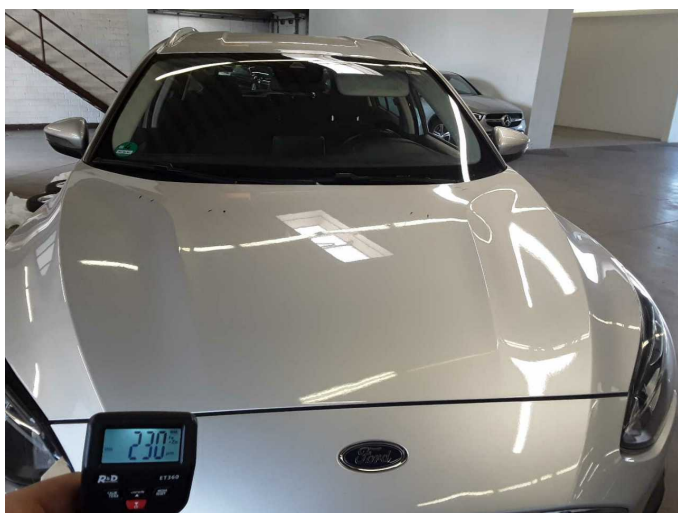
Bonnet: 230 µm

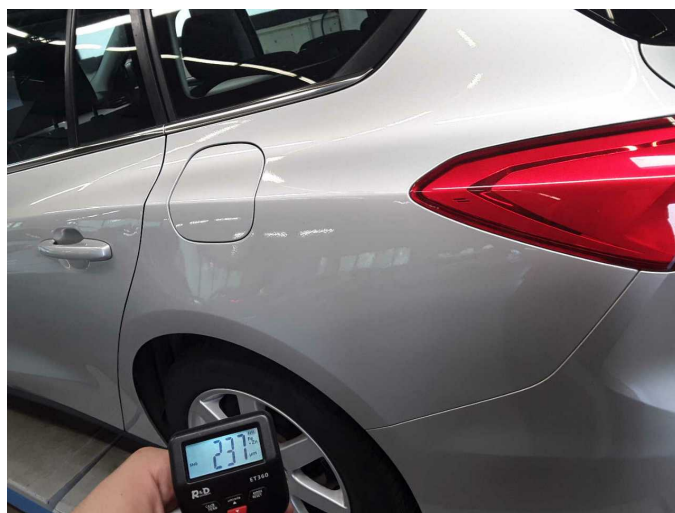
Side panel - rear left side: 237 µm

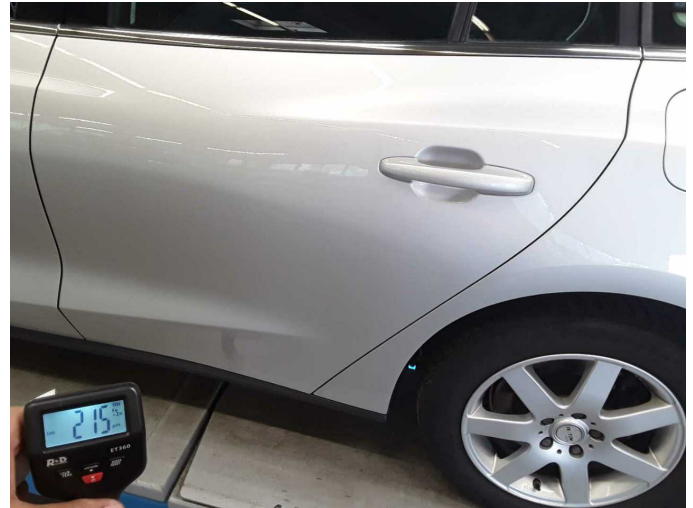
Door - rear left side: 215 µm

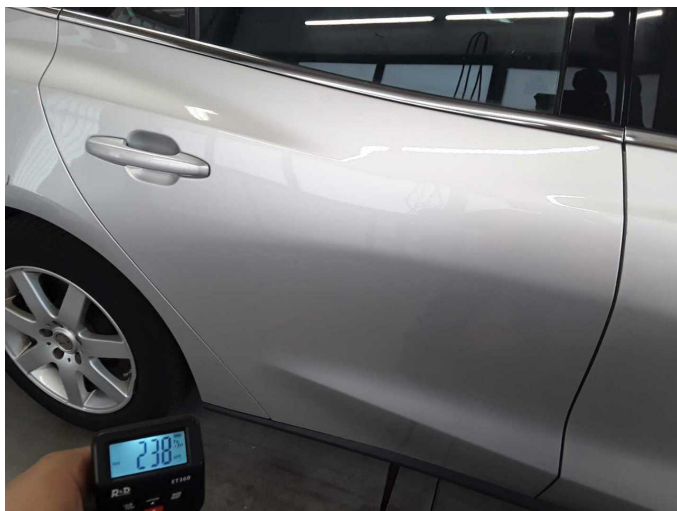
Door - rear right side: 238 µm

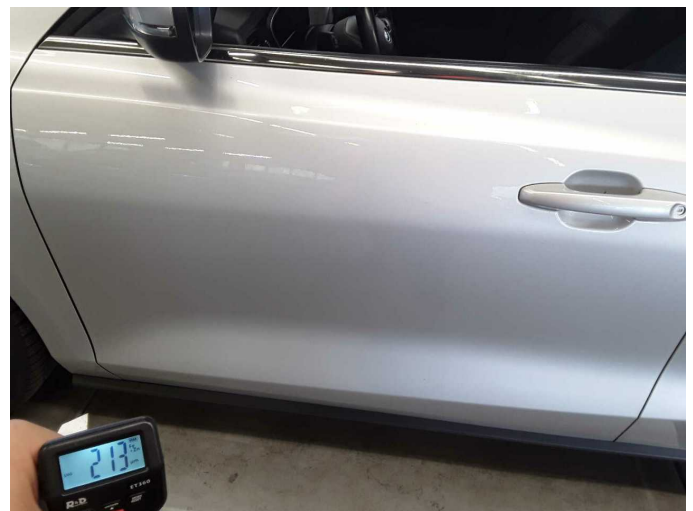
Door - front left side: 213 µm

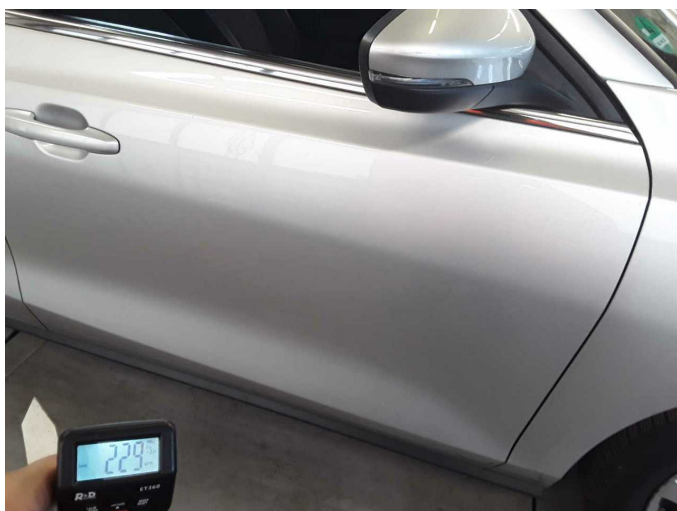
Door - front right side: 229 µm
