Expertise

Protocol number: 46381892  
Order No. / Reference: 26529119  
Inspection date: 7 Jul 2026

Manufacturer: Kia

Model: Ceed SW 1.6 GDI DCT OPF Plug-in-Hybrid Spirit

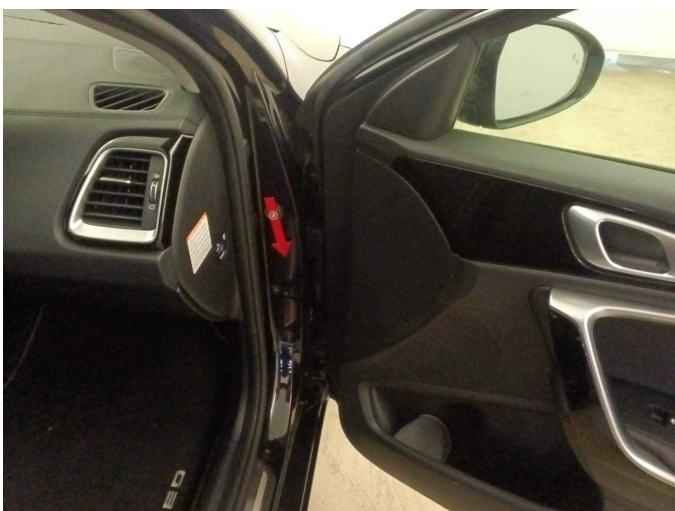
| No. | Component group | Description |
|---|---|---|
| 1 | Door - front right side | Door (Türfeststeller, Schraube lose) - Malposition - Un- / install |

**Damage 1:** Door - front right side: Door (Türfeststeller, Schraube lose) - Malposition - Un- / install

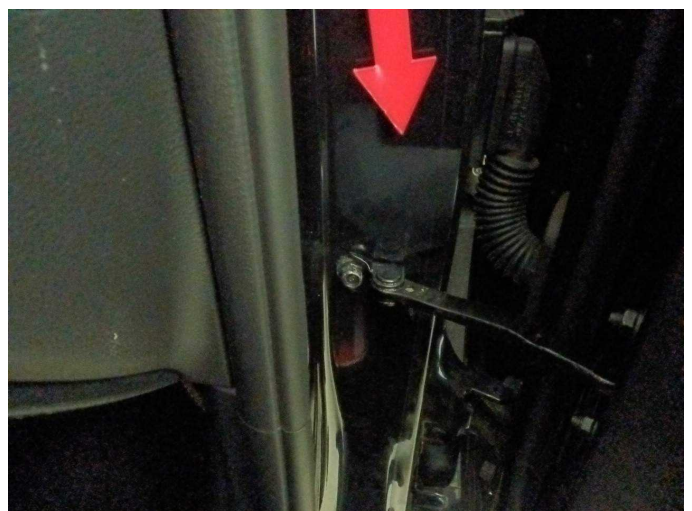
**Damage 1:** Door - front right side: Door (Türfeststeller, Schraube lose) - Malposition - Un- / install

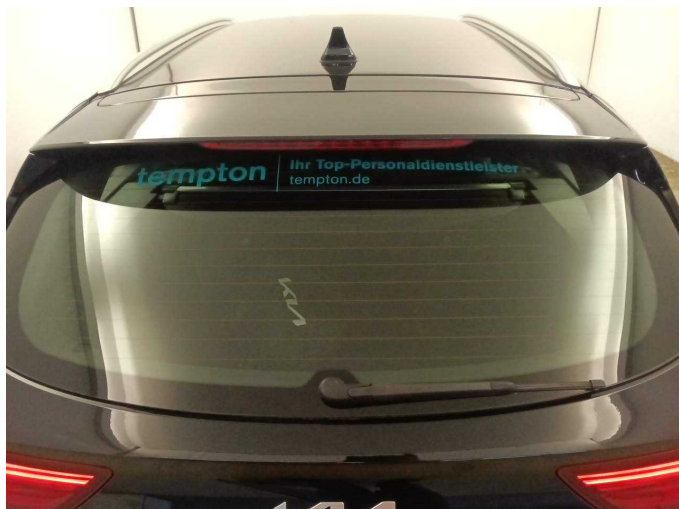
| No. | Component group | Description |
|---|---|---|
| 2 | Vehicle glazing | Rear window - Glued / labelled - Remove |

**Damage 2:** Vehicle glazing: Rear window - Glued / labelled - Remove

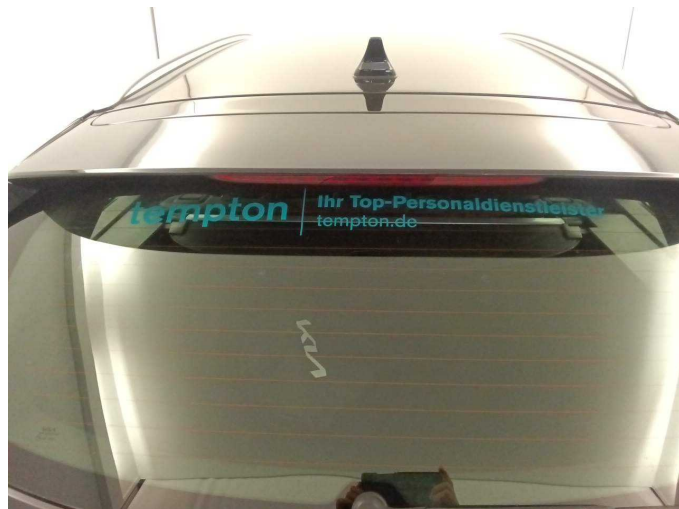
**Damage 2:** Vehicle glazing: Rear window - Glued / labelled - Remove

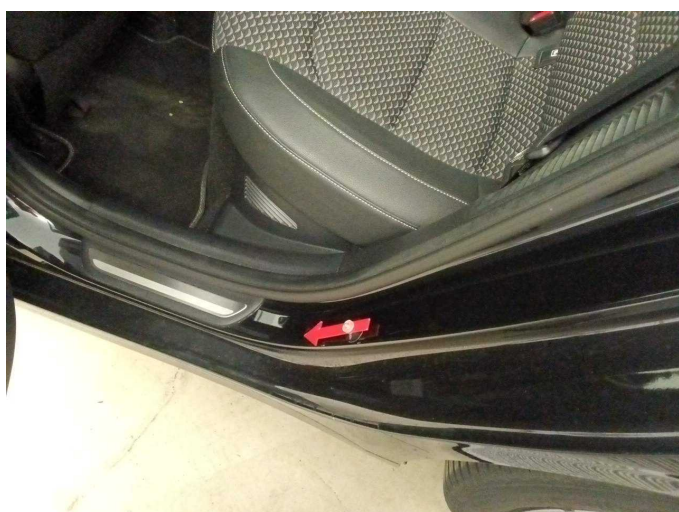
| No. | Component group | Description |
|---|---|---|
| 3 | Sill - left side | Sill - dent(s) - Smooth repair work |

**Damage 3:** Sill - left side: Sill - dent(s) - Smooth repair work

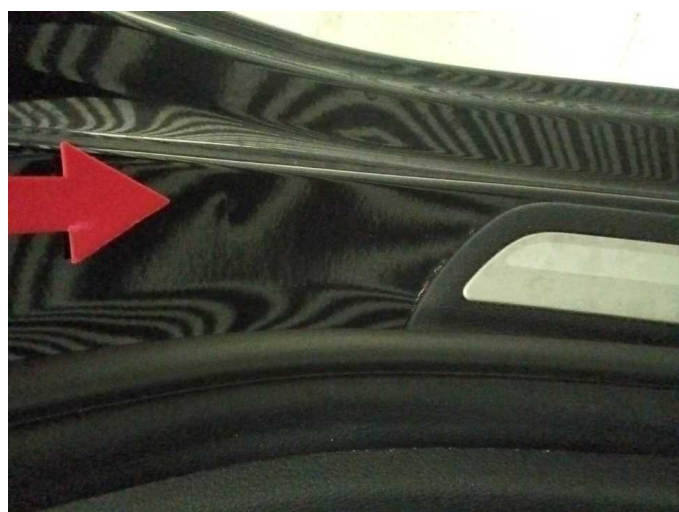
**Damage 3:** Sill - left side: Sill - dent(s) - Smooth repair work

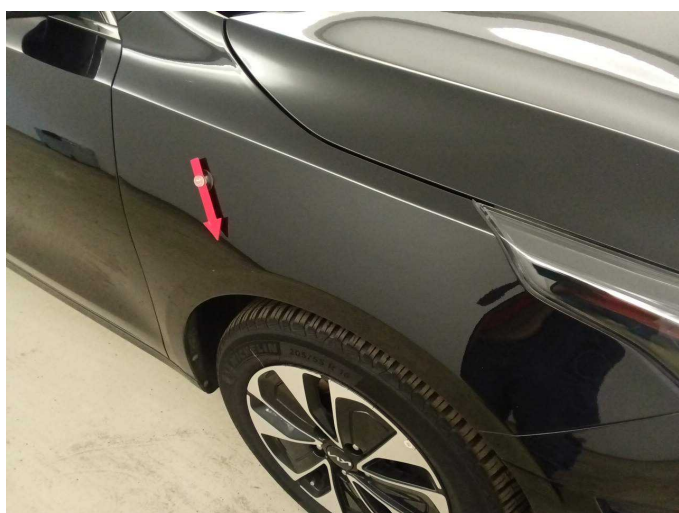
| No. | Component group | Description |
|---|---|---|
| 4 | Mudguard - right side | Mudguard - right side - Scratch(es) - Smart repair |

**Damage 4:** Mudguard - right side: Mudguard - right side - Scratch(es) - Smart repair

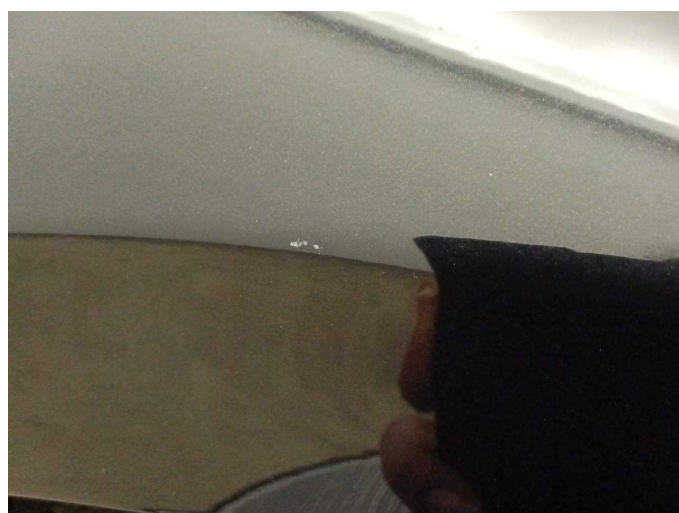
**Damage 4:** Mudguard - right side: Mudguard - right side - Scratch(es) - Smart repair

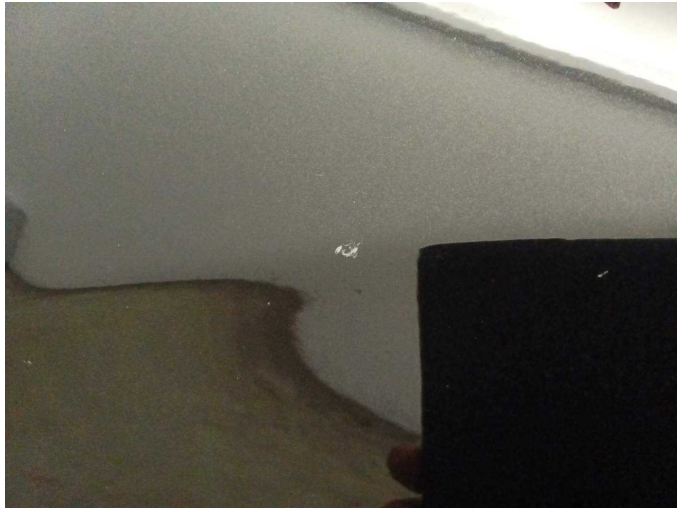
**Damage 4:** Mudguard - right side: Mudguard - right side - Scratch(es) - Smart repair

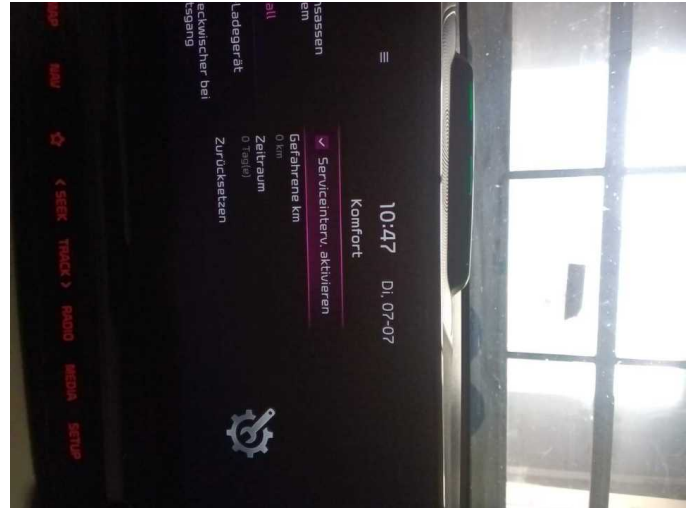
| No. | Component group | Description |
|---|---|---|
| 6 | Misc. | Inspection / maintenance (keine Historie) - Due - Perform |

**Damage 6:** Misc.: Inspection / maintenance (keine Historie) - Due - Perform

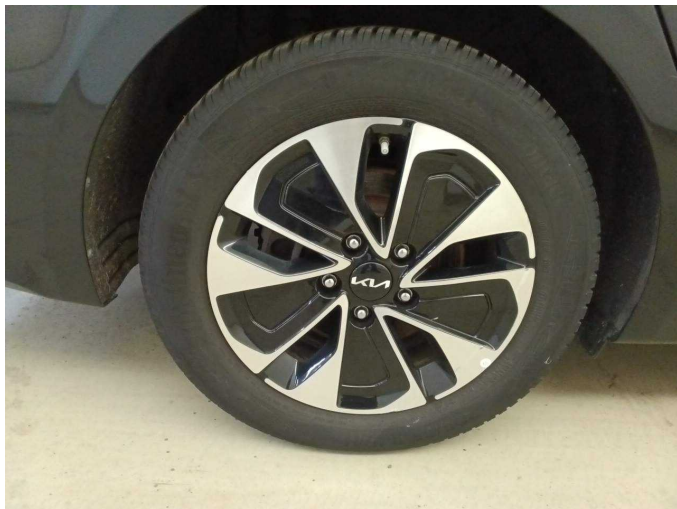
| No. | Component group | Description |
|---|---|---|
| 7 | Wheel / tyres | Alloy rim - rear right side - Scratch(es) - Replace |

**Damage 7:** Wheel / tyres: Alloy rim - rear right side - Scratch(es) - Replace

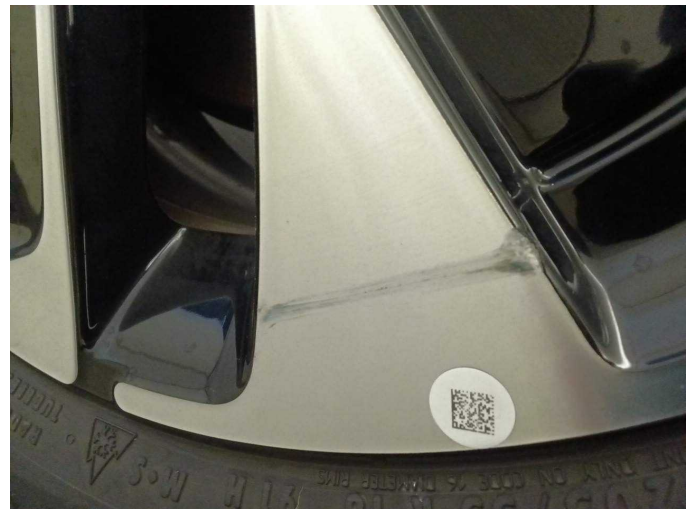
**Damage 7:** Wheel / tyres: Alloy rim - rear right side - Scratch(es) - Replace

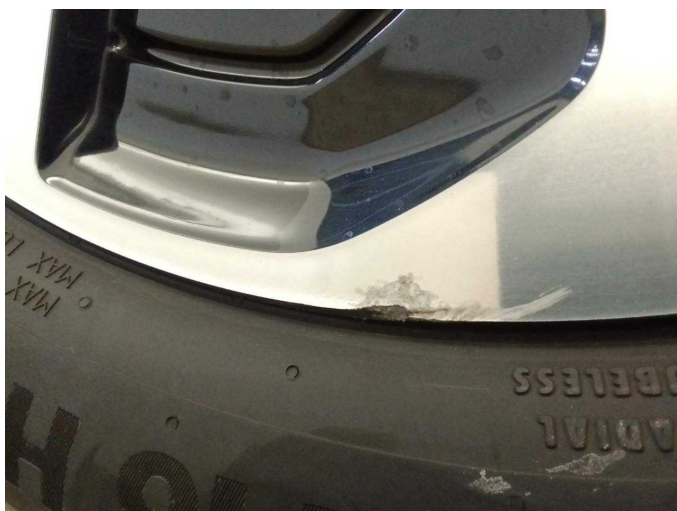
**Damage 7:** Wheel / tyres: Alloy rim - rear right side - Scratch(es) - Replace

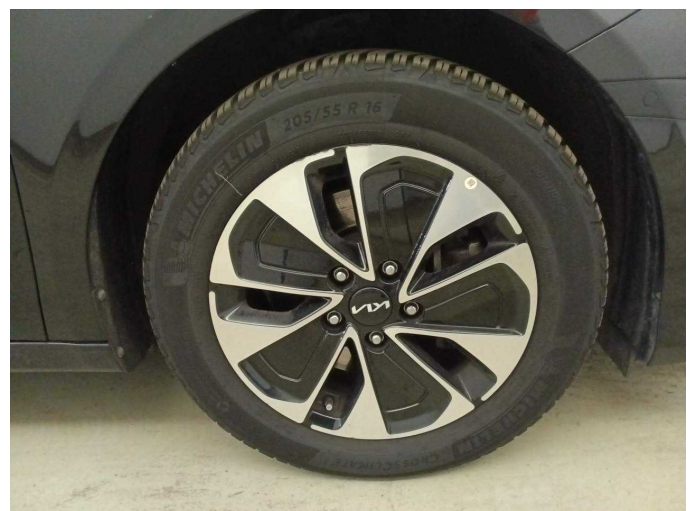
| No. | Component group | Description |
|---|---|---|
| 8 | Wheel / tyres | Alloy rim - front right side - Scratch(es) - Replace |

**Damage 8:** Wheel / tyres: Alloy rim - front right side - Scratch(es) - Replace

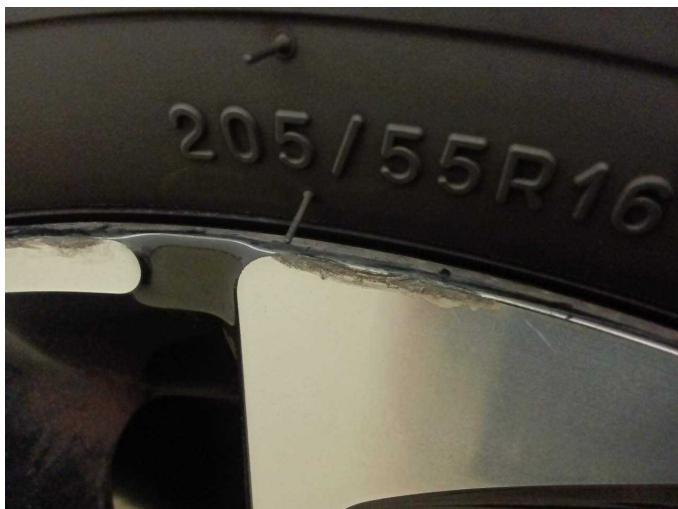
**Damage 8:** Wheel / tyres: Alloy rim - front right side - Scratch(es) - Replace

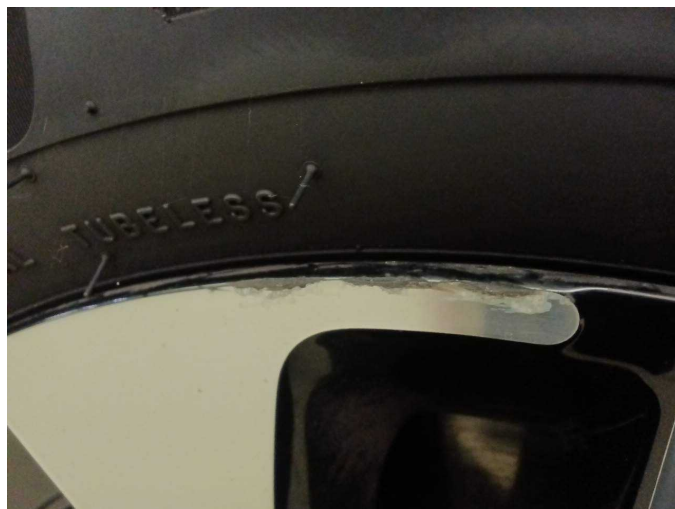
**Damage 8:** Wheel / tyres: Alloy rim - front right side - Scratch(es) - Replace

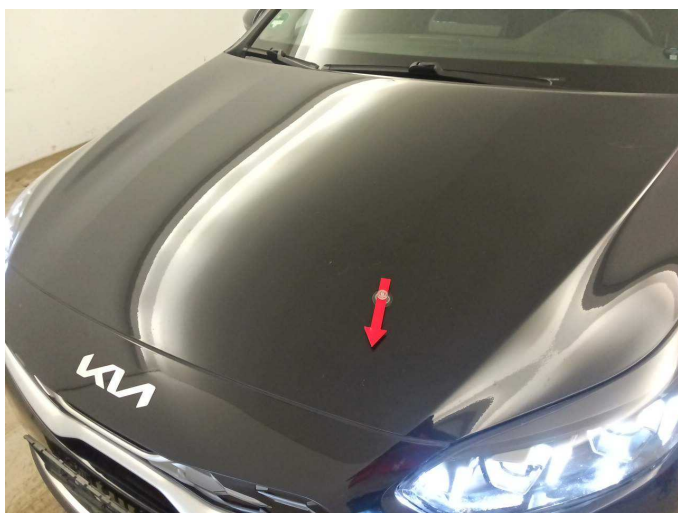
| No. | Component group | Description |
|---|---|---|
| 9 | Bonnet | Bonnet - Stone chips - Paint |

**Damage 9:** Bonnet: Bonnet - Stone chips - Paint

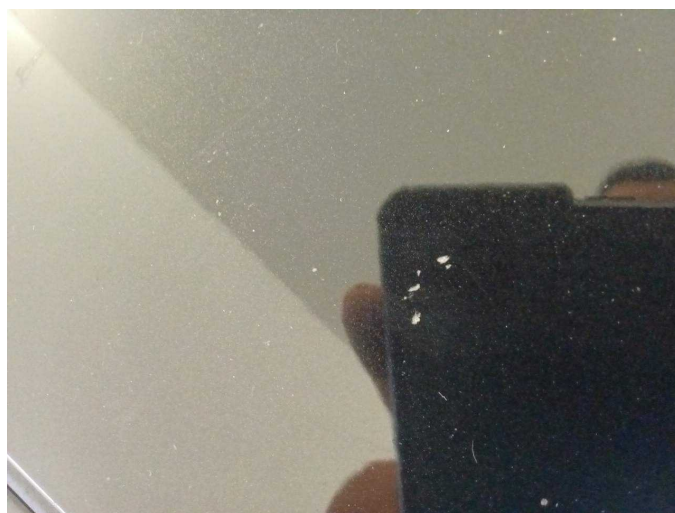
**Damage 9:** Bonnet: Bonnet - Stone chips - Paint

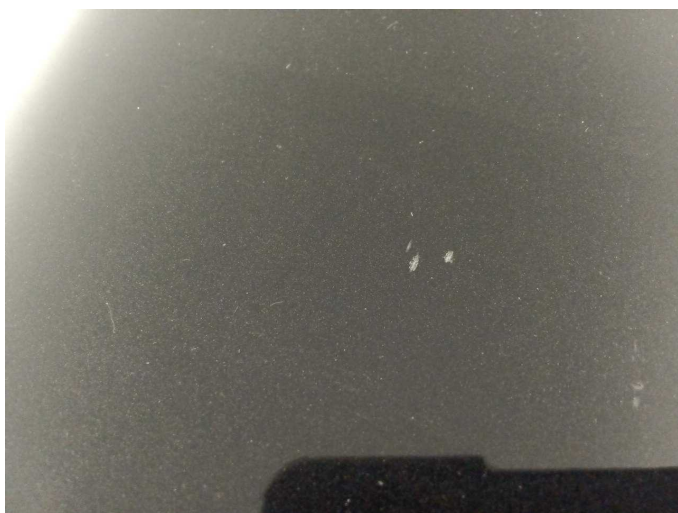
**Damage 9:** Bonnet: Bonnet - Stone chips - Paint

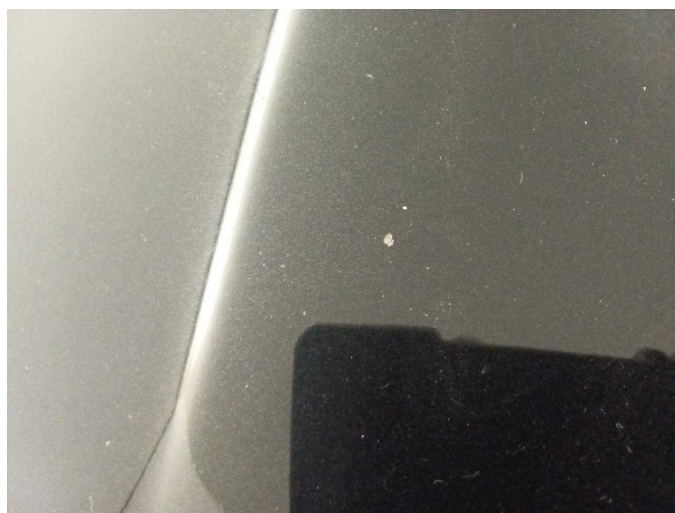
**Damage 9:** Bonnet: Bonnet - Stone chips - Paint

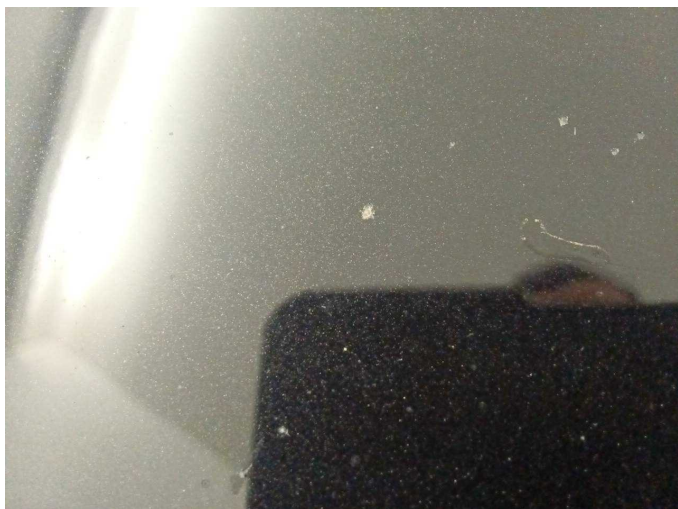
**Damage 9:** Bonnet: Bonnet - Stone chips - Paint

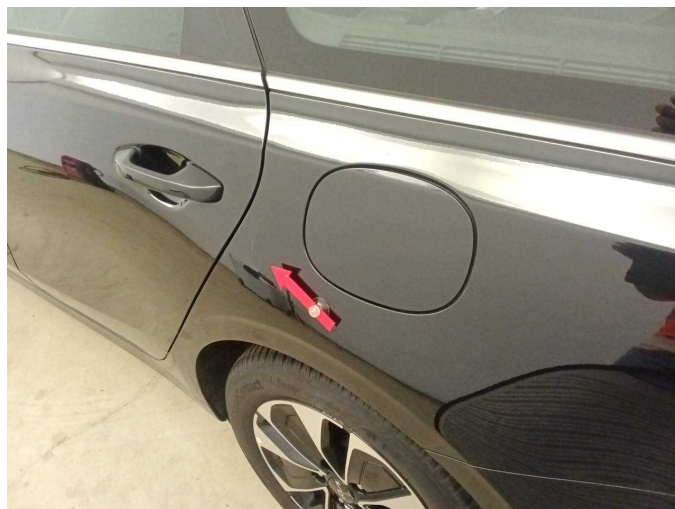
| No. | Component group | Description |
|---|---|---|
| 10 | Side panel - rear left side | Side panel - Dent / paintcoat damage - Repair and paint |

**Damage 10:** Side panel - rear left side: Side panel - Dent / paintcoat damage - Repair and paint

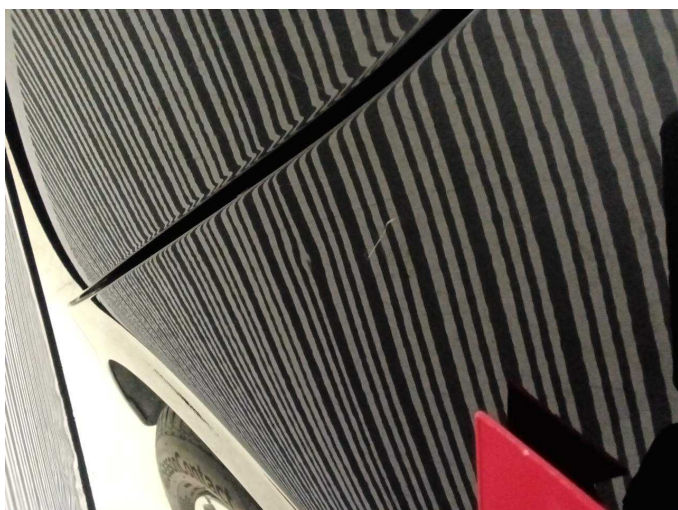
**Damage 10:** Side panel - rear left side: Side panel - Dent / paintcoat damage - Repair and paint

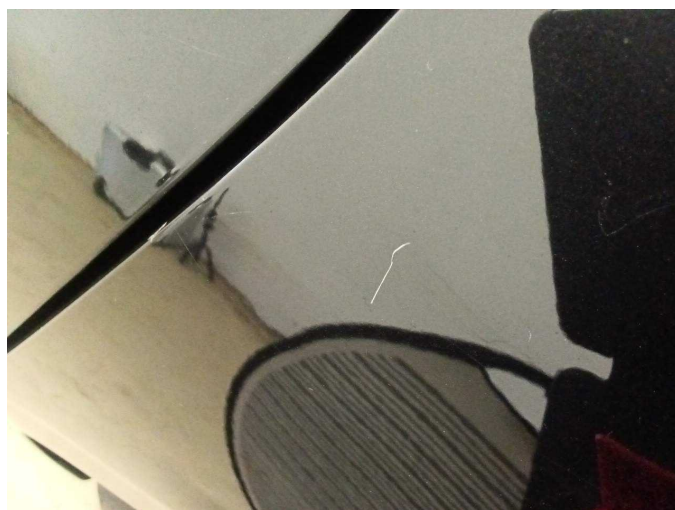
**Damage 10:** Side panel - rear left side: Side panel - Dent / paintcoat damage - Repair and paint

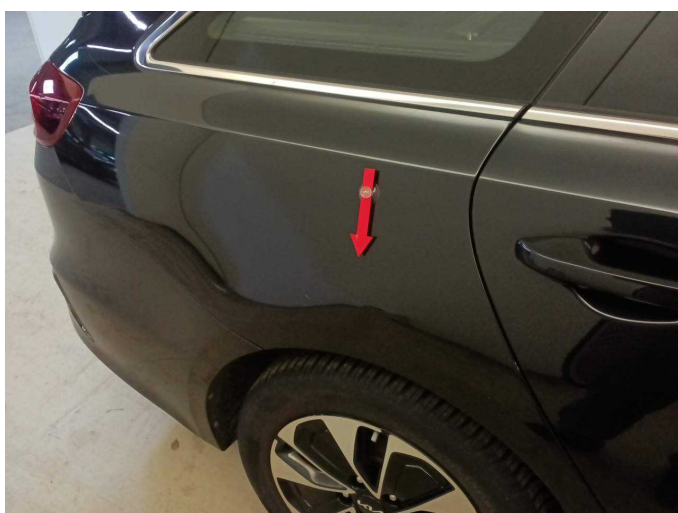
| No. | Component group | Description |
|---|---|---|
| 11 | Side panel - rear right side | Side panel - Dent / paintcoat damage - Repair and paint |

**Damage 11:** Side panel - rear right side: Side panel - Dent / paintcoat damage - Repair and paint

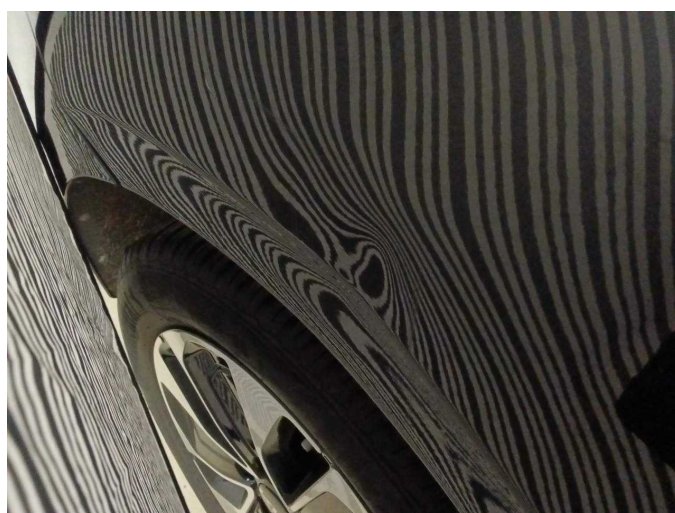
**Damage 11:** Side panel - rear right side: Side panel - Dent / paintcoat damage - Repair and paint

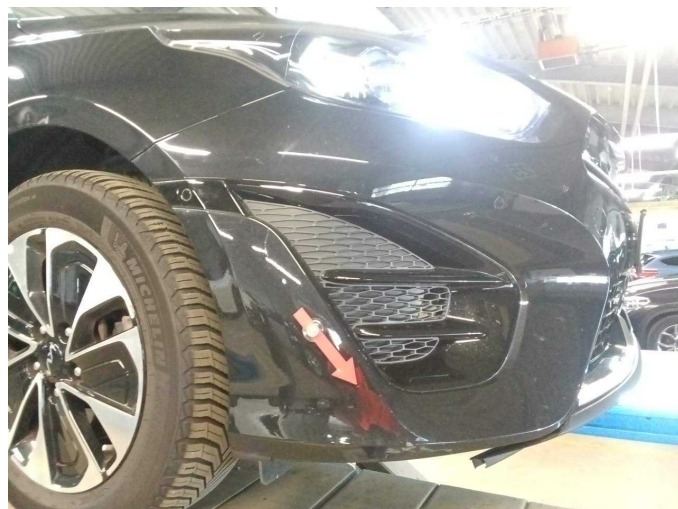
| No. | Component group | Description |
|---|---|---|
| 12 | Front bumper | Front bumper - Broken / torn - Replace |

**Damage 12:** Front bumper: Front bumper - Broken / torn - Replace

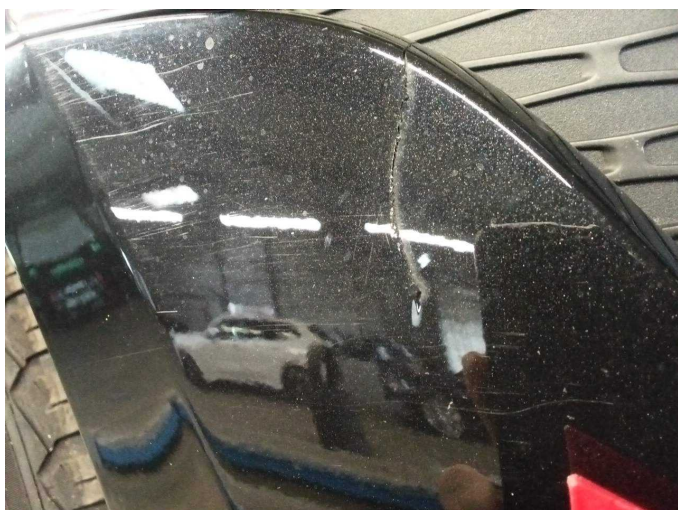
**Damage 12:** Front bumper: Front bumper - Broken / torn - Replace

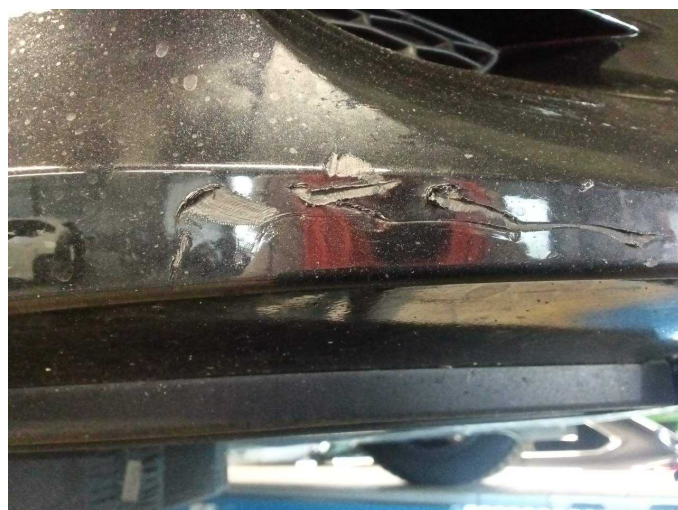
**Damage 12:** Front bumper: Front bumper - Broken / torn - Replace

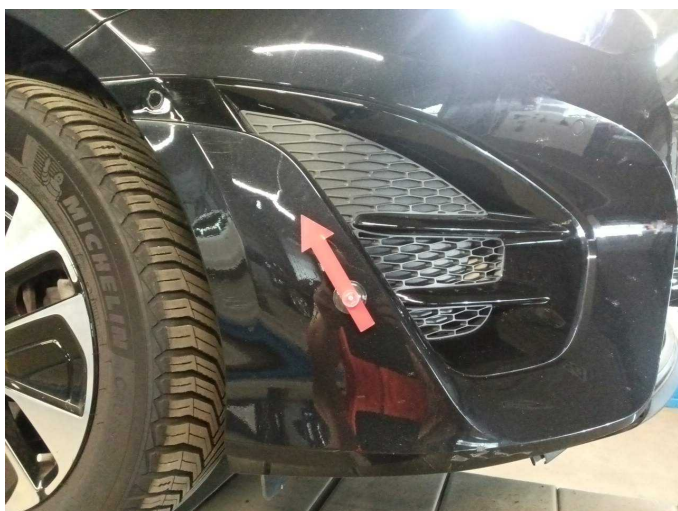
**Damage 12:** Front bumper: Front bumper - Broken / torn - Replace

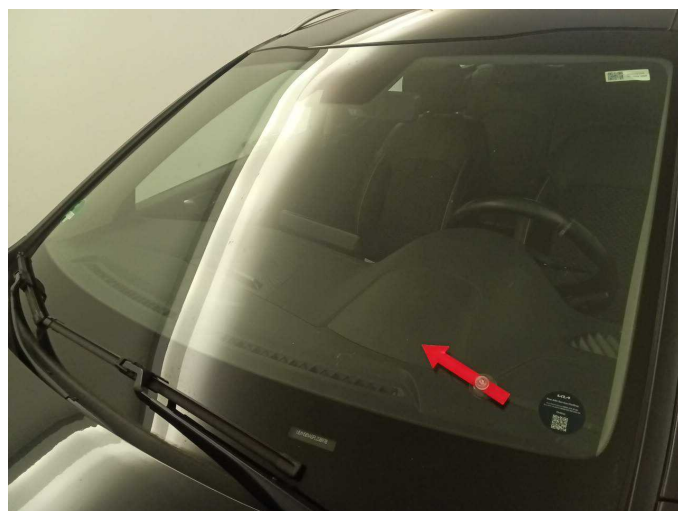
| No. | Component group | Description |
|---|---|---|
| 1 | Vehicle glazing | Windscreen - Stone chips - No deduction |

**Wear and tear 1:** Vehicle glazing: Windscreen - Stone chips - No deduction

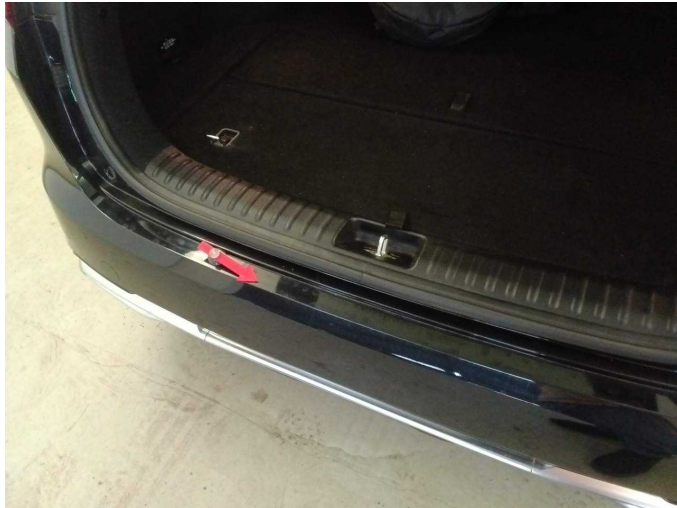
| No. | Component group | Description |
|---|---|---|
| 2 | Rear bumper | Rear bumper - Scratch(es) - No deduction |

**Wear and tear 2:** Rear bumper: Rear bumper - Scratch(es) - No deduction

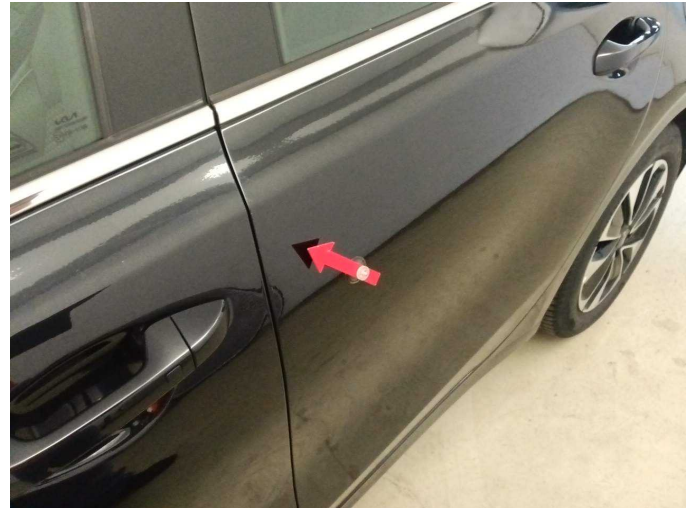
| No. | Component group | Description |
|---|---|---|
| 3 | Door - rear left side | Door - Scratch(es) - No deduction |

**Wear and tear 3:** Door - rear left side: Door - Scratch(es) - No deduction

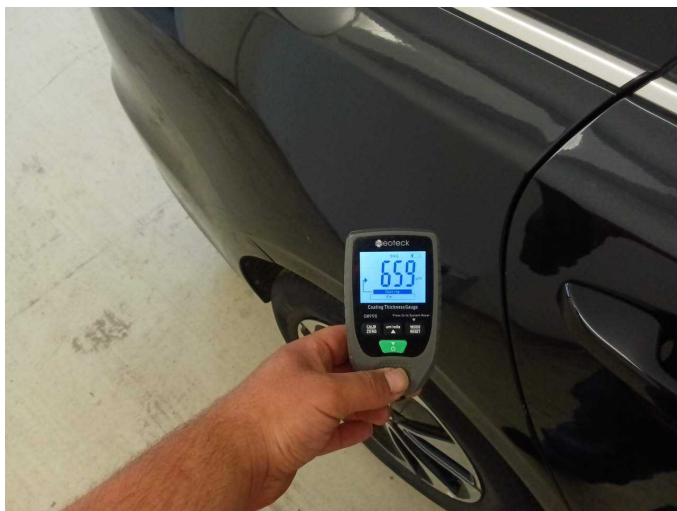
1 Side panel - rear right side, Door - front right side

**Side panel - rear right side:** 659 µm

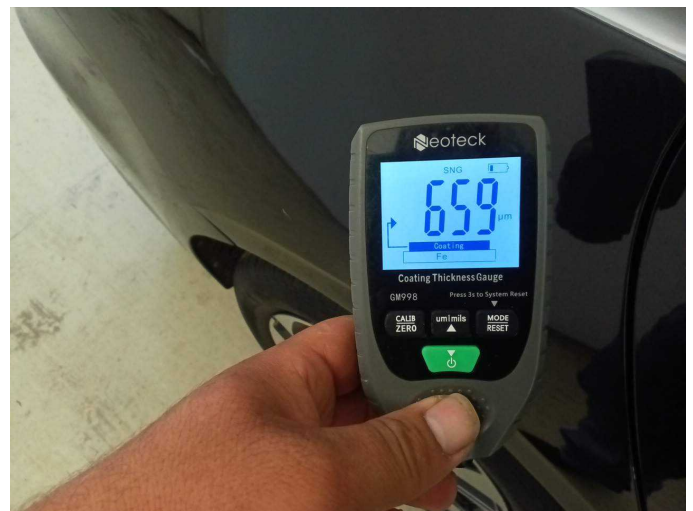
**Side panel - rear right side:** 659 µm

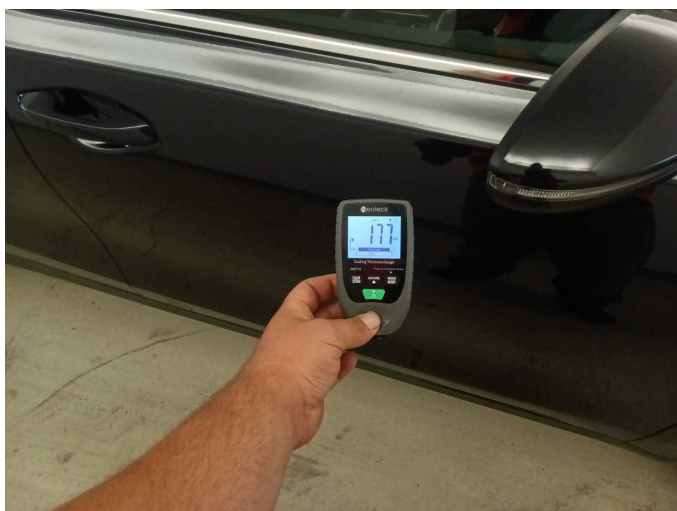
**Door - front right side:** 177 µm

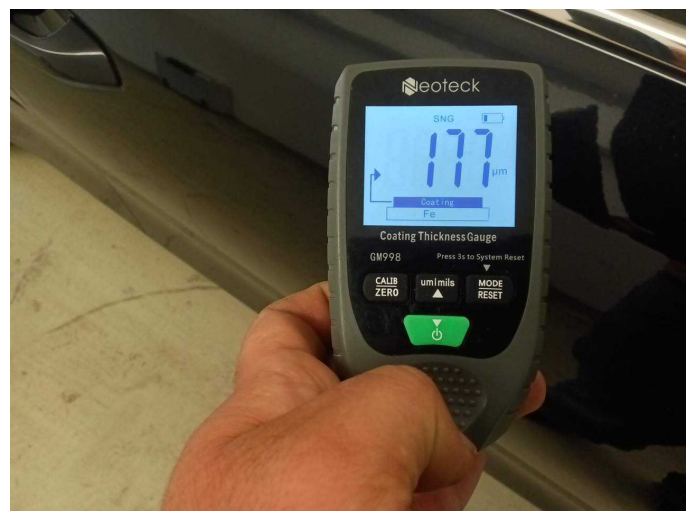
**Door - front right side:** 177 µm
