## Expertise

Protocol number: 46238637  
Order No. / Reference: 26350006  
Inspection date: 26 Jun 2026

Manufacturer: Ford

Model: e-Transit 350 L3H3 Lkw HA Basis

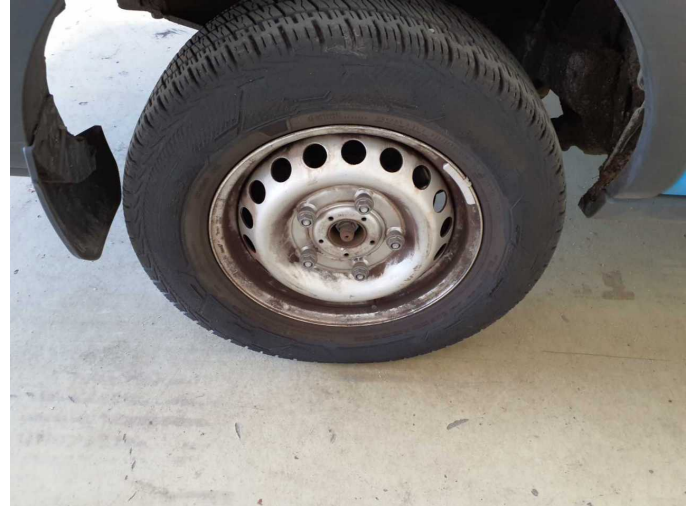
Damage 2: Wheel / tyres: Wheel cover - rear right side - Missing - Replace

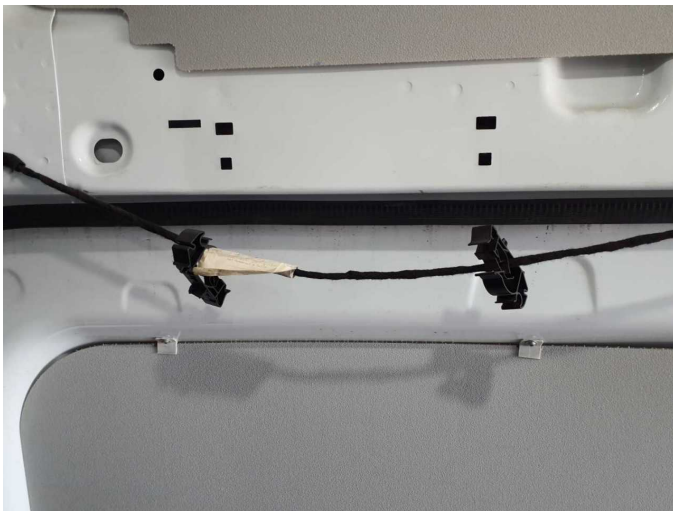
Damage 3: Trim / covers: Trim / covers - Broken / torn - Replace

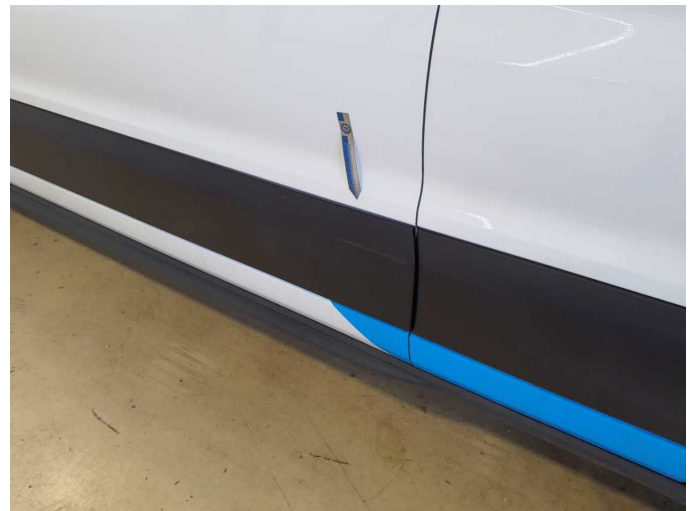
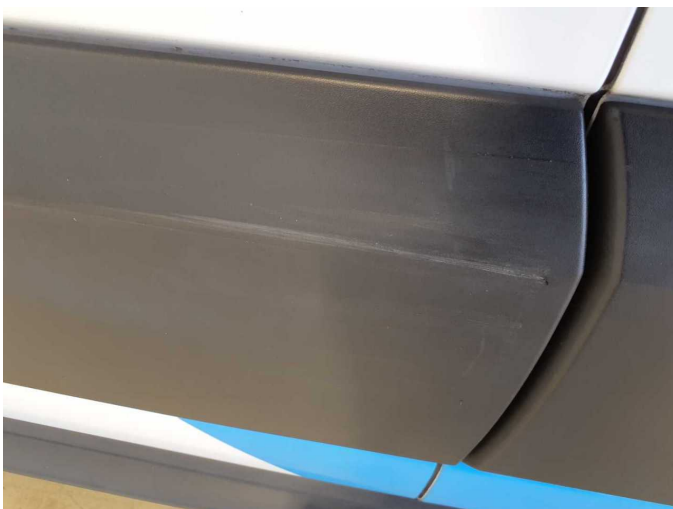
Damage 4: Side panel - rear left side: Brightware - Scratch(es) - Loss in value

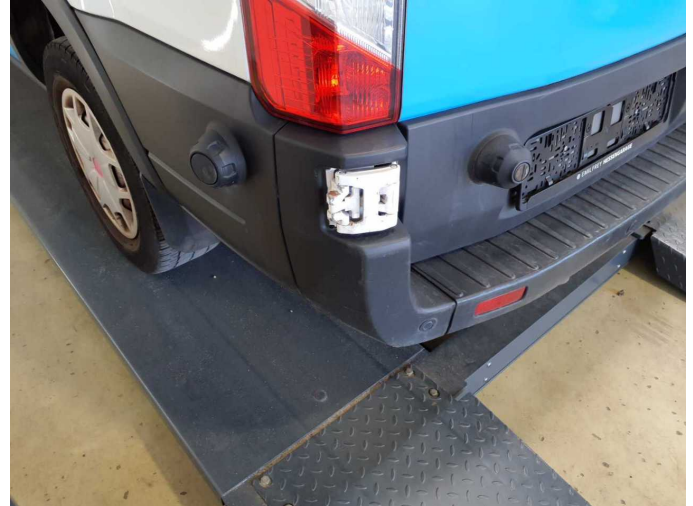
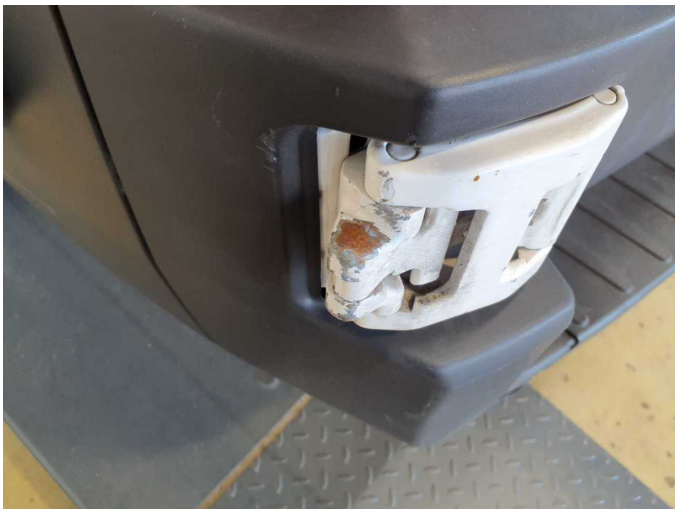
**Damage 6:** Boot lid / rear door: Hinge - Corrosion - Smart repair

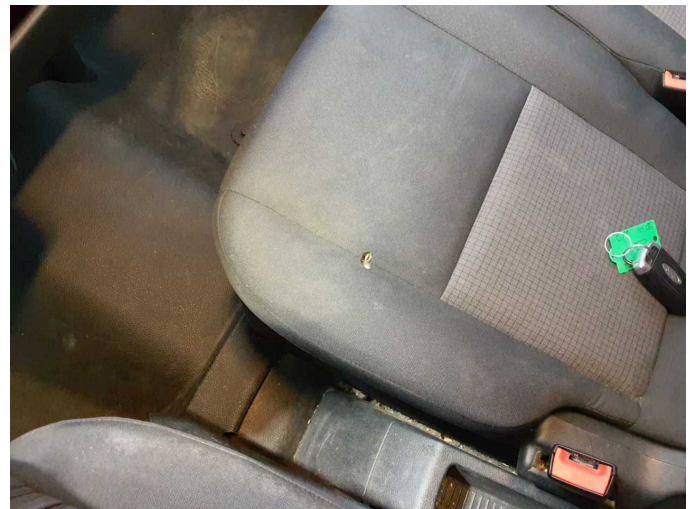
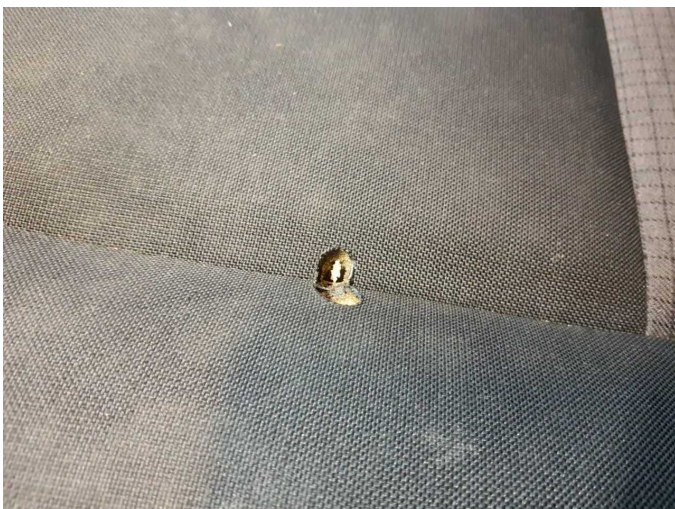
**Damage 7:** Seat - front: Seat cover - right side - Burn hole (cigarettes) - Smart repair

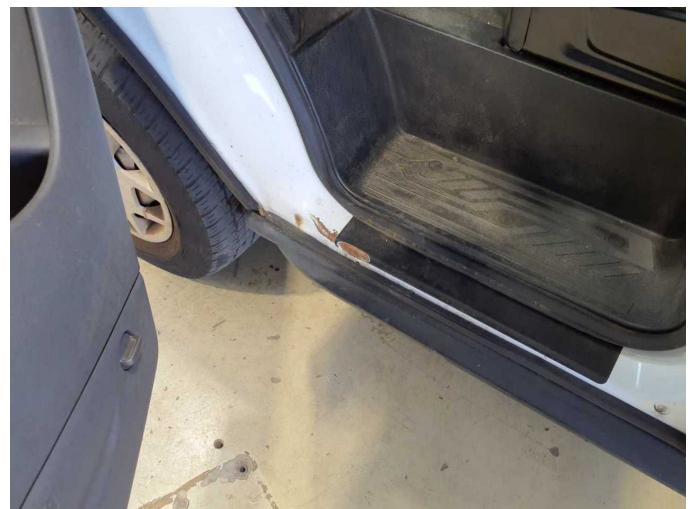
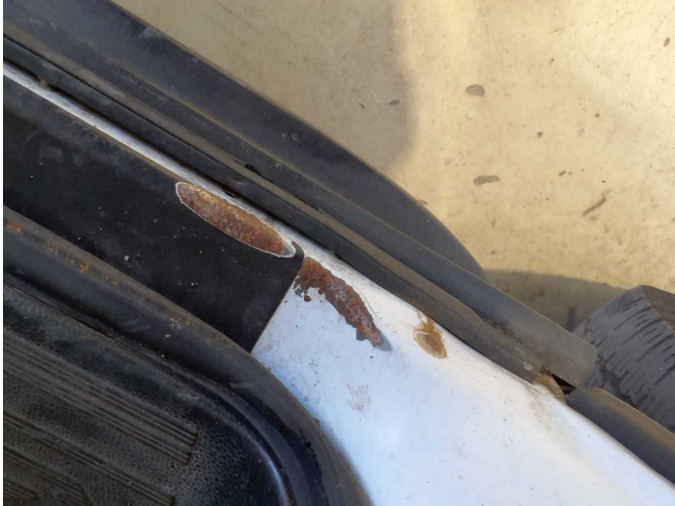
**Damage 8:** Sill - left side: Sill - Corrosion - Smart repair

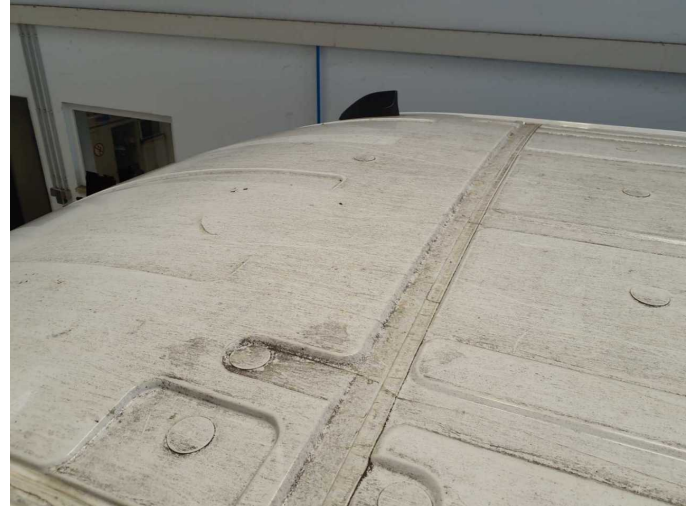
**Damage 9:** Roof: Roof (Mehrkosten möglich) - Soiled - Conditioning

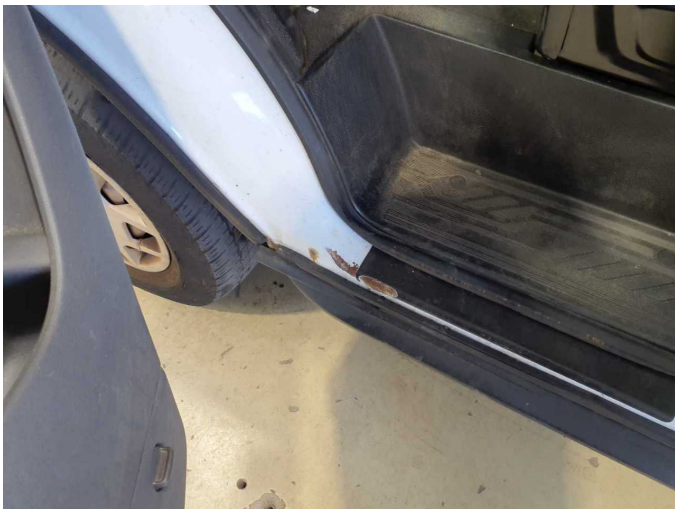
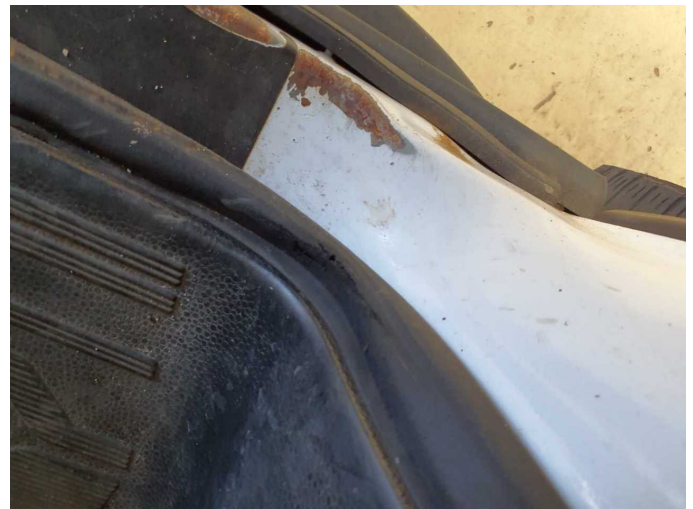
**Damage 10:** Door - front left side: Door seal - Broken / torn - Replace

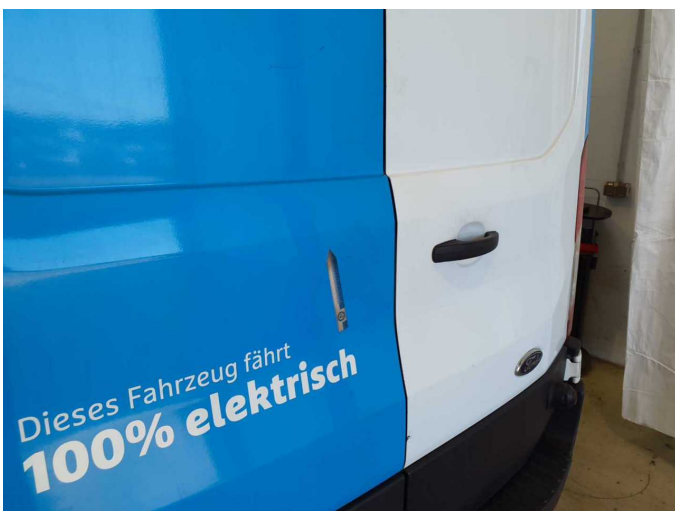
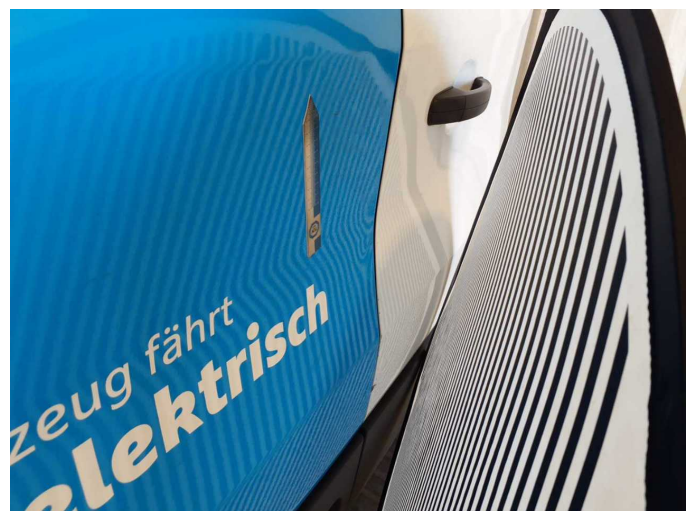
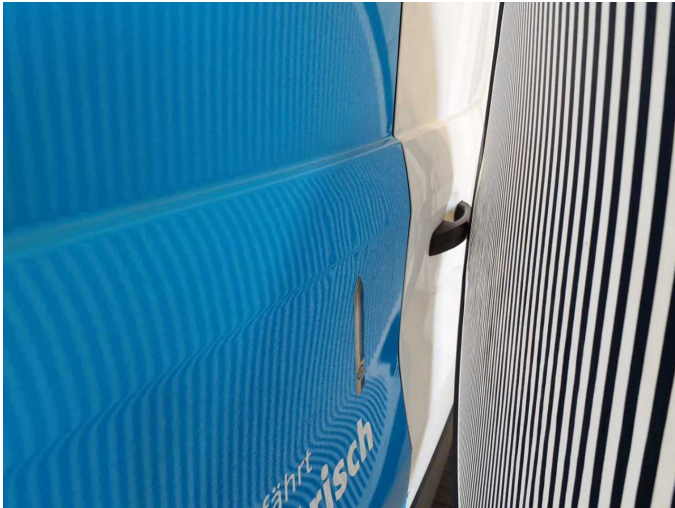
**Damage 11:** Boot lid / rear door: Rear door - left side - dent(s) - Smart repair

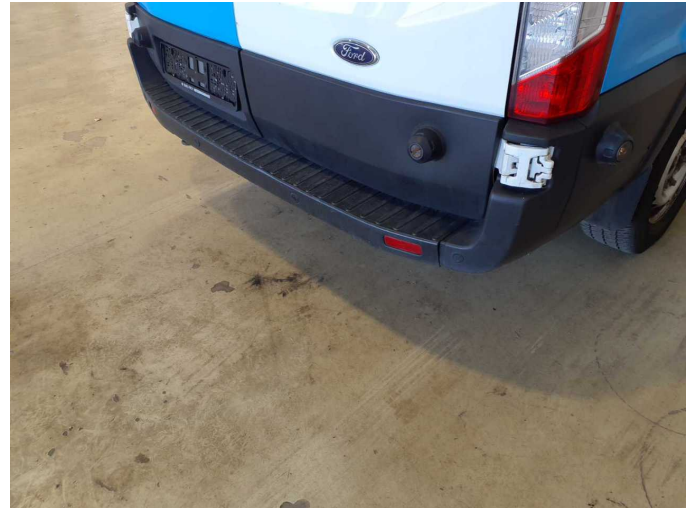
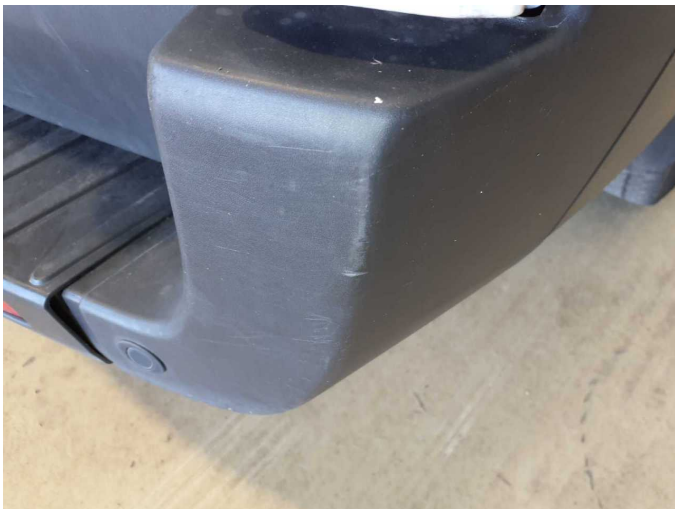
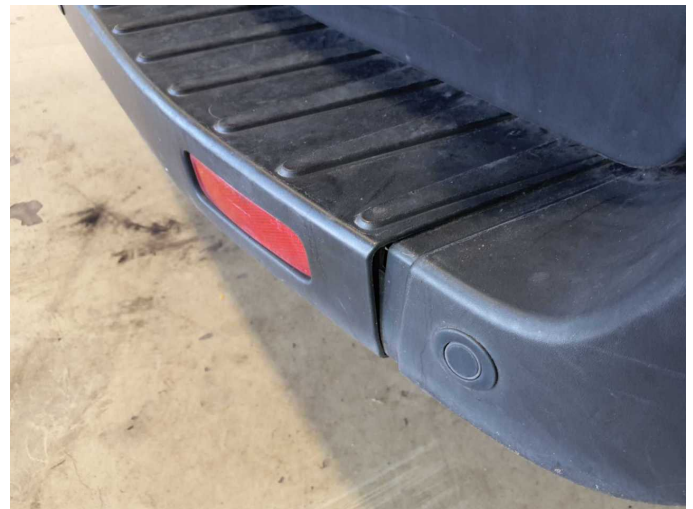
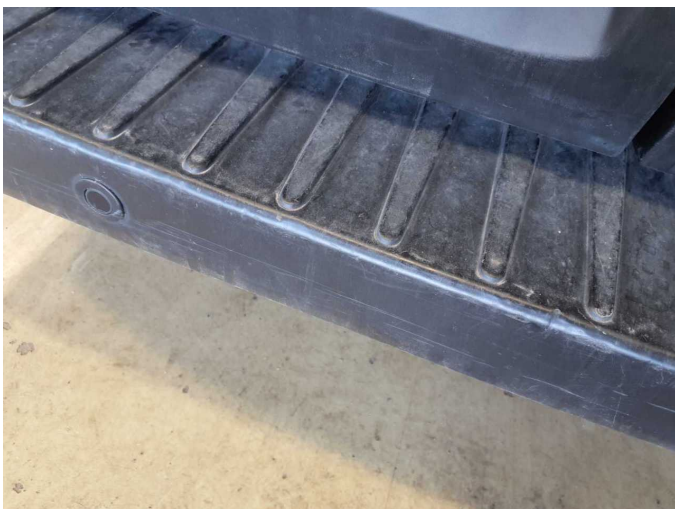
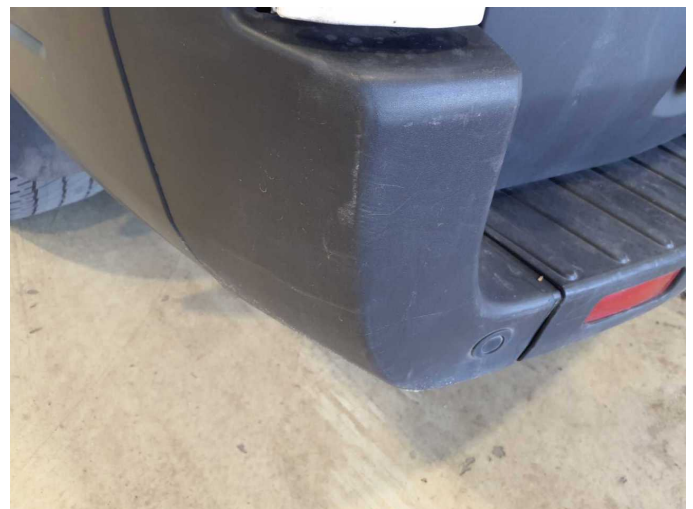
**Damage 12:** Rear bumper: Rear bumper (unpainted) - Scratch(es) - Loss in value

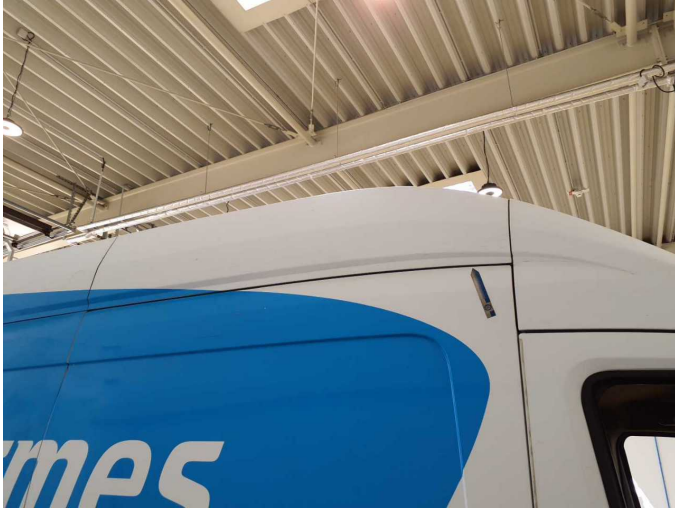
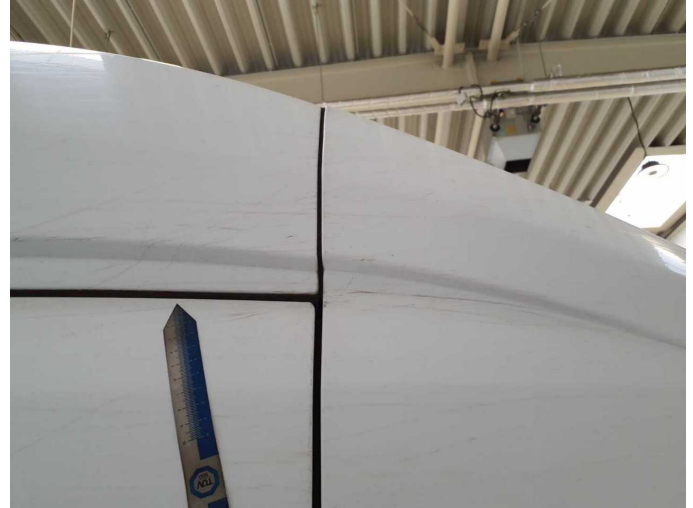
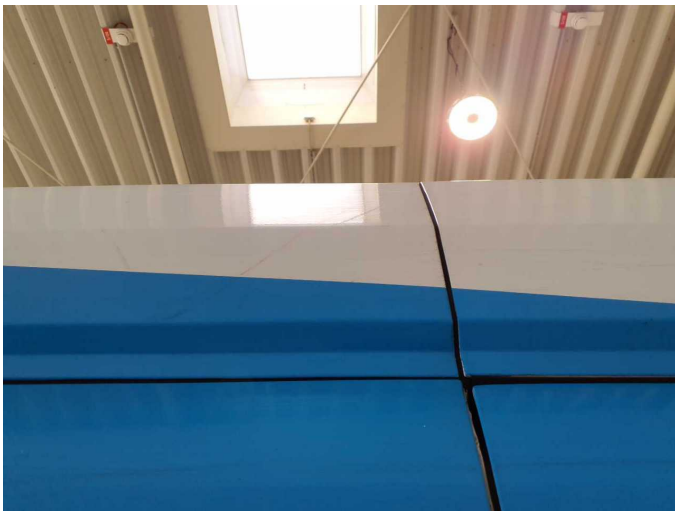
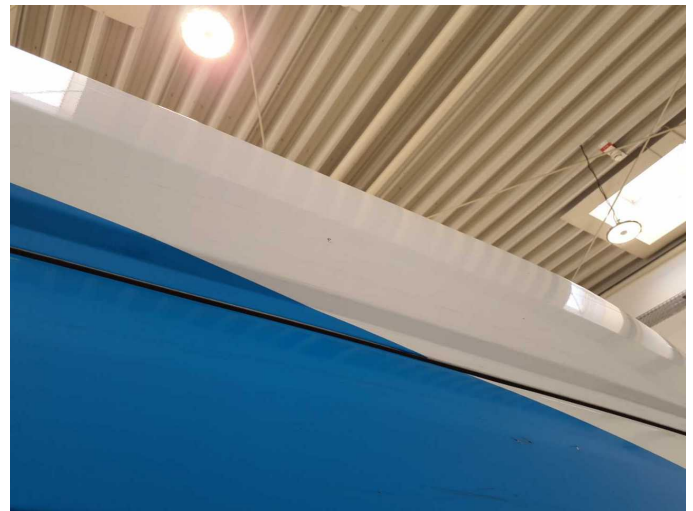
**Damage 13:** Roof: Roof rail - right side - Scratch(es) - Smart repair

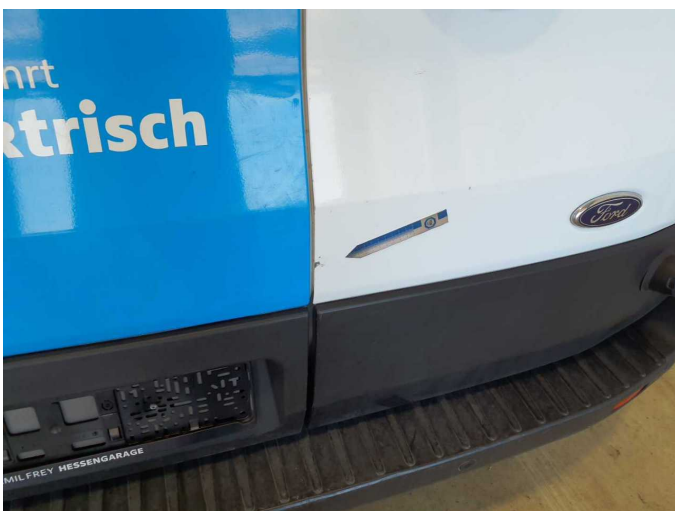
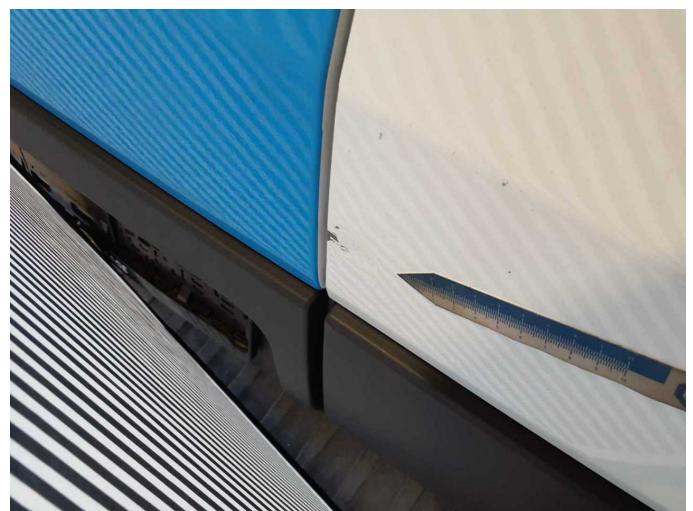
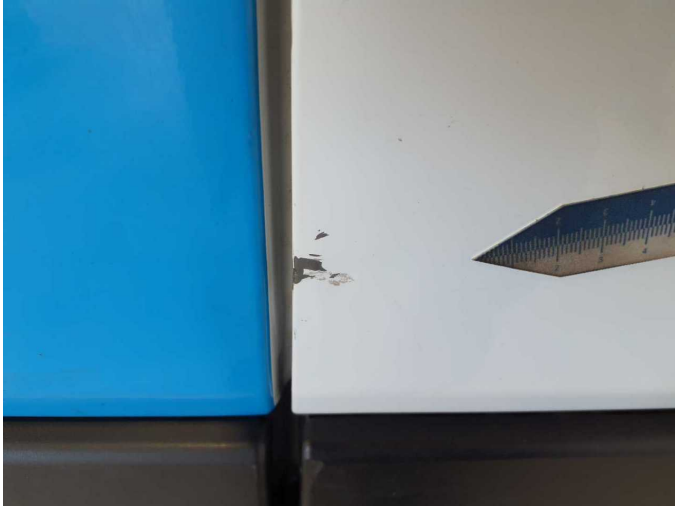
**Damage 14:** Boot lid / rear door: Rear door - right side - Dent / paintcoat damage - Smart repair

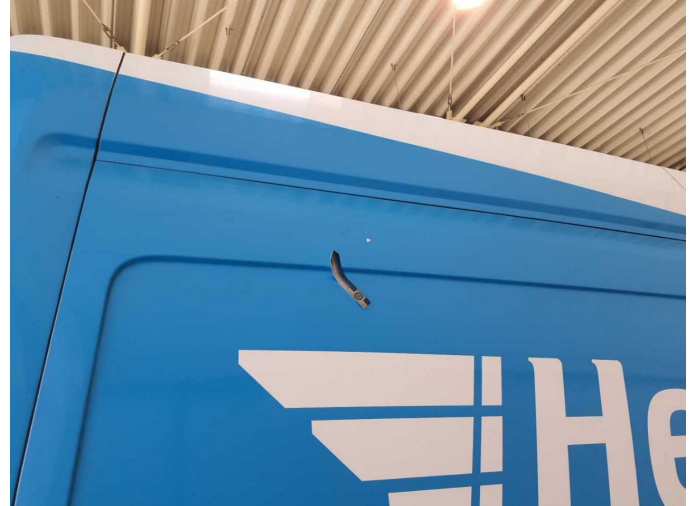
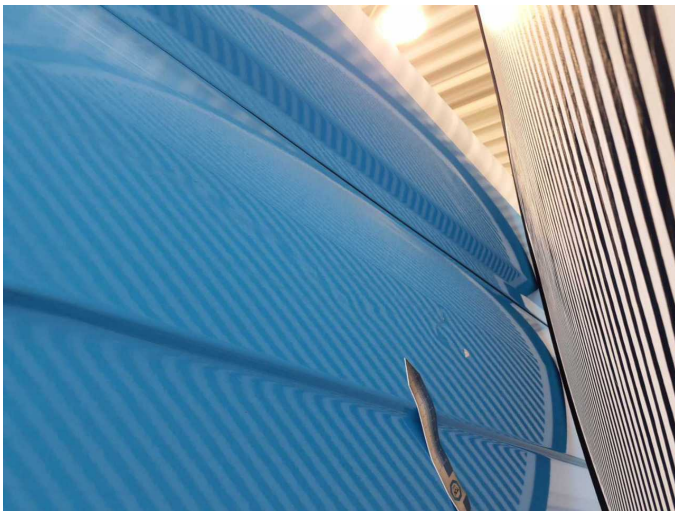
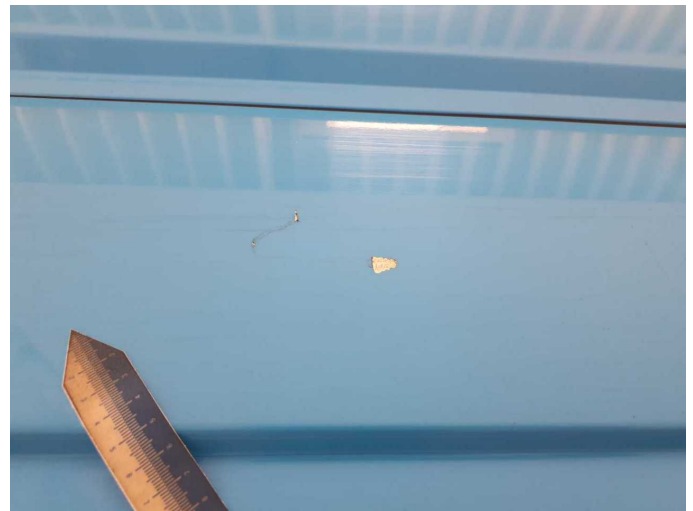
**Damage 15:** Side panel - rear right side: Side panel (Oberhalb) - Dent / paintcoat damage - Smart repair

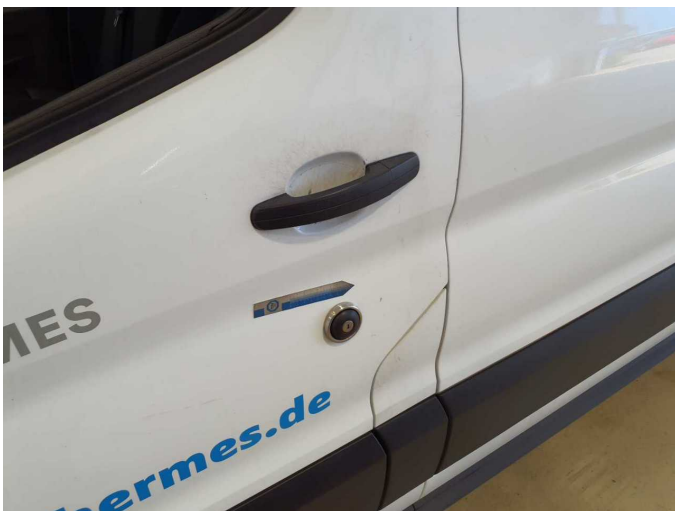
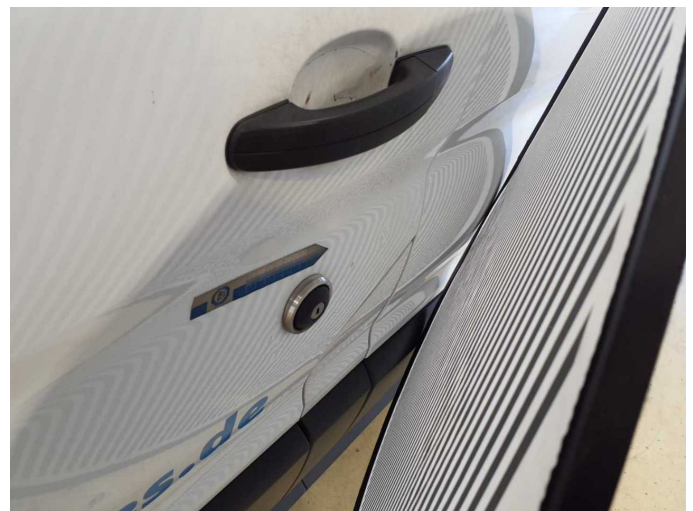
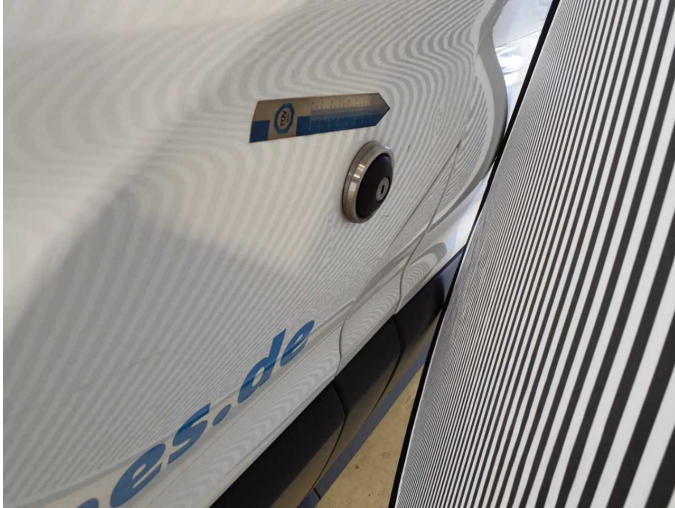
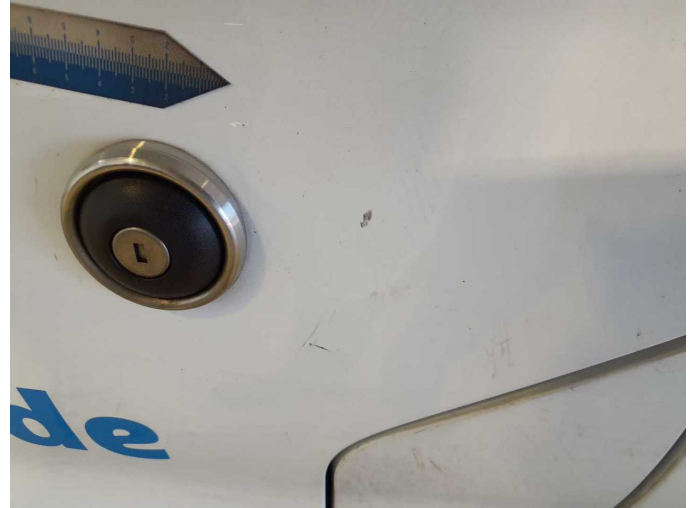
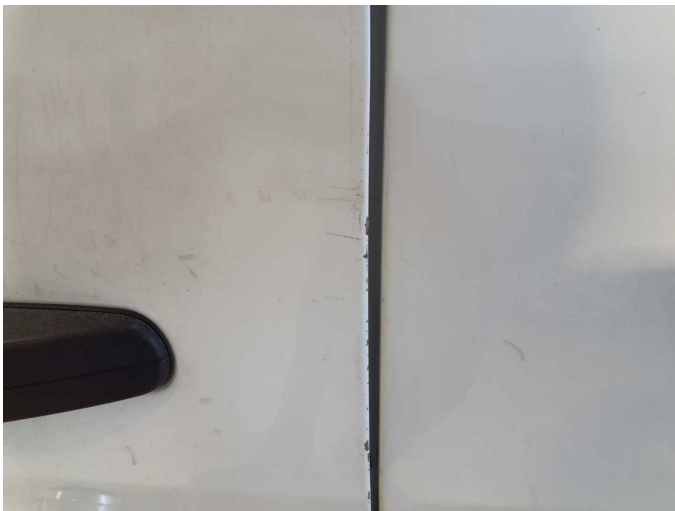
**Damage 16:** Door - front left side: Door (teilweise) - Dent / paintcoat damage - Smart repair

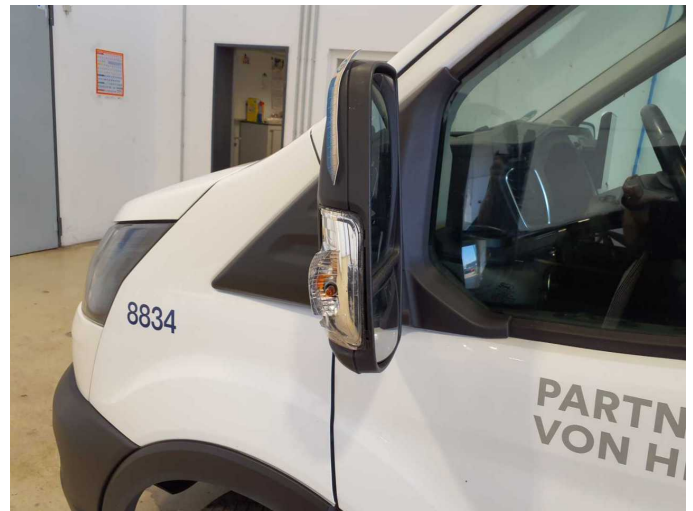
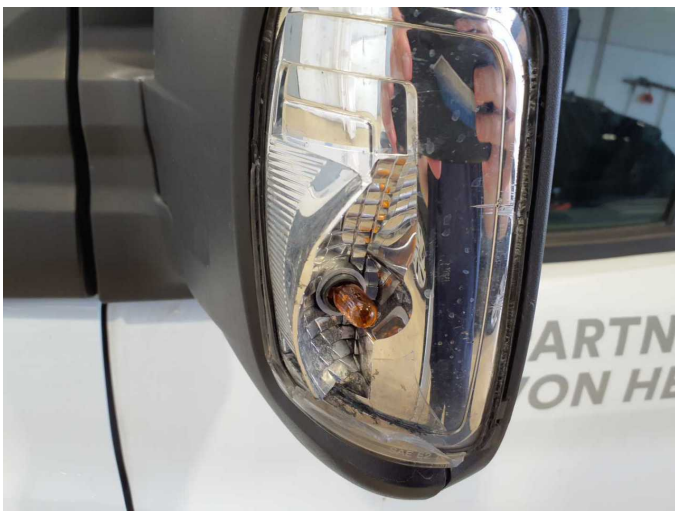
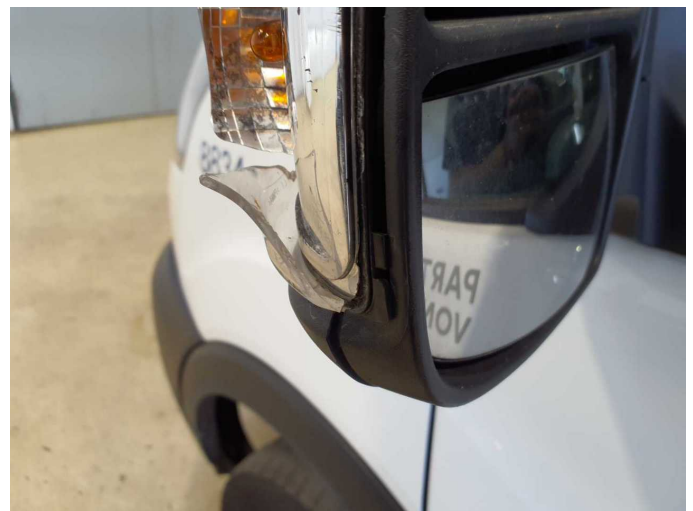
**Damage 17:** Wing mirror - left side: Wing mirror - Broken / torn - Replace

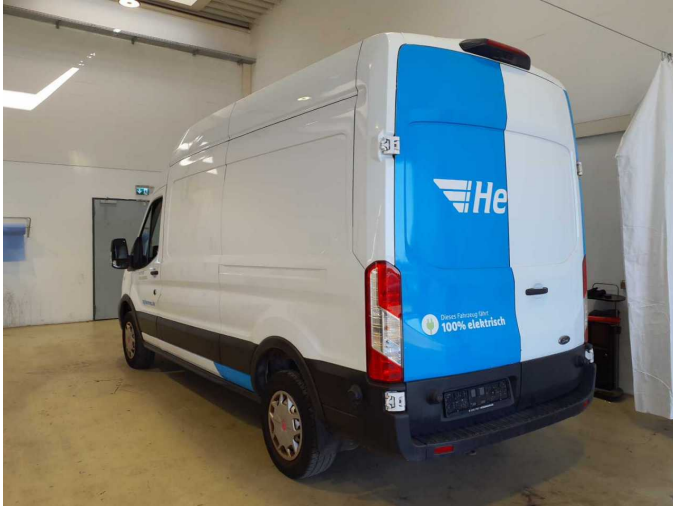
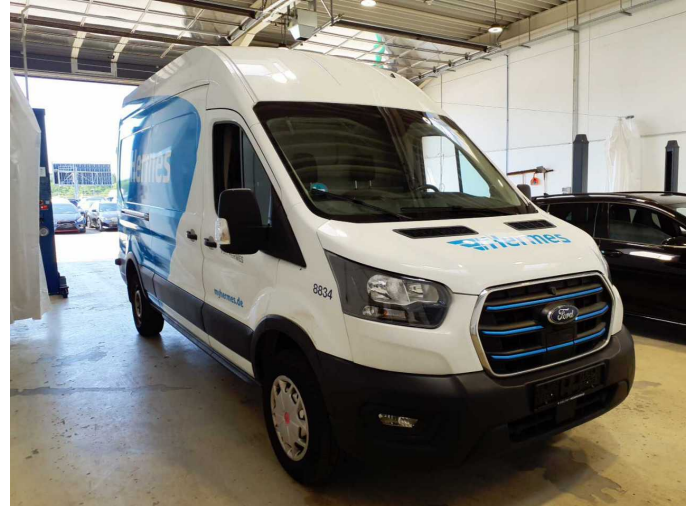
**Damage 18:** Body: Body - Glued / labelled - De-glue / neutralise

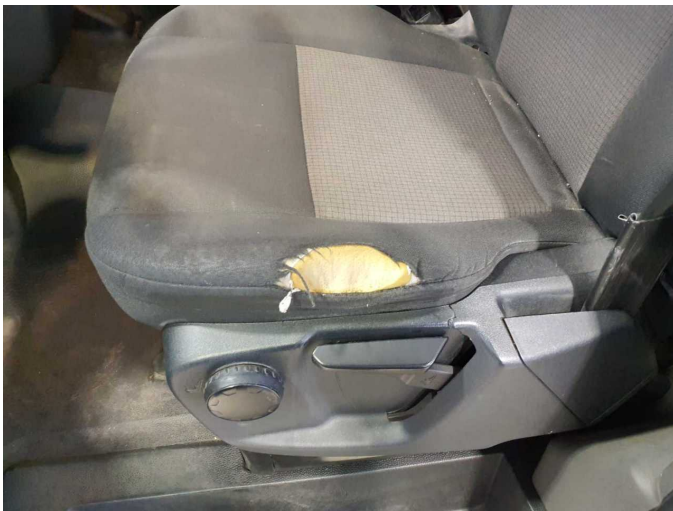
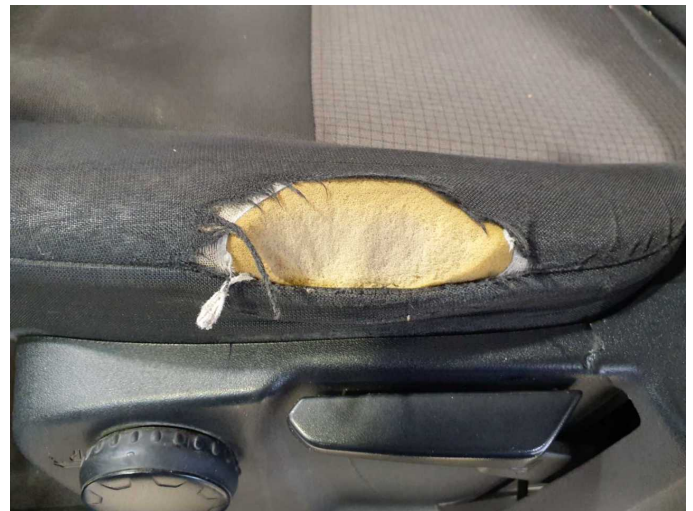
**Damage 19:** Seat - front: Seat cover - left side (+ Polster) - Broken / torn - Replace

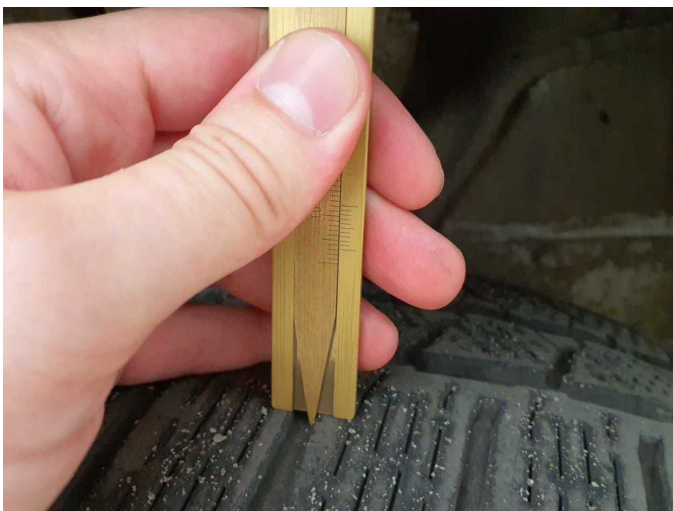
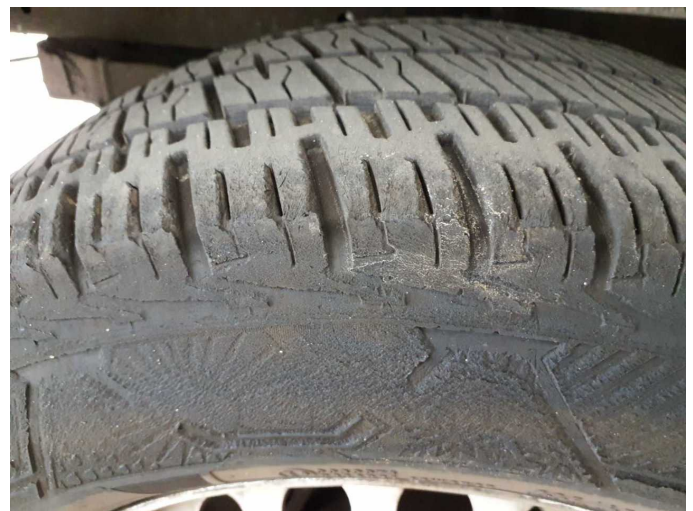
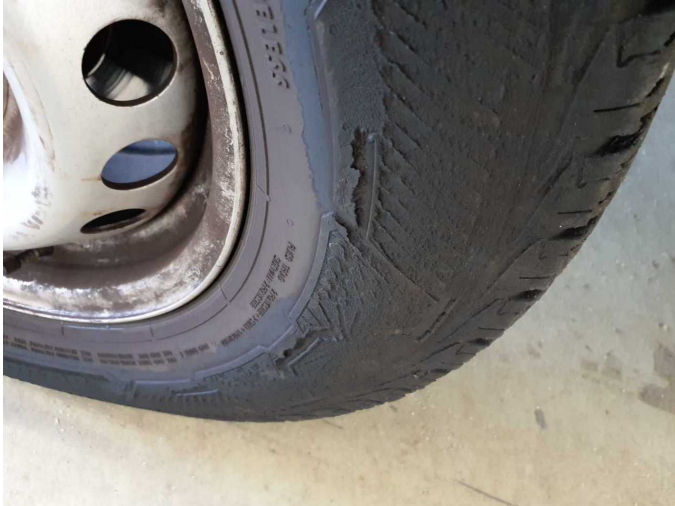
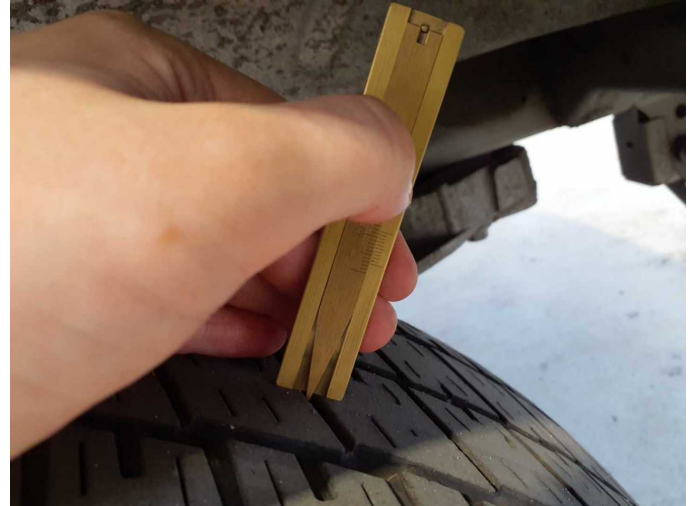
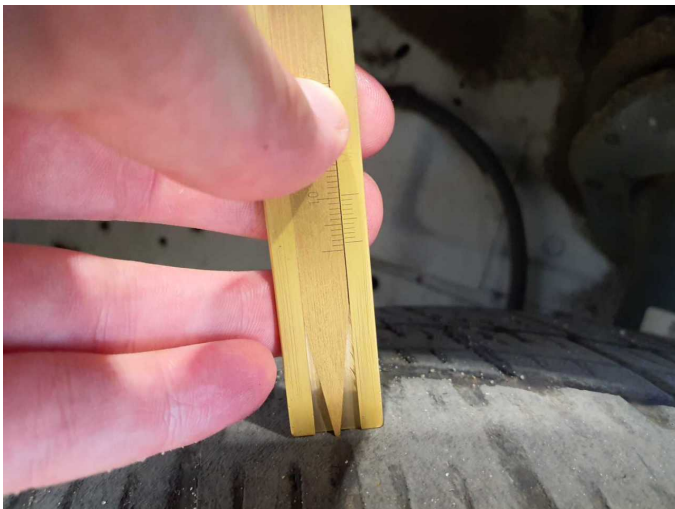
#	Tyre size	Type of tyre	Manufacturer	Tread depth
1)	235/65 R16 121R	All-season tyres on Steel rim with wheel cover	Barum	1mm / 3mm
2)	235/65 R16 121R	All-season tyres on Steel rim with wheel cover	Barum	2mm / 5mm

**Damage 20:** Wheel / tyres: Tyres - complete set (Und porös, nicht fahrbereit) - Does not meet the leasing specifications - Replace

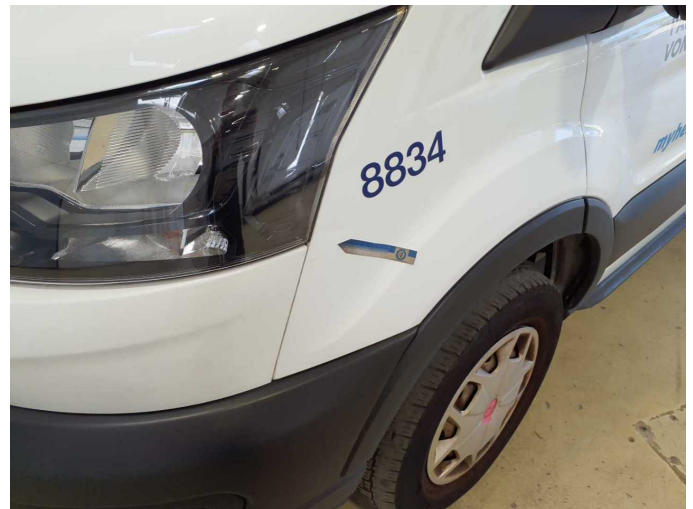
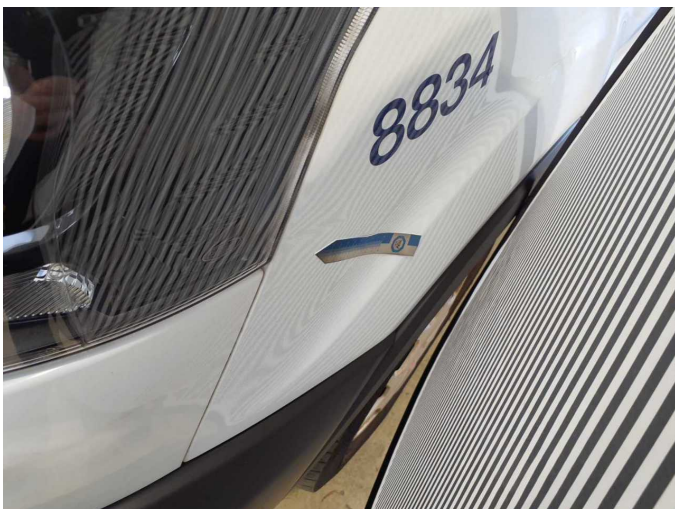
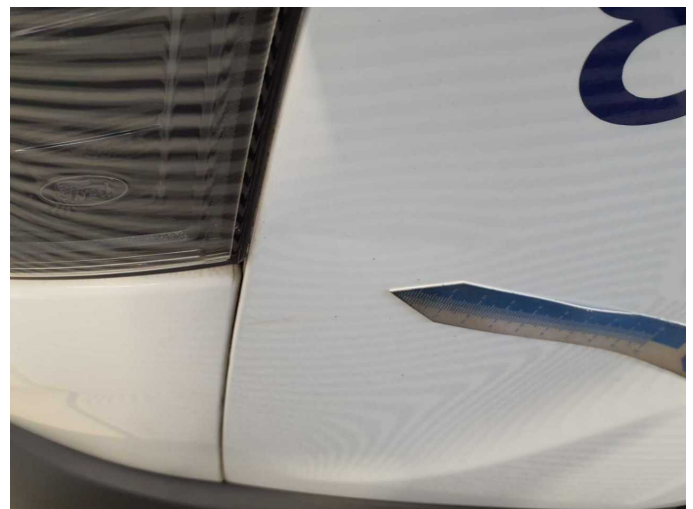
**Damage 21:** Mudguard - left side: Mudguard - left side - Dent / paintcoat damage - Repair and paint

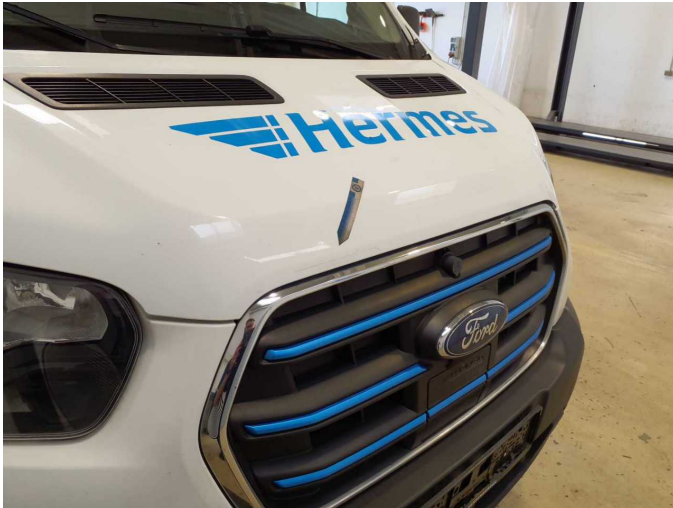
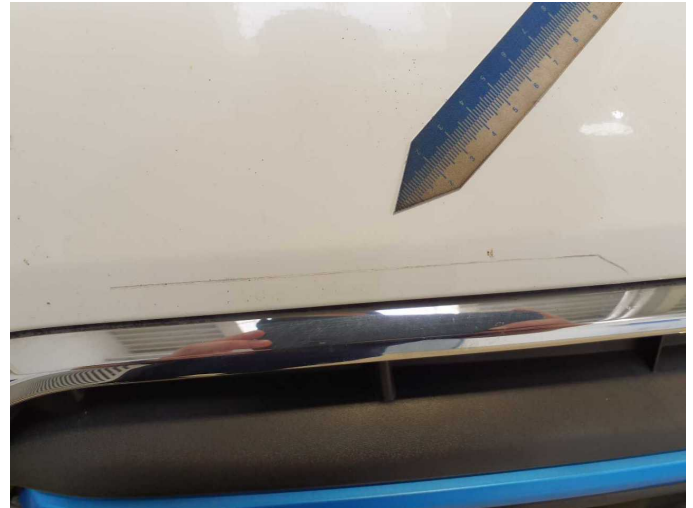
**Damage 22:** Bonnet: Bonnet - Scratch(es) - Paint

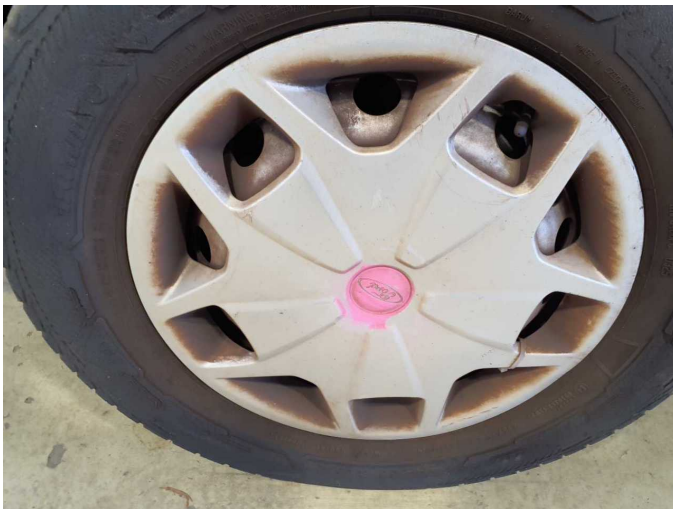
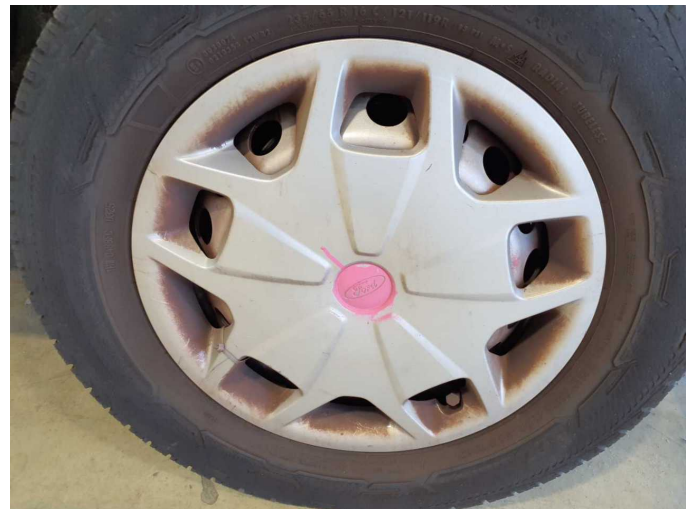
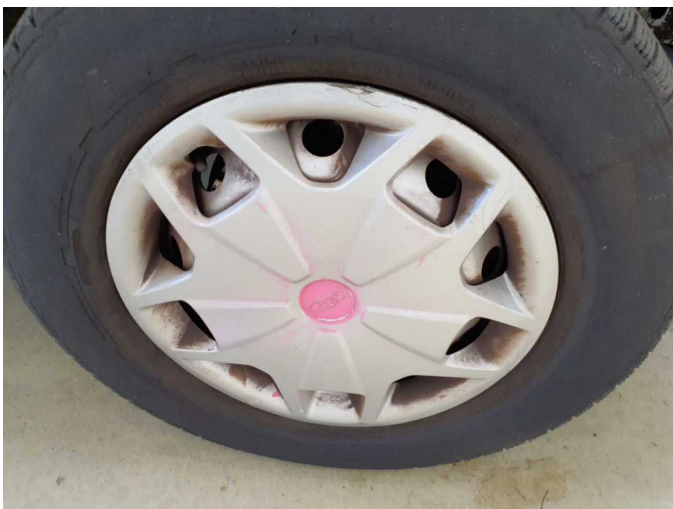
**Wear and tear 4:** Wheel / tyres: Wheel cover set - complete (3x) - Damaged - No deduction

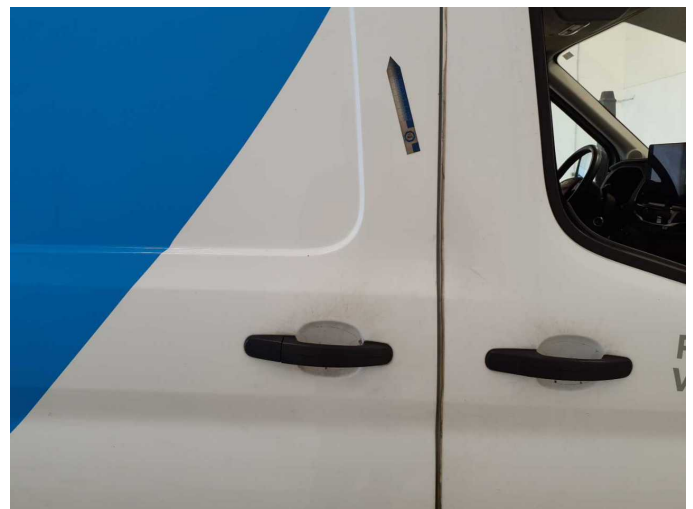
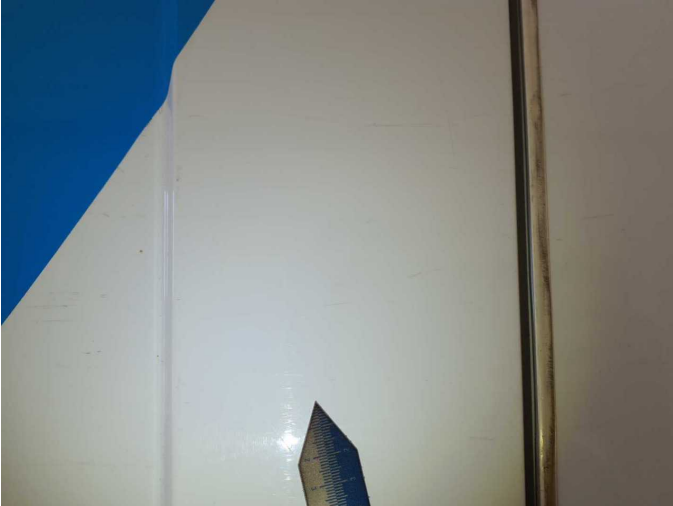
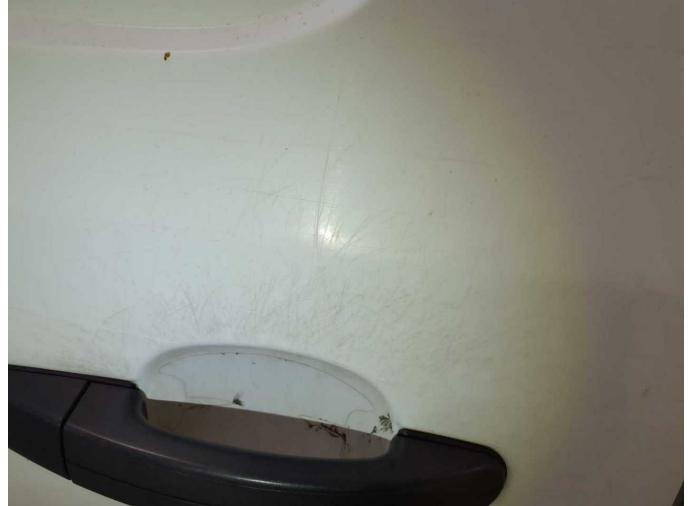
**Wear and tear 5:** Sliding door, right: Sliding door - Scratch(es) - Conditioning

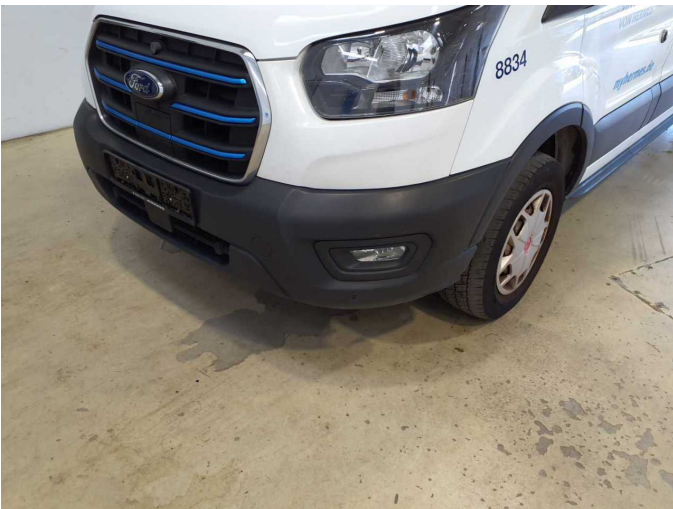
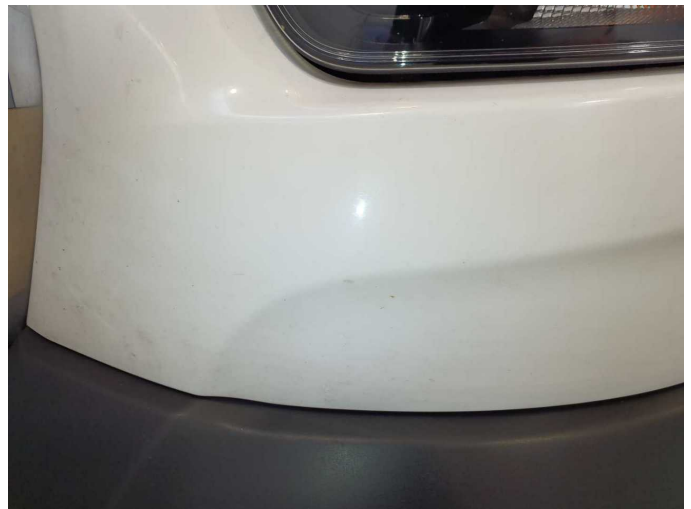
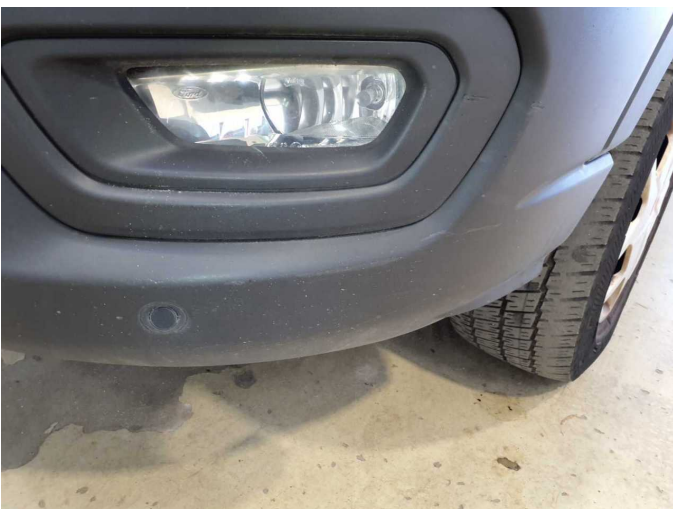
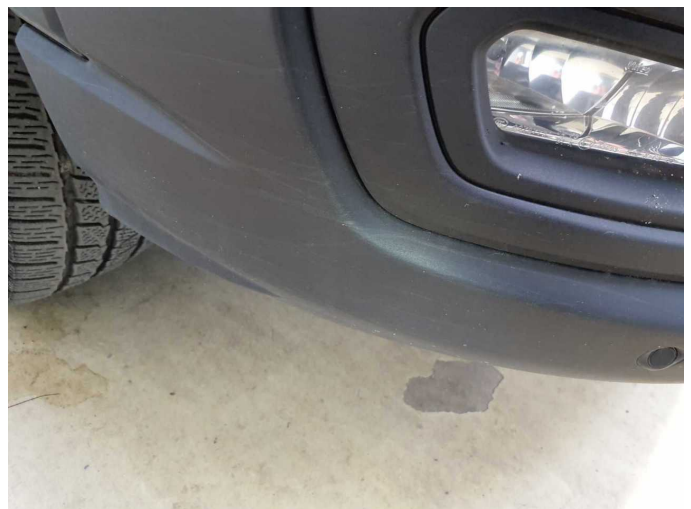
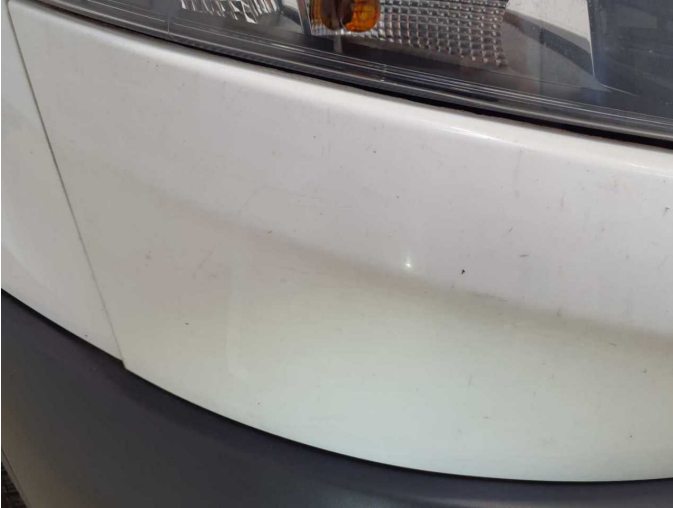
**Wear and tear 6:** Front bumper: Front bumper (im Unfall berücksichtigt) - Scratch(es)

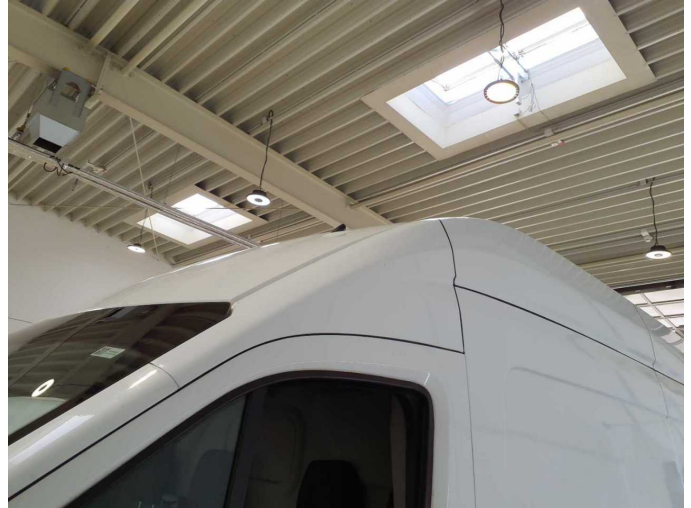
**Missing part 1:** Roof: Stub aerial - Missing - Replace
