## Expertise

Protocol number: 46238637  
Order No. / Reference: 26350006  
Inspection date: 26 Jun 2026

Manufacturer: Ford

Model: e-Transit 350 L3H3 Lkw HA Basis

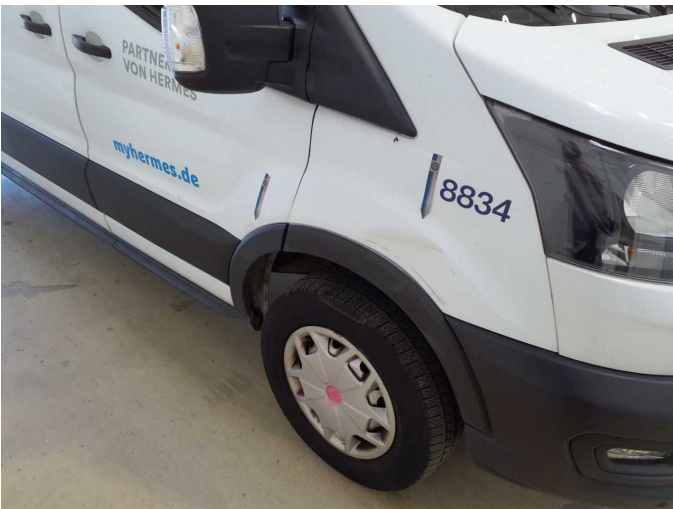
**Accident 1:** Front, Side right
