## Expertise

Protocol number: 46040697  
Order No. / Reference: 26489592  
Inspection date: 19 Jun 2026

Model: Transit Connect 230 L2 LKW S&S Autm. Trend Kombi

VIN: WF07XXWPG7NY79070

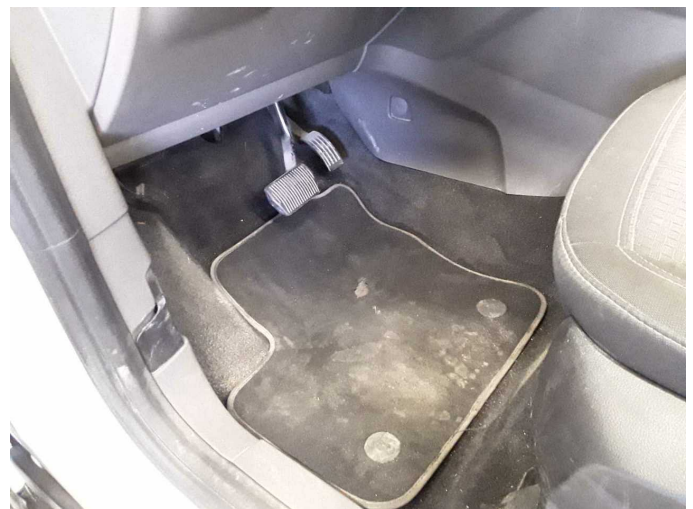
Damage 1: Trim / covers: Floor mats - Damaged - Replace

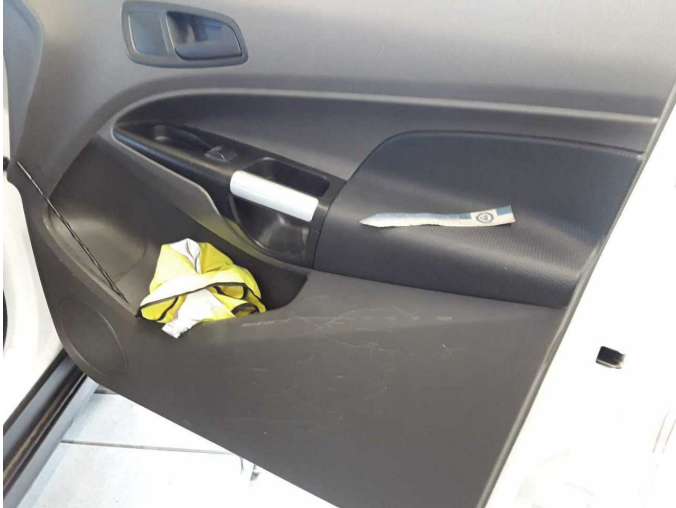
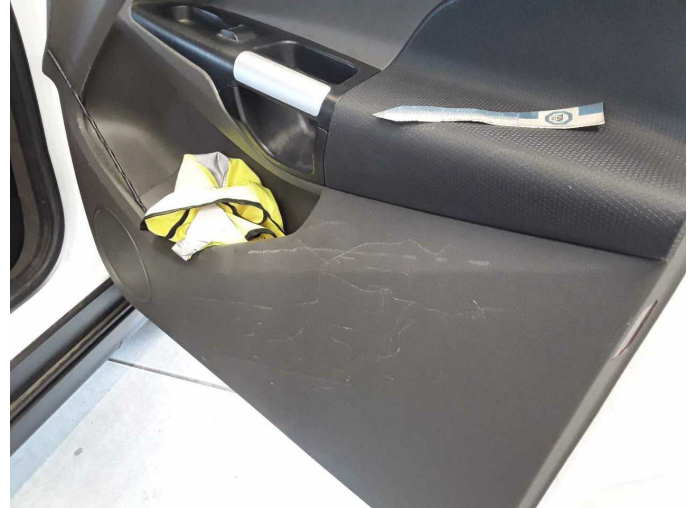
**Damage 2:** Trim / covers: Door trim - front right side - Scratched - Loss in value

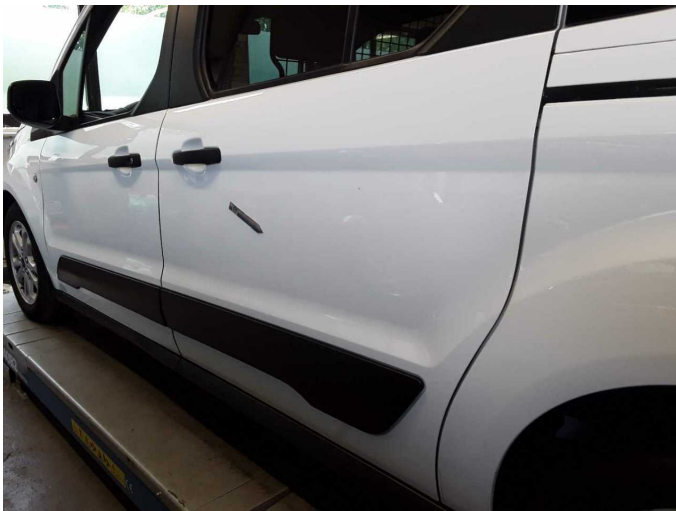
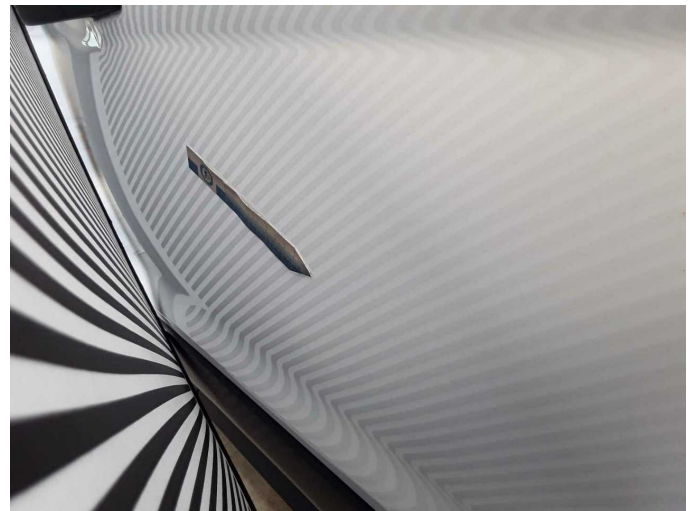
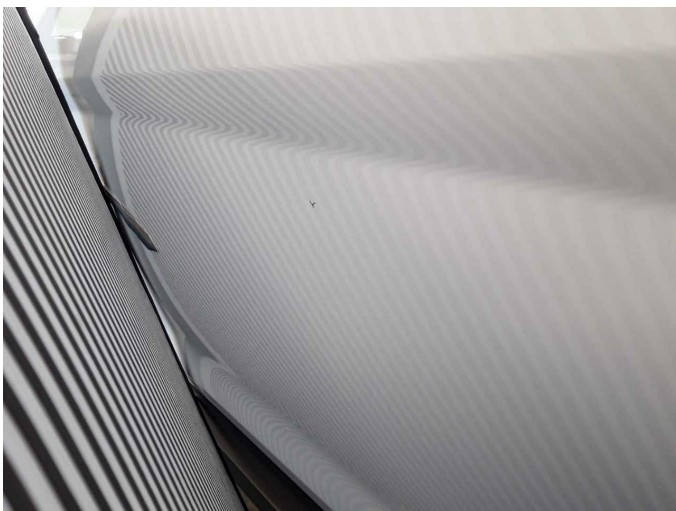
**Damage 3:** Door - rear left side: Door - dent(s) - Smooth repair work

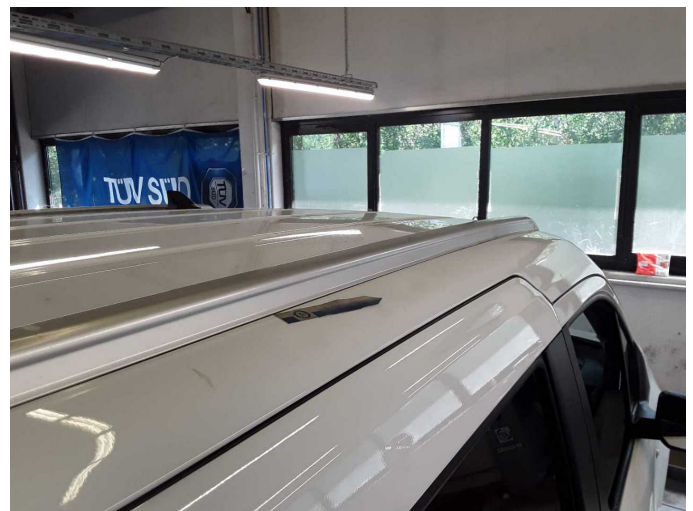
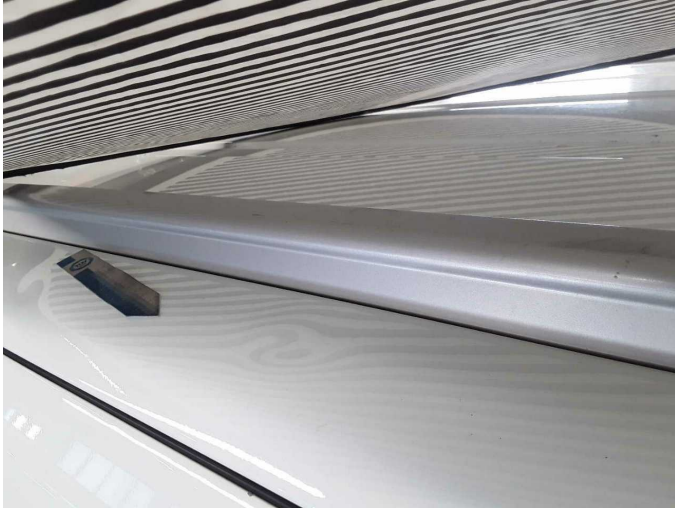
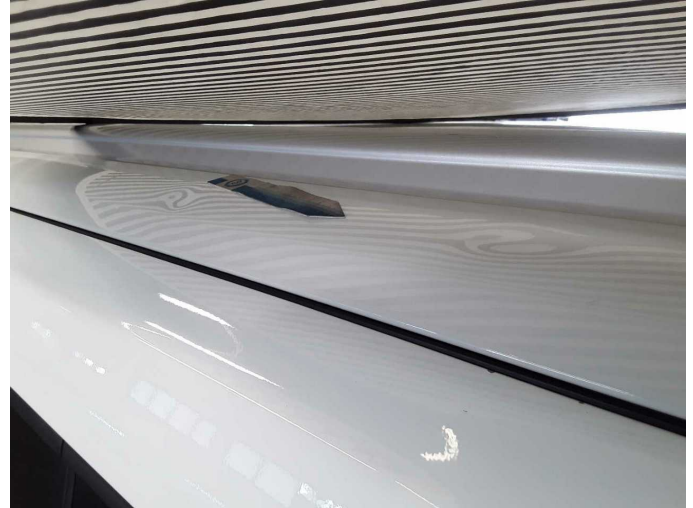
**Damage 4:** Roof: Roof rail - right side - dent(s) - Smart repair

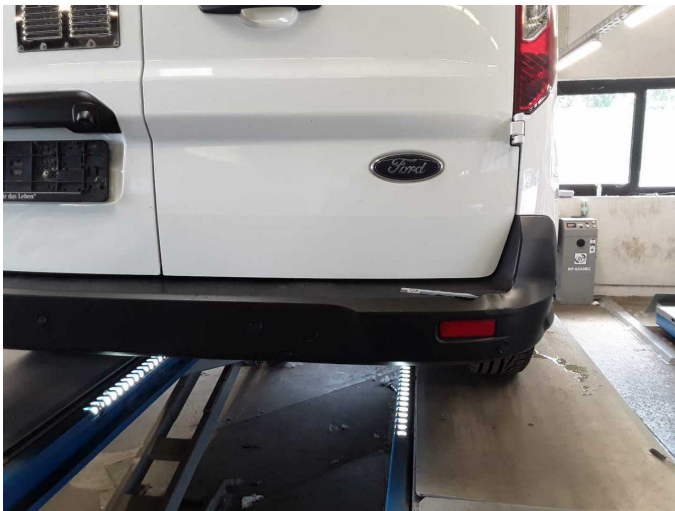
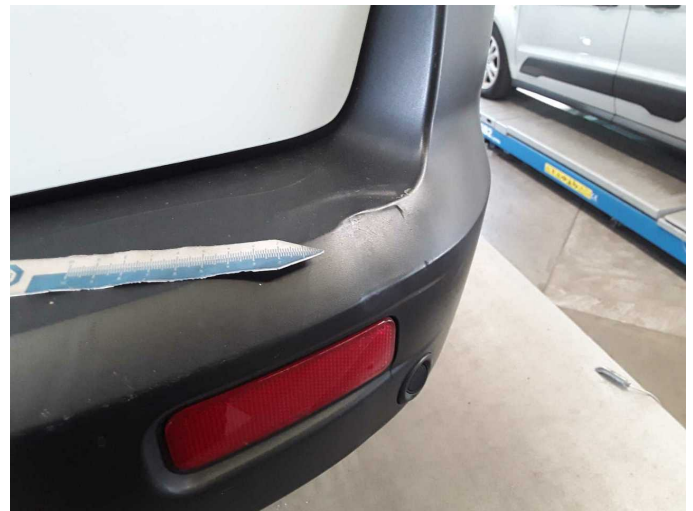
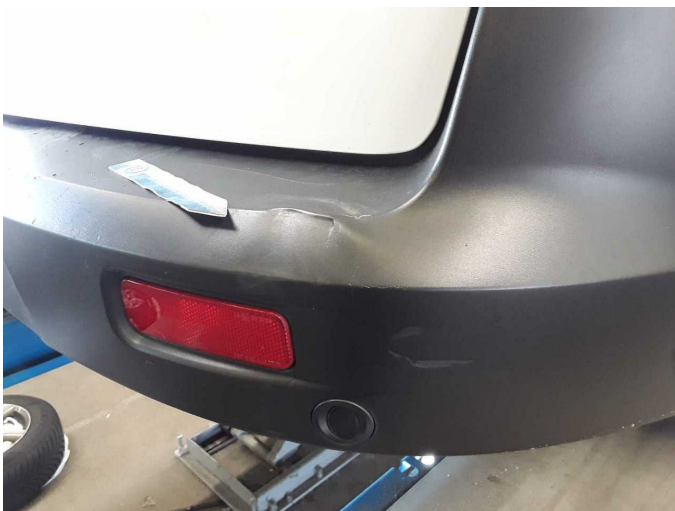
**Damage 5:** Rear bumper: Rear bumper (unpainted) - Deformed - Replace

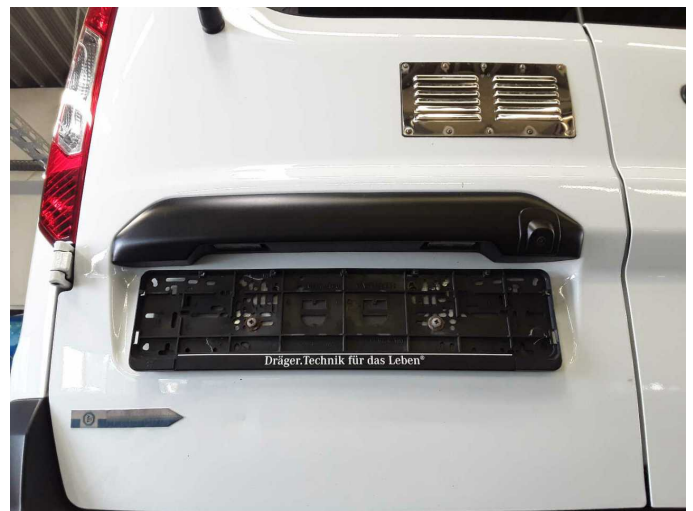
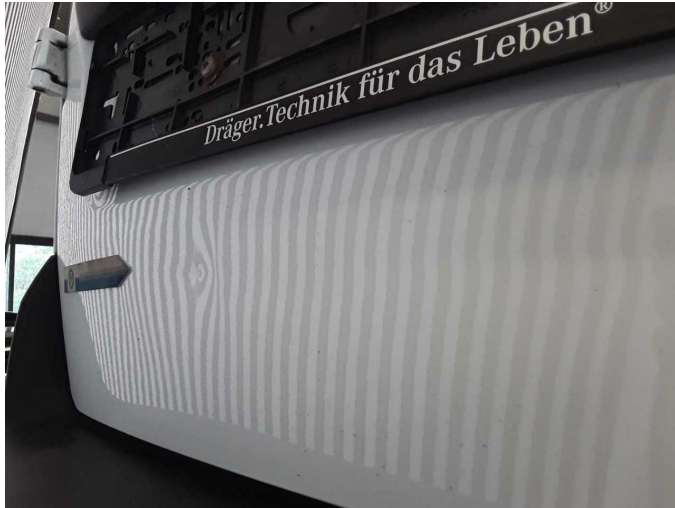
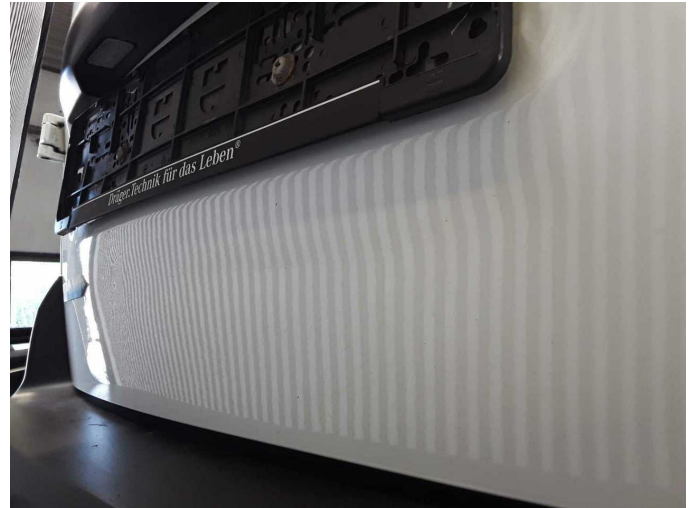
**Damage 6:** Boot lid / rear door: Rear door - left side - Deformed - Repair and paint

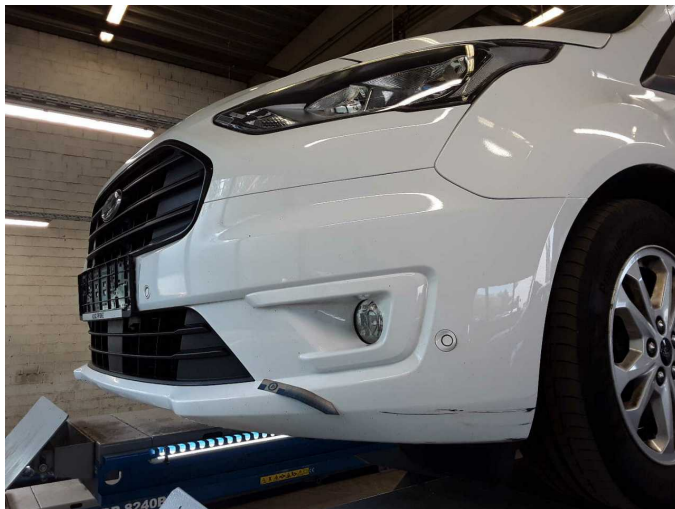
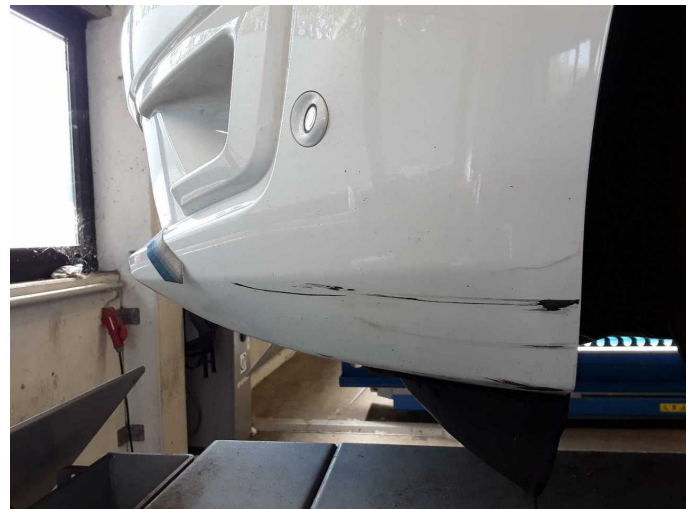
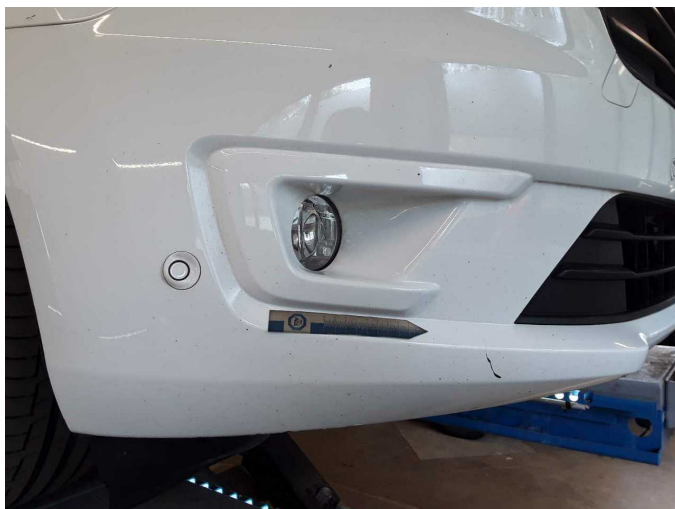
**Damage 7:** Front bumper: Front bumper - Scratch(es) - Paint

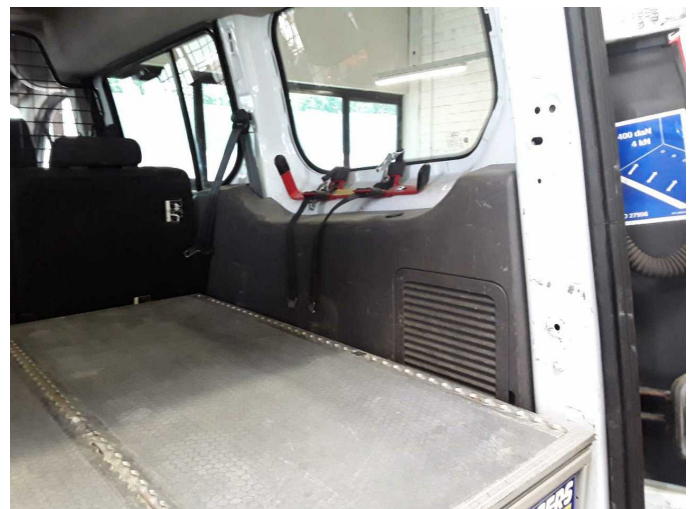
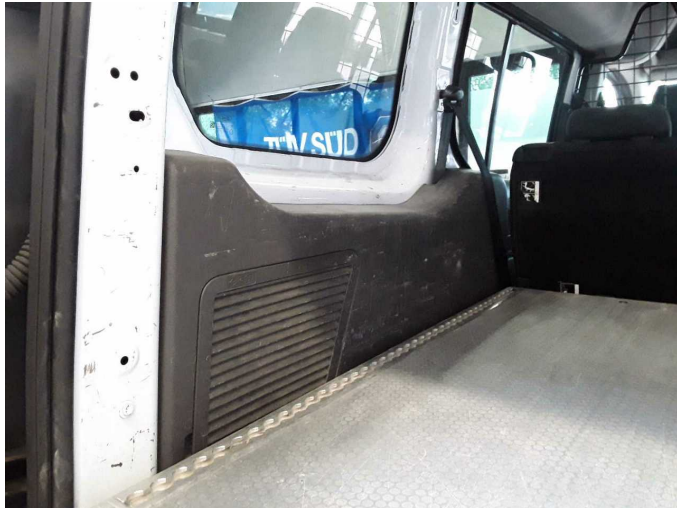
**Wear and tear 1:** Interior: Interior - Scratch(es) - No deduction
