## Expertise

Protocol number: 46093593  
Order No. / Reference: 26533360  
Inspection date: 18 Jun 2026

Manufacturer: Seat

Model: Cupra Born 170kW/77kWh

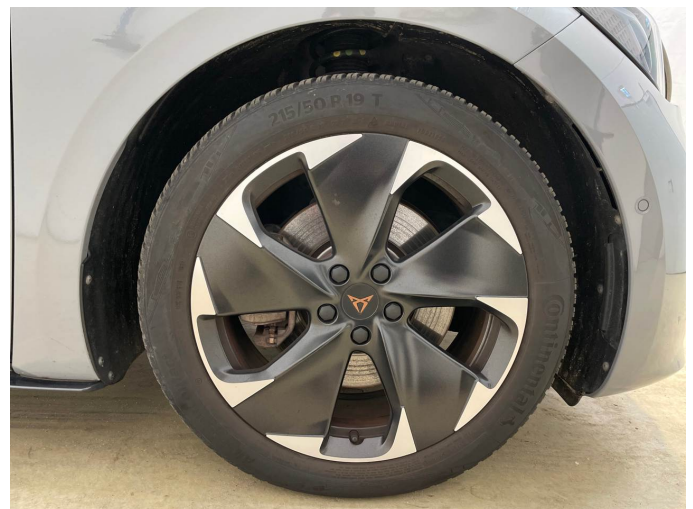
#	Tyre size	Type of tyre	Manufacturer	Tread depth
1)	215/50 R19 93T	All-season tyres on Light alloy	Continental	7mm / 7mm
2)	215/50 R19 93T	All-season tyres on Light alloy	Continental	6mm / 6mm

Figure 12: Mounted tyres

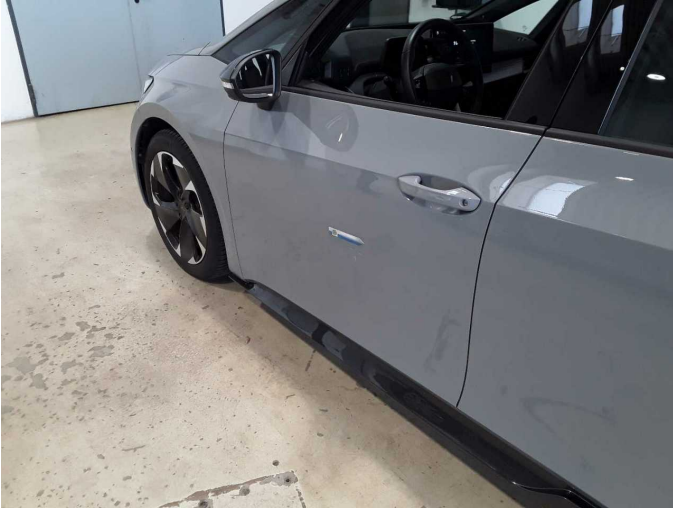
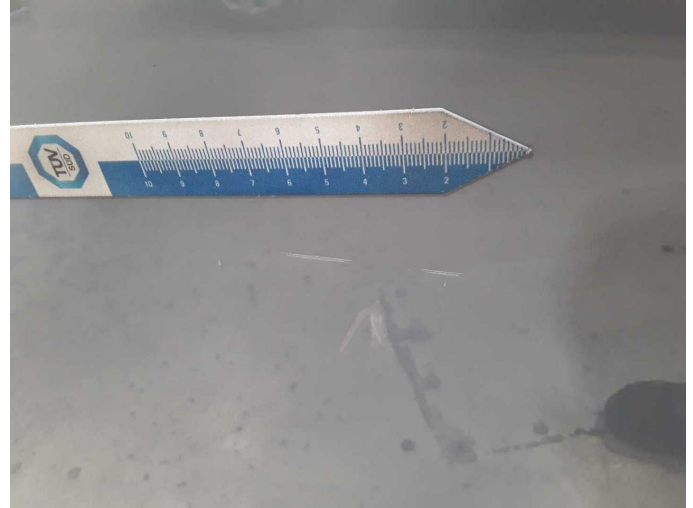
No.	Component group	Description
1	Door - front left side	Door - Scratch(es) - Paint

**Damage 1:** Door - front left side: Door - Scratch(es) - Paint
