Expertise

Protocol number: 46545629  
Order No. / Reference: 26539771  
Inspection date: 16 Jul 2026

Manufacturer: Ford

Model: Focus Turnier 1.0 EcoBoost Hybrid COOL&CONNECT

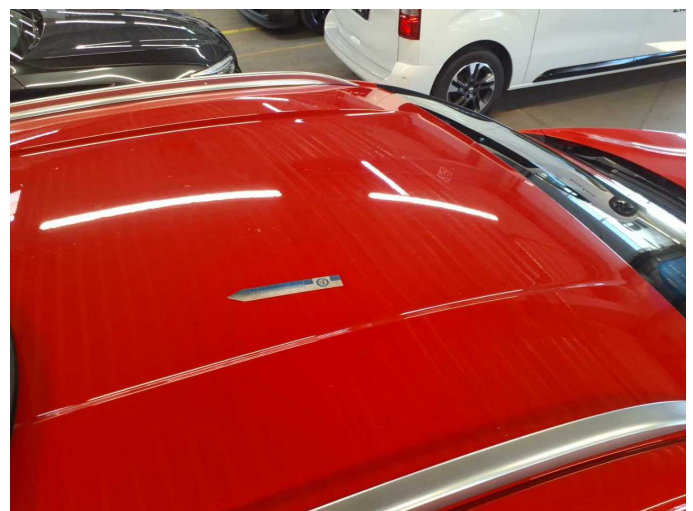
| No. | Component group | Description |
|---|---|---|
| 1 | Roof | Roof - dent(s) - Smooth repair work |

Damage 1: Roof: Roof - dent(s) - Smooth repair work

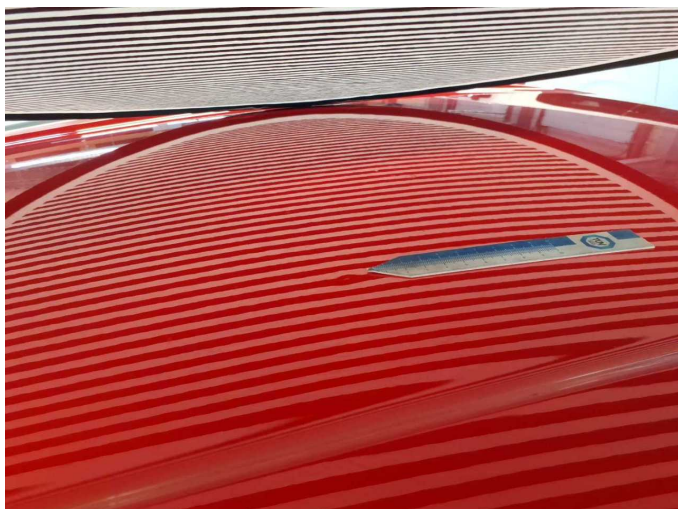
**Damage 1:** Roof: Roof - dent(s) - Smooth repair work

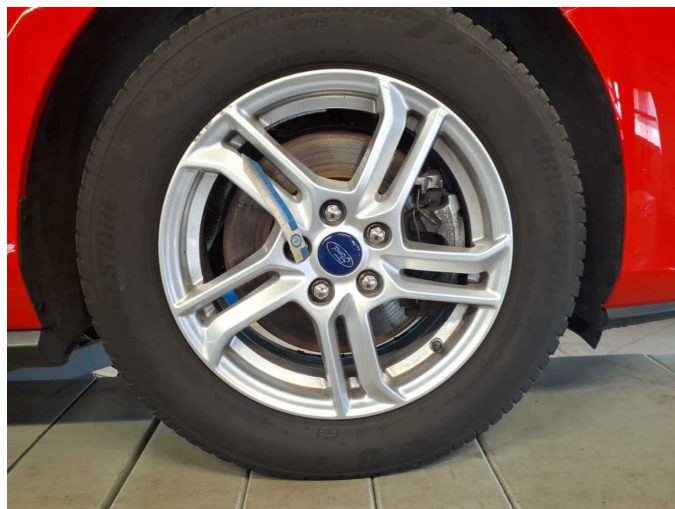
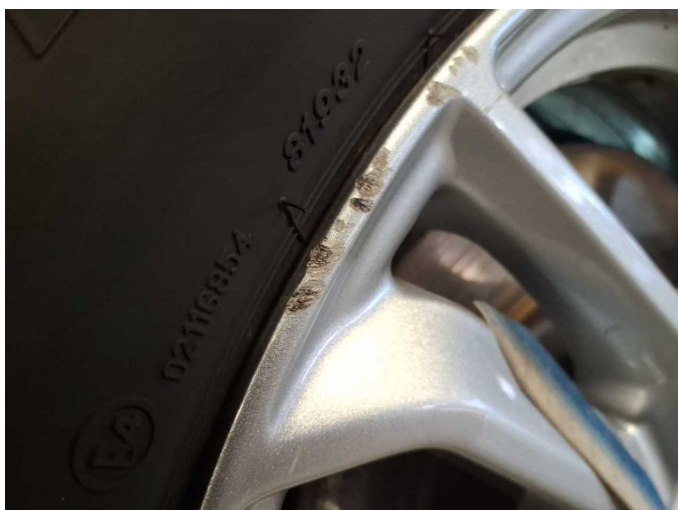
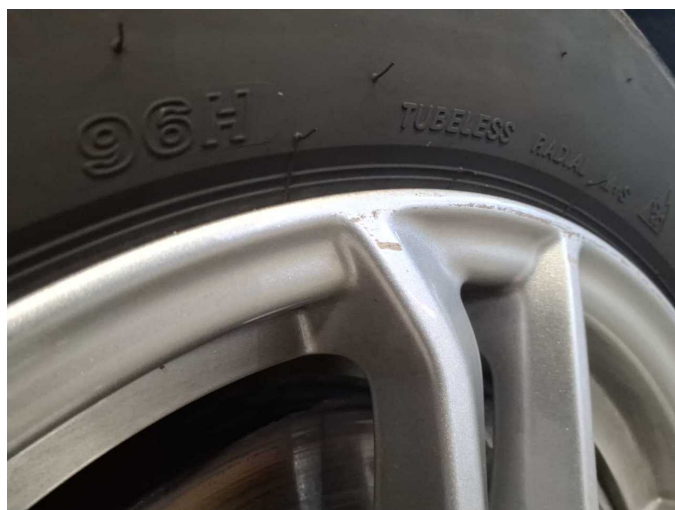
| No. | Component group | Description |
|---|---|---|
| 2 | Wheel / tyres | Alloy rim - front right side - Scratched - Smart repair |

**Damage 2:** Wheel / tyres: Alloy rim - front right side - Scratched - Smart repair

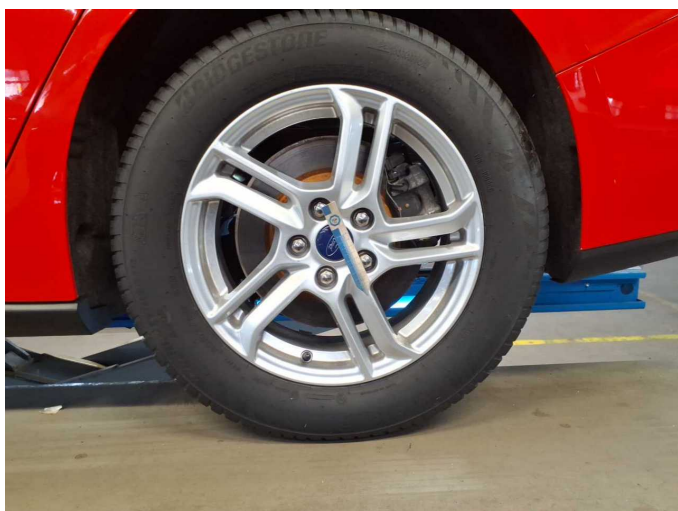
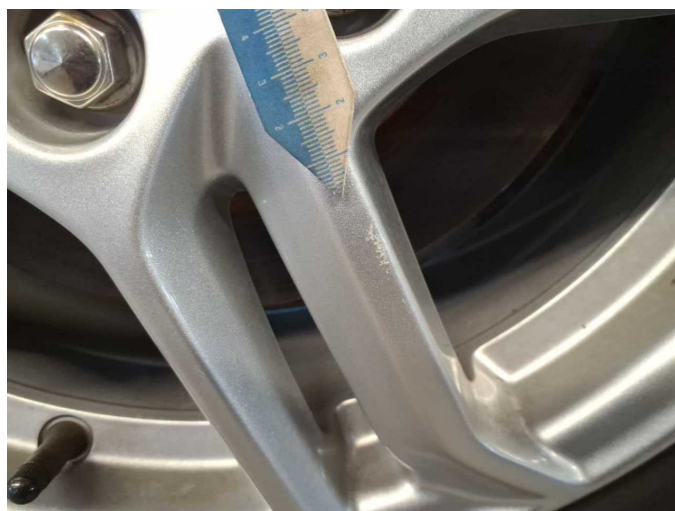
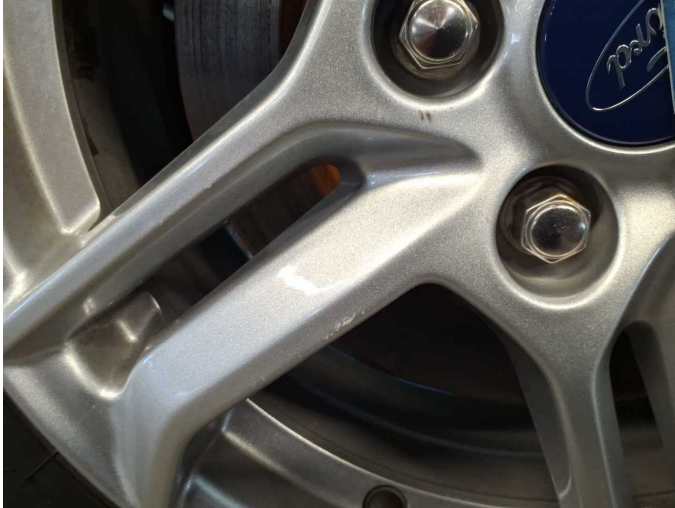
| No. | Component group | Description |
|---|---|---|
| 3 | Wheel / tyres | Alloy rim - rear left side - Scratched - Smart repair |

**Damage 3:** Wheel / tyres: Alloy rim - rear left side - Scratched - Smart repair

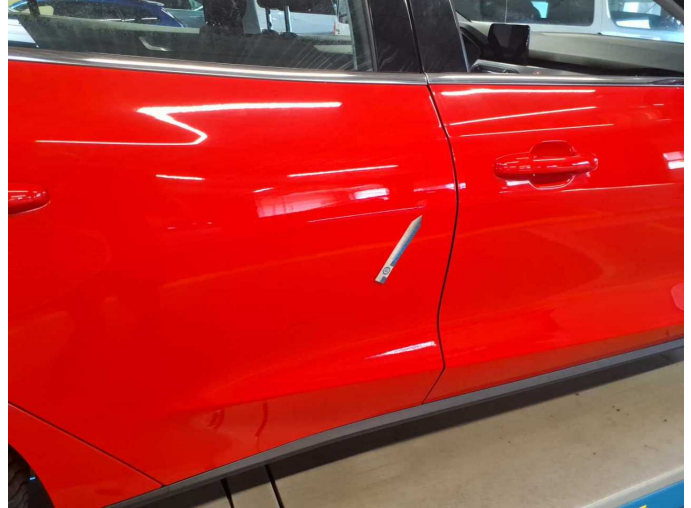
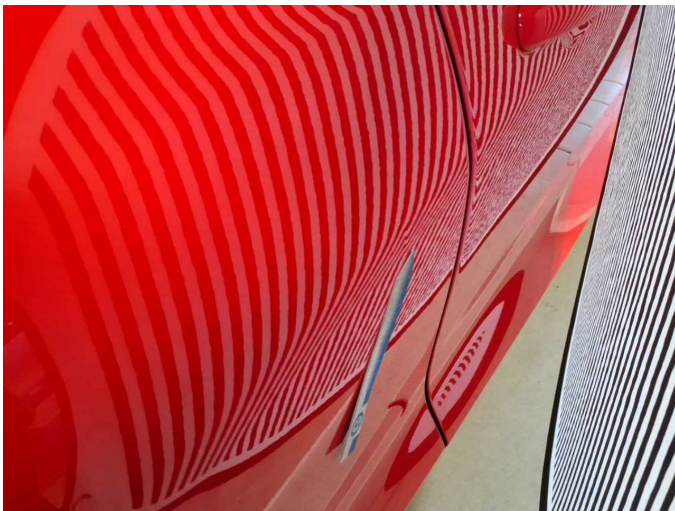
| No. | Component group | Description |
|---|---|---|
| 4 | Door - rear right side | Door - Dent / paintcoat damage - Smart repair |

**Damage 4:** Door - rear right side: Door - Dent / paintcoat damage - Smart repair

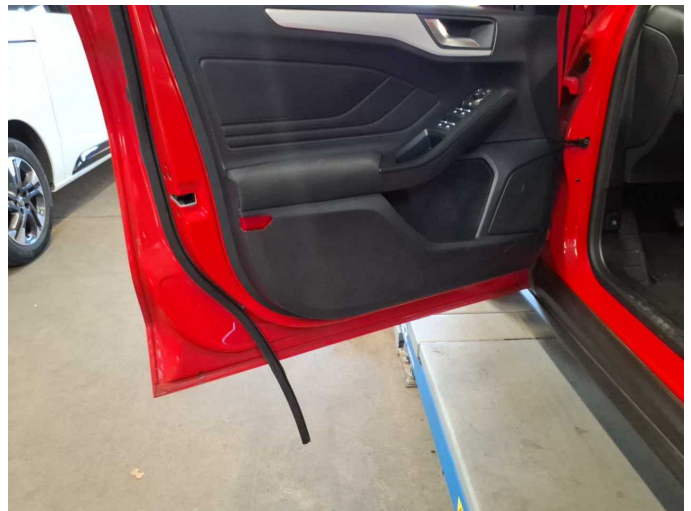
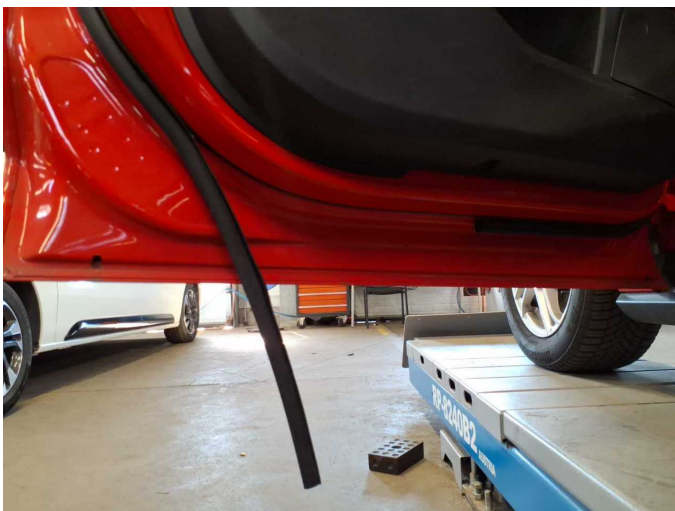
| No. | Component group | Description |
|---|---|---|
| 5 | Door - front left side | Door (Dichtung) - Damaged - Replace |

**Damage 5:** Door - front left side: Door (Dichtung) - Damaged - Replace

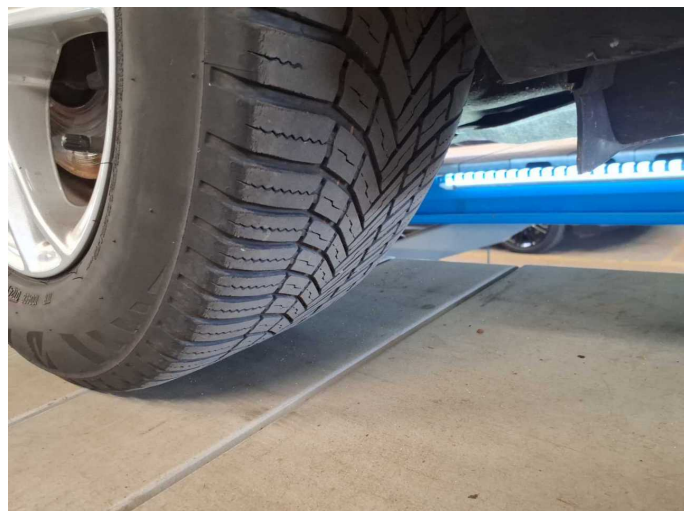
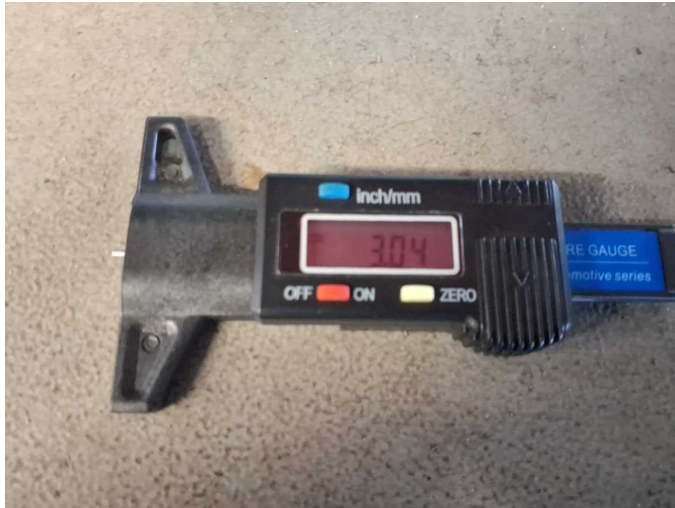
| No. | Component group | Description |
|---|---|---|
| 6 | Wheel / tyres | Tyre - front - Does not meet the leasing specifications - Replace |

**Damage 6:** Wheel / tyres: Tyre - front - Does not meet the leasing specifications - Replace

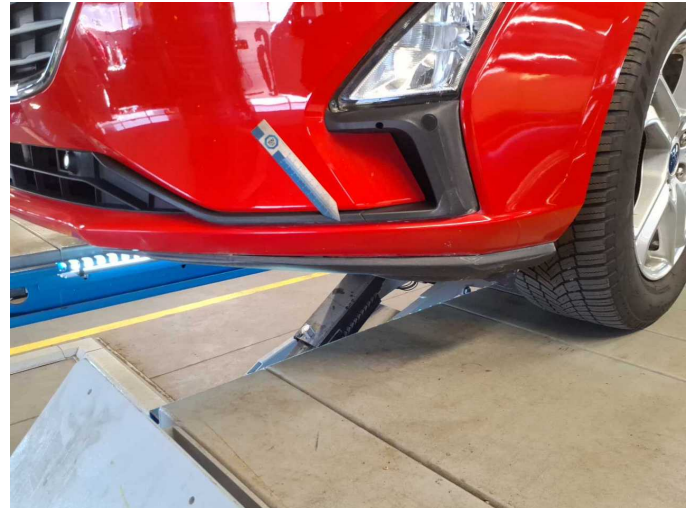
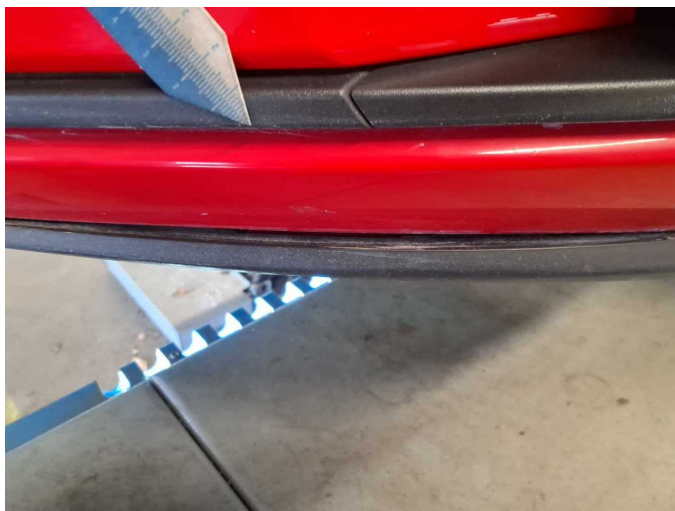
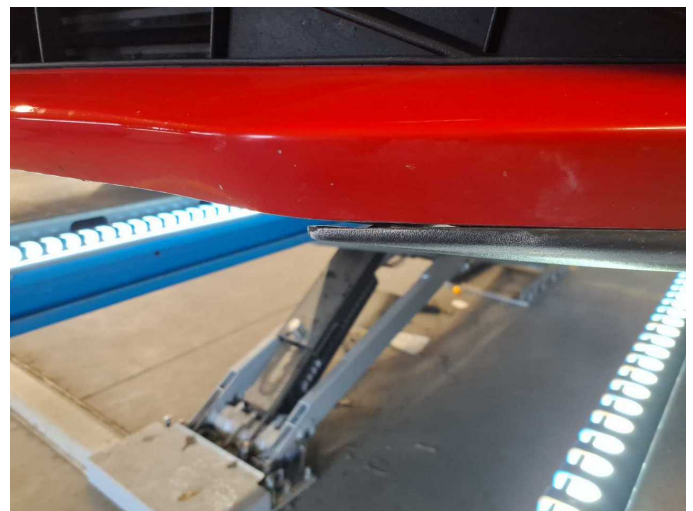
| No. | Component group | Description |
|---|---|---|
| 7 | Front bumper | Spoiler - Damaged - Replace |

**Damage 7:** Front bumper: Spoiler - Damaged - Replace

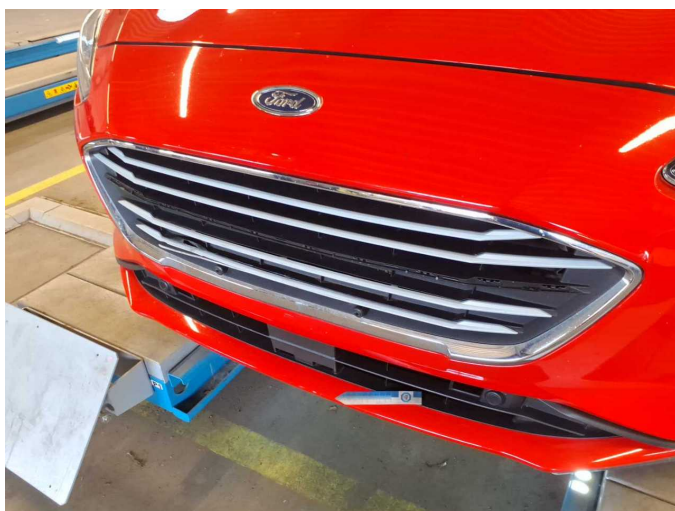
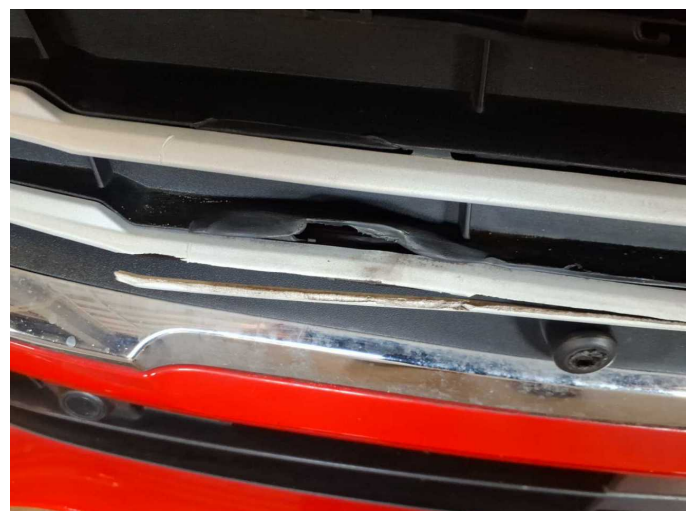
| No. | Component group | Description |
|---|---|---|
| 8 | Bonnet | Radiator grille (inkl PDC links) - Damaged - Replace |

**Damage 8:** Bonnet: Radiator grille (inkl PDC links) - Damaged - Replace

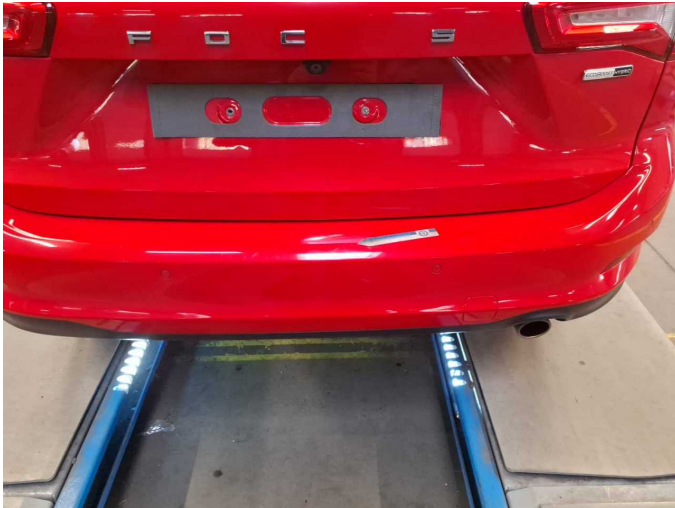
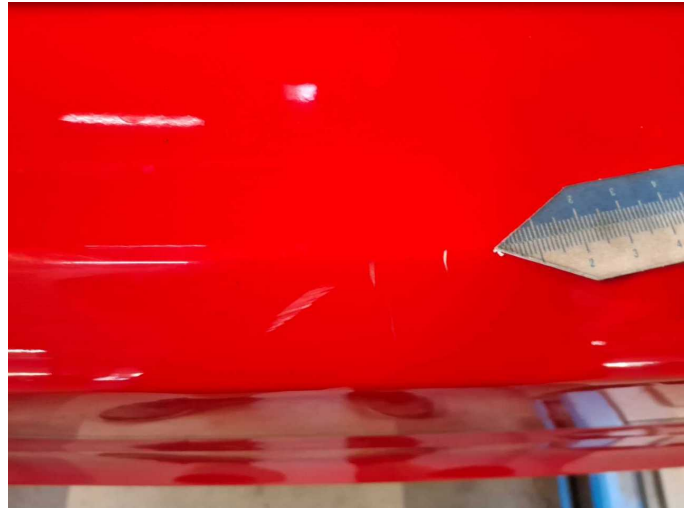
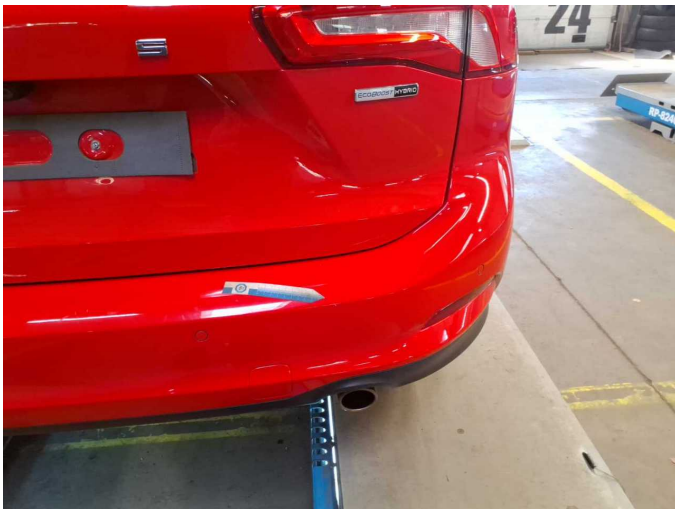
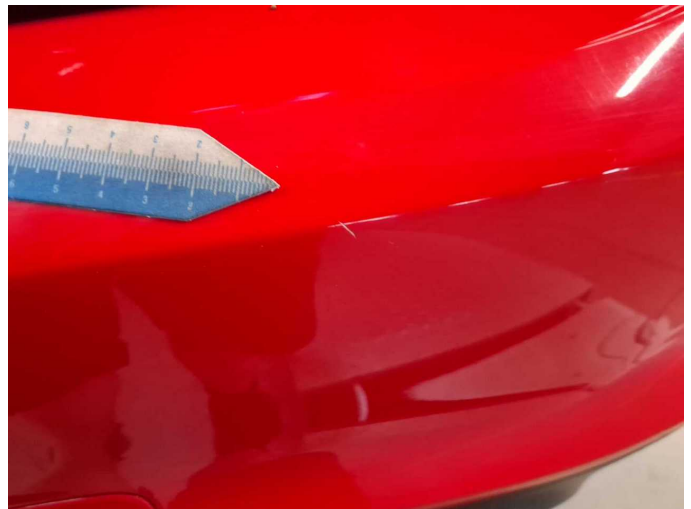
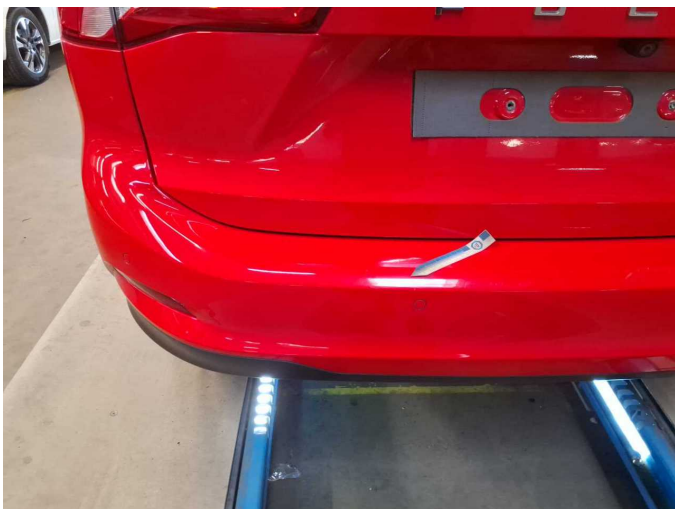
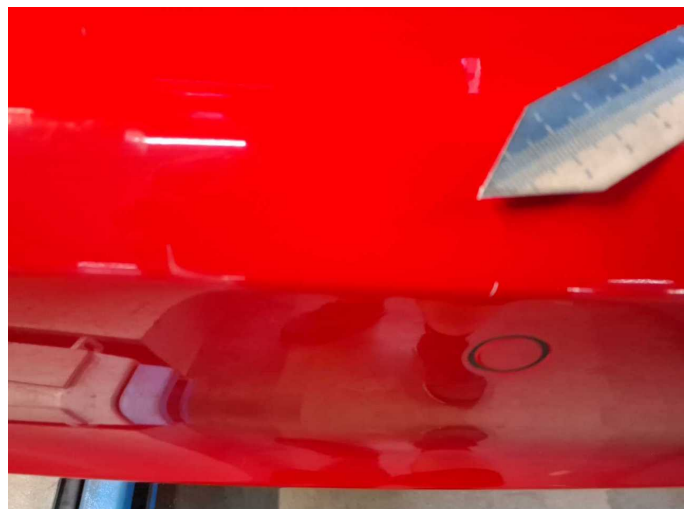
| No. | Component group | Description |
|---|---|---|
| 9 | Rear bumper | Rear bumper - Scratched - Paint |

**Damage 9:** Rear bumper: Rear bumper - Scratched - Paint

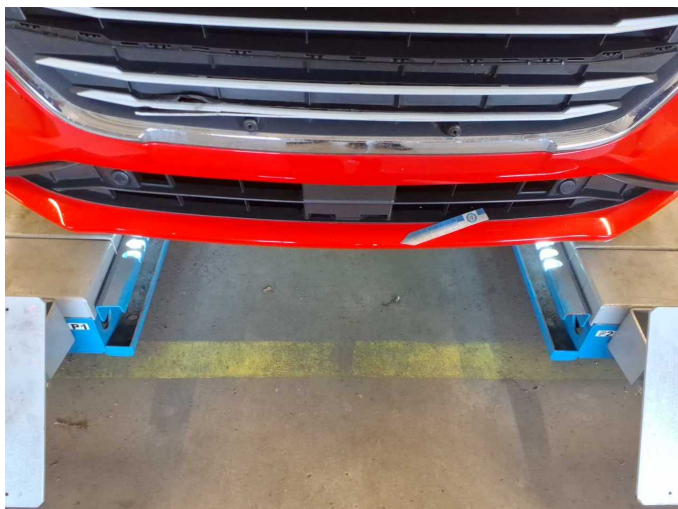
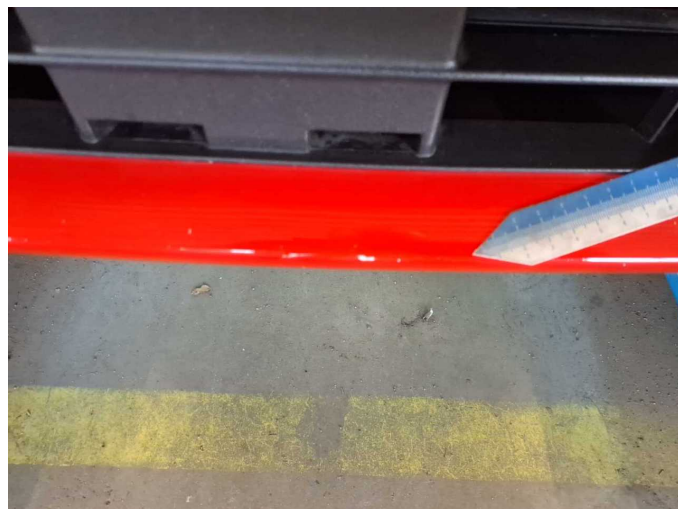
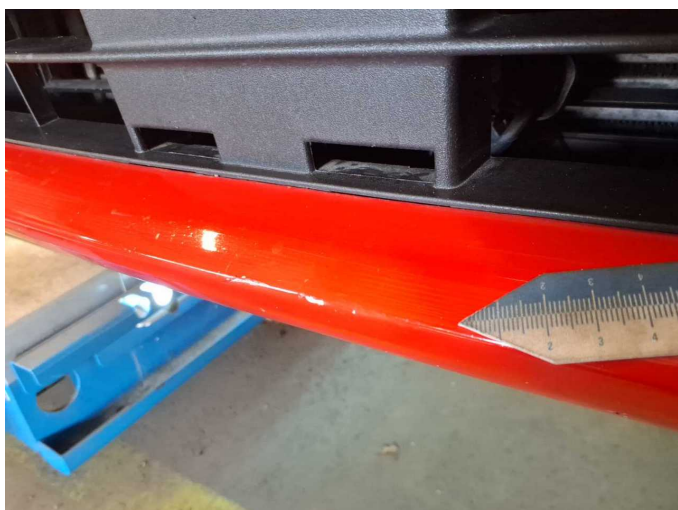
| No. | Component group | Description |
|---|---|---|
| 10 | Front bumper | Front bumper - Damaged - Paint |

**Damage 10:** Front bumper: Front bumper - Damaged - Paint

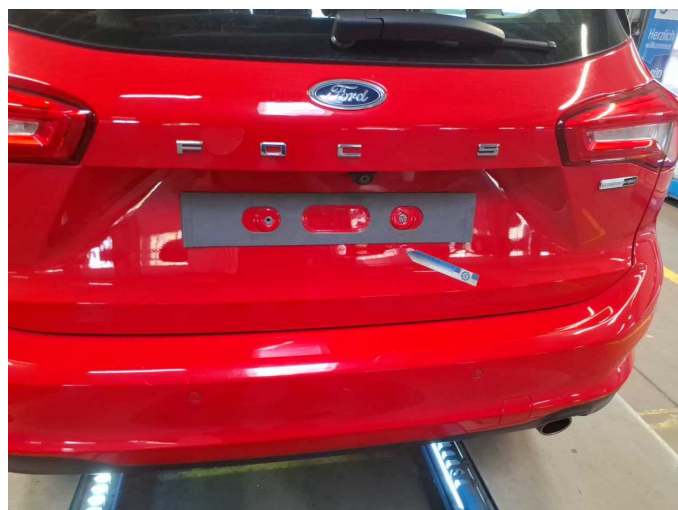
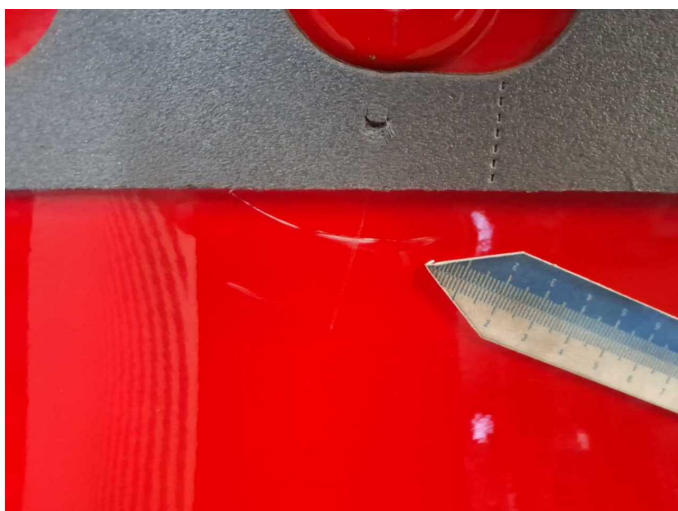
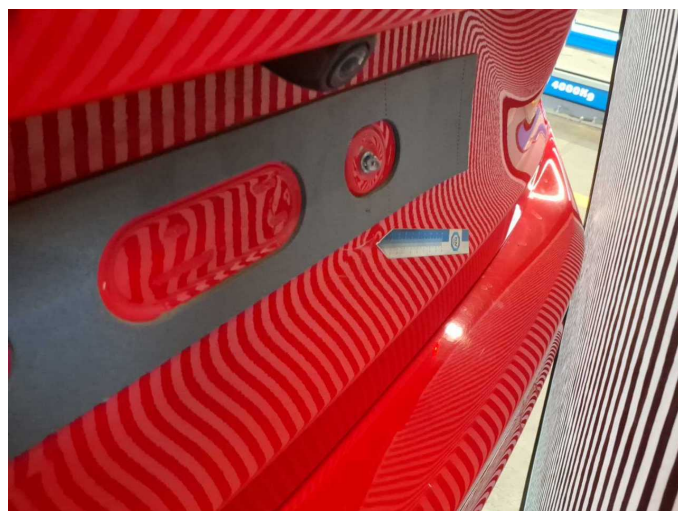
| No. | Component group | Description |
|---|---|---|
| 11 | Boot lid / rear door | Boot lid - Dent / paintcoat damage - Repair and paint |

**Damage 11:** Boot lid / rear door: Boot lid - Dent / paintcoat damage - Repair and paint
