Expertise

Protocol number: 45806735
Order No. / Reference: 26382615
Inspection date: 20 May 2026

Manufacturer: Peugeot

Model: 308 SW BlueHDi 130 Allure

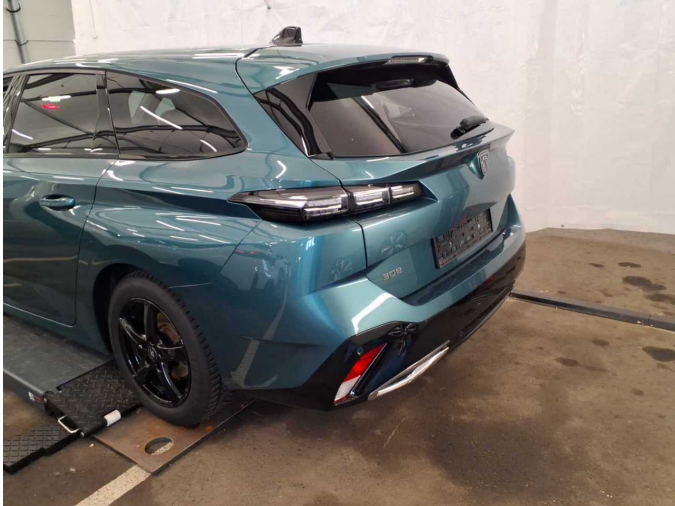
Damage 1: Rear bumper: Rear bumper - Scratch(es) - Smart repair

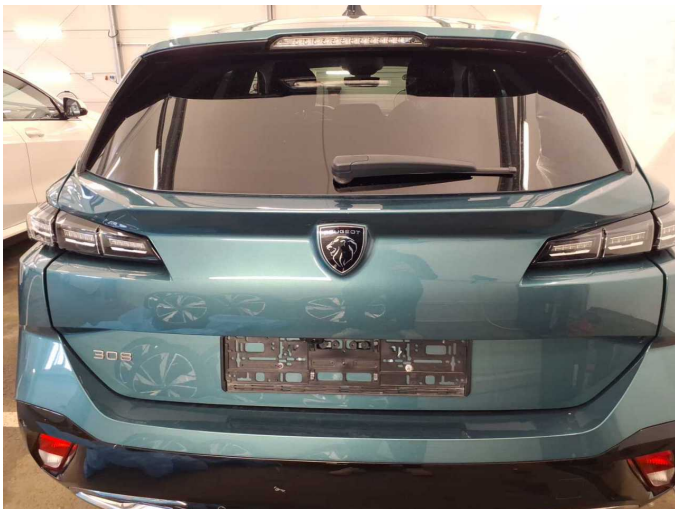
Damage 2: Boot lid / rear door: Boot lid - Scratched - Smart repair

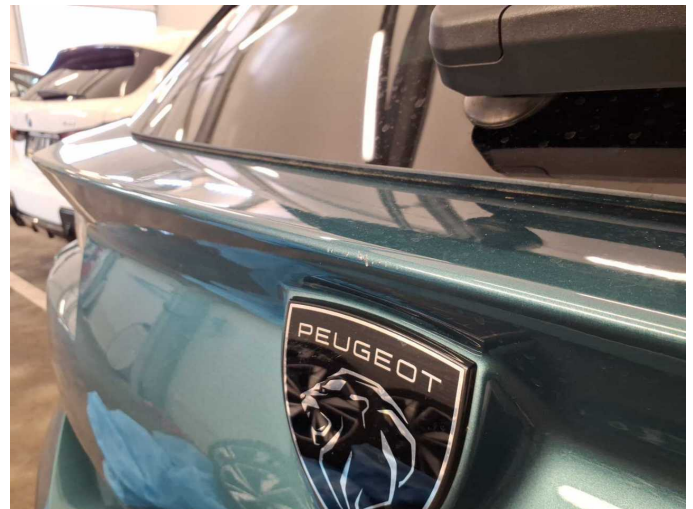
Damage 2: Boot lid / rear door: Boot lid - Scratched - Smart repair

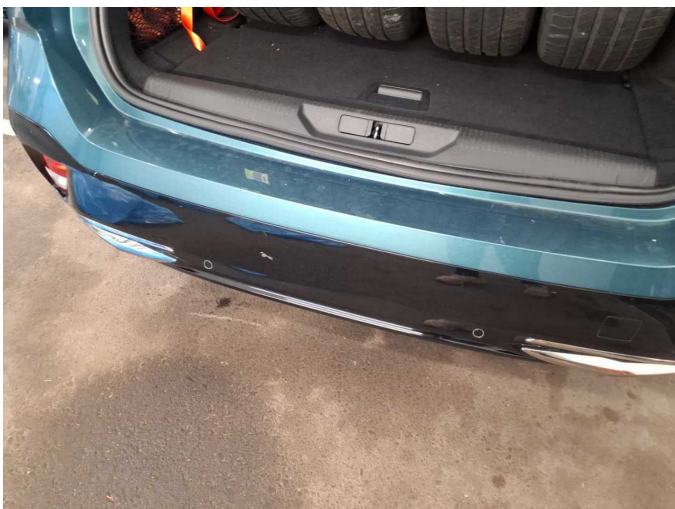
Damage 3: Rear bumper: Spoiler - Scratched - Replace

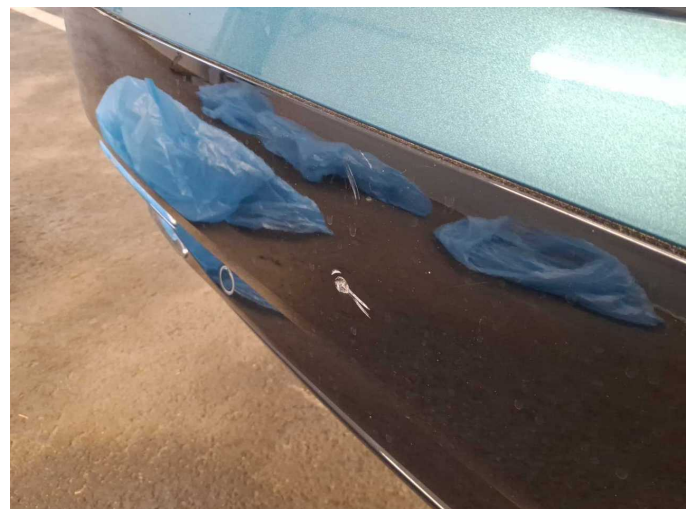
Damage 3: Rear bumper: Spoiler - Scratched - Replace

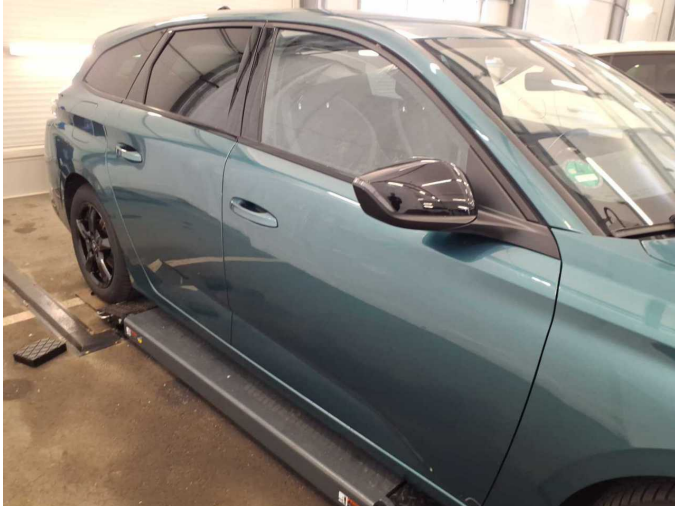
Damage 4: Door - front right side: Door - Dent / paintcoat damage - Repair and paint

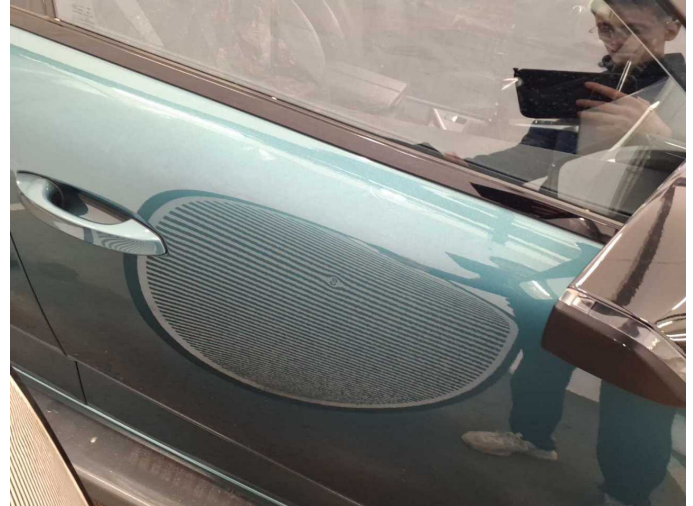
Damage 4: Door - front right side: Door - Dent / paintcoat damage - Repair and paint

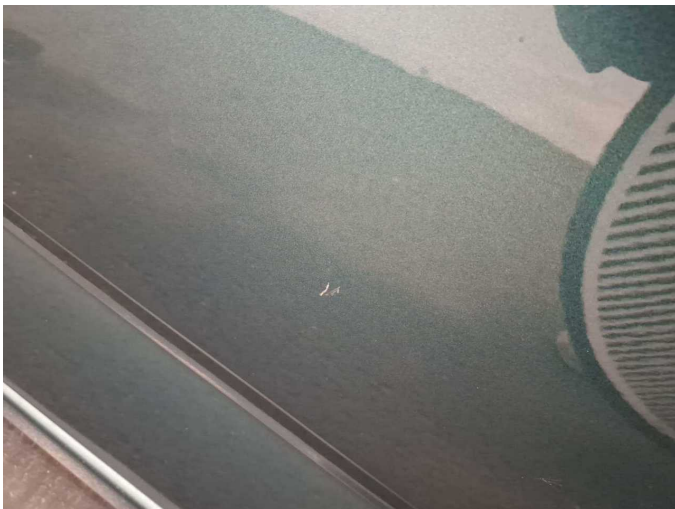
Damage 4: Door - front right side: Door - Dent / paintcoat damage - Repair and paint

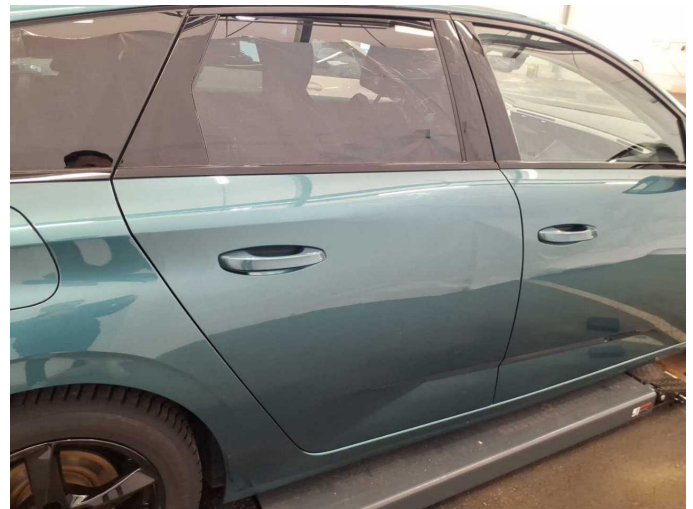
Damage 5: Door - rear right side: Door - Scratch(es) - Paint

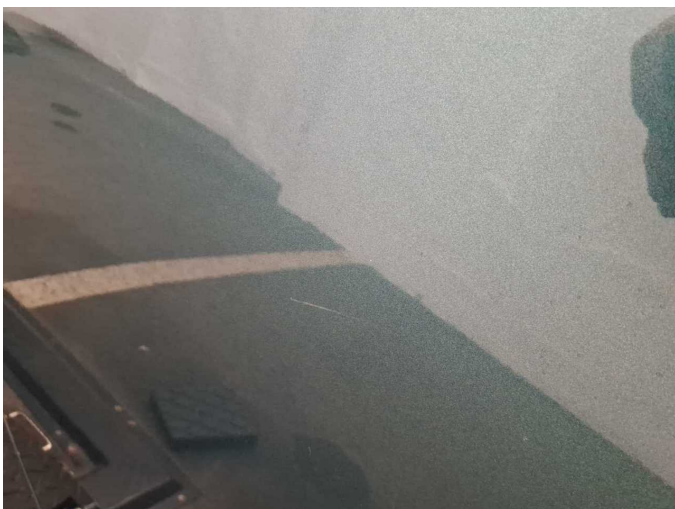
Damage 5: Door - rear right side: Door - Scratch(es) - Paint

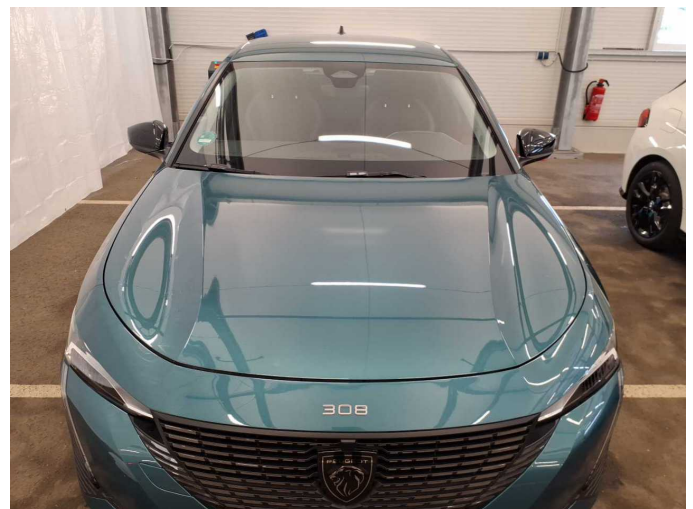
Wear and tear 4: Bonnet: Bonnet - dent(s) - No deduction

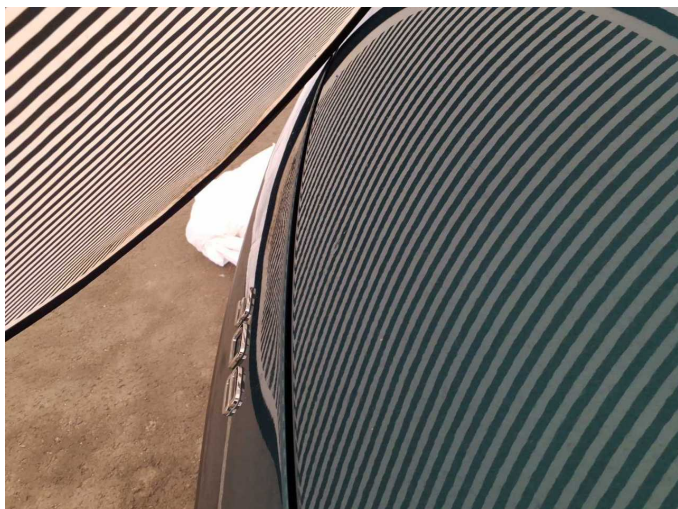
Wear and tear 4: Bonnet: Bonnet - dent(s) - No deduction
