Expertise

Protocol number: 46406208  
Order No. / Reference: 26571364  
Inspection date: 8 Jul 2026

Manufacturer: Opel

Model: Astra 1.5 D Start/Stop Sports Tourer Automatik Edition

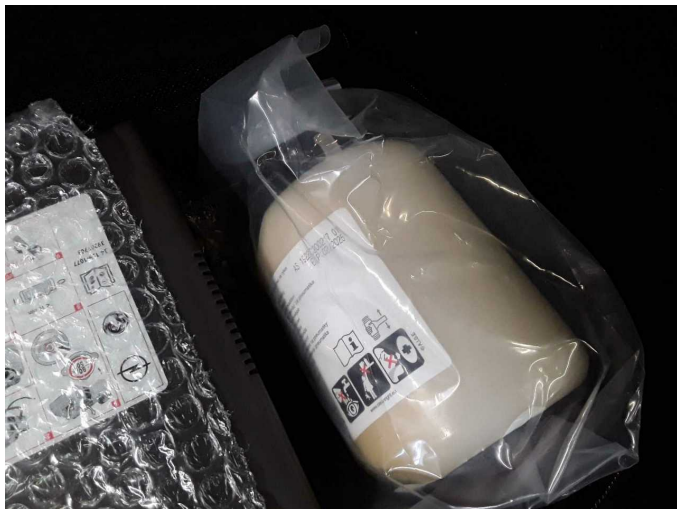
| No. | Component group | Description |
|---|---|---|
| 1 | Equipment | Tirefit filler - Expired - Replace |

Damage 1: Equipment: Tirefit filler - Expired - Replace

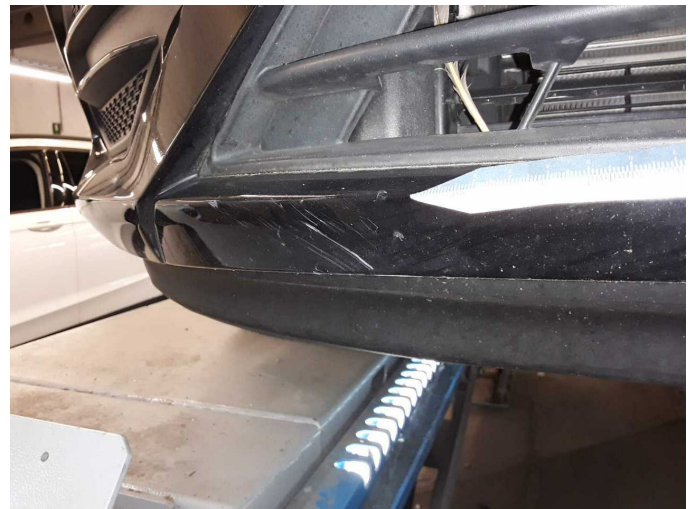
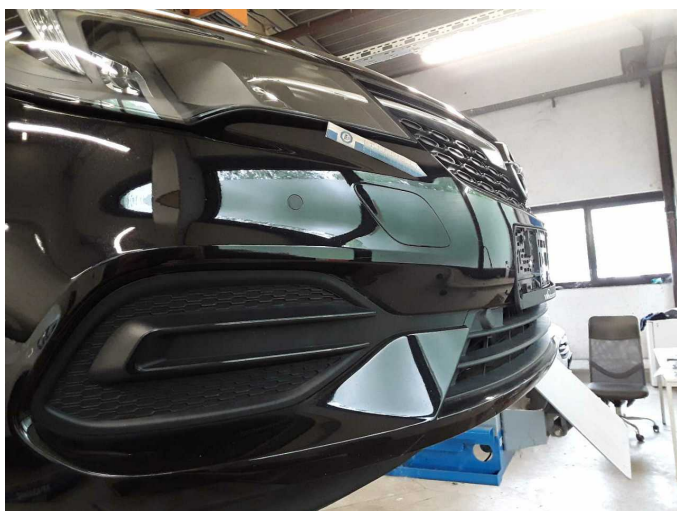
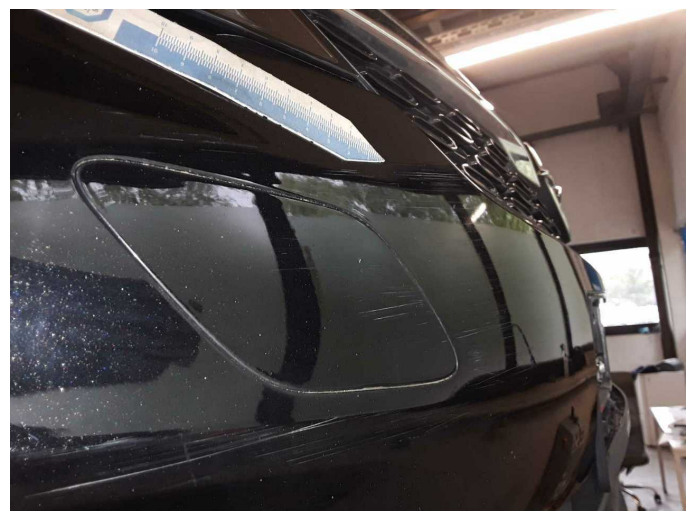
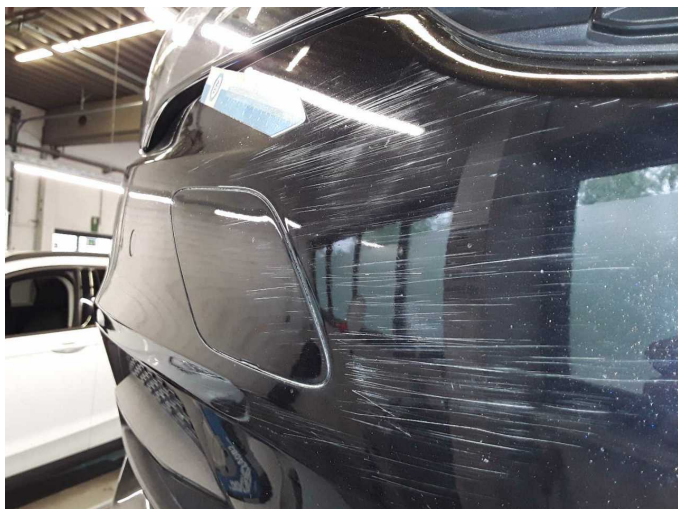
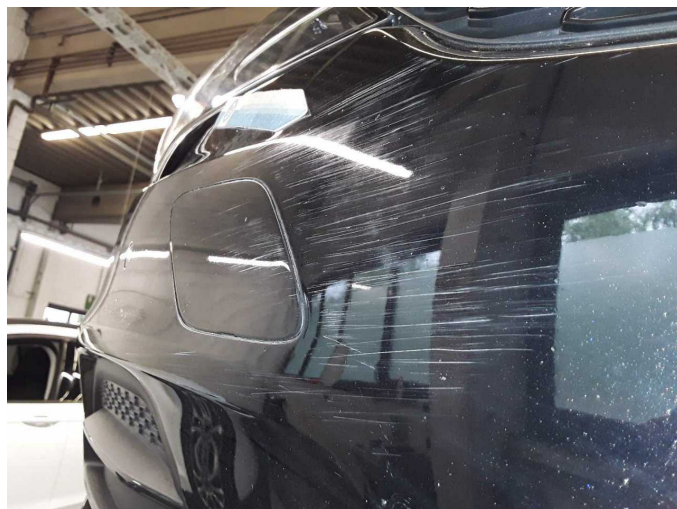
| No. | Component group | Description |
|---|---|---|
| 2 | Front bumper | Front bumper - Scratched - Paint |

Damage 2: Front bumper: Front bumper - Scratched - Paint

**Damage 2:** Front bumper: Front bumper - Scratched - Paint

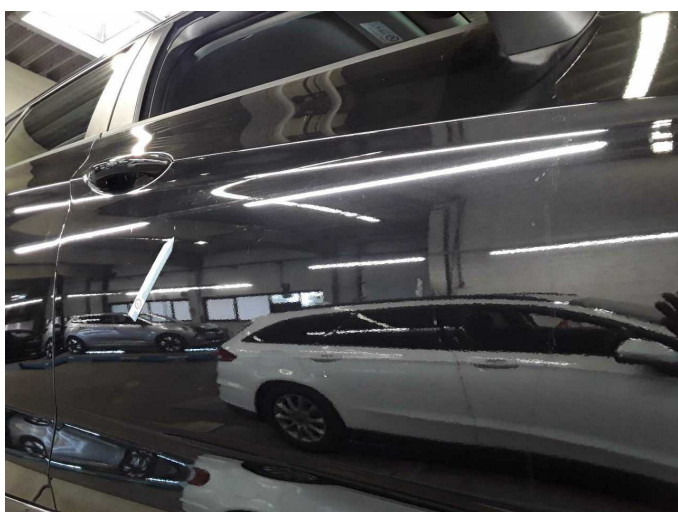
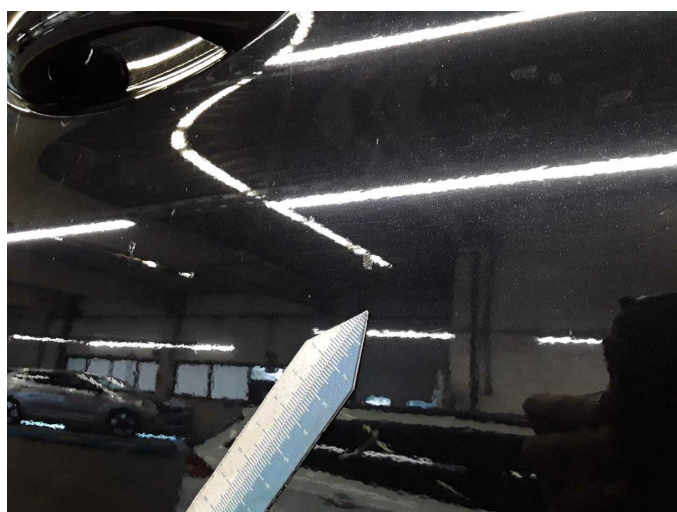
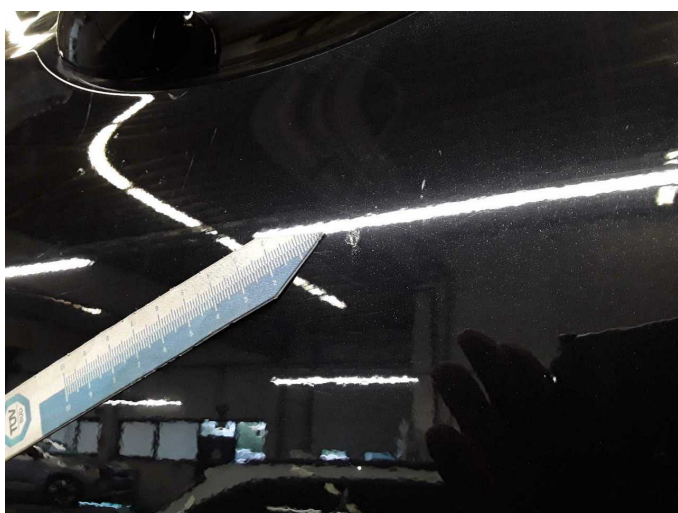
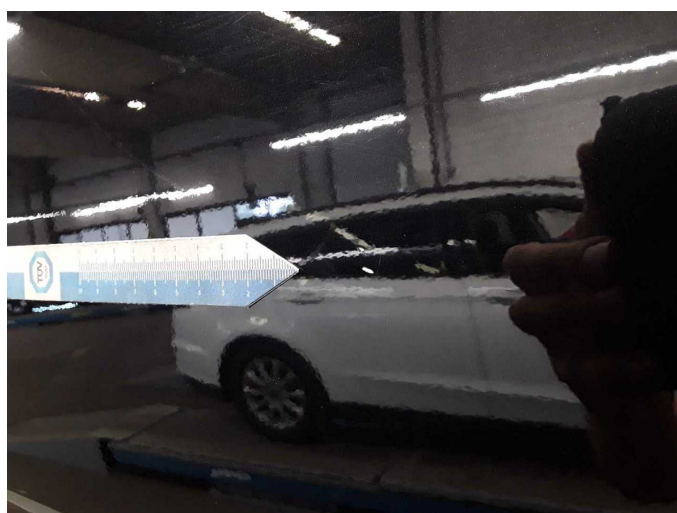
| No. | Component group | Description |
|---|---|---|
| 3 | Door - front right side | Door (Vogelkot eingebrannt) - Paint defect - Paint |

**Damage 3:** Door - front right side: Door (Vogelkot eingebrannt) - Paint defect - Paint

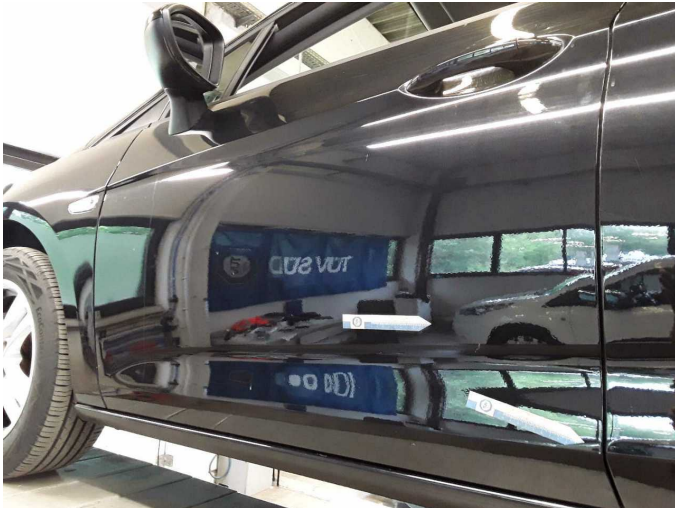
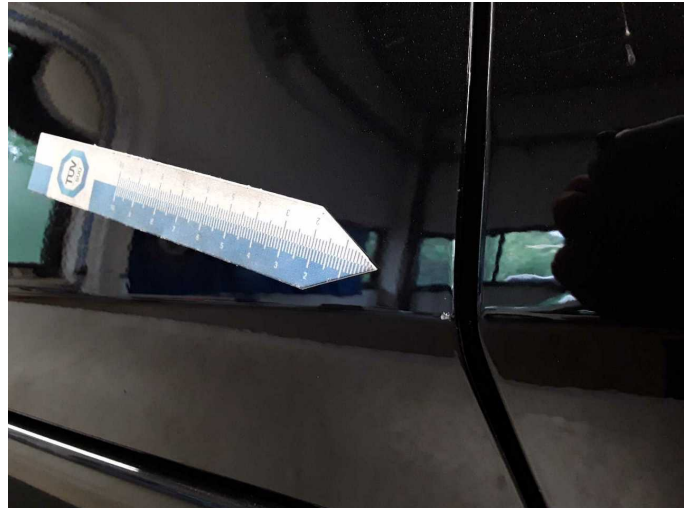
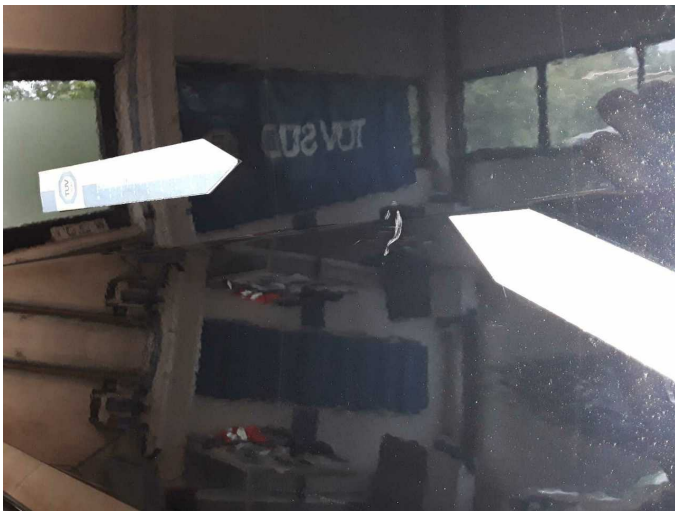
| No. | Component group | Description |
|---|---|---|
| 4 | Door - front left side | Door - Scratch(es) - Paint |

**Damage 4:** Door - front left side: Door - Scratch(es) - Paint

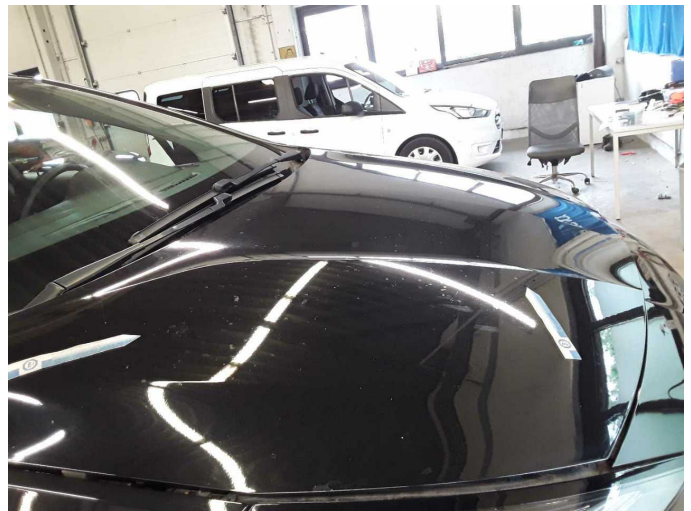
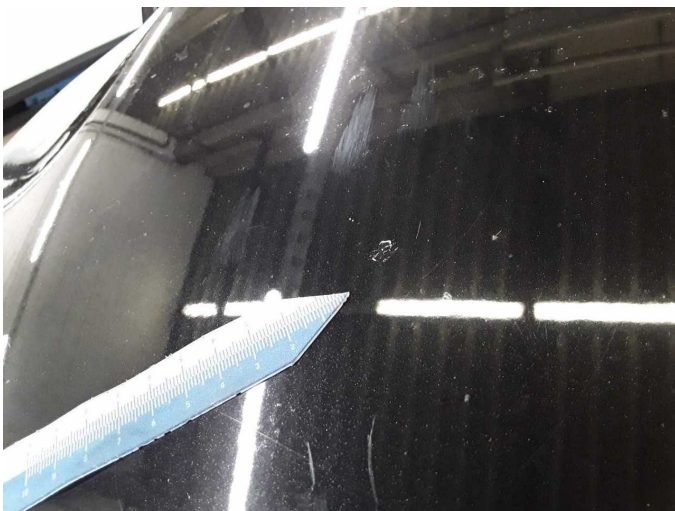
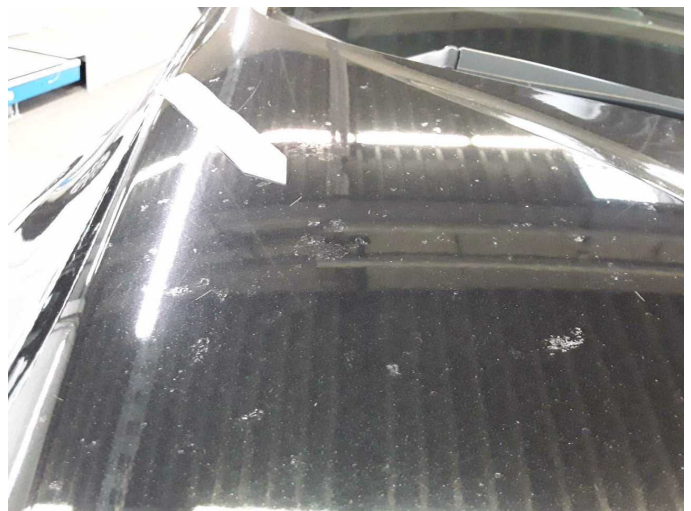
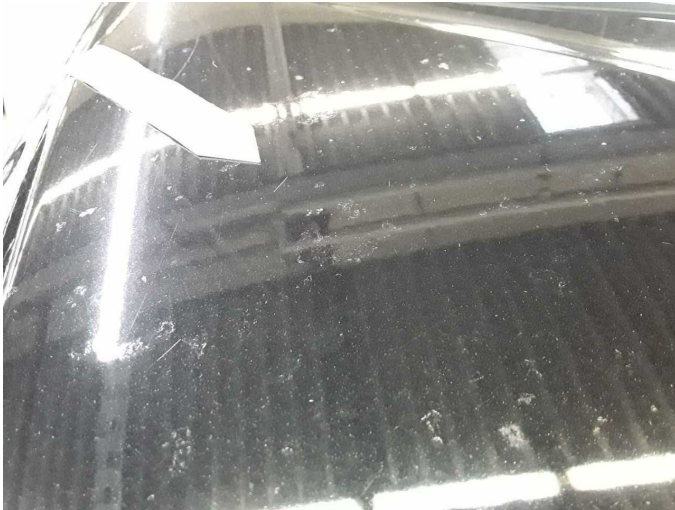
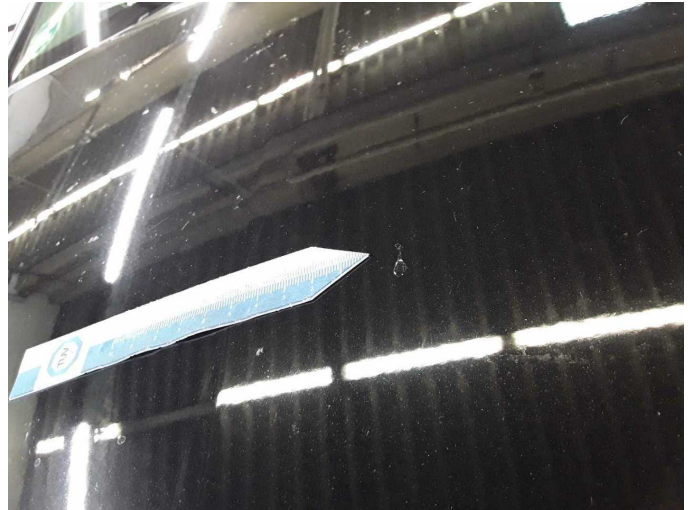
| No. | Component group | Description |
|---|---|---|
| 5 | Bonnet | Bonnet (Vogelkot eingebrannt) - Paint defect - Paint |

**Damage 5:** Bonnet: Bonnet (Vogelkot eingebrannt) - Paint defect - Paint

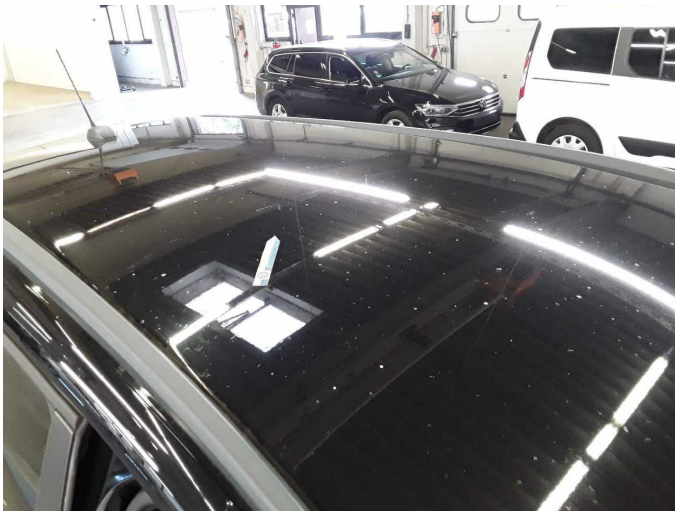
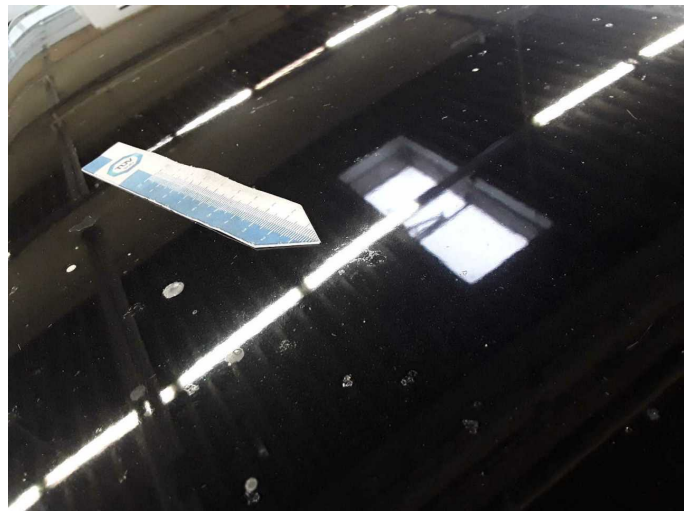
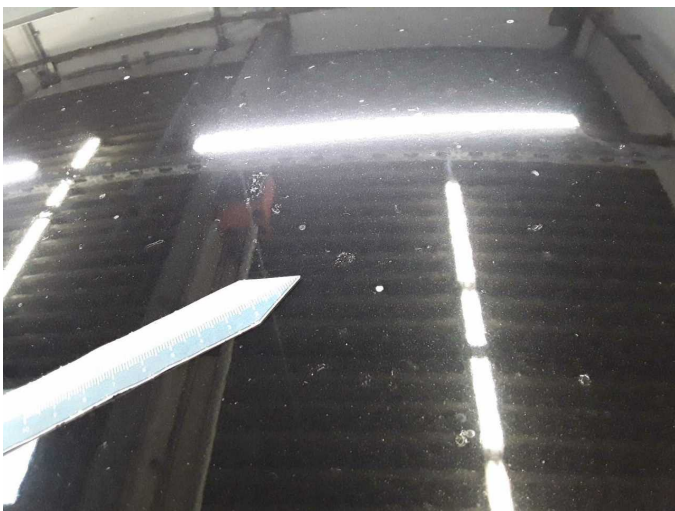
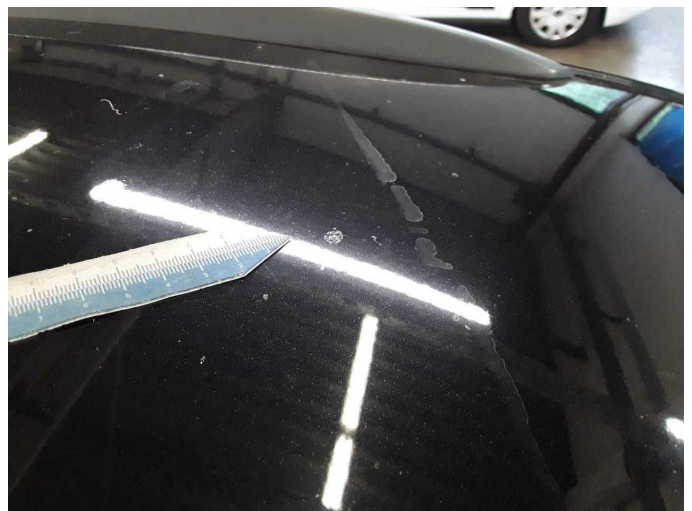
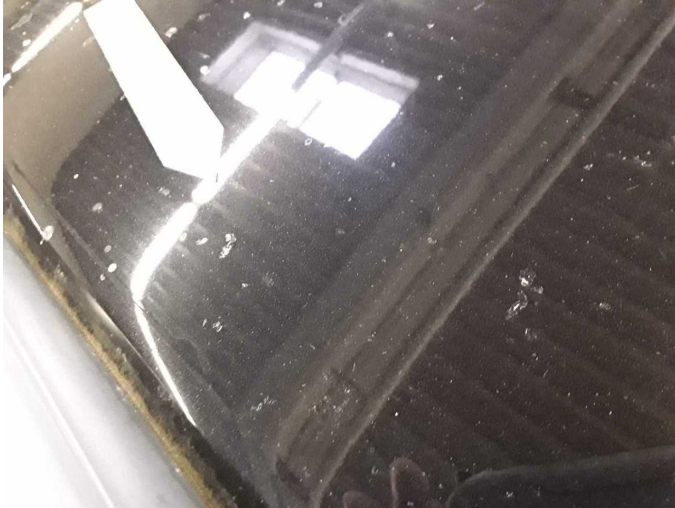
| No. | Component group | Description |
|---|---|---|
| 6 | Roof | Roof (Vogelkot eingebrannt) - Paint defect - Paint |

**Damage 6:** Roof: Roof (Vogelkot eingebrannt) - Paint defect - Paint
