MACDAM

Polestar Polestar 2 '19 BEV

Vehicle information

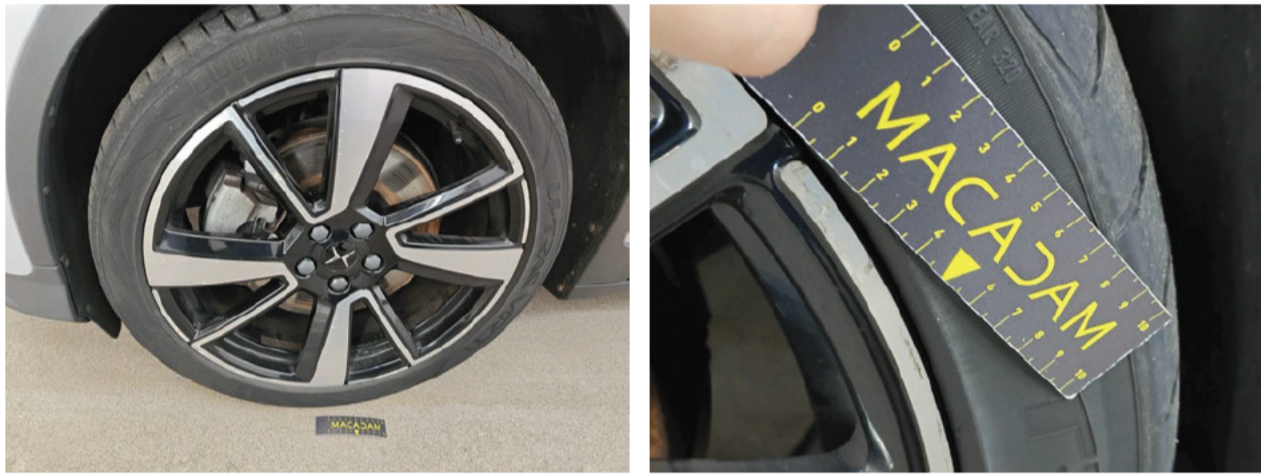
Alloy rim FL
 Scratch(es)
 Repair and paint (complete)
 Left

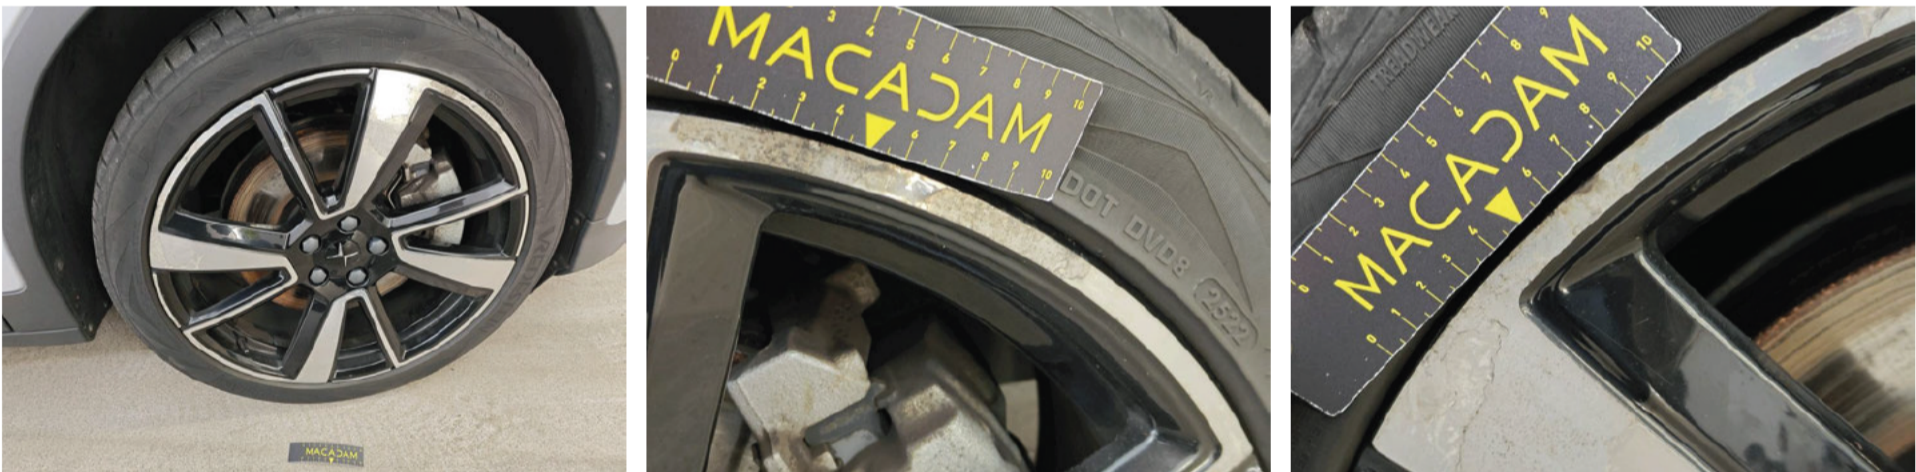
Alloy rim FR
 Scratch(es)
 Repair and paint (complete)
 Right

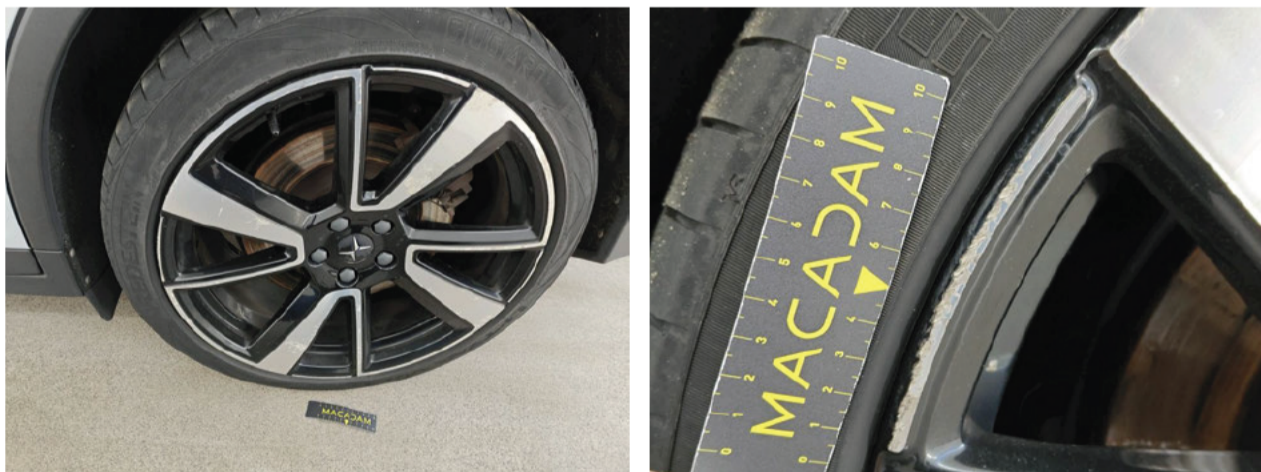
Alloy rim RL
 Scratch(es)
 Repair and paint (complete)
 Left

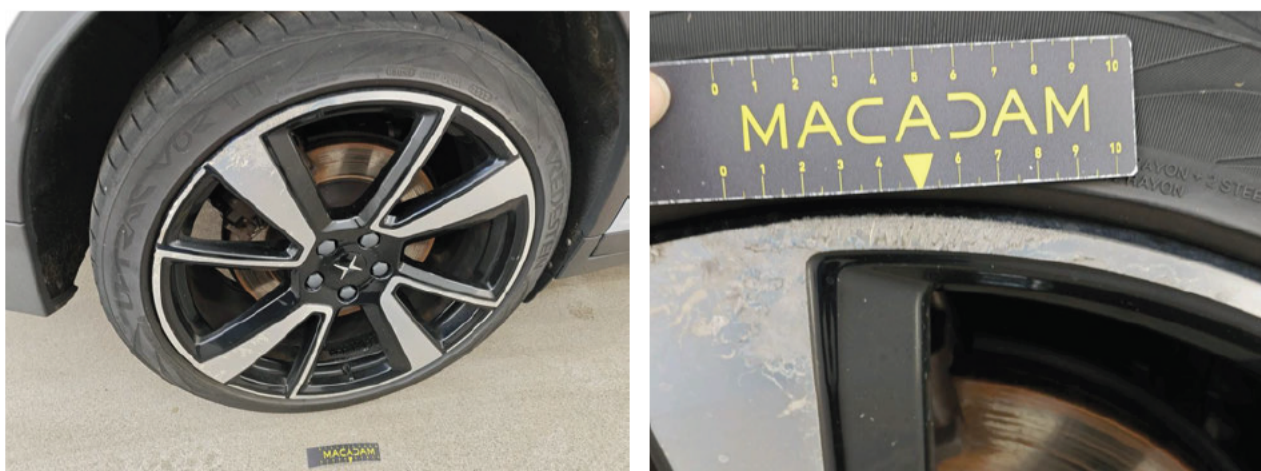
Alloy rim RR
 Scratch(es)
 Repair and paint (complete)
 Right

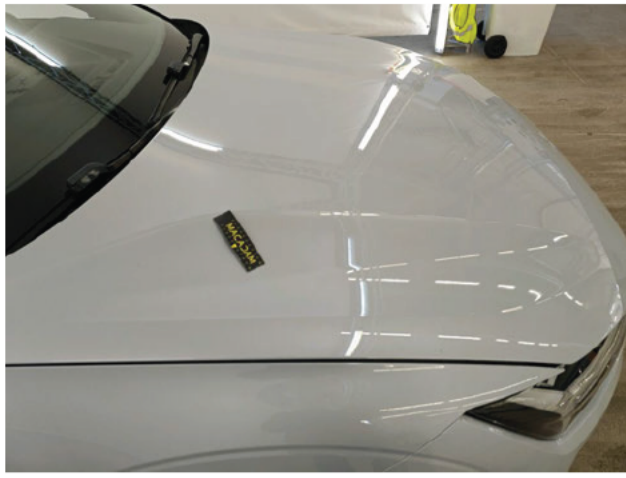
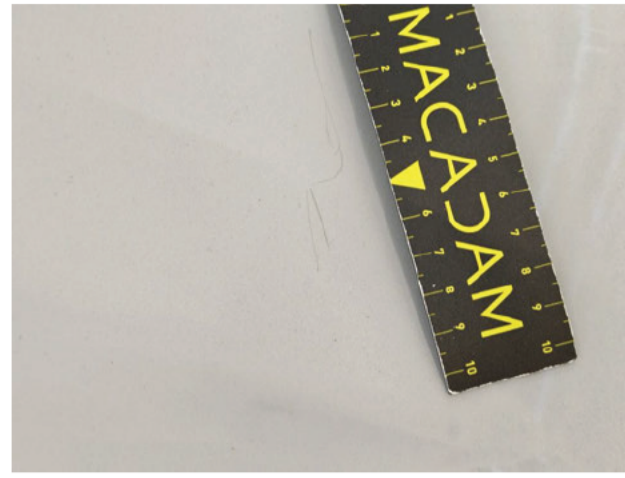
Bonnet
Scratch(es)
Repair and paint (complete)
Front

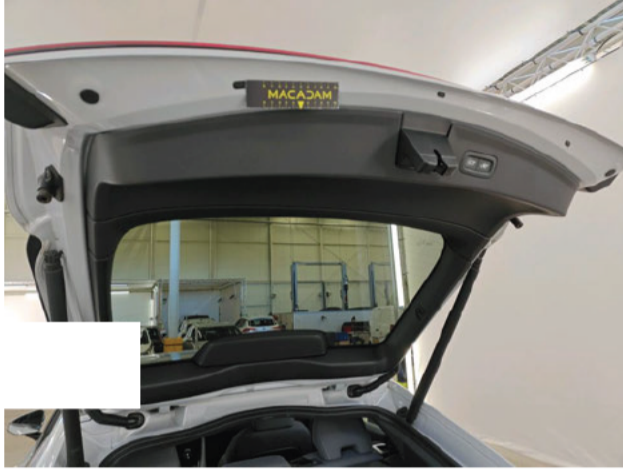
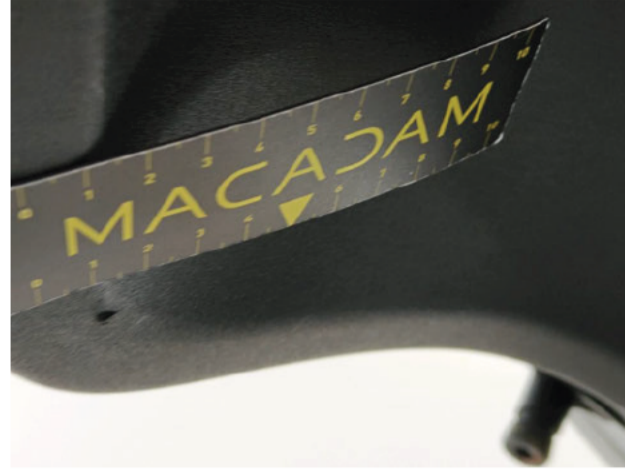
Boot lid covering R
Scratch(es)
Smart repair
Rear

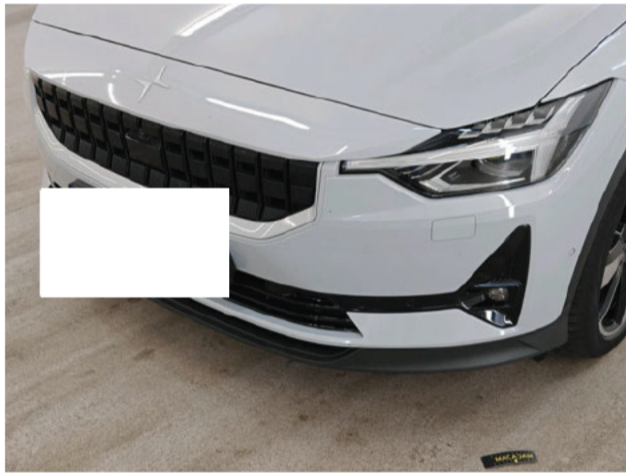
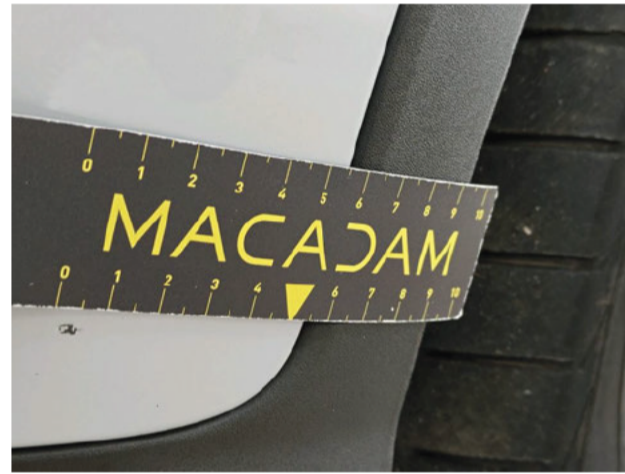
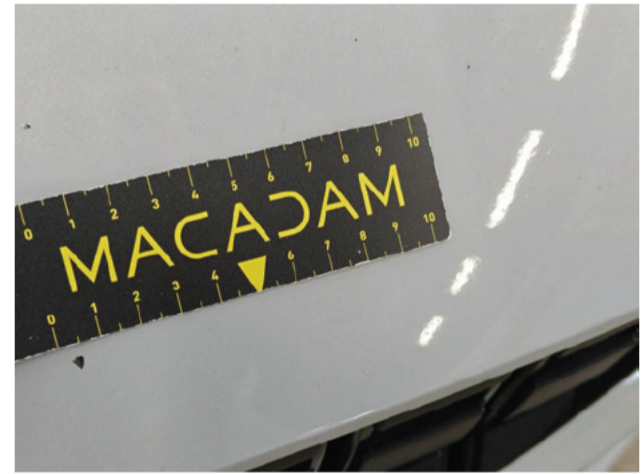
Bumper F
Scratch(es)
Repair and paint (complete)
Front

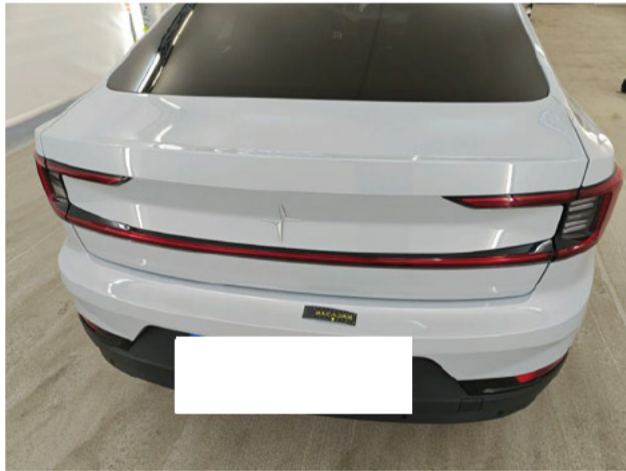
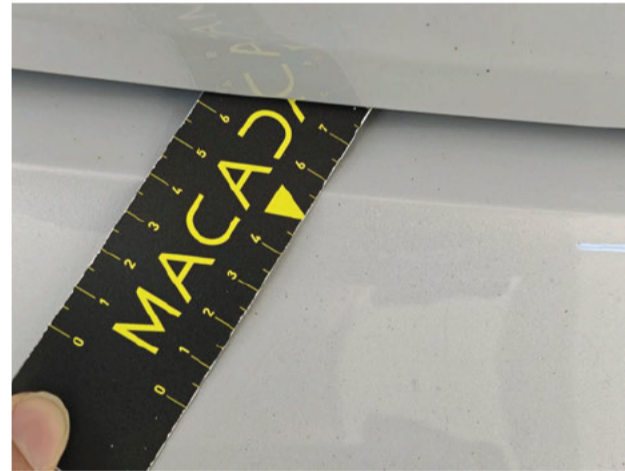
Bumper R
Scratch(es)
Repair and paint (complete)
Rear

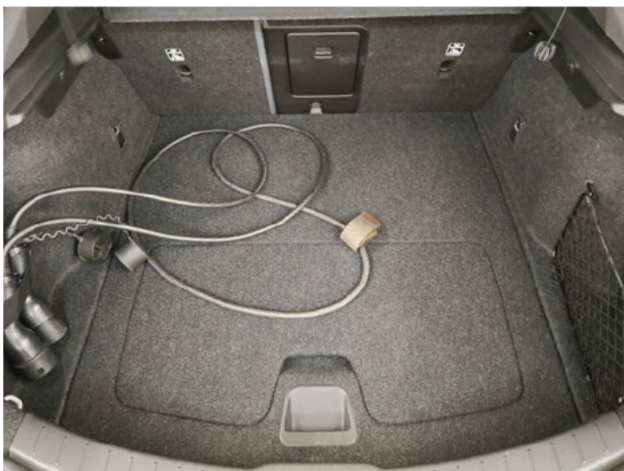
Charging cable (normal)
Missing
Replace
Rear

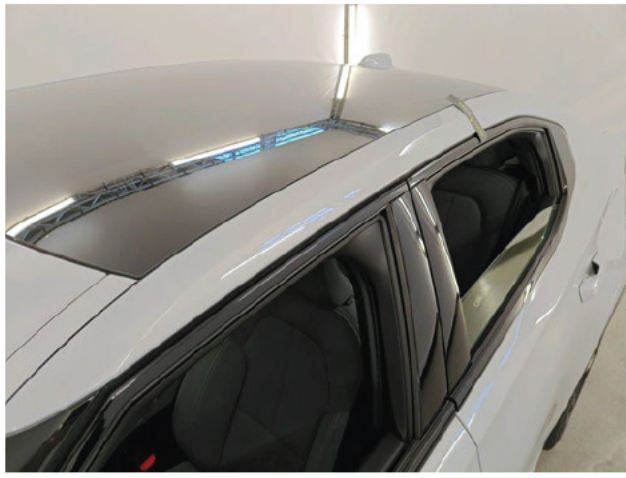
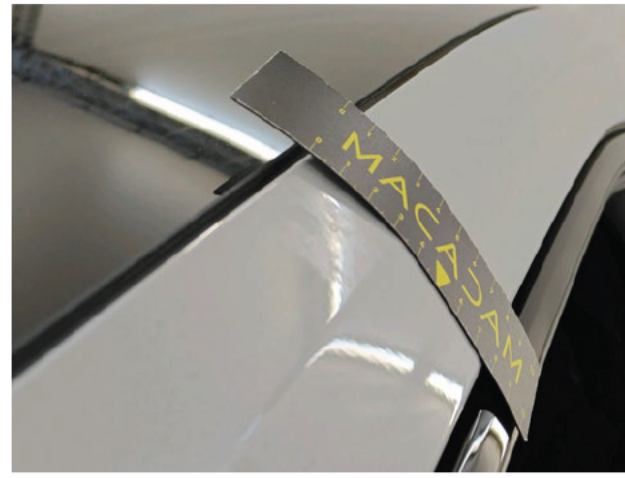
Roof pillar L
 Chemical polution
 Repair and paint (complete)
 Left

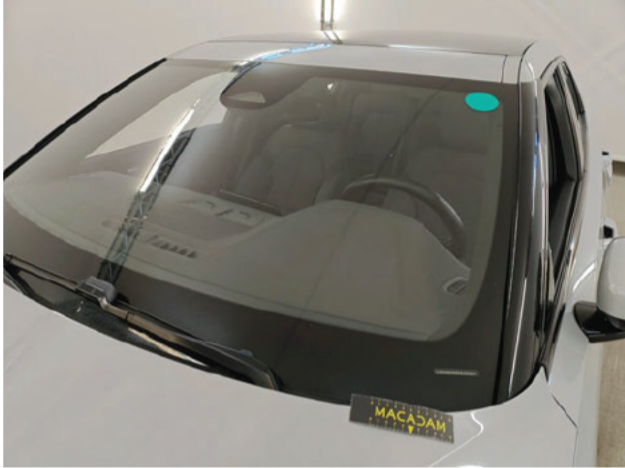
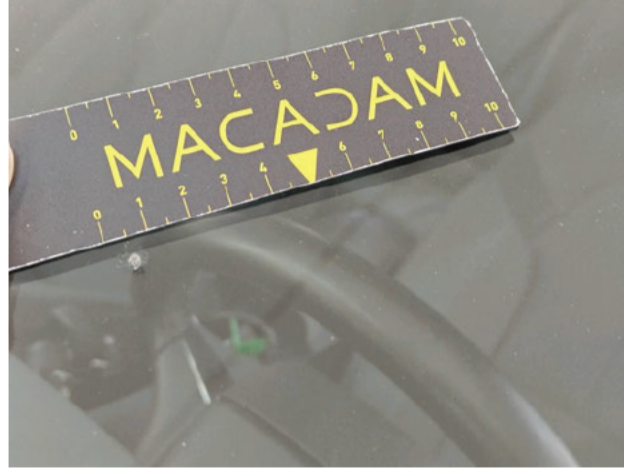
Windscreen
 Stone chip(s)
 Windscreen repair
 Front
