Expertise

Protocol number: 45872571
Order No. / Reference: 26446156
Inspection date: 9 Jun 2026

Model: Focus Turnier 1.5 EcoBlue Start-Stopp-System Aut. TITANIUM

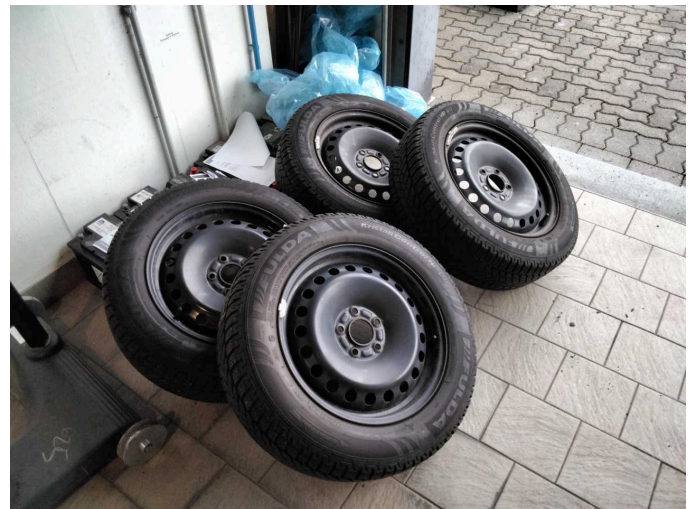
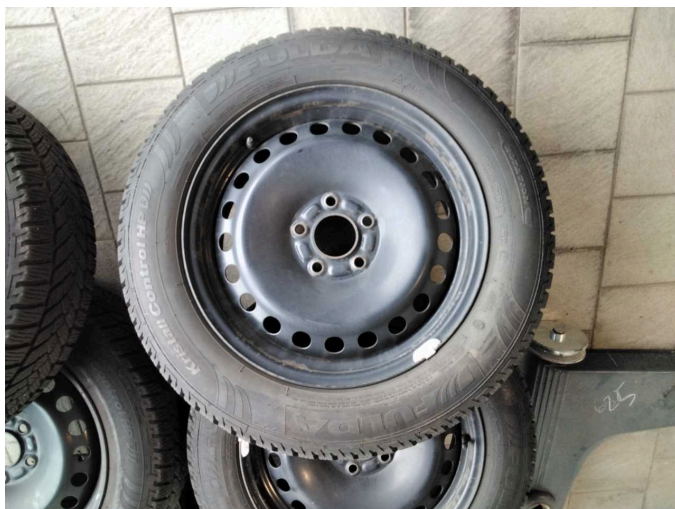
Der beiliegende Radsatz ist nicht Bestandteil der vorliegenden Fahrzeugausstattung.

Figure 16: Additional tyres

Figure 17: Additional tyres

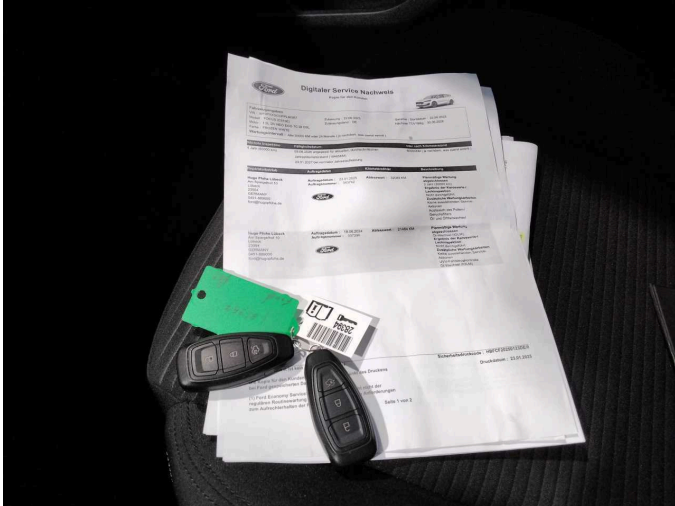
Documents - Log book

Missing part 1: Documents: Log book - Missing - Replace

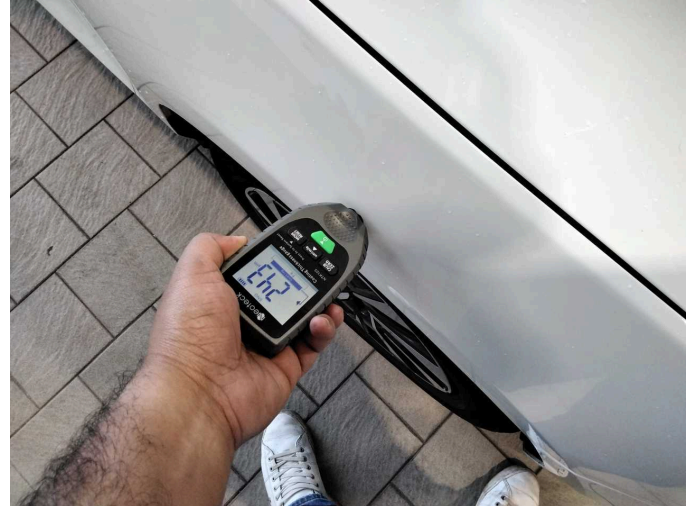
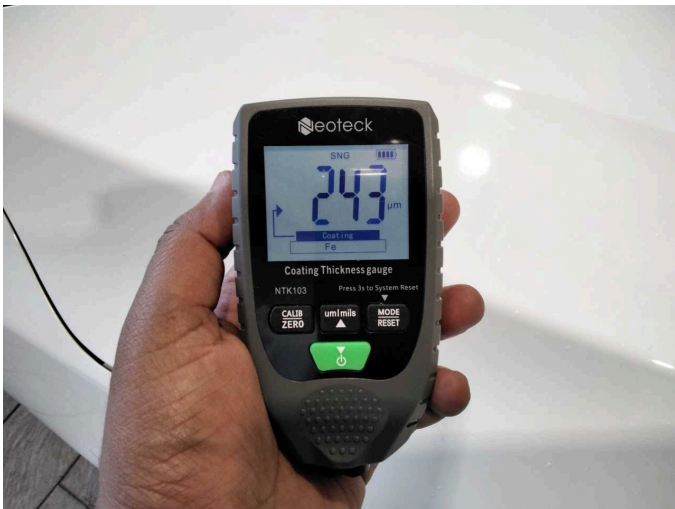
No.	Previous damage	Extent of damage (Net)
1	Side right, Professionally repaired, Invoice of repair done	Non-existent

1 Mudguard - right side, Professionally carried out, Invoice of repair done

Mudguard - right side 243 µm |

Repainting 1: Mudguard - right side
