Expertise

Protocol number: 46404128  
Order No. / Reference: 26539896  
Inspection date: 8 Jul 2026

Manufacturer: Ford

Model: Kuga 2.5 Duratec PHEV VIGNALE

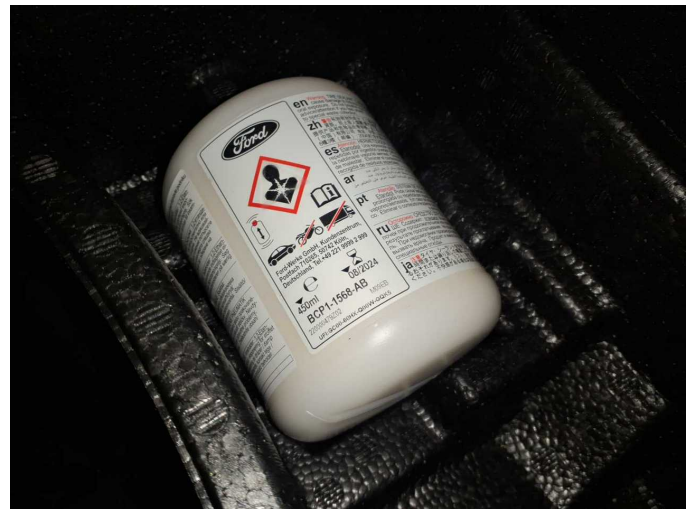
| No. | Component group | Description |
|---|---|---|
| 1 | Equipment | Tirefit filler - Expired - Replace |

Damage 1: Equipment: Tirefit filler - Expired - Replace

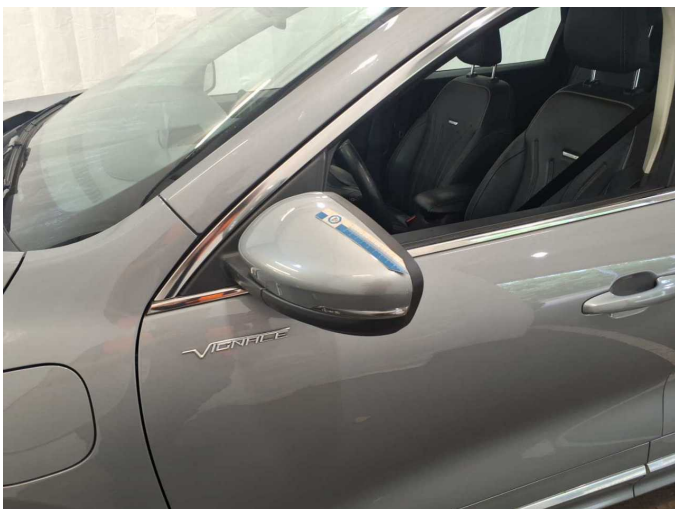
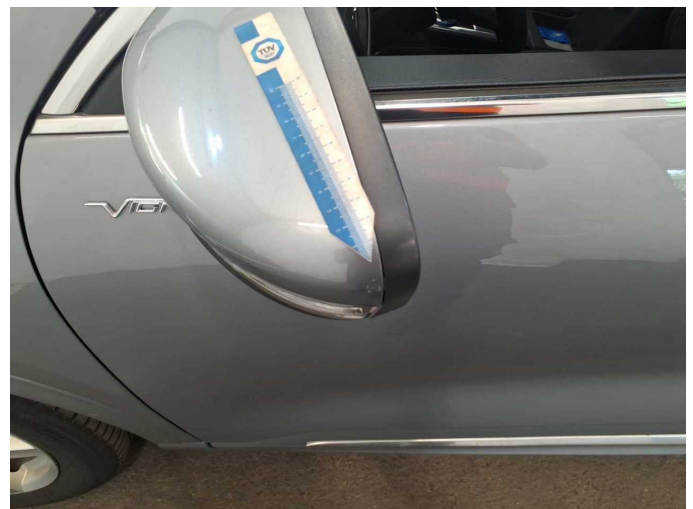
| No. | Component group | Description |
|---|---|---|
| 2 | Wing mirror - left side | Cap - Scratch(es) - Smart repair |

Damage 2: Wing mirror - left side: Cap - Scratch(es) - Smart repair

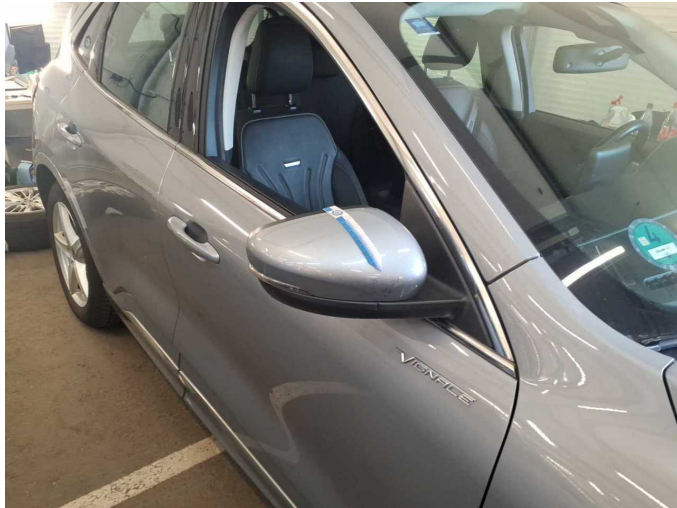
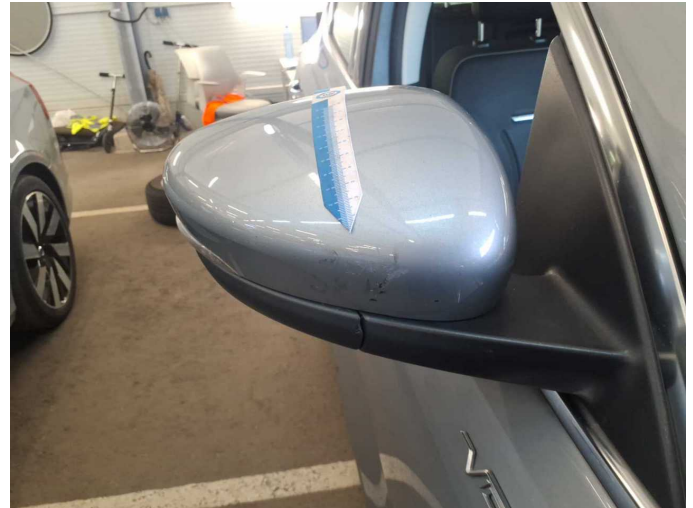
| No. | Component group | Description |
|---|---|---|
| 3 | Wing mirror - right side | Cap - Scratched - Smart repair |

**Damage 3:** Wing mirror - right side: Cap - Scratched - Smart repair

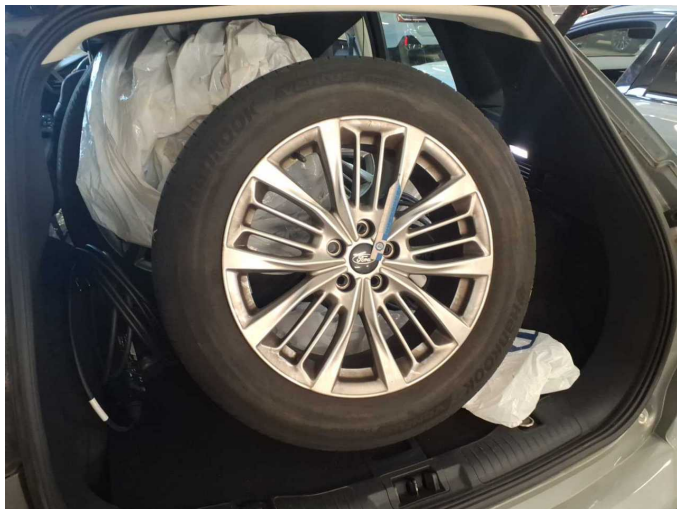
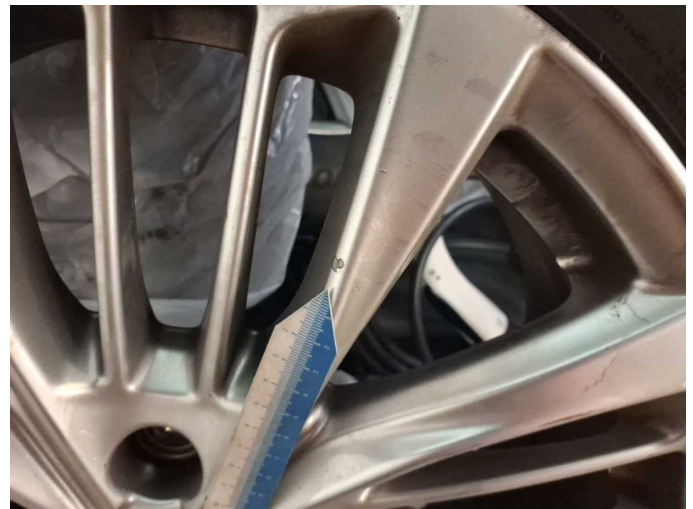
| No. | Component group | Description |
|---|---|---|
| 4 | 2nd wheel set | 1 alloy rim - Scratch(es) - Loss in value |

**Damage 4:** 2nd wheel set: 1 alloy rim - Scratch(es) - Loss in value

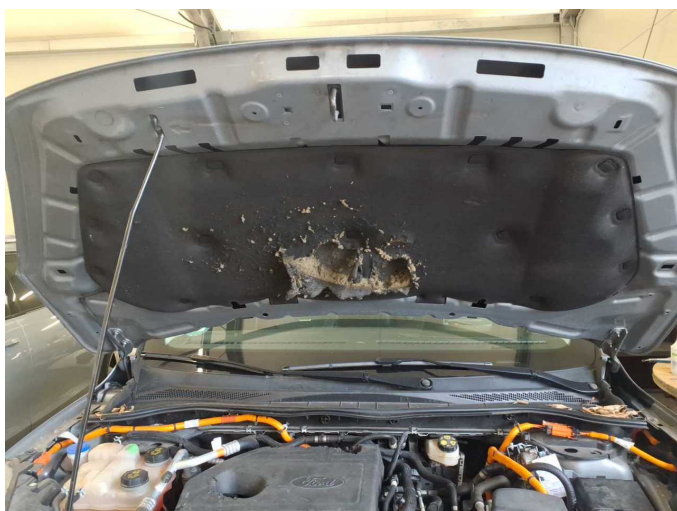
| No. | Component group | Description |
|---|---|---|
| 5 | Bonnet | Insulation lining - Damage caused by marten / rodent - Replace |

**Damage 5:** Bonnet: Insulation lining - Damage caused by marten / rodent - Replace

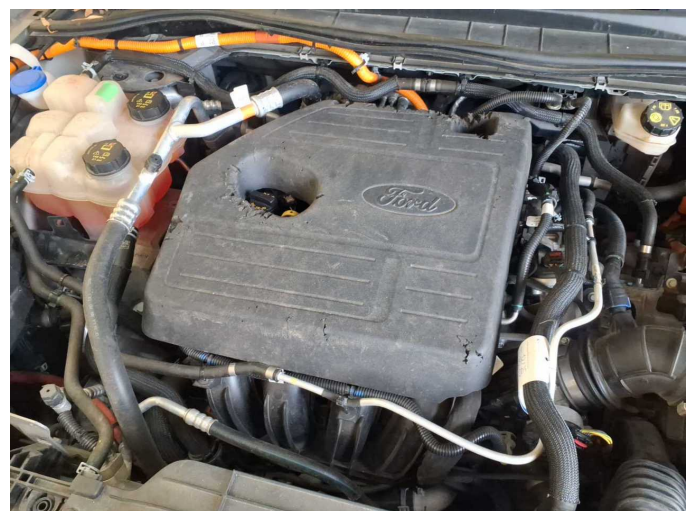
| No. | Component group | Description |
|---|---|---|
| 6 | Engine | Engine cover - Damage caused by marten / rodent - Replace |

**Damage 6:** Engine: Engine cover - Damage caused by marten / rodent - Replace

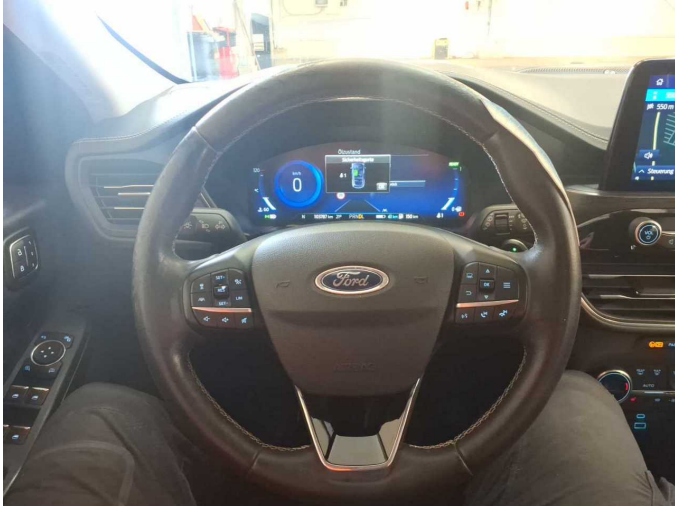
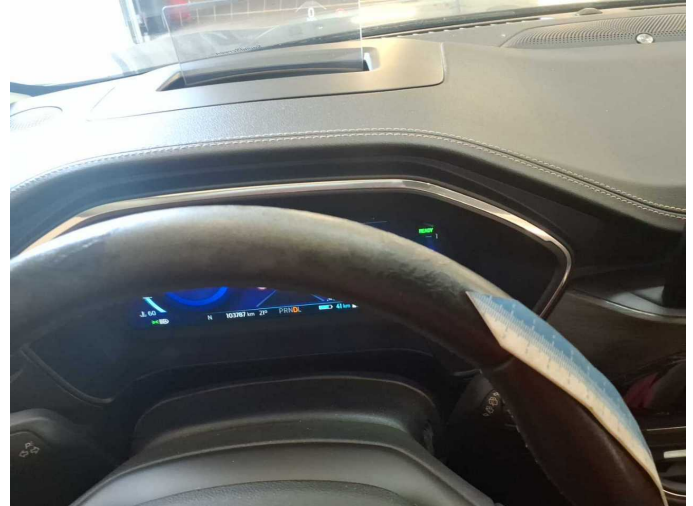
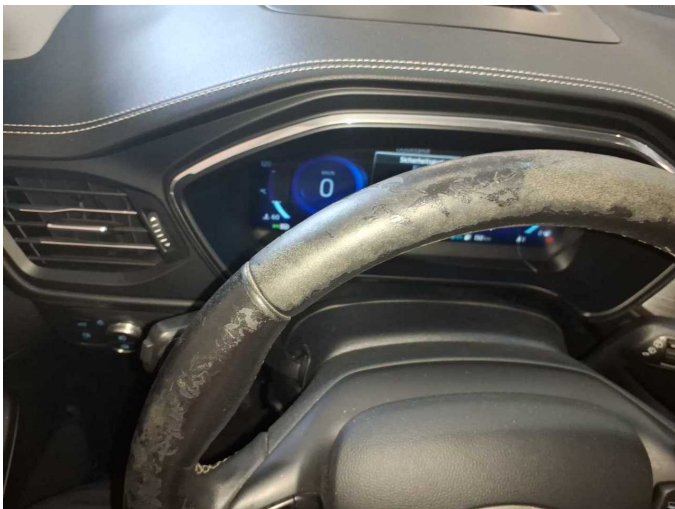
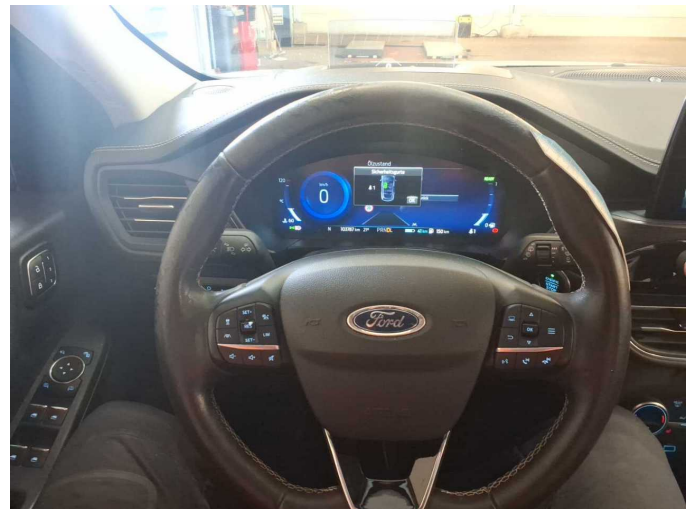
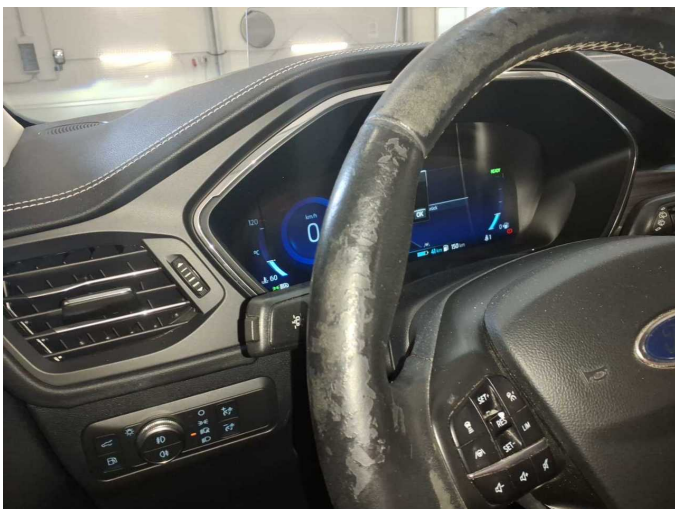
| No. | Component group | Description |
|---|---|---|
| 7 | Steering system | Steering wheel - Glued / labelled - Replace |

**Damage 7:** Steering system: Steering wheel - Glued / labelled - Replace

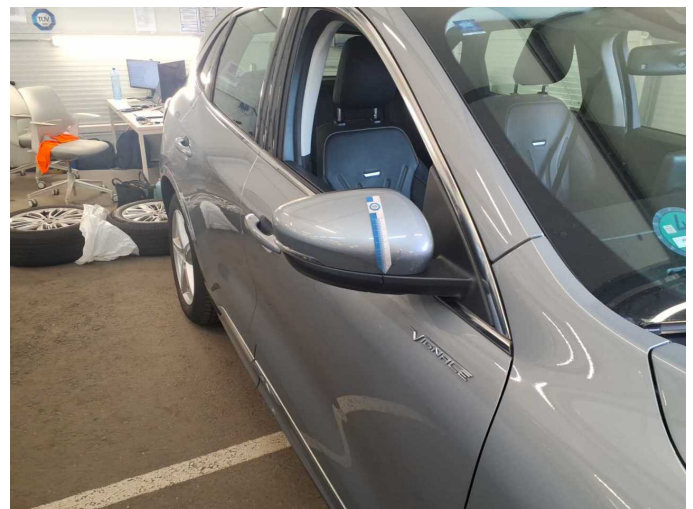
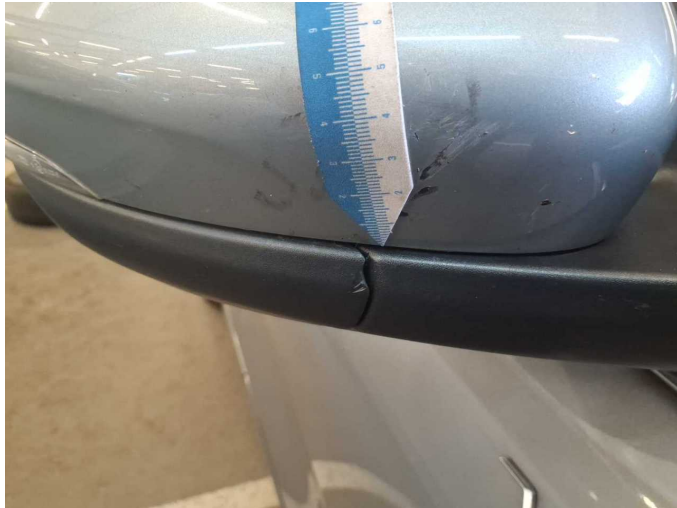
| No. | Component group | Description |
|---|---|---|
| 8 | Wing mirror - right side | Mirror housing - Scratch(es) - Replace |

**Damage 8:** Wing mirror - right side: Mirror housing - Scratch(es) - Replace

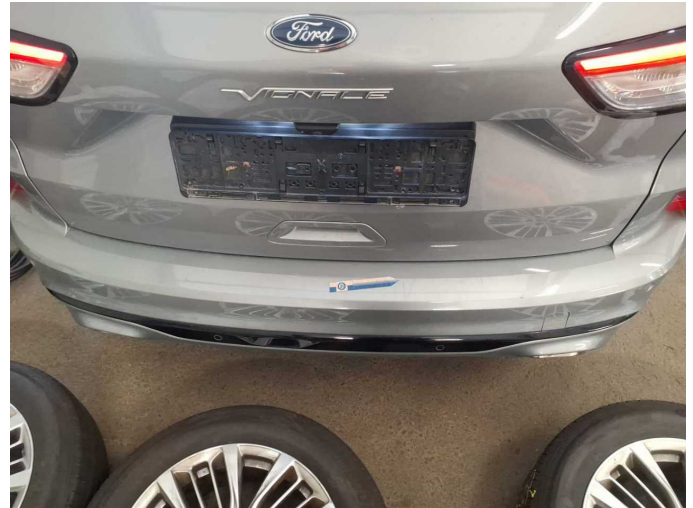
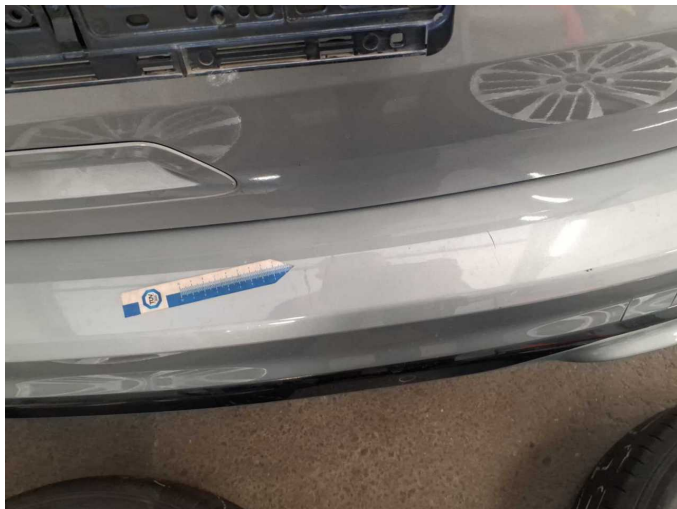
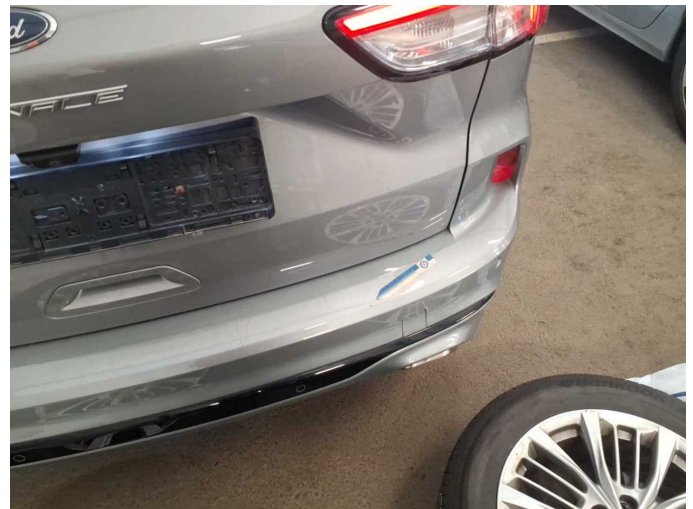
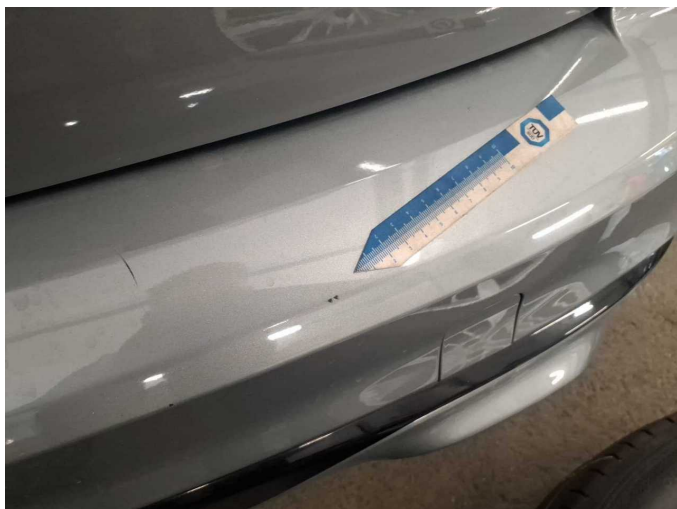
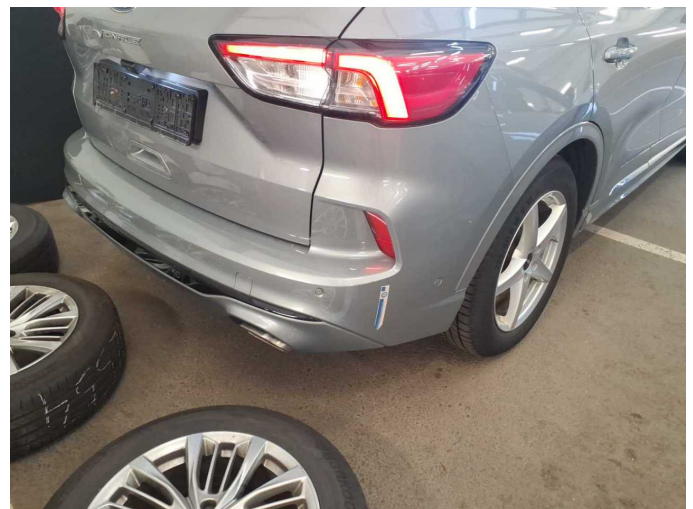
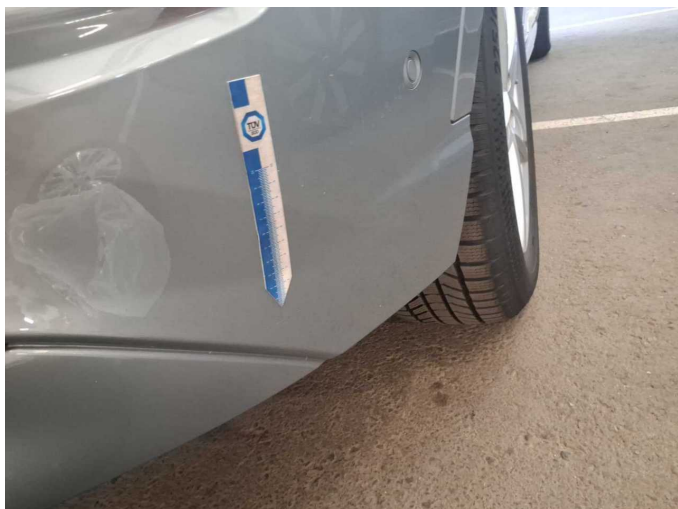
| No. | Component group | Description |
|---|---|---|
| 9 | Rear bumper | Rear bumper - Scratched - Paint |

**Damage 9:** Rear bumper: Rear bumper - Scratched - Paint

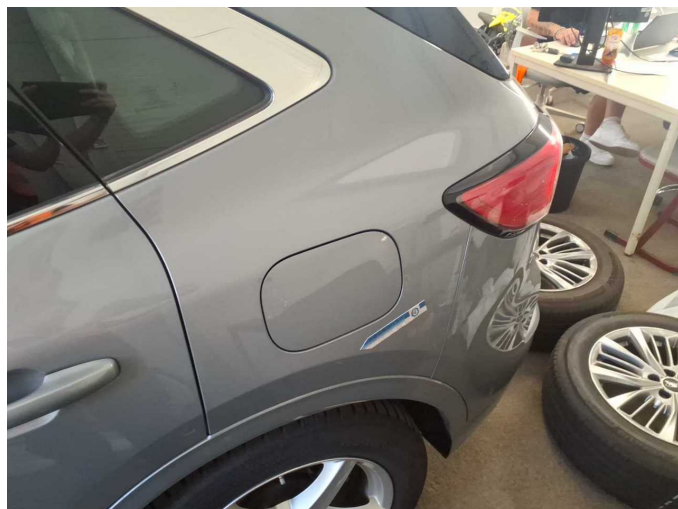
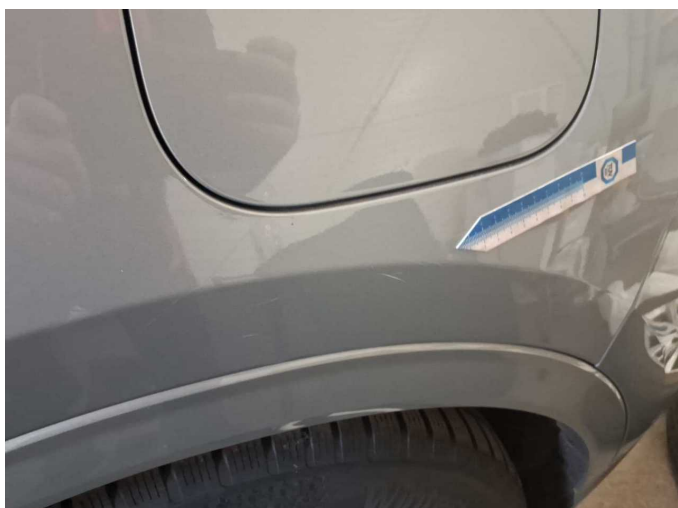
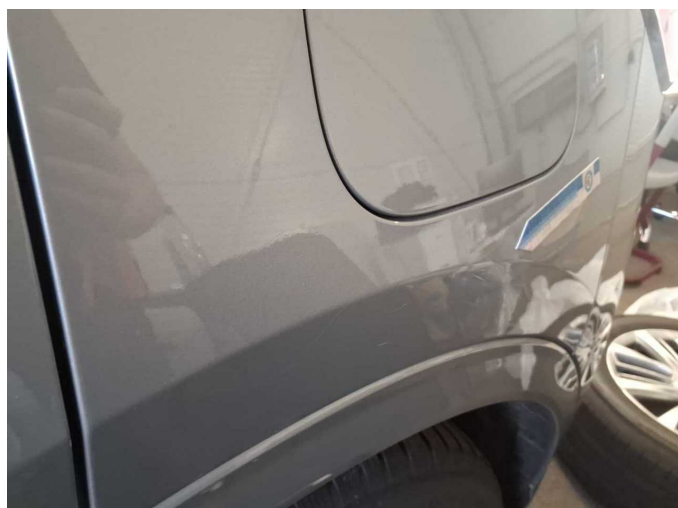
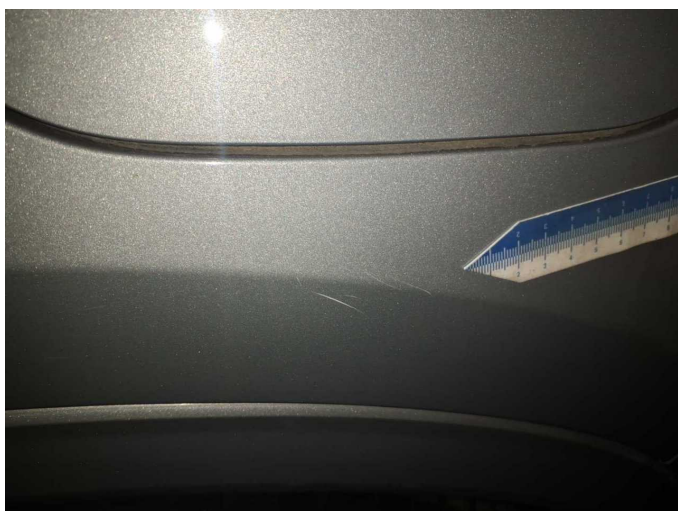
| No. | Component group | Description |
|---|---|---|
| 10 | Side panel - rear left side | Side panel - Scratch(es) - Paint |

**Damage 10:** Side panel - rear left side: Side panel - Scratch(es) - Paint

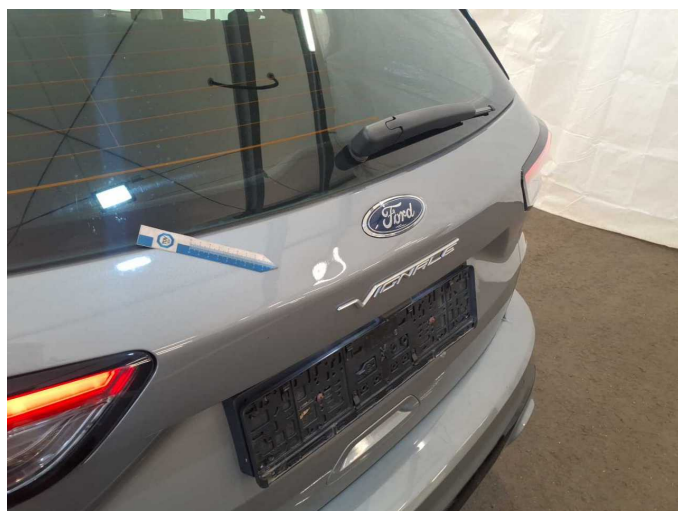
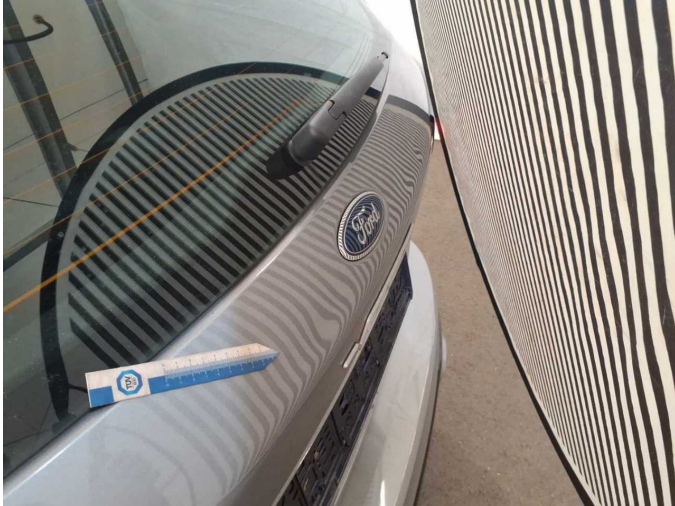
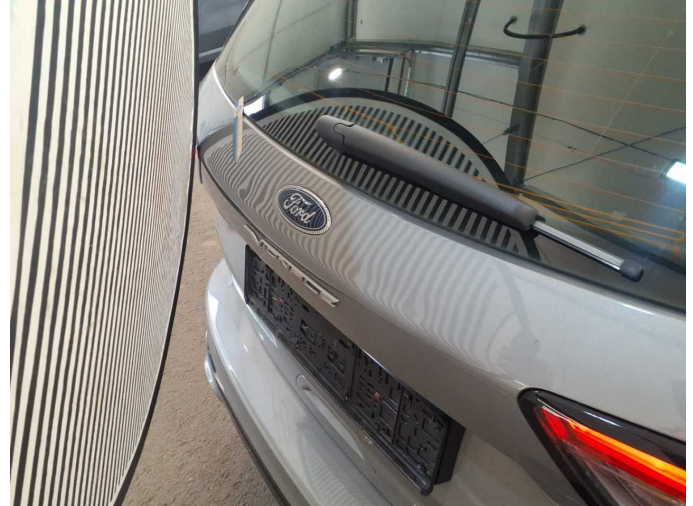
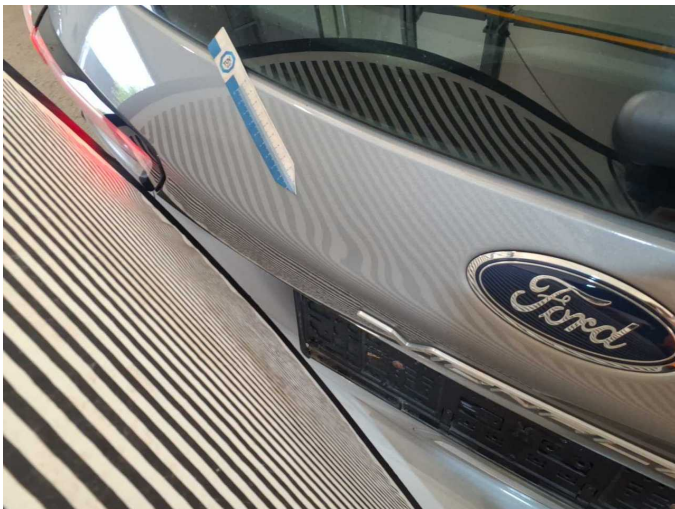
| No. | Component group | Description |
|---|---|---|
| 11 | Boot lid / rear door | Boot lid - dent(s) - Repair and paint |

**Damage 11:** Boot lid / rear door: Boot lid - dent(s) - Repair and paint

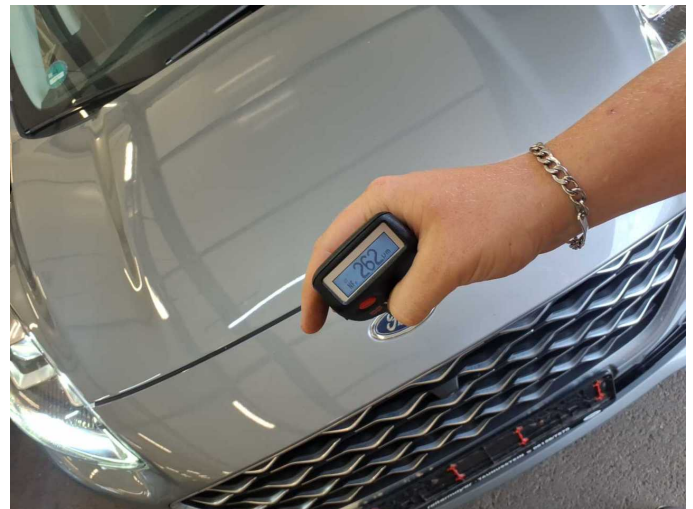
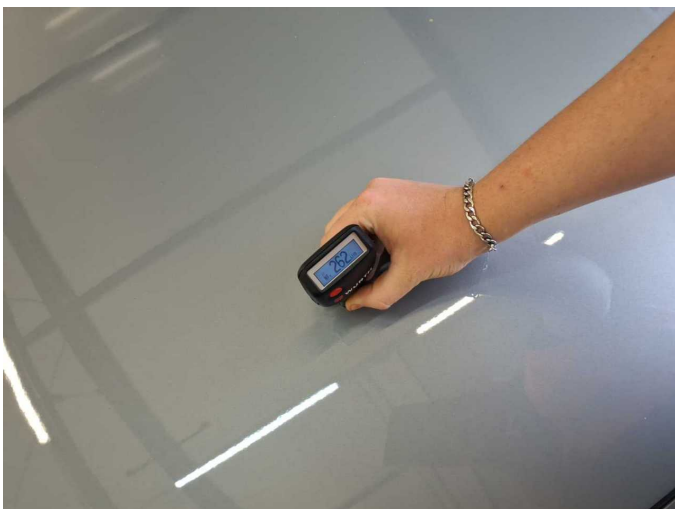
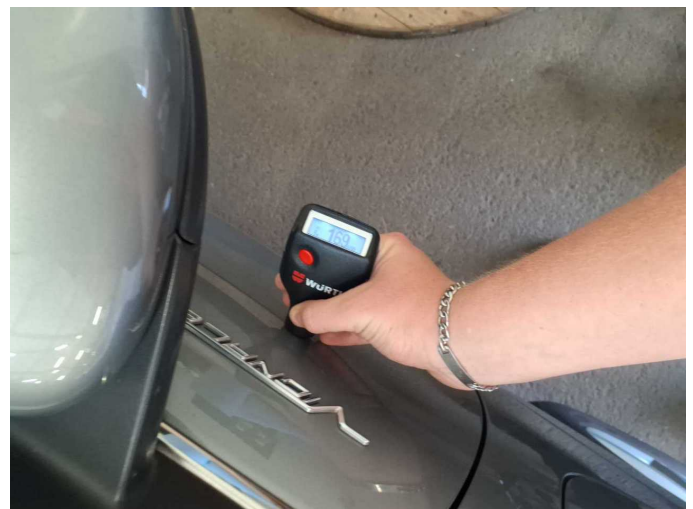
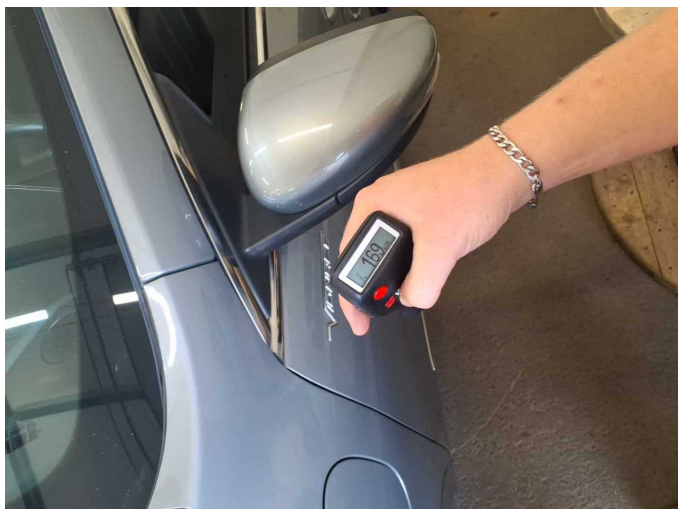
| No. | Repainting |
|---|---|
| 1 | Bonnet, Door - front left side, Professionally carried out |

| Bonnet | 262 µm | Door - front left side | 169 µm |

**Repainting 1:** Bonnet, Door - front left side
