Expertise

Protocol number: 46193234
Order No. / Reference: 26151800
Inspection date: 21 May 2026

Manufacturer: Mercedes-Benz

Model: Vito 116 CDI Extralang HA Aut. PRO

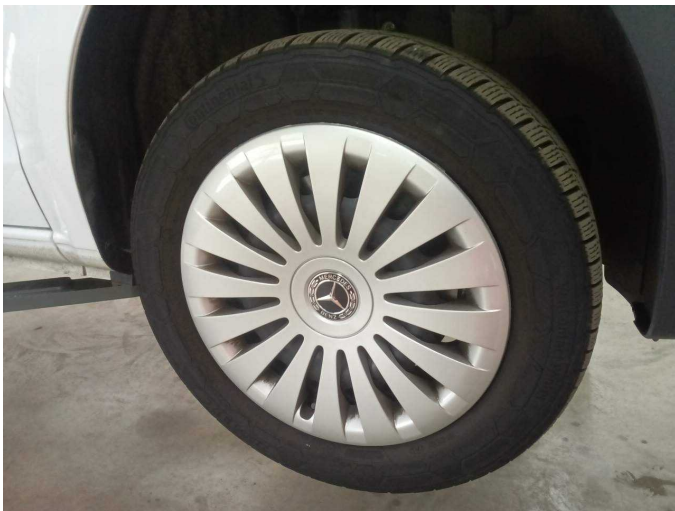
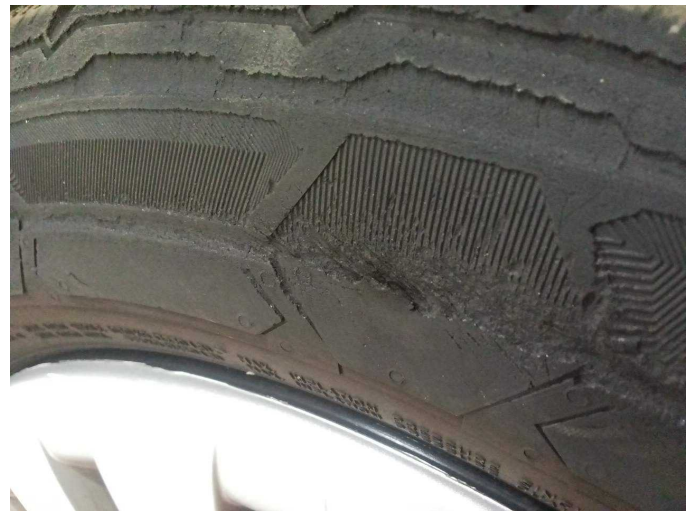
Damage 3: Wheel / tyres: Tyre - front right side - Porous / cracked - Replace

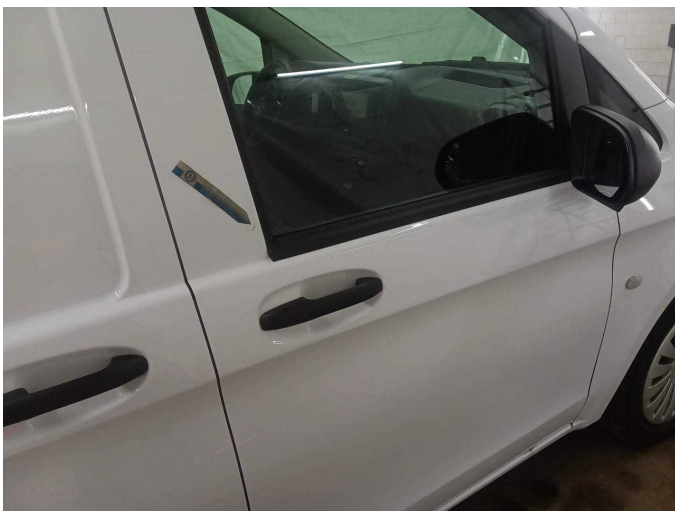
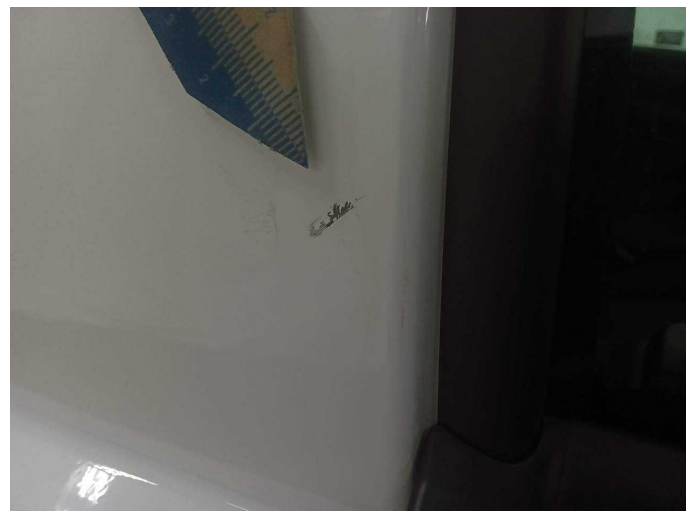
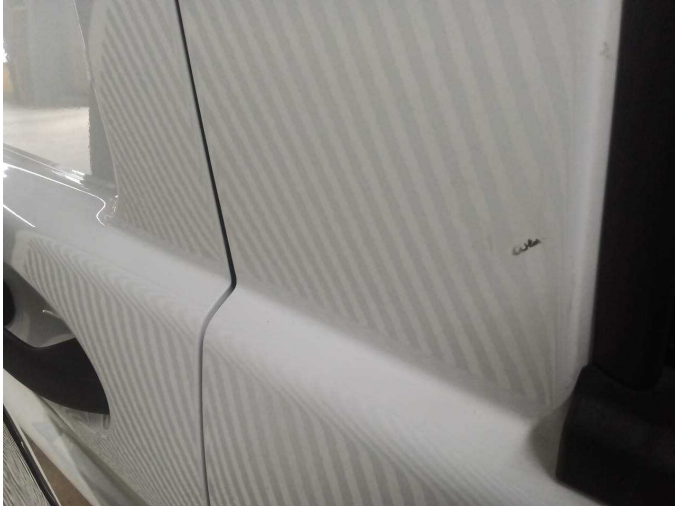
Damage 4: Door - front right side: Door - Dent / paintcoat damage - Smart repair

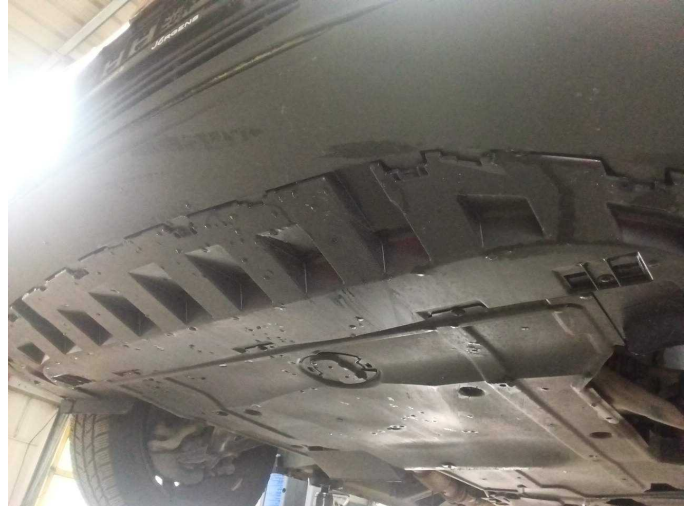
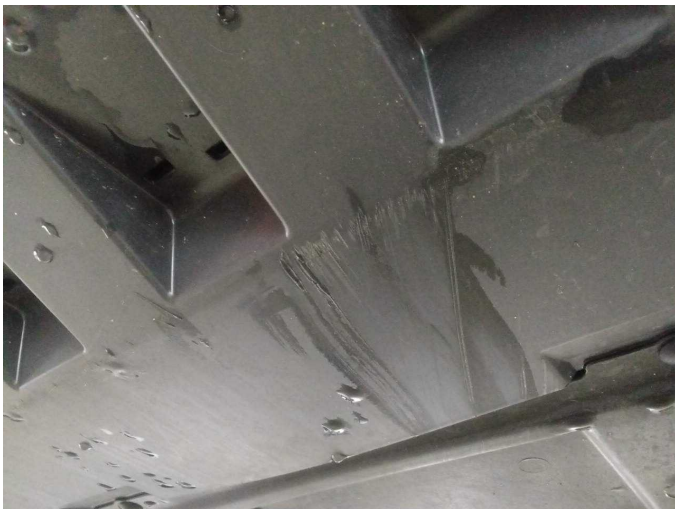
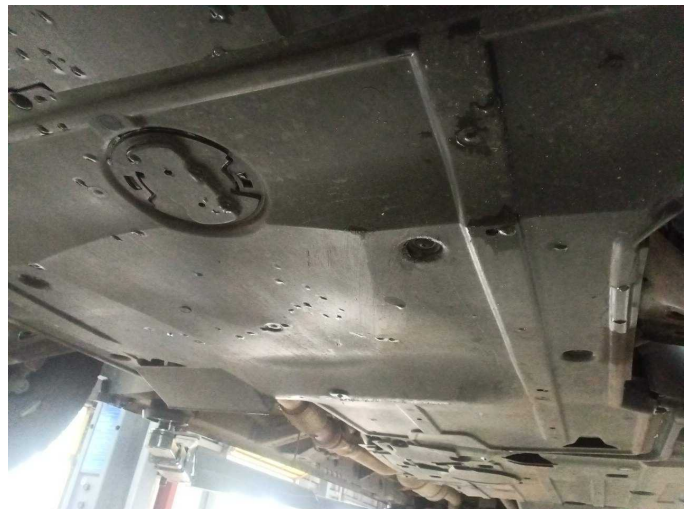
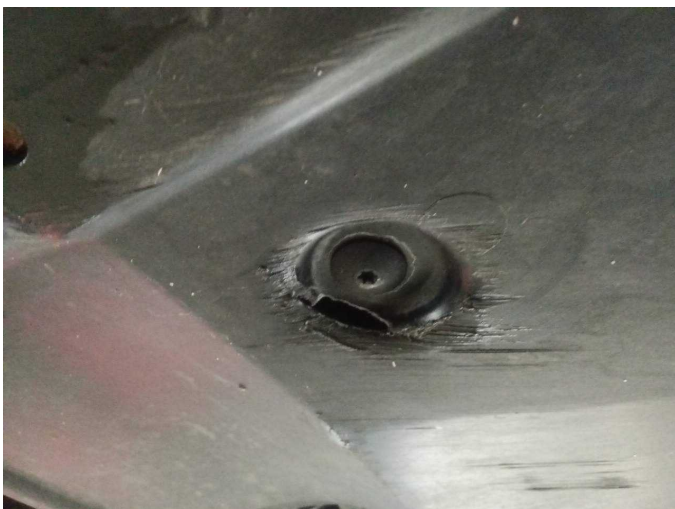
Damage 5: Body: Underbody panelling - Scratched - Replace

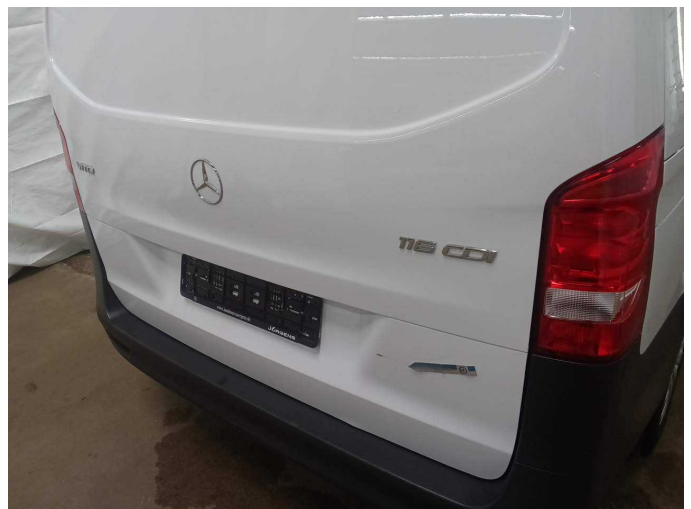
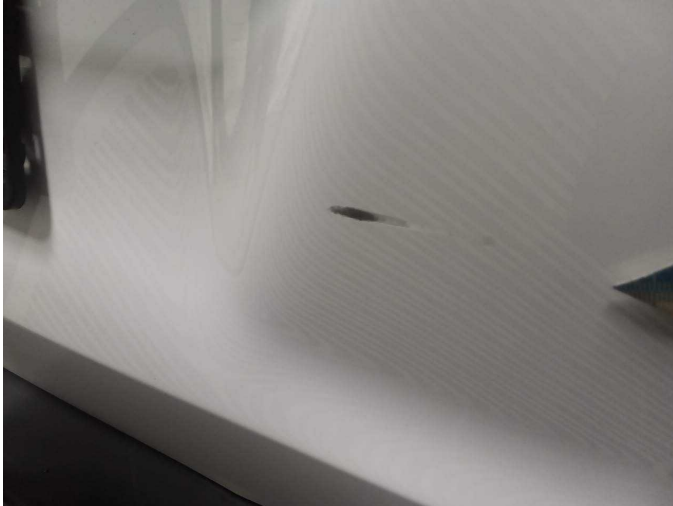
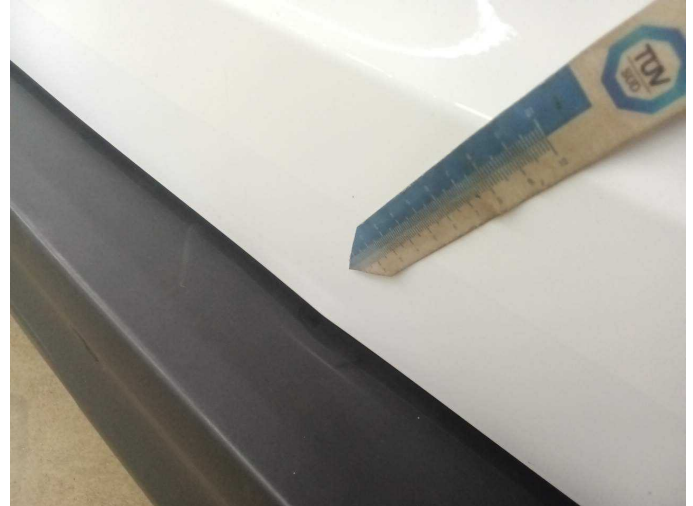
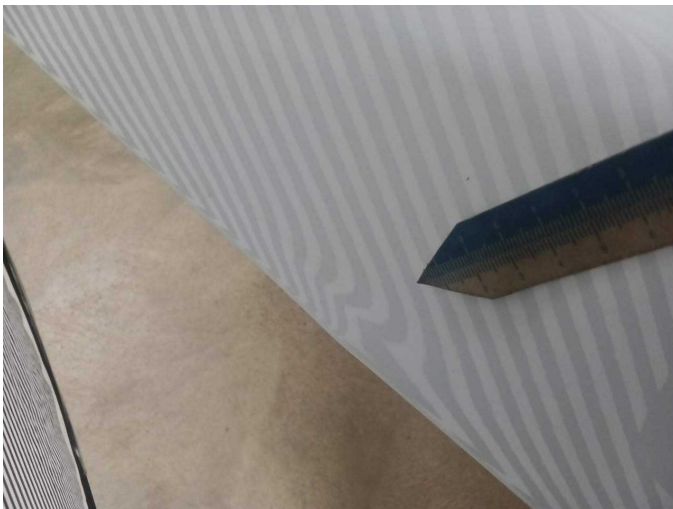
Damage 6: Boot lid / rear door: Boot lid - Dent / paintcoat damage - Repair and paint

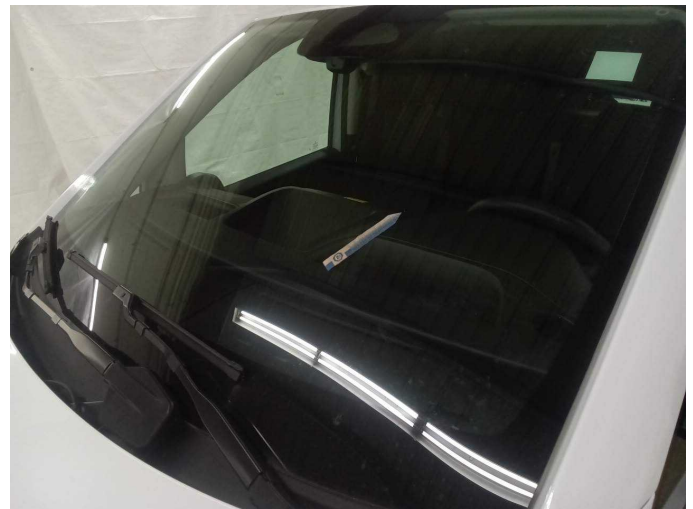
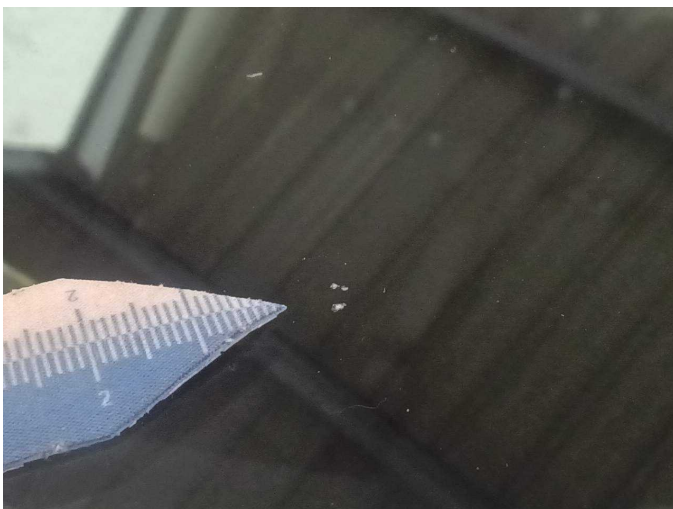
Wear and tear 3: Vehicle glazing: Windscreen - Stone chips - No deduction
