Expertise

Protocol number: 46326154  
Order No. / Reference: 26474789  
Inspection date: 24 Jun 2026

Manufacturer: Mazda

Model: 2 SKYACTIV-G 90 M HYBRID Homura

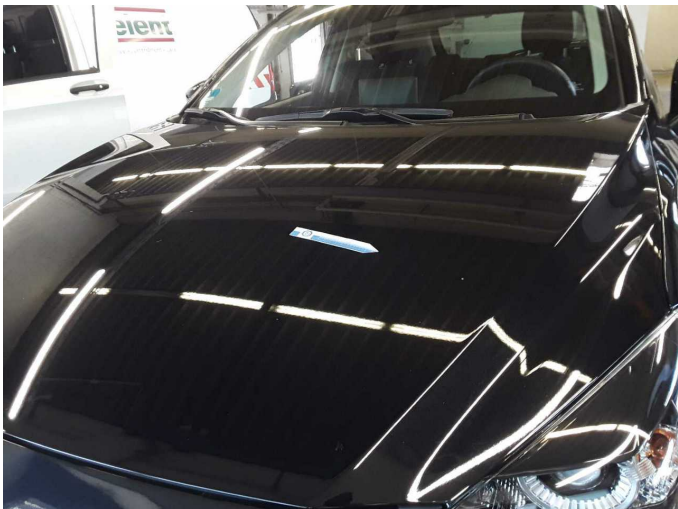
| No. | Component group | Description |
|---|---|---|
| 1 | Bonnet | Bonnet - dent(s) - Smooth repair work |

Damage 1: Bonnet: Bonnet - dent(s) - Smooth repair work

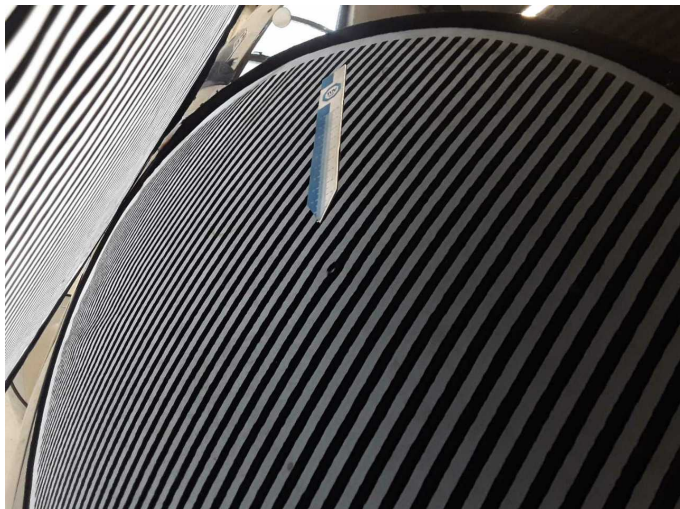
Damage 1: Bonnet: Bonnet - dent(s) - Smooth repair work

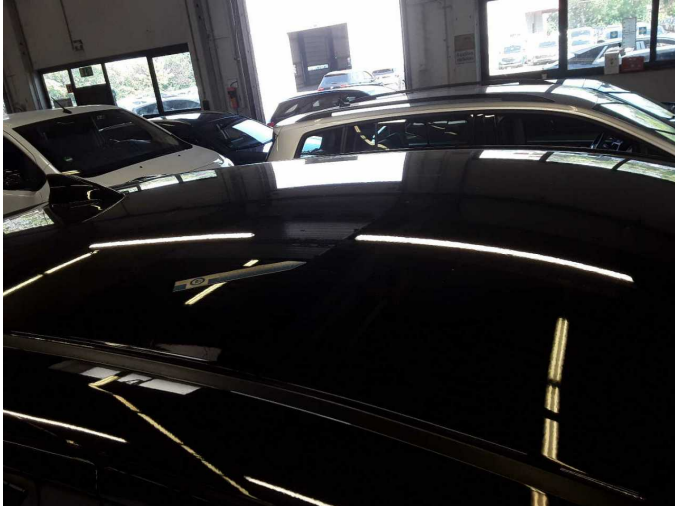
| No. | Component group | Description |
|---|---|---|
| 2 | Roof | Roof - dent(s) - Smooth repair work |

**Damage 2:** Roof: Roof - dent(s) - Smooth repair work

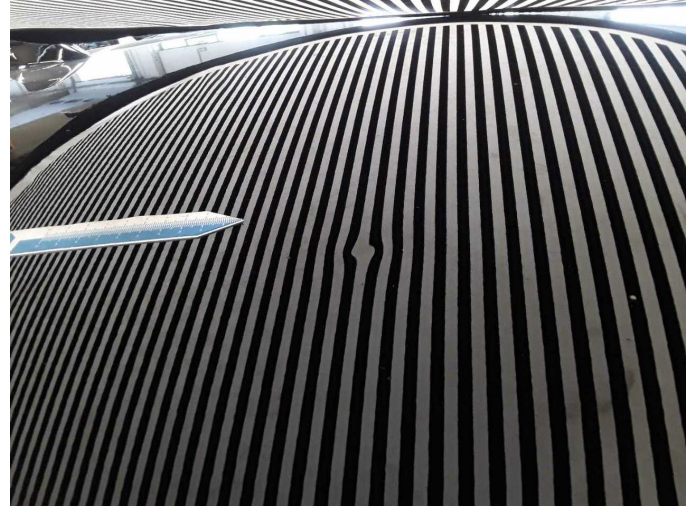
**Damage 2:** Roof: Roof - dent(s) - Smooth repair work

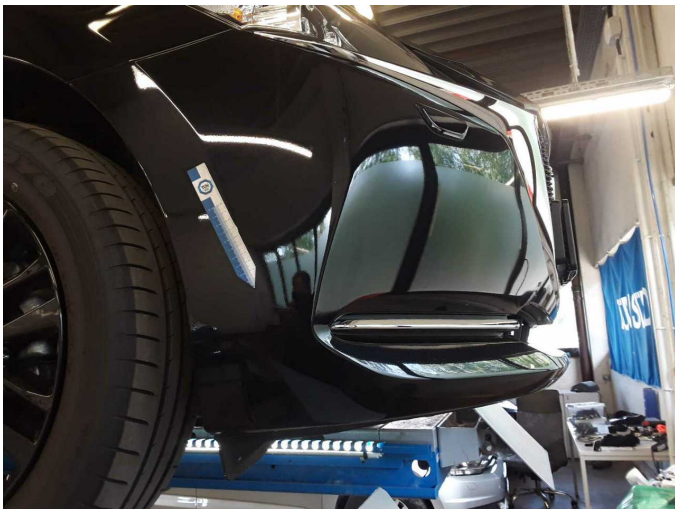
| No. | Component group | Description |
|---|---|---|
| 3 | Front bumper | Front bumper - Scratch(es) - Smart repair |

**Damage 3:** Front bumper: Front bumper - Scratch(es) - Smart repair

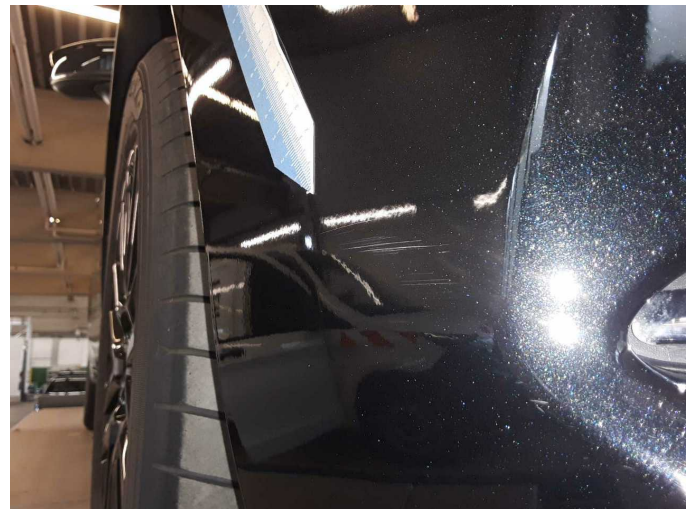
**Damage 3:** Front bumper: Front bumper - Scratch(es) - Smart repair

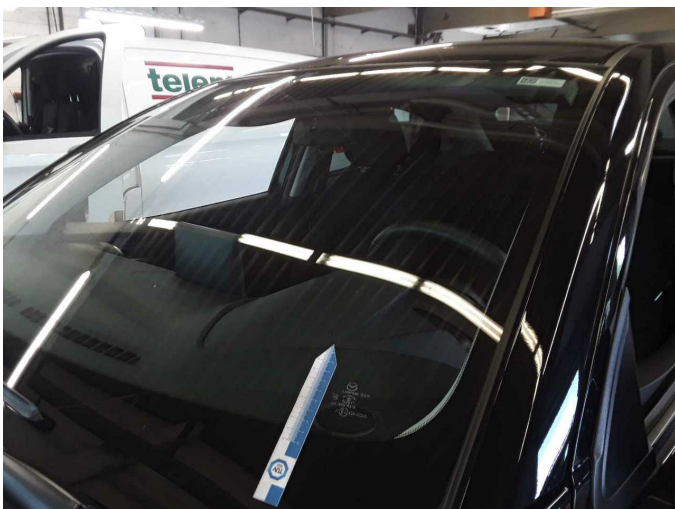
| No. | Component group | Description |
|---|---|---|
| 1 | Vehicle glazing | Windscreen - Stone chips - No deduction |

**Wear and tear 1:** Vehicle glazing: Windscreen - Stone chips - No deduction

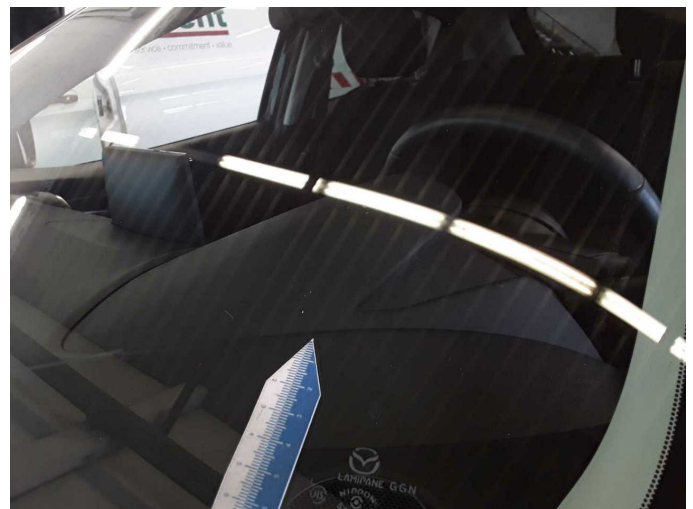
**Wear and tear 1:** Vehicle glazing: Windscreen - Stone chips - No deduction

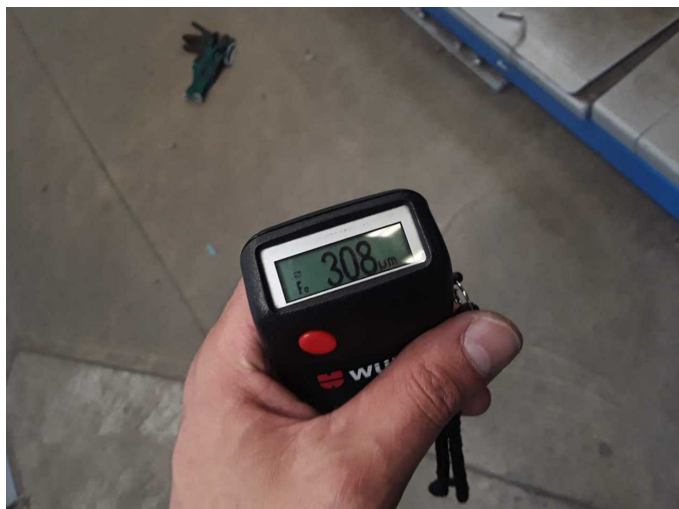
| No. | Repainting |
|---|---|
| 1 | Door - rear right side, Professionally carried out, Invoice of repair done Non-existent |

**Repainting 1:** Door - rear right side

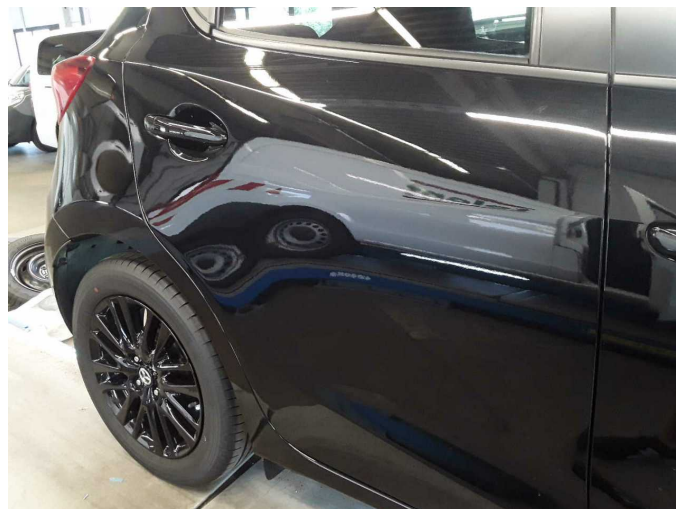
**Repainting 1:** Door - rear right side
