Expertise

Protocol number: 46332227
Order No. / Reference: 26185504
Inspection date: 2 Jul 2026

Model: Vito 116 CDI Extralang HA Aut. PRO

VIN: W1VVLCEZ6T4567731

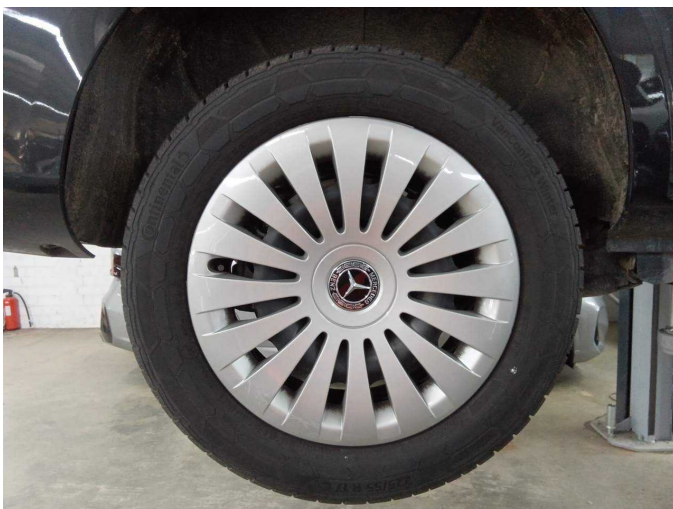
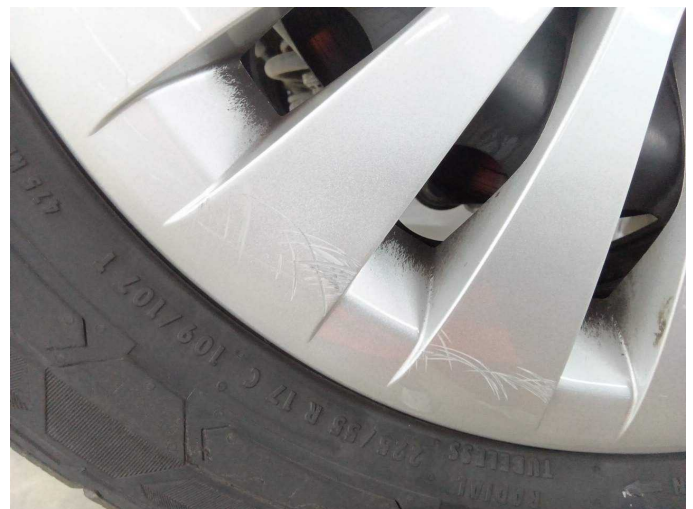
Damage 1: Wheel / tyres: Wheel cover - rear right side - Scratch(es) - Replace

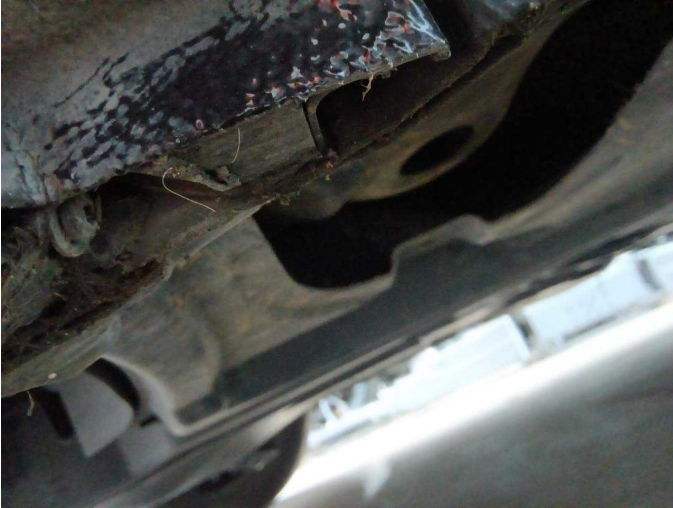
Damage 2: Sill - left side: Jacking point - front - Missing - Replace

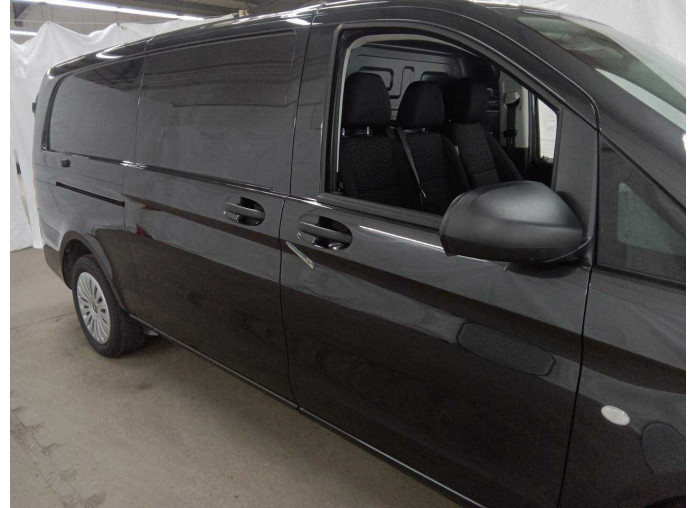
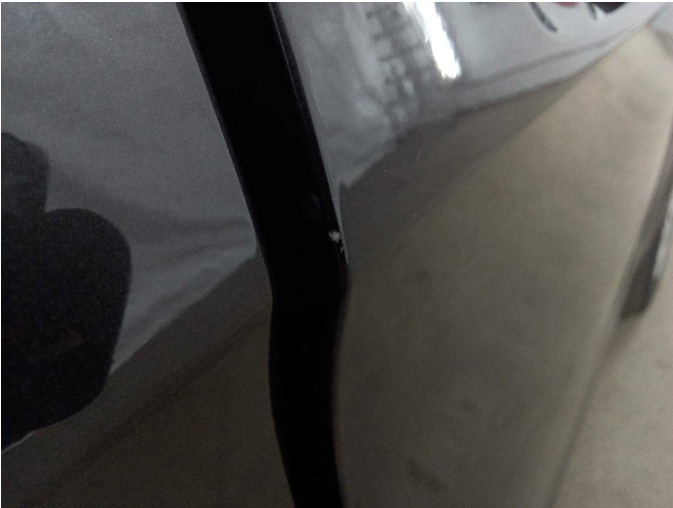
Damage 3: Door - front right side: Door edge - Scratch(es) - Smart repair

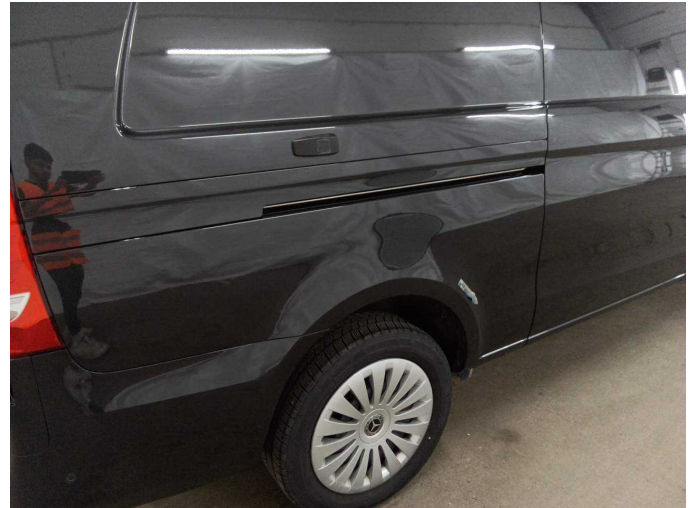
Damage 4: Side panel - rear right side: Mudguard - rear right side - Stone chips - Smart repair

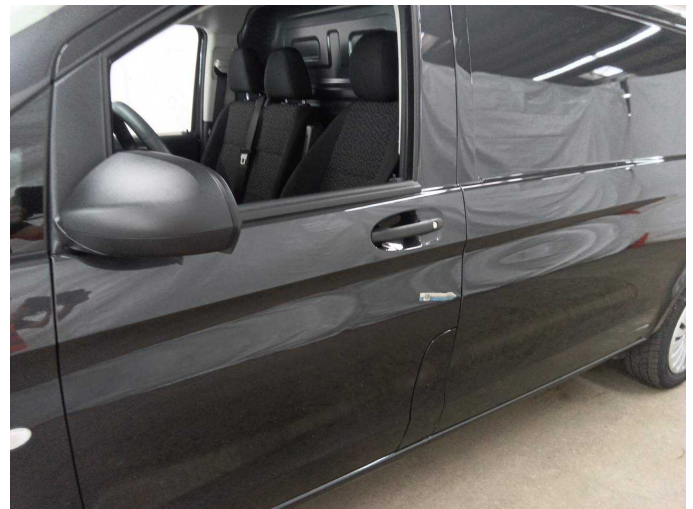
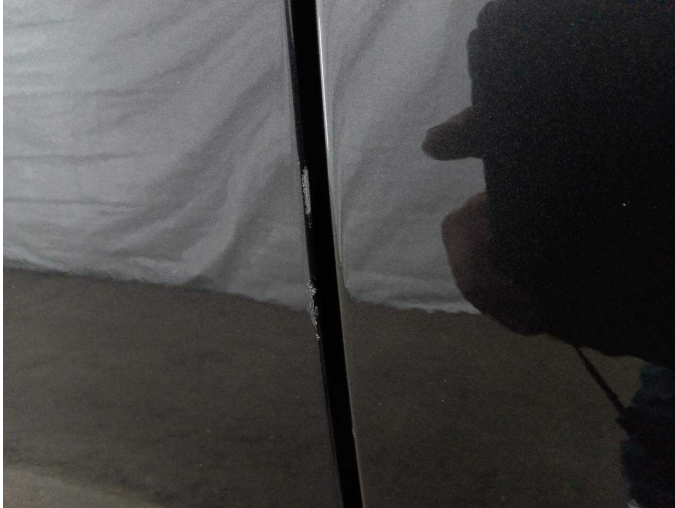
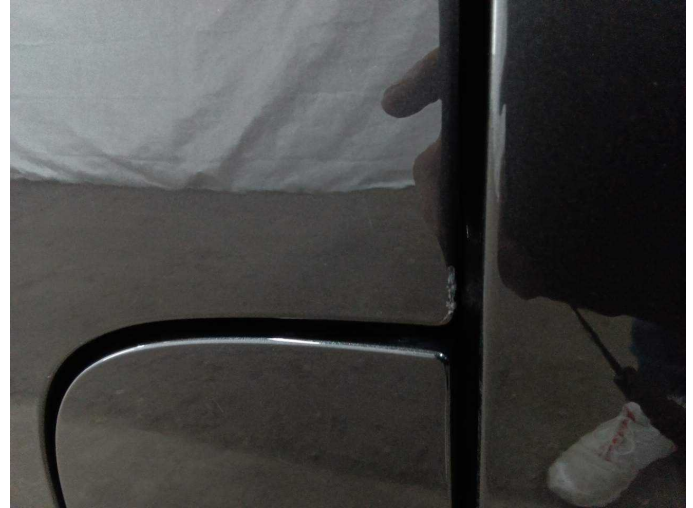
Damage 5: Door - front left side: Door edge - Scratch(es) - Smart repair

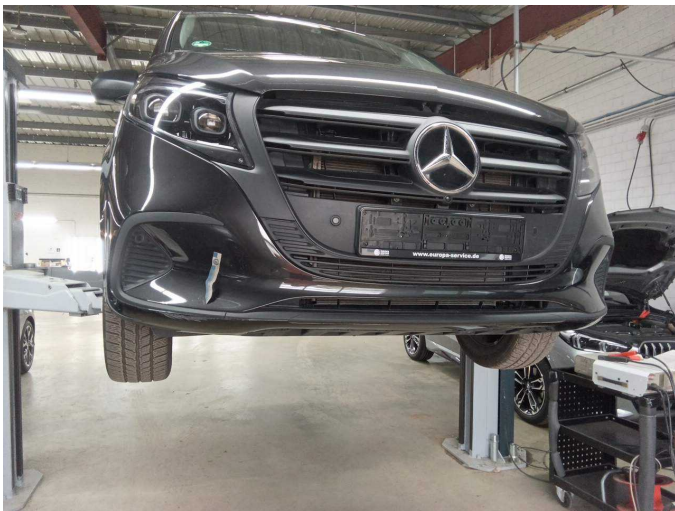
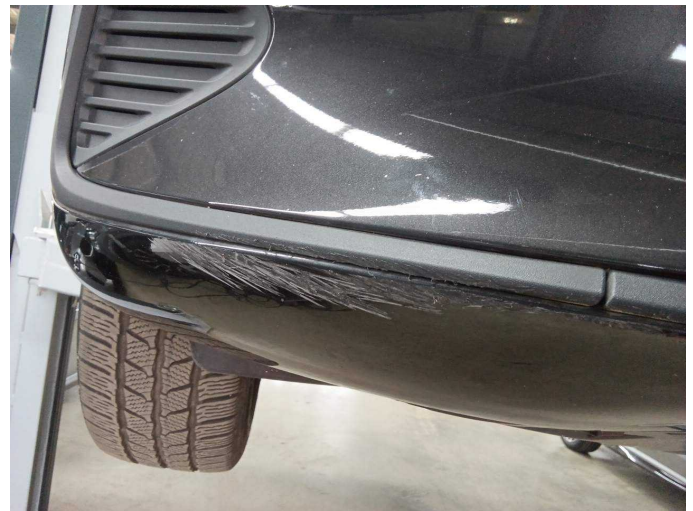
Damage 6: Front bumper: Front bumper - Scratch(es) - Paint

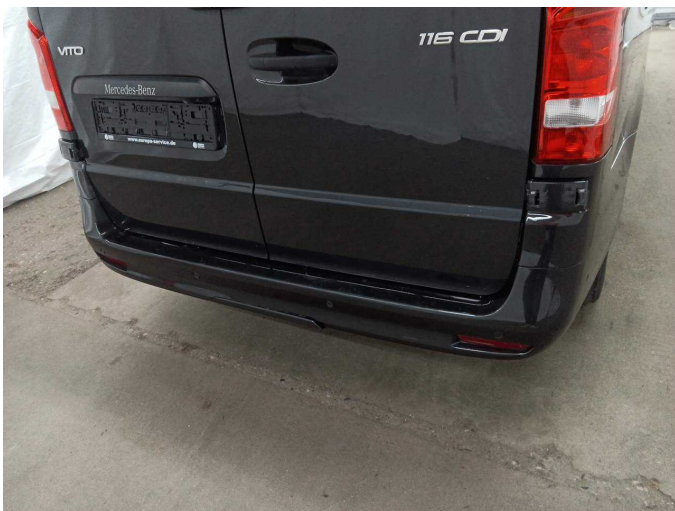
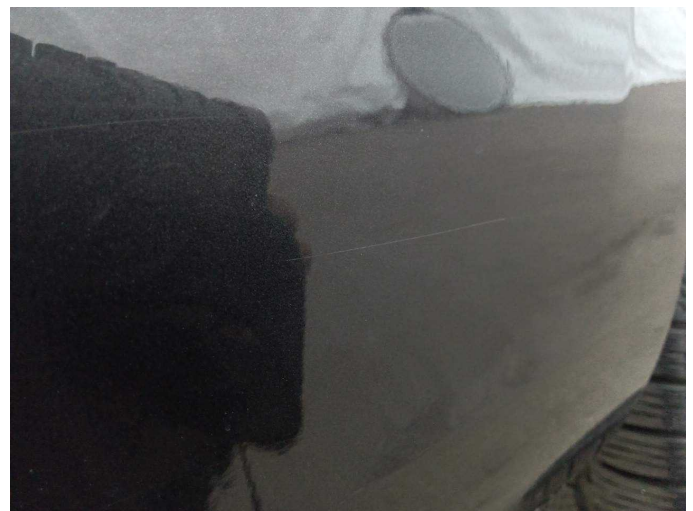
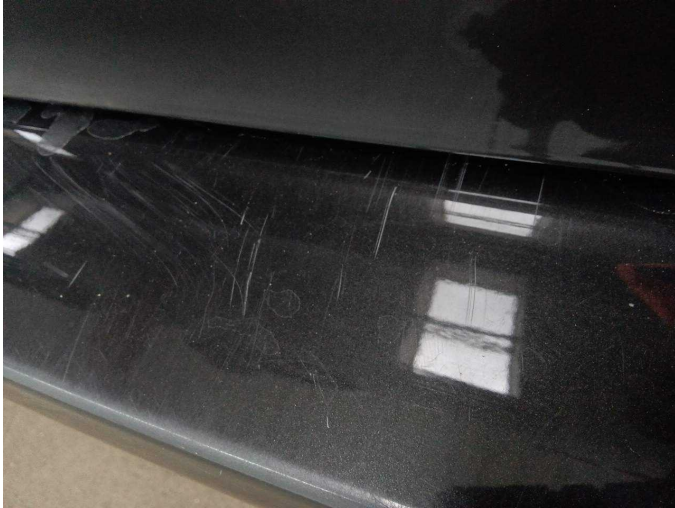
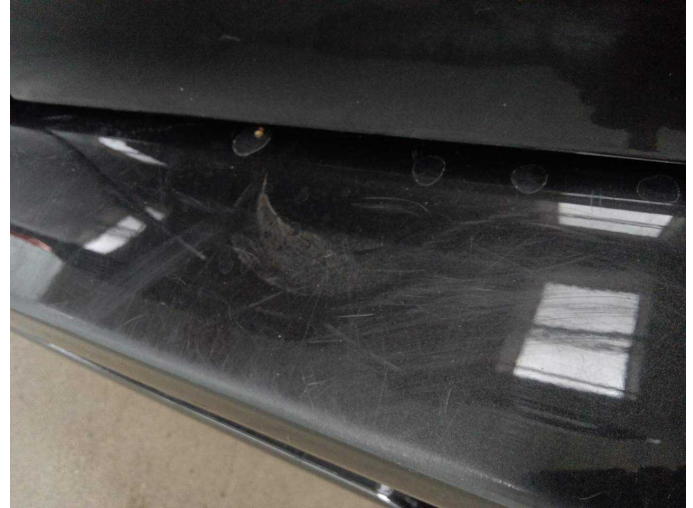
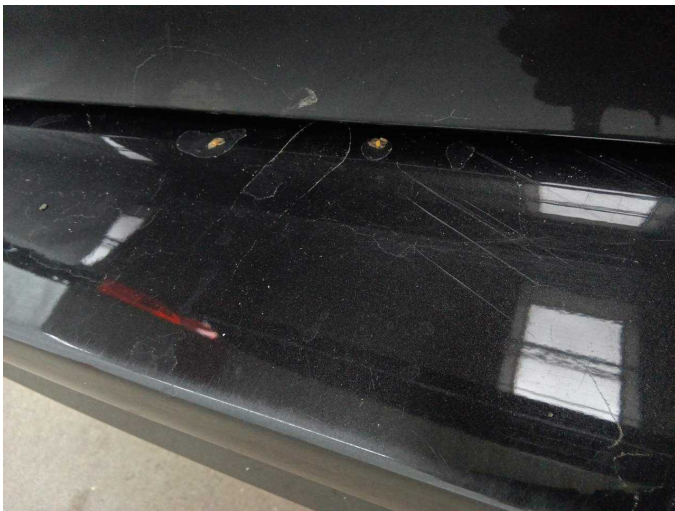
Damage 7: Rear bumper: Rear bumper - Scratch(es) - Paint

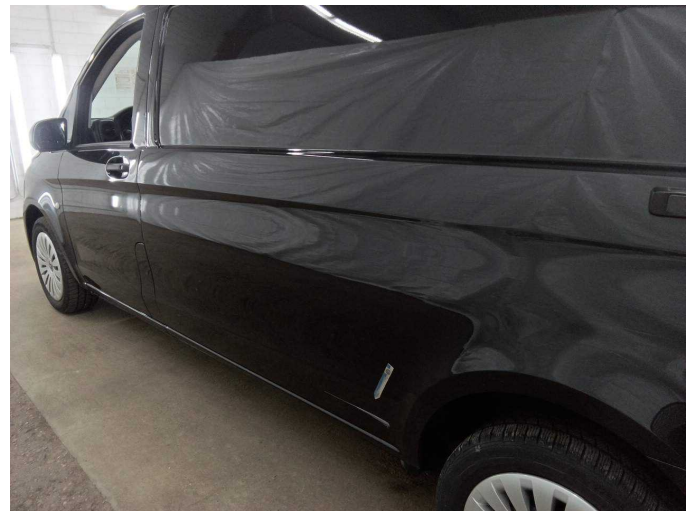
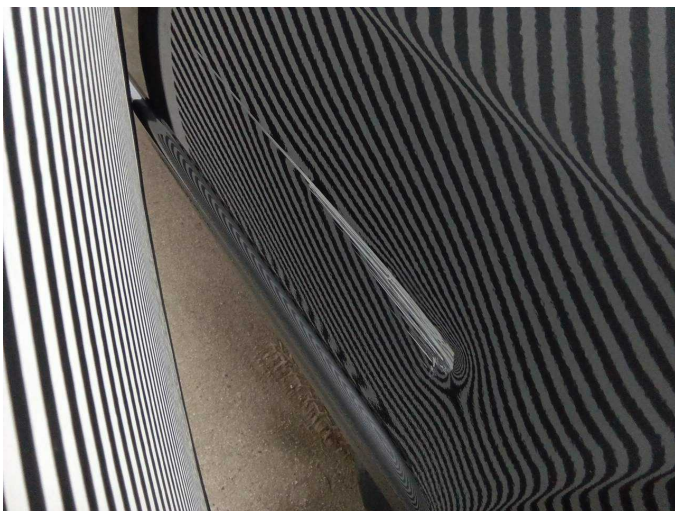
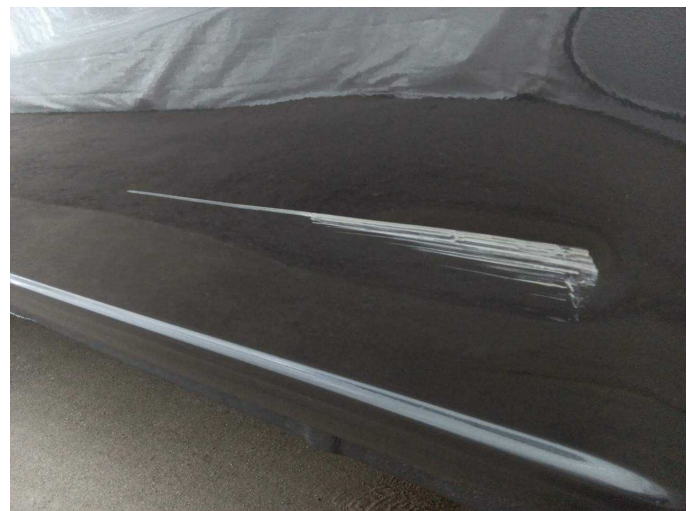
Damage 8: Side panel - rear left side: Side panel - Dent / paintcoat damage - Repair and paint
