Expertise

Protocol number: 46529253  
Order No. / Reference: 26733729  
Inspection date: 15 Jul 2026

Manufacturer: Ford

Model: Focus Turnier 1.0 EcoBoost Hybrid ST-LINE STYLE

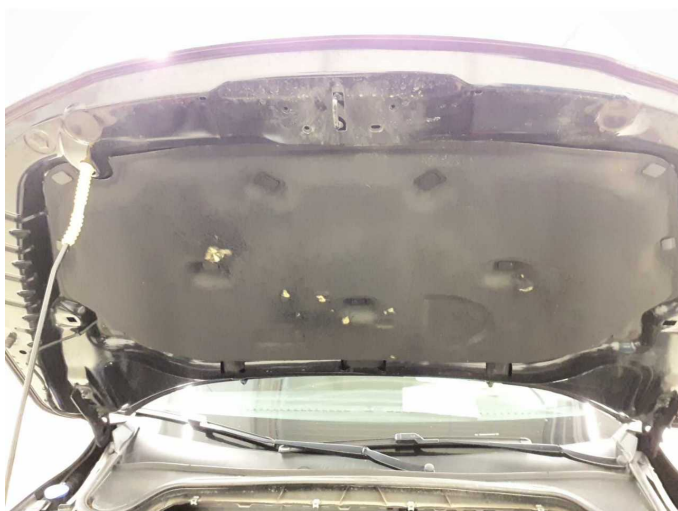
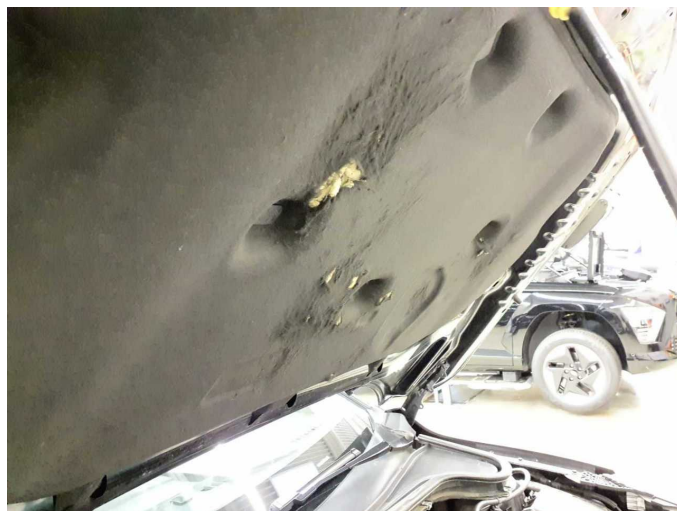
| No. | Component group | Description |
|---|---|---|
| 1 | Bonnet | Insulation lining - Broken / torn - Replace |

**Damage 1:** Bonnet: Insulation lining - Broken / torn - Replace

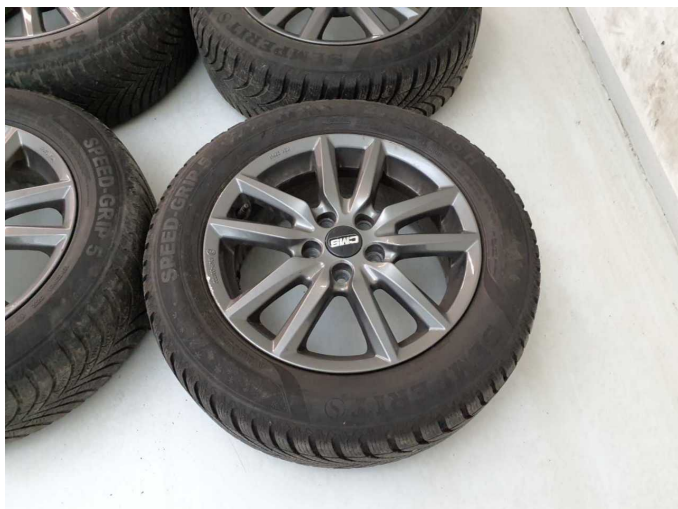
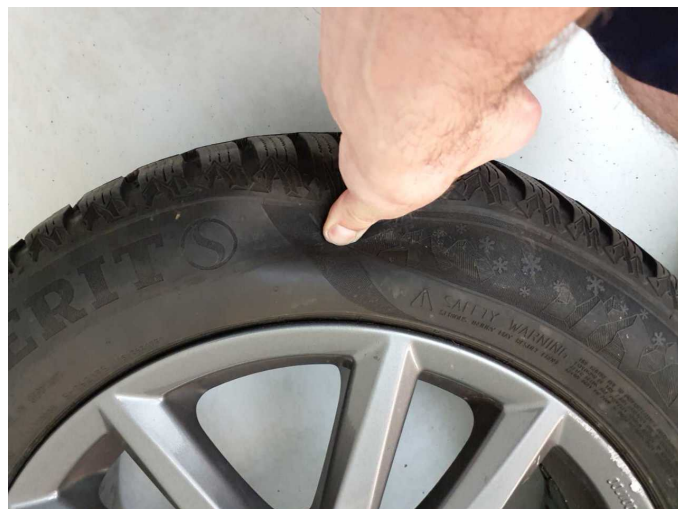
| No. | Component group | Description |
|---|---|---|
| 2 | 2nd wheel set | 1 tyre - Defective - Replace |

**Damage 2:** 2nd wheel set: 1 tyre - Defective - Replace

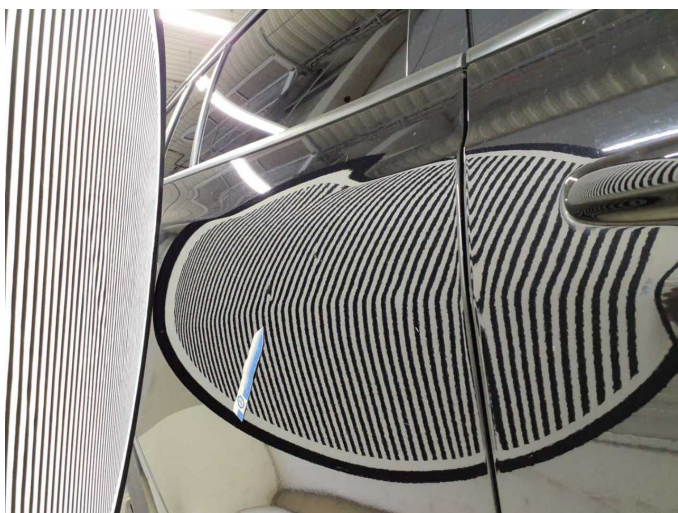
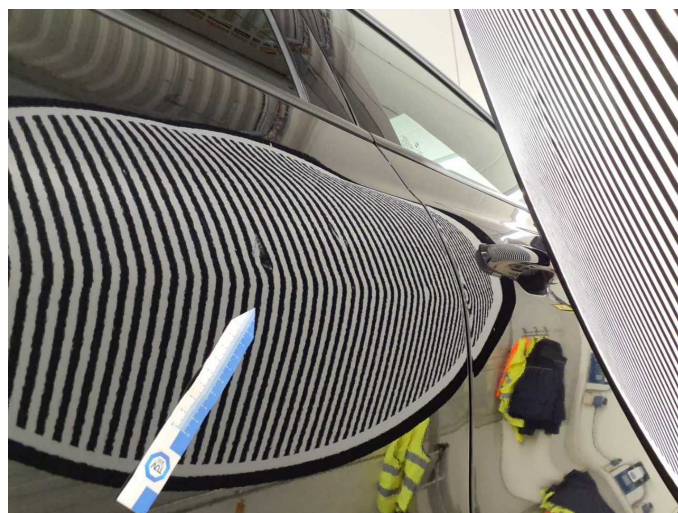
| No. | Component group | Description |
|---|---|---|
| 3 | Door - rear right side | Door - dent(s) - Smart repair |

**Damage 3:** Door - rear right side: Door - dent(s) - Smart repair

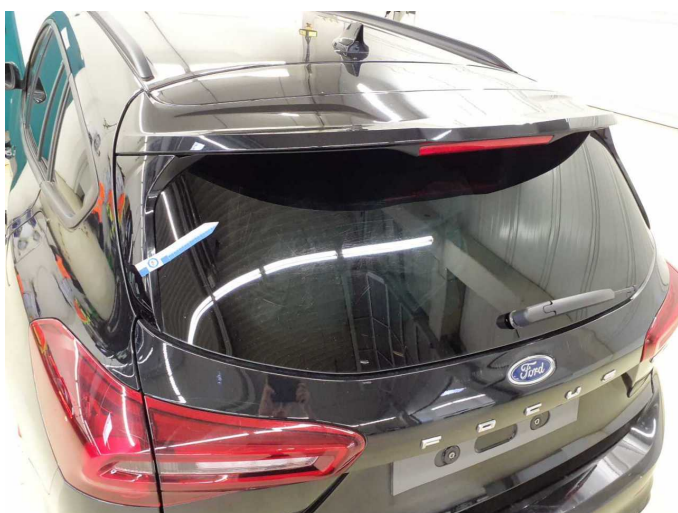
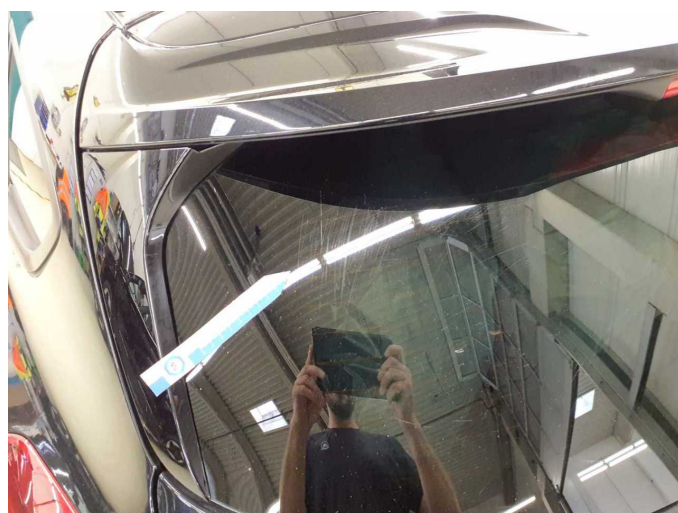
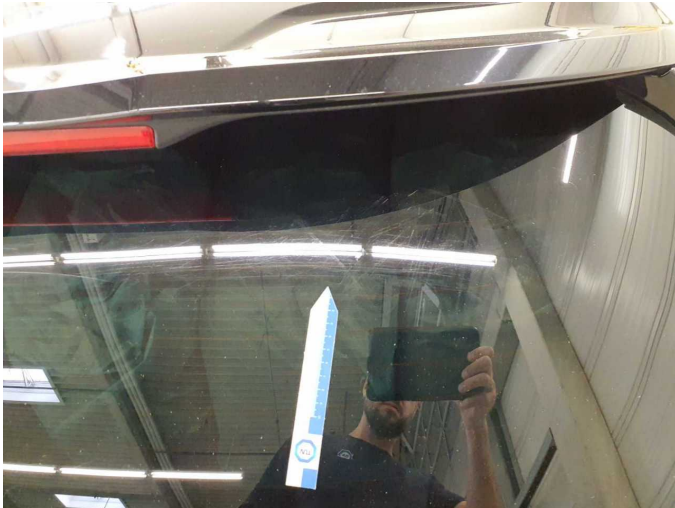
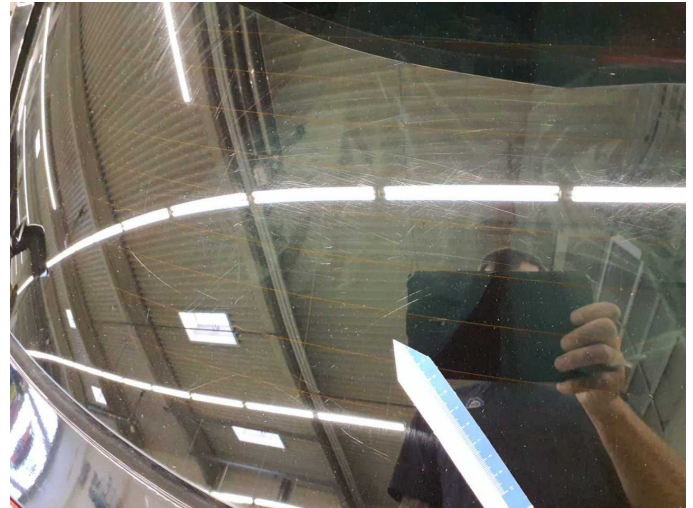
| No. | Component group | Description |
|---|---|---|
| 4 | Vehicle glazing | Rear window - Scratched - Loss in value |

**Damage 4:** Vehicle glazing: Rear window - Scratched - Loss in value

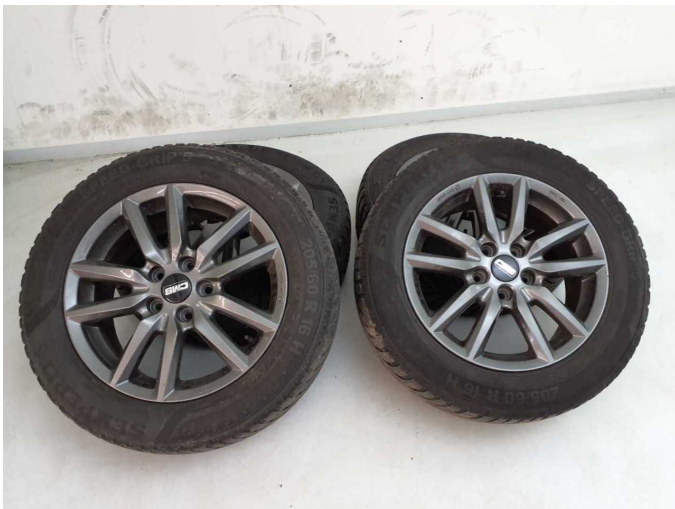
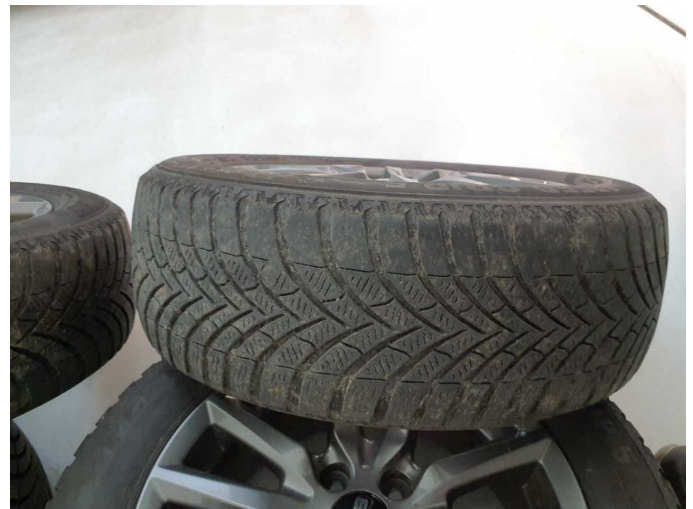
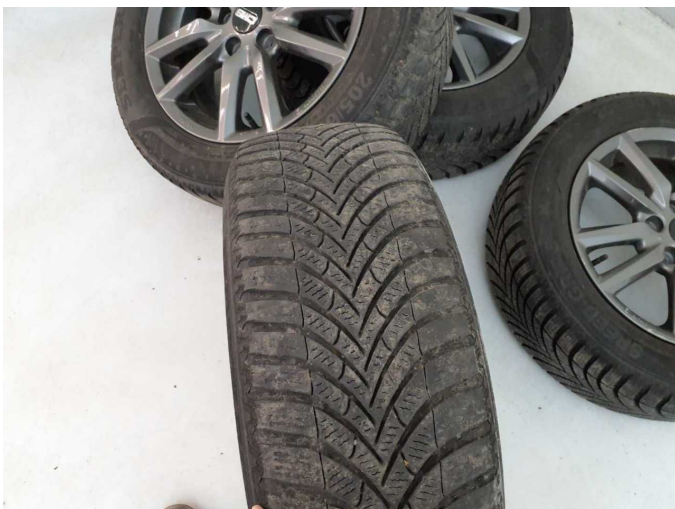
| No. | Component group | Description |
|---|---|---|
| 5 | 2nd wheel set | 2 tyres (Einseitig abgefahren) - Worn - Replace |

**Damage 5:** 2nd wheel set: 2 tyres (Einseitig abgefahren) - Worn - Replace

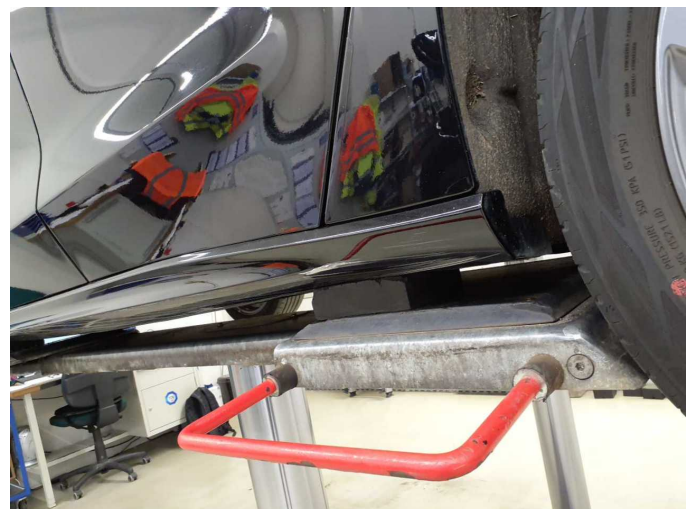
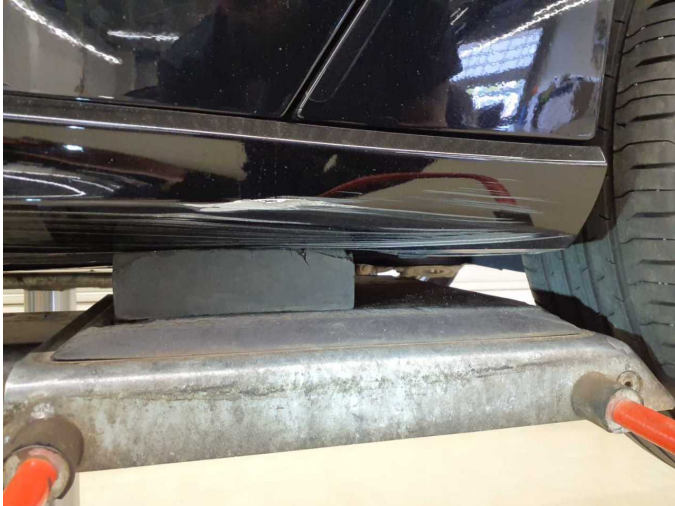
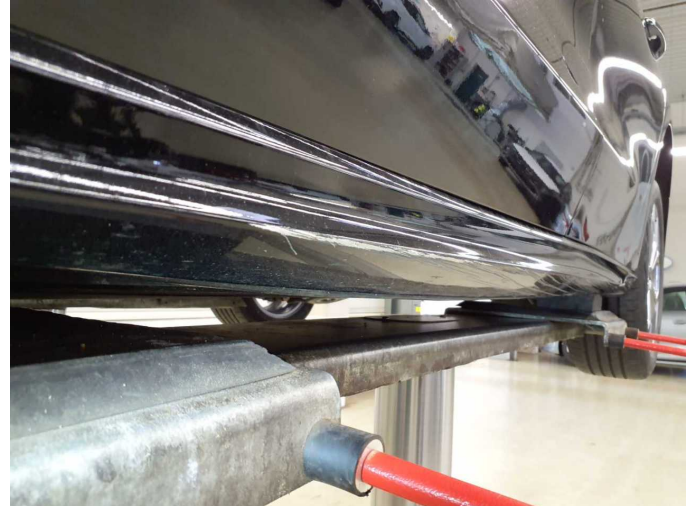
| No. | Component group | Description |
|---|---|---|
| 6 | Sill - left side | Trim - Scratched - Paint |

**Damage 6:** Sill - left side: Trim - Scratched - Paint

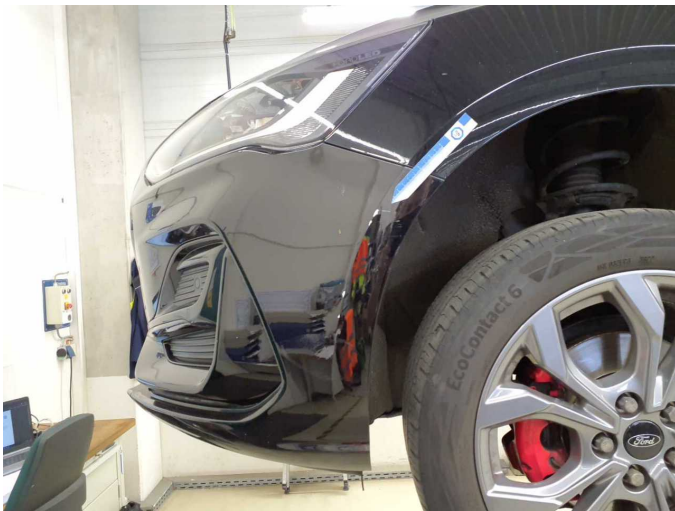
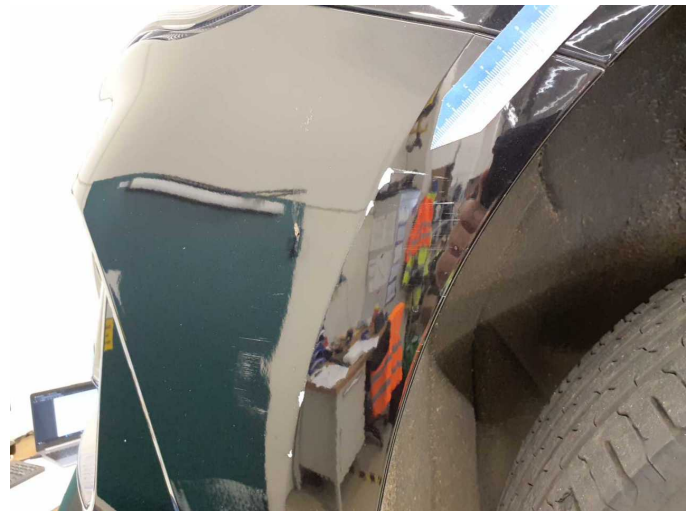
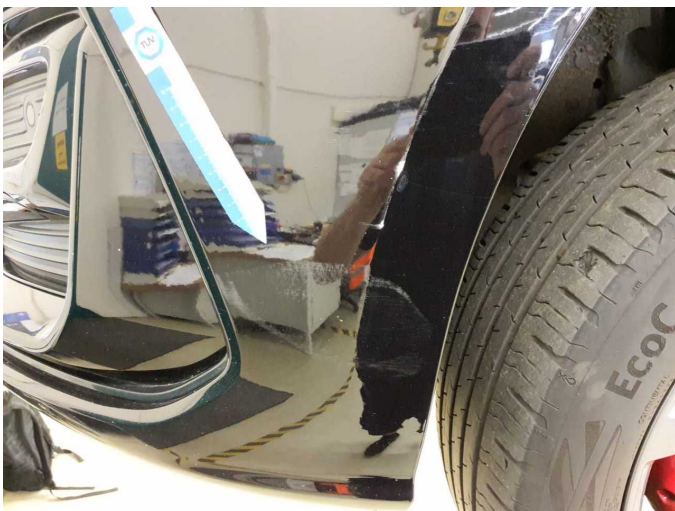
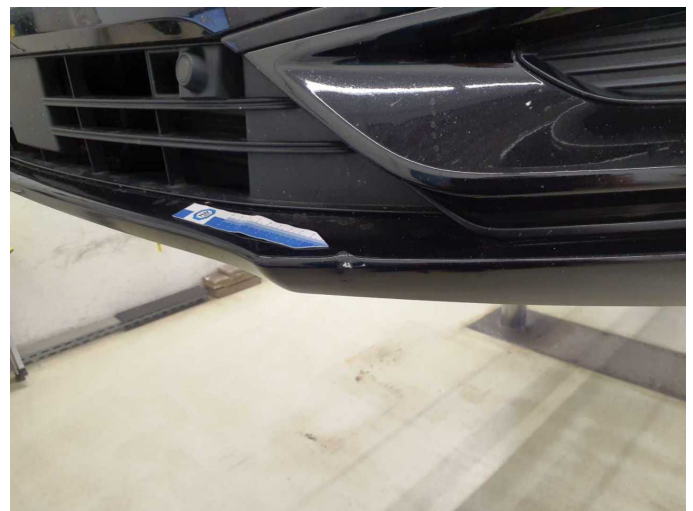
| No. | Component group | Description |
|---|---|---|
| 7 | Front bumper | Bumper with Parktronic - Scratched - Paint |

**Damage 7:** Front bumper: Bumper with Parktronic - Scratched - Paint

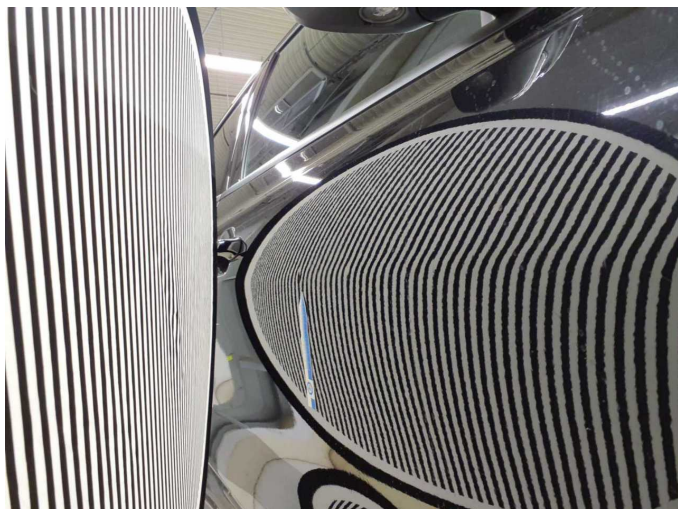
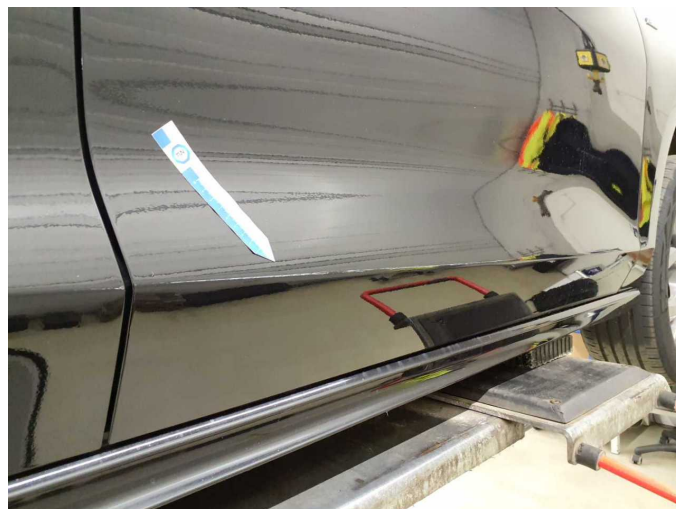
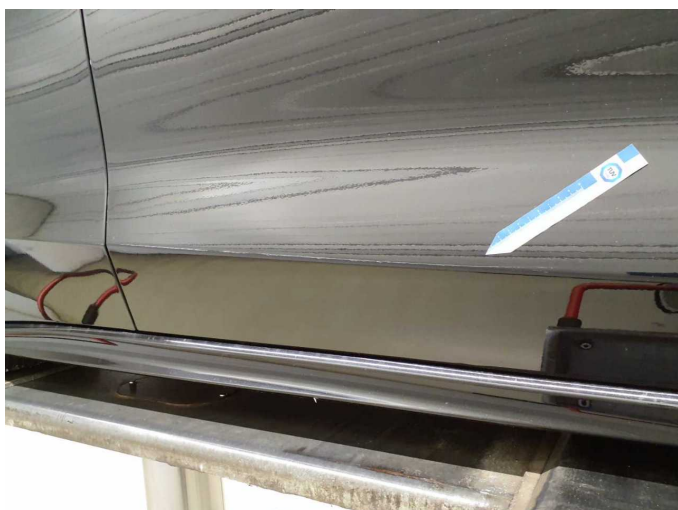
| No. | Component group | Description |
|---|---|---|
| 8 | Door - front right side | Door - Dent / paintcoat damage - Repair and paint |

**Damage 8:** Door - front right side: Door - Dent / paintcoat damage - Repair and paint

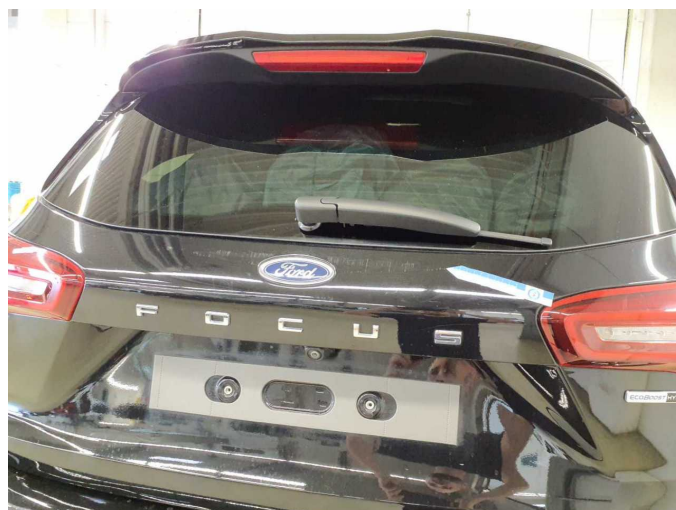
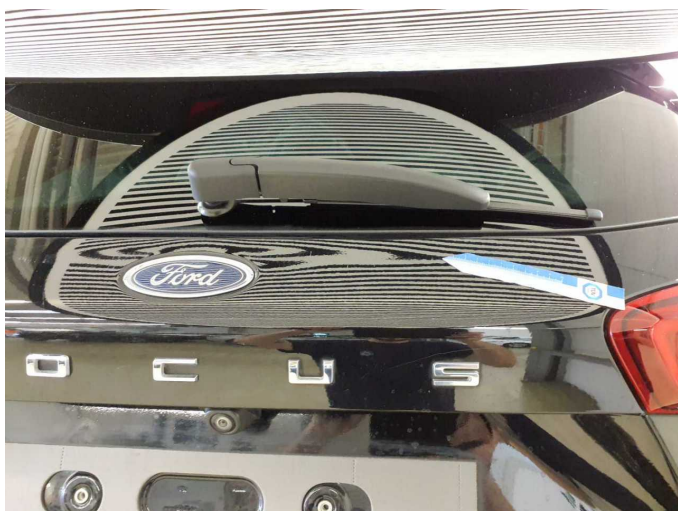
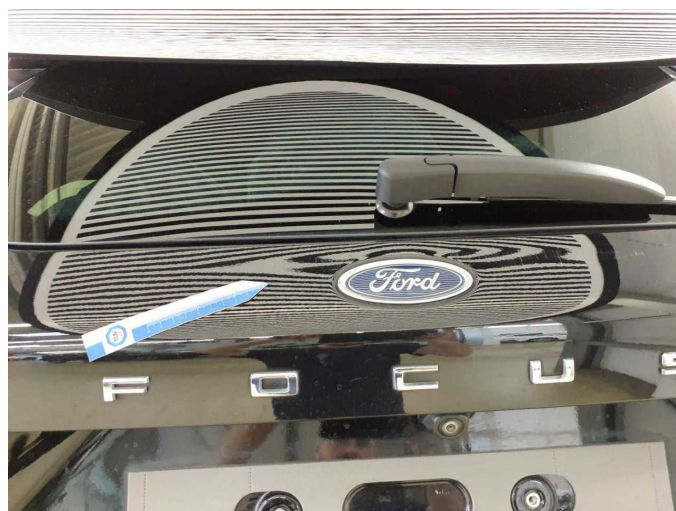
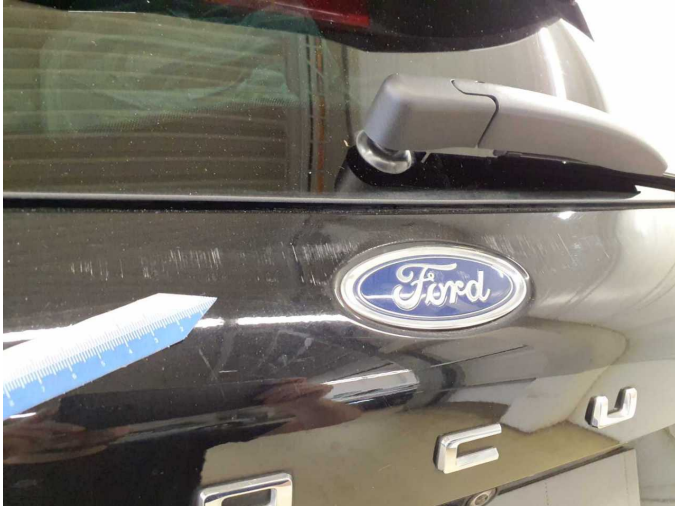
| No. | Component group | Description |
|---|---|---|
| 9 | Boot lid / rear door | Boot lid - Dent / paintcoat damage - Repair and paint |

**Damage 9:** Boot lid / rear door: Boot lid - Dent / paintcoat damage - Repair and paint

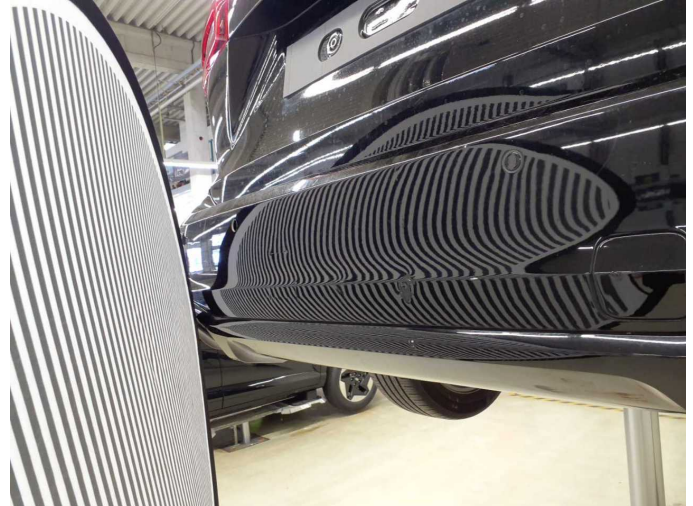
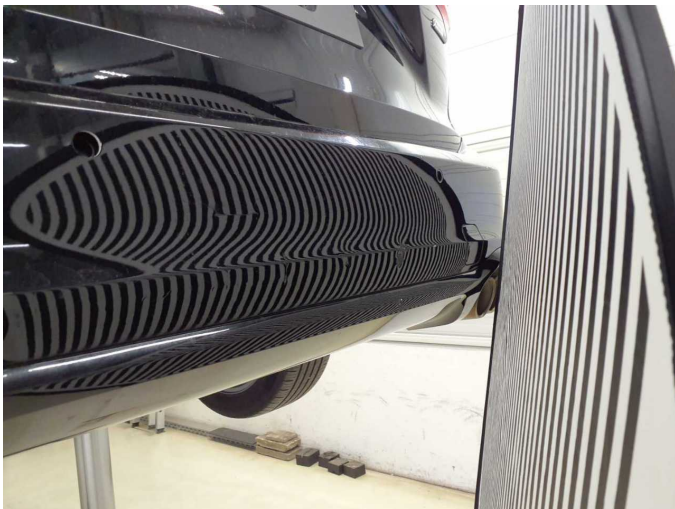
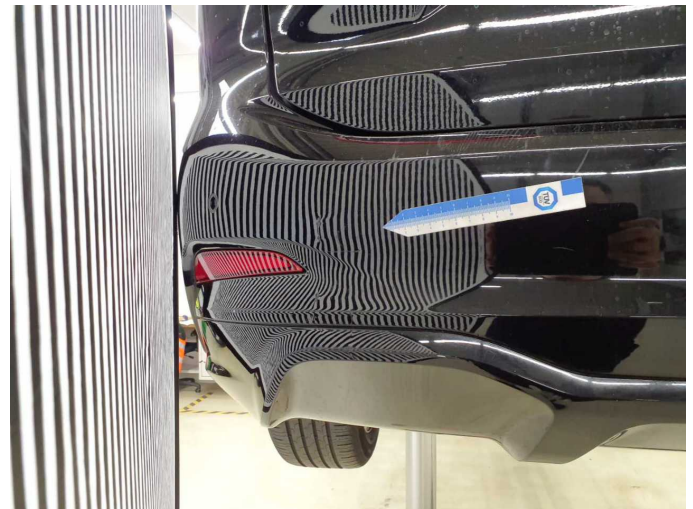
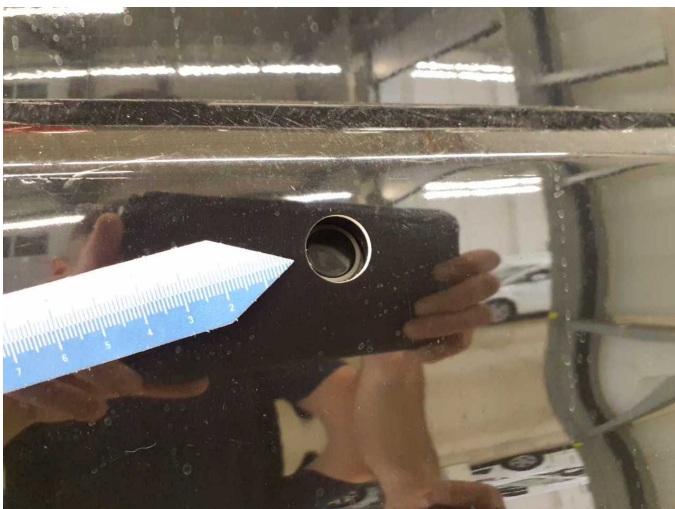
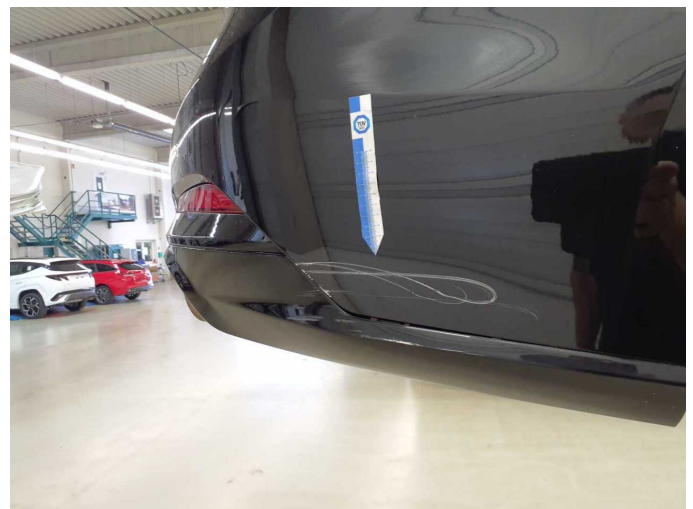
| No. | Component group | Description |
|---|---|---|
| 10 | Rear bumper | Bumper with Parktronic - Deformed - Replace |

**Damage 10:** Rear bumper: Bumper with Parktronic - Deformed - Replace
