Expertise

Protocol number: 46012019
Order No. / Reference: 26489514
Inspection date: 18 Jun 2026

Manufacturer: Ford

Model: Transit Connect 230 L2 S&S Trend

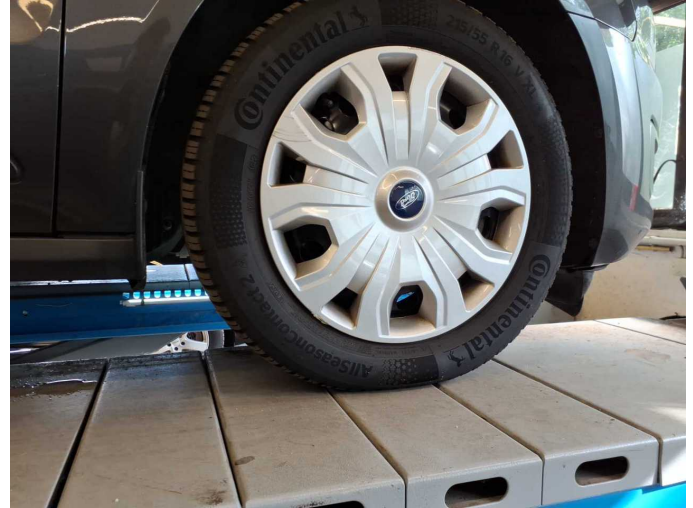
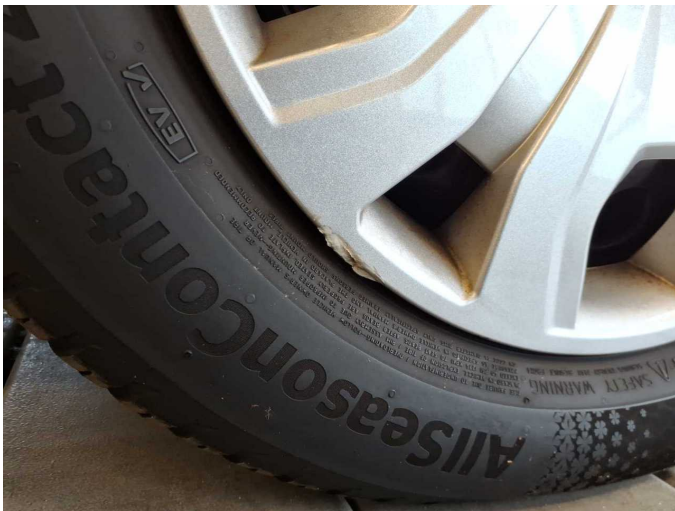
No.	Component group	Description
1	Wheel / tyres	Wheel cover - front right side - Scratched - Replace
2	Equipment	Tirefit filler - Expired - Replace
3	Tail light	Tail lamp - right side - Broken / torn - Replace
4	Front bumper	Front bumper (Sandstrahleffekt) - Stone chips - Paint

Damage 1: Wheel / tyres: Wheel cover - front right side - Scratched - Replace

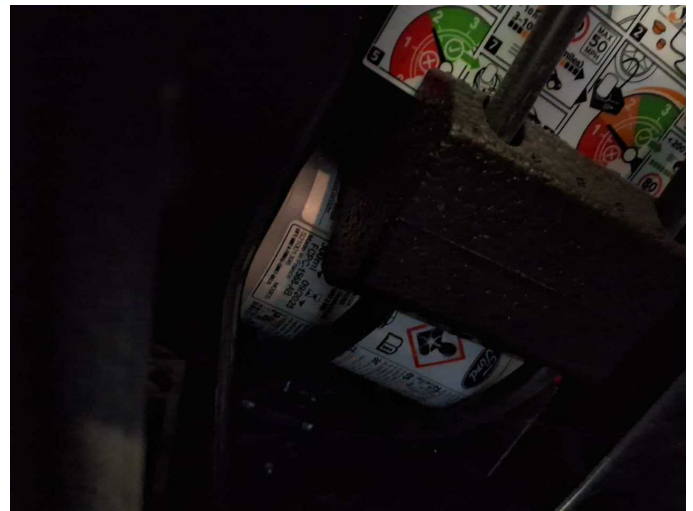
Damage 2: Equipment: Tirefit filler - Expired - Replace

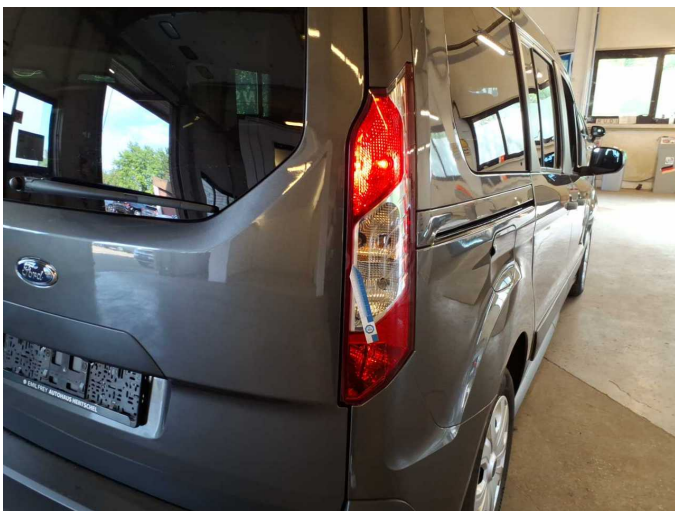
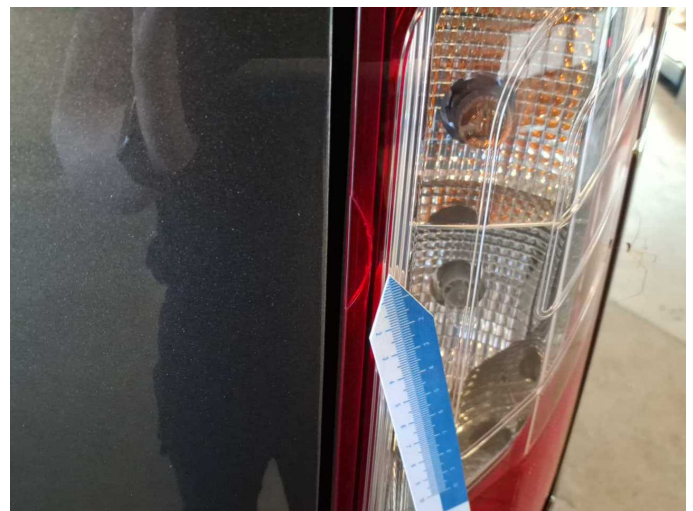
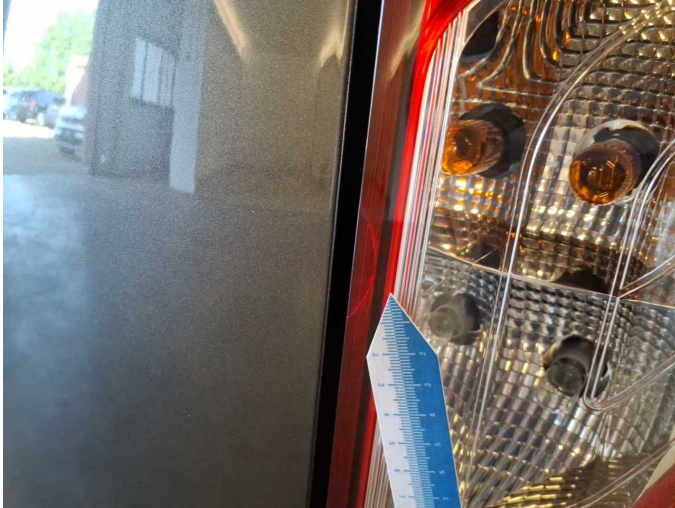
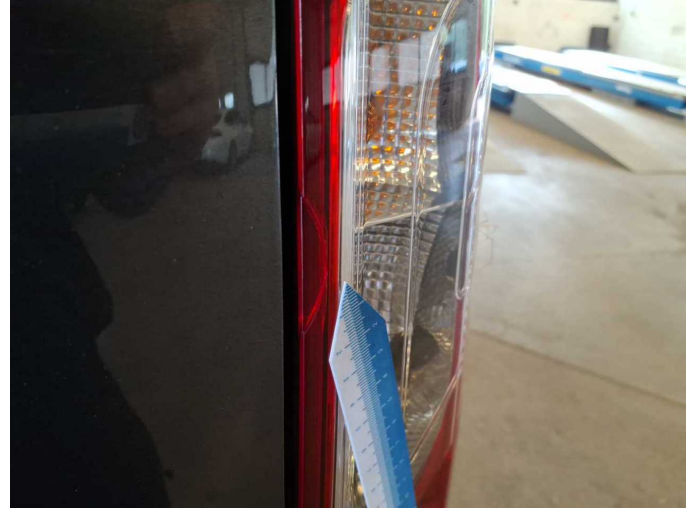
Damage 3: Tail light: Tail lamp - right side - Broken / torn - Replace

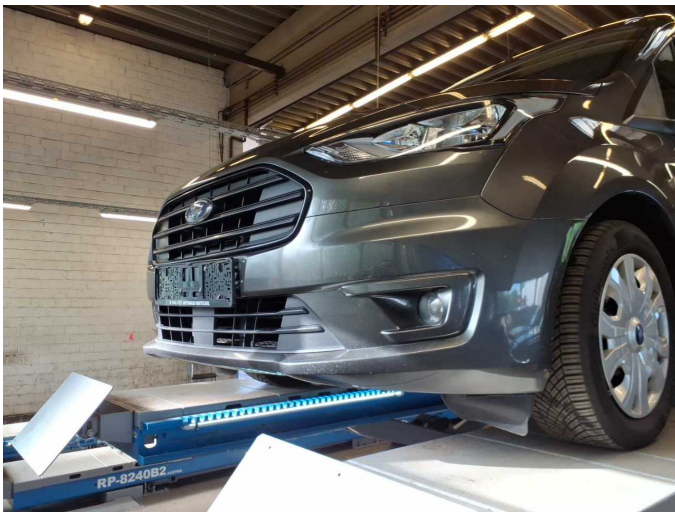
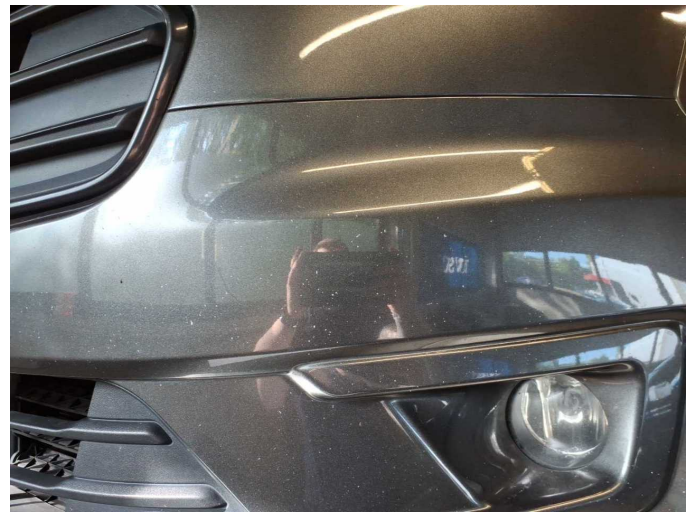
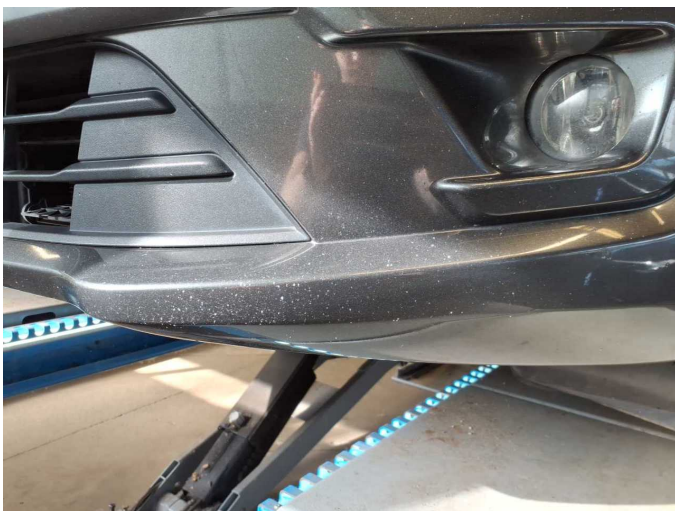
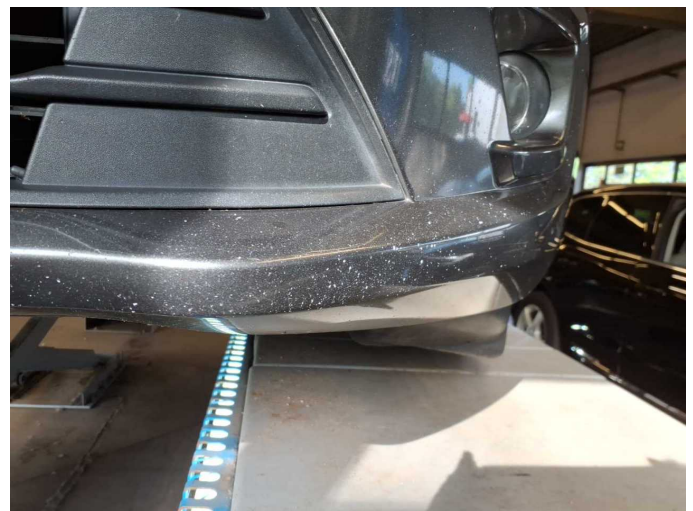
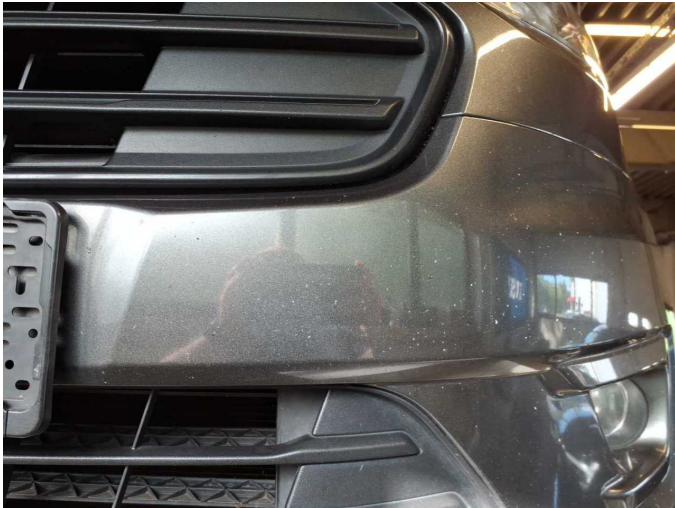
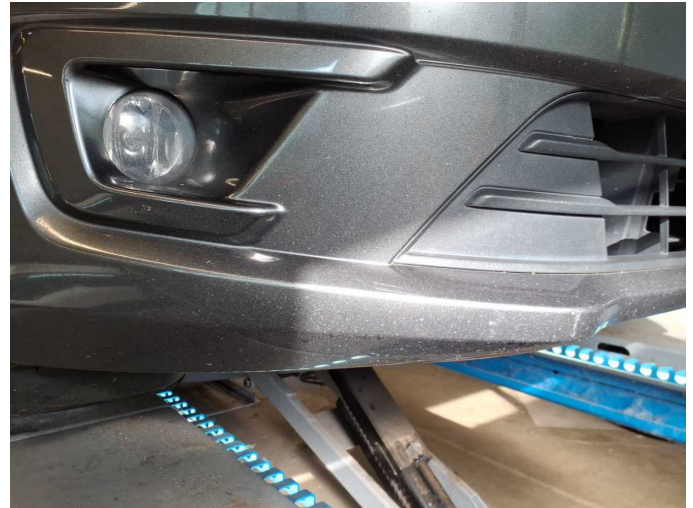
Damage 4: Front bumper: Front bumper (Sandstrahleffekt) - Stone chips - Paint

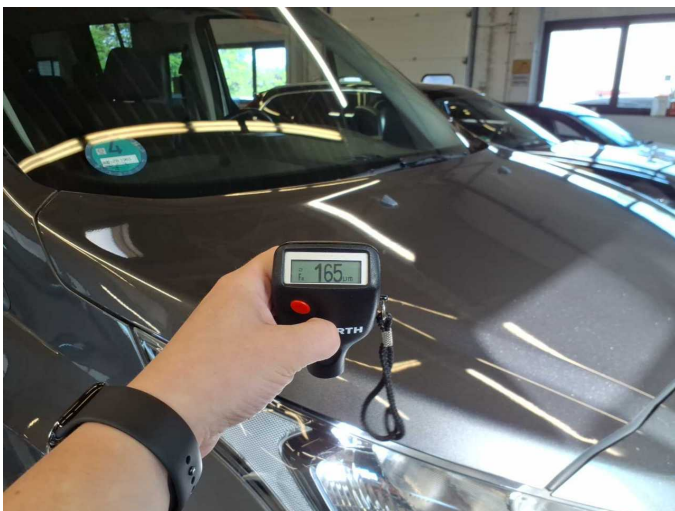
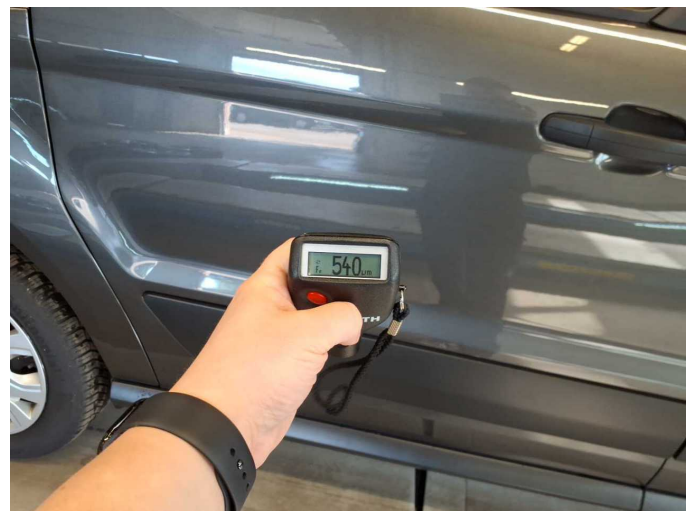
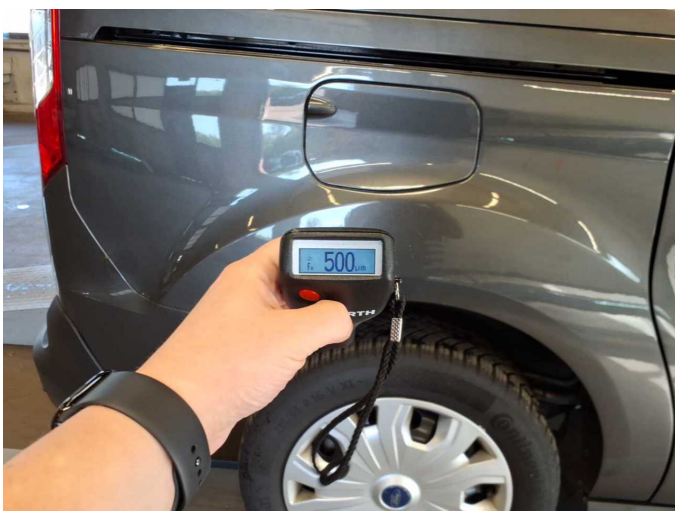
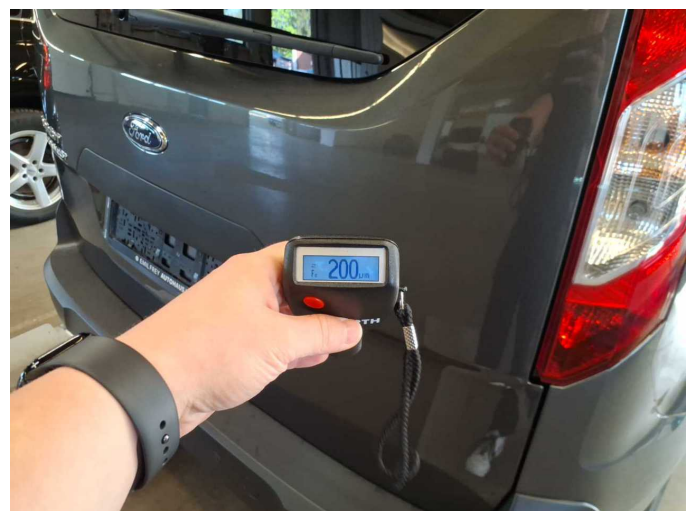
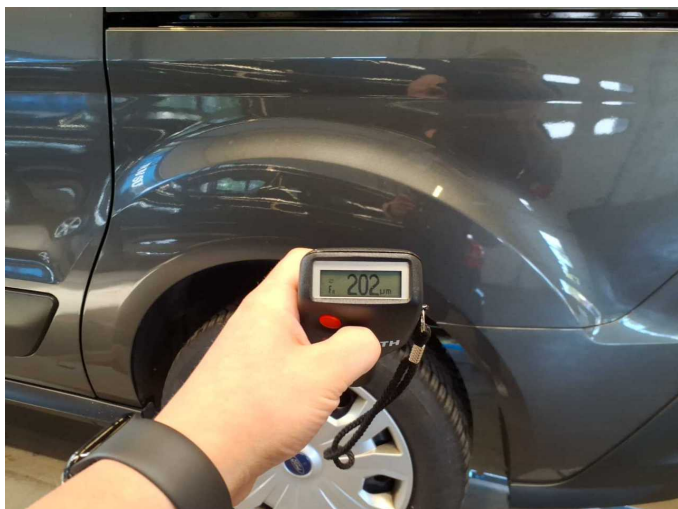
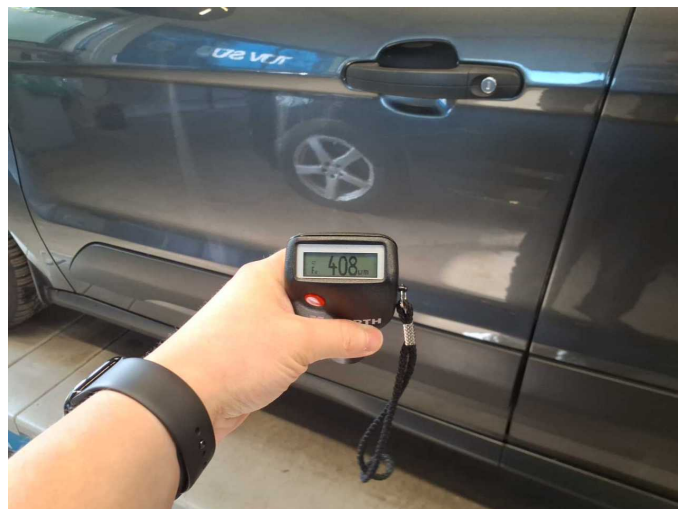
No.	Repainting
1	Boot lid / rear door, Bonnet, Side panel - rear left side, Side panel - rear right side, Door - rear right side, Door - front left side, Professionally carried out, Invoice of repair done

Boot lid / rear door	200 µm	Bonnet	165 µm
Side panel - rear left side	202 µm	Side panel - rear right side	500 µm
Door - rear right side	540 µm	Door - front left side	408 µm

Repainting 1: Boot lid / rear door, Bonnet, Side panel - rear left side, Side panel - rear right side, Door - rear right side, Door - front left side
