Expertise

Protocol number: 46726778  
Order No. / Reference: 26750211-1  
Inspection date: 17 Jul 2026

Manufacturer: Ford

Model: Mondeo Turnier 2.0 EcoBlue Aut. Titanium

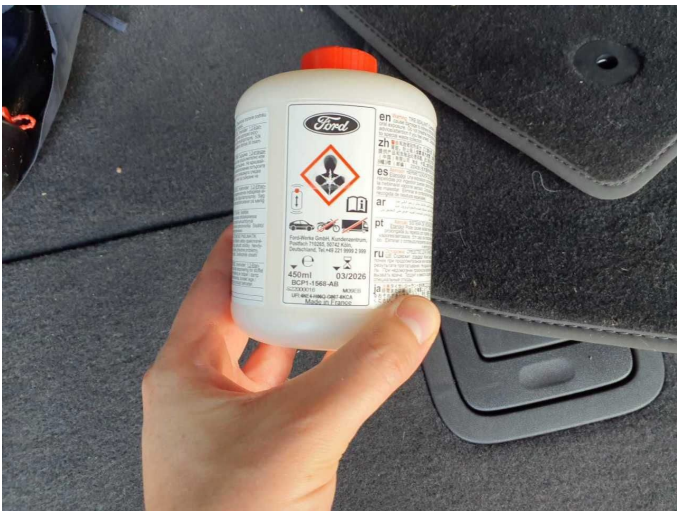
| No. | Component group | Description |
|---|---|---|
| 1 | Equipment | Tirefit filler - Expired - Replace |

Damage 1: Equipment: Tirefit filler - Expired - Replace

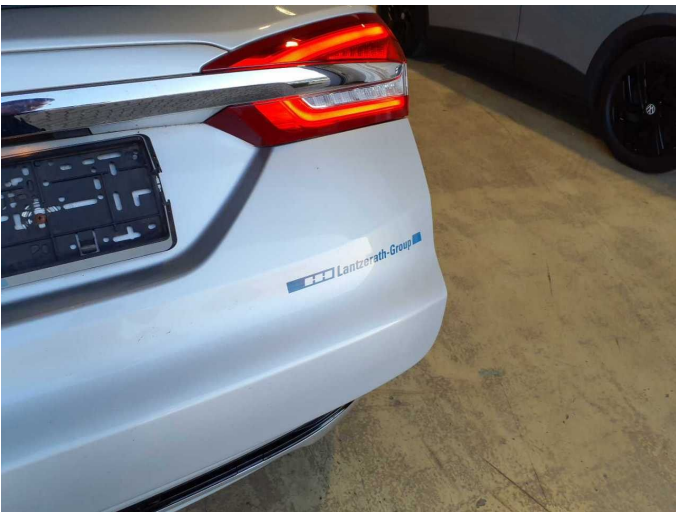
| No. | Component group | Description |
|---|---|---|
| 2 | Boot lid / rear door | Boot lid - Glued / labelled - De-glue / neutralise |

Damage 2: Boot lid / rear door: Boot lid - Glued / labelled - De-glue / neutralise

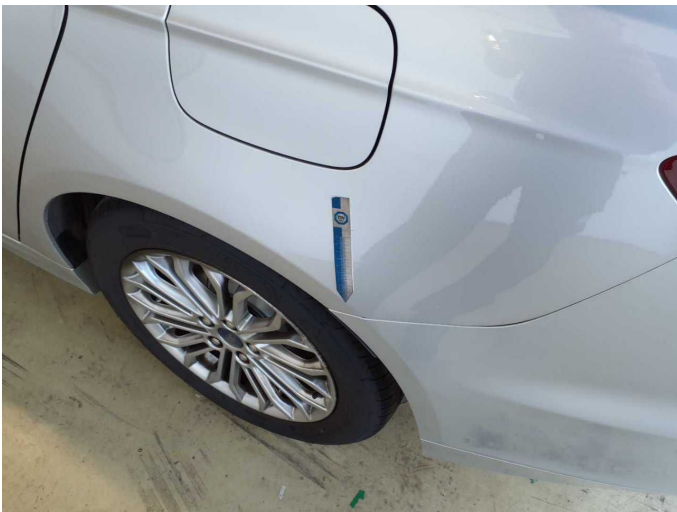
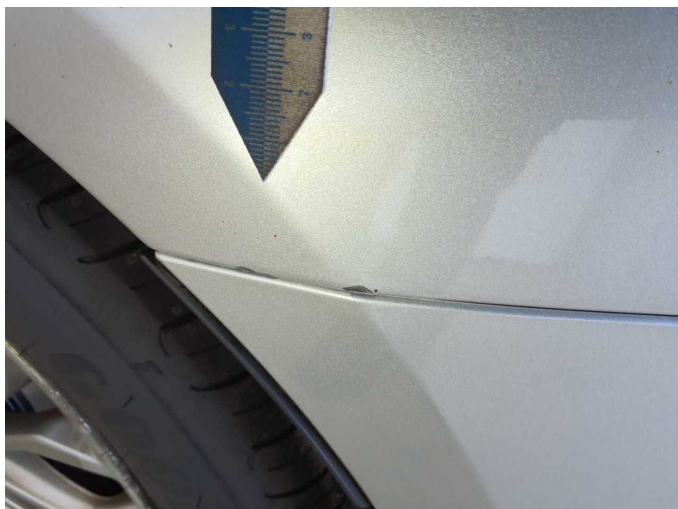
| No. | Component group | Description |
|---|---|---|
| 3 | Side panel - rear left side | Side panel - Scratch(es) - Smart repair |

Damage 3: Side panel - rear left side: Side panel - Scratch(es) - Smart repair

**Damage 3:** Side panel - rear left side: Side panel - Scratch(es) - Smart repair

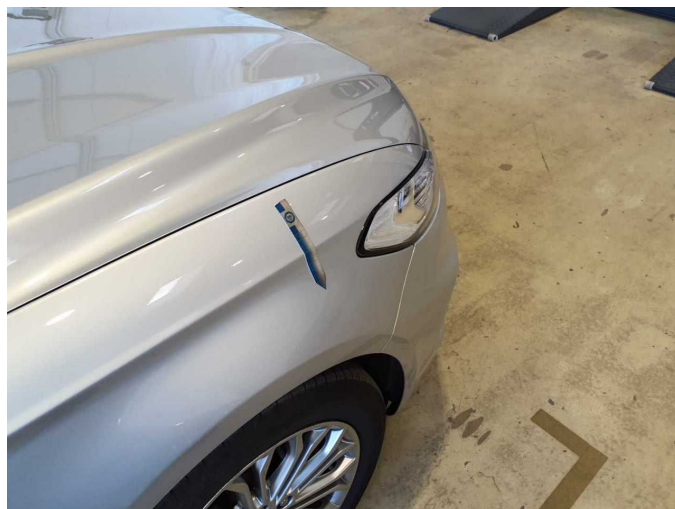
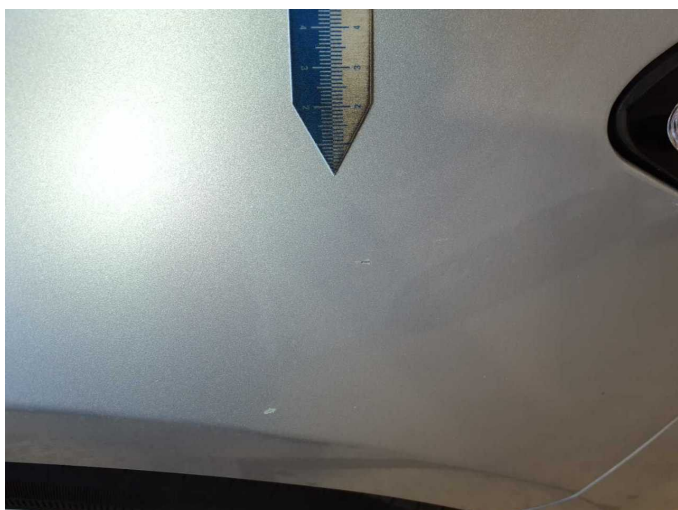
| No. | Component group | Description |
|---|---|---|
| 4 | Mudguard - right side | Mudguard - right side - Scratch(es) - Smart repair |

**Damage 4:** Mudguard - right side: Mudguard - right side - Scratch(es) - Smart repair

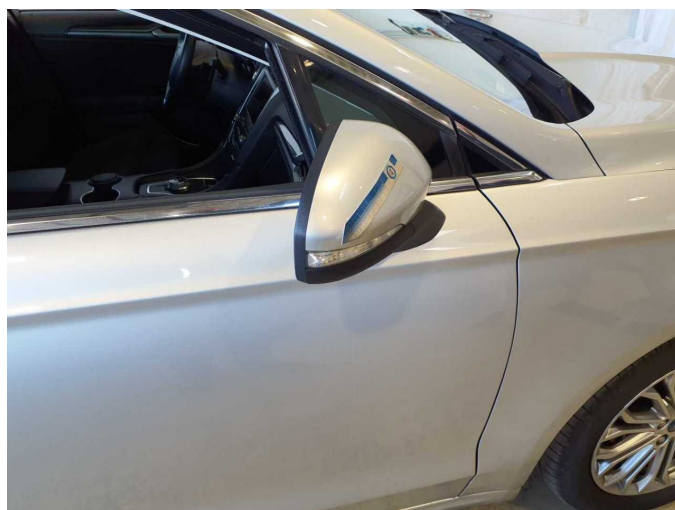
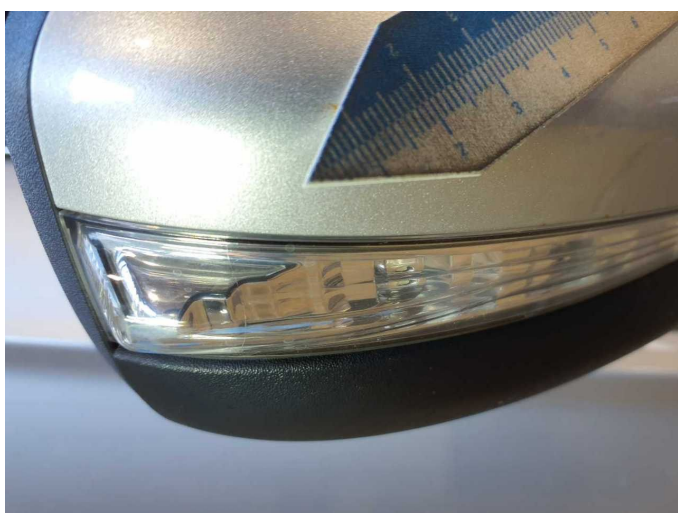
| No. | Component group | Description |
|---|---|---|
| 5 | Indicator - front | Mirror - right side - Scratch(es) - Replace |

**Damage 5:** Indicator - front: Mirror - right side - Scratch(es) - Replace

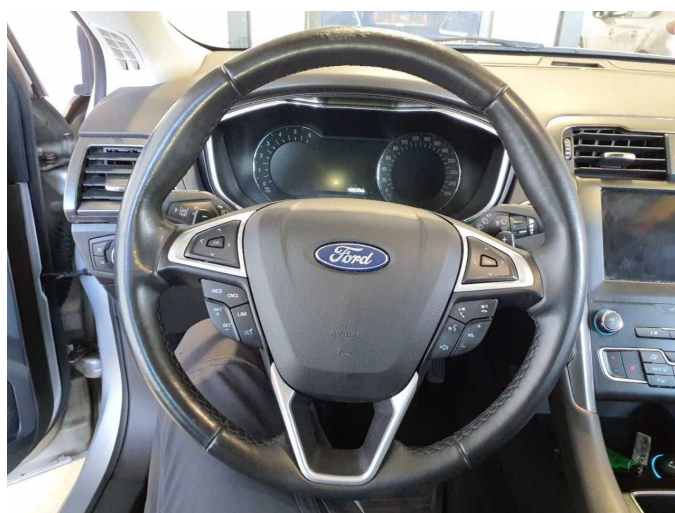
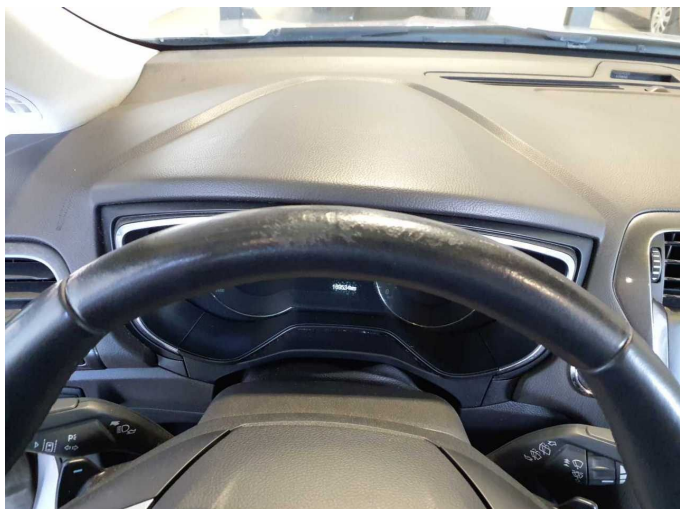
| No. | Component group | Description |
|---|---|---|
| 6 | Steering system | Steering wheel - Scratch(es) - Loss in value |

**Damage 6:** Steering system: Steering wheel - Scratch(es) - Loss in value

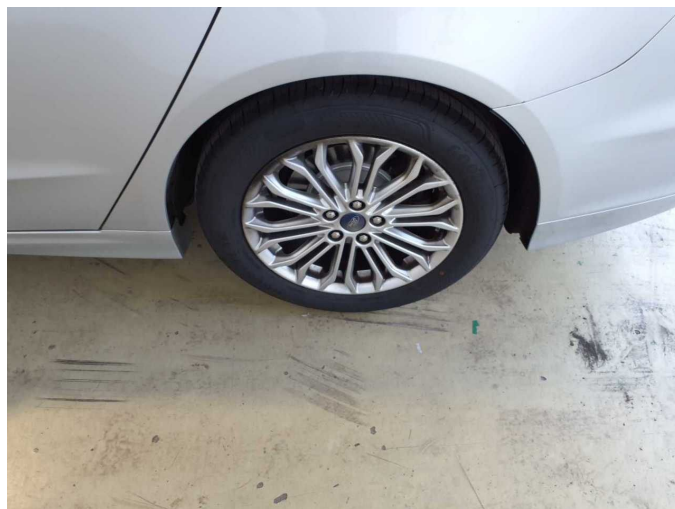
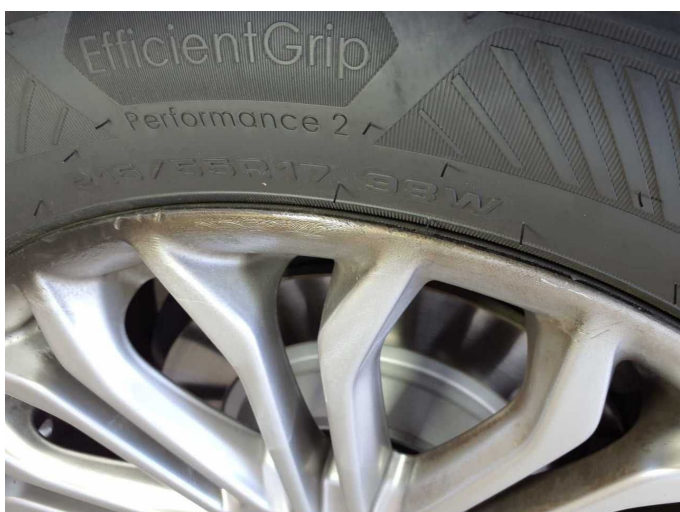
| No. | Component group | Description |
|---|---|---|
| 7 | Wheel / tyres | Alloy rim - rear left side - Scratched - Replace |

**Damage 7:** Wheel / tyres: Alloy rim - rear left side - Scratched - Replace

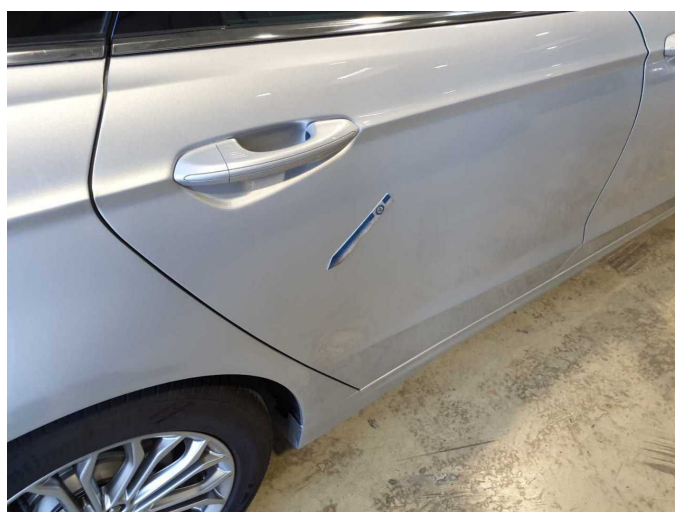
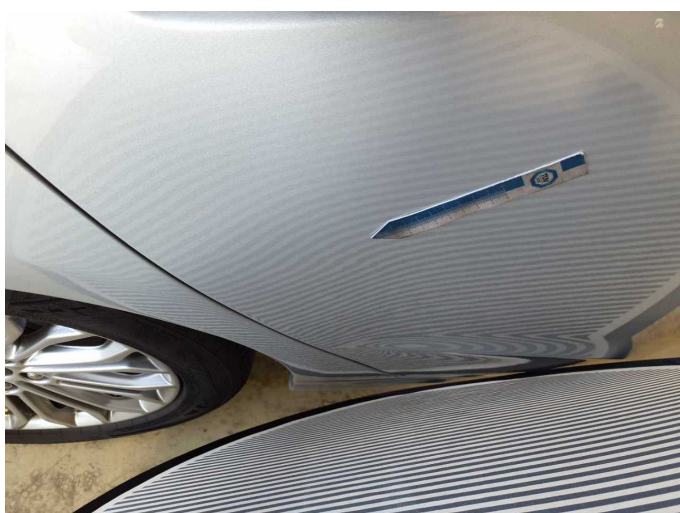
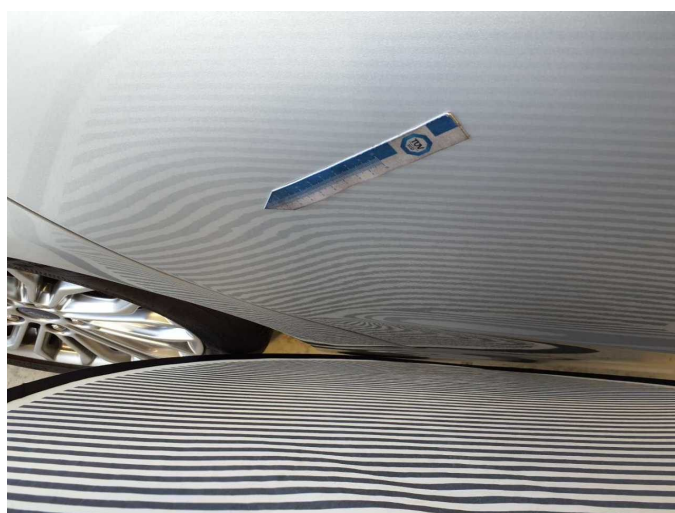
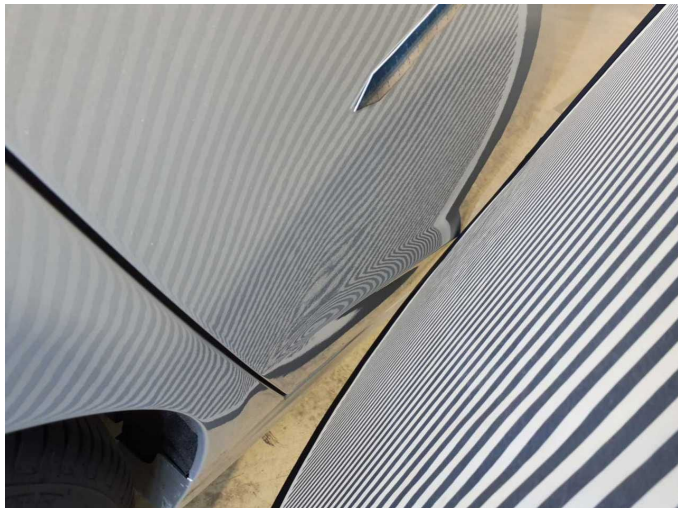
| No. | Component group | Description |
|---|---|---|
| 8 | Door - rear right side | Door (Wellig) - Unprofessionally repaired - Repair and paint |

**Damage 8:** Door - rear right side: Door (Wellig) - Unprofessionally repaired - Repair and paint

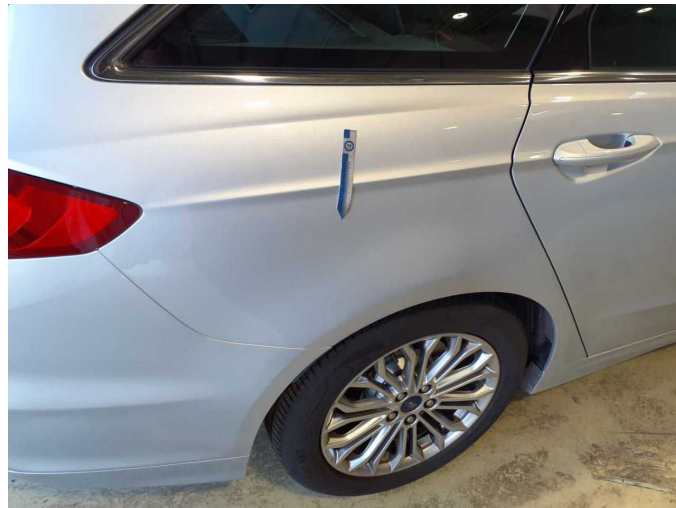
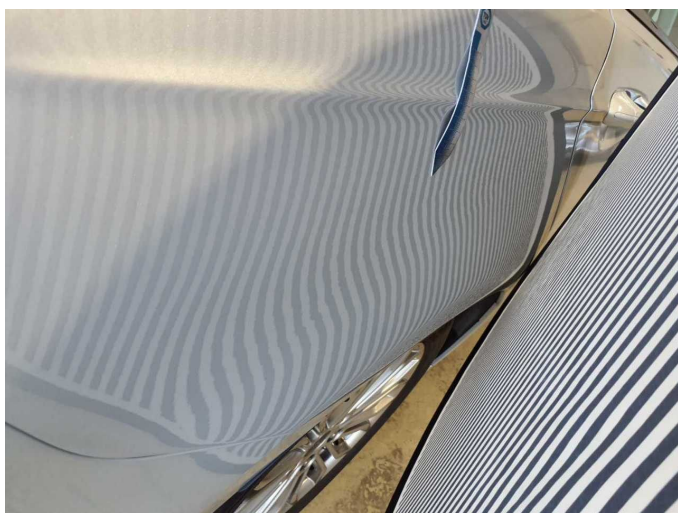
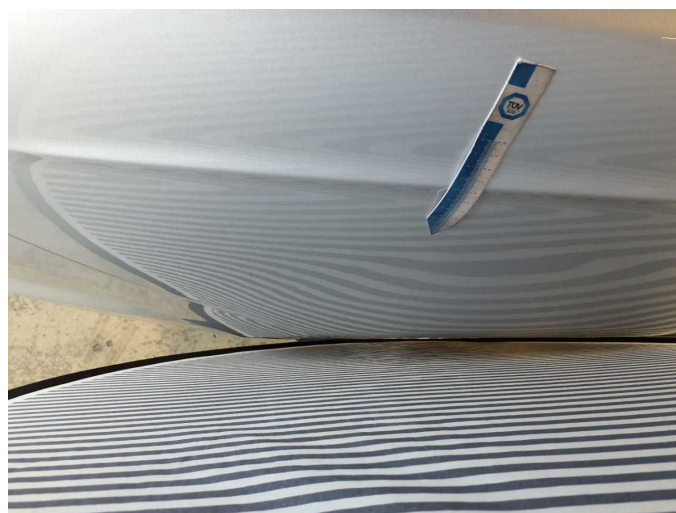
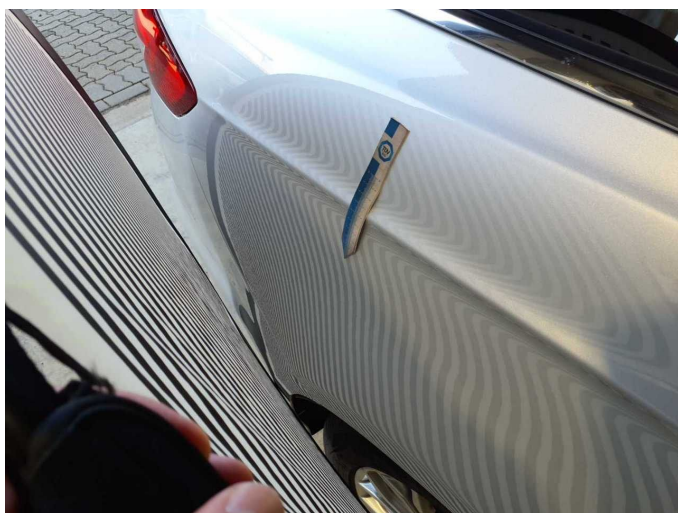
| No. | Component group | Description |
|---|---|---|
| 9 | Side panel - rear right side | Side panel (Wellig) - Unprofessionally repaired - Repair and paint |

**Damage 9:** Side panel - rear right side: Side panel (Wellig) - Unprofessionally repaired - Repair and paint

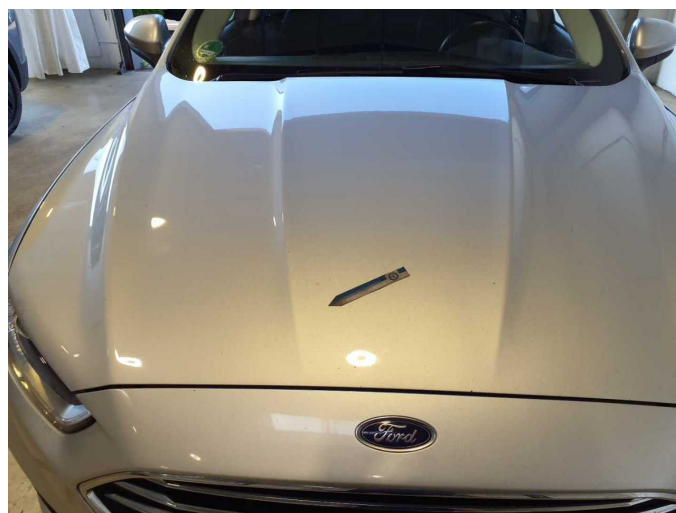
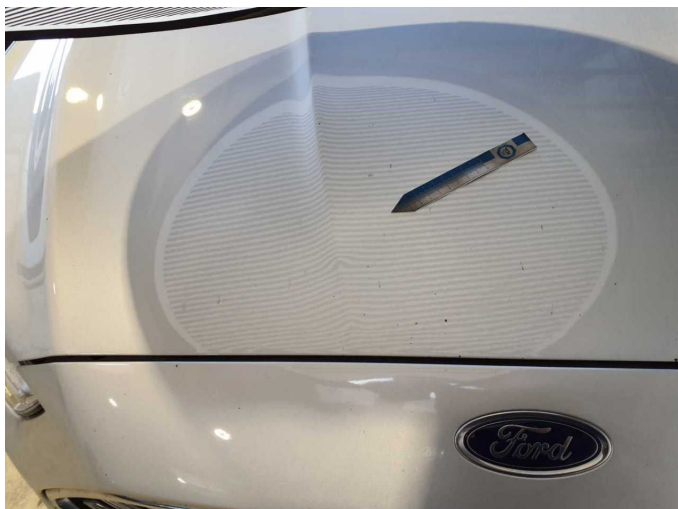
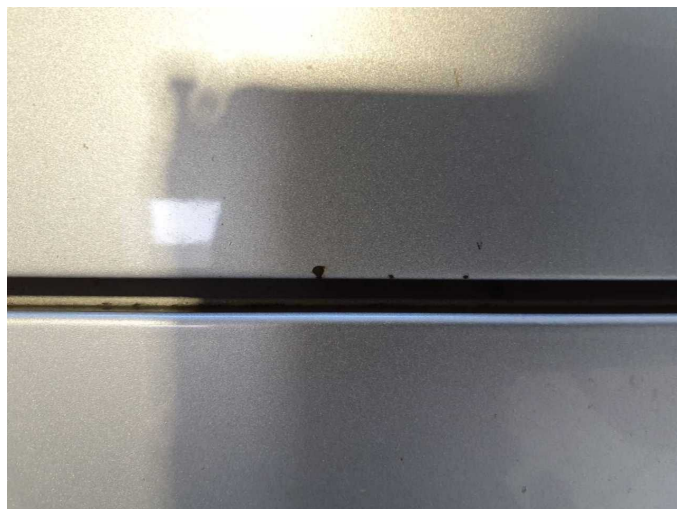
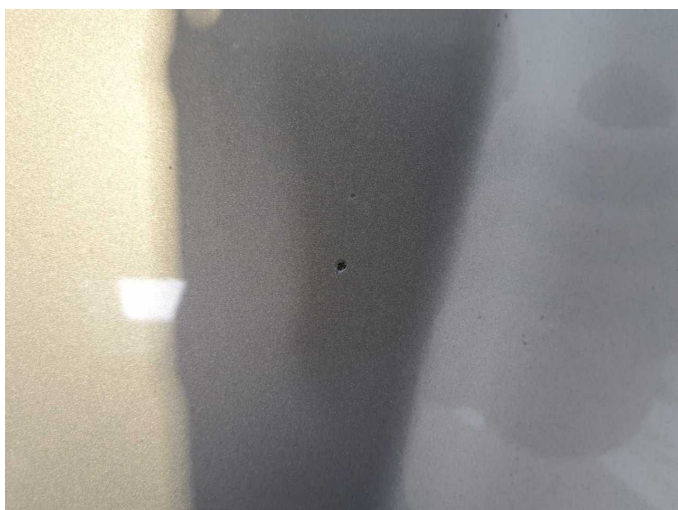
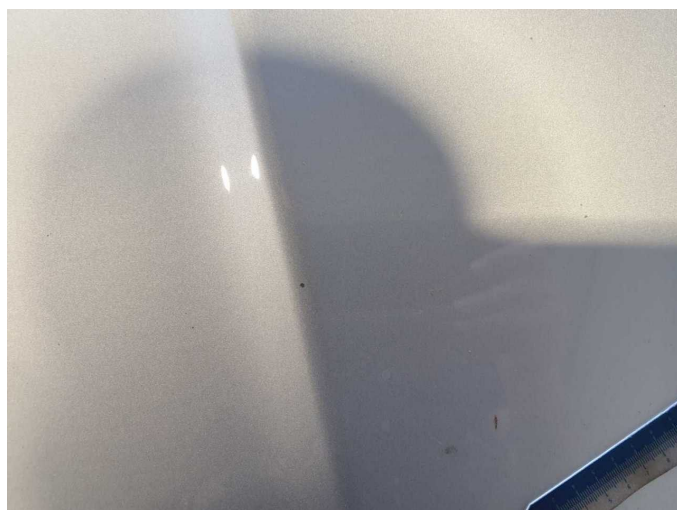
| No. | Component group | Description |
|---|---|---|
| 10 | Bonnet | Bonnet - Corrosion - Repair and paint |

**Damage 10:** Bonnet: Bonnet - Corrosion - Repair and paint

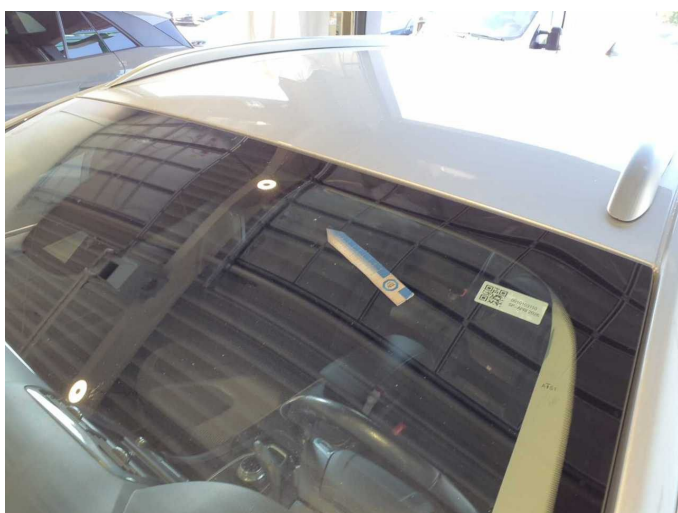
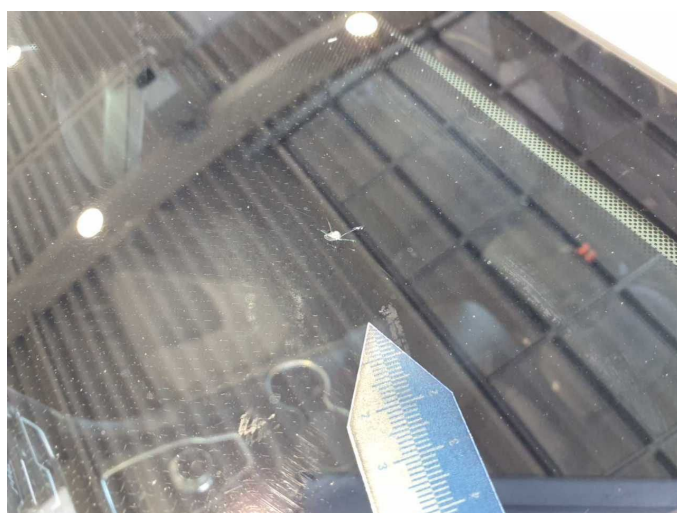
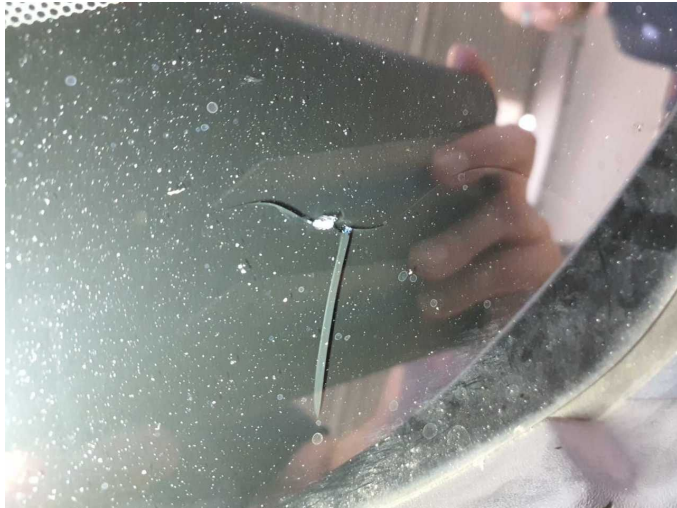
| No. | Component group | Description |
|---|---|---|
| 11 | Vehicle glazing | Windscreen - Stone chips - Replace |

**Damage 11:** Vehicle glazing: Windscreen - Stone chips - Replace

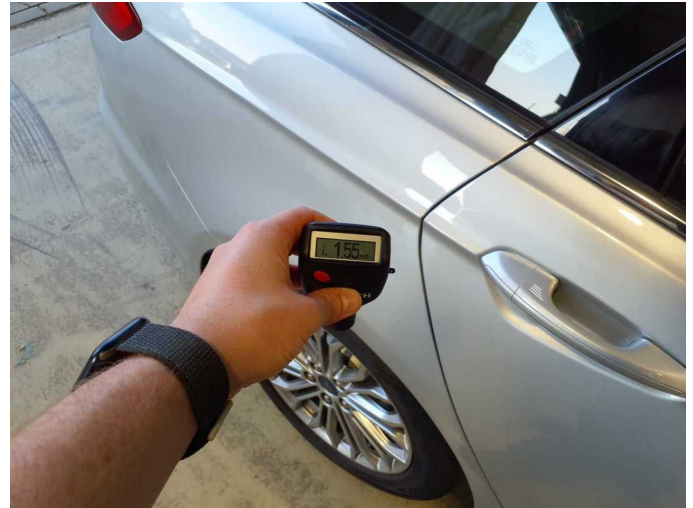
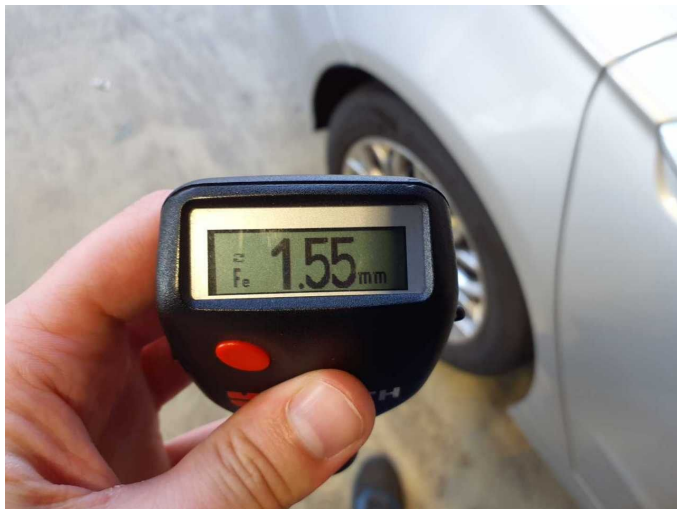
- 1 Side panel - rear right side, Unprofessionally carried out, Invoice of repair done Non-existent
- 2 Door - rear right side, Unprofessionally carried out, Invoice of repair done Non-existent

| Side panel - rear right side | 1,550<br>µm | Door - rear right side | 346 µm |

**Repainting 1:** Side panel - rear right side

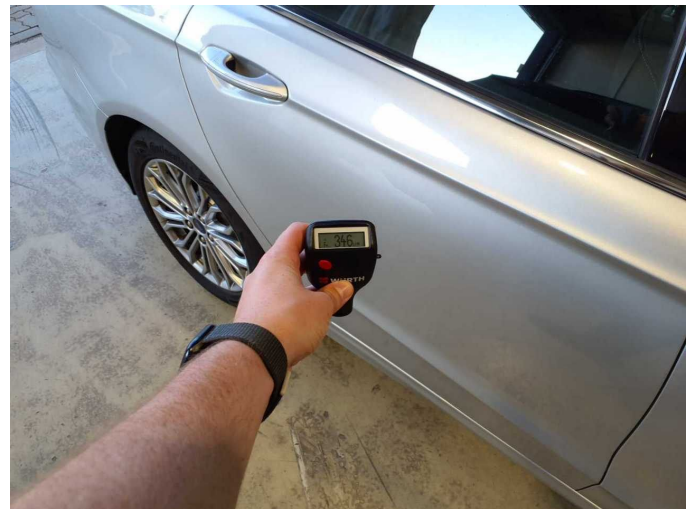
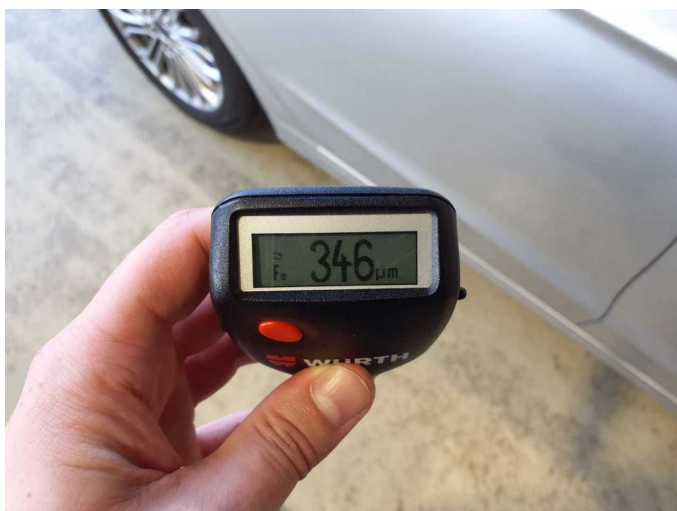
**Repainting 2:** Door - rear right side
