## Expertise

Protocol number: 45689421  
Order No. / Reference: 26414751  
Inspection date: 28 May 2026

Manufacturer: Seat

Model: Leon 2.0 TDI DSG FR Plus

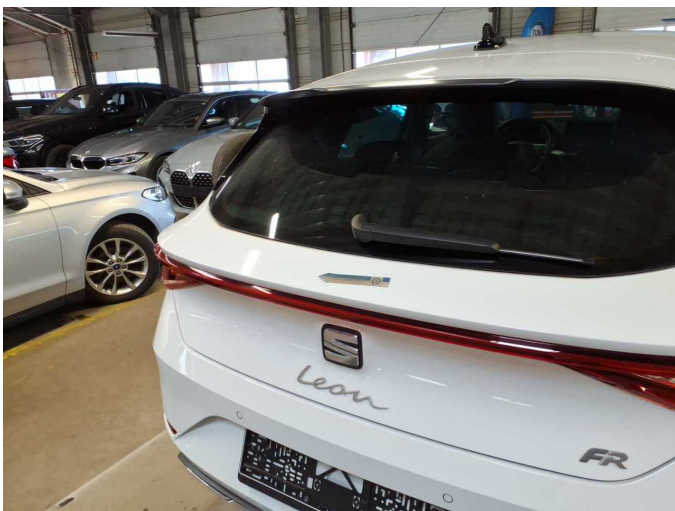
Damage 2: Boot lid / rear door: Boot lid - dent(s) - Smooth repair work

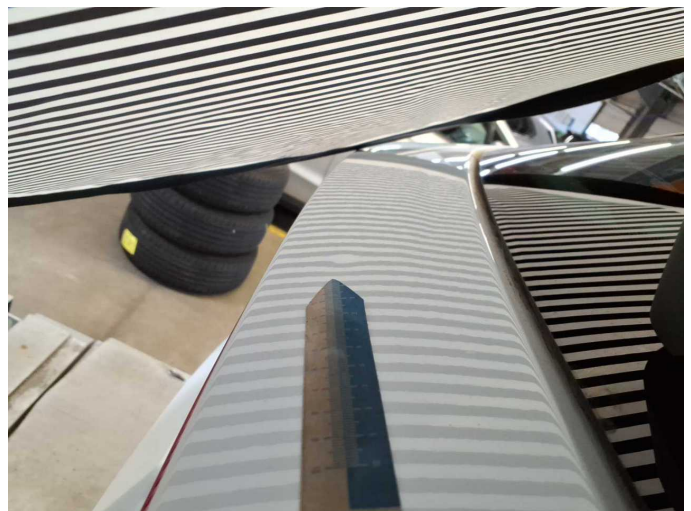
Damage 2: Boot lid / rear door: Boot lid - dent(s) - Smooth repair work

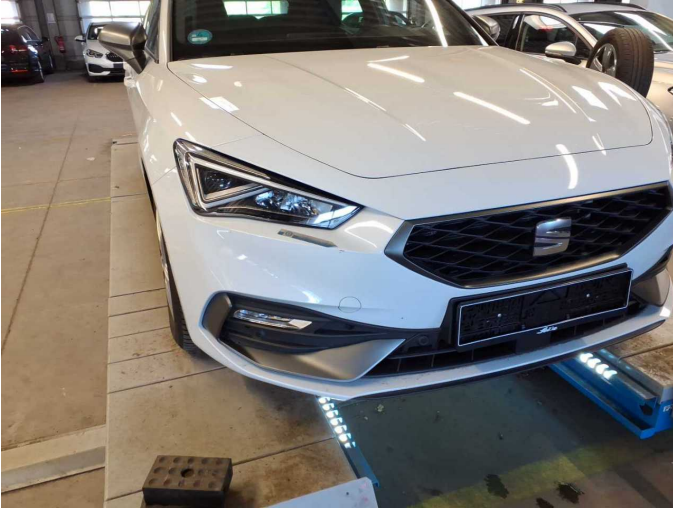
**Damage 3:** Front bumper: Front bumper (Kratzer) - Stone chips - Paint

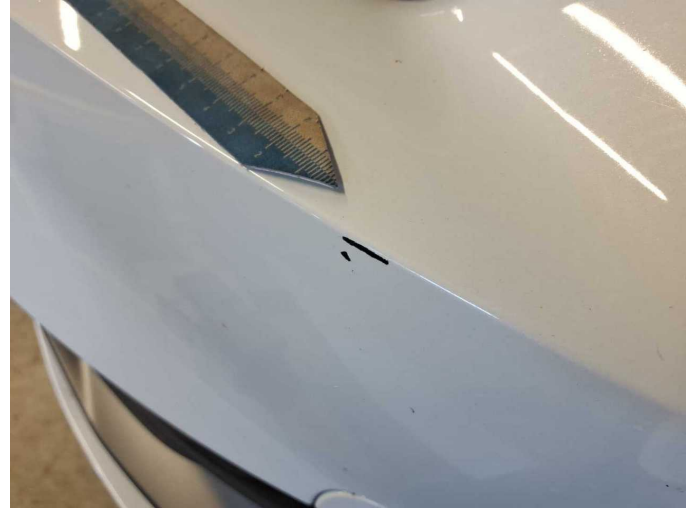
**Damage 3:** Front bumper: Front bumper (Kratzer) - Stone chips - Paint

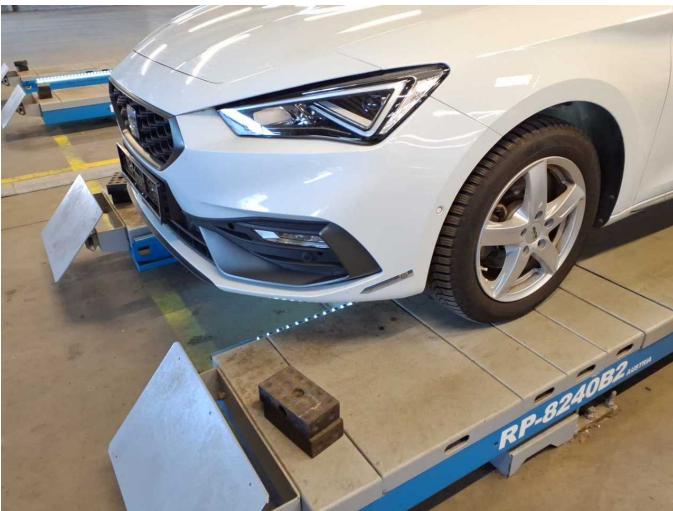
**Damage 3:** Front bumper: Front bumper (Kratzer) - Stone chips - Paint

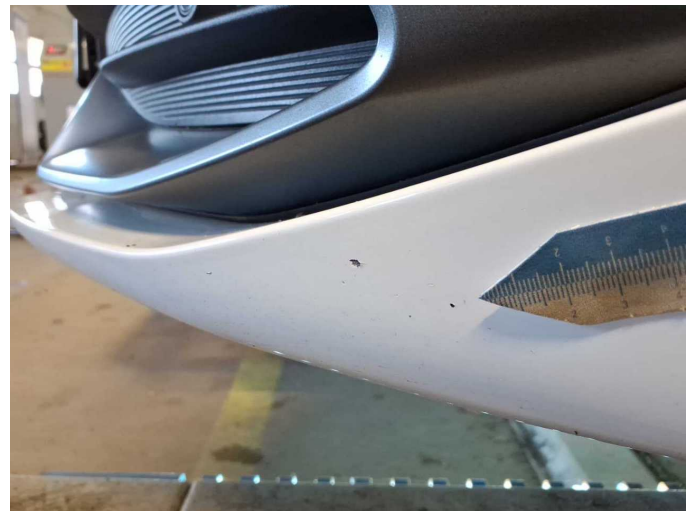
**Damage 3:** Front bumper: Front bumper (Kratzer) - Stone chips - Paint
