## Expertise

Protocol number: 45560188  
Order No. / Reference: 26302864  
Inspection date: 21 May 2026

Manufacturer: Opel

Model: Astra 1.5 D Start/Stop Sports Tourer Automatik Business Edition

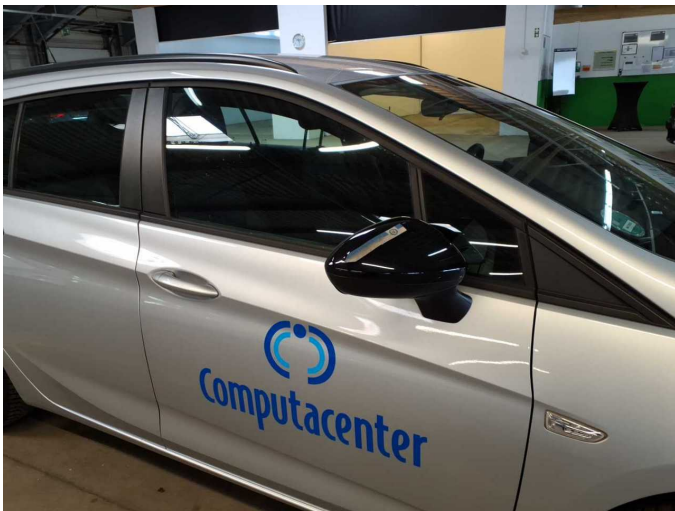
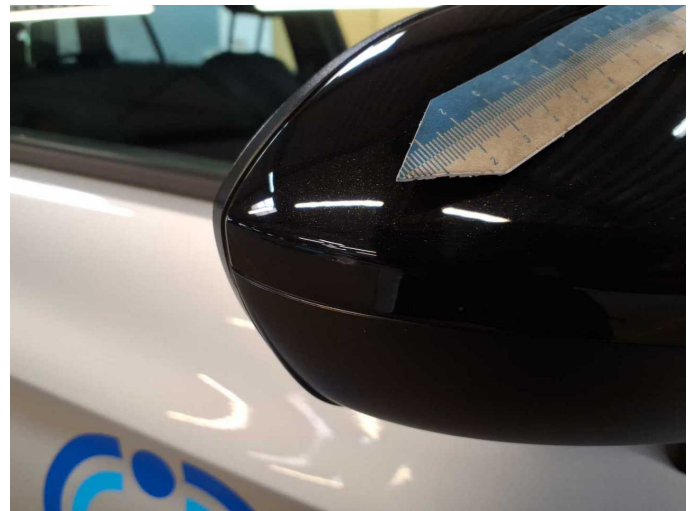
Damage 1: Wing mirror - right side: Cap - Scratch(es) - Smart repair

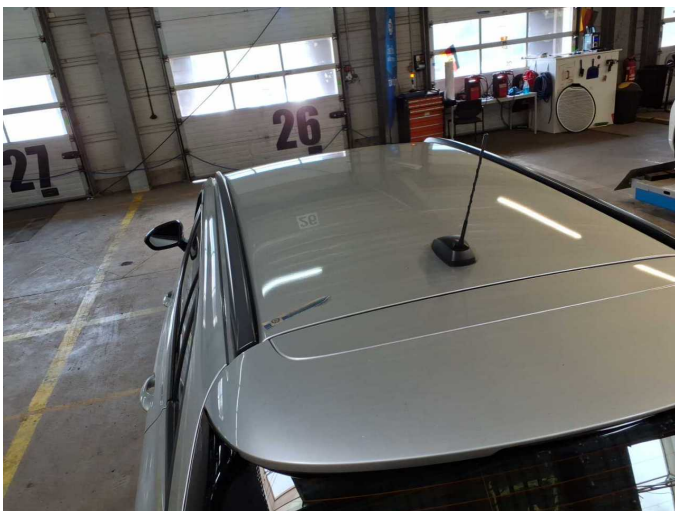
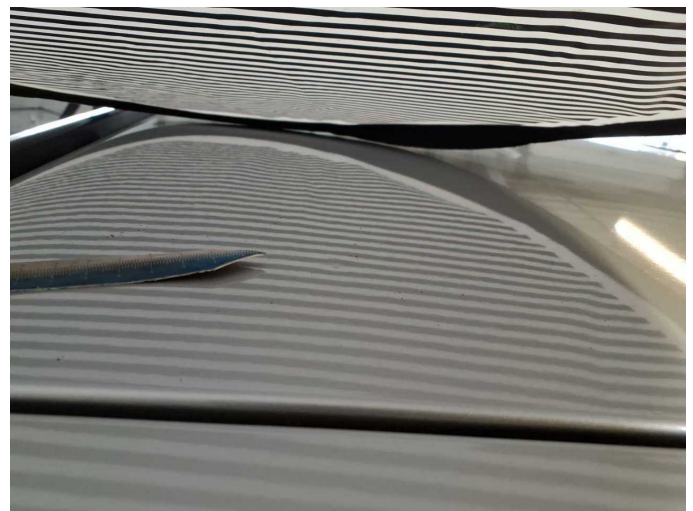
Damage 2: Roof: Roof - dent(s) - Smooth repair work

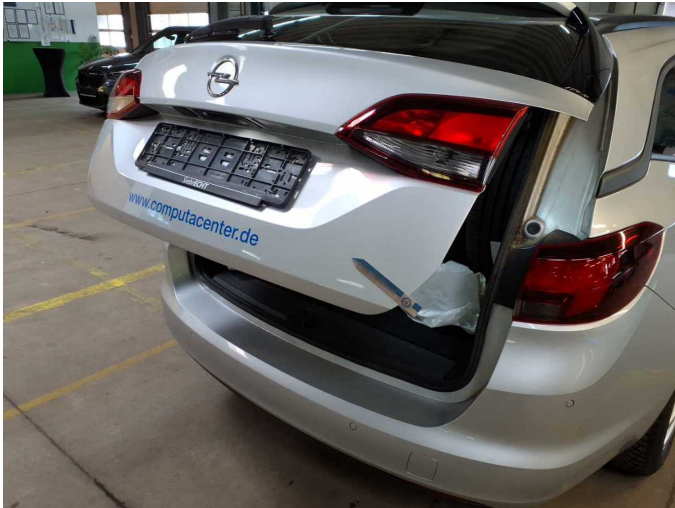
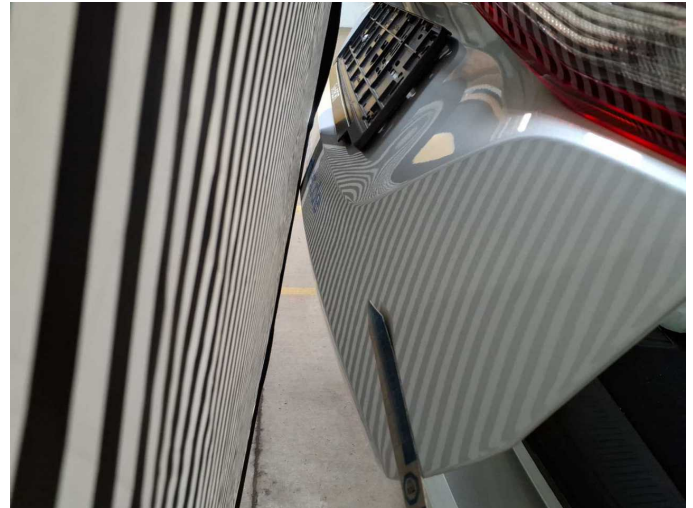
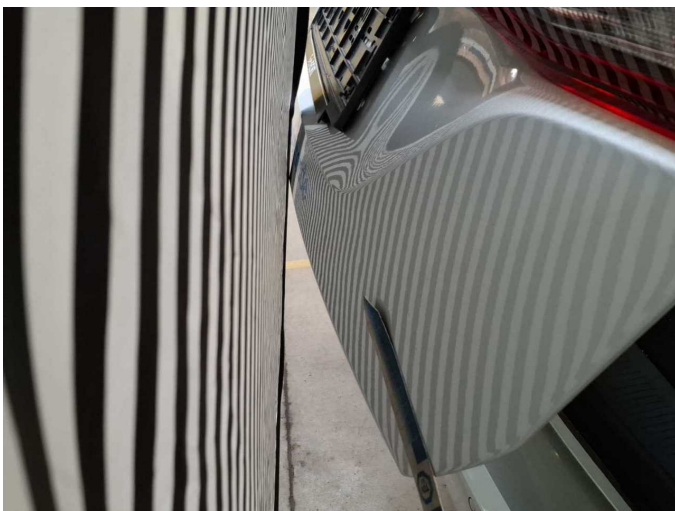
**Damage 3:** Boot lid / rear door: Boot lid - dent(s) - Smooth repair work

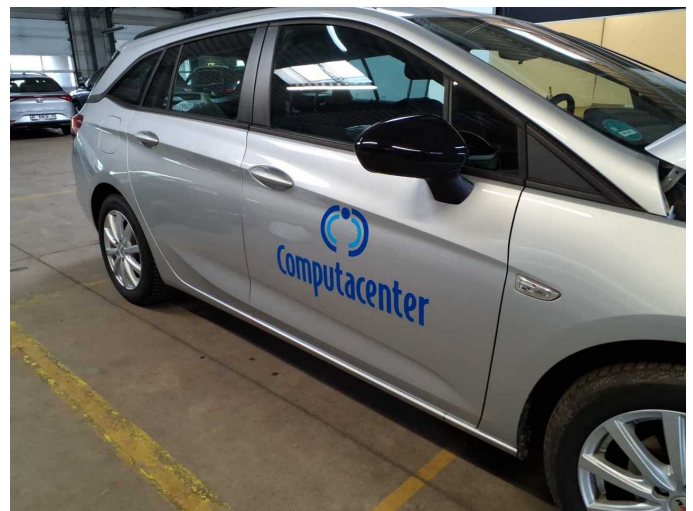
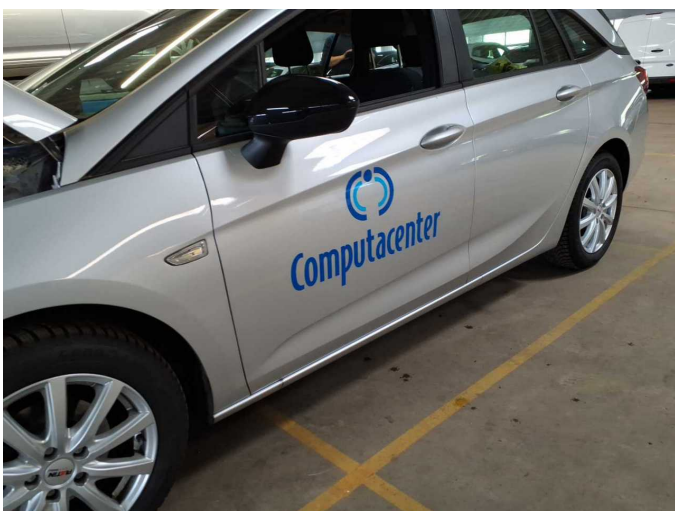
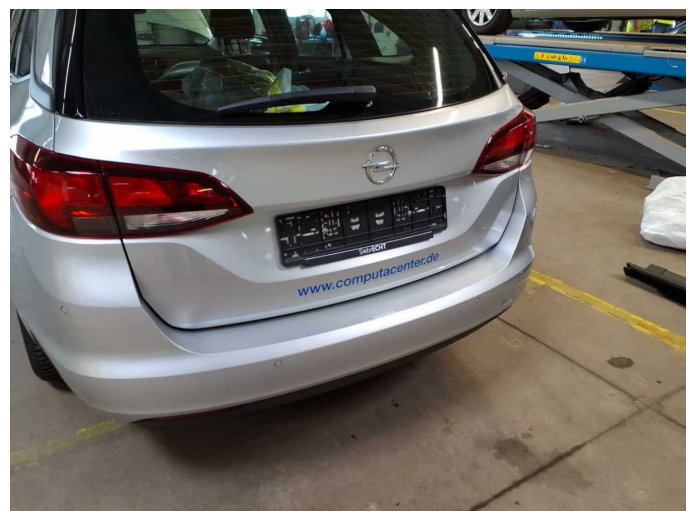
**Damage 4:** Body: Body - Glued / labelled - De-glug / neutralise

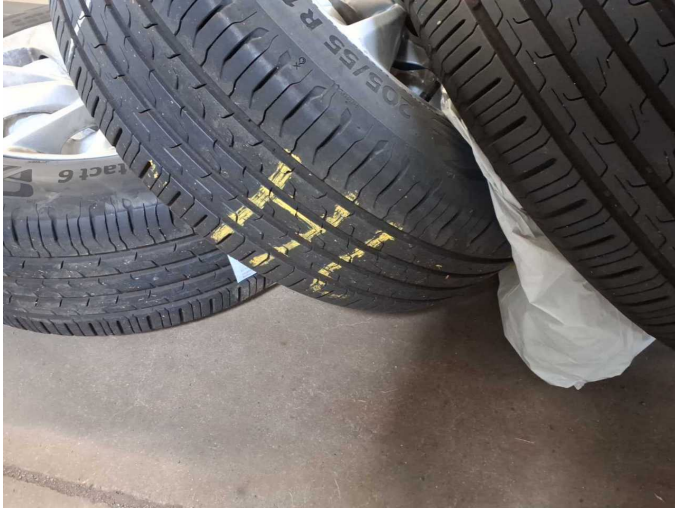
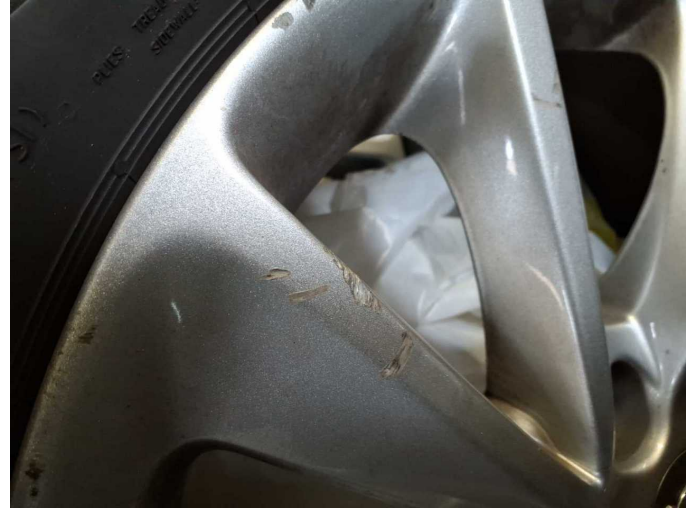
**Damage 5:** 2nd wheel set: 1 alloy rim - Scratch(es) - Loss in value

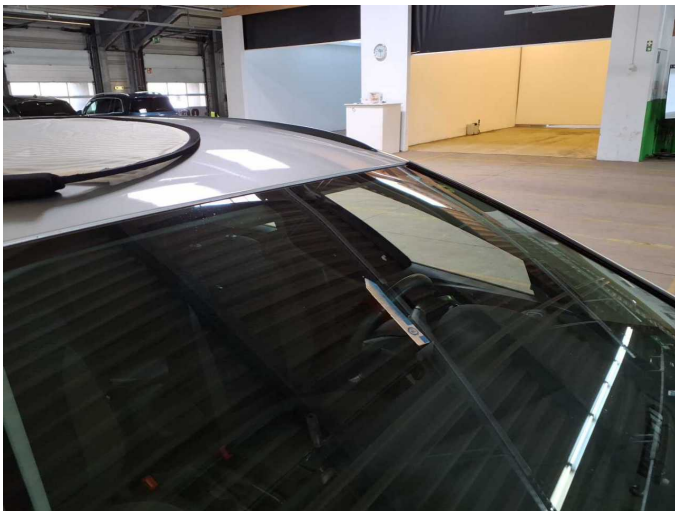
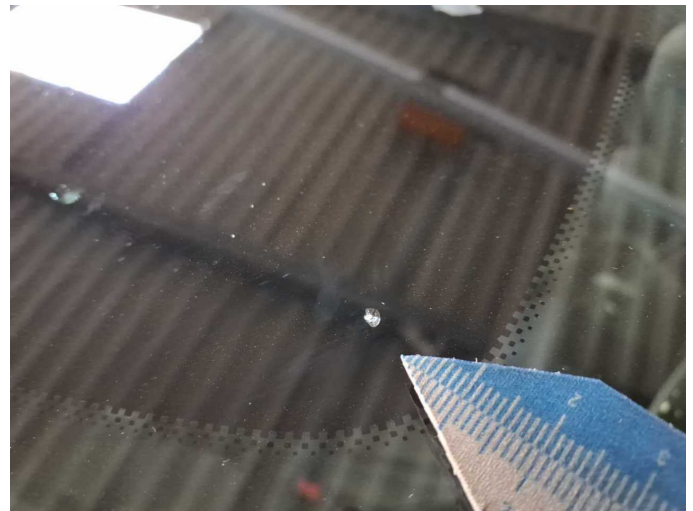
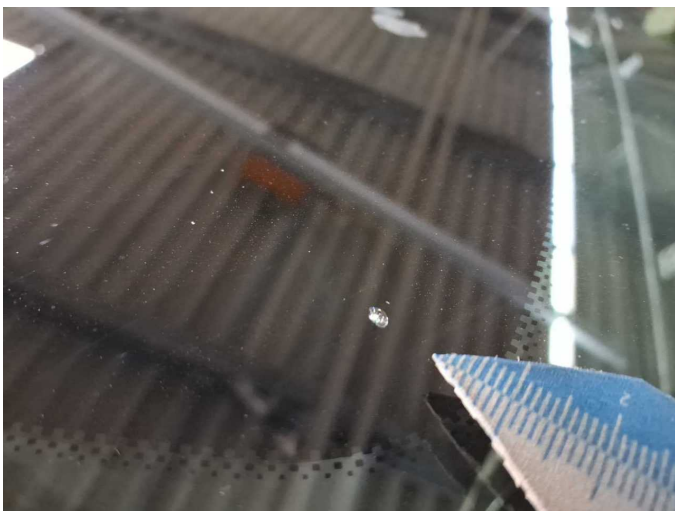
**Damage 6:** Vehicle glazing: Windscreen - Stone chips - Replace

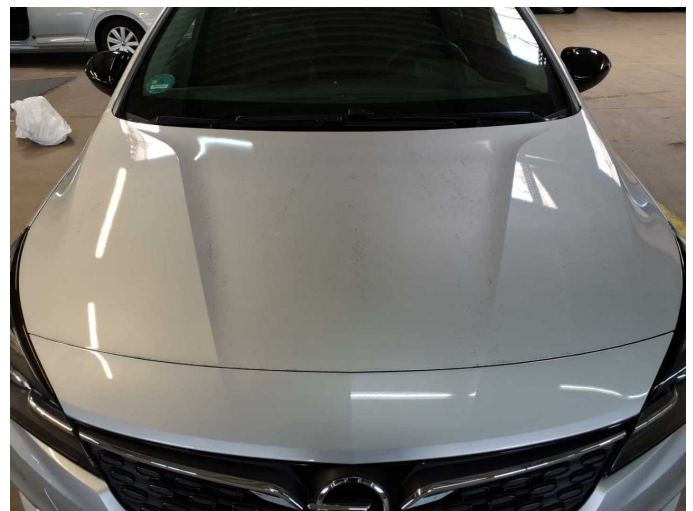
**Wear and tear 2:** Bonnet: Bonnet - Soiled - No deduction

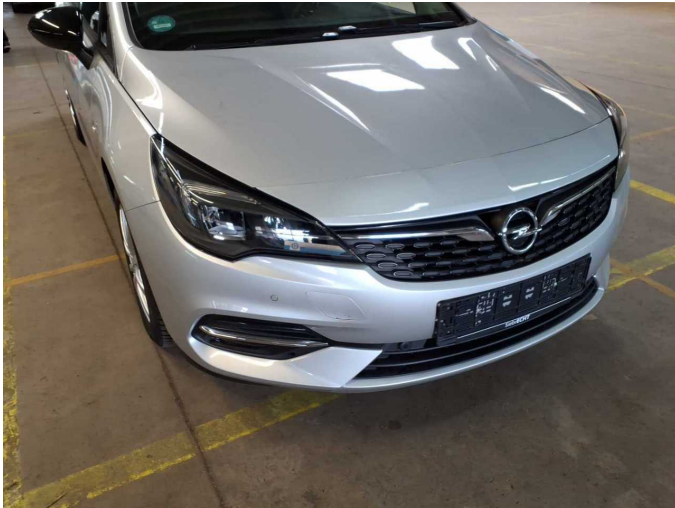
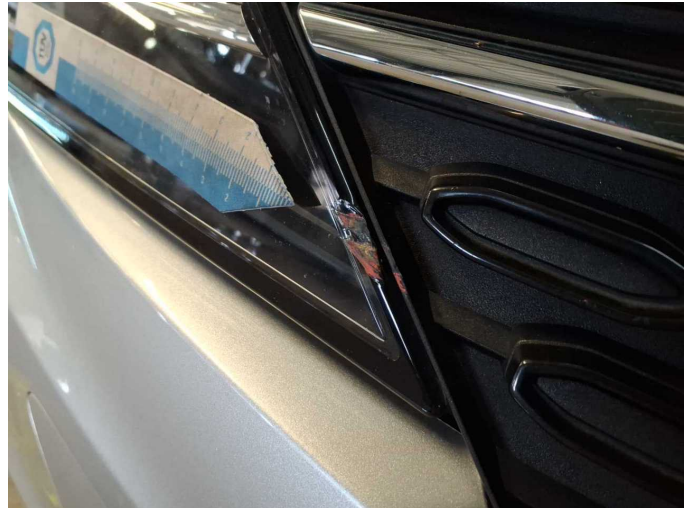
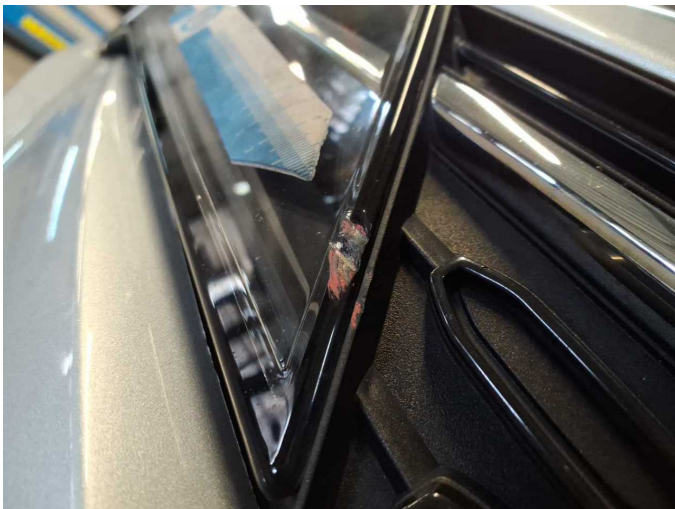
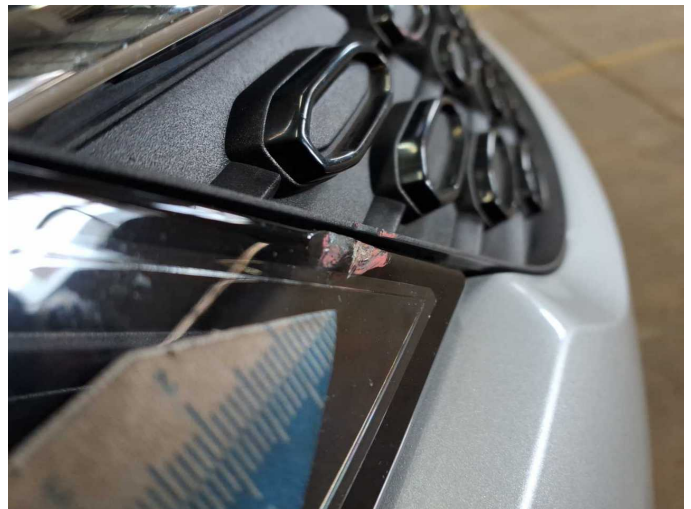
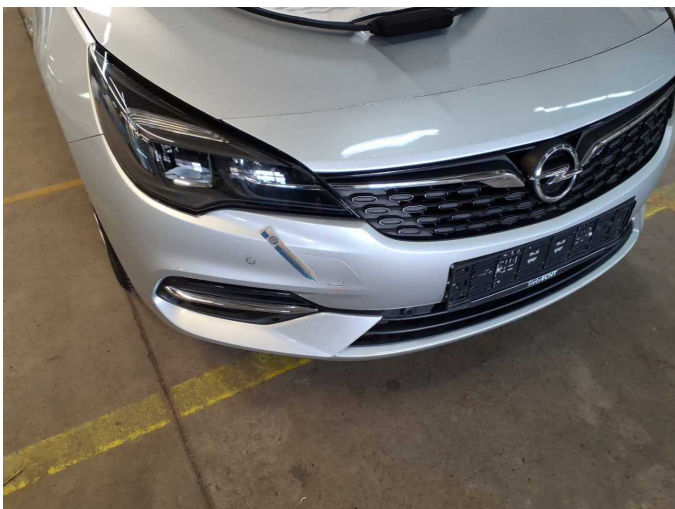
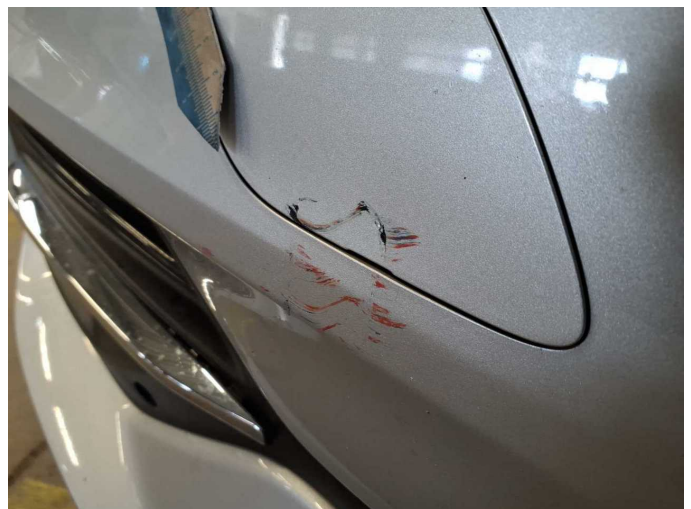
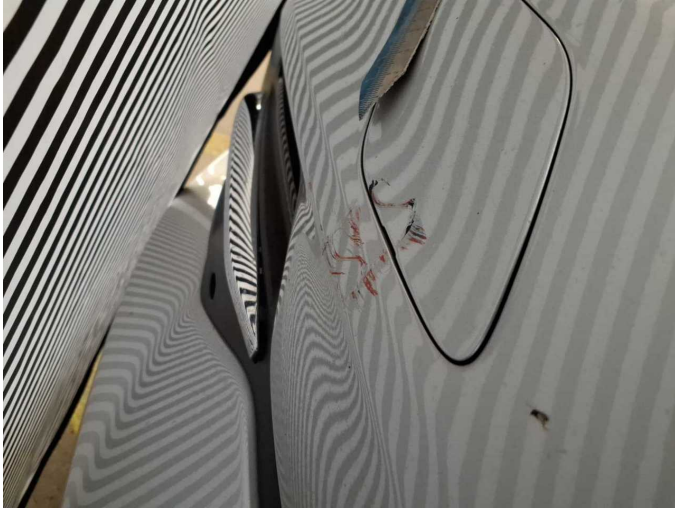
Accident 1: Front

Non-repaired previous damages were found at the vehicle. The necessary repair costs are listed in the expert report or if necessary, are listed in detail in a separately enclosed repair cost calculation.

Die beigefügte Reparaturkostenkalkulation wurde nach bestem Wissen und Gewissen unter eingeschränkten Besichtigungsbedingung im demontagefreien Zustand erstellt. Es können aufgrund verdeckter Beschädigung erhebliche Mehrkosten und somit Abweichung der für den Unfall ausgewiesenen Reparaturkosten nicht ausgeschlossen werden.
