Expertise

Protocol number: 46474831  
Order No. / Reference: 26646132  
Inspection date: 13 Jul 2026

Manufacturer: Opel

Model: Insignia Sports Tourer 2.0 Diesel Aut. Business

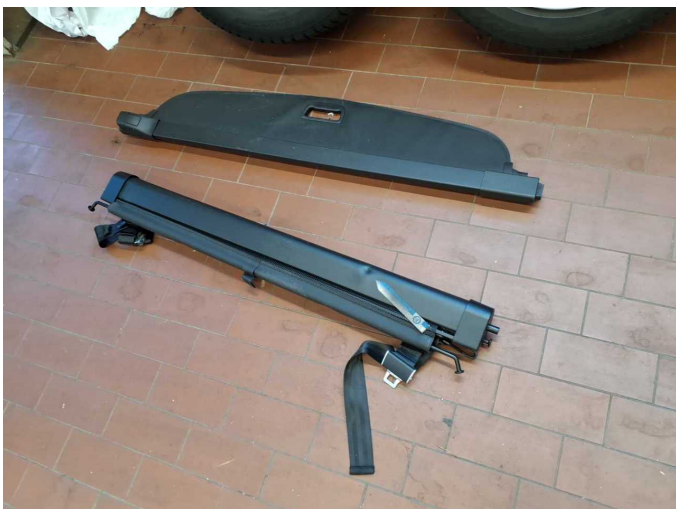
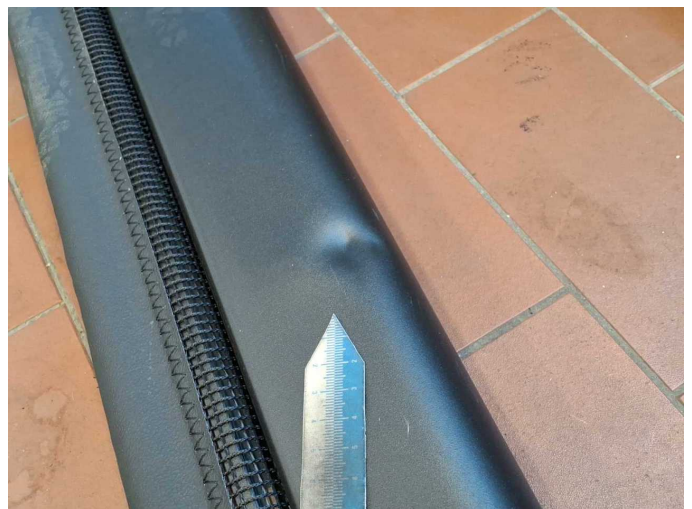
| No. | Component group | Description |
|---|---|---|
| 1 | Interior | Separation net - dent(s) - Loss in value |

Damage 1: Interior: Separation net - dent(s) - Loss in value

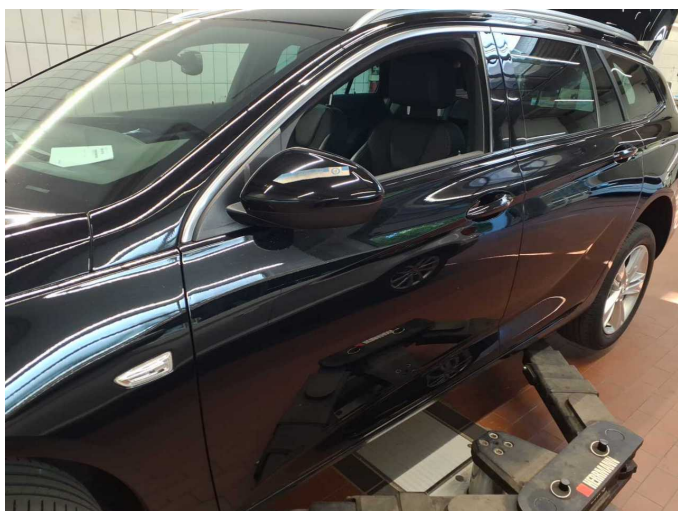
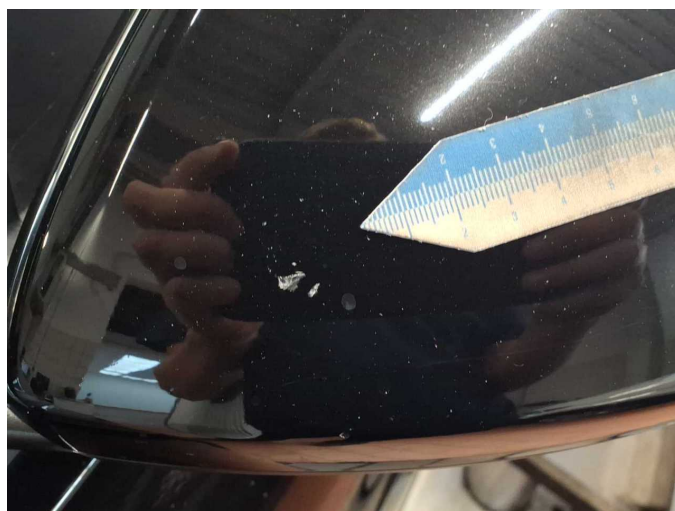
| No. | Component group | Description |
|---|---|---|
| 2 | Wing mirror - left side | Cap - Scratch(es) - Smart repair |

**Damage 2:** Wing mirror - left side: Cap - Scratch(es) - Smart repair

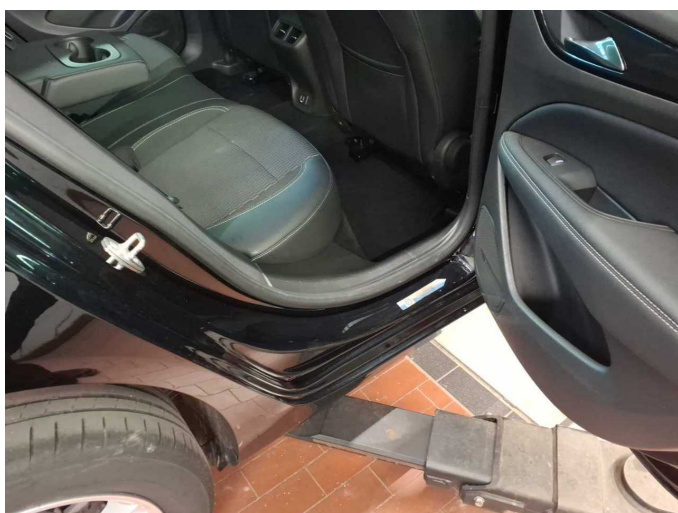
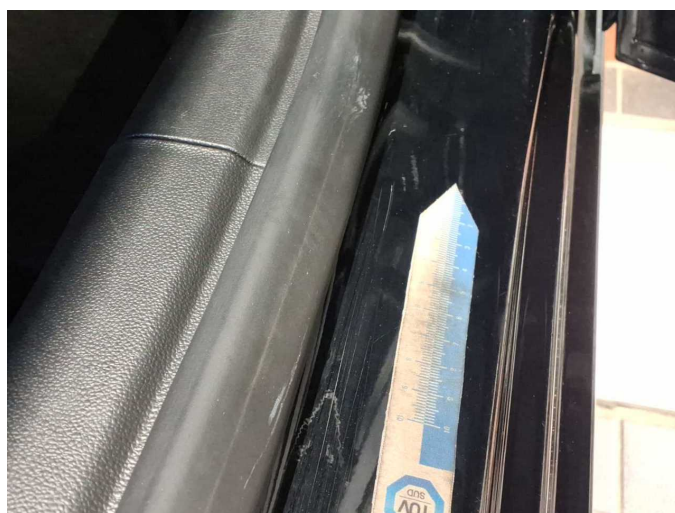
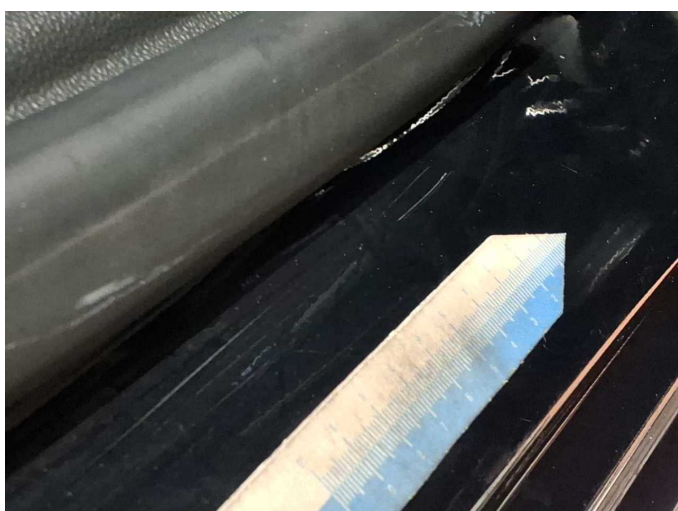
| No. | Component group | Description |
|---|---|---|
| 3 | Side panel - rear right side | Sill - Scratch(es) - Smart repair |

**Damage 3:** Side panel - rear right side: Sill - Scratch(es) - Smart repair

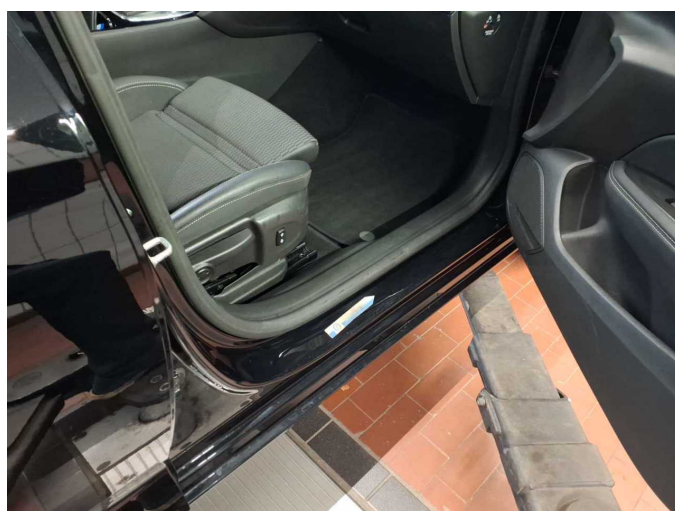
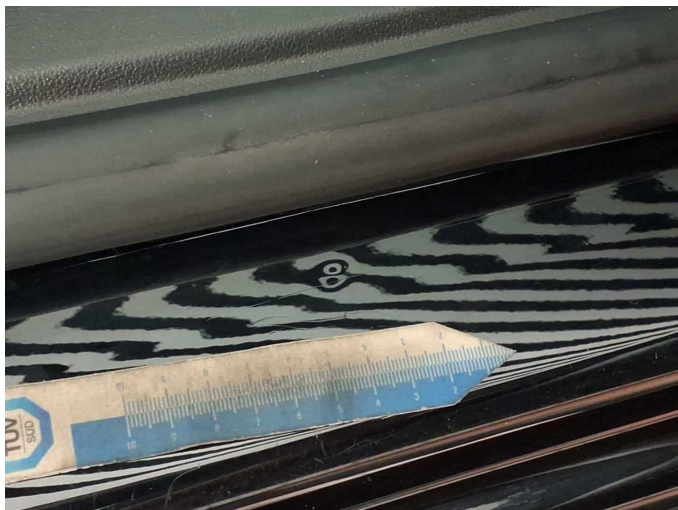
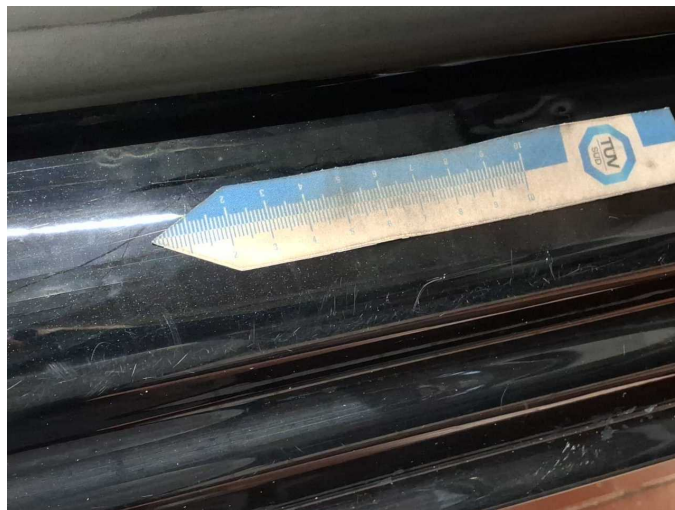
| No. | Component group | Description |
|---|---|---|
| 4 | Sill - right side | Sill (+ Kratzer) - dent(s) - Smart repair |

**Damage 4:** Sill - right side: Sill (+ Kratzer) - dent(s) - Smart repair

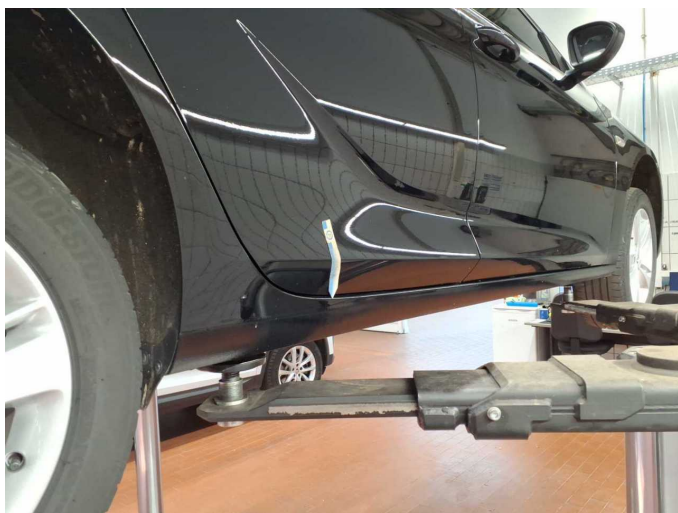
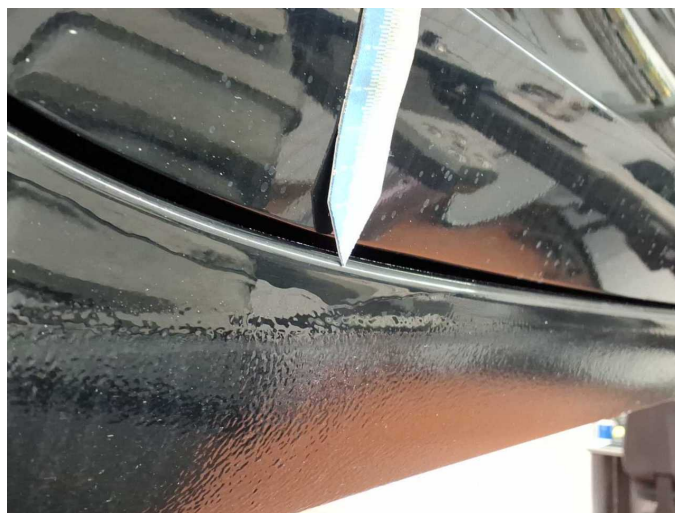
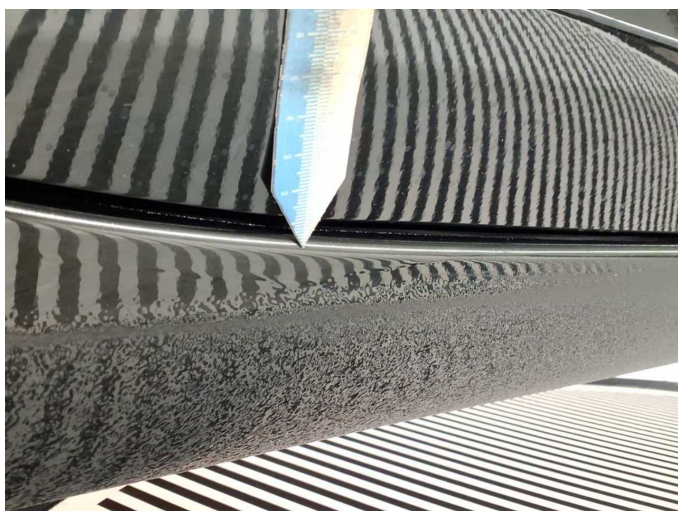
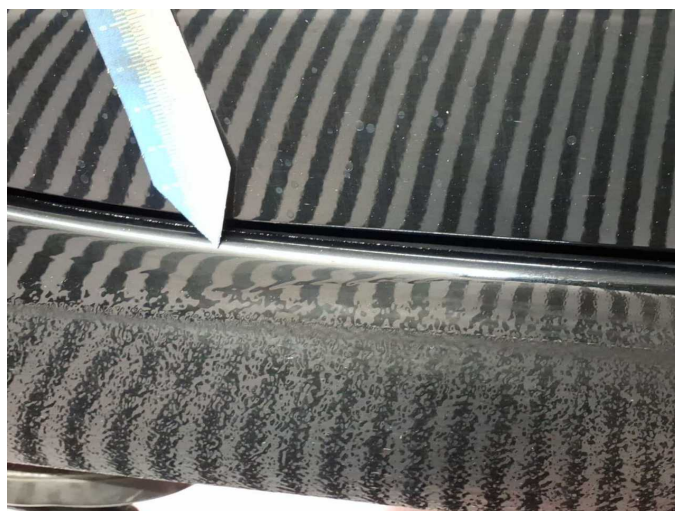
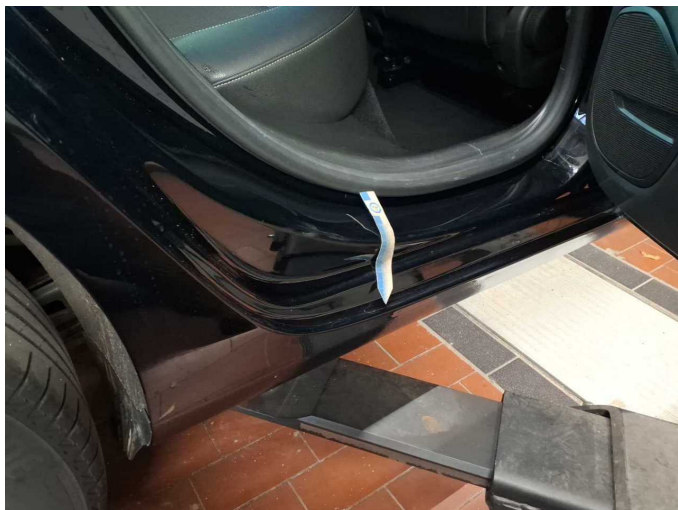
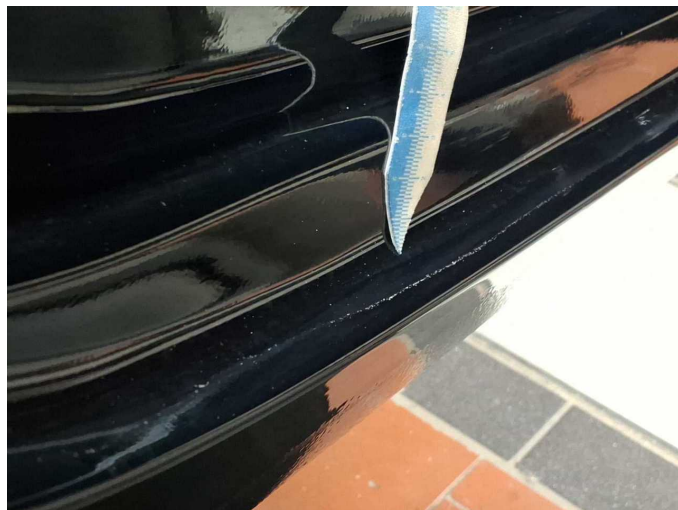
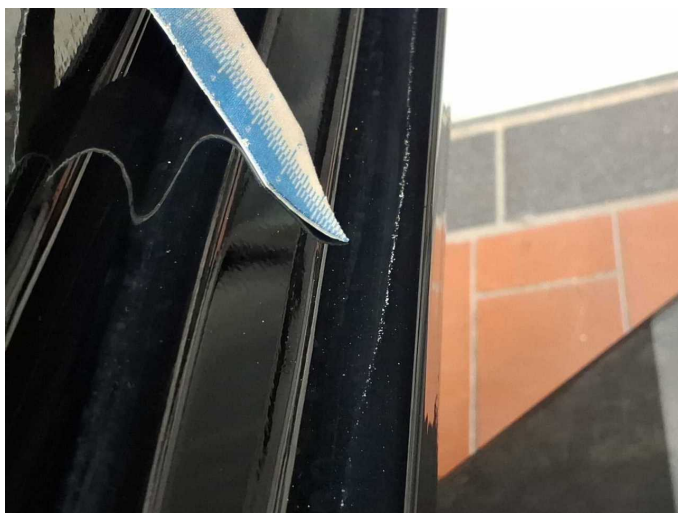
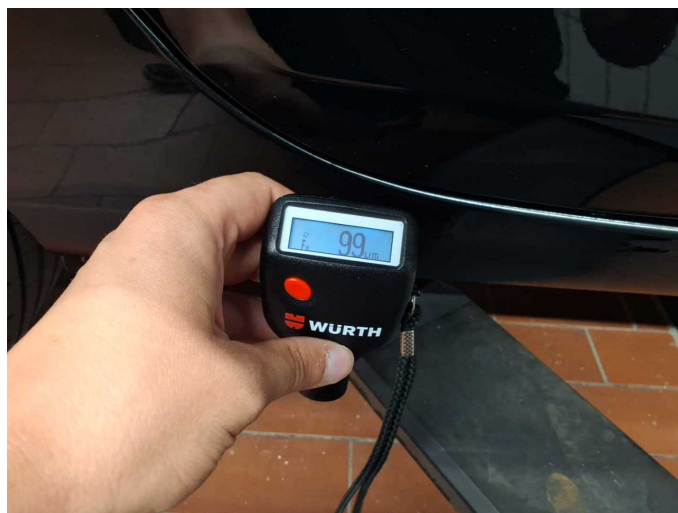
| No. | Component group | Description |
|---|---|---|
| 5 | Sill - right side | Sill (Lackläufer) - Unprofessionally repaired - Repair and paint |

**Damage 5:** Sill - right side: Sill (Lackläufer) - Unprofessionally repaired - Repair and paint

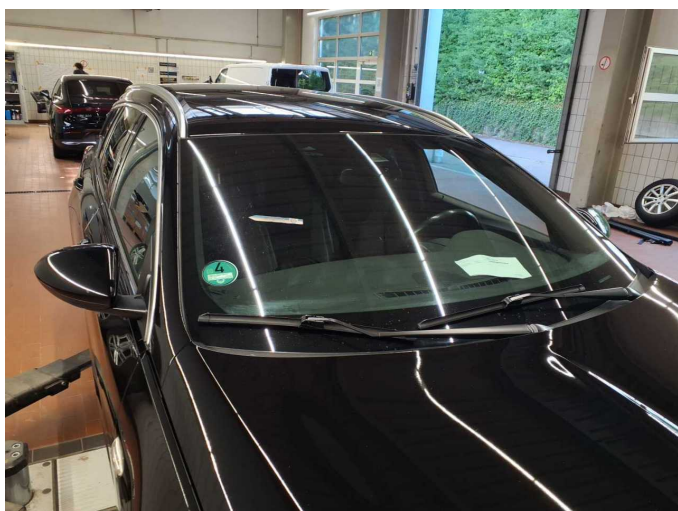
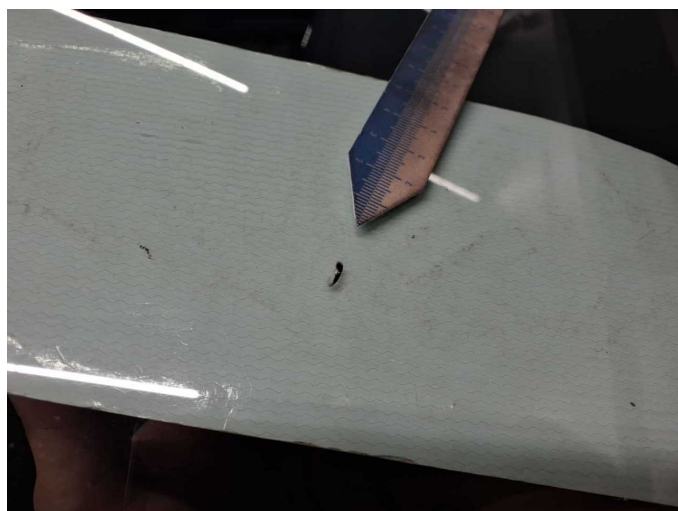
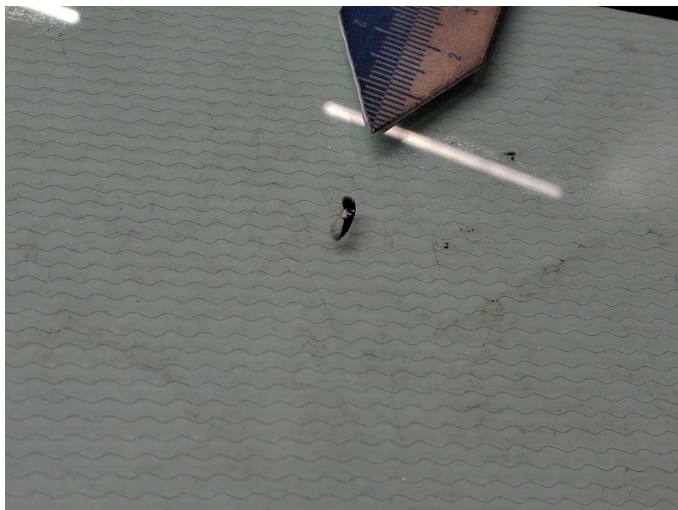
| No. | Component group | Description |
|---|---|---|
| 6 | Vehicle glazing | Windscreen (mit Heizung) - Stone chips - Replace |

**Damage 6:** Vehicle glazing: Windscreen (mit Heizung) - Stone chips - Replace
