Expertise

Protocol number: 47105275  
Order No. / Reference: 26733985  
Inspection date: 17 Aug 2026

Manufacturer: Ford

Model: Mondeo Turnier 2.0 EcoBlue Aut. Titanium

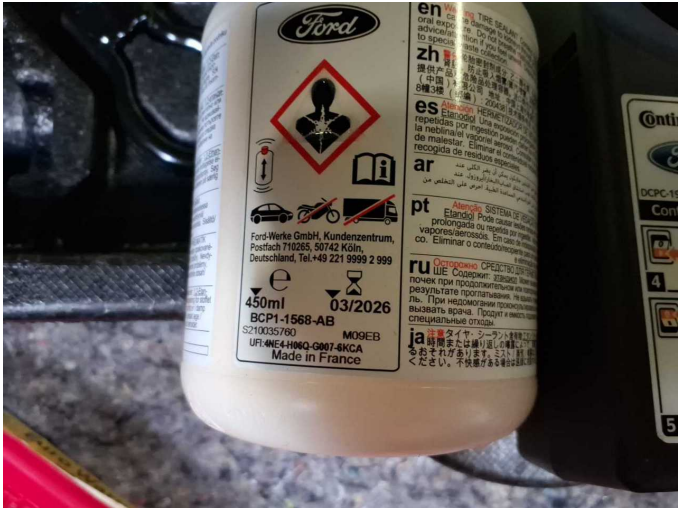
| No. | Component group | Description |
|---|---|---|
| 1 | Equipment | Tirefit filler - Expired - Replace |

Damage 1: Equipment: Tirefit filler - Expired - Replace

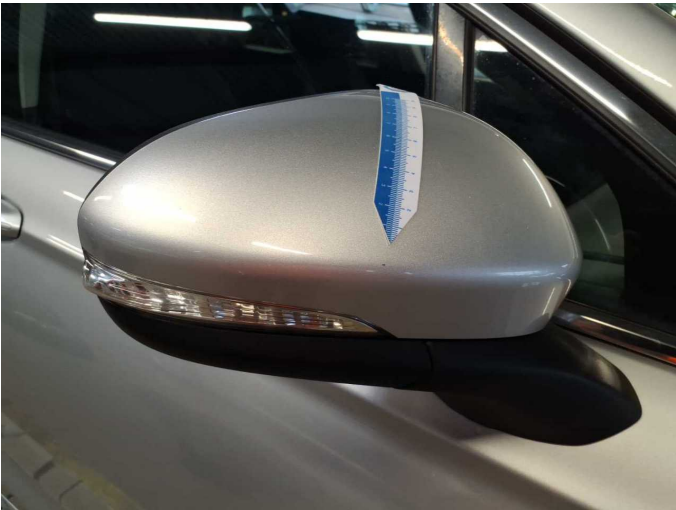
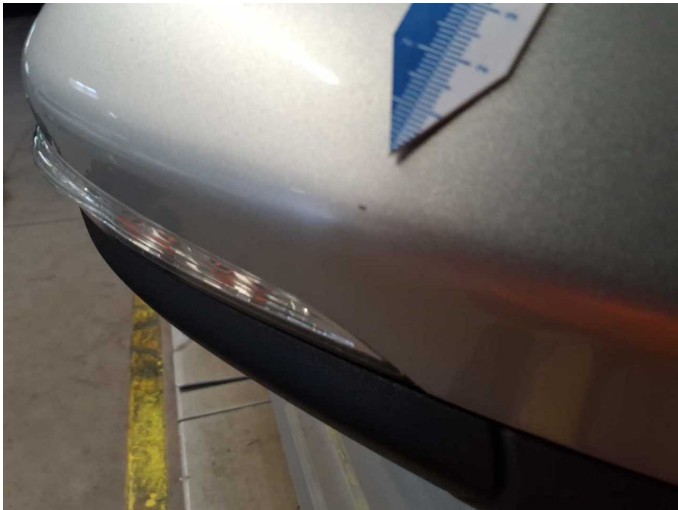
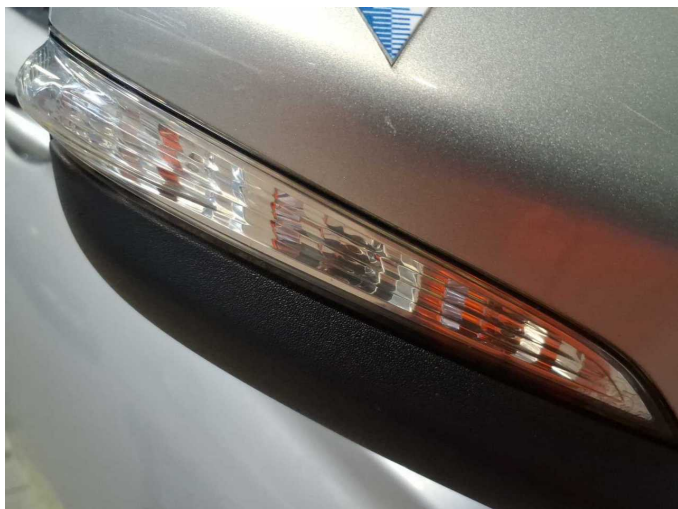
| No. | Component group | Description |
|---|---|---|
| 2 | Wing mirror - right side | Cap - Scratch(es) - Smart repair |

Damage 2: Wing mirror - right side: Cap - Scratch(es) - Smart repair

**Damage 2:** Wing mirror - right side: Cap - Scratch(es) - Smart repair

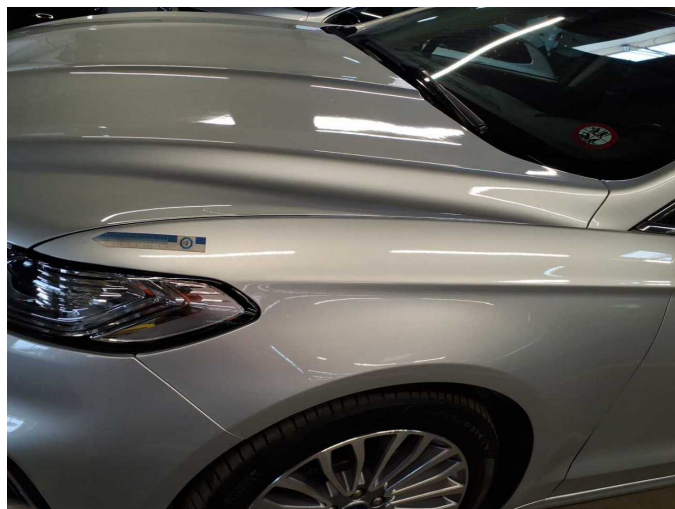
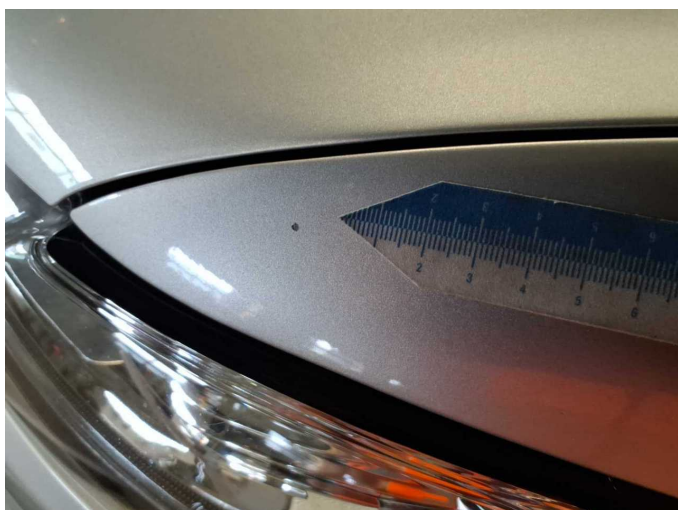
| No. | Component group | Description |
|---|---|---|
| 3 | Mudguard - left side | Mudguard - left side - Stone chips - Smart repair |

**Damage 3:** Mudguard - left side: Mudguard - left side - Stone chips - Smart repair

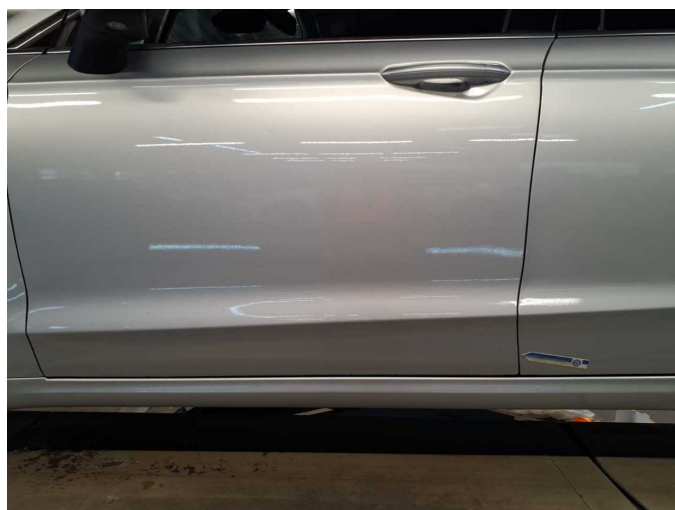
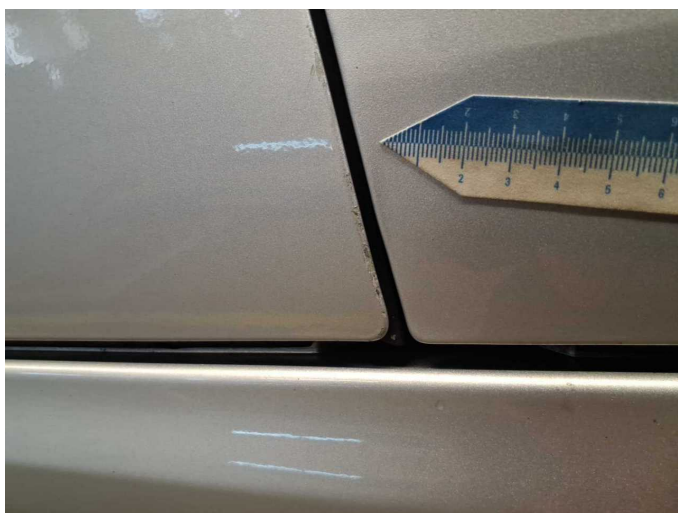
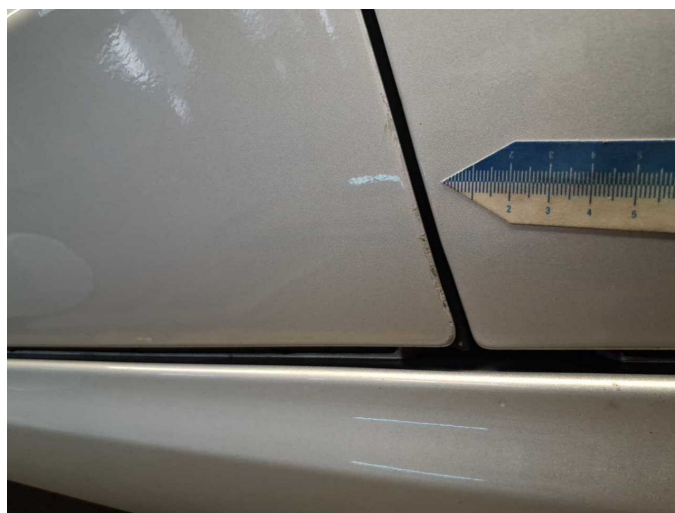
| No. | Component group | Description |
|---|---|---|
| 4 | Door - front left side | Door edge - Scratch(es) - Smart repair |

**Damage 4:** Door - front left side: Door edge - Scratch(es) - Smart repair

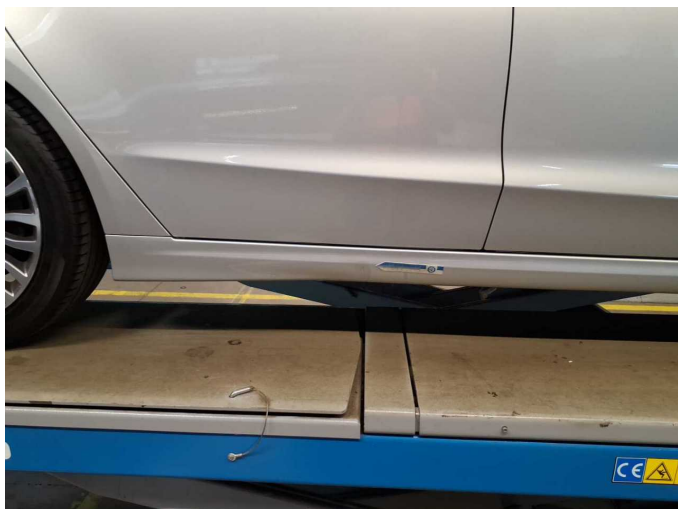
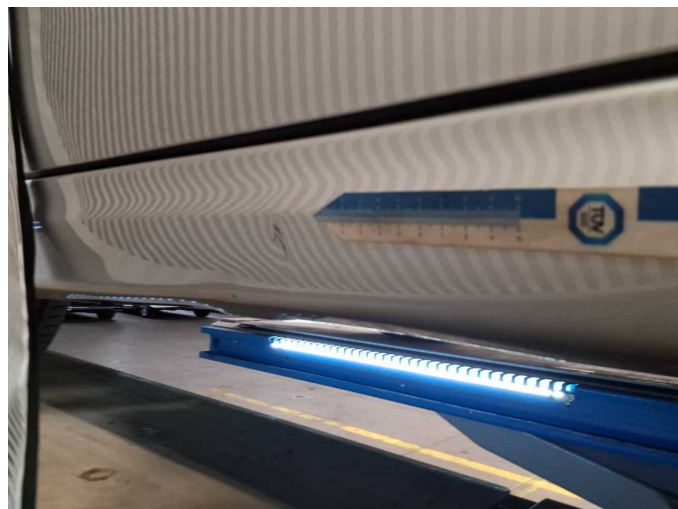
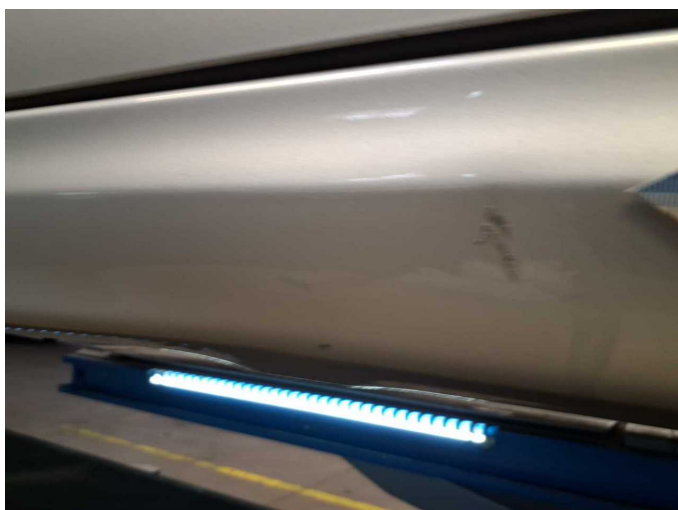
| No. | Component group | Description |
|---|---|---|
| 5 | Sill - right side | Trim - Dent / paintcoat damage - Smart repair |

**Damage 5:** Sill - right side: Trim - Dent / paintcoat damage - Smart repair

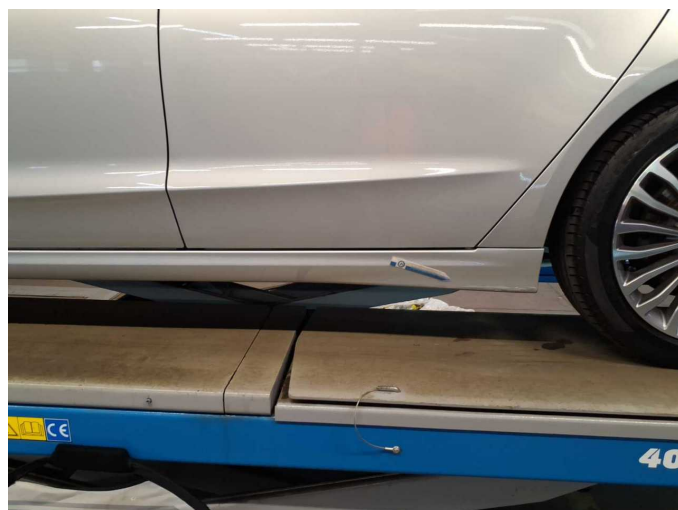
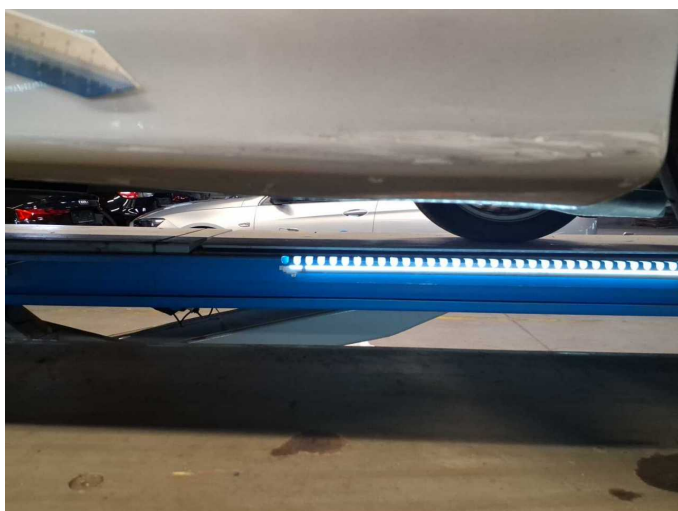
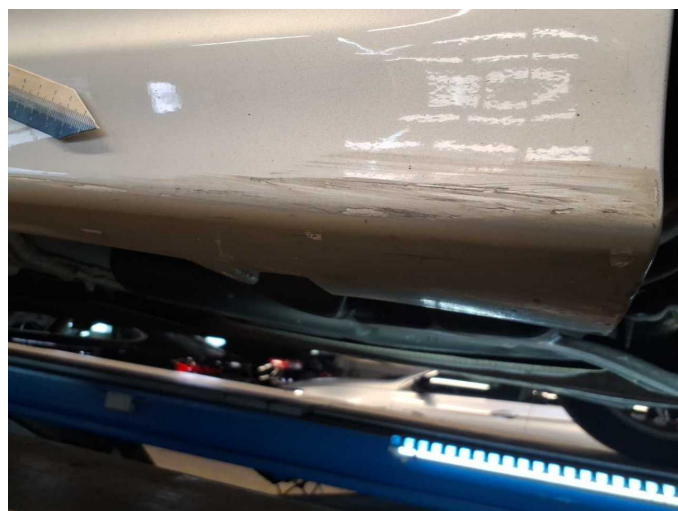
| No. | Component group | Description |
|---|---|---|
| 6 | Sill - left side | Sill - Scratch(es) - Repair and paint |

**Damage 6:** Sill - left side: Sill - Scratch(es) - Repair and paint

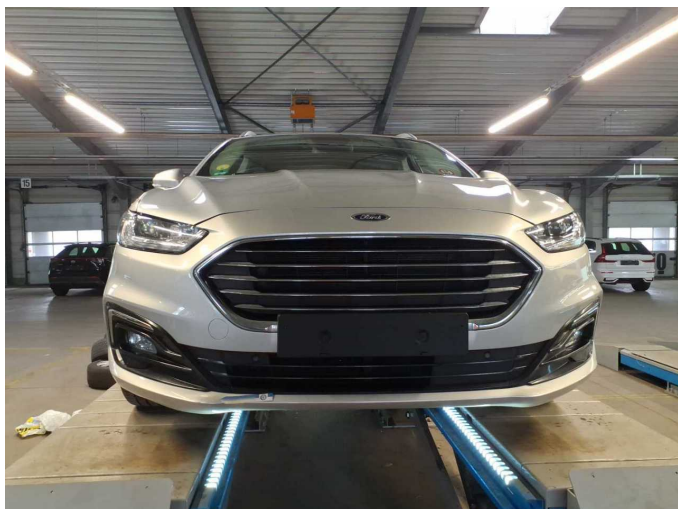
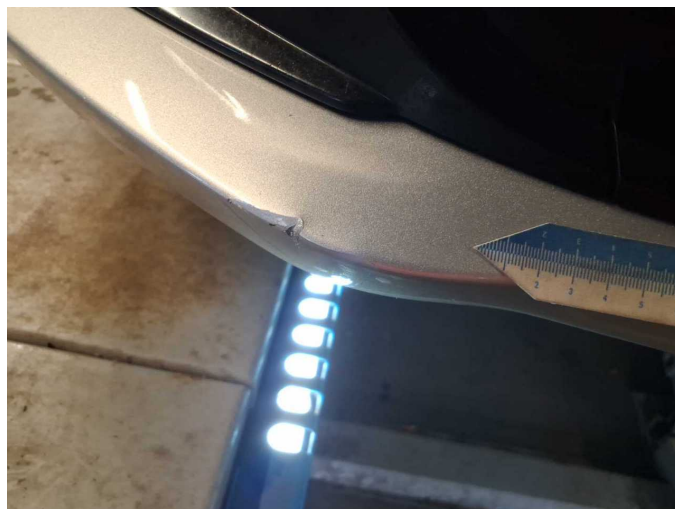
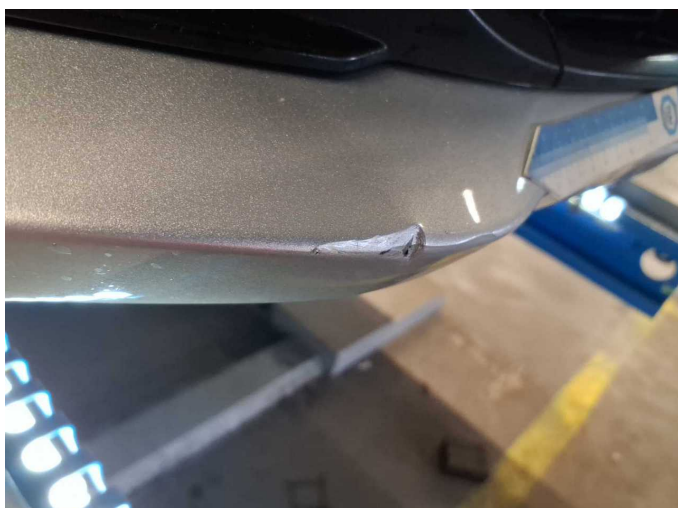
| No. | Component group | Description |
|---|---|---|
| 7 | Front bumper | Front bumper - Scratched - Repair and paint |

**Damage 7:** Front bumper: Front bumper - Scratched - Repair and paint

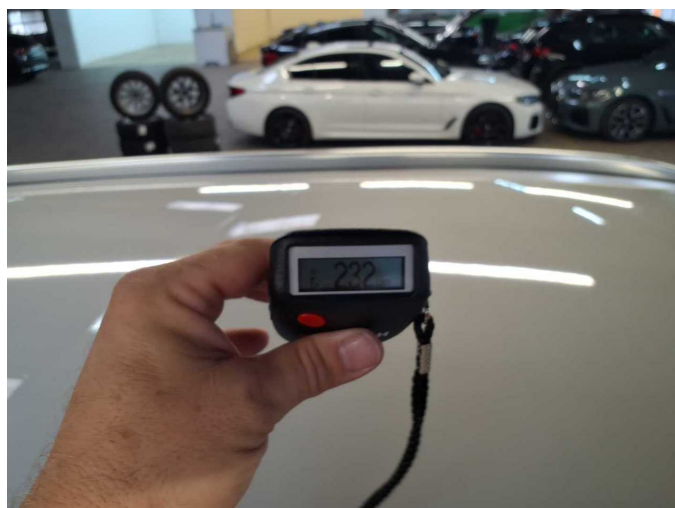
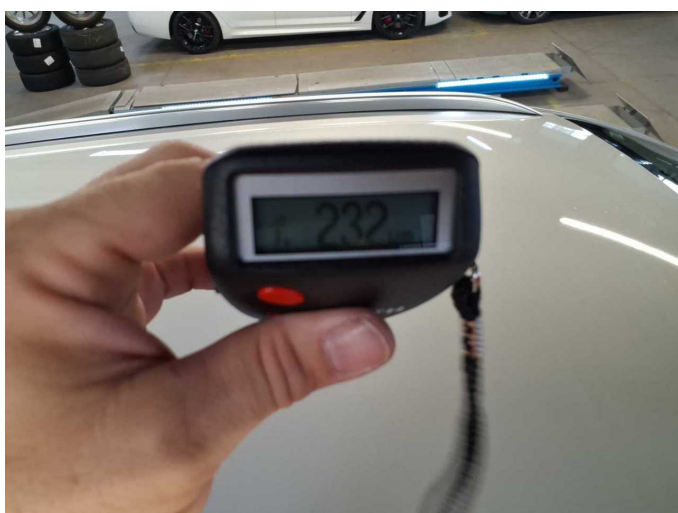
**Repainting 1:** Roof

| Roof | 232 µm | Roof rail - right side | 227 µm |

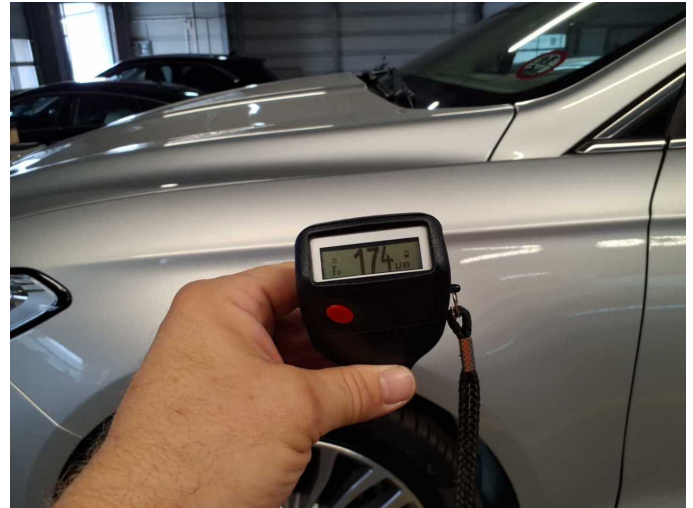
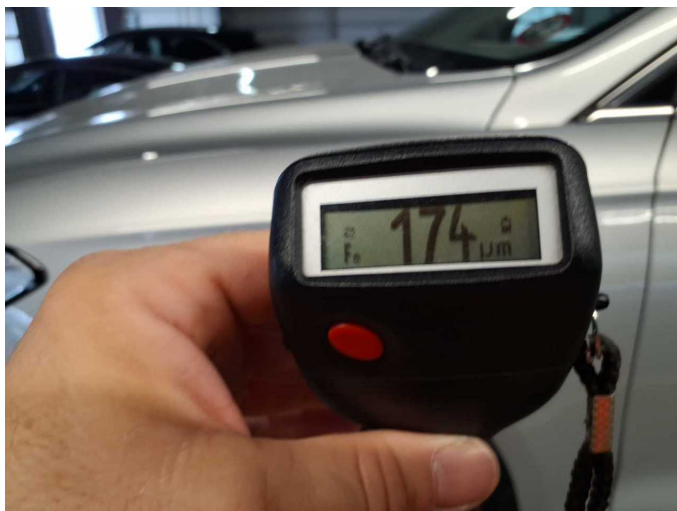
**Repainting 3:** Mudguard - left side

| Mudguard - left side | 174 µm | Mudguard - right side | 198 µm |

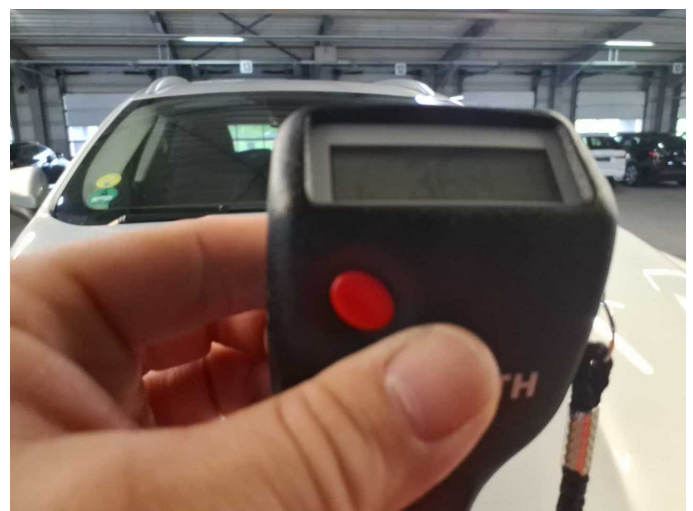
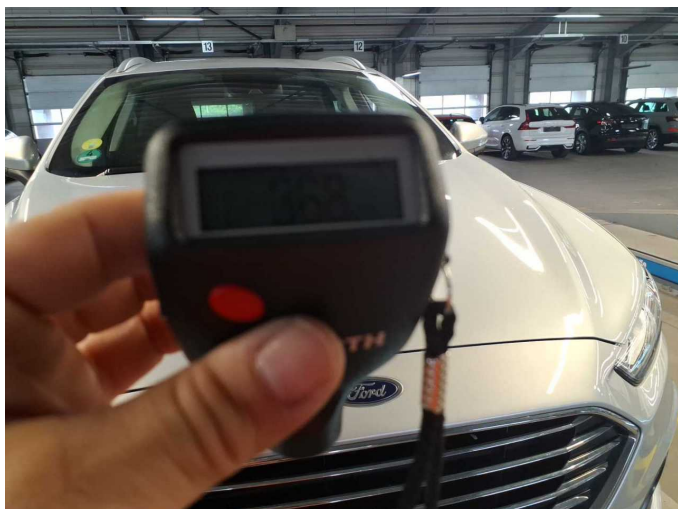
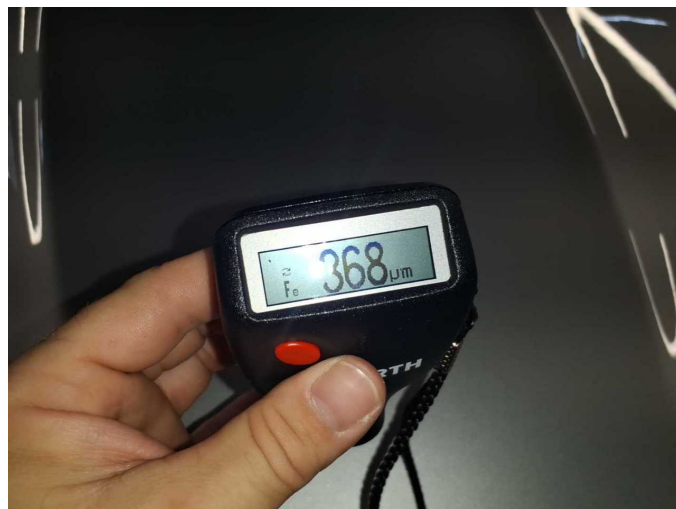
**Repainting 5:** Bonnet

| Bonnet | 368 µm | Side panel - rear right side | 175 µm |

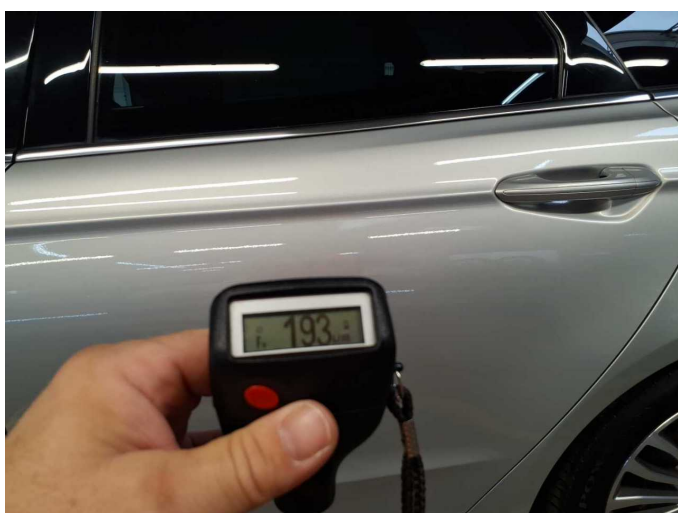
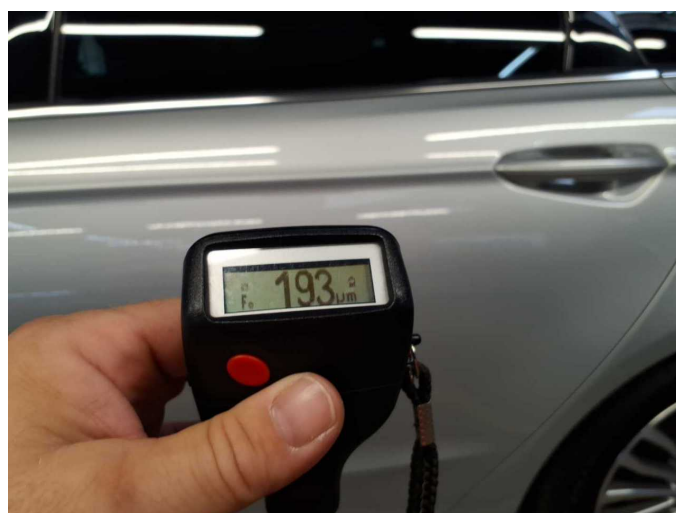
**Repainting 7: Door - rear left side**

| Door - rear left side | 193 µm | Door - rear right side | 178 µm |

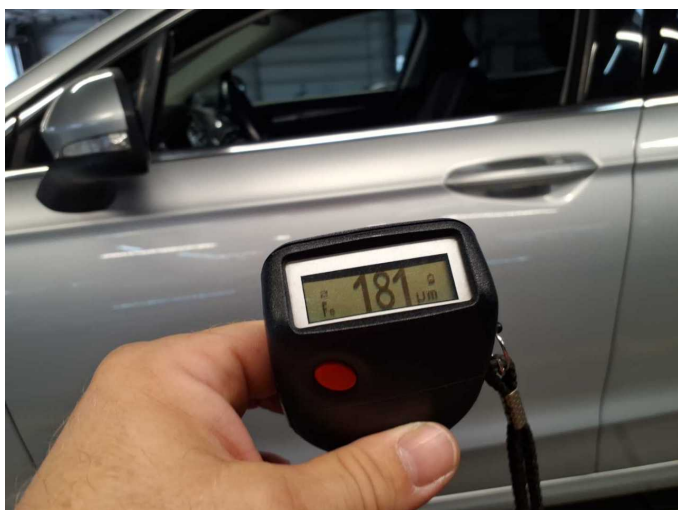
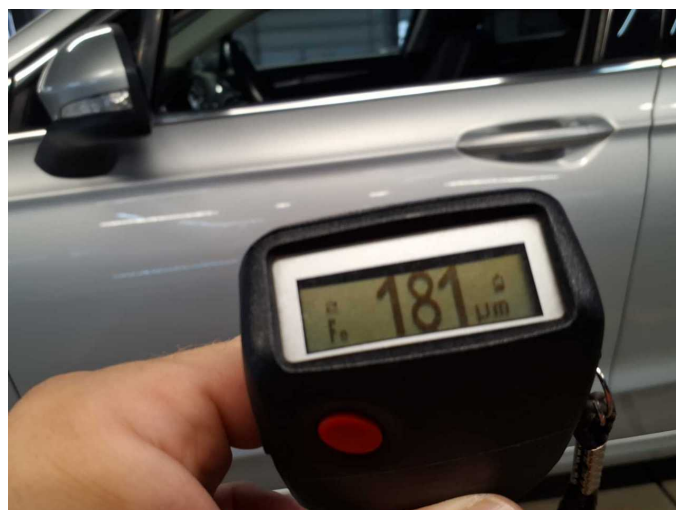
**Repainting 9:** Door - front left side

| Door - front left side | 181 µm | Door - front right side | 269 µm |
