## Expertise

Protocol number: 46322618  
Order No. / Reference: 26497494  
Inspection date: 3 Jul 2026

Manufacturer: Opel

Model: Crossland X 1.5 Diesel Start/Stop Automatik Innovation

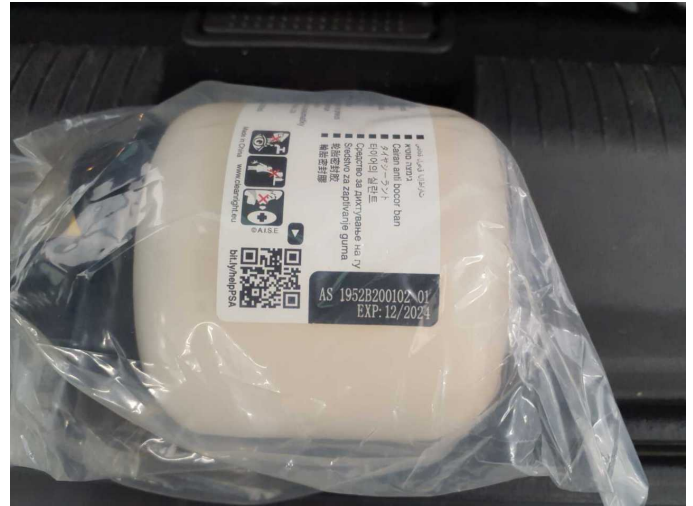
Damage 1: Equipment: Tirefit filler - Expired - Replace

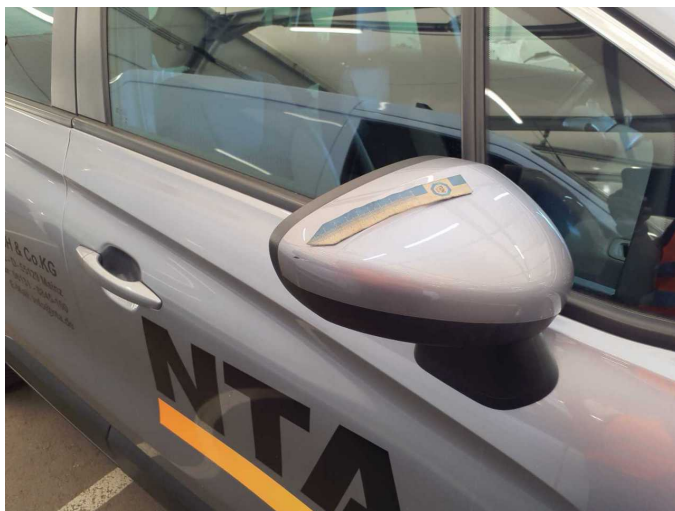
Damage 2: Wing mirror - right side: Cap - Scratch(es) - Smart repair

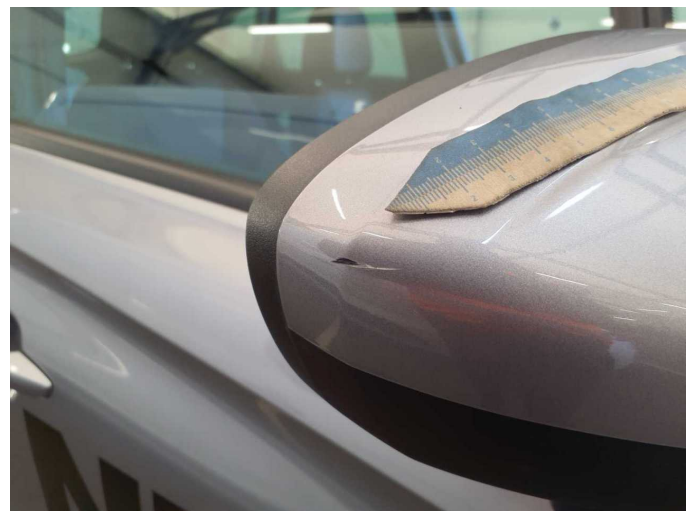
Damage 2: Wing mirror - right side: Cap - Scratch(es) - Smart repair

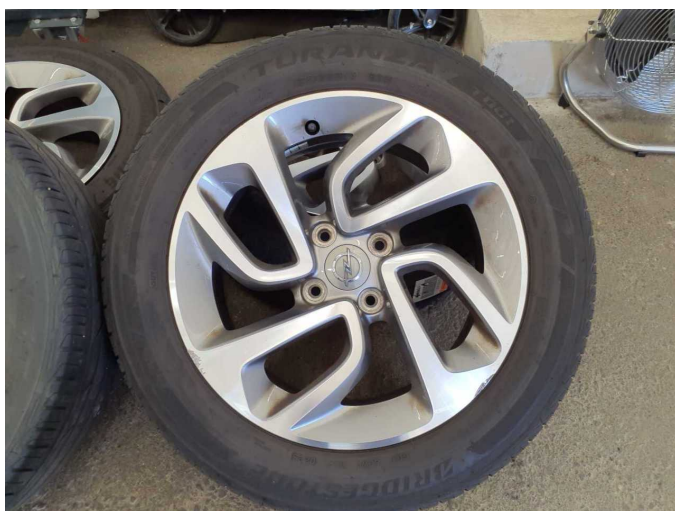
Damage 3: 2nd wheel set: 1 alloy rim - Scratch(es) - Loss in value

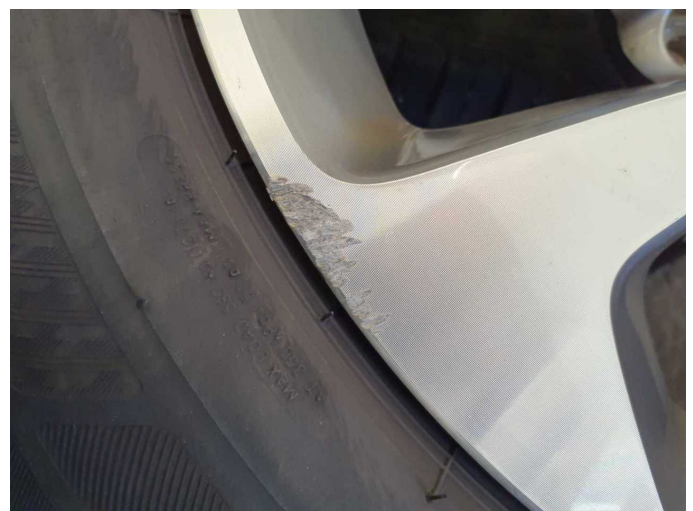
Damage 3: 2nd wheel set: 1 alloy rim - Scratch(es) - Loss in value

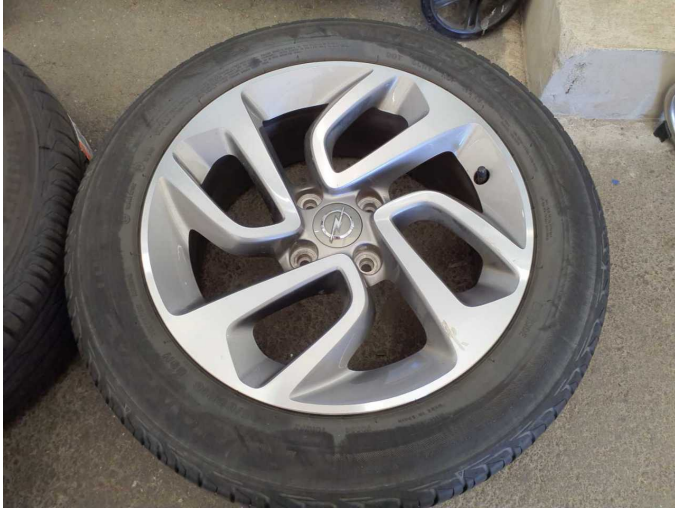
**Damage 4:** 2nd wheel set: 1 alloy rim - Scratch(es) - Loss in value

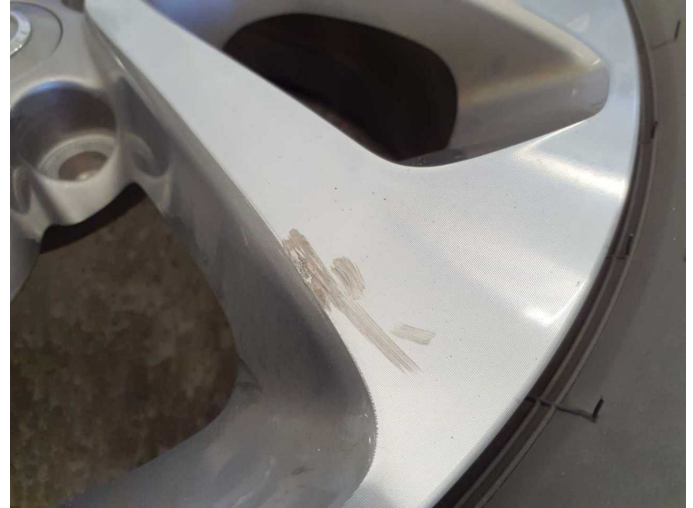
**Damage 4:** 2nd wheel set: 1 alloy rim - Scratch(es) - Loss in value

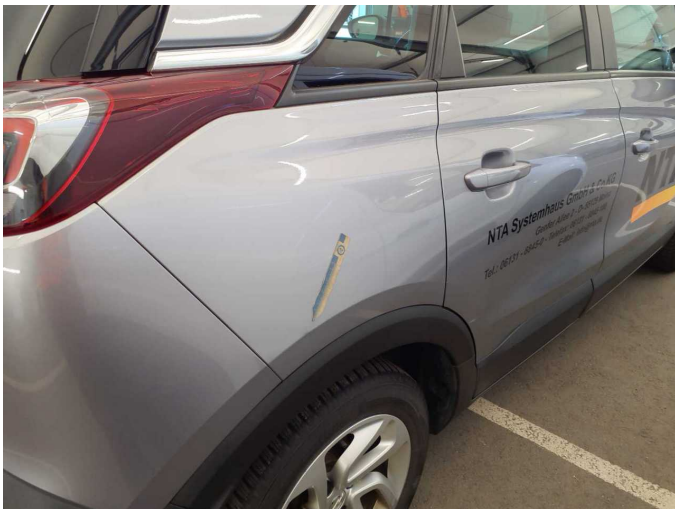
**Damage 5:** Side panel - rear right side: Side panel - dent(s) - Smart repair

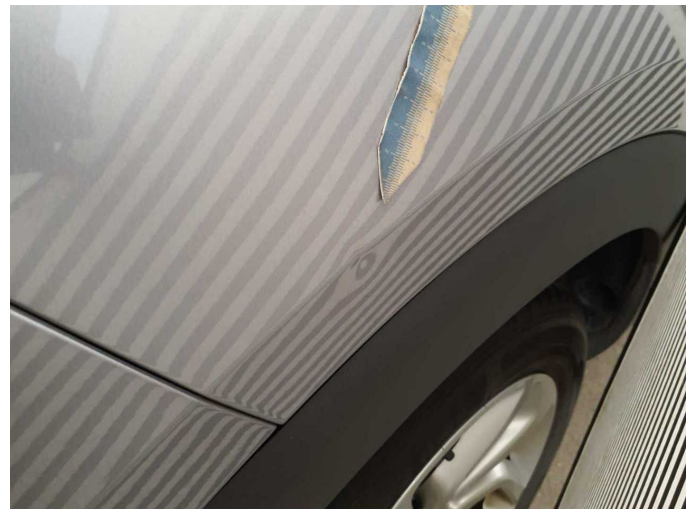
**Damage 5:** Side panel - rear right side: Side panel - dent(s) - Smart repair

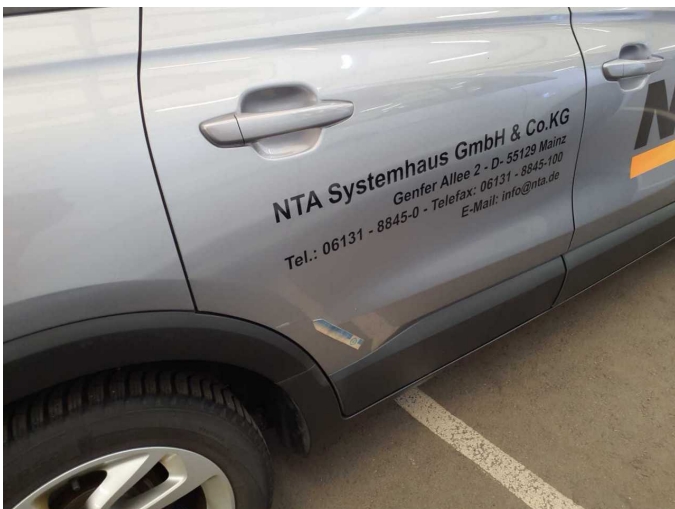
**Damage 6:** Door - rear right side: Door - Scratch(es) - Smart repair

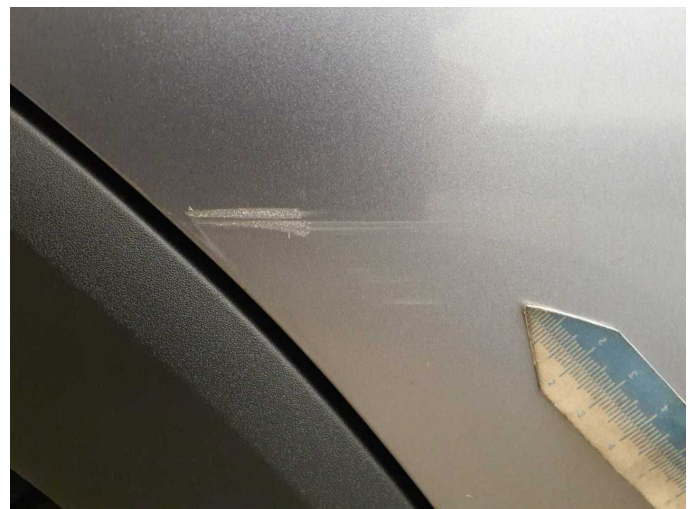
**Damage 6:** Door - rear right side: Door - Scratch(es) - Smart repair

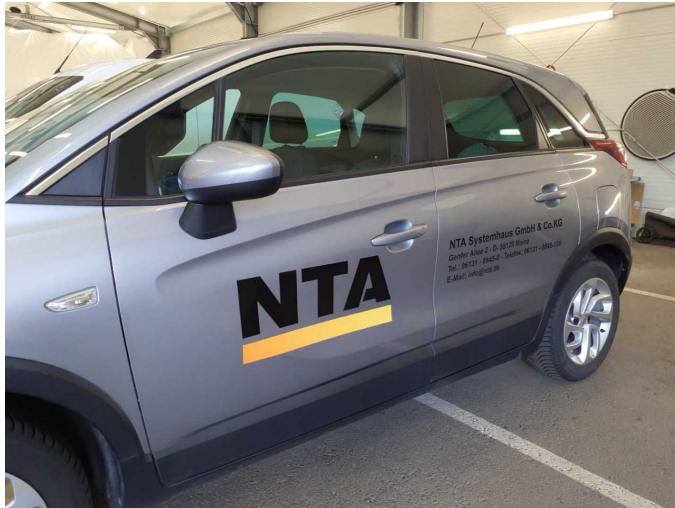
**Damage 7:** Body: Body - Glued / labelled - De-glude / neutralise

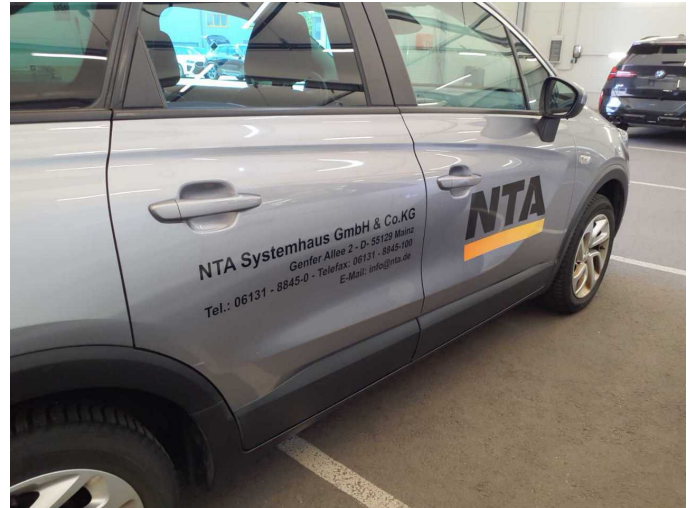
**Damage 7:** Body: Body - Glued / labelled - De-glude / neutralise

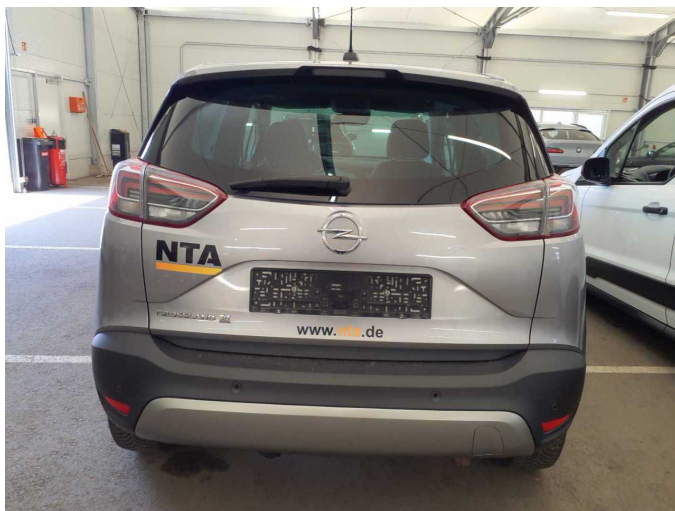
**Damage 7:** Body: Body - Glued / labelled - De-glude / neutralise

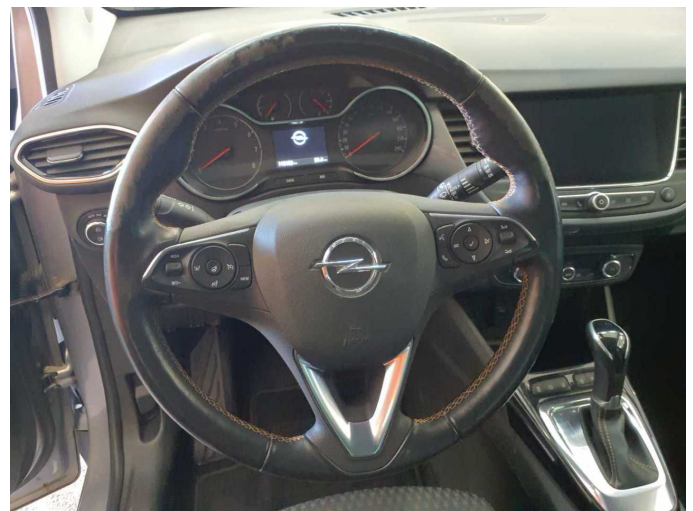
**Damage 8:** Steering system: Steering wheel sheath (Leder) - Worn - Replace

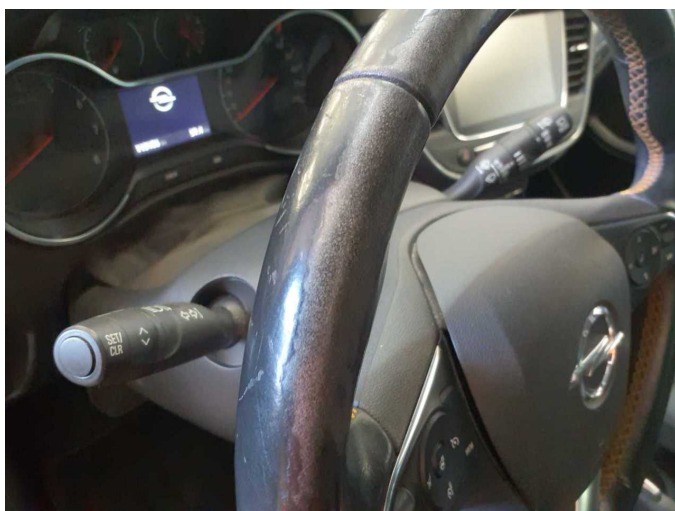
**Damage 8:** Steering system: Steering wheel sheath (Leder) - Worn - Replace

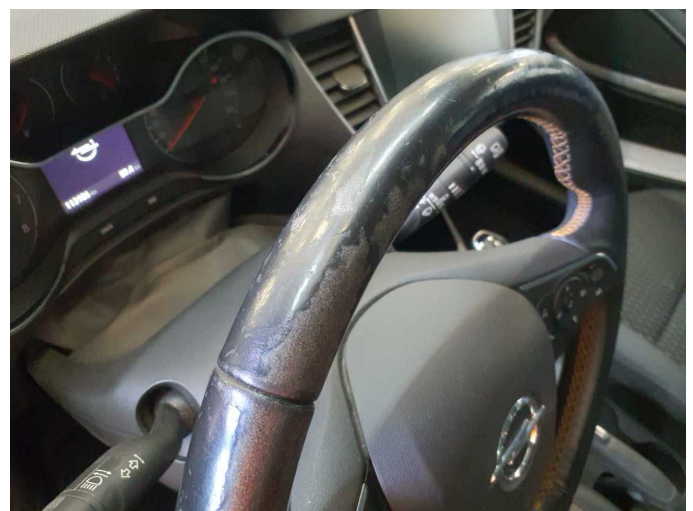
**Damage 8:** Steering system: Steering wheel sheath (Leder) - Worn - Replace

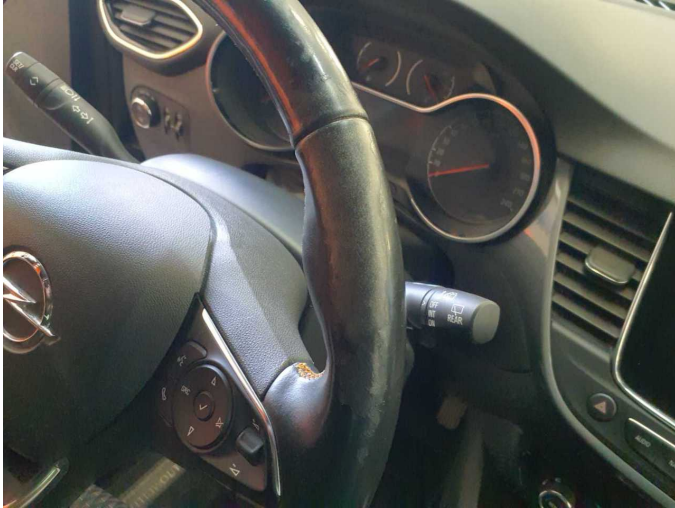
**Damage 8:** Steering system: Steering wheel sheath (Leder) - Worn - Replace

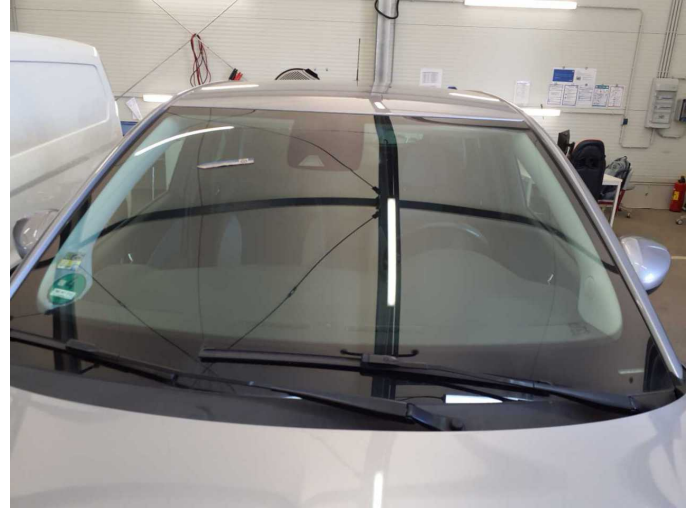
**Damage 9:** Vehicle glazing: Windscreen - Broken / torn - Replace

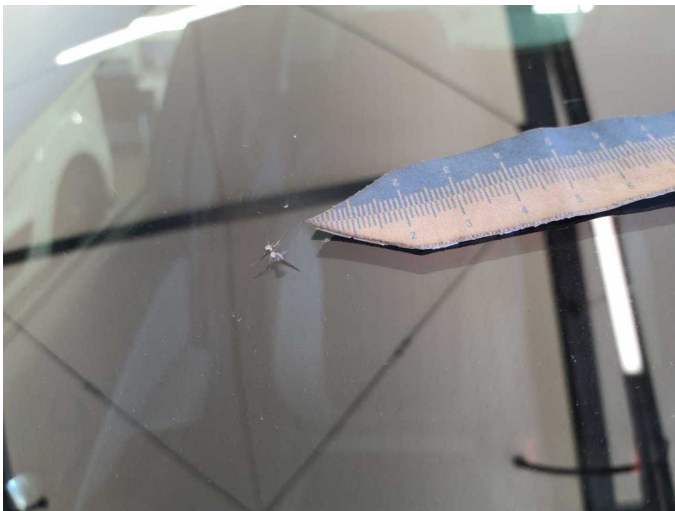
**Damage 9:** Vehicle glazing: Windscreen - Broken / torn - Replace

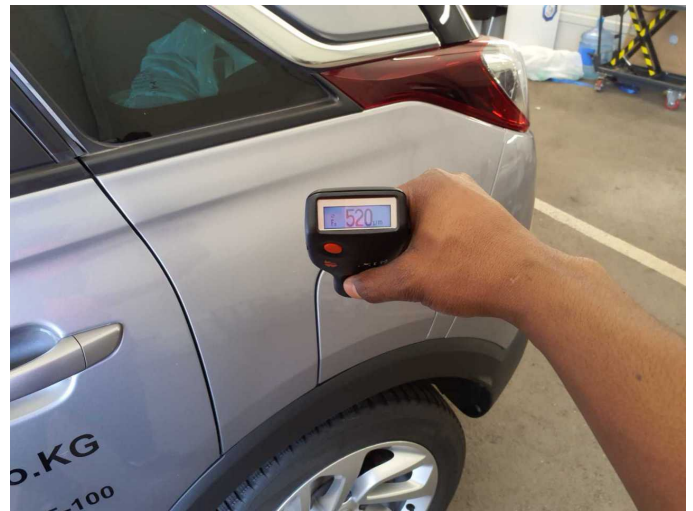
1 Side panel - rear left side, Professionally carried out, Invoice of repair done Non-existent

Side panel - rear left side 520 µm |

**Repainting 1:** Side panel - rear left side

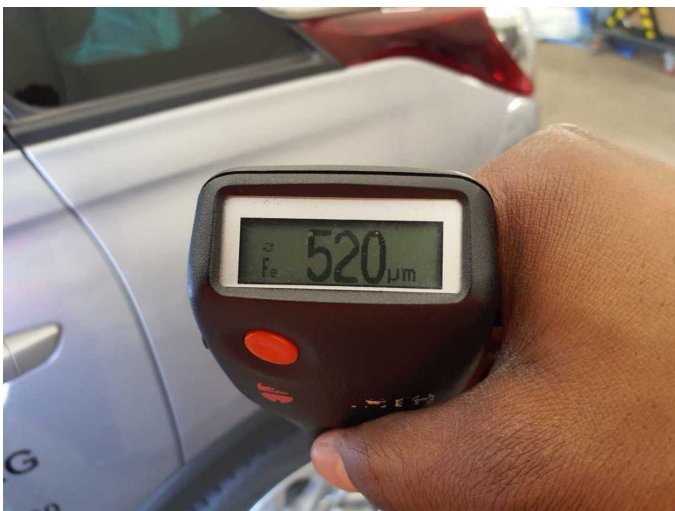
**Repainting 1:** Side panel - rear left side
