Expertise

Protocol number: 46623711  
Order No. / Reference: 26512627  
Inspection date: 17 Jul 2026

Manufacturer: Mercedes-Benz  
VIN: W1VVLFEZ1P4263360

Model: Vito 116 CDI Tourer Lang Aut. BASE

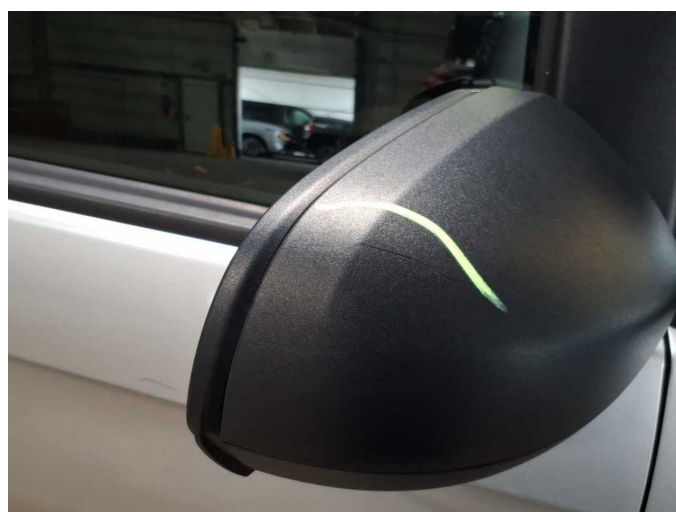
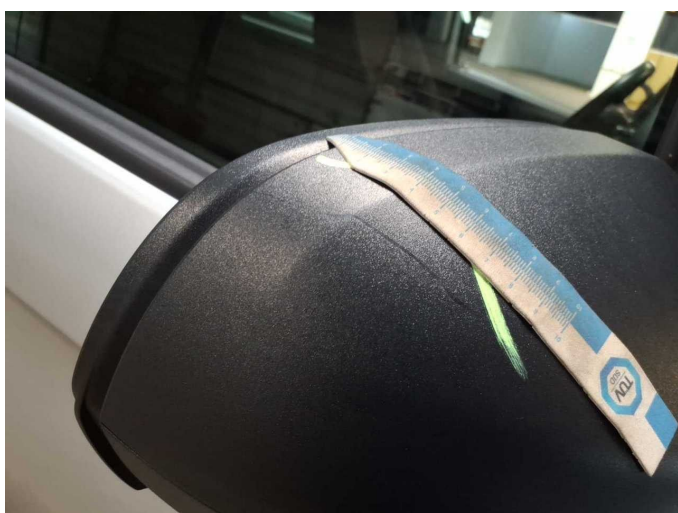
| No. | Component group | Description |
|---|---|---|
| 1 | Wing mirror - right side | Cap - Scratch(es) - Smart repair |

Damage 1: Wing mirror - right side: Cap - Scratch(es) - Smart repair

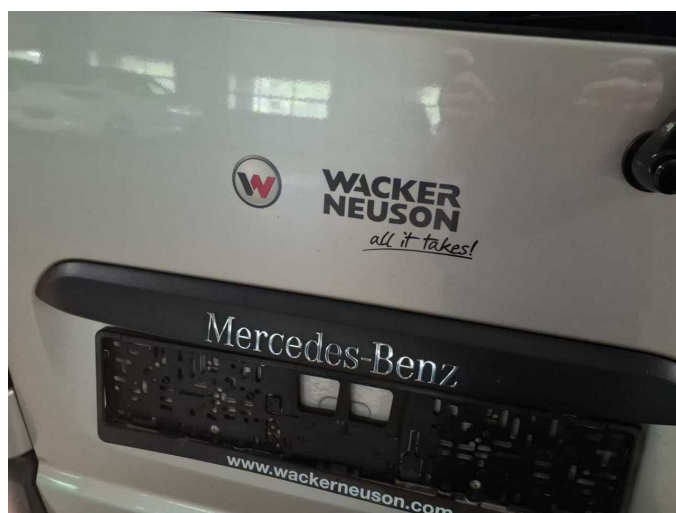
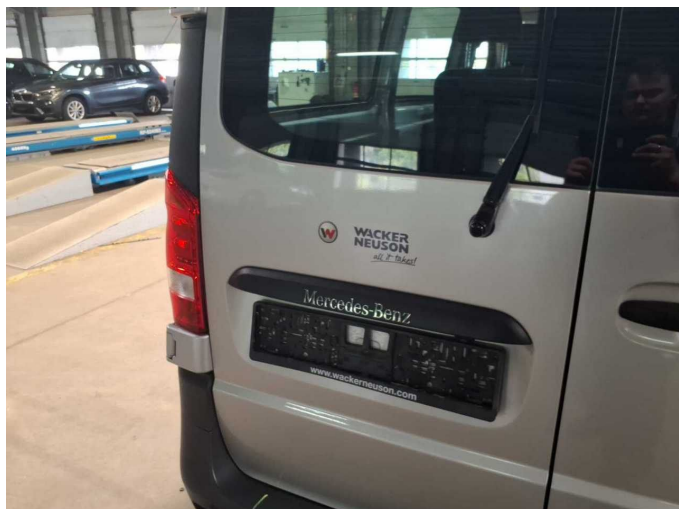
| No. | Component group | Description |
|---|---|---|
| 2 | Boot lid / rear door | Rear door - left side - Glued / labelled - De-glue / neutralise |

Damage 2: Boot lid / rear door: Rear door - left side - Glued / labelled - De-glue / neutralise

**Damage 2:** Boot lid / rear door: Rear door - left side - Glued / labelled - De-glue / neutralise

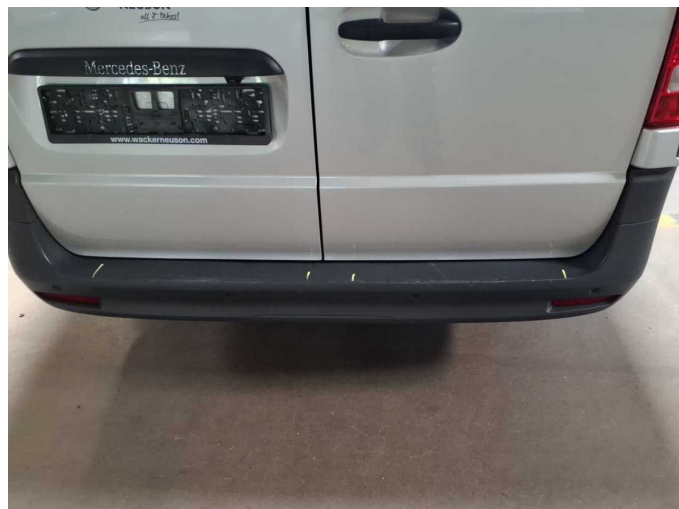
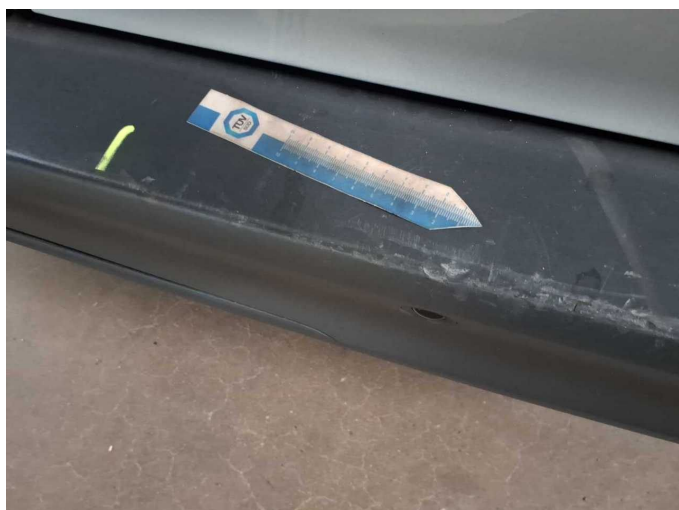
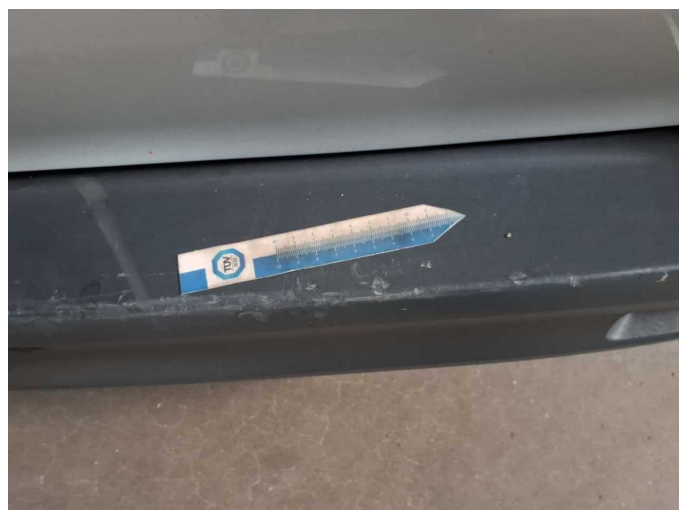
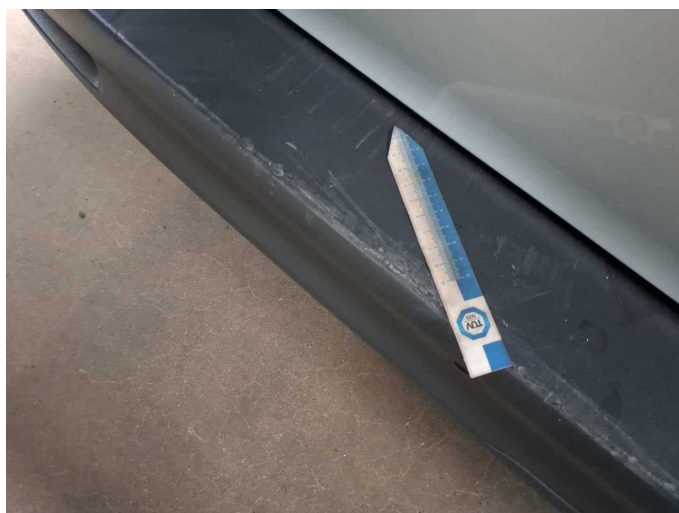
| No. | Component group | Description |
|---|---|---|
| 3 | Rear bumper | Rear bumper (unpainted) - Scratch(es) - Loss in value |

**Damage 3:** Rear bumper: Rear bumper (unpainted) - Scratch(es) - Loss in value

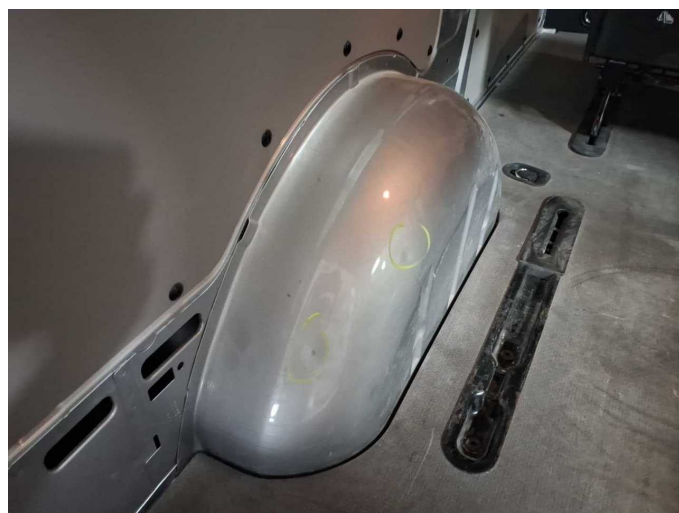
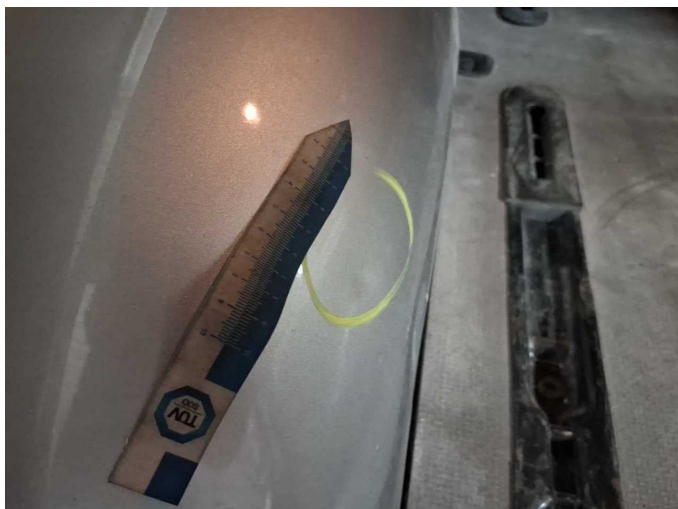
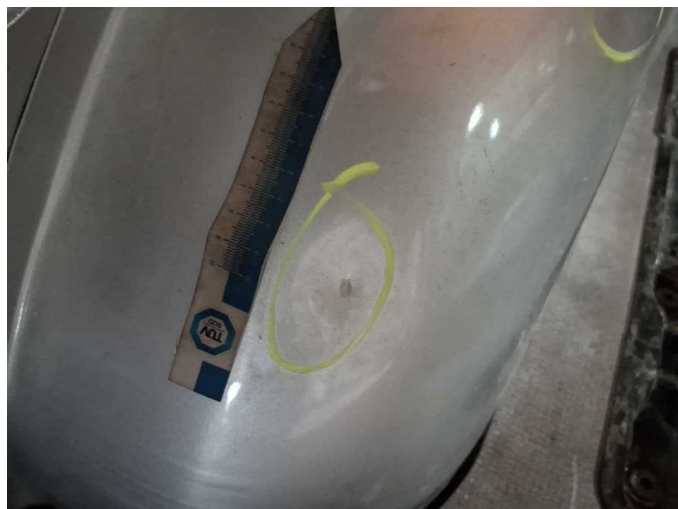
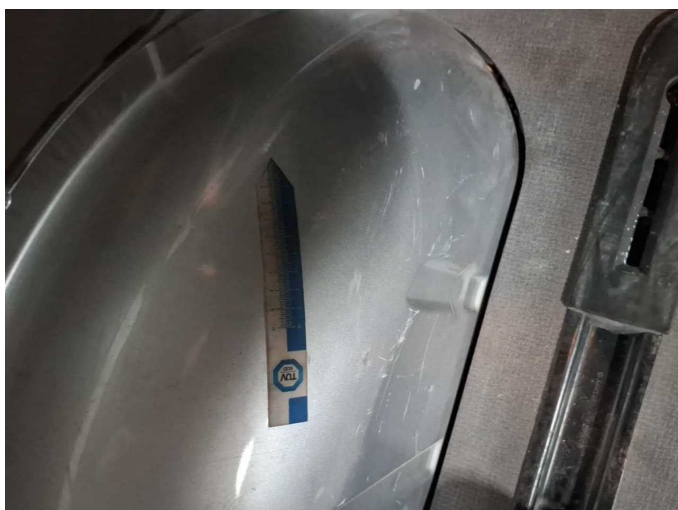
| No. | Component group | Description |
|---|---|---|
| 4 | Side panel - rear left side | Wheel arch (Innen) - Dent / paintcoat damage - Smart repair |

**Damage 4:** Side panel - rear left side: Wheel arch (Innen) - Dent / paintcoat damage - Smart repair

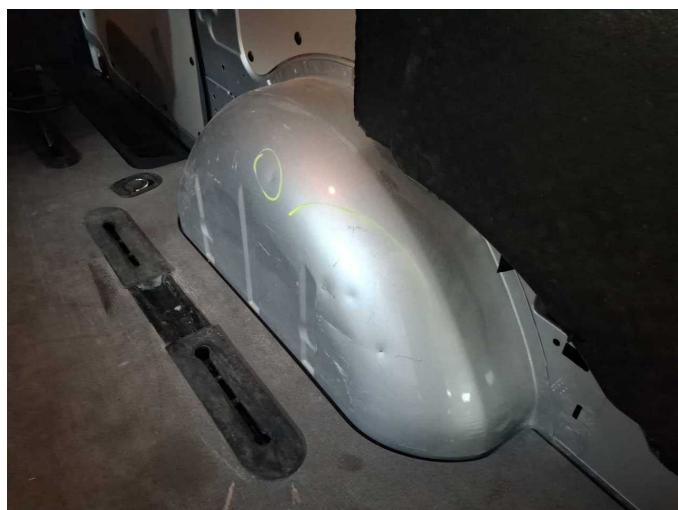
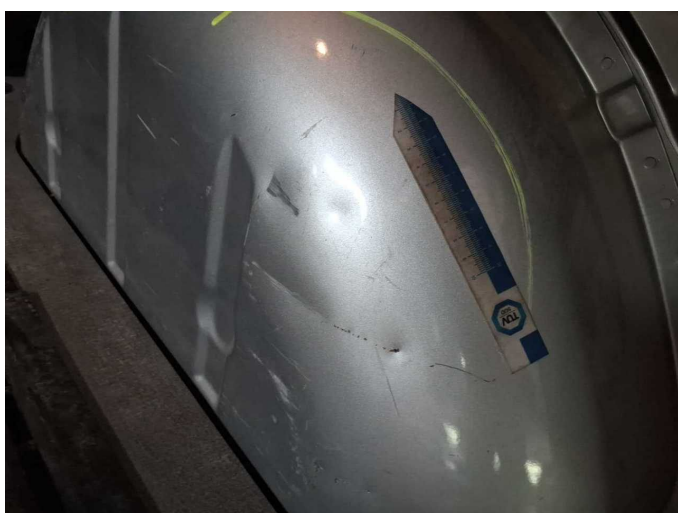
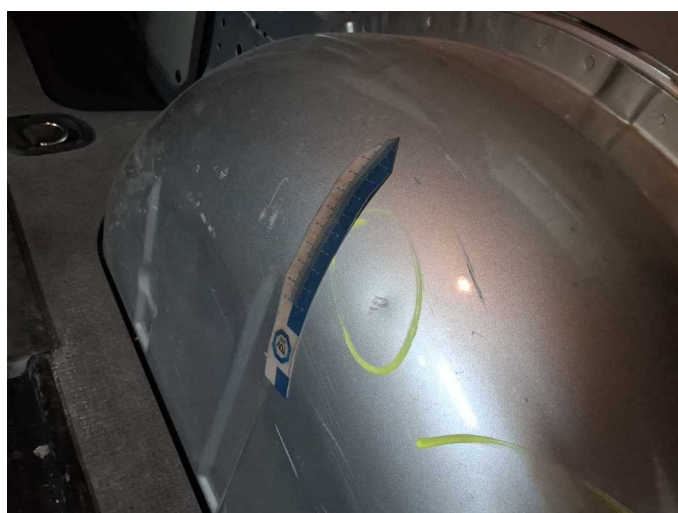
| No. | Component group | Description |
|---|---|---|
| 5 | Side panel - rear right side | Wheel arch (Innen) - Dent / paintcoat damage - Smart repair |

**Damage 5:** Side panel - rear right side: Wheel arch (Innen) - Dent / paintcoat damage - Smart repair

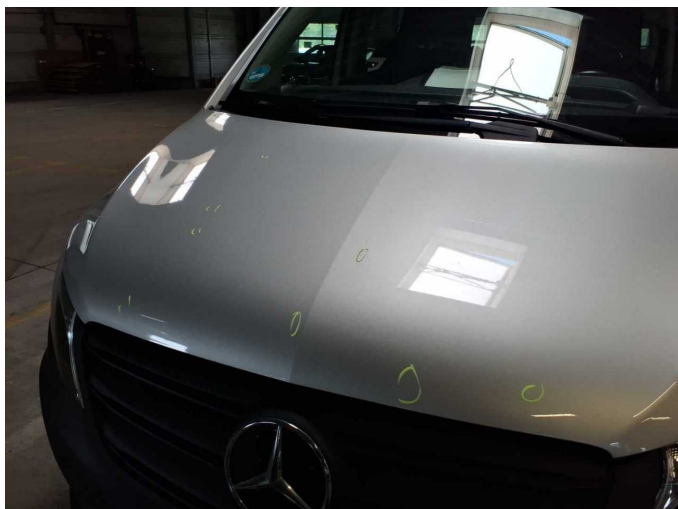
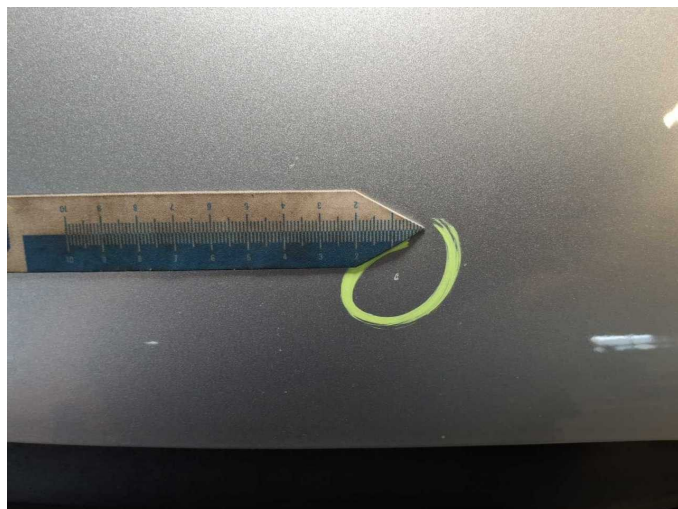
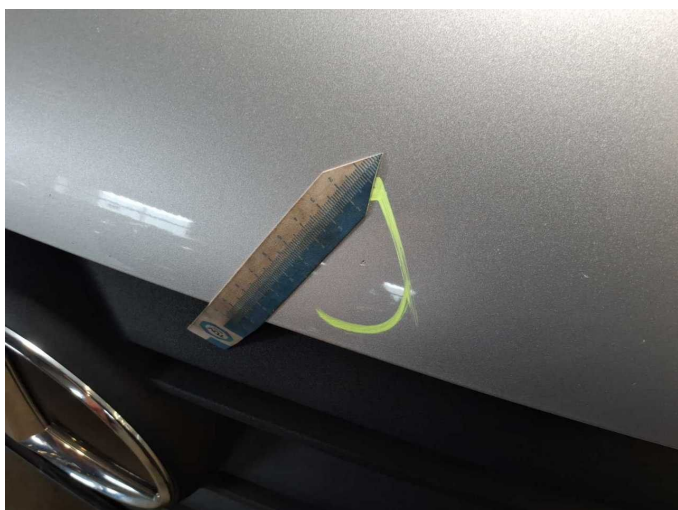
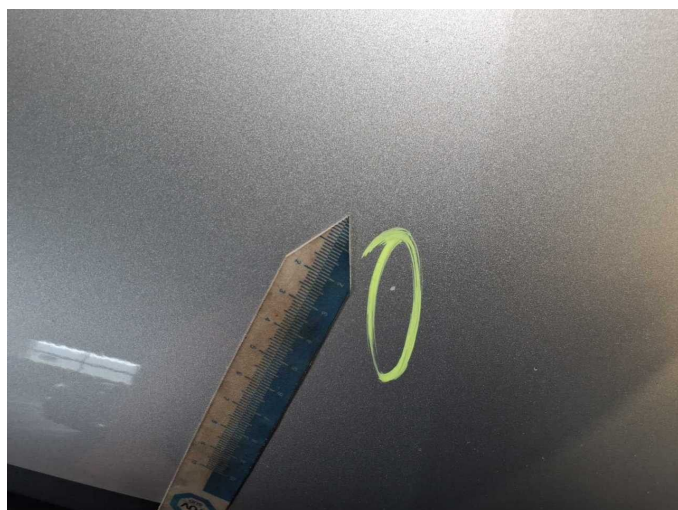
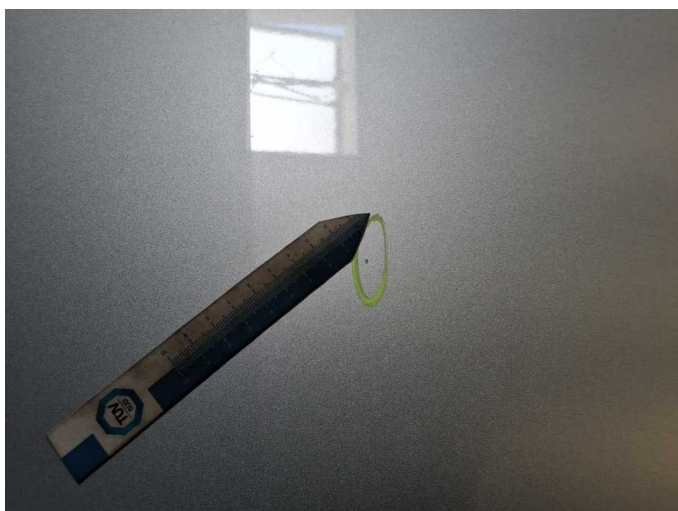
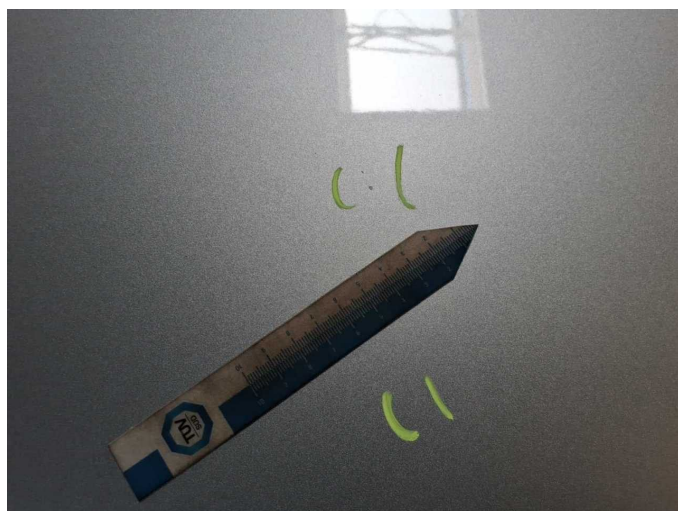
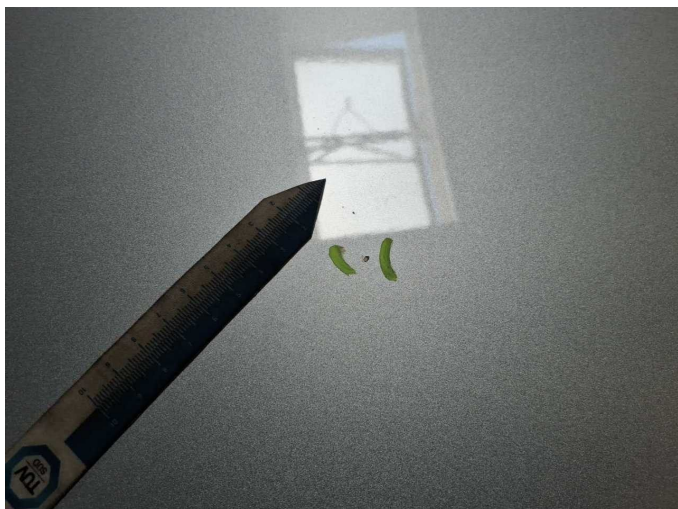
| No. | Component group | Description |
|---|---|---|
| 6 | Bonnet | Bonnet - Stone chips - Paint |

**Damage 6:** Bonnet: Bonnet - Stone chips - Paint

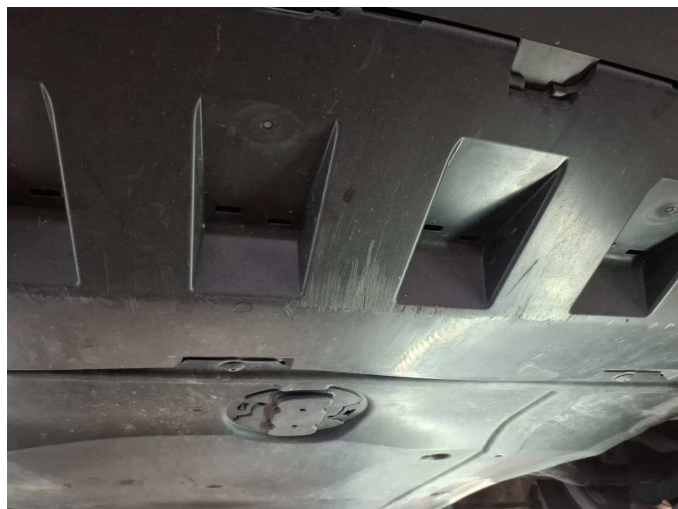
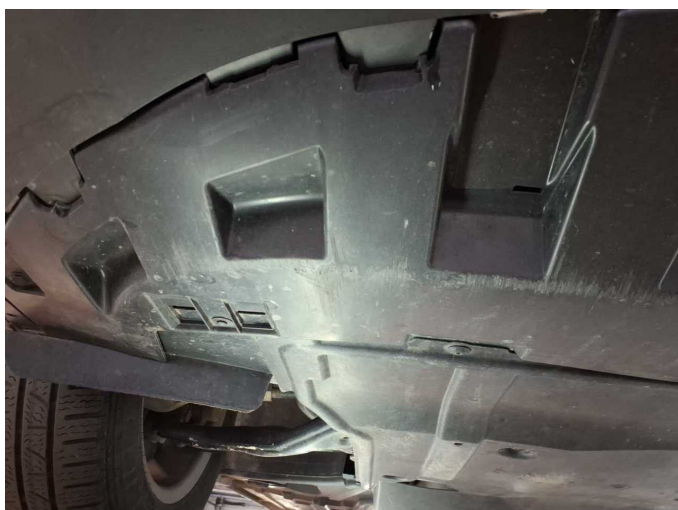
| No. | Component group | Description |
|---|---|---|
| 1 | Body | Underbody panelling - Scratched |

**Wear and tear 1:** Body: Underbody panelling - Scratched
