Expertise

Protocol number: 46695485  
Order No. / Reference: 26747179  
Inspection date: 21 Jul 2026

| Manufacturer: Opel | Model: Astra 1.5 D Start/Stop Sports Tourer Automatik Design&Tech |
| VIN: W0VBE8EV6N8044130 | |

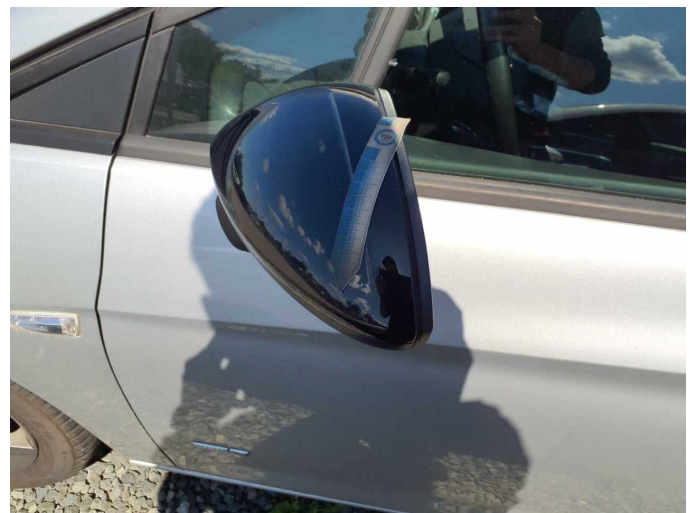
| No. | Component group | Description |
|---|---|---|
| 1 | Wing mirror - left side | Cap - Scratch(es) - Smart repair |

**Damage 1:** Wing mirror - left side: Cap - Scratch(es) - Smart repair

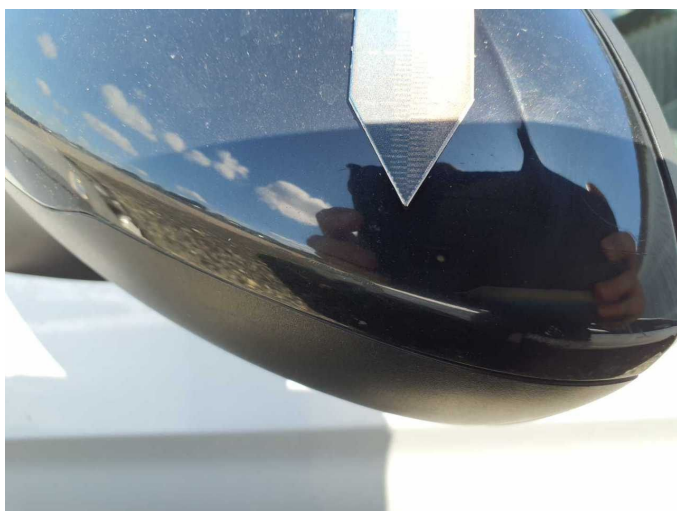
**Damage 1:** Wing mirror - left side: Cap - Scratch(es) - Smart repair

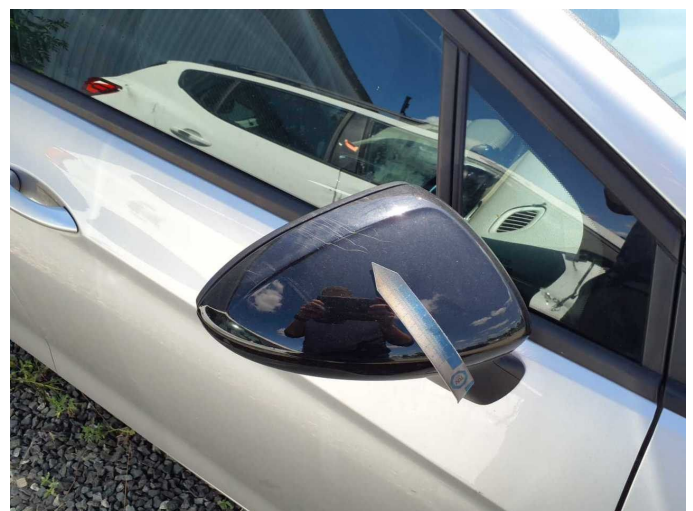
| No. | Component group | Description |
|---|---|---|
| 2 | Wing mirror - right side | Cap - Scratch(es) - Smart repair |

**Damage 2:** Wing mirror - right side: Cap - Scratch(es) - Smart repair

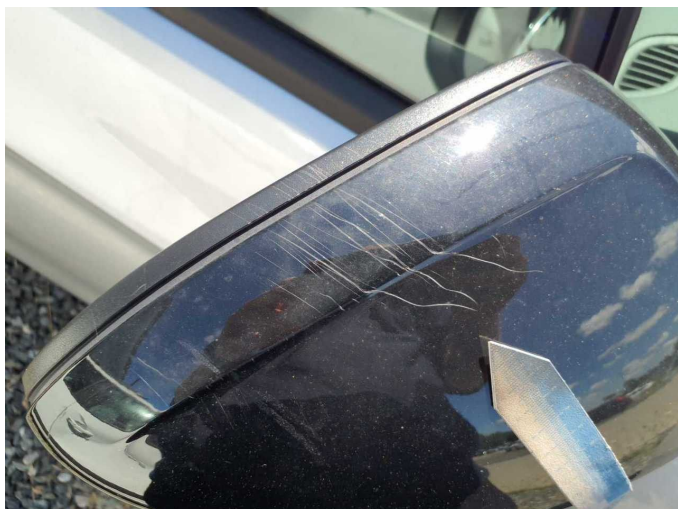
**Damage 2:** Wing mirror - right side: Cap - Scratch(es) - Smart repair

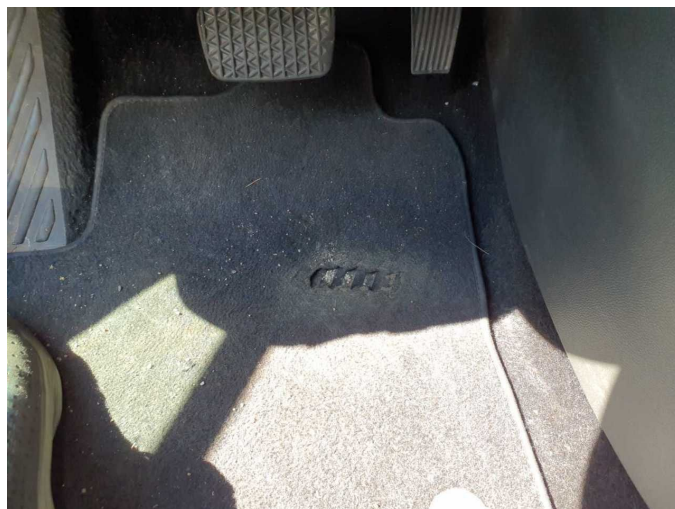
| No. | Component group | Description |
|---|---|---|
| 3 | Trim / covers | Floor mats - Broken / torn - Replace |

**Damage 3:** Trim / covers: Floor mats - Broken / torn - Replace

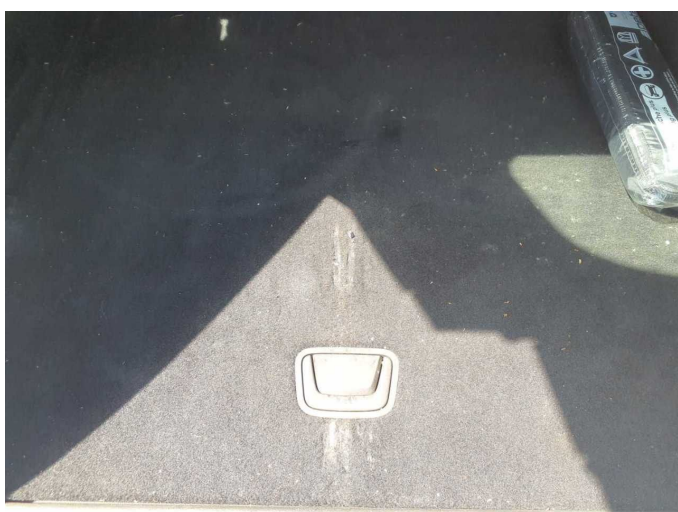
| No. | Component group | Description |
|---|---|---|
| 4 | Interior | Cargo area floor - Scratch(es) - Loss in value |

**Damage 4:** Interior: Cargo area floor - Scratch(es) - Loss in value

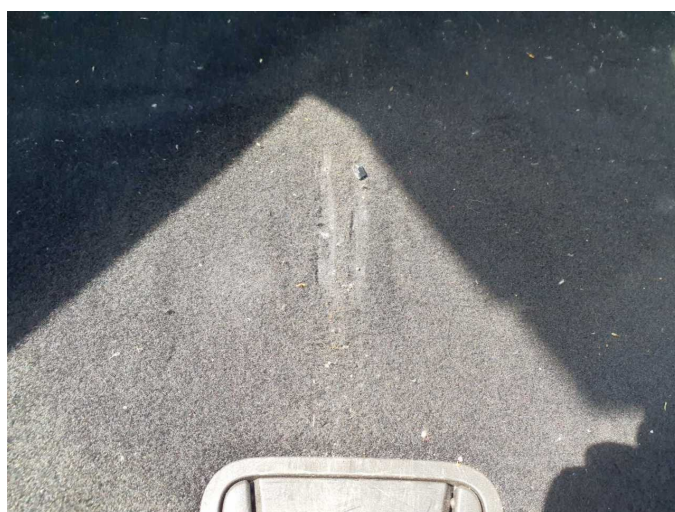
**Damage 4:** Interior: Cargo area floor - Scratch(es) - Loss in value

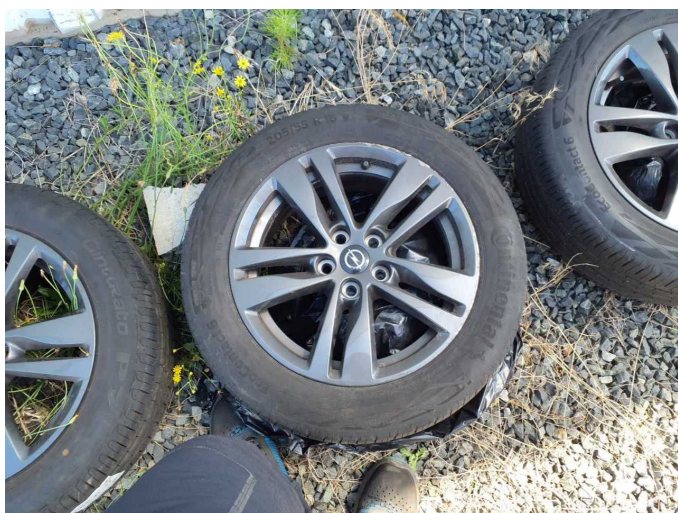
| No. | Component group | Description |
|---|---|---|
| 5 | 2nd wheel set | 1 tyre - Broken / torn - Replace |

**Damage 5:** 2nd wheel set: 1 tyre - Broken / torn - Replace

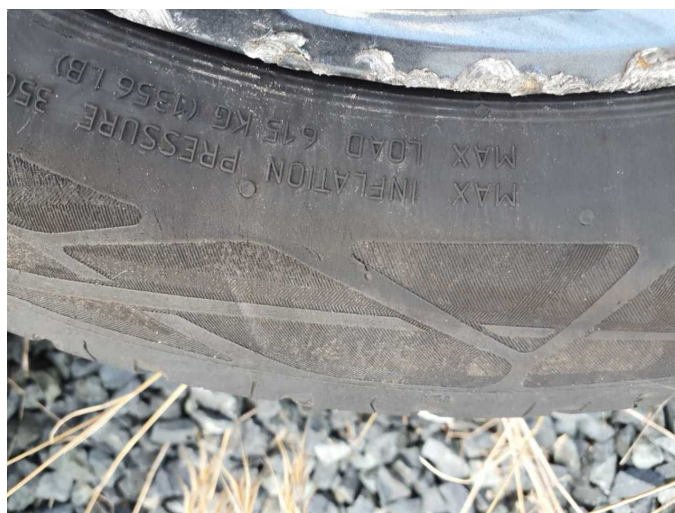
**Damage 5:** 2nd wheel set: 1 tyre - Broken / torn - Replace

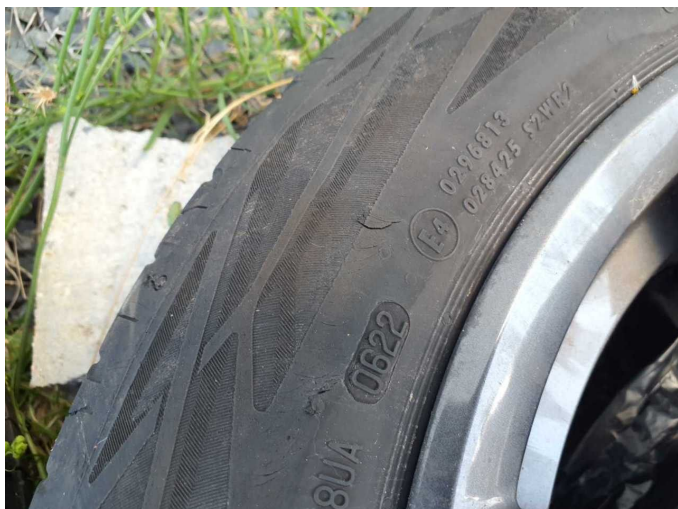
**Damage 5:** 2nd wheel set: 1 tyre - Broken / torn - Replace

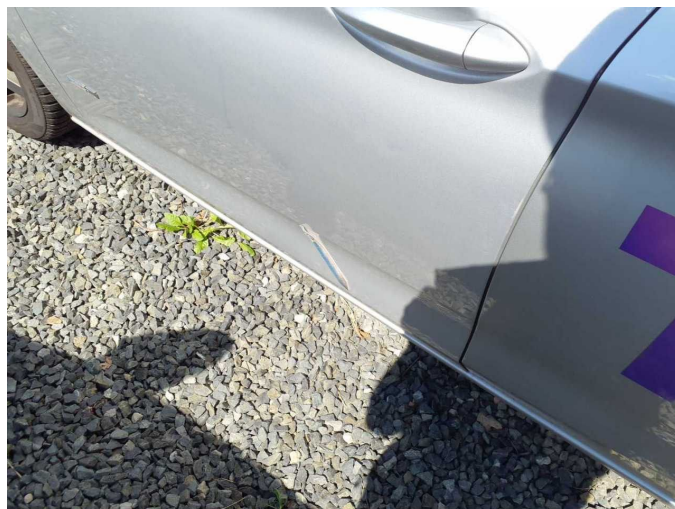
| No. | Component group | Description |
|---|---|---|
| 6 | Door - front left side | Door - Scratch(es) - Smart repair |

**Damage 6:** Door - front left side: Door - Scratch(es) - Smart repair

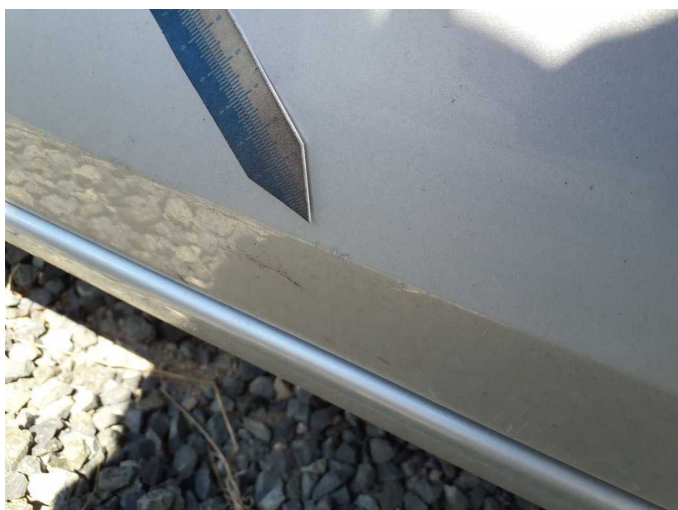
**Damage 6:** Door - front left side: Door - Scratch(es) - Smart repair

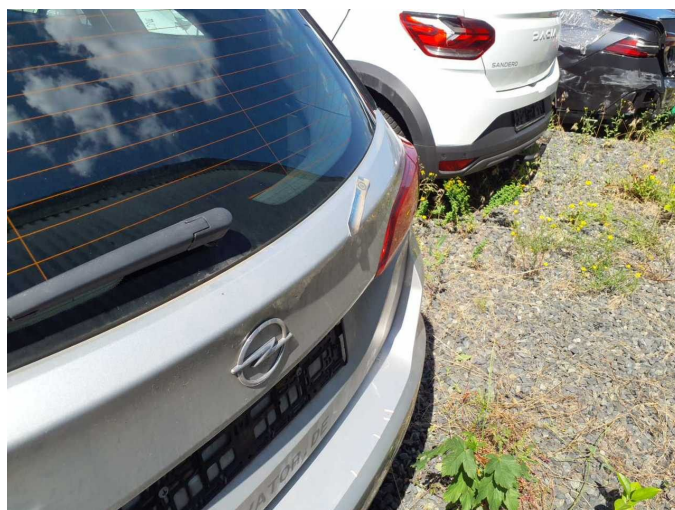
| No. | Component group | Description |
|---|---|---|
| 7 | Boot lid / rear door | Boot lid - Scratch(es) - Smart repair |

**Damage 7:** Boot lid / rear door: Boot lid - Scratch(es) - Smart repair

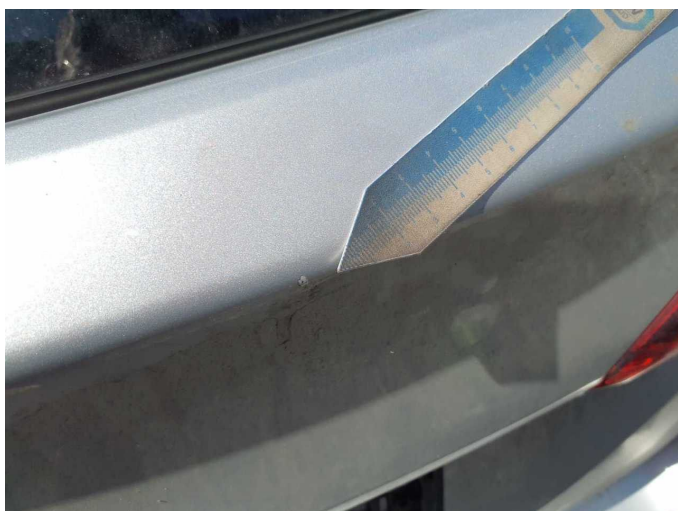
**Damage 7:** Boot lid / rear door: Boot lid - Scratch(es) - Smart repair

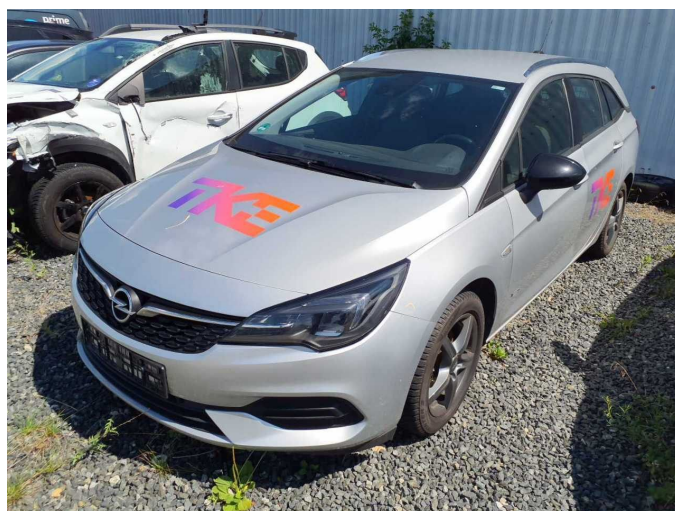
| No. | Component group | Description |
|---|---|---|
| 8 | Body | Body - Glued / labelled - De-glue / neutralise |

**Damage 8:** Body: Body - Glued / labelled - De-glue / neutralise

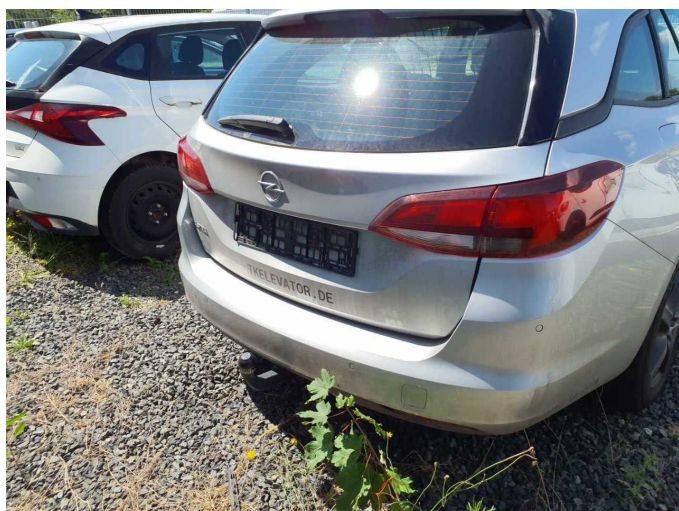
**Damage 8:** Body: Body - Glued / labelled - De-glue / neutralise

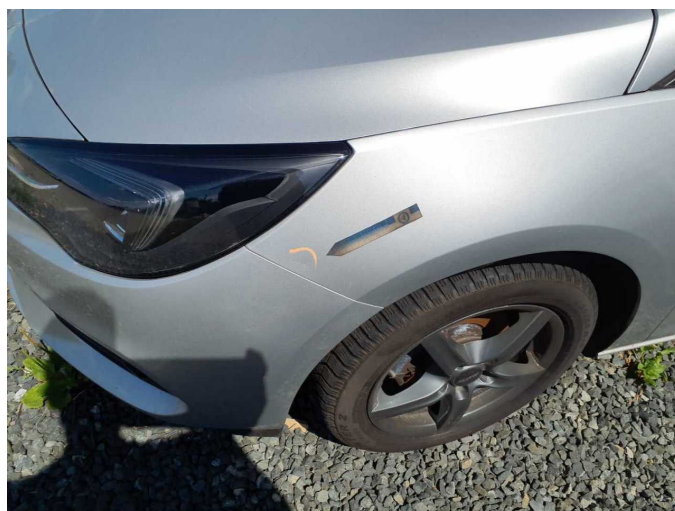
| No. | Component group | Description |
|---|---|---|
| 9 | Mudguard - left side | Mudguard - left side - Dent / paintcoat damage - Smart repair |

**Damage 9:** Mudguard - left side: Mudguard - left side - Dent / paintcoat damage - Smart repair

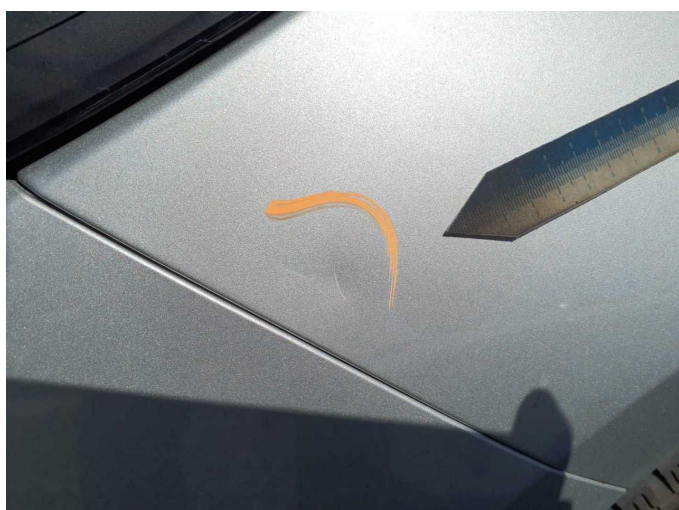
**Damage 9:** Mudguard - left side: Mudguard - left side - Dent / paintcoat damage - Smart repair

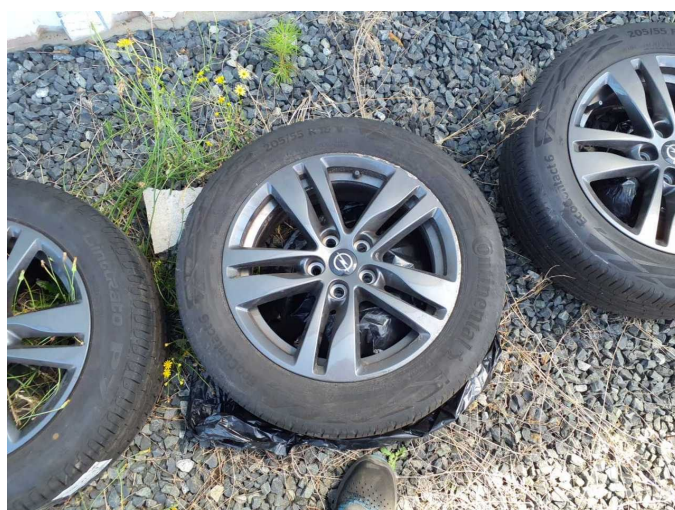
| No. | Component group | Description |
|---|---|---|
| 10 | 2nd wheel set | 1 alloy rim - Scratch(es) - Replace |

**Damage 10:** 2nd wheel set: 1 alloy rim - Scratch(es) - Replace

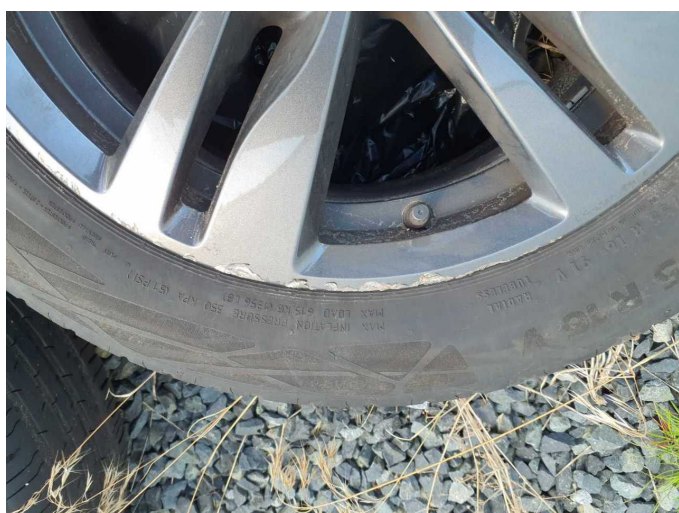
**Damage 10:** 2nd wheel set: 1 alloy rim - Scratch(es) - Replace

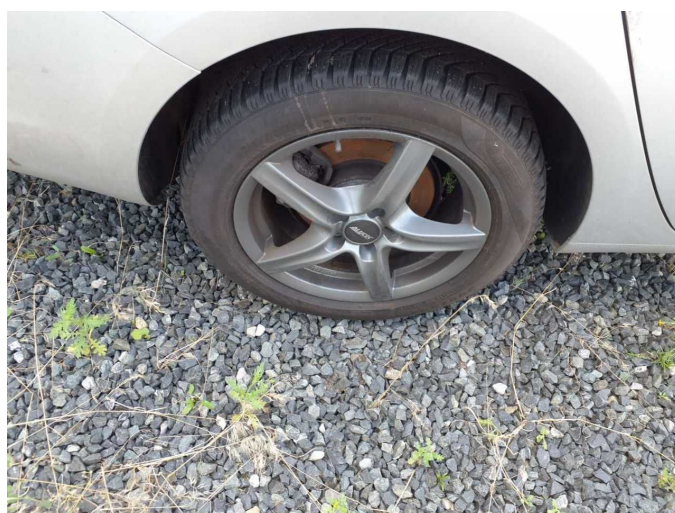
| No. | Component group | Description |
|---|---|---|
| 11 | Braking system | Brake discs and pads - rear (Tragbild mangelhaft, Rost) - Corrosion - Replace |

**Damage 11:** Braking system: Brake discs and pads - rear (Tragbild mangelhaft, Rost) - Corrosion - Replace

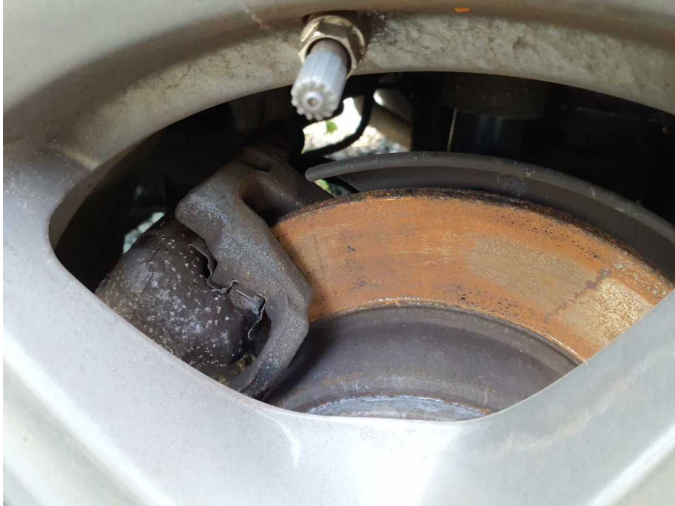
**Damage 11:** Braking system: Brake discs and pads - rear (Tragbild mangelhaft, Rost) - Corrosion - Replace

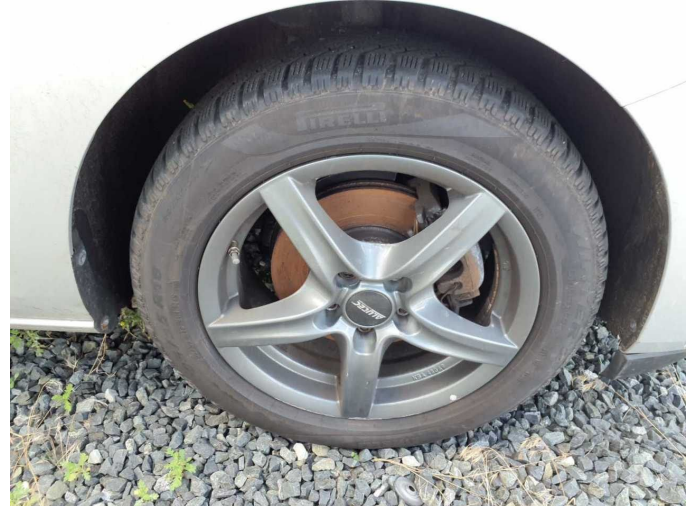
| No. | Component group | Description |
|---|---|---|
| 12 | Braking system | Brake discs and brake pads - front (Tragbild mangelhaft, Rost) - Corrosion - Replace |

**Damage 12:** Braking system: Brake discs and brake pads - front (Tragbild mangelhaft, Rost) - Corrosion - Replace

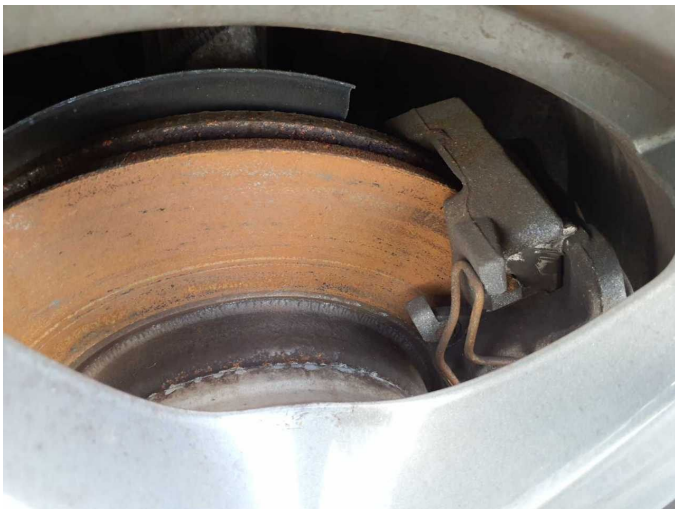
**Damage 12:** Braking system: Brake discs and brake pads - front (Tragbild mangelhaft, Rost) - Corrosion - Replace

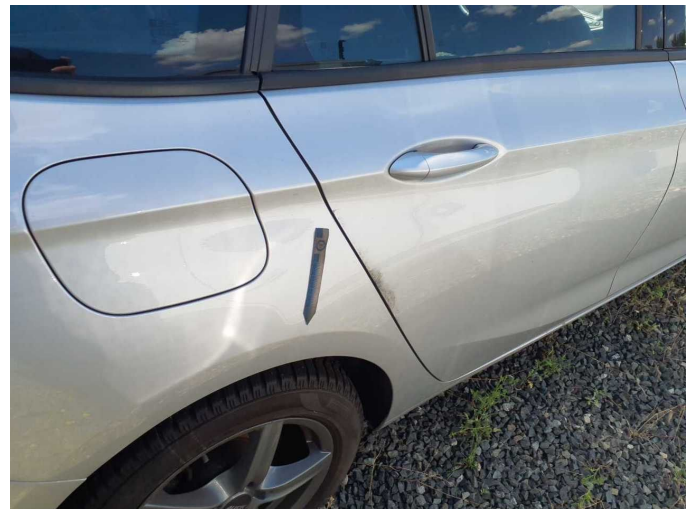
| No. | Component group | Description |
|---|---|---|
| 13 | Side panel - rear right side | Side panel - Dent / paintcoat damage - Repair and paint |

**Damage 13:** Side panel - rear right side: Side panel - Dent / paintcoat damage - Repair and paint

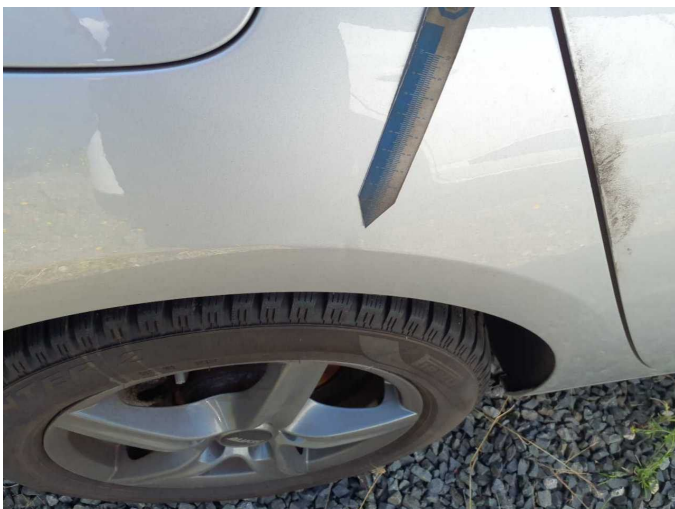
**Damage 13:** Side panel - rear right side: Side panel - Dent / paintcoat damage - Repair and paint

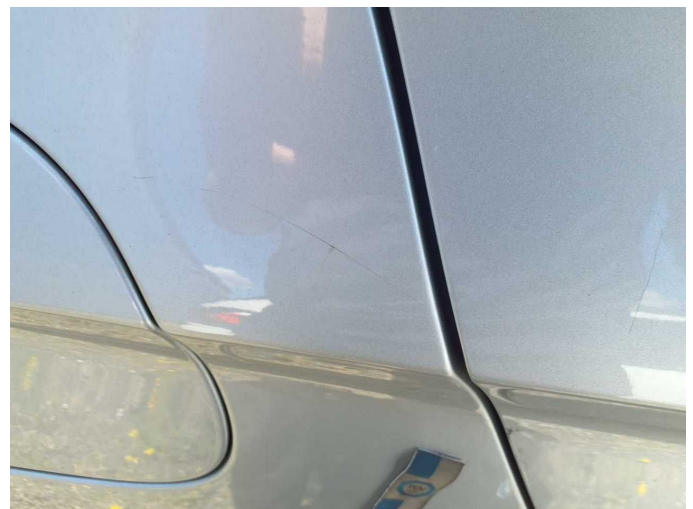
**Damage 13:** Side panel - rear right side: Side panel - Dent / paintcoat damage - Repair and paint

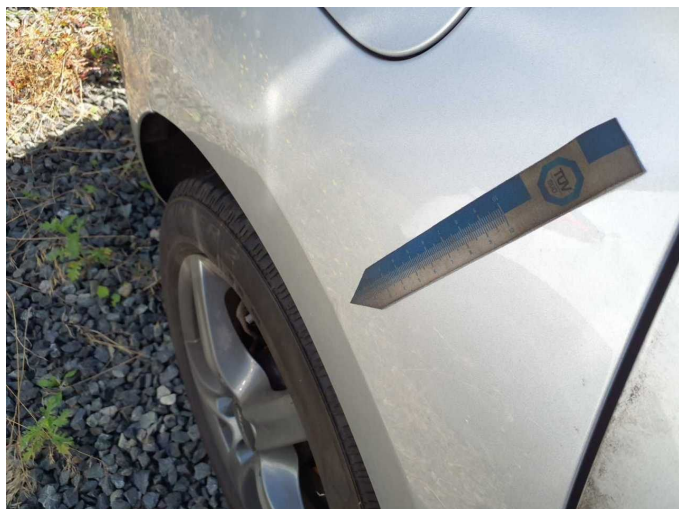
**Damage 13:** Side panel - rear right side: Side panel - Dent / paintcoat damage - Repair and paint

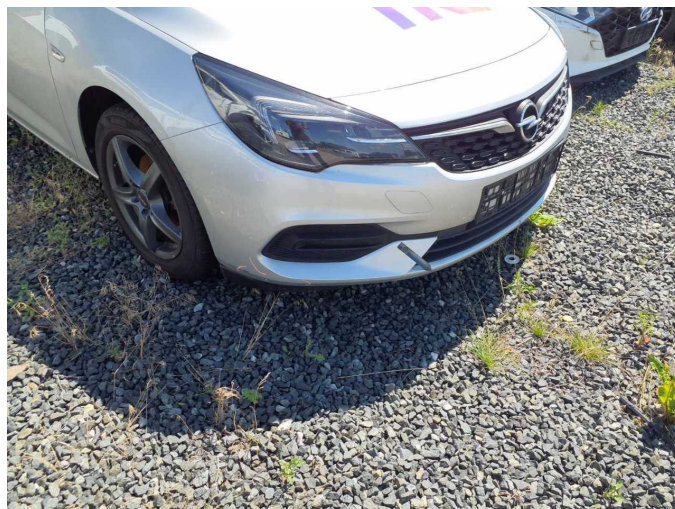
| No. | Component group | Description |
|---|---|---|
| 14 | Front bumper | Front bumper - Scratch(es) - Paint |

**Damage 14:** Front bumper: Front bumper - Scratch(es) - Paint

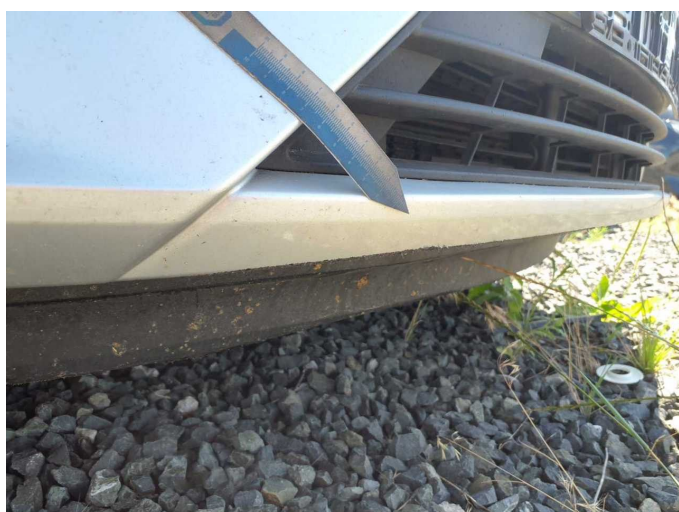
**Damage 14:** Front bumper: Front bumper - Scratch(es) - Paint

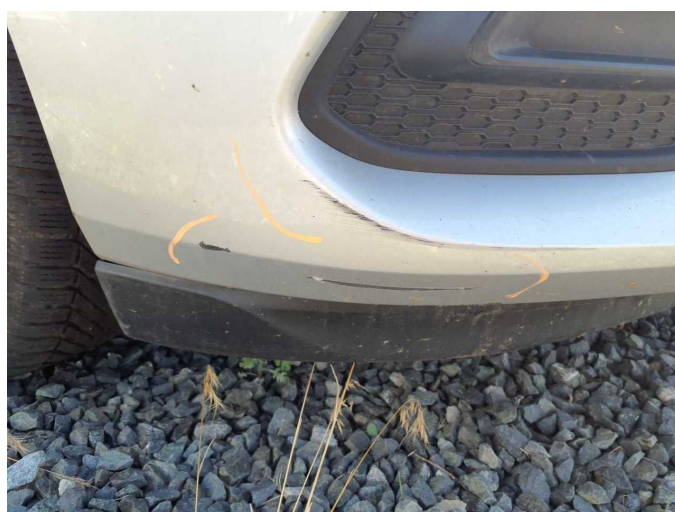
**Damage 14:** Front bumper: Front bumper - Scratch(es) - Paint

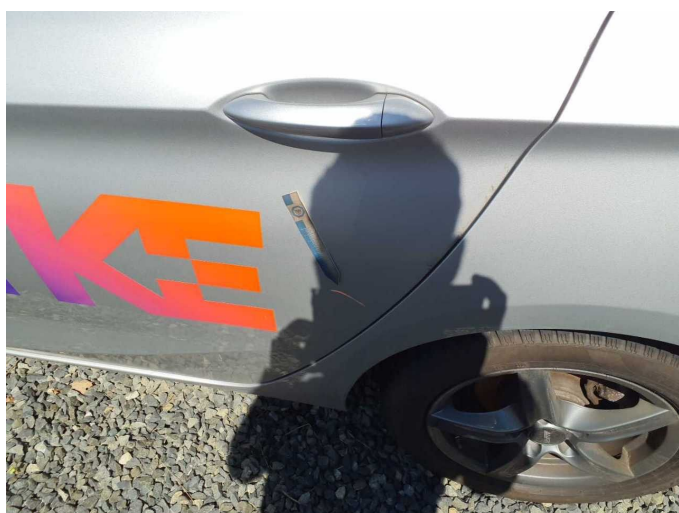
| No. | Component group | Description |
|---|---|---|
| 15 | Door - rear left side | Door - Scratch(es) - Paint |

**Damage 15:** Door - rear left side: Door - Scratch(es) - Paint

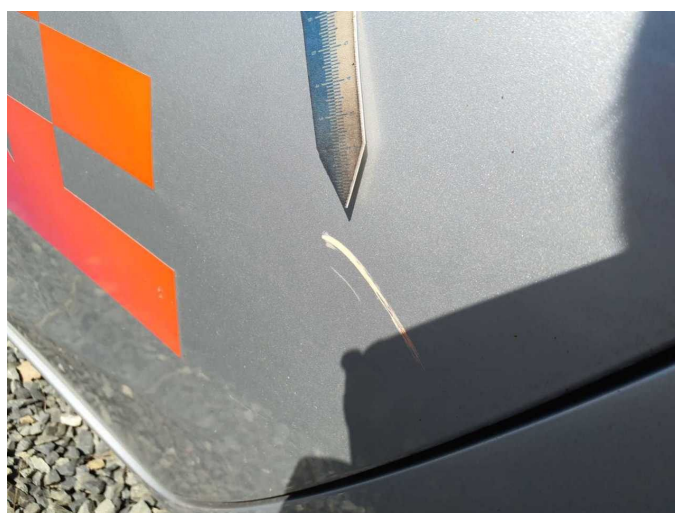
**Damage 15:** Door - rear left side: Door - Scratch(es) - Paint

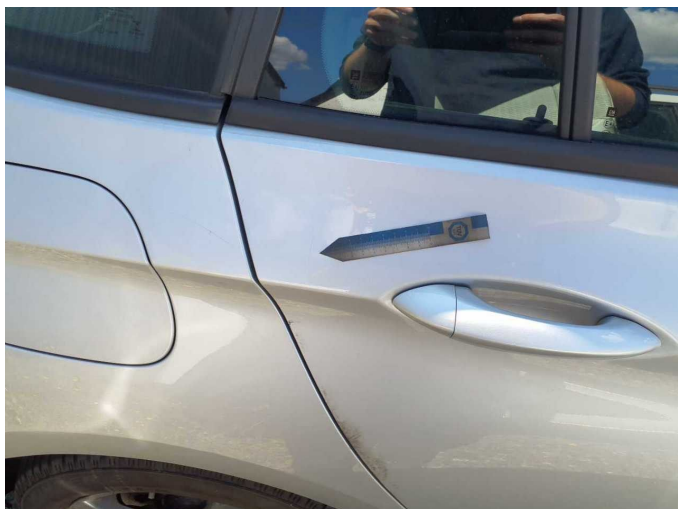
| No. | Component group | Description |
|---|---|---|
| 16 | Door - rear right side | Door - Scratch(es) - Paint |

**Damage 16:** Door - rear right side: Door - Scratch(es) - Paint

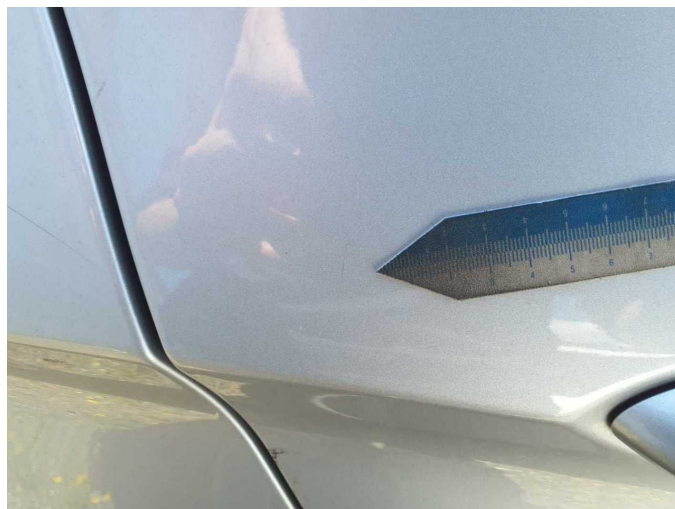
**Damage 16:** Door - rear right side: Door - Scratch(es) - Paint

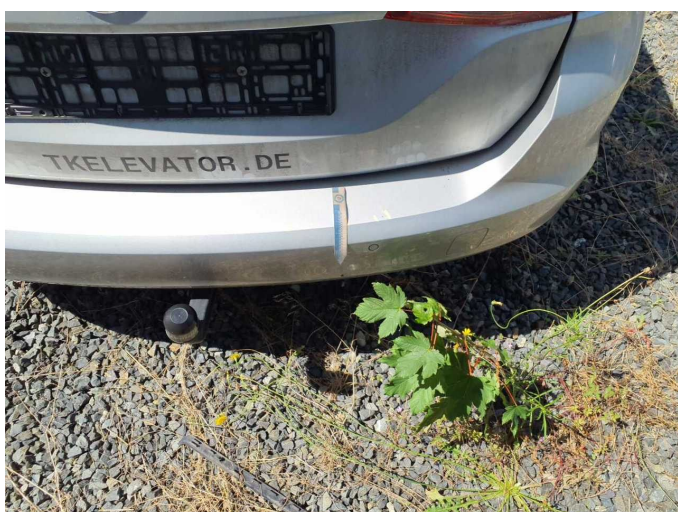
| No. | Component group | Description |
|---|---|---|
| 17 | Rear bumper | Rear bumper - Dent / paintcoat damage - Repair and paint |

**Damage 17:** Rear bumper: Rear bumper - Dent / paintcoat damage - Repair and paint

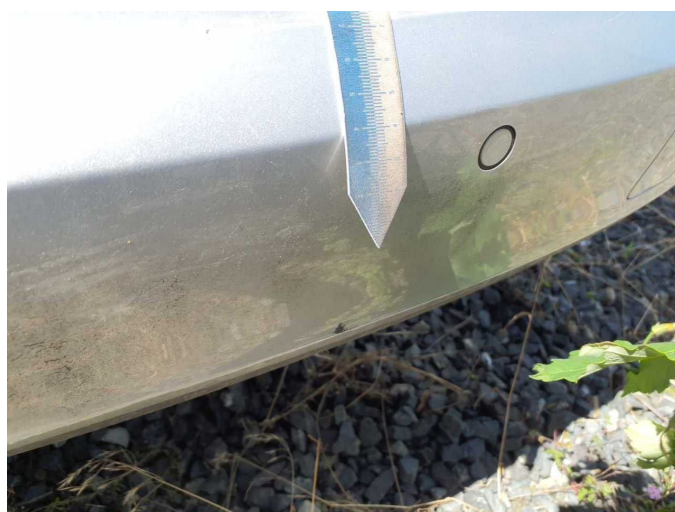
**Damage 17:** Rear bumper: Rear bumper - Dent / paintcoat damage - Repair and paint

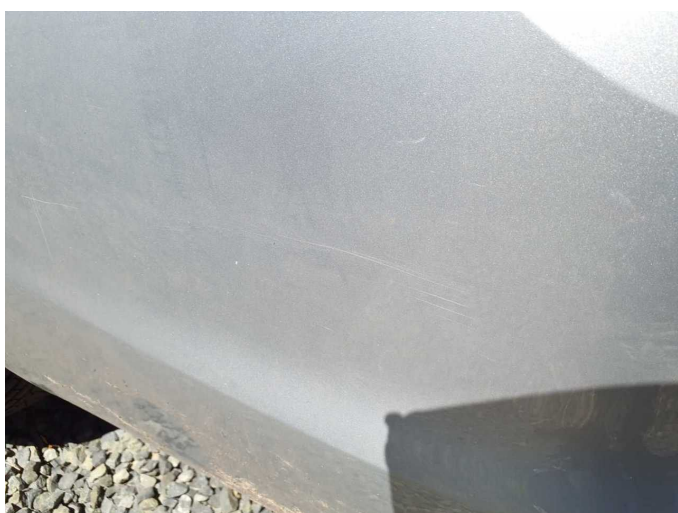
**Damage 17:** Rear bumper: Rear bumper - Dent / paintcoat damage - Repair and paint

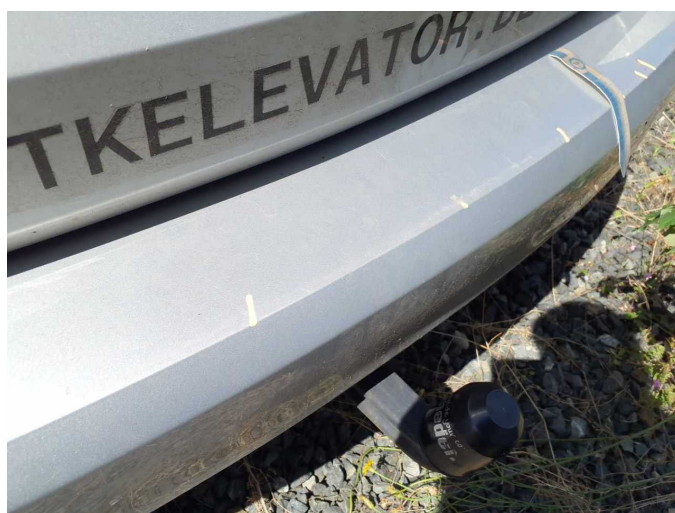
**Damage 17:** Rear bumper: Rear bumper - Dent / paintcoat damage - Repair and paint

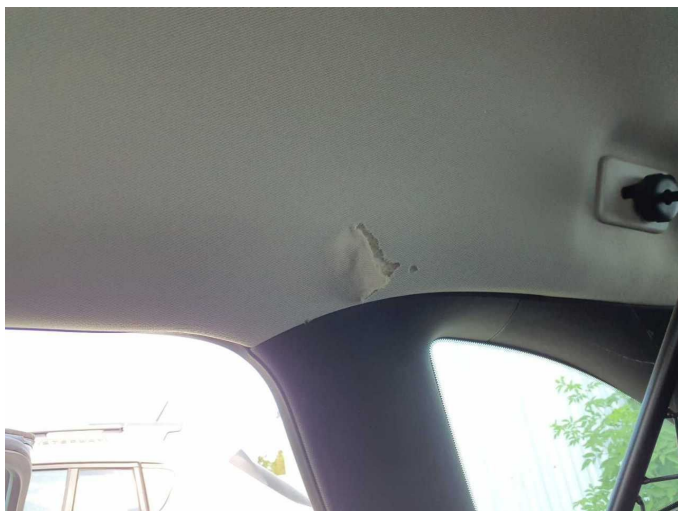
| No. | Component group | Description |
|---|---|---|
| 18 | Trim / covers | Roof lining - Broken / torn - Replace |

**Damage 18:** Trim / covers: Roof lining - Broken / torn - Replace

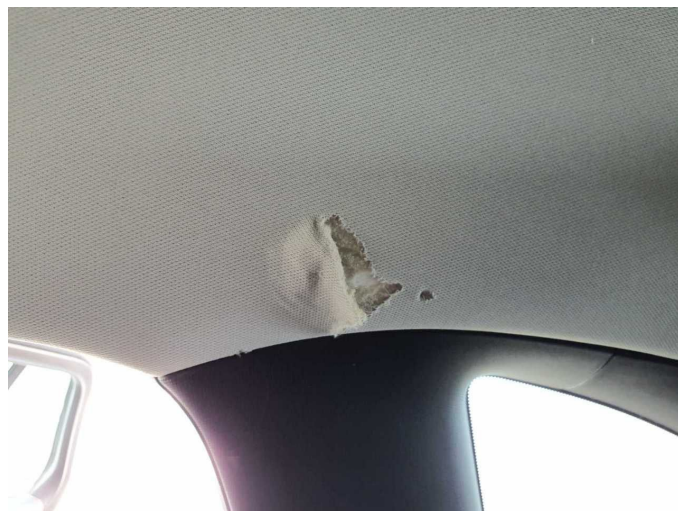
**Damage 18:** Trim / covers: Roof lining - Broken / torn - Replace

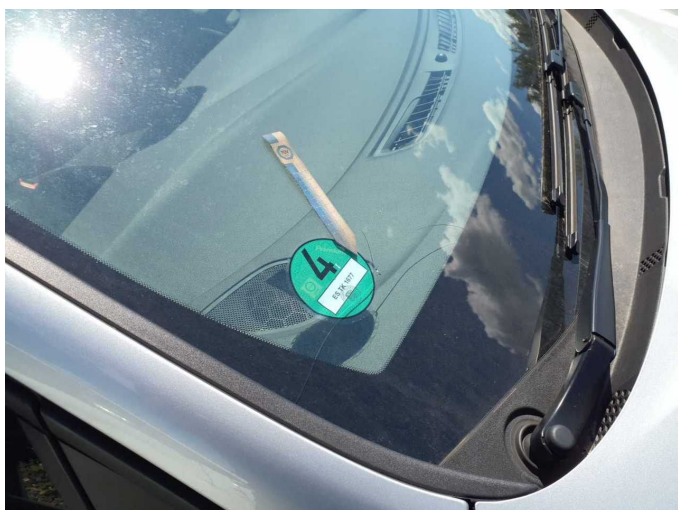
| No. | Component group | Description |
|---|---|---|
| 19 | Vehicle glazing | Windscreen - Broken / torn - Replace |

**Damage 19:** Vehicle glazing: Windscreen - Broken / torn - Replace

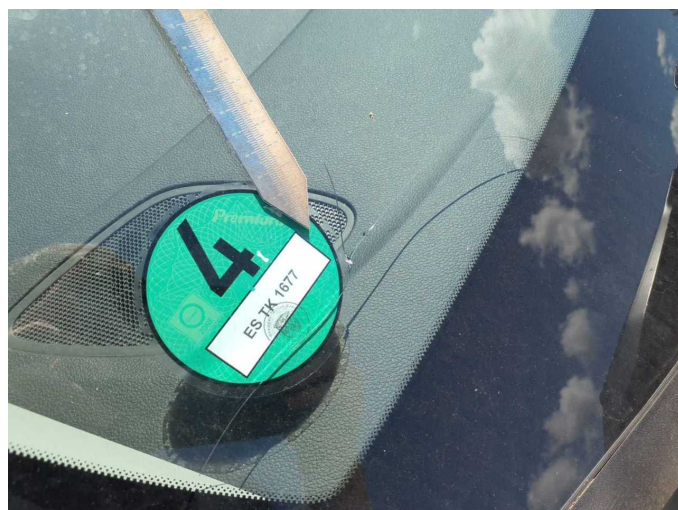
**Damage 19:** Vehicle glazing: Windscreen - Broken / torn - Replace

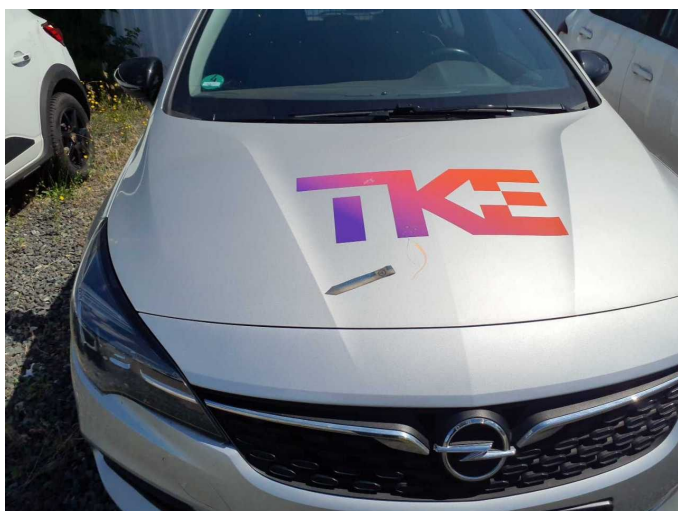
| No. | Component group | Description |
|---|---|---|
| 20 | Bonnet | Bonnet - Dent / paintcoat damage - Repair and paint |

**Damage 20:** Bonnet: Bonnet - Dent / paintcoat damage - Repair and paint

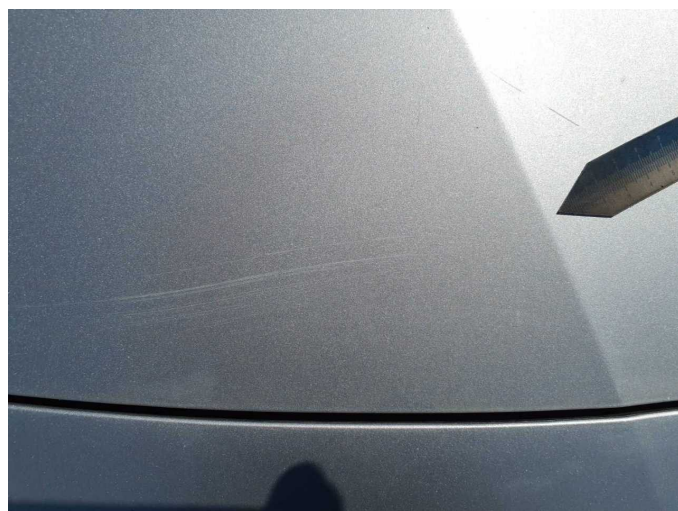
**Damage 20:** Bonnet: Bonnet - Dent / paintcoat damage - Repair and paint

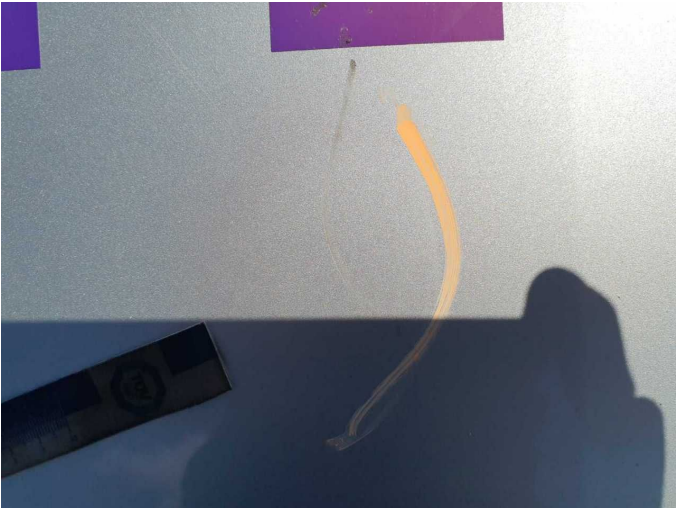
Damage 20: Bonnet: Bonnet - Dent / paintcoat damage - Repair and paint

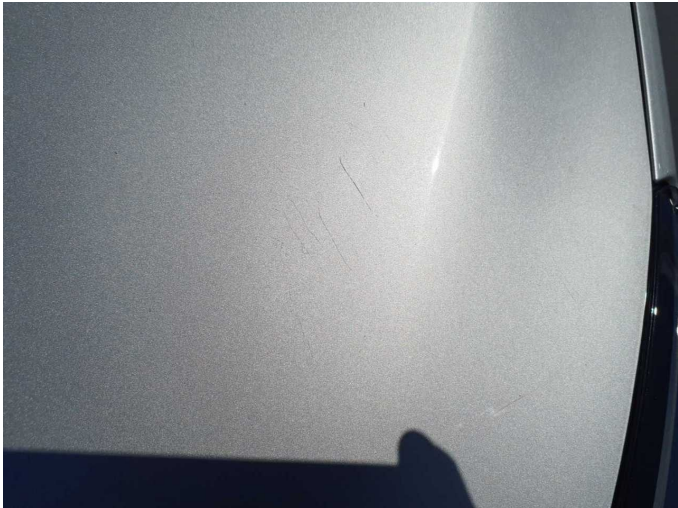
Damage 20: Bonnet: Bonnet - Dent / paintcoat damage - Repair and paint

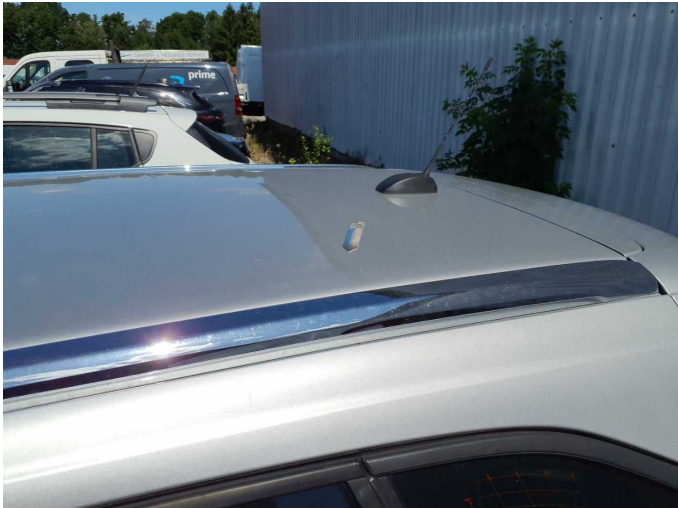
| No. | Component group | Description |
|---|---|---|
| 22 | Roof | Roof - Scratch(es) - Paint |

Damage 22: Roof: Roof - Scratch(es) - Paint

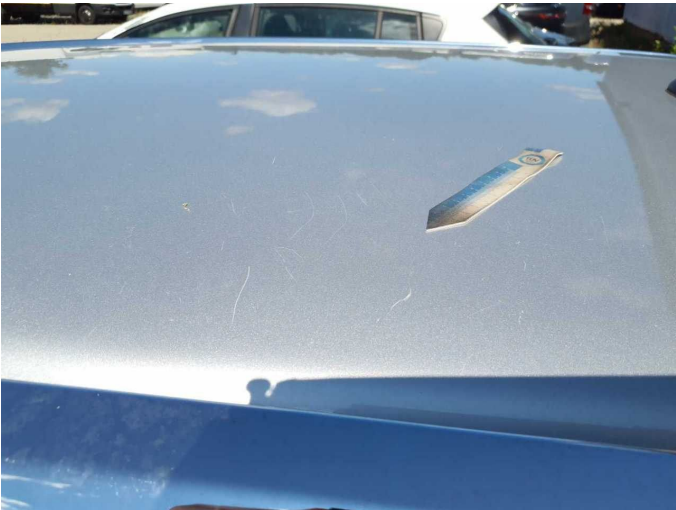
Damage 22: Roof: Roof - Scratch(es) - Paint

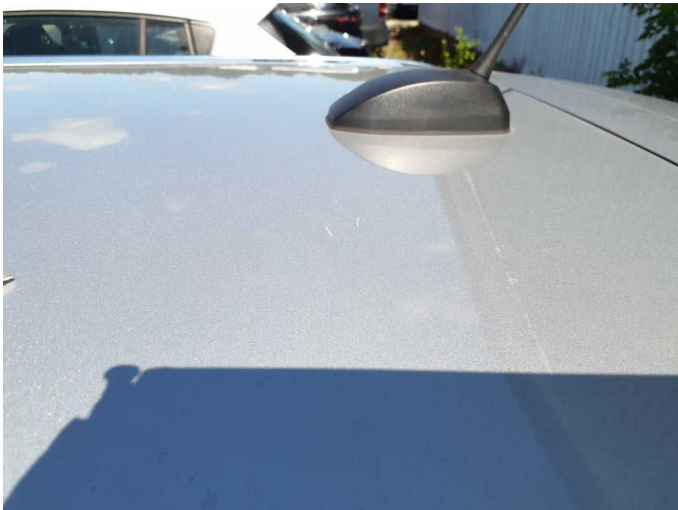
Damage 22: Roof: Roof - Scratch(es) - Paint

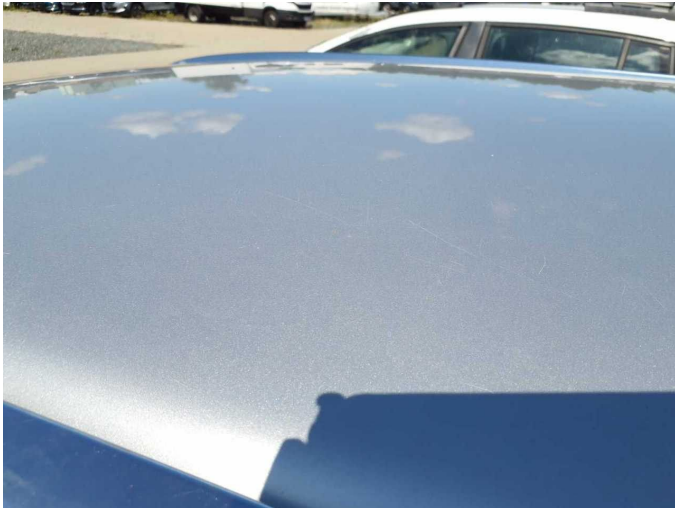
**Damage 22:** Roof: Roof - Scratch(es) - Paint

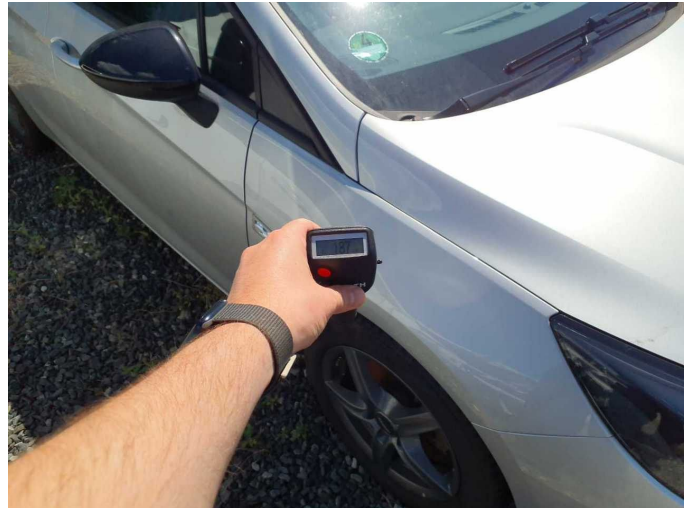
| No. | Repainting |
|---|---|
| 1 | Mudguard - right side, Professionally carried out, Invoice of repair done Non-existent |

| Mudguard - right side | 187 µm | Side panel - rear left side | 285 µm |

**Repainting 1:** Mudguard - right side

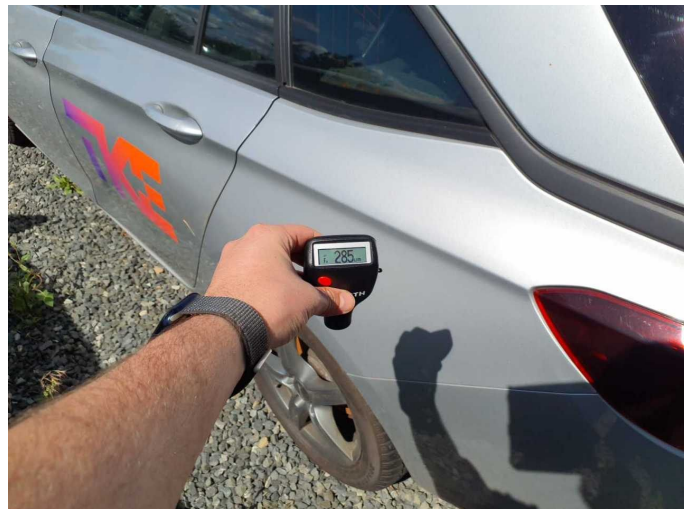
| No. | Repainting |
|---|---|
| 2 | Side panel - rear left side, Professionally carried out, Invoice of repair done Non-existent |

**Repainting 2:** Side panel - rear left side

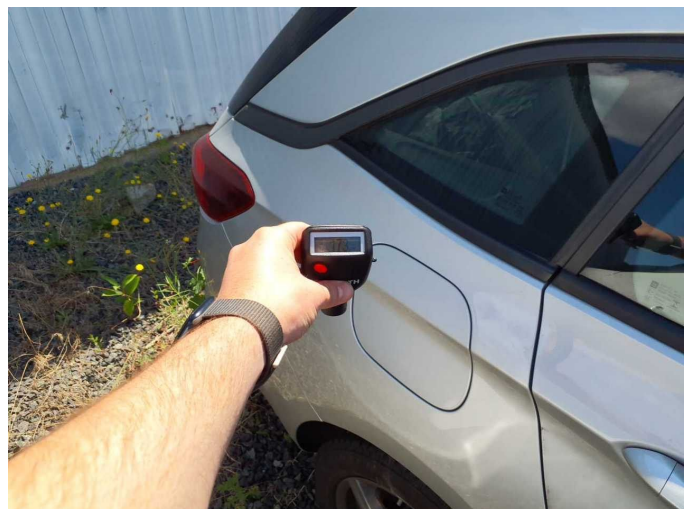
| No. | Repainting |
|---|---|
| 3 | Side panel - rear right side, Professionally carried out, Invoice of repair done Non-existent |

| Side panel - rear right side | 173 µm | Door - front left side | 169 µm |

**Repainting 3:** Side panel - rear right side

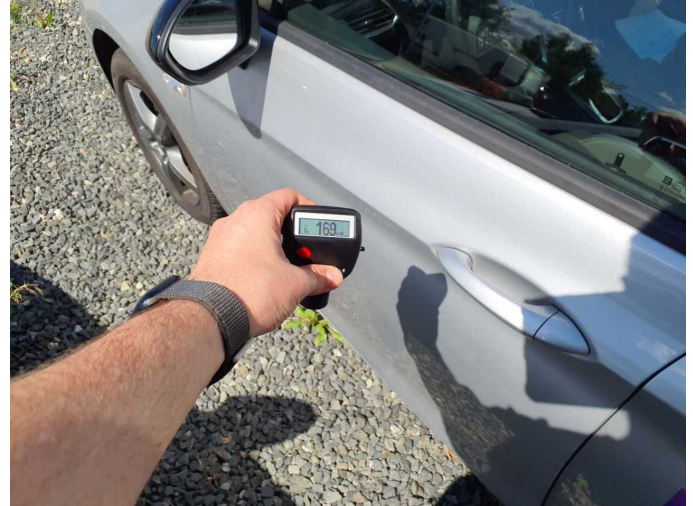
| No. | Repainting |
|---|---|
| 4 | Door - front left side, Professionally carried out, Invoice of repair done Non-existent |

**Repainting 4:** Door - front left side
