Protocol number: 46029915
Order No. / Reference: 26494821
Inspection date: 17 Jun 2026

Manufacturer: Ford

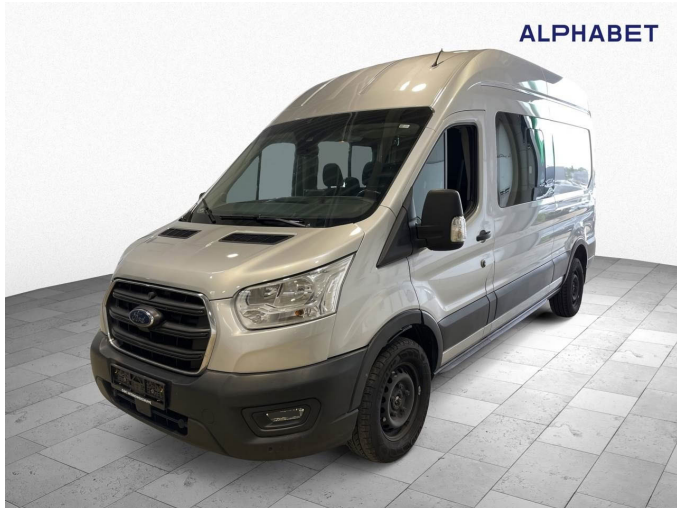
Figure 1: Diagonal front (left)

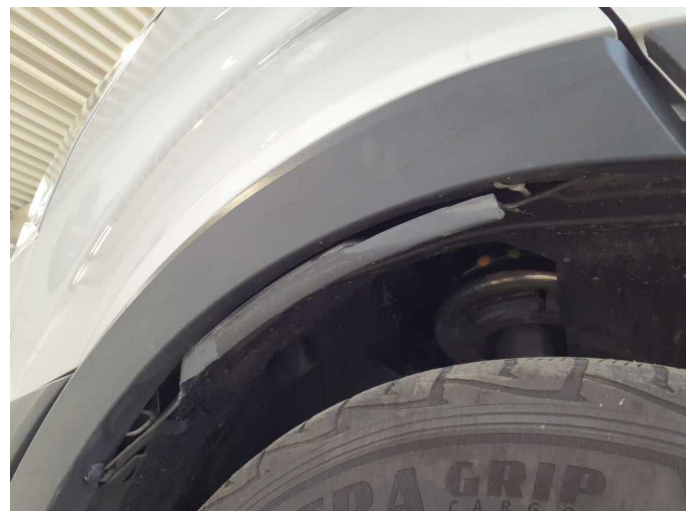
Damage 1: Body: Wheel well - front left side (Radhausschale) - Malposition - Un- / install

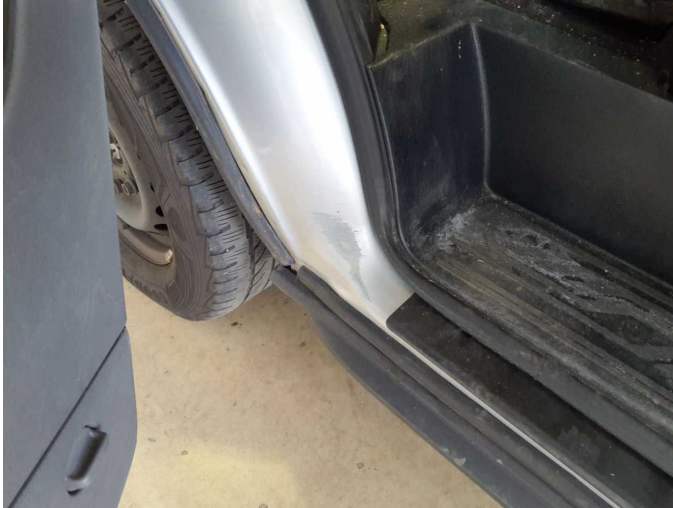
Damage 2: Sill - left side: Sill - Scratched - Smart repair

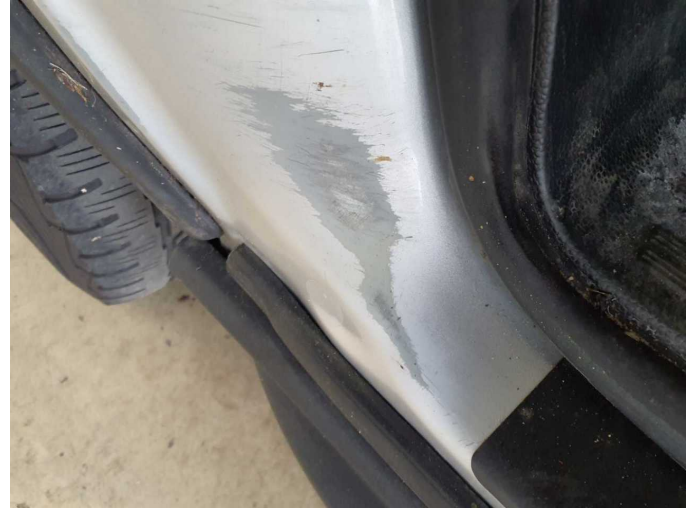
Damage 2: Sill - left side: Sill - Scratched - Smart repair

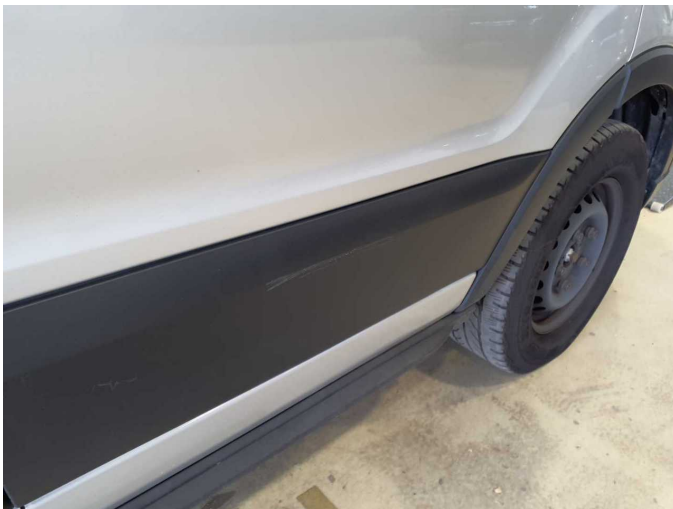
Damage 3: Door - front right side: Brightware - lower - Scratched - Replace

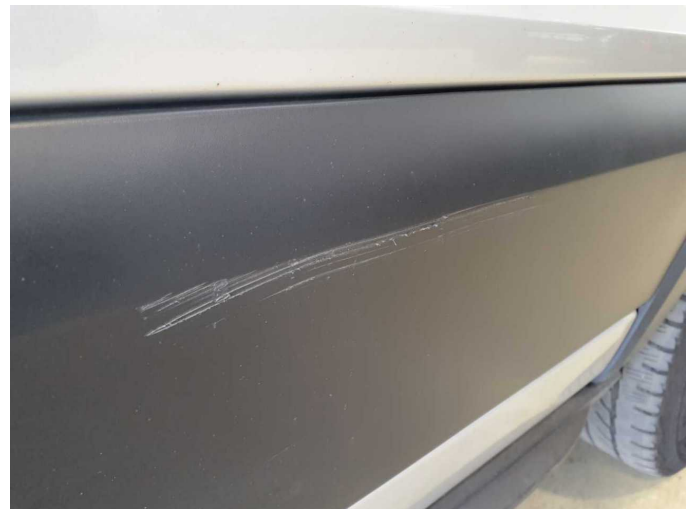
Damage 3: Door - front right side: Brightware - lower - Scratched - Replace

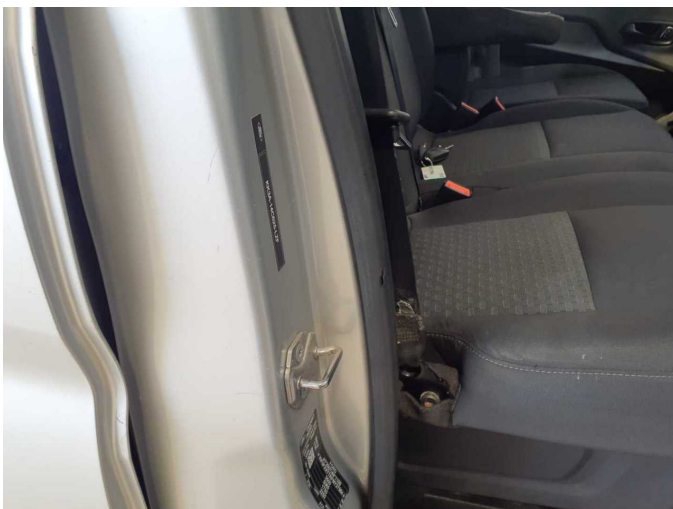
Damage 4: Door - front right side: Door seal - Broken / torn - Replace

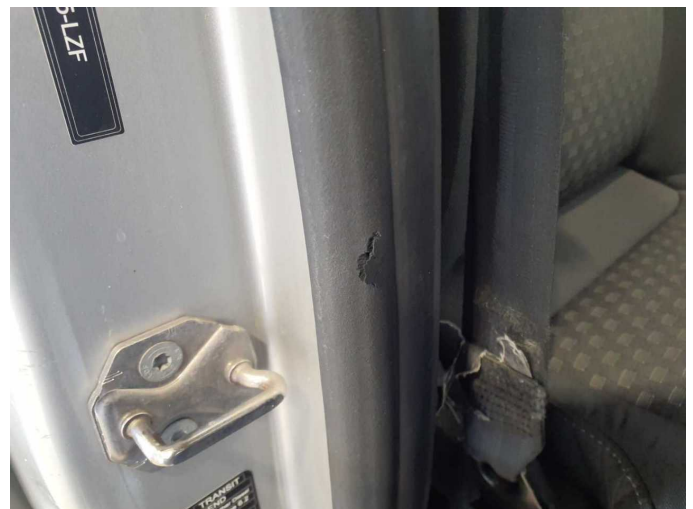
Damage 4: Door - front right side: Door seal - Broken / torn - Replace

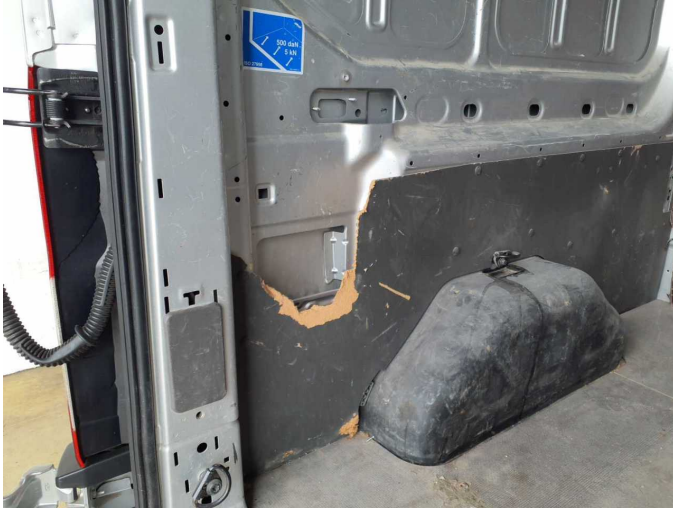
Damage 5: Trim / covers: Boot lining - Broken / torn - Replace

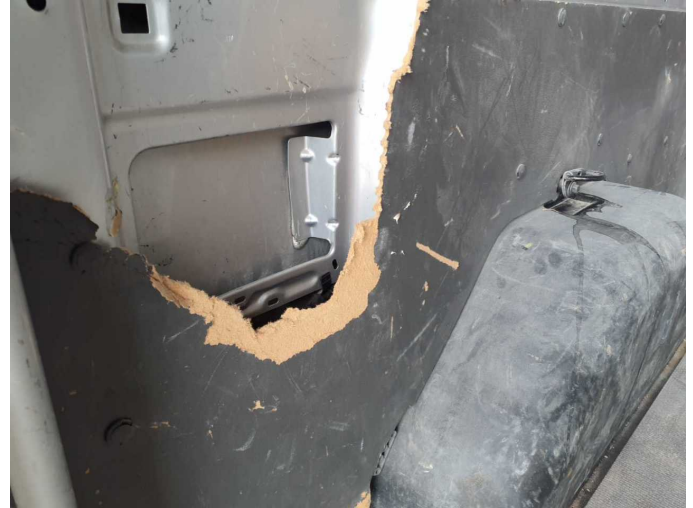
Damage 5: Trim / covers: Boot lining - Broken / torn - Replace

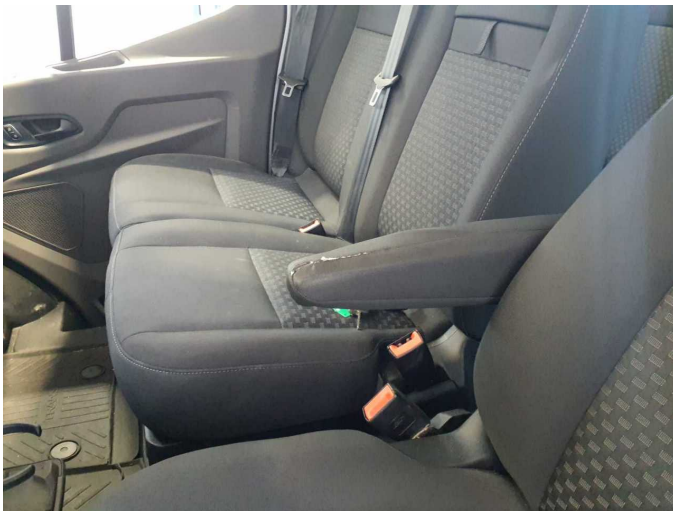
Damage 6: Seat - front: Armrest seat - left side, inner - Broken / torn - Replace

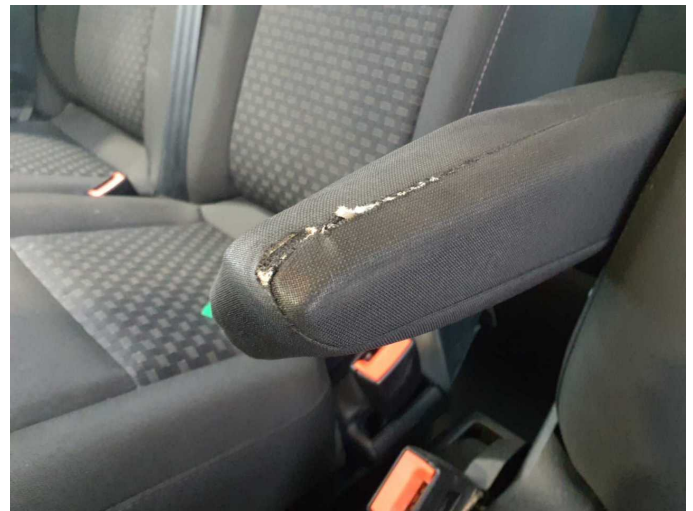
Damage 6: Seat - front: Armrest seat - left side, inner - Broken / torn - Replace

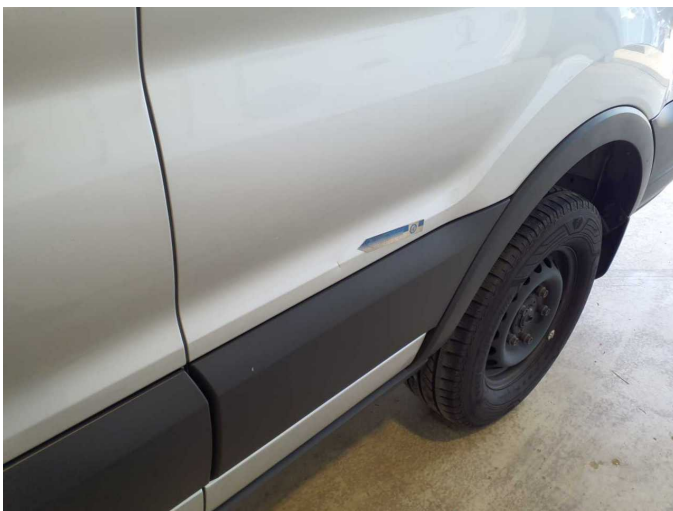
Damage 7: Side panel - rear left side: Side panel - Dent / paintcoat damage - Smart repair

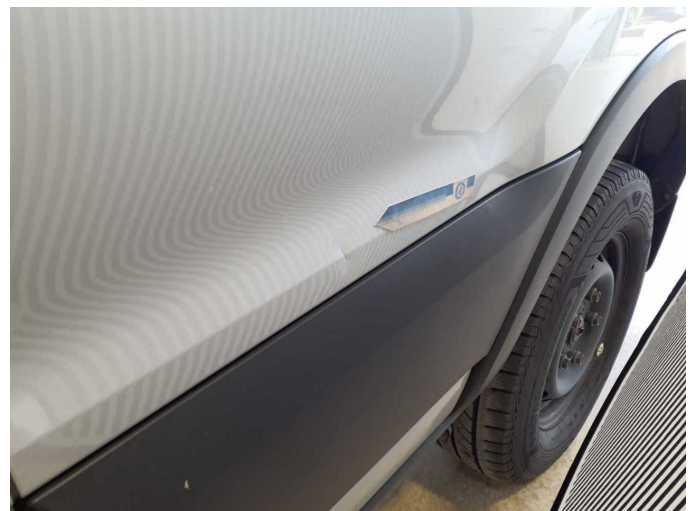
Damage 7: Side panel - rear left side: Side panel - Dent / paintcoat damage - Smart repair

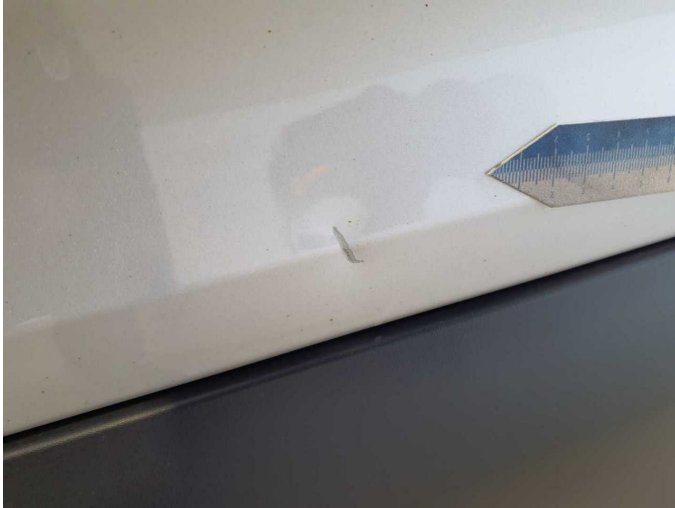
Damage 7: Side panel - rear left side: Side panel - Dent / paintcoat damage - Smart repair

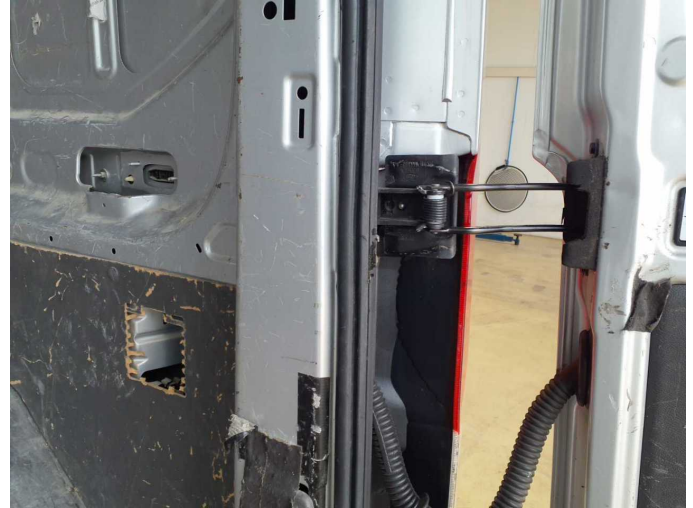
Damage 8: Boot lid / rear door: Seal - Broken / torn - Replace

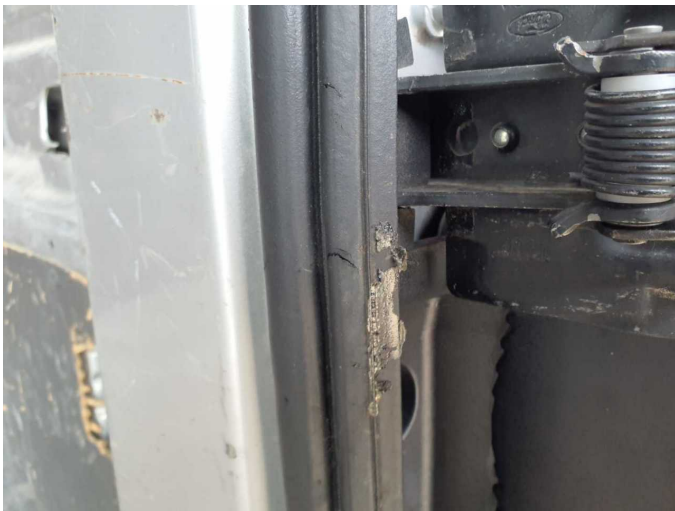
Damage 8: Boot lid / rear door: Seal - Broken / torn - Replace

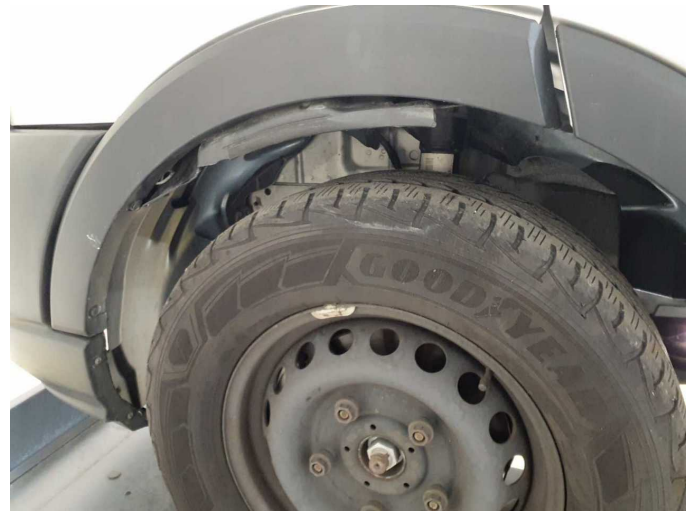
Damage 9: Wheel / tyres: Tyre - front - Does not meet the leasing specifications - Replace

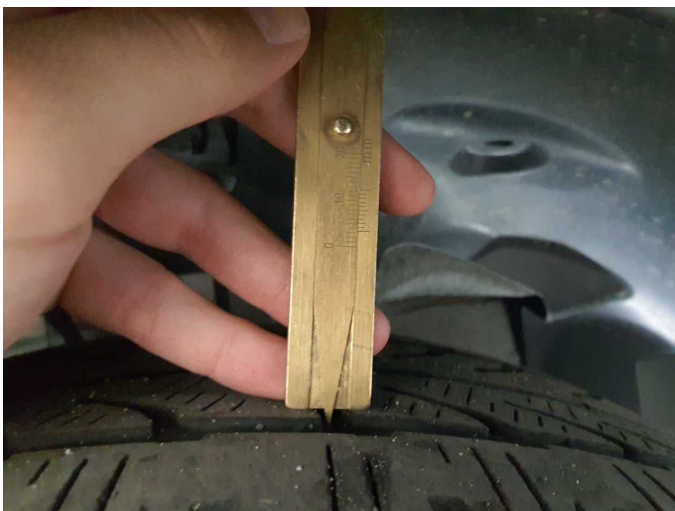
Damage 9: Wheel / tyres: Tyre - front - Does not meet the leasing specifications - Replace

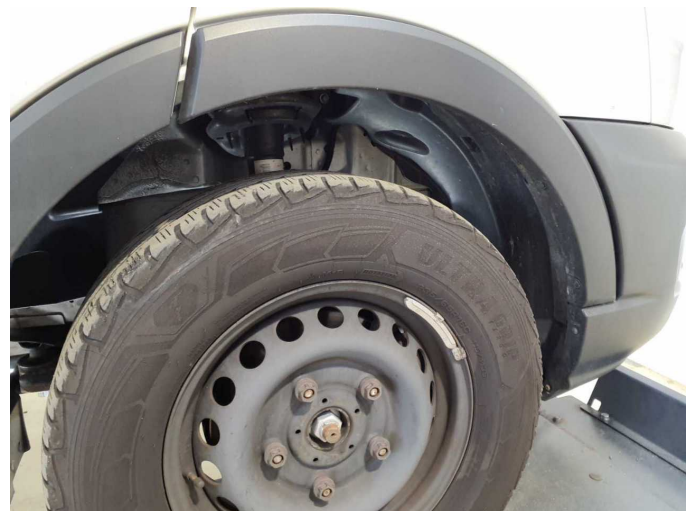
Damage 9: Wheel / tyres: Tyre - front - Does not meet the leasing specifications - Replace

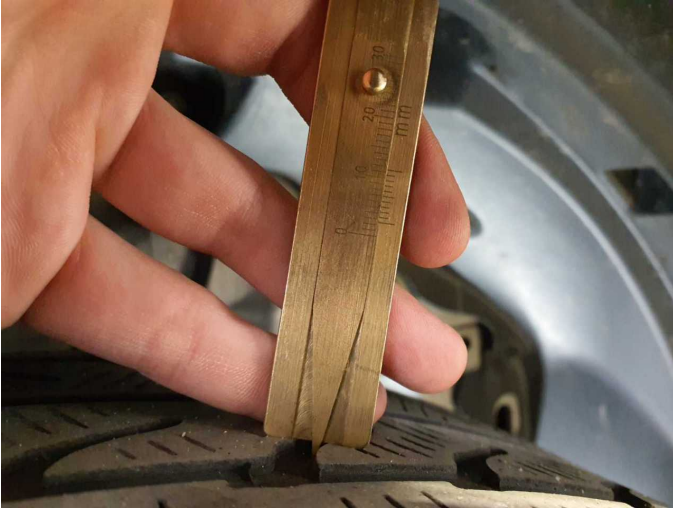
Damage 9: Wheel / tyres: Tyre - front - Does not meet the leasing specifications - Replace

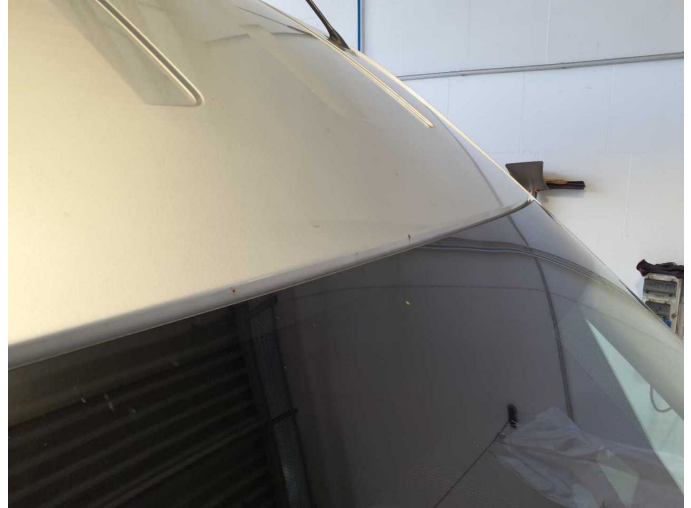
Damage 10: Roof: Roof (vorne) - Corrosion - Loss in value

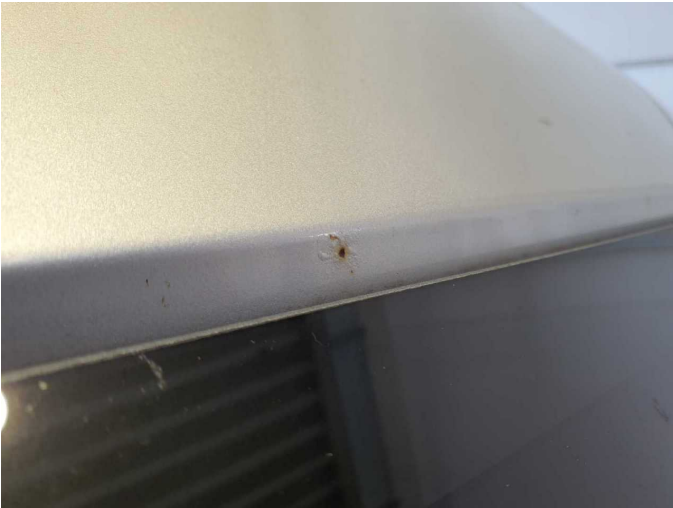
Damage 10: Roof: Roof (vorne) - Corrosion - Loss in value

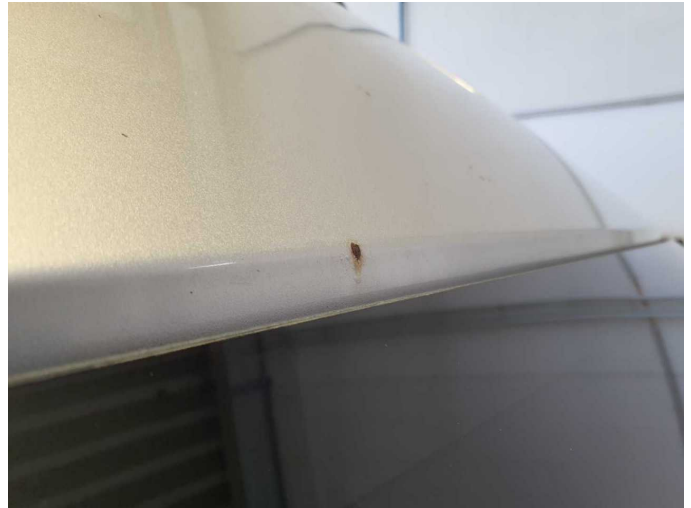
Damage 10: Roof: Roof (vorne) - Corrosion - Loss in value

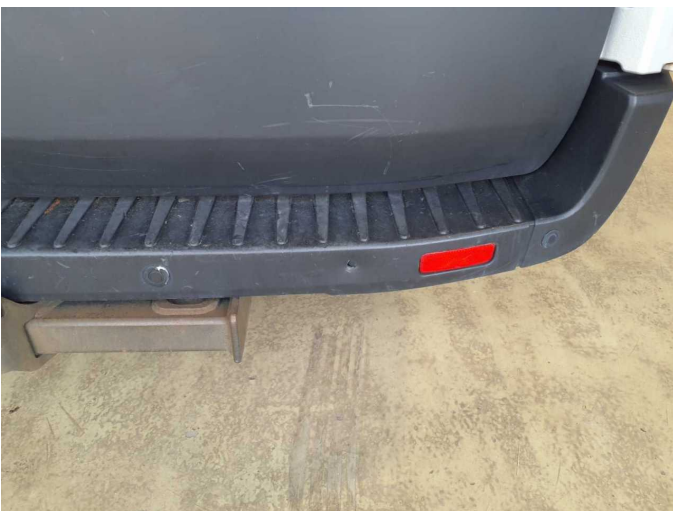
Damage 11: Rear bumper: Rear bumper - Broken / torn - Replace

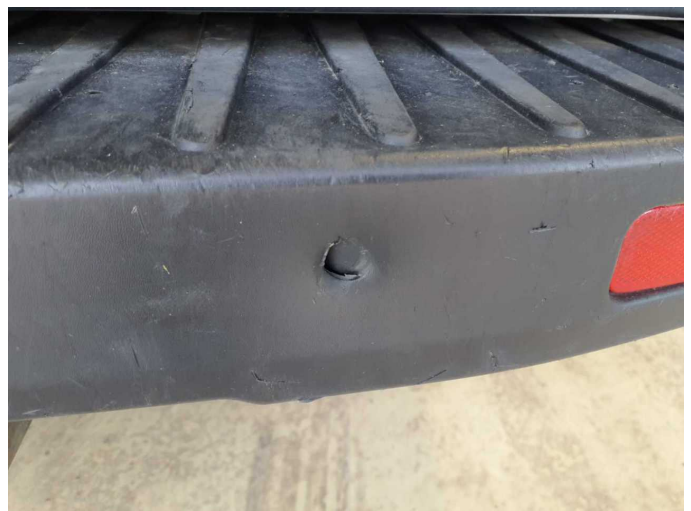
Damage 11: Rear bumper: Rear bumper - Broken / torn - Replace

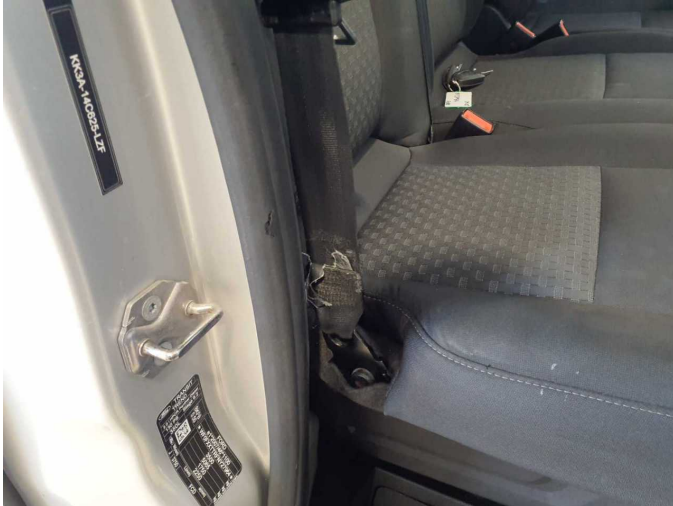
Damage 12: Seat belts - front: Seat belt - front right side - Broken / torn - Replace

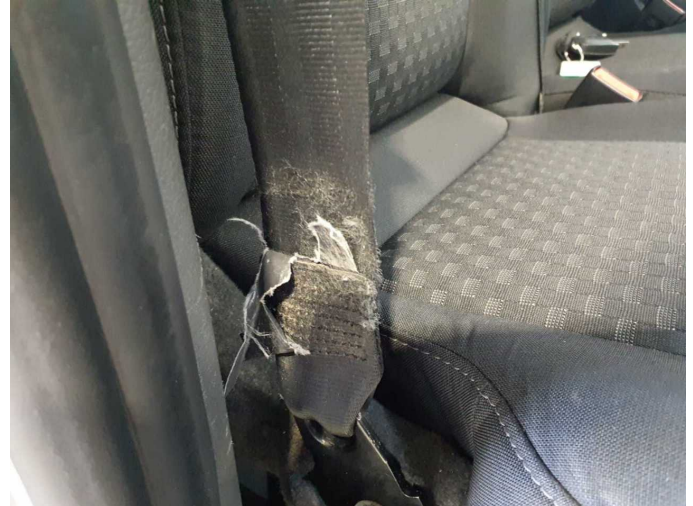
Damage 12: Seat belts - front: Seat belt - front right side - Broken / torn - Replace

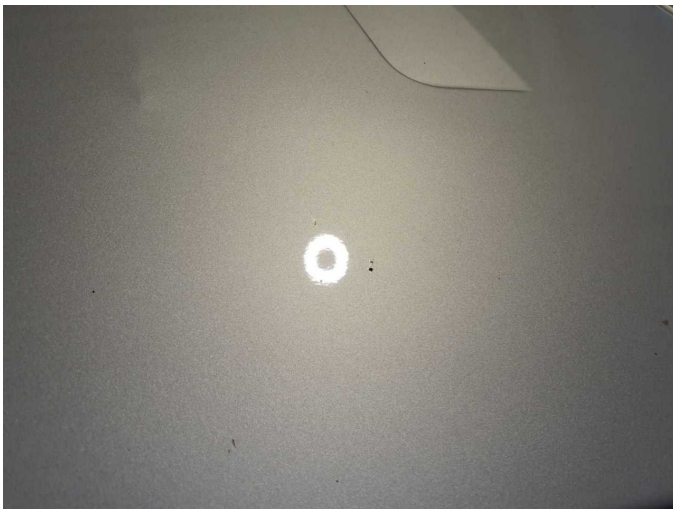
Damage 13: Roof: Roof (hinten) - Dent / paintcoat damage - Loss in value

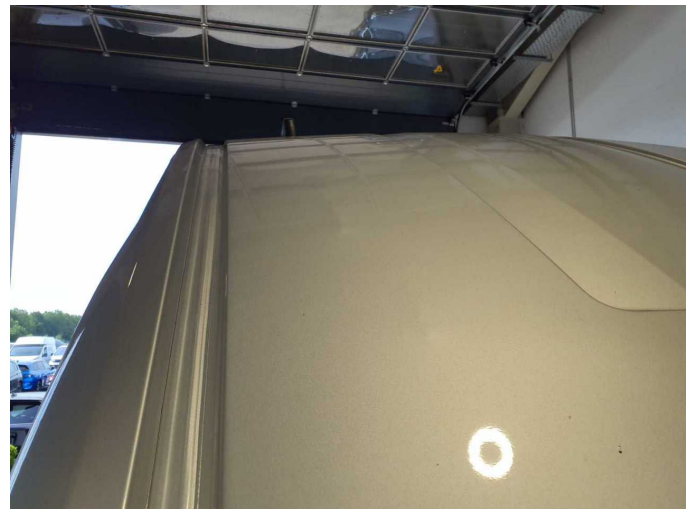
Damage 13: Roof: Roof (hinten) - Dent / paintcoat damage - Loss in value

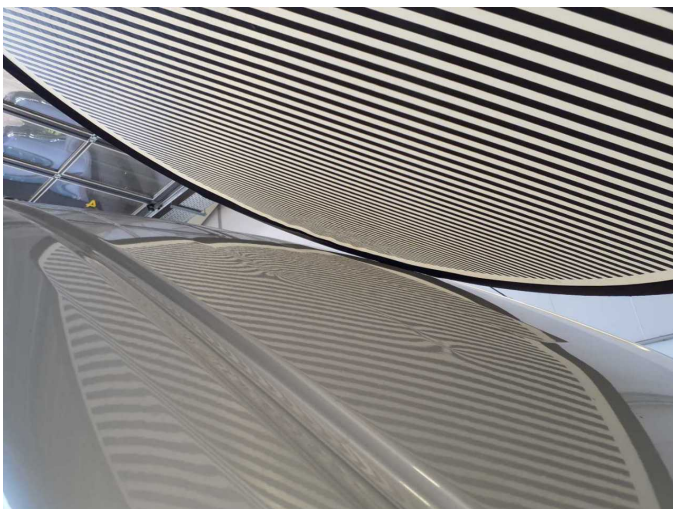
Damage 13: Roof: Roof (hinten) - Dent / paintcoat damage - Loss in value

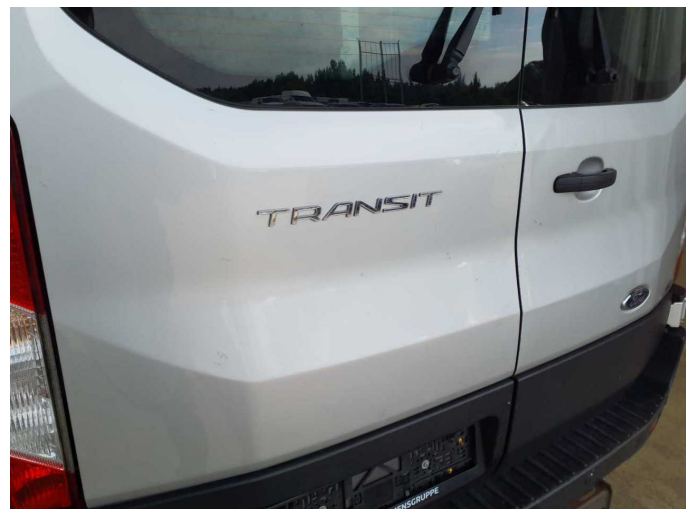
Damage 14: Boot lid / rear door: Rear door - left side - dent(s) - Repair and paint

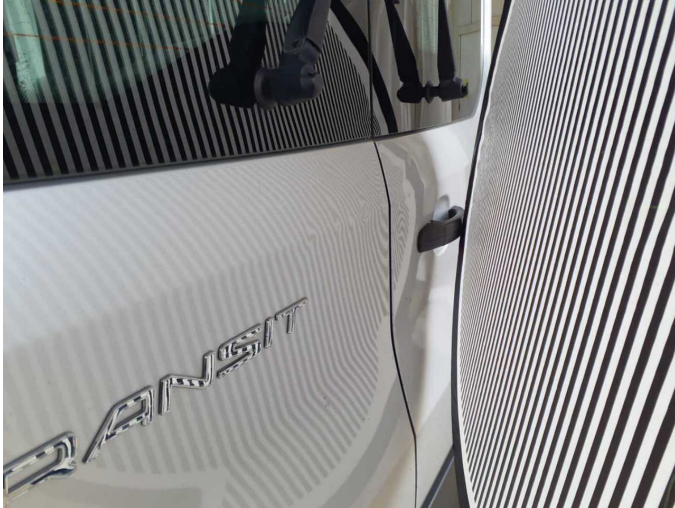
Damage 14: Boot lid / rear door: Rear door - left side - dent(s) - Repair and paint

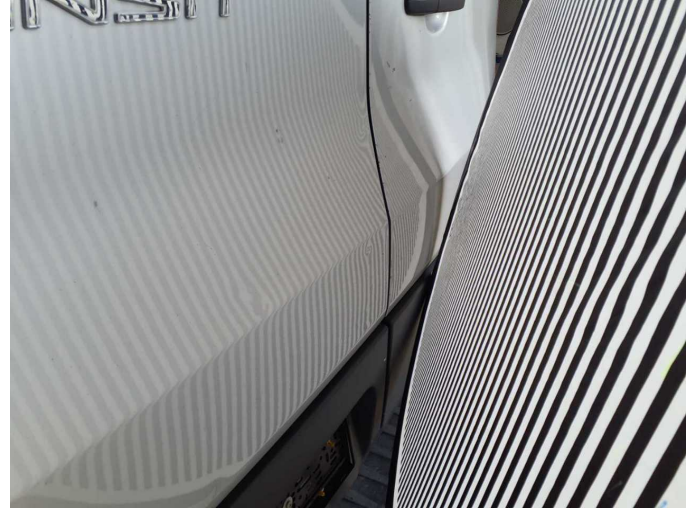
Damage 14: Boot lid / rear door: Rear door - left side - dent(s) - Repair and paint

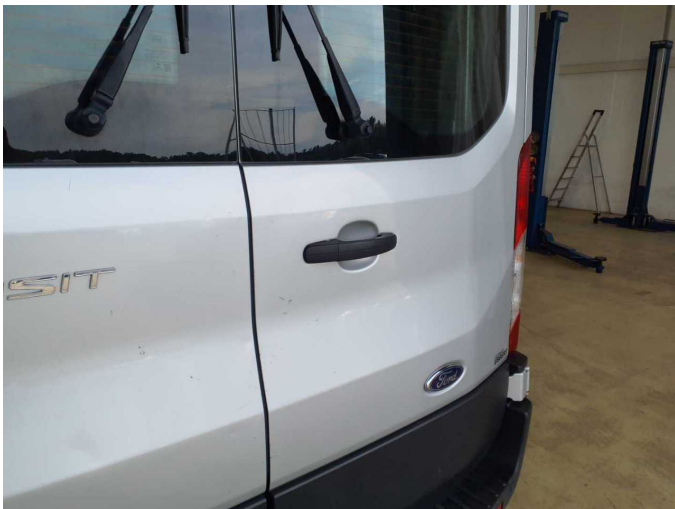
Damage 15: Boot lid / rear door: Rear door - right side - dent(s) - Repair and paint

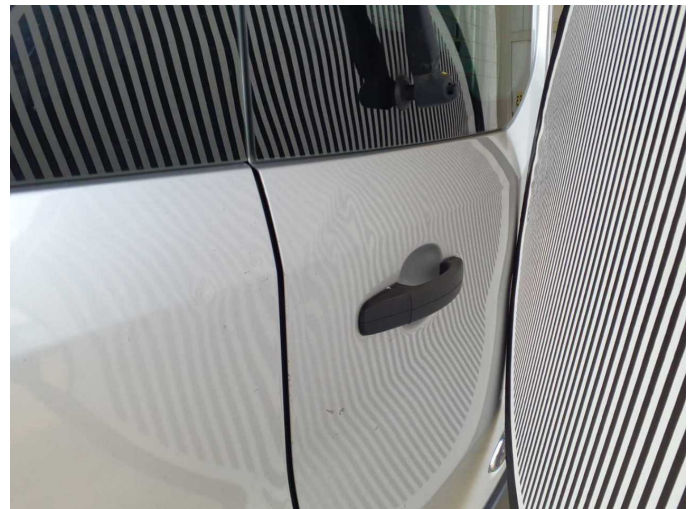
Damage 15: Boot lid / rear door: Rear door - right side - dent(s) - Repair and paint

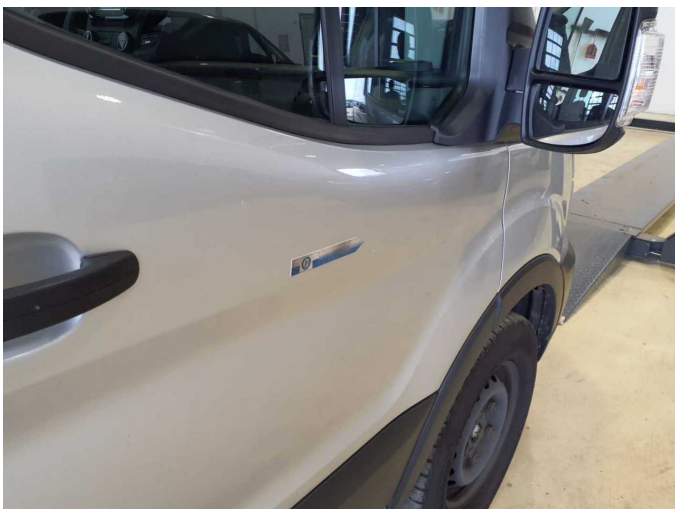
Damage 16: Door - front right side: Door - Dent / paintcoat damage - Repair and paint

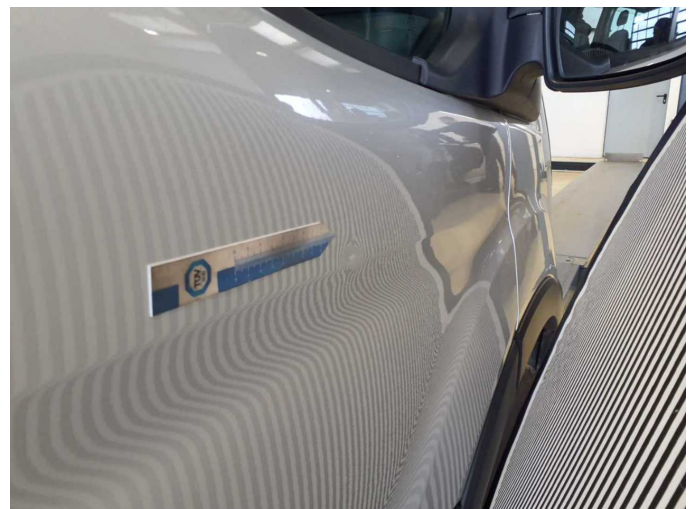
Damage 16: Door - front right side: Door - Dent / paintcoat damage - Repair and paint

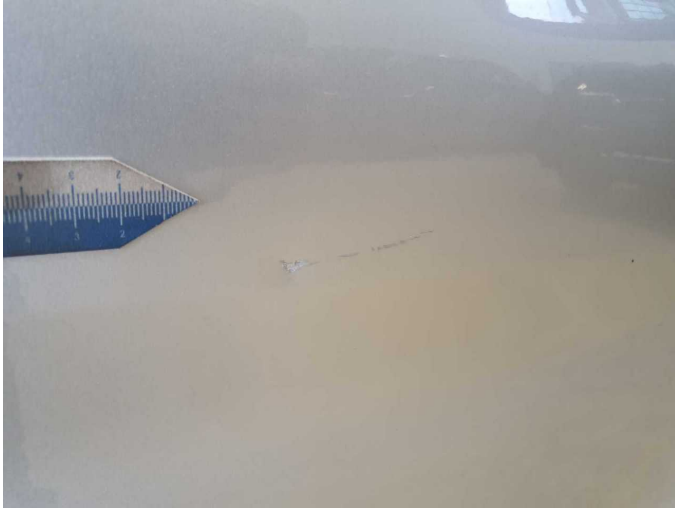
Damage 16: Door - front right side: Door - Dent / paintcoat damage - Repair and paint

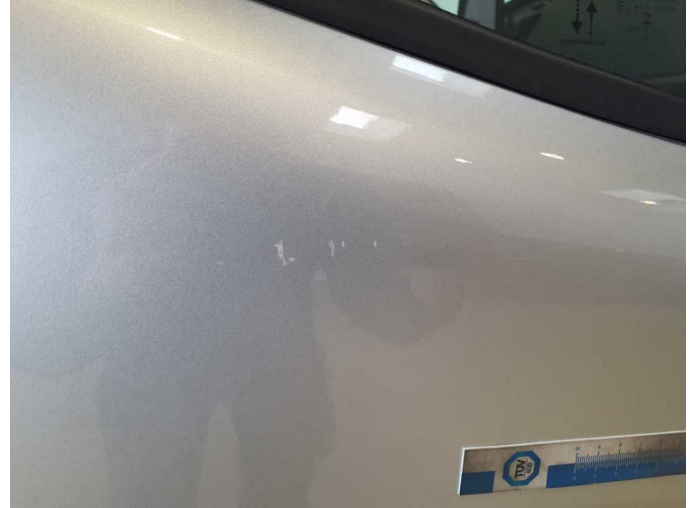
Damage 16: Door - front right side: Door - Dent / paintcoat damage - Repair and paint

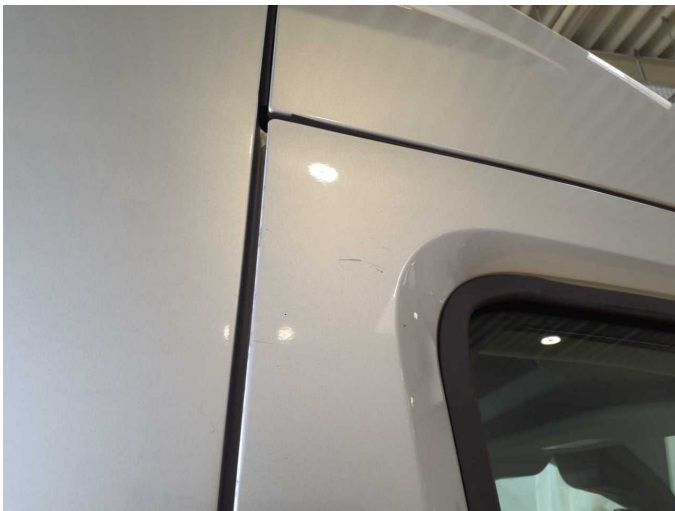
Damage 16: Door - front right side: Door - Dent / paintcoat damage - Repair and paint

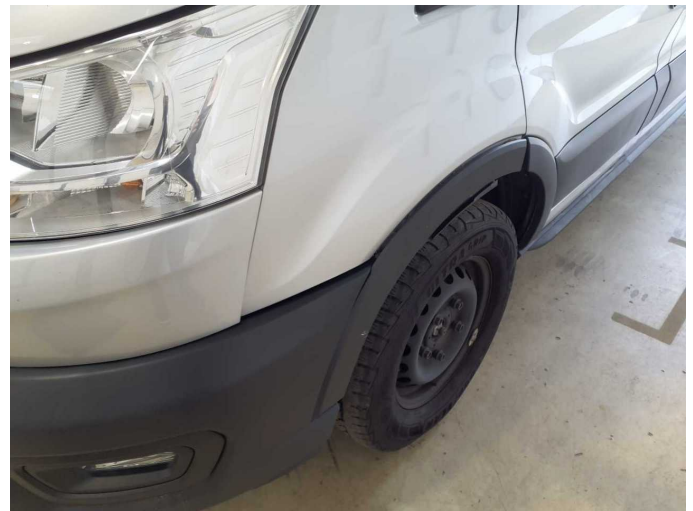
Damage 17: Mudguard - left side: Mudguard - left side (+ Radlauf) - Deformed - Replace

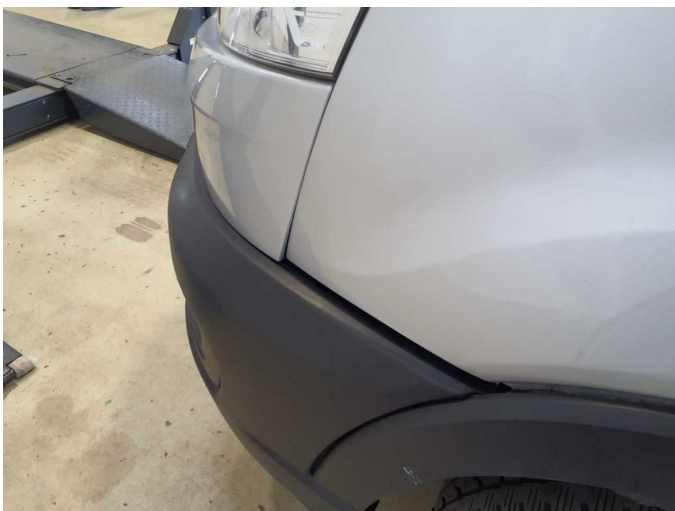
Damage 17: Mudguard - left side: Mudguard - left side (+ Radlauf) - Deformed - Replace

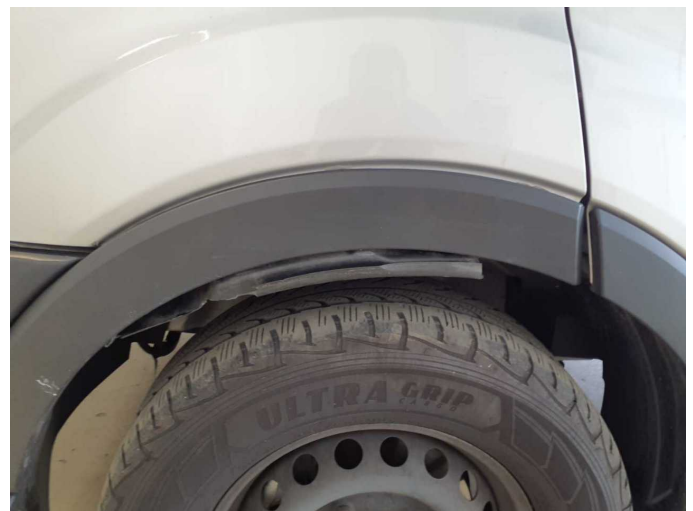
Damage 17: Mudguard - left side: Mudguard - left side (+ Radlauf) - Deformed - Replace

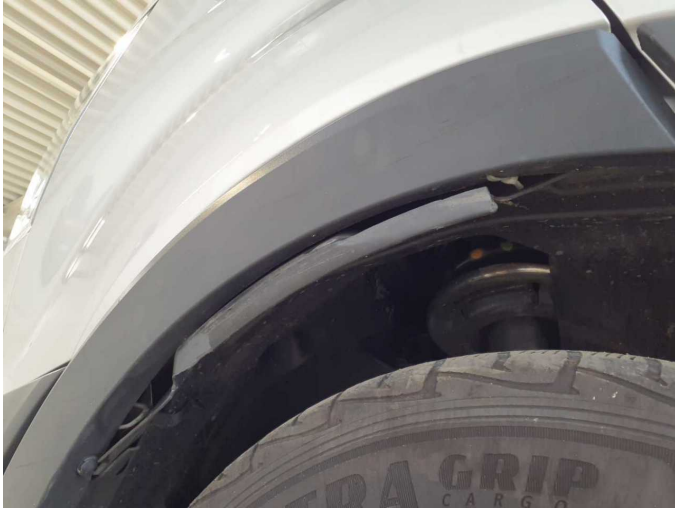
Damage 17: Mudguard - left side: Mudguard - left side (+ Radlauf) - Deformed - Replace

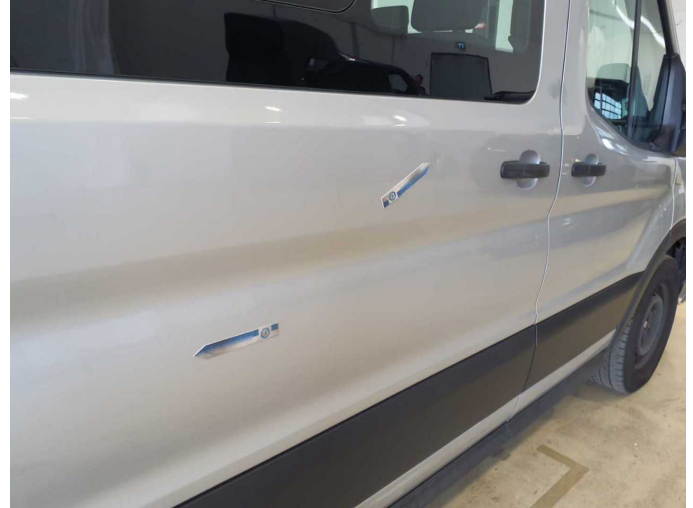
Damage 18: Sliding door, right: Sliding door - Dent / paintcoat damage - Repair and paint

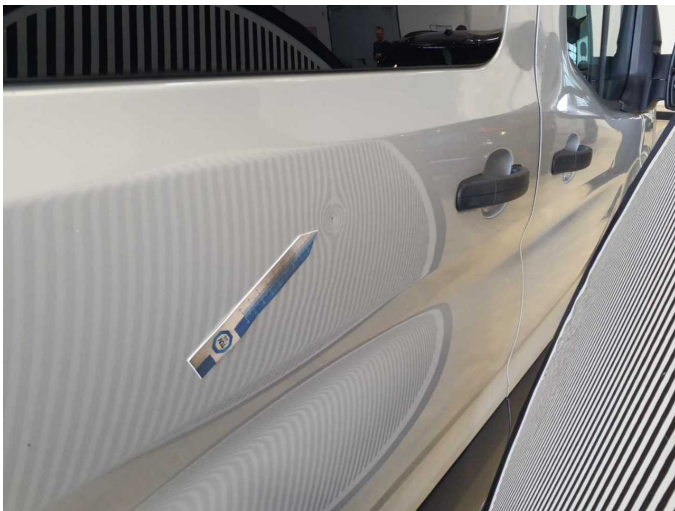
Damage 18: Sliding door, right: Sliding door - Dent / paintcoat damage - Repair and paint

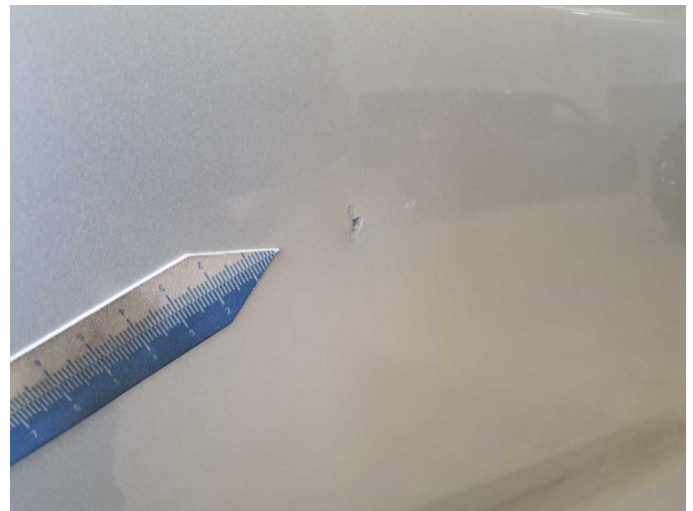
Damage 18: Sliding door, right: Sliding door - Dent / paintcoat damage - Repair and paint

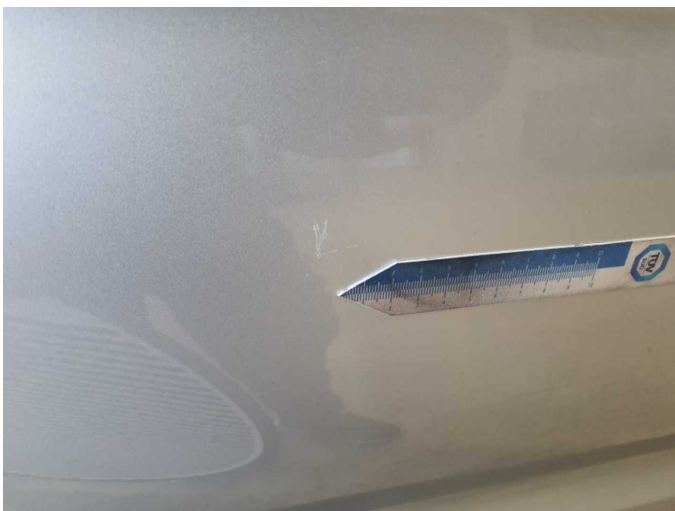
Damage 18: Sliding door, right: Sliding door - Dent / paintcoat damage - Repair and paint

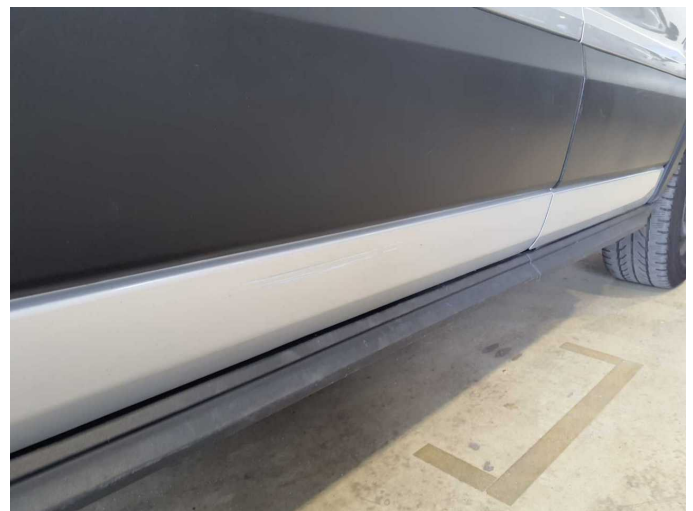
Damage 18: Sliding door, right: Sliding door - Dent / paintcoat damage - Repair and paint

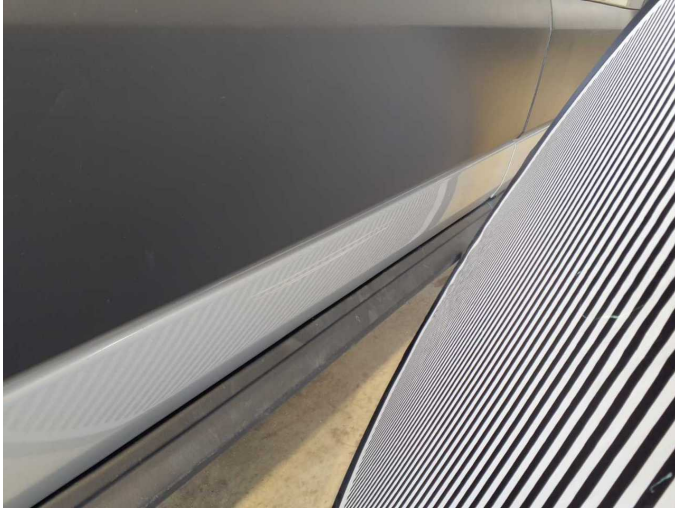
Damage 18: Sliding door, right: Sliding door - Dent / paintcoat damage - Repair and paint

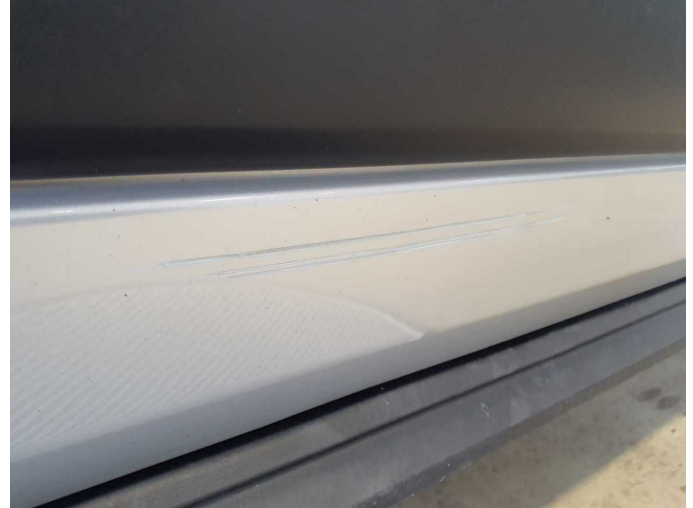
Damage 18: Sliding door, right: Sliding door - Dent / paintcoat damage - Repair and paint

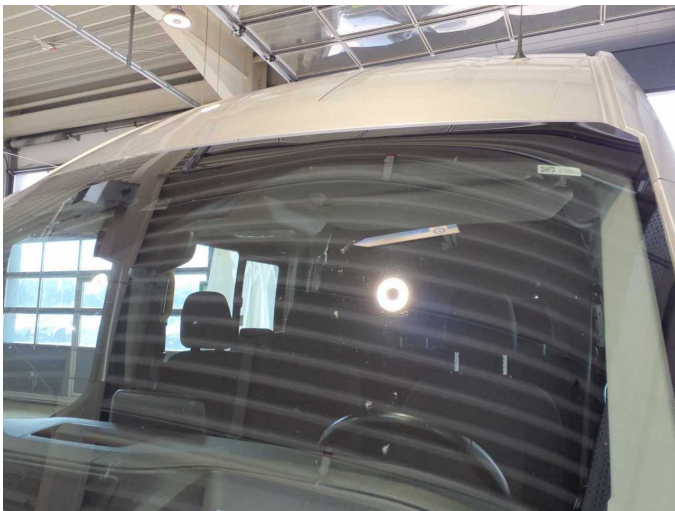
Damage 19: Vehicle glazing: Windscreen - Stone chips - repair according to calculation

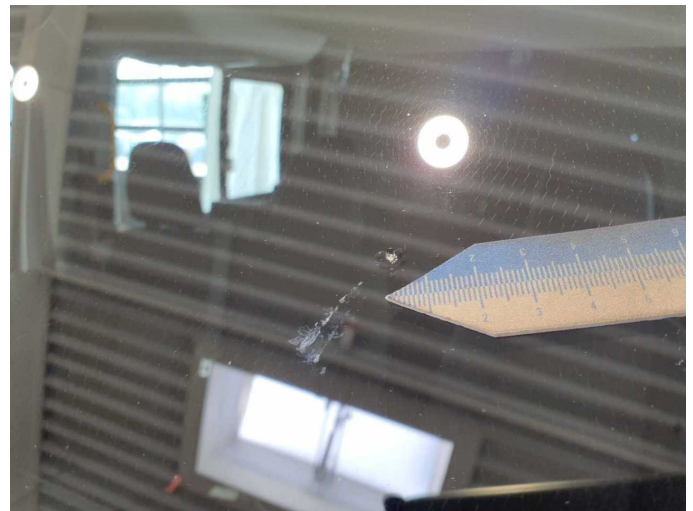
Damage 19: Vehicle glazing: Windscreen - Stone chips - repair according to calculation

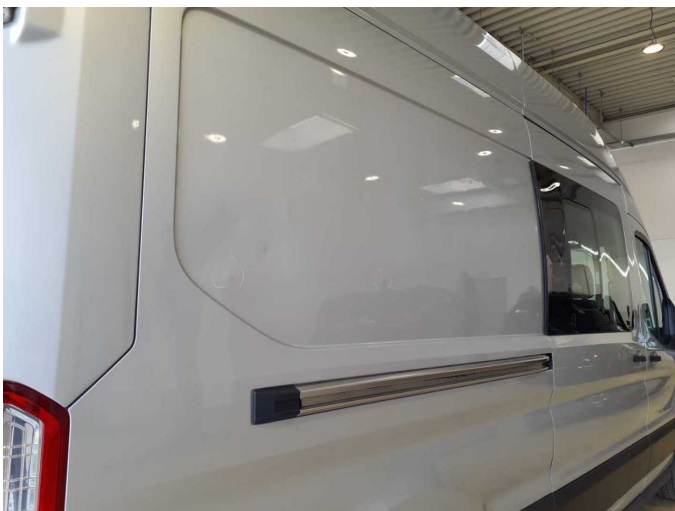
Damage 20: Side panel - rear right side: Side panel - dent(s) - Repair and paint

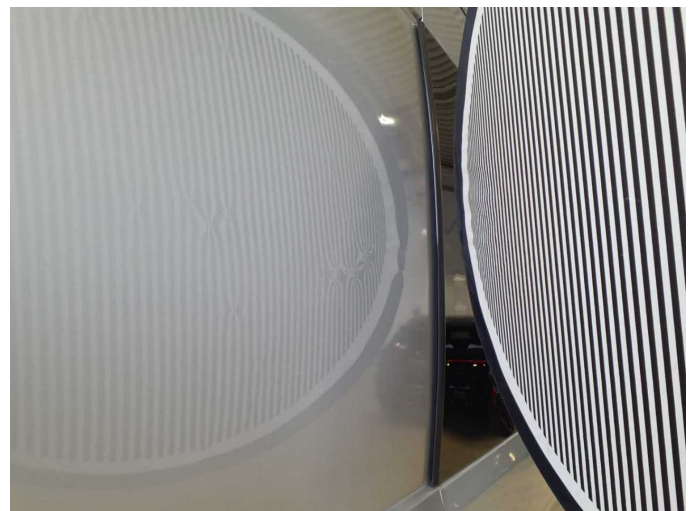
Damage 20: Side panel - rear right side: Side panel - dent(s) - Repair and paint

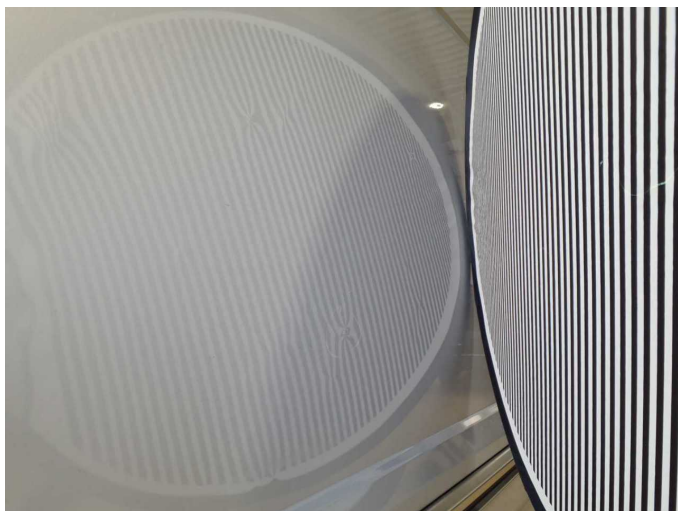
Damage 20: Side panel - rear right side: Side panel - dent(s) - Repair and paint

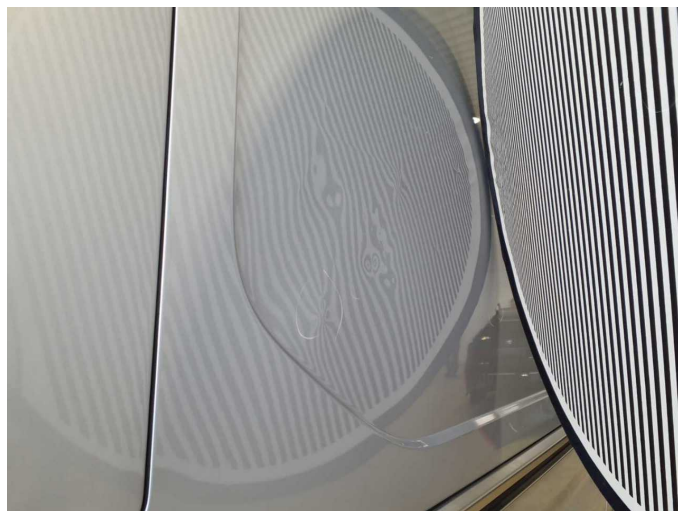
Damage 20: Side panel - rear right side: Side panel - dent(s) - Repair and paint
