Expertise

Protocol number: 45861342
Order No. / Reference: 26476003
Inspection date: 9 Jun 2026

Model: S-Max 2.5 Duratec FHEV TITANIUM

VIN: WF0JXXWPCHPC17726

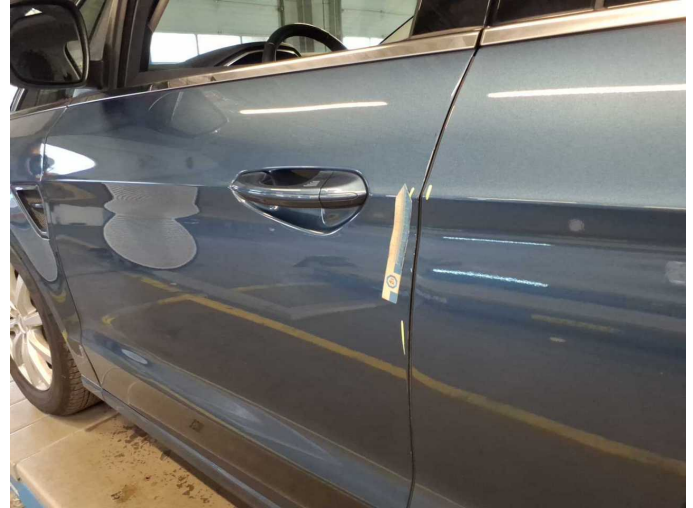
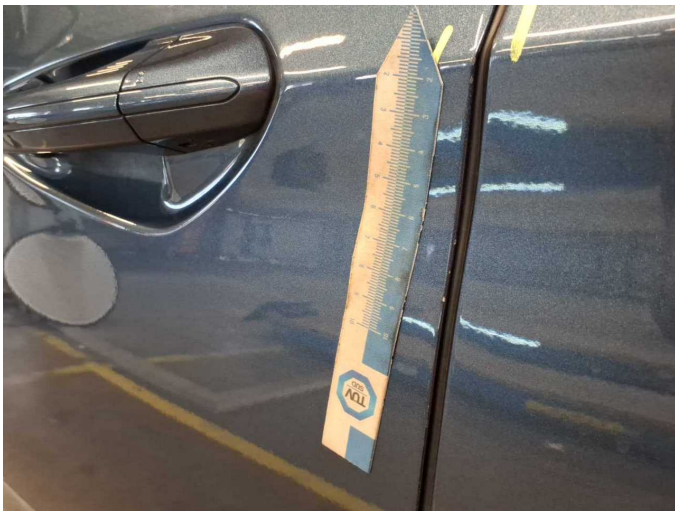
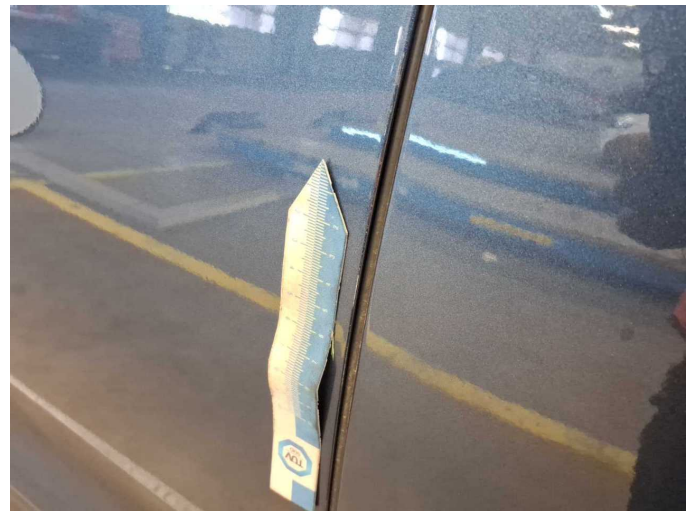
Damage 1: Door - front left side: Door - Scratch(es) - Smart repair

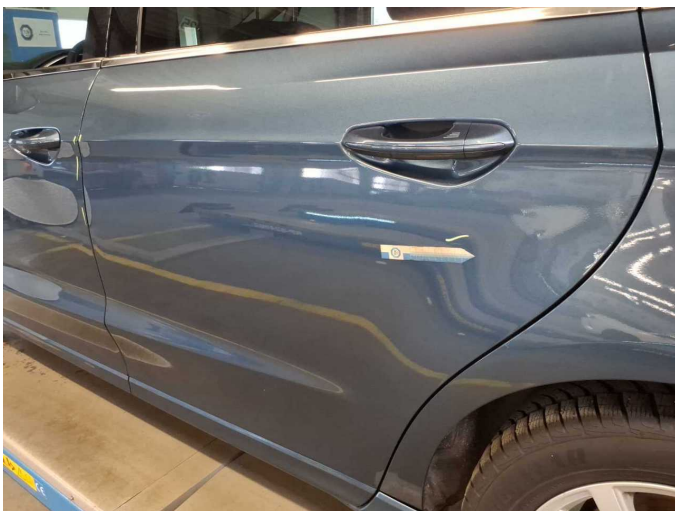
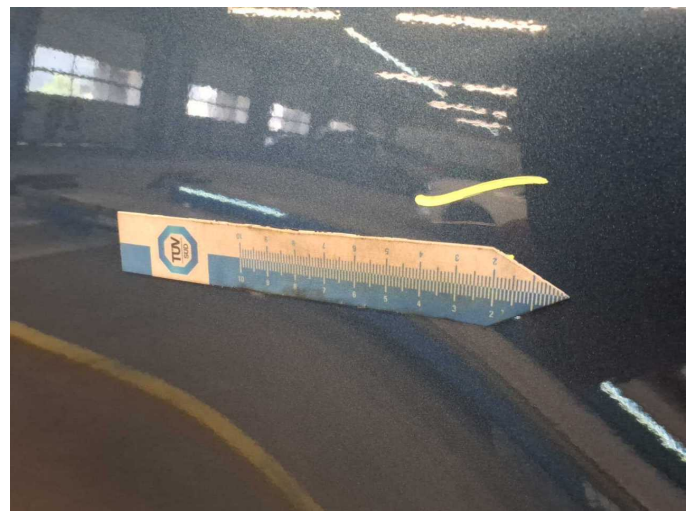
Damage 2: Door - rear left side: Door - Scratch(es) - Smart repair

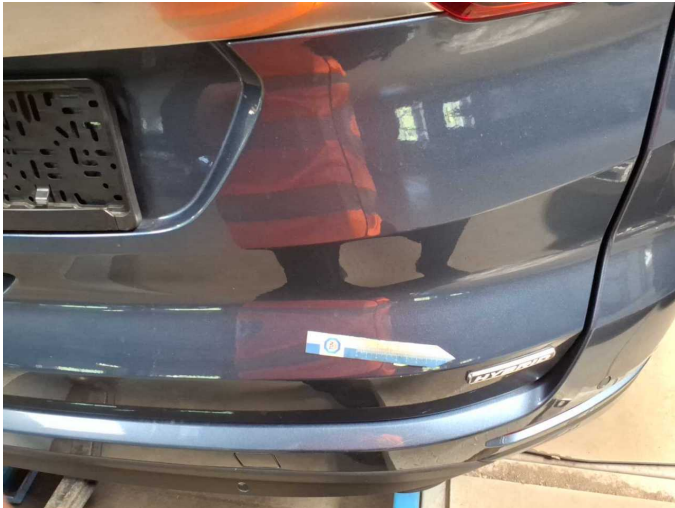
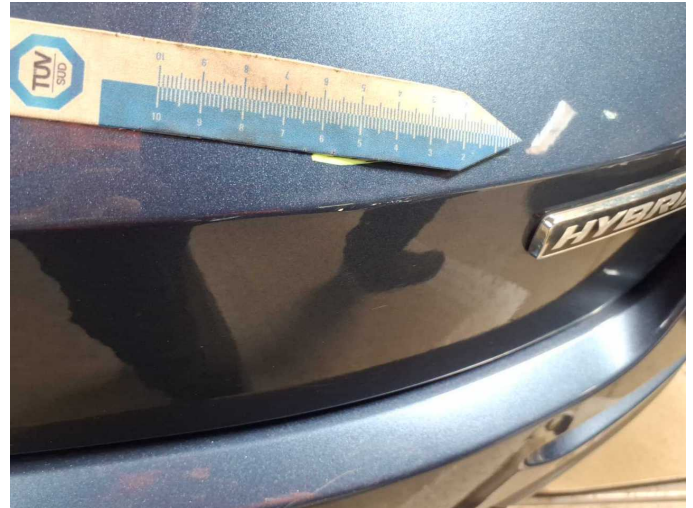
Damage 3: Boot lid / rear door: Boot lid - Scratch(es) - Smart repair

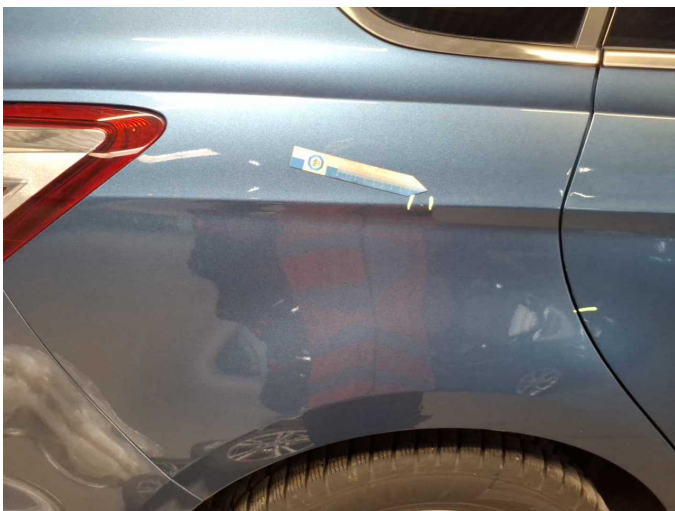
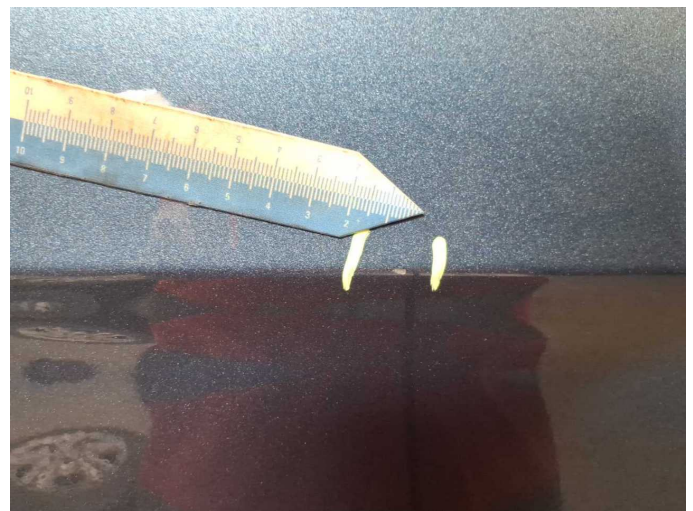
Damage 4: Side panel - rear right side: Side panel - Scratch(es) - Smart repair

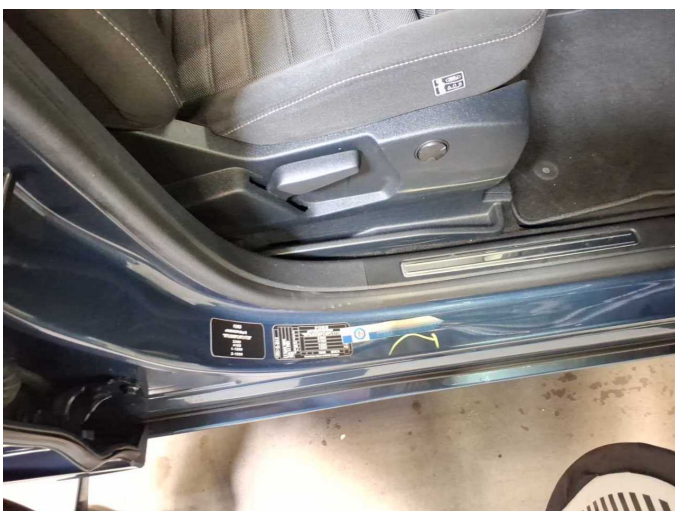
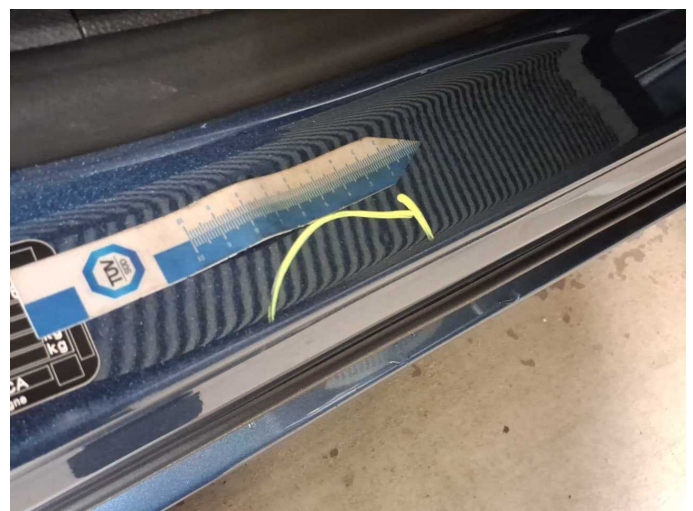
Damage 5: Sill - right side: Sill - Dent / paintcoat damage - Smart repair

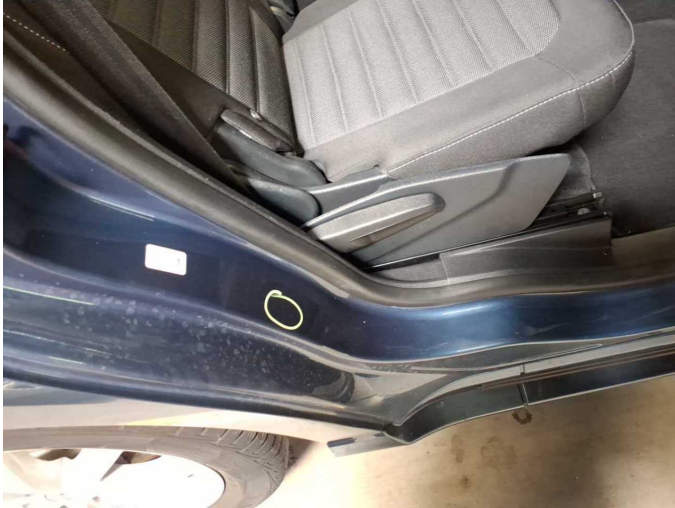
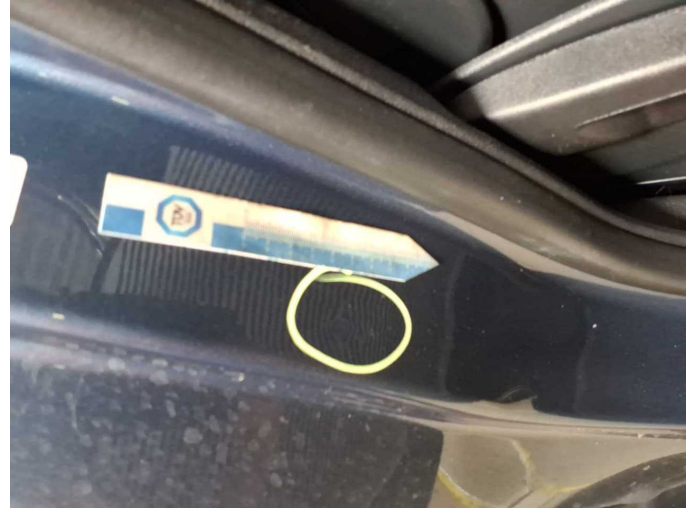
Damage 6: Side panel - rear right side: Sill - Dent / paintcoat damage - Smart repair

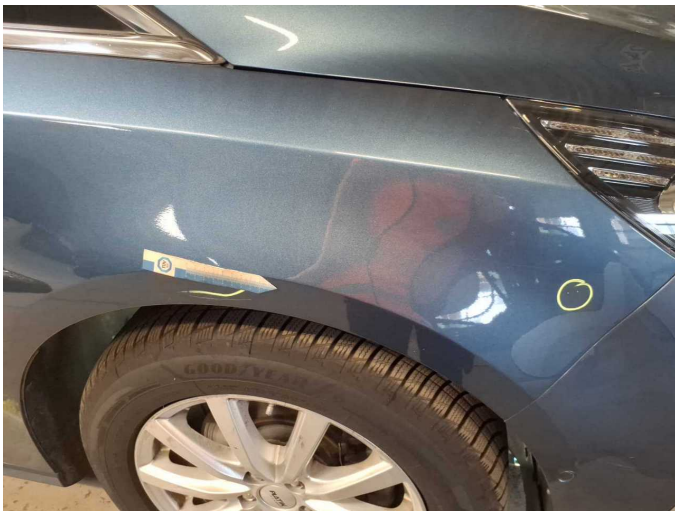
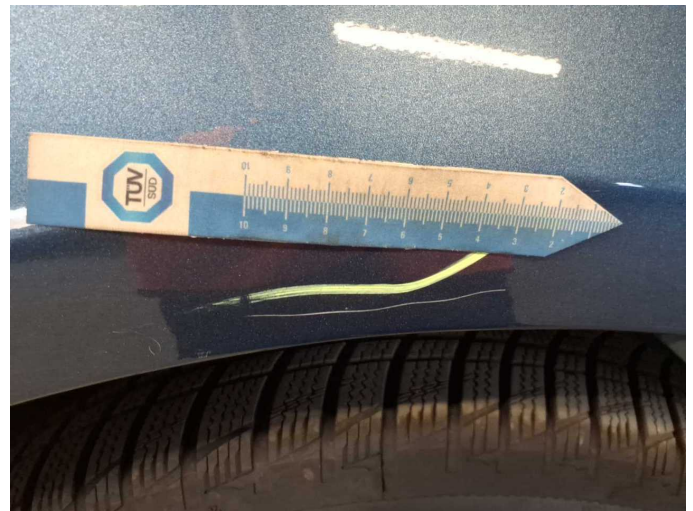
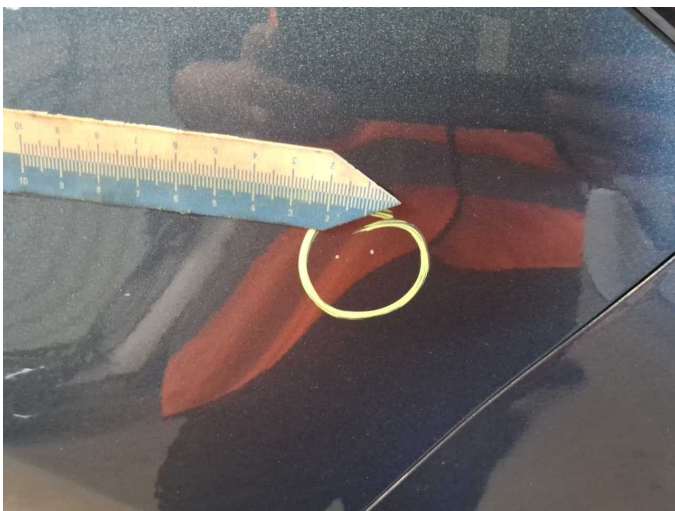
Damage 7: Mudguard - right side: Mudguard - right side - Scratch(es) - Smart repair

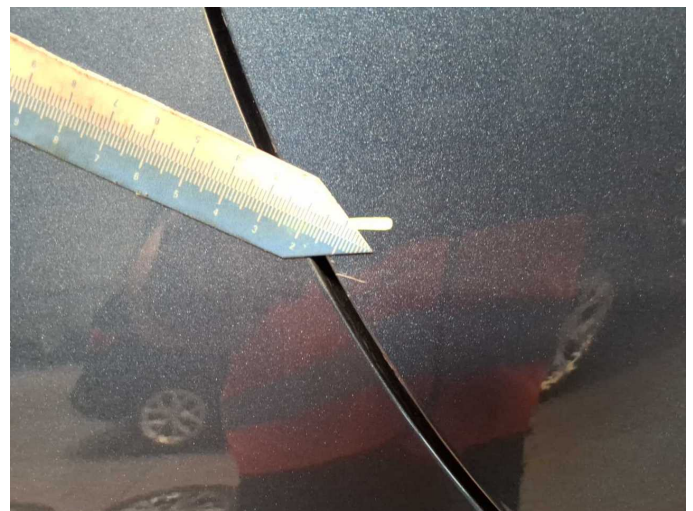
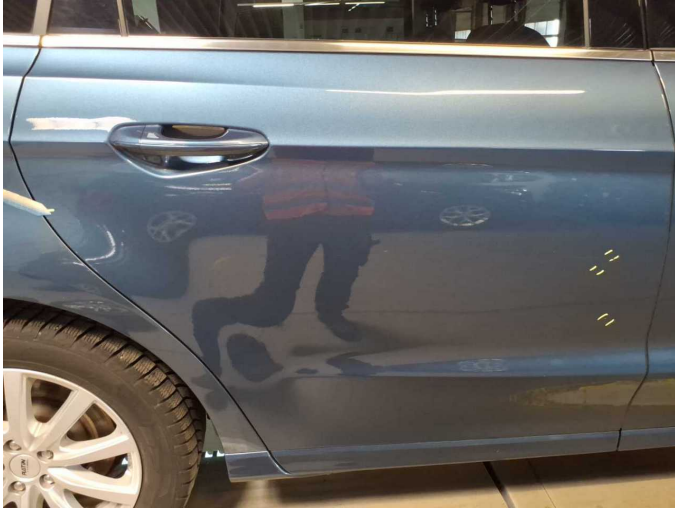
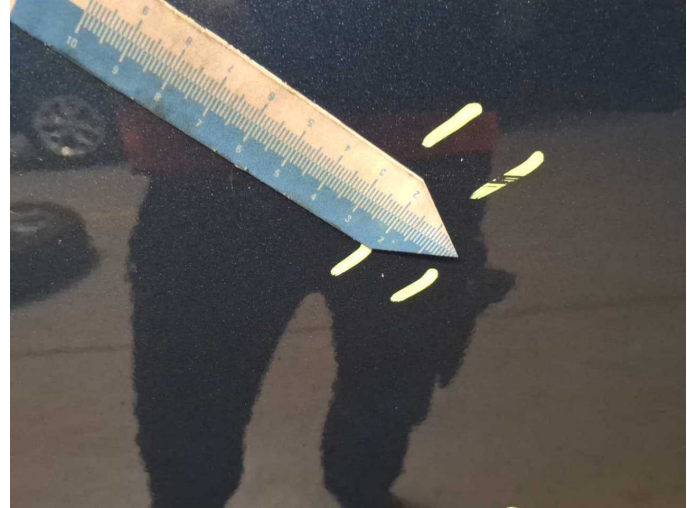
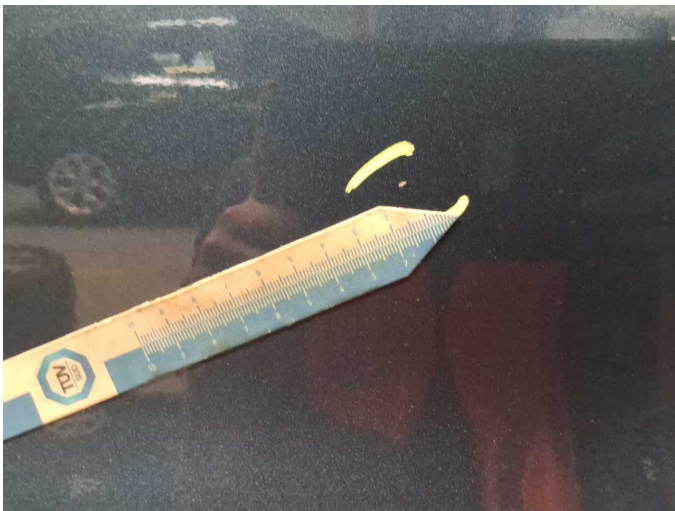
Damage 8: Door - rear right side: Door - Scratch(es) - Smart repair

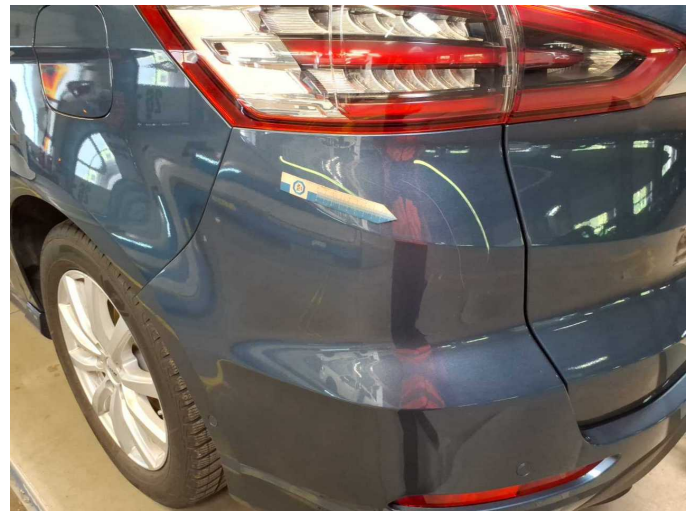
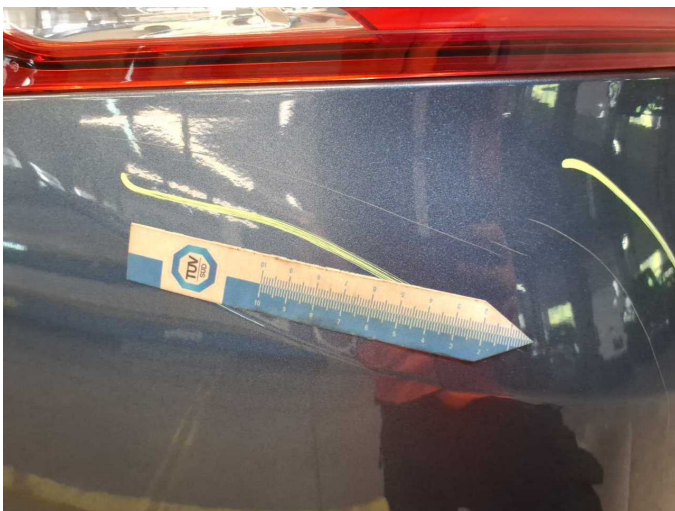
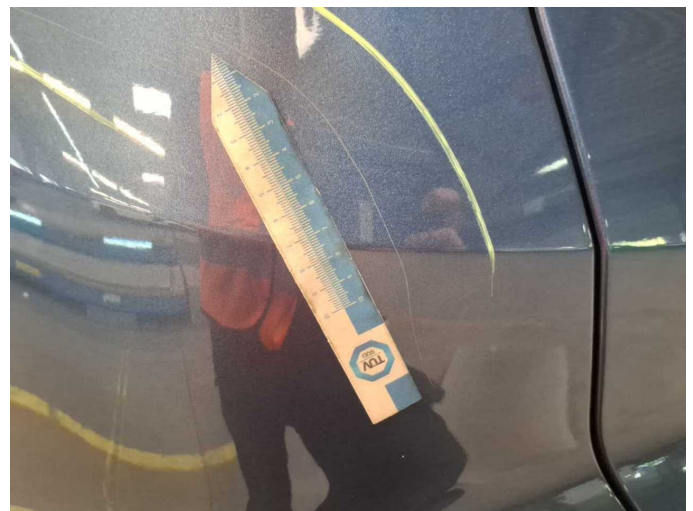
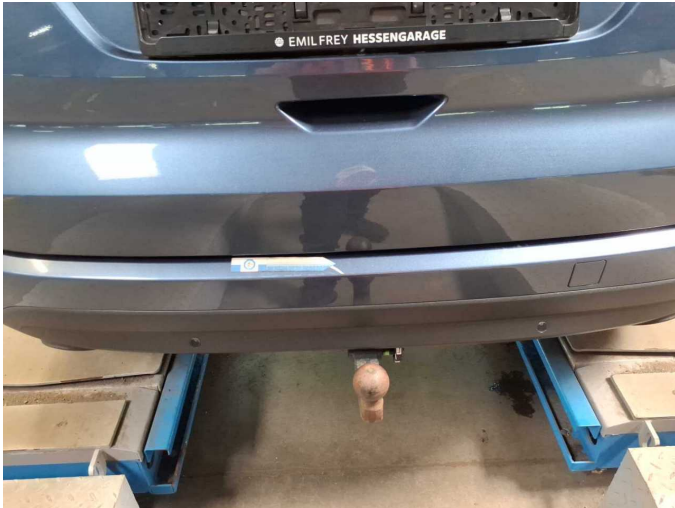
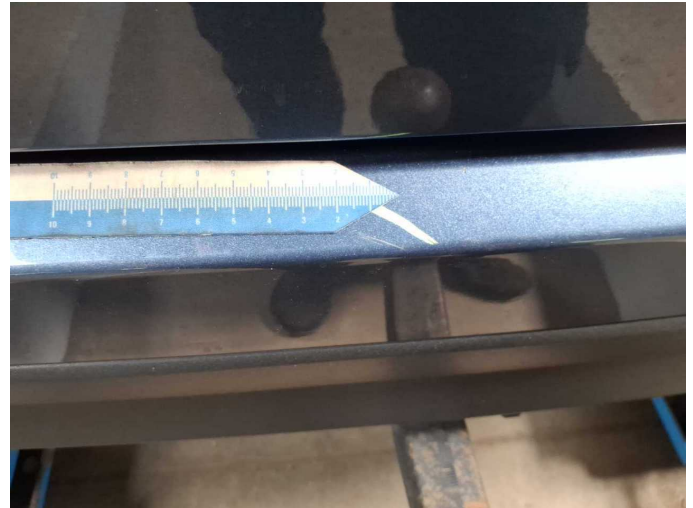
Damage 9: Rear bumper: Rear bumper - Scratch(es) - Paint

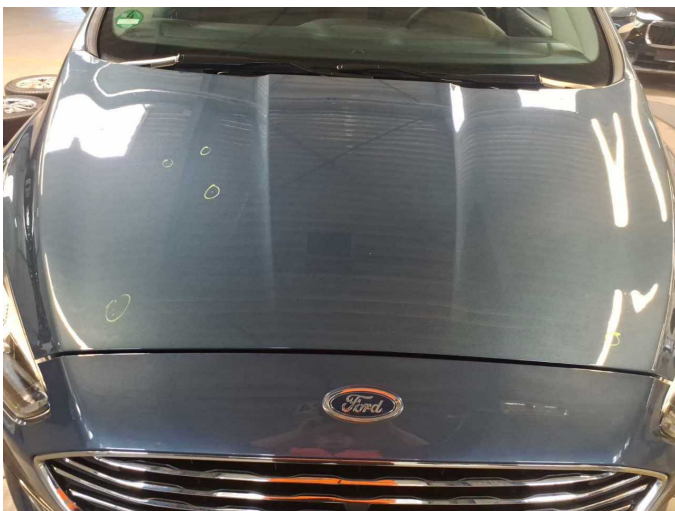
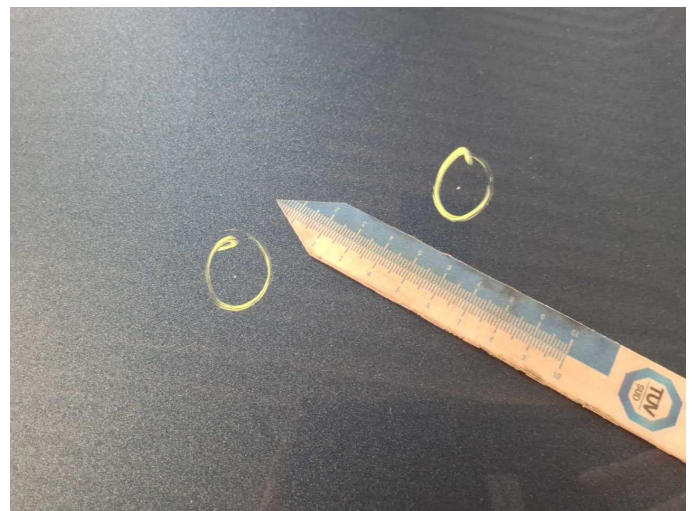
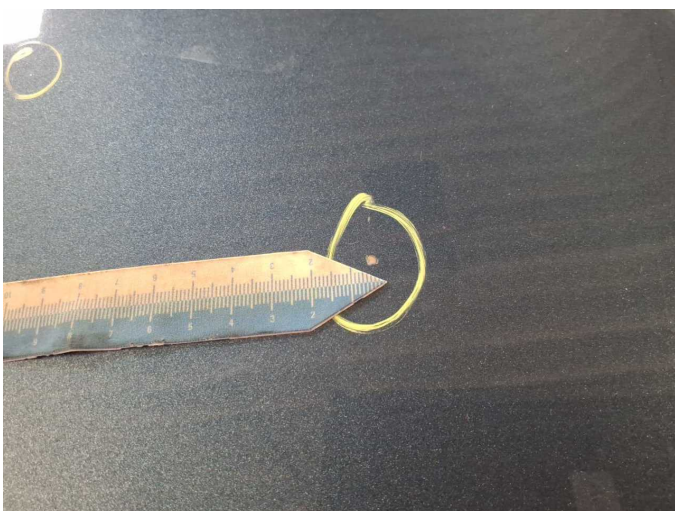
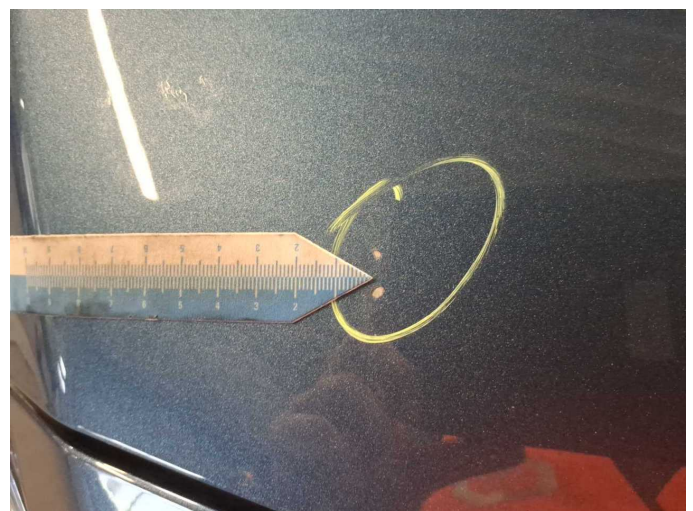
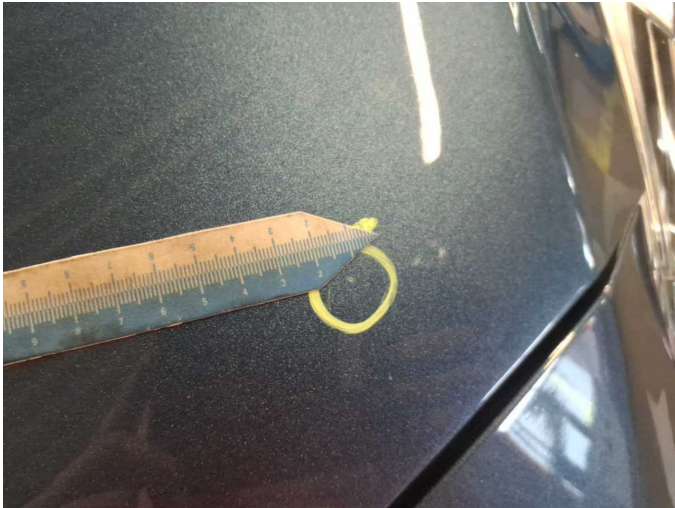
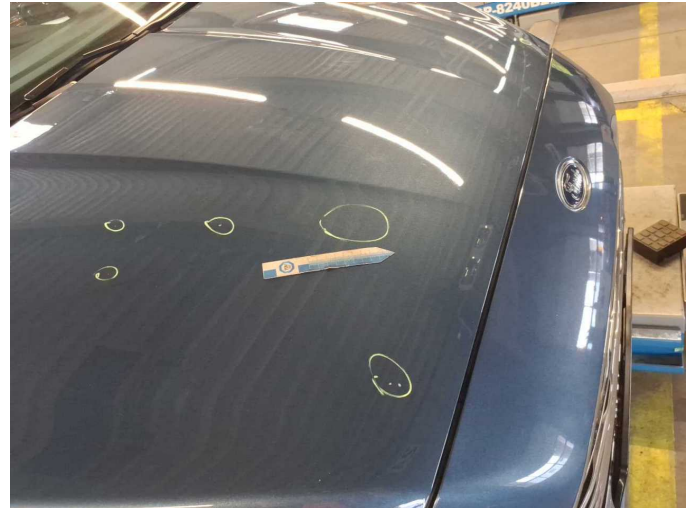
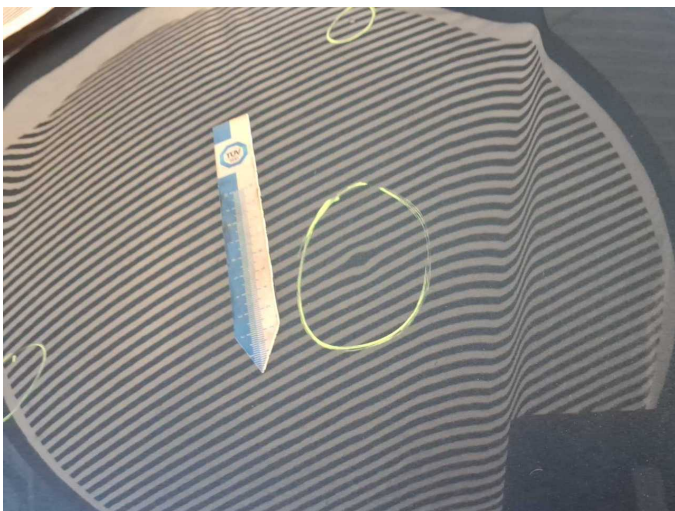
Damage 10: Bonnet: Bonnet - Dent / paintcoat damage - Repair and paint

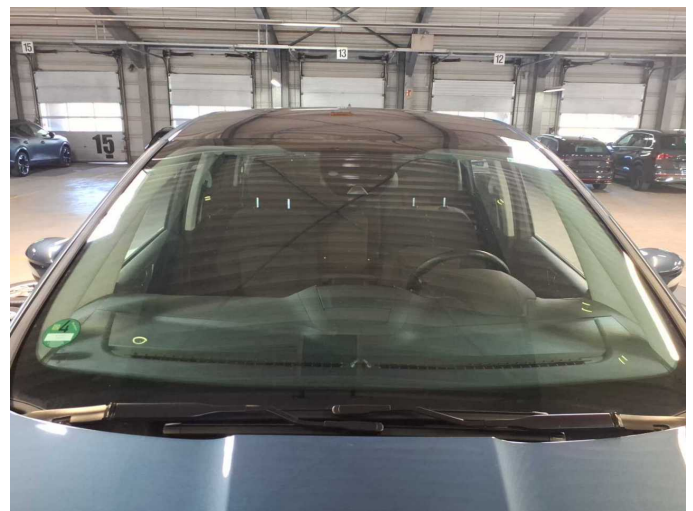
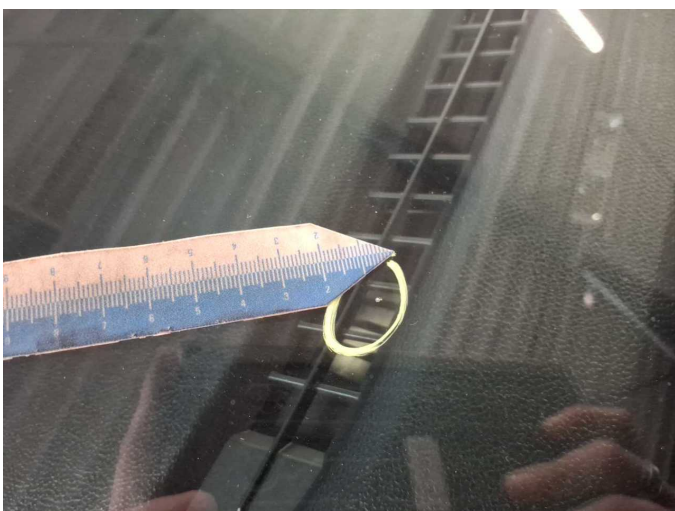
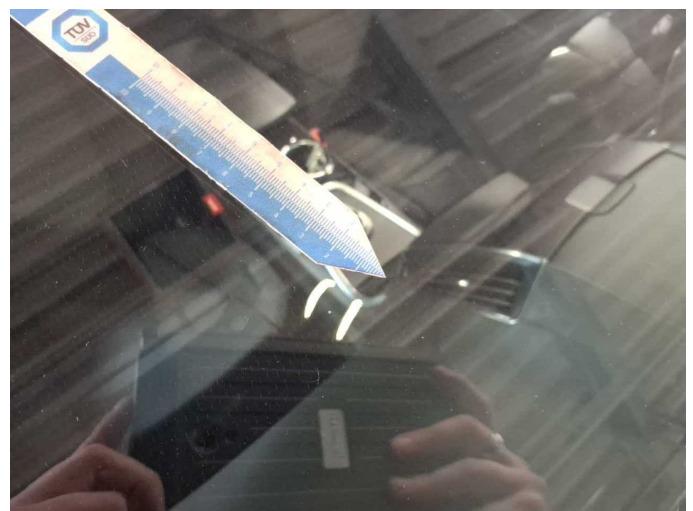
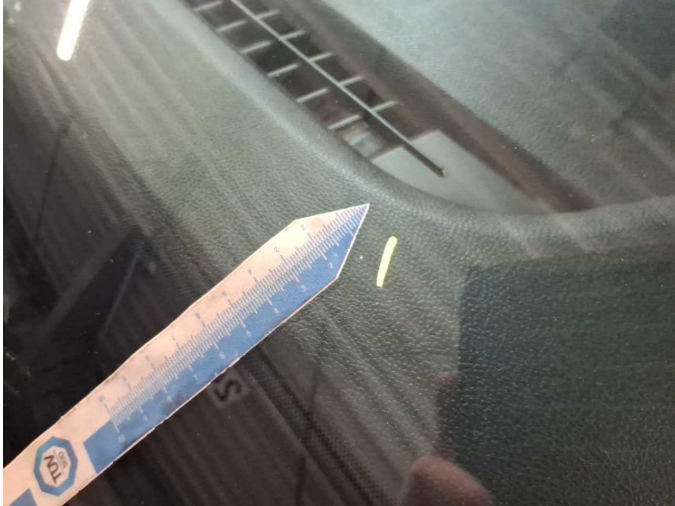
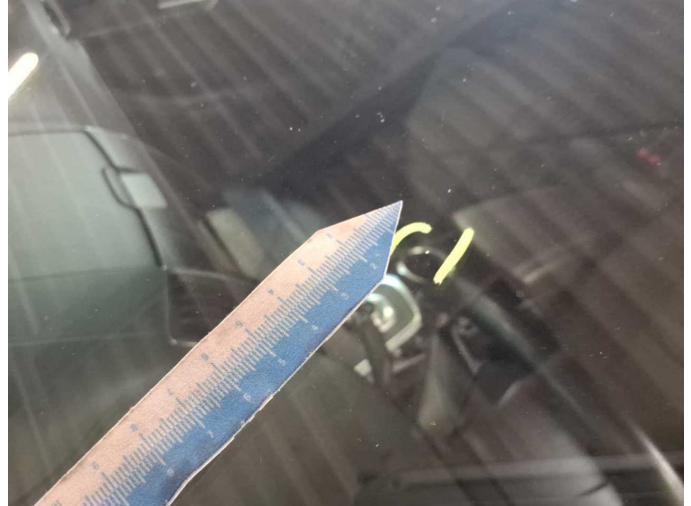
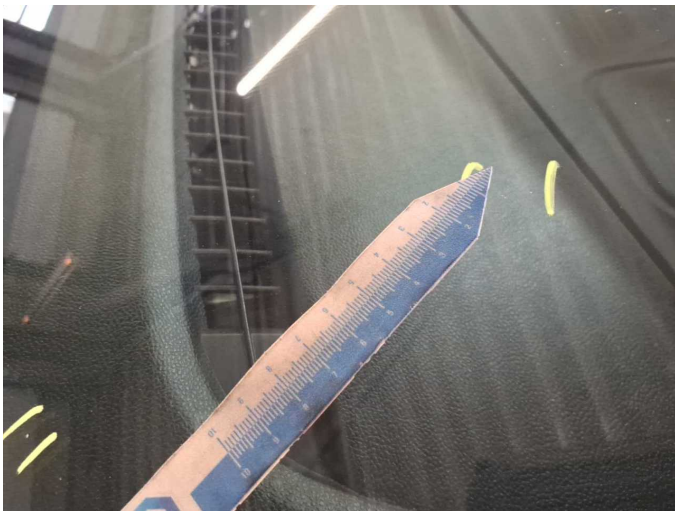
Wear and tear 1: Vehicle glazing: Windscreen - Stone chips

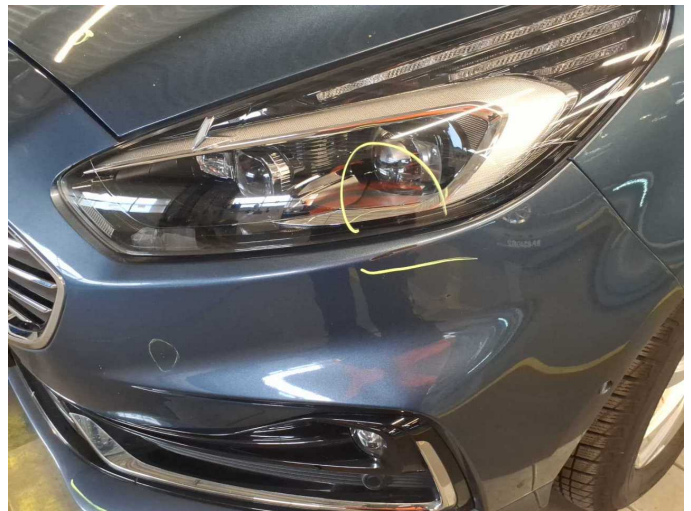
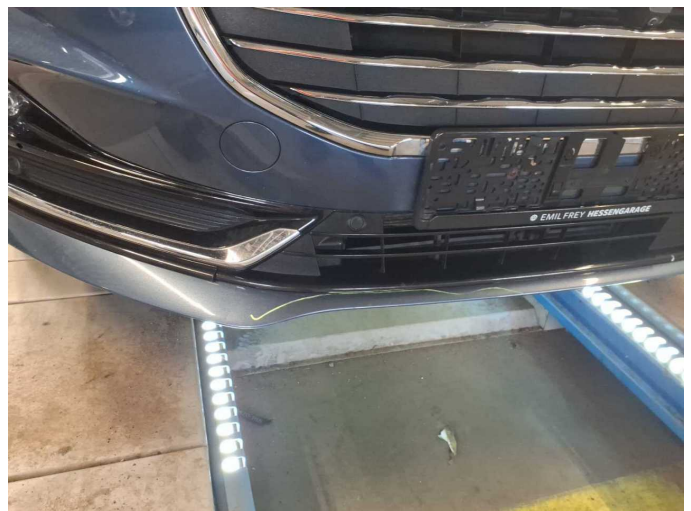
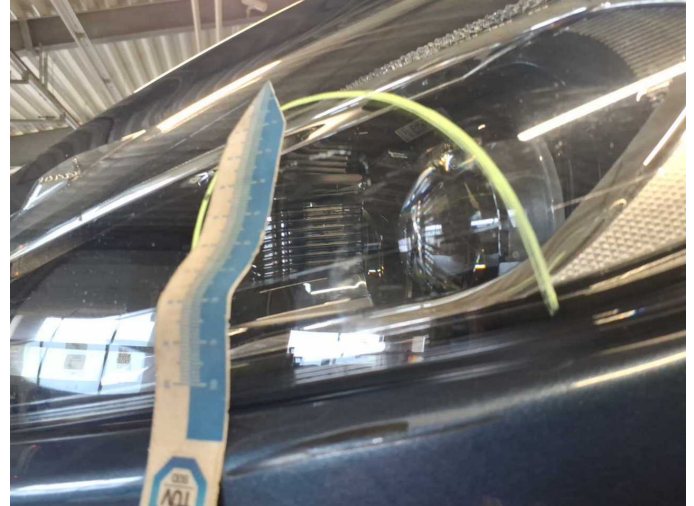
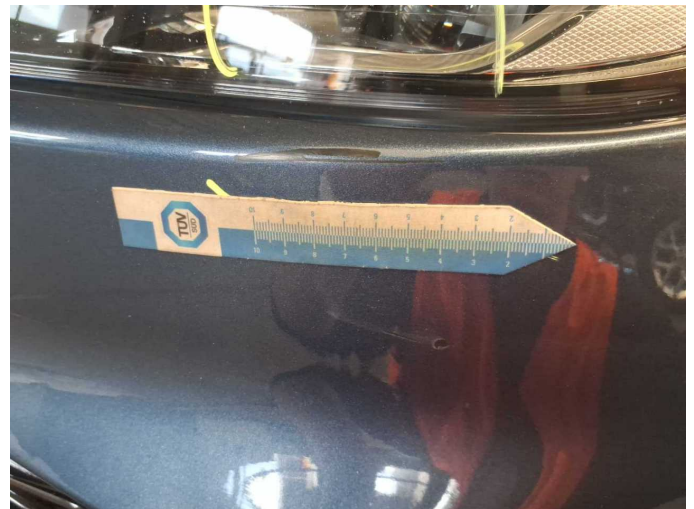
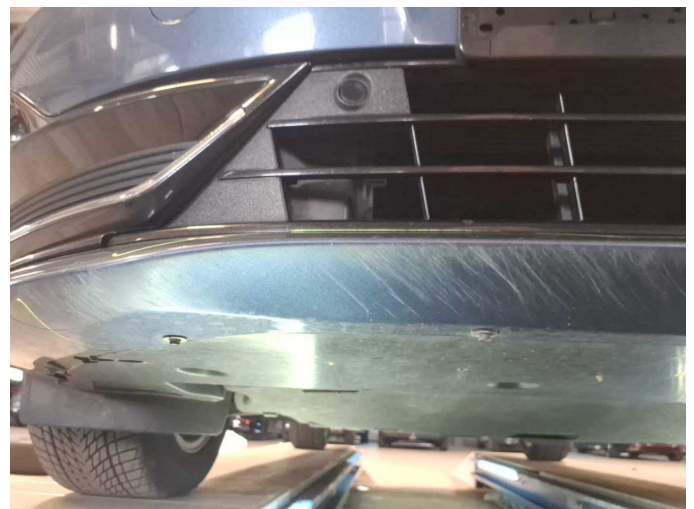
Accident 1: Front

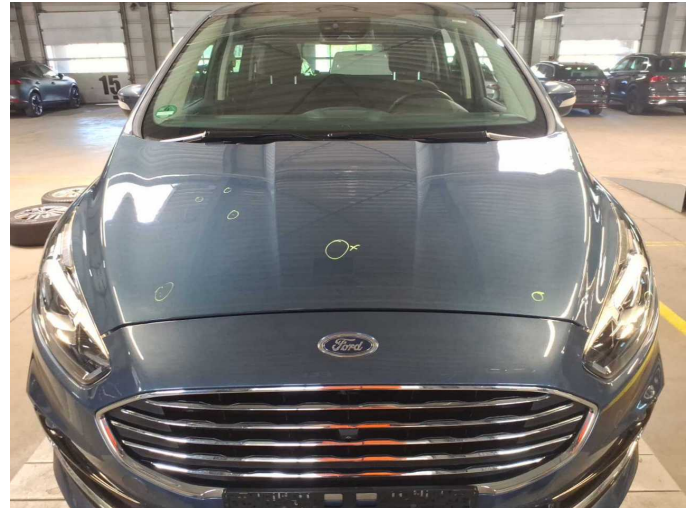
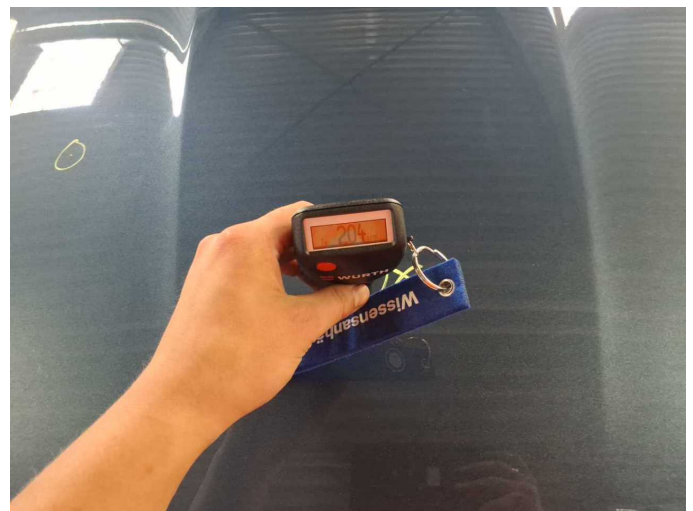
1 Bonnet, Professionally carried out, Invoice of repair done Non-existent

Bonnet 204 µm |

Repainting 1: Bonnet

Bonnet: 204 µm
