Expertise

Protocol number: 46541856  
Order No. / Reference: 26657046  
Inspection date: 15 Jul 2026

Manufacturer: Nissan

Model: Navara DC 4x4 Autm. N-Guard

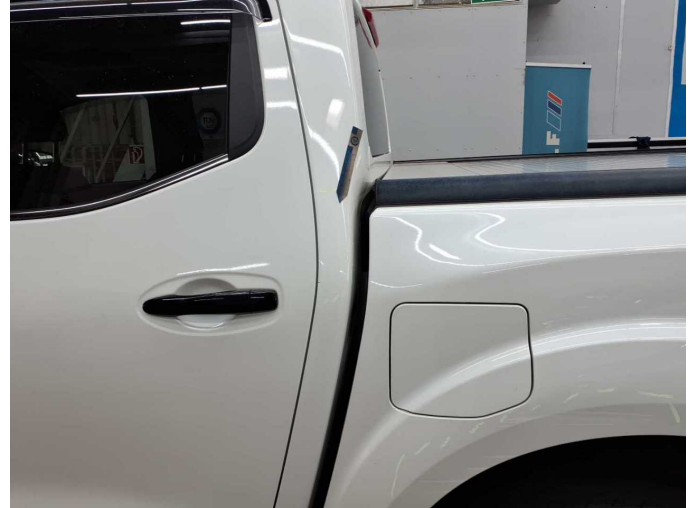
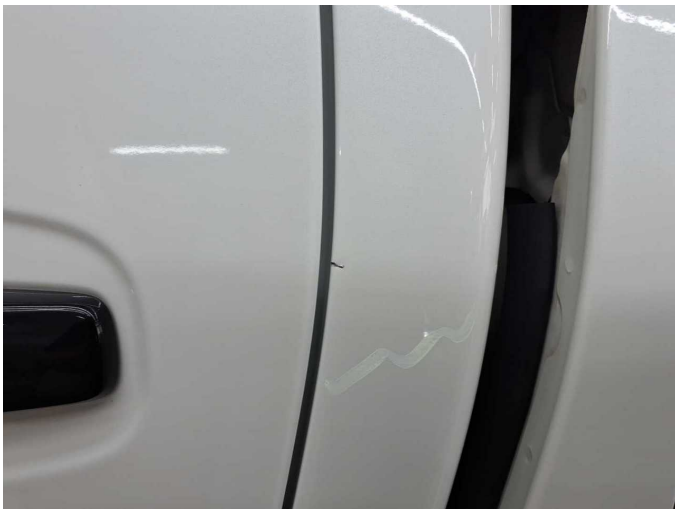
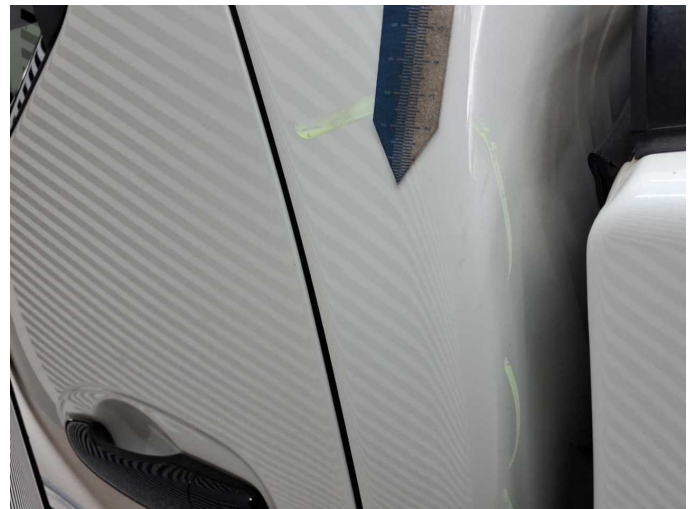
| No. | Component group | Description |
|---|---|---|
| 1 | Body | C-pillar - left side - Scratch(es) - Smart repair |

**Damage 1:** Body: C-pillar - left side - Scratch(es) - Smart repair

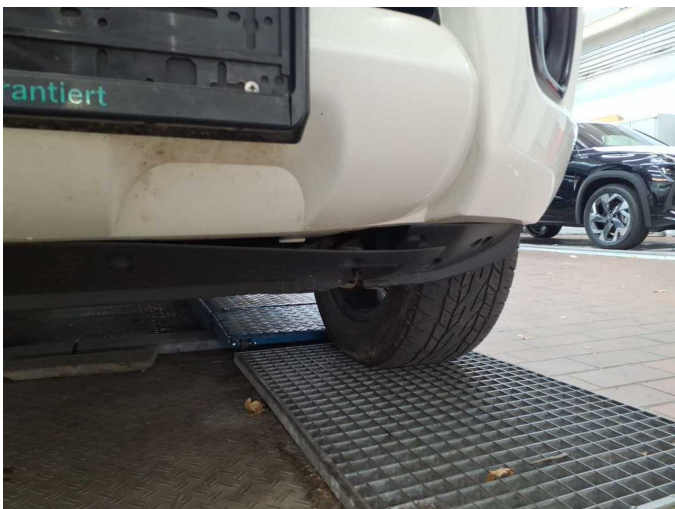
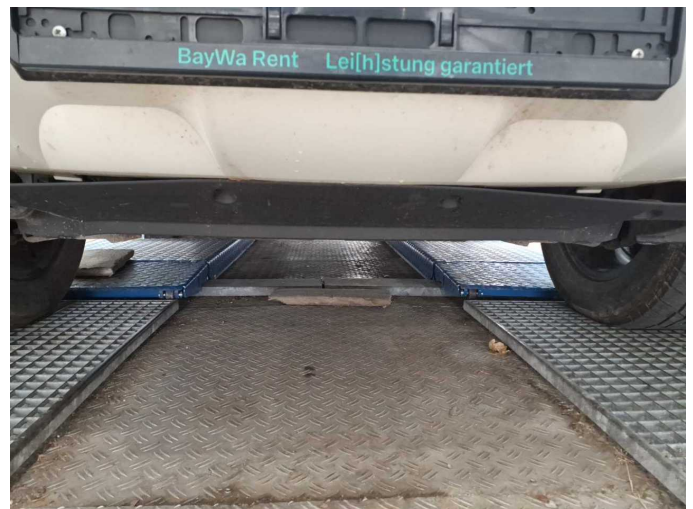
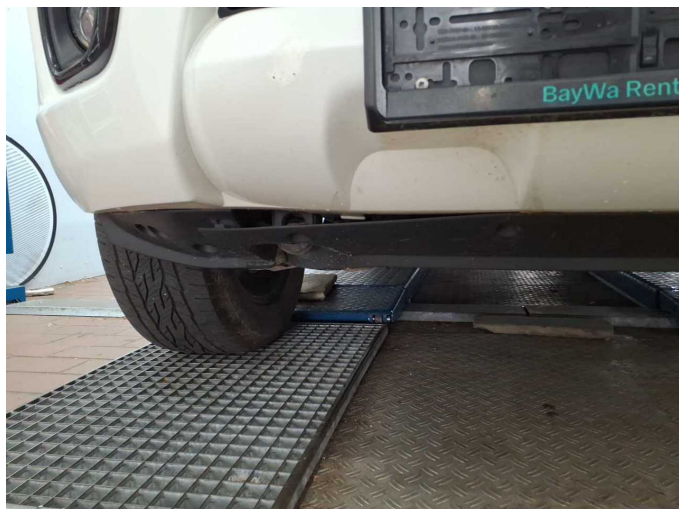
| No. | Component group | Description |
|---|---|---|
| 2 | Front bumper | Spoiler - Loose - Replace |

**Damage 2:** Front bumper: Spoiler - Loose - Replace

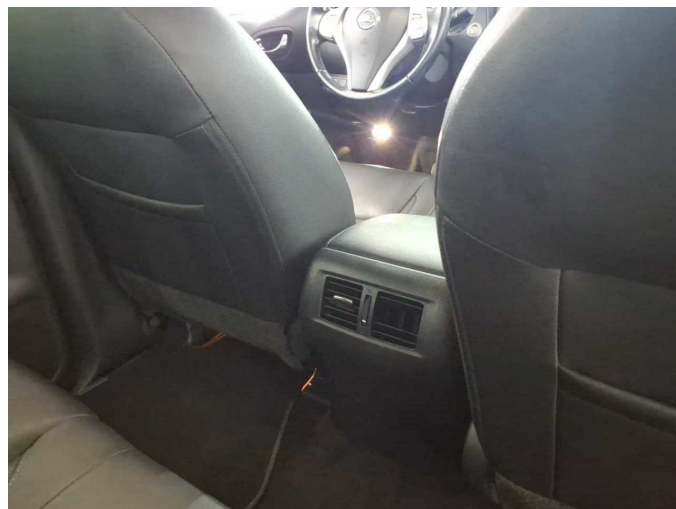
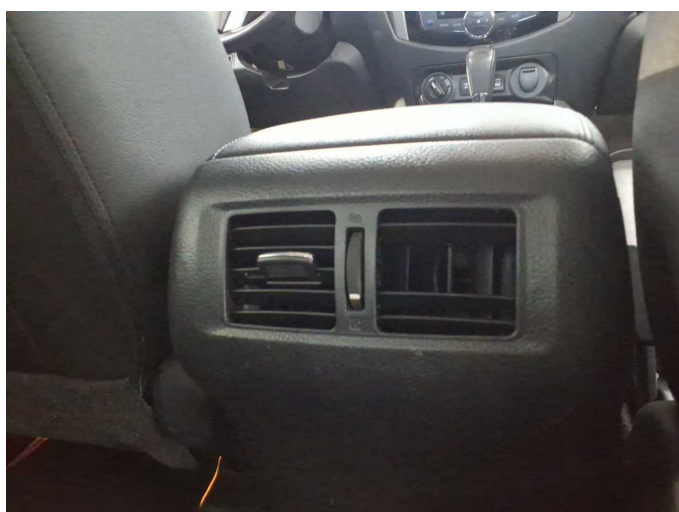
| No. | Component group | Description |
|---|---|---|
| 3 | Instrument panel | Air nozzle - centre (Hinten) - Broken / torn - Replace |

**Damage 3:** Instrument panel: Air nozzle - centre (Hinten) - Broken / torn - Replace

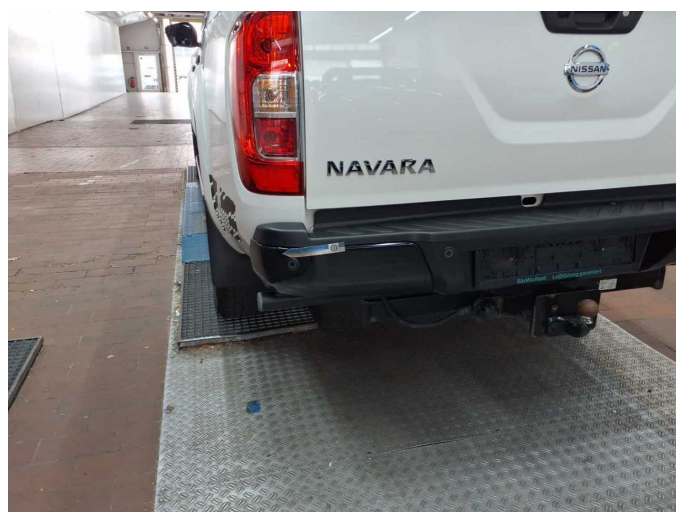
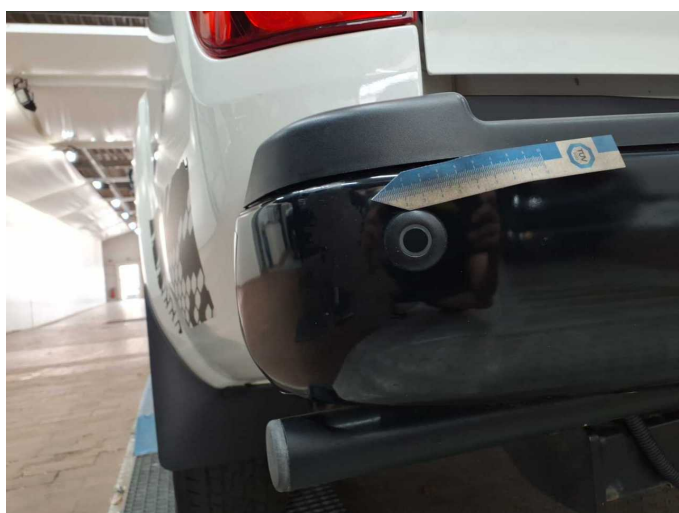
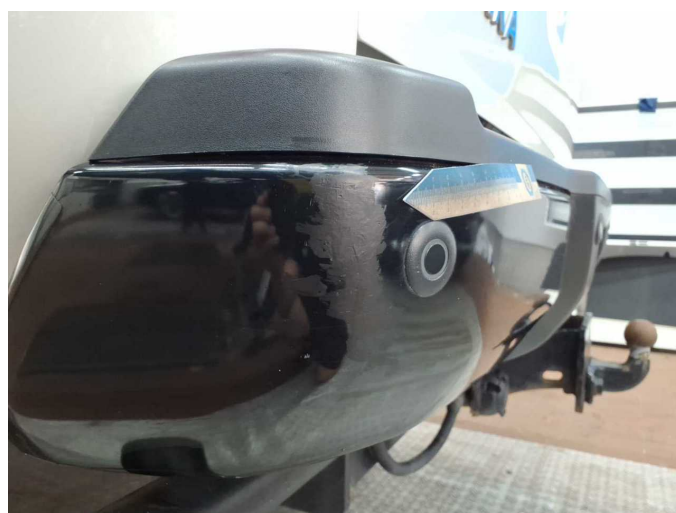
| No. | Component group | Description |
|---|---|---|
| 4 | Rear bumper | Rear bumper (Linke Blende) - Scratch(es) - Paint |

**Damage 4:** Rear bumper: Rear bumper (Linke Blende) - Scratch(es) - Paint

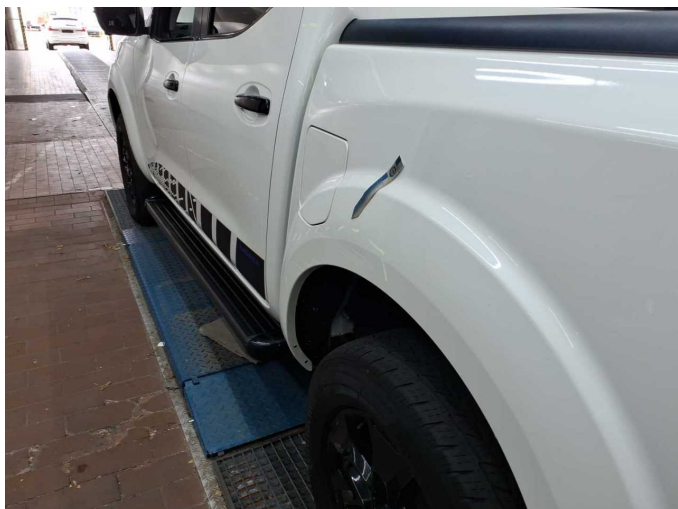
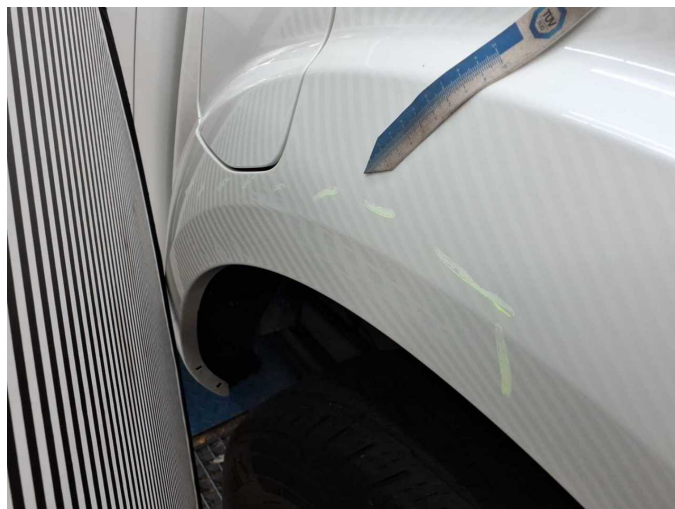
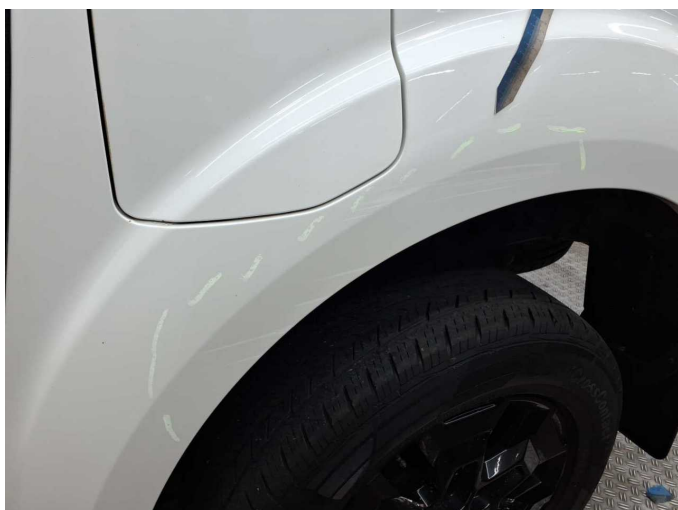
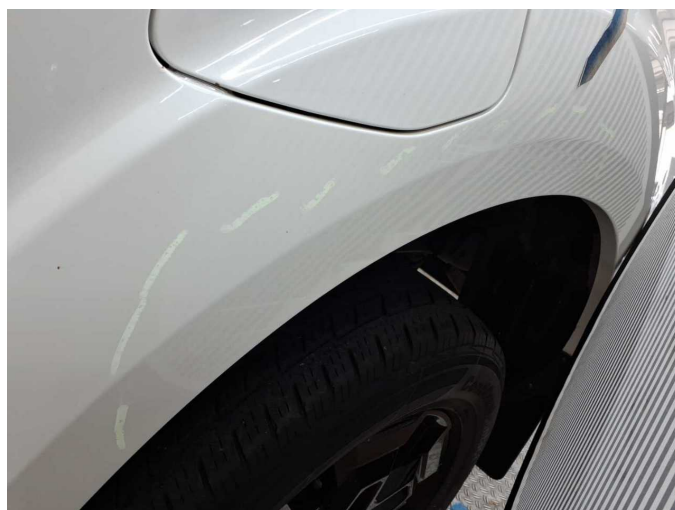
| No. | Component group | Description |
|---|---|---|
| 5 | Side panel - rear left side | Side panel - Dent / paintcoat damage - Repair and paint |

**Damage 5:** Side panel - rear left side: Side panel - Dent / paintcoat damage - Repair and paint

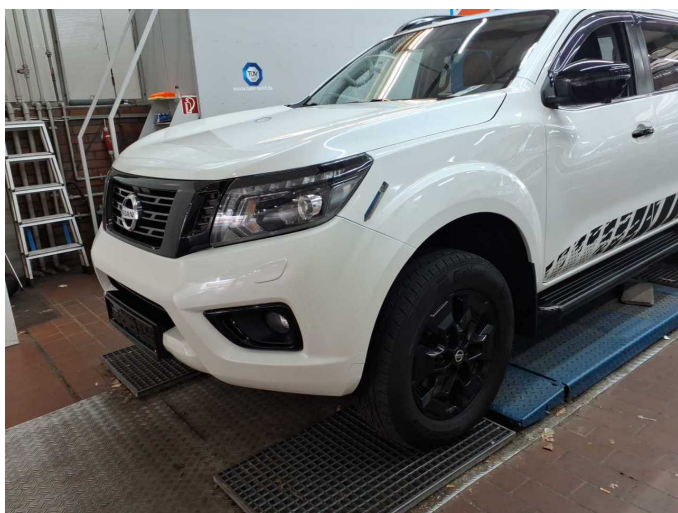
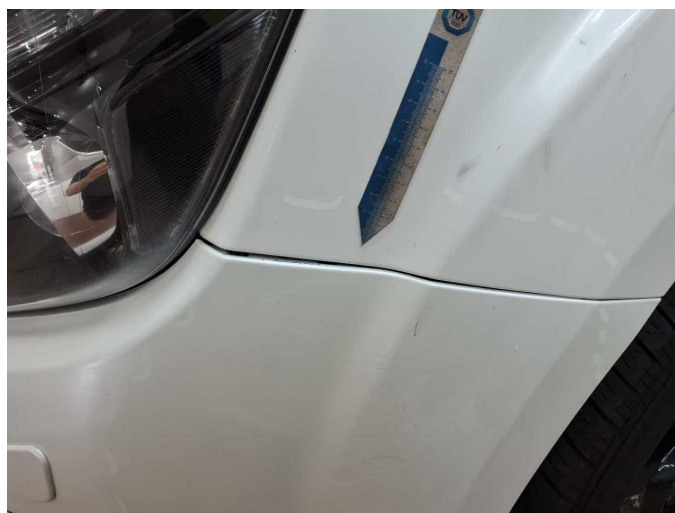
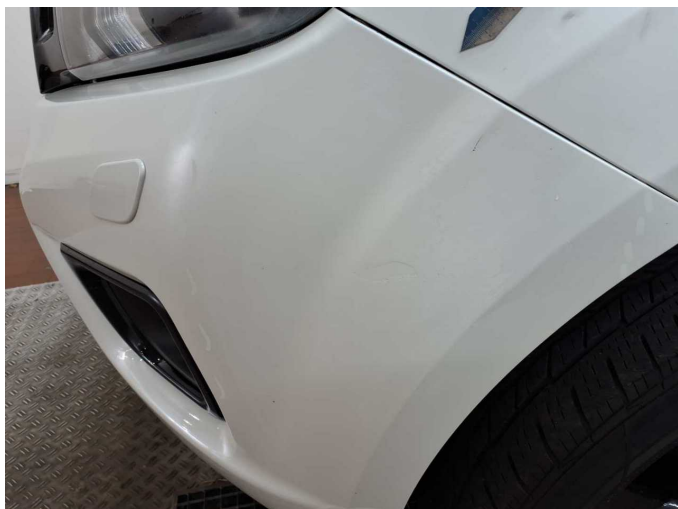
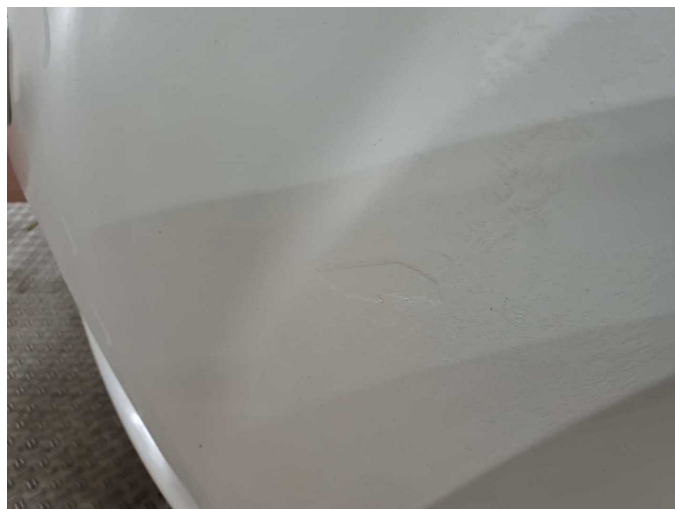
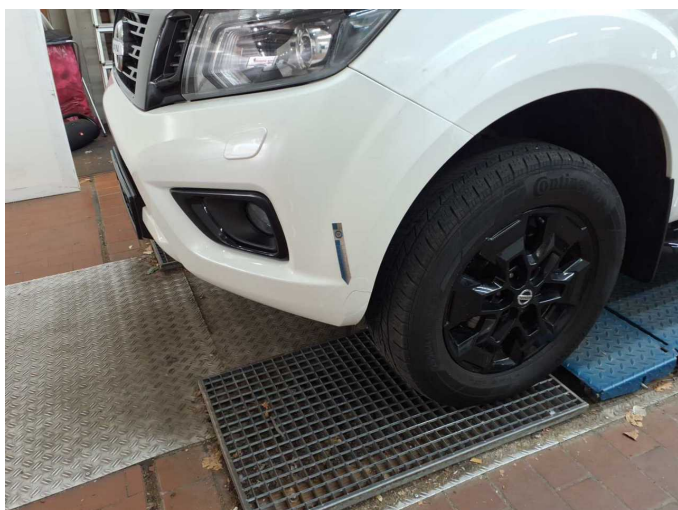
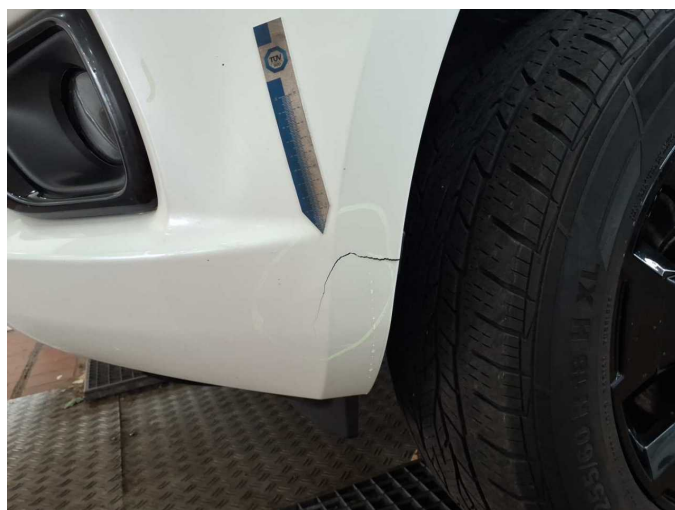
| No. | Component group | Description |
|---|---|---|
| 6 | Front bumper | Front bumper (gerissen, schlecht lackiert, Fehlstellung) - Unprofessionally repaired - Replace |

- Das Fahrzeug befand sich zum Besichtigungszeitpunkt in nicht fachgerecht reparierten Zustand. Schadenausweitung möglich, Zusatzkosten können entstehen.

**Damage 6:** Front bumper: Front bumper (gerissen, schlecht lackiert, Fehlstellung) - Unprofessionally repaired - Replace

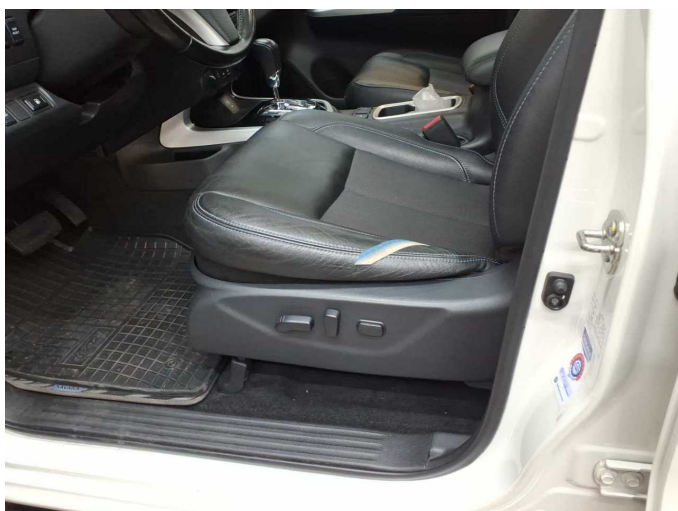
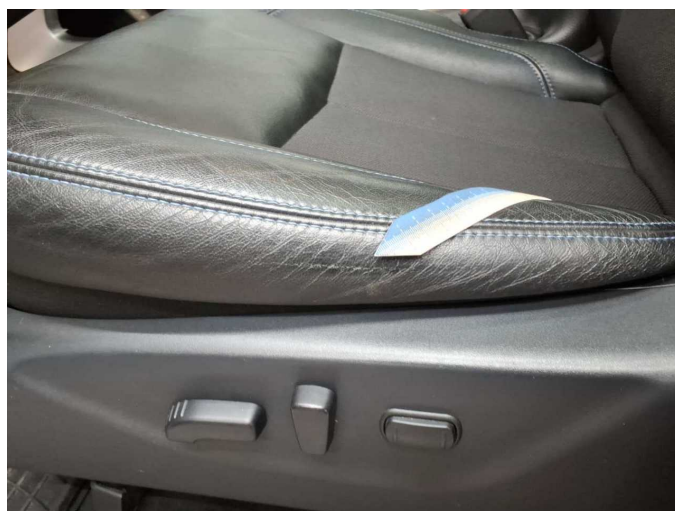
| No. | Component group | Description |
|---|---|---|
| 7 | Seat - front | Seat cover - left side - Abrasion - No deduction |

**Wear and tear 7:** Seat - front: Seat cover - left side - Abrasion - No deduction

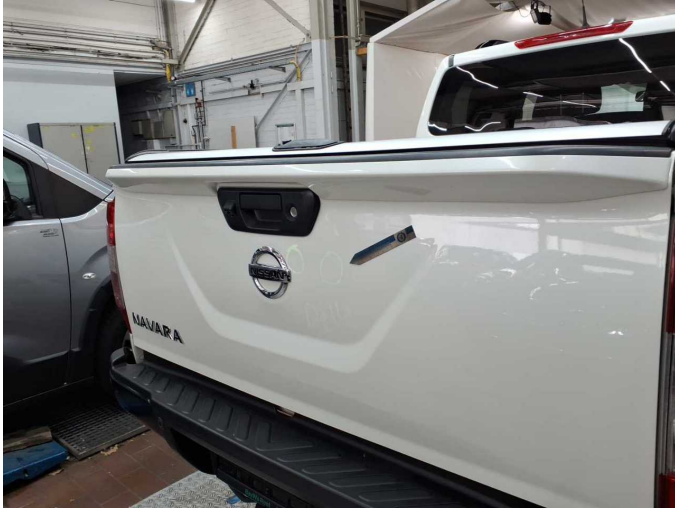
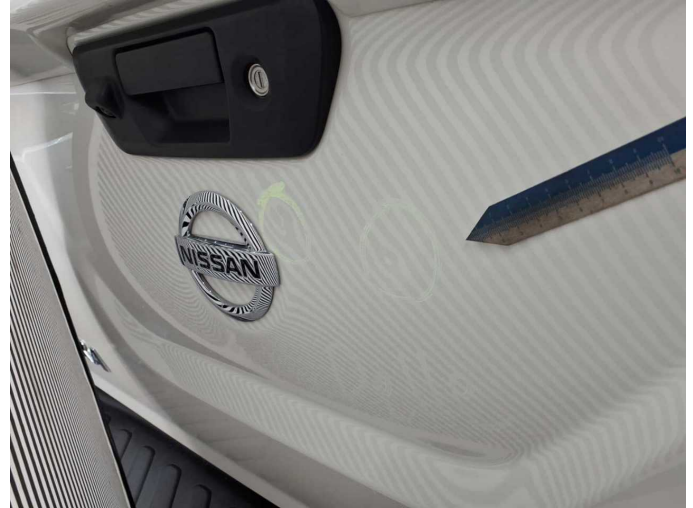
| No. | Component group | Description |
|---|---|---|
| 8 | Boot lid / rear door | Boot lid - Dent / paintcoat damage - No deduction |

**Wear and tear 8:** Boot lid / rear door: Boot lid - Dent / paintcoat damage -  
No deduction
