Expertise

Protocol number: 46627993  
Order No. / Reference: 26611919  
Inspection date: 1 Jul 2026

Manufacturer: Opel

Model: Insignia Sports Tourer 2.0 Diesel Aut. Business

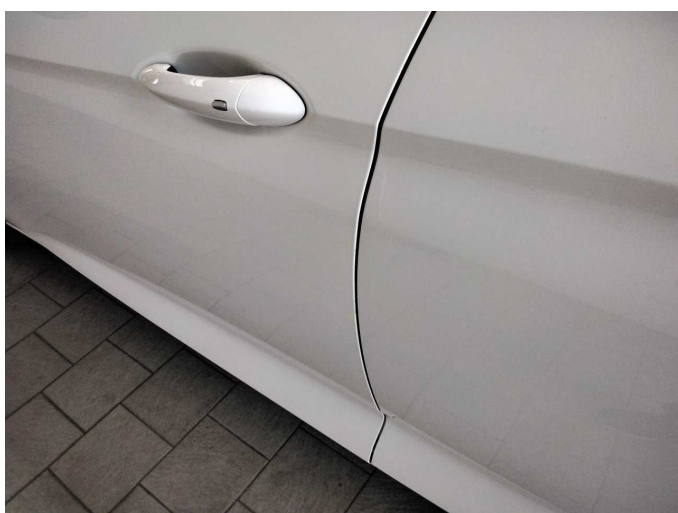
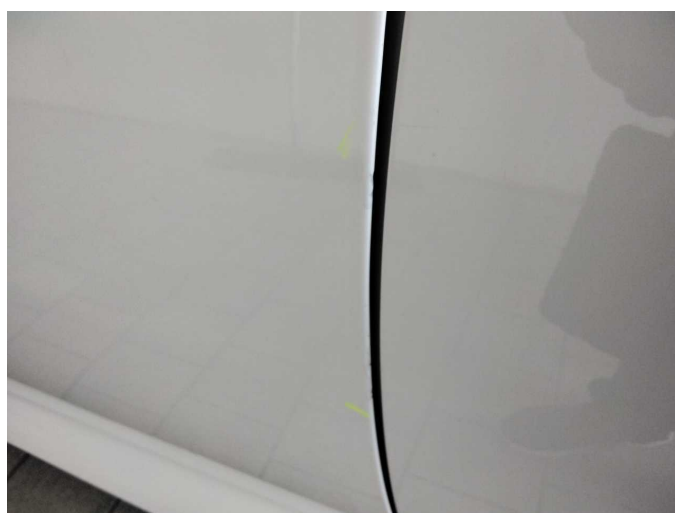
| No. | Component group | Description |
|---|---|---|
| 1 | Door - front left side | Door edge - Scratch(es) - Smart repair |

Damage 1: Door - front left side: Door edge - Scratch(es) - Smart repair

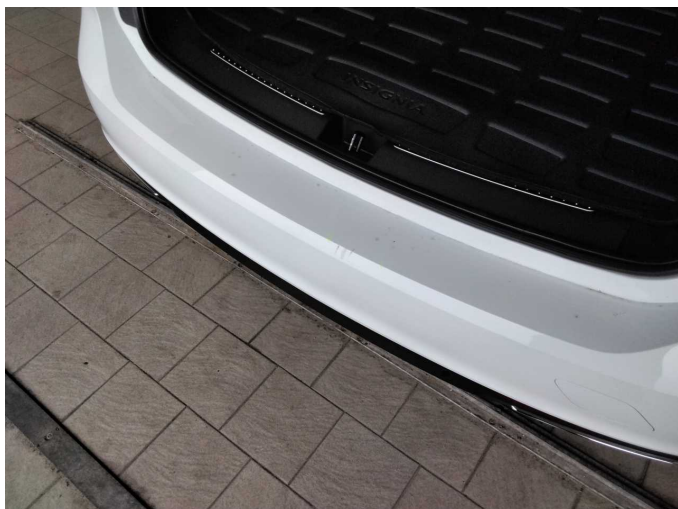
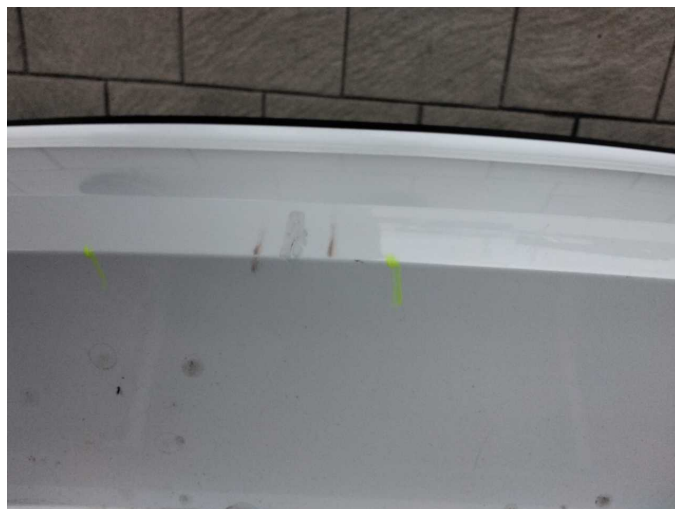
| No. | Component group | Description |
|---|---|---|
| 2 | Rear bumper | Rear bumper - Scratch(es) - Smart repair |

**Damage 2:** Rear bumper: Rear bumper - Scratch(es) - Smart repair

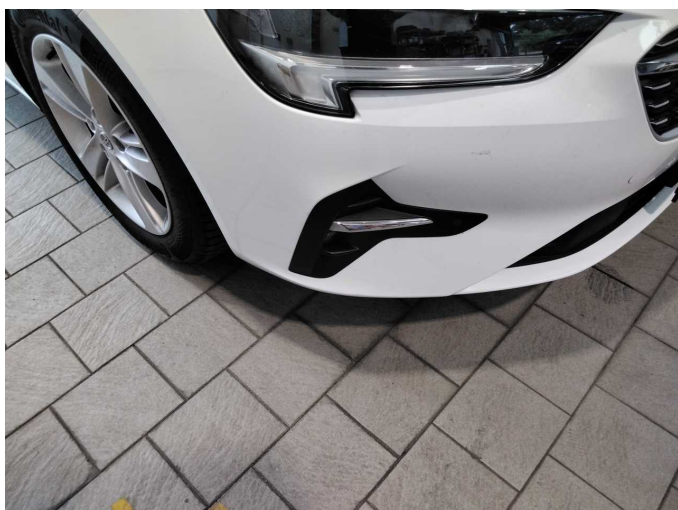
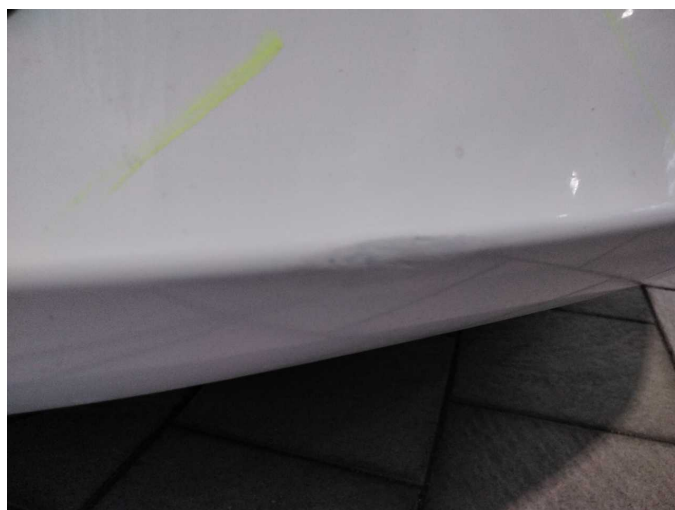
| No. | Component group | Description |
|---|---|---|
| 3 | Front bumper | Front bumper - Scratch(es) - Smart repair |

**Damage 3:** Front bumper: Front bumper - Scratch(es) - Smart repair

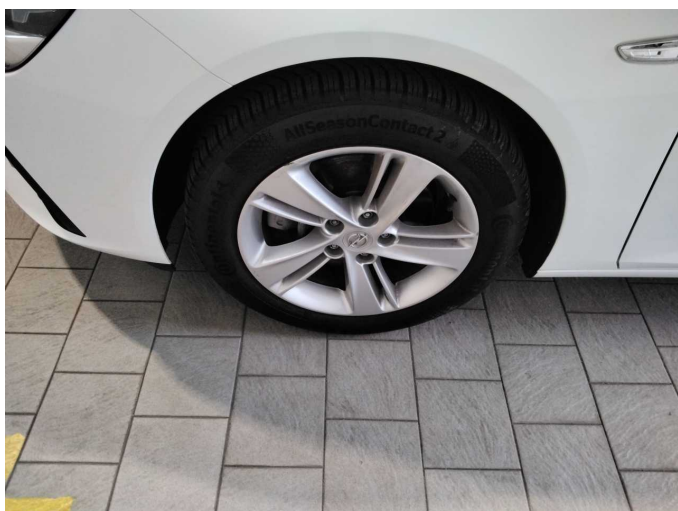
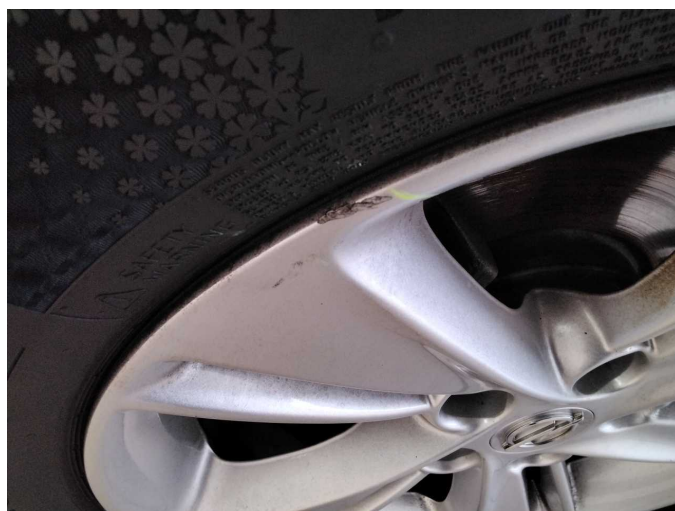
| No. | Component group | Description |
|---|---|---|
| 4 | Wheel / tyres | Alloy rim - front left side - Scratch(es) - Loss in value |

**Damage 4:** Wheel / tyres: Alloy rim - front left side - Scratch(es) - Loss in value

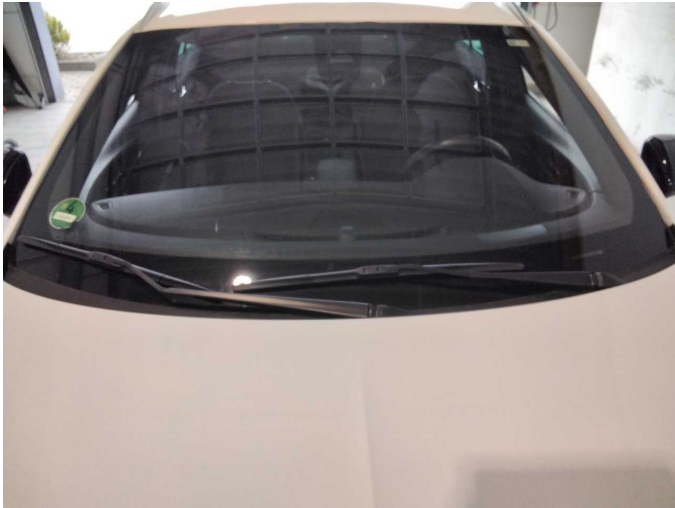
| No. | Component group | Description |
|---|---|---|
| 1 | Vehicle glazing | Windscreen - Stone chips - No deduction |

**Wear and tear 1:** Vehicle glazing: Windscreen - Stone chips - No deduction

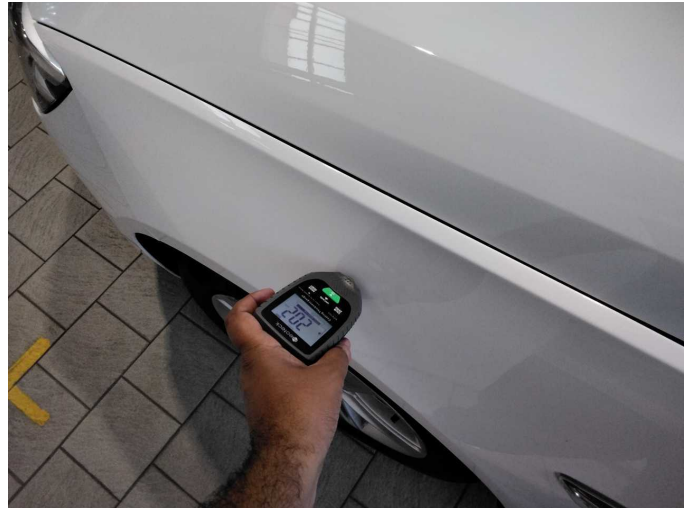
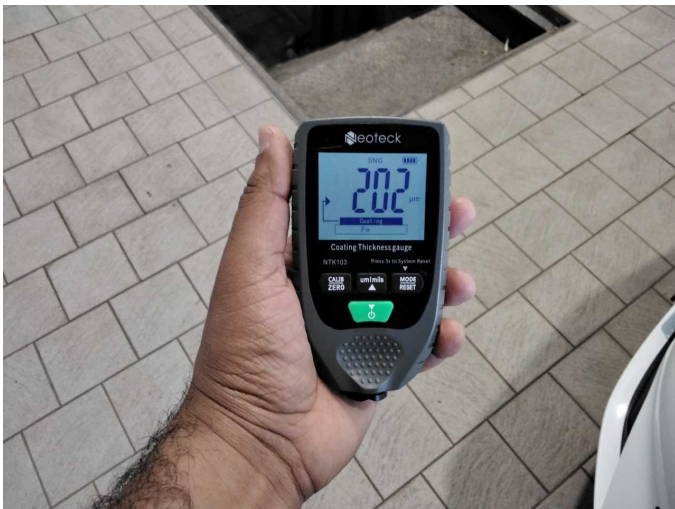
**Mudguard - left side:** 202 µm

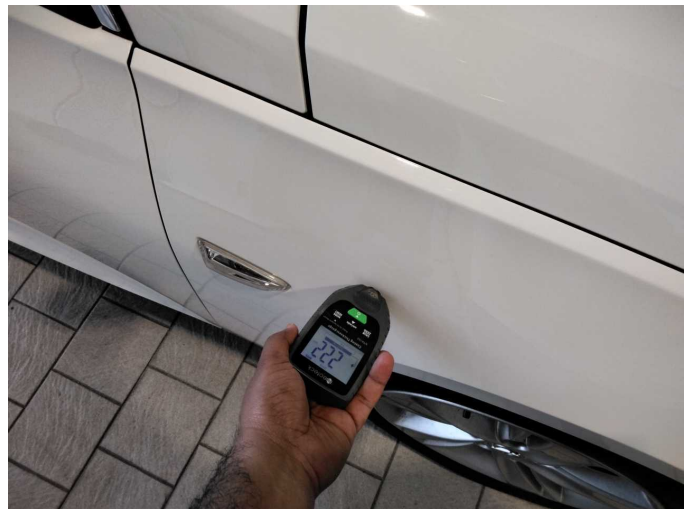
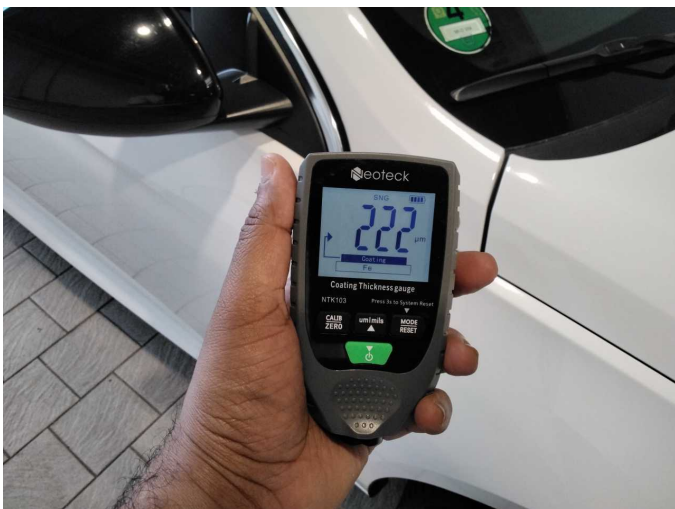
| No. | Repainting |
|---|---|
| 1 | Mudguard - right side, Door - rear left side, Door - rear right side, Door - front left side, Professionally carried out |

**Mudguard - right side:** 222 µm

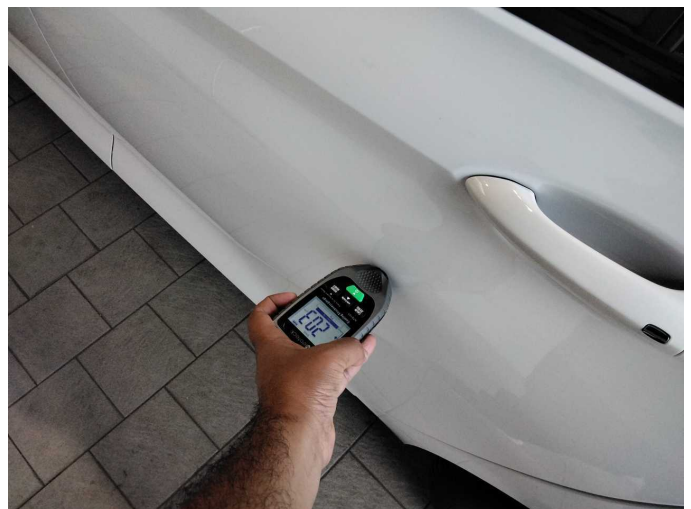
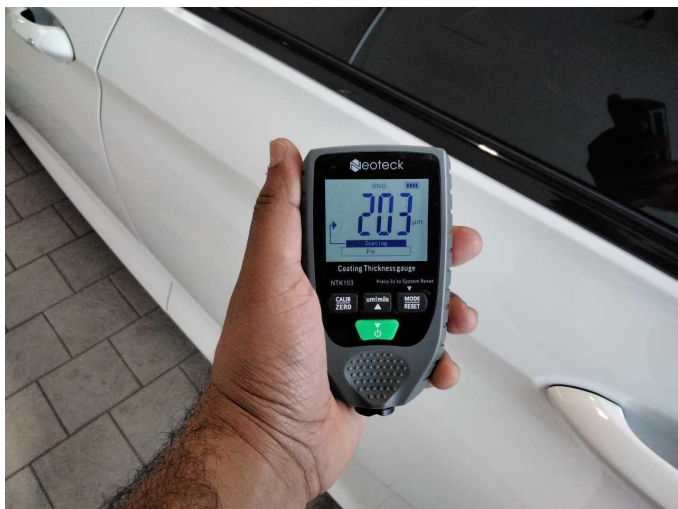
**Door - rear left side:** 203 µm

Door - rear left side: 203 µm

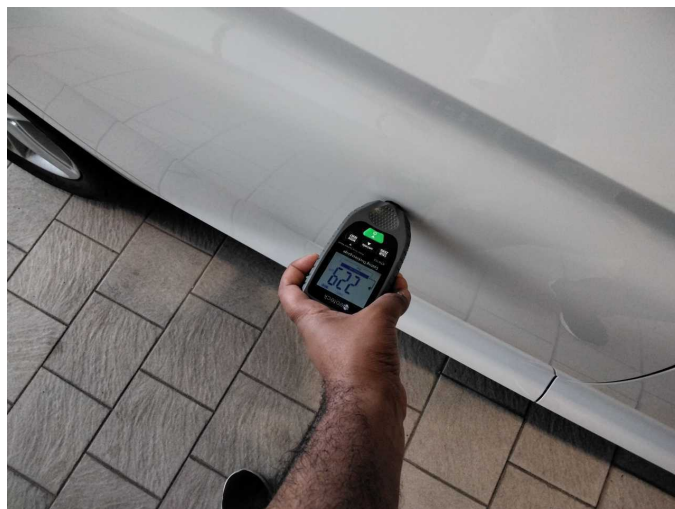
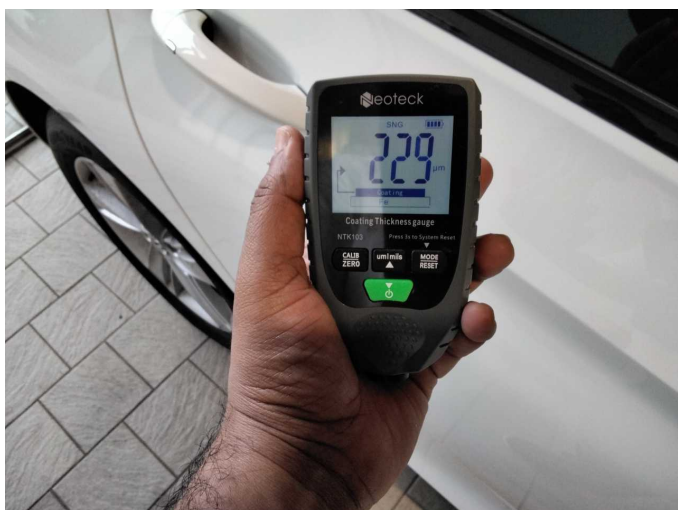
Door - rear right side: 229 µm

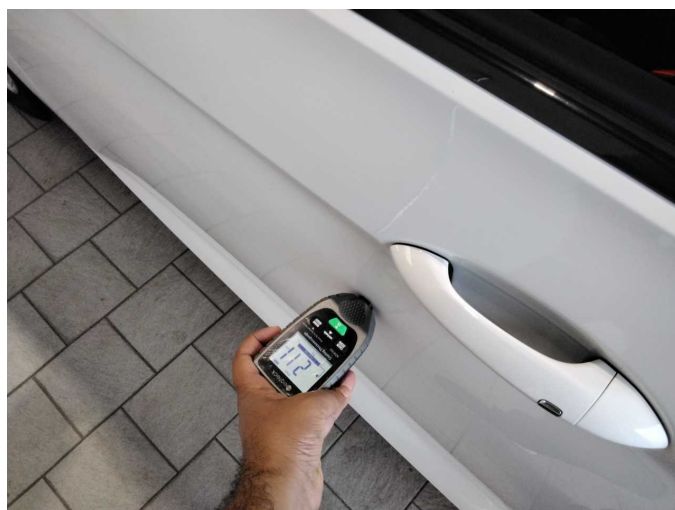
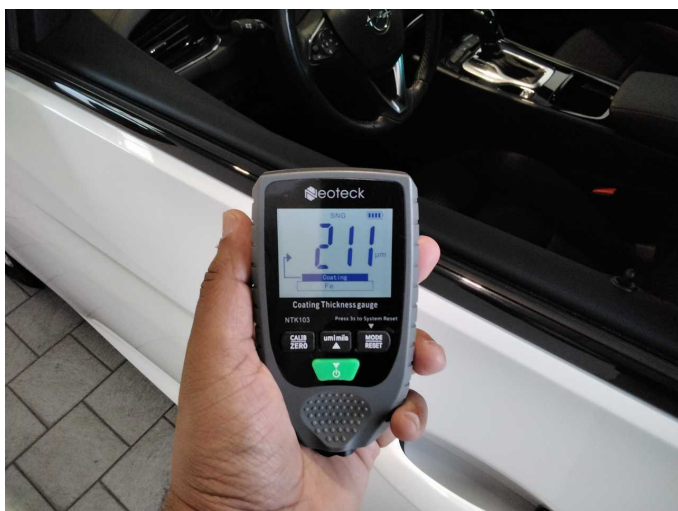
Door - front left side: 211 µm

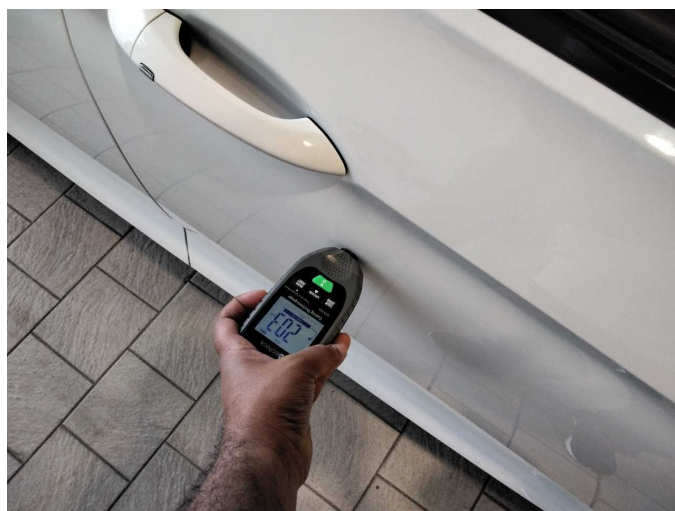
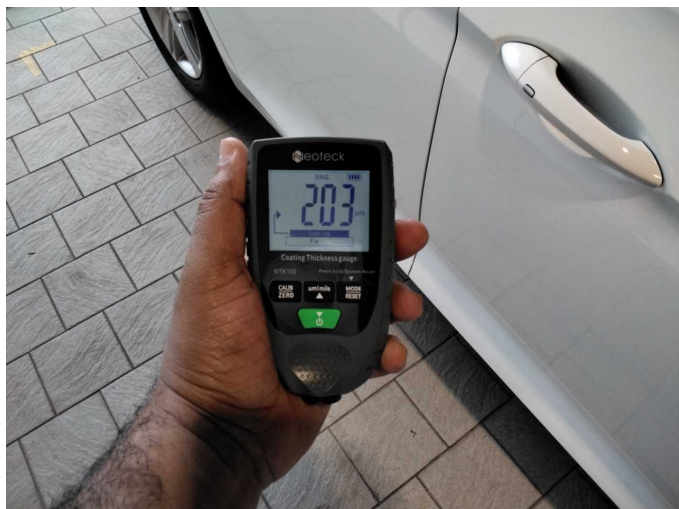
Door - front right side: 203 µm
