Expertise

Protocol number: 46232083
Order No. / Reference: 26153815
Inspection date: 15 Jun 2026

Model: Vito 116 CDI Tourer Extralang Aut. PRO

VIN: W1VVLGFZ4T4545880

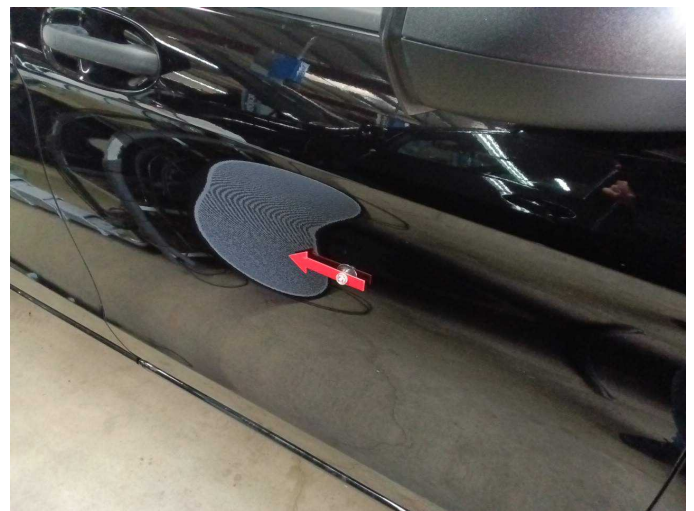
Damage 1: Door - front right side: Door - dent(s) - Smooth repair work

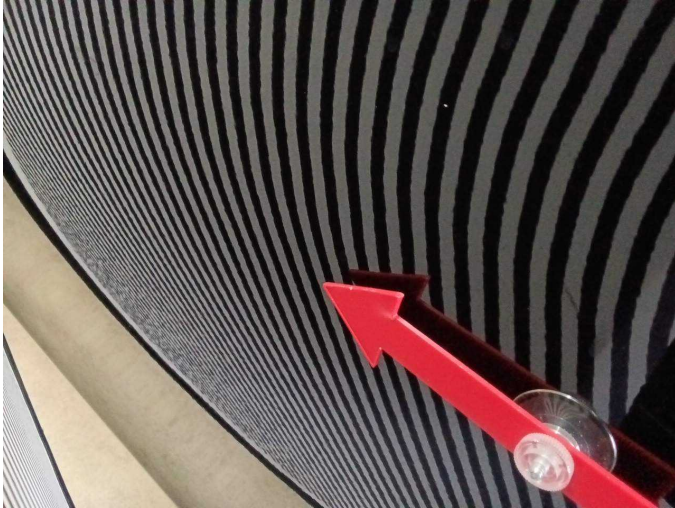
Damage 1: Door - front right side: Door - dent(s) - Smooth repair work

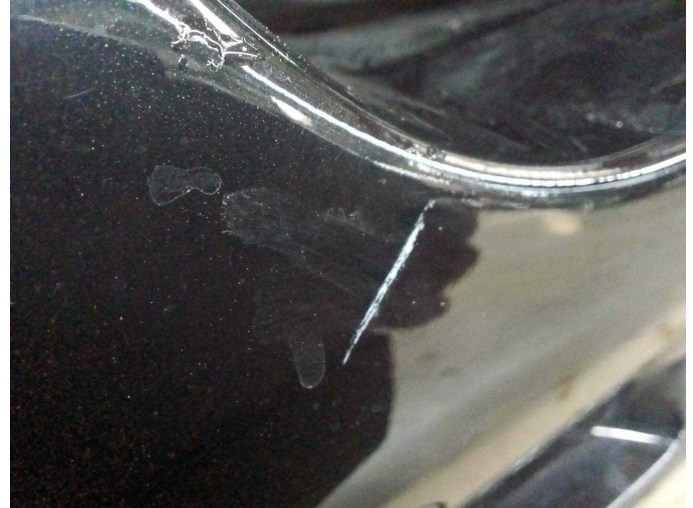
Damage 2: Rear bumper: Rear bumper - Scratch(es) - Smart repair

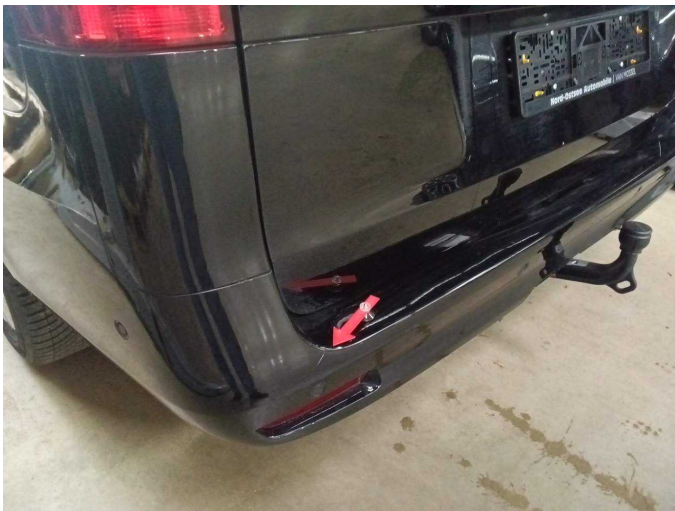
Damage 2: Rear bumper: Rear bumper - Scratch(es) - Smart repair

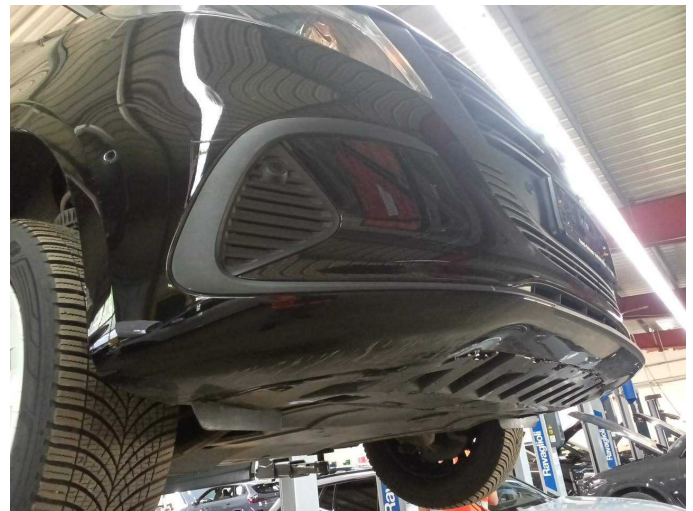
Damage 3: Front bumper: Front bumper - Scratched - Paint

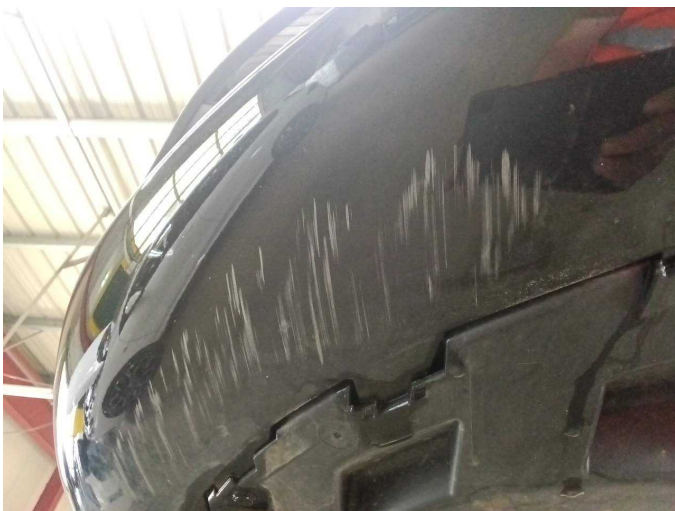
Damage 3: Front bumper: Front bumper - Scratched - Paint

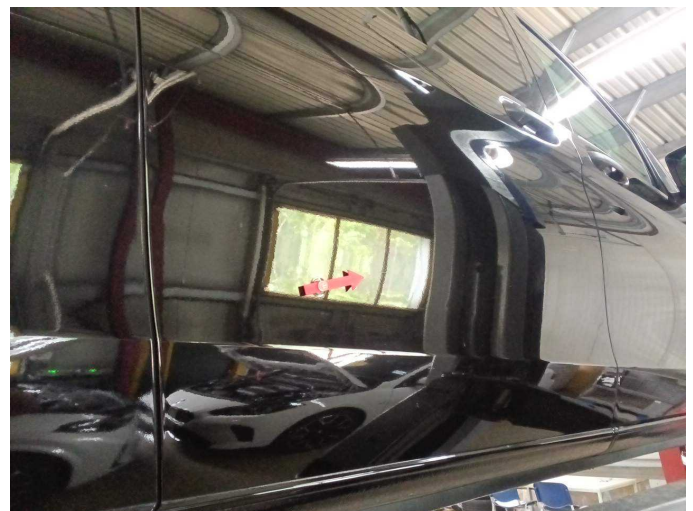
Damage 4: Sliding door, right: Sliding door - Scratch(es) - Paint

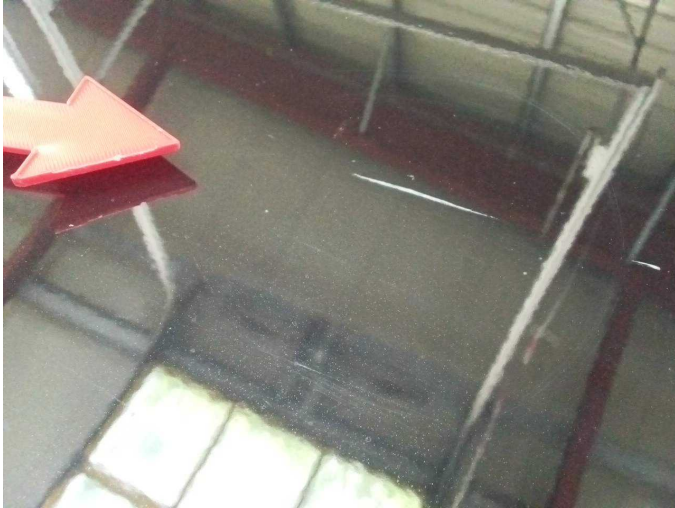
Damage 4: Sliding door, right: Sliding door - Scratch(es) - Paint

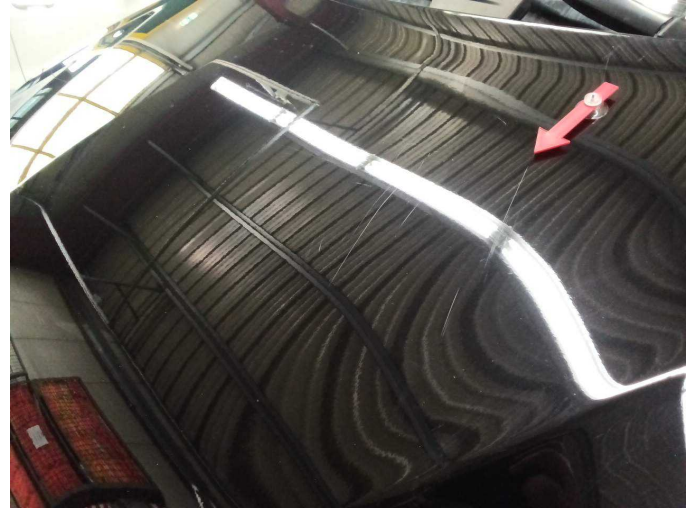
Damage 5: Bonnet: Bonnet - Scratch(es) - Paint

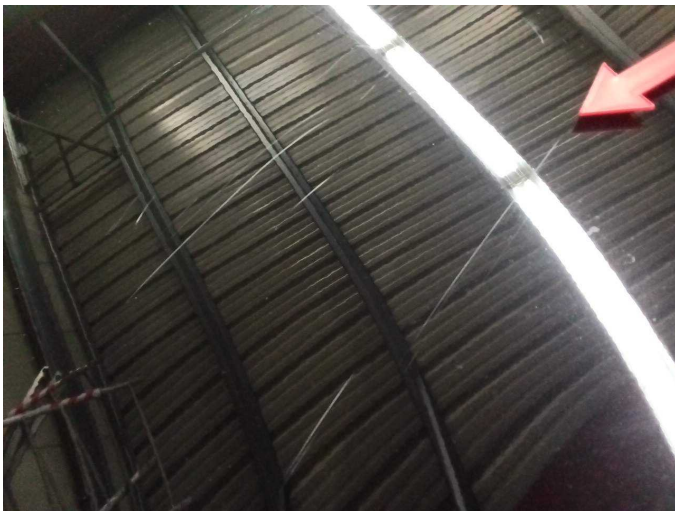
Damage 5: Bonnet: Bonnet - Scratch(es) - Paint

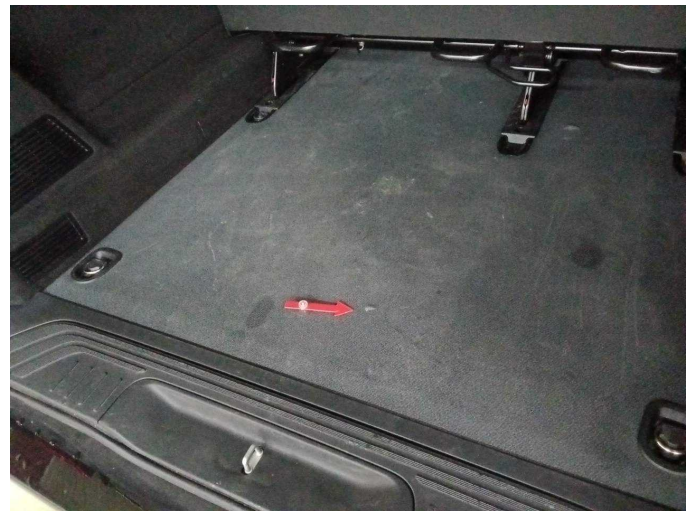
Damage 6: Rear of vehicle: Boot floor - Holes - Replace

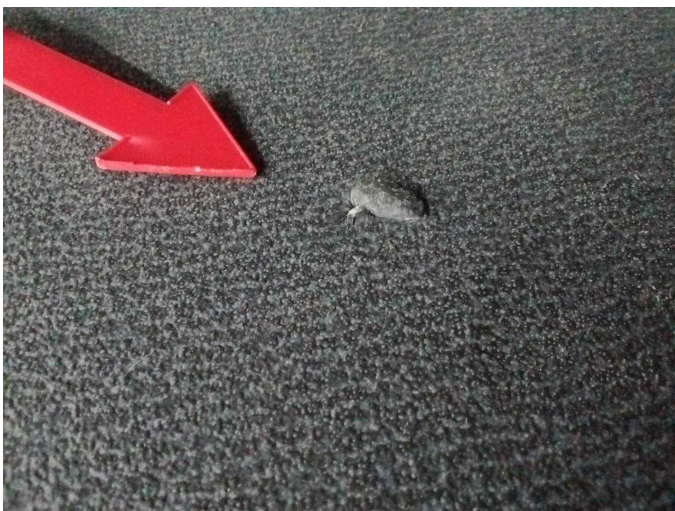
Damage 6: Rear of vehicle: Boot floor - Holes - Replace

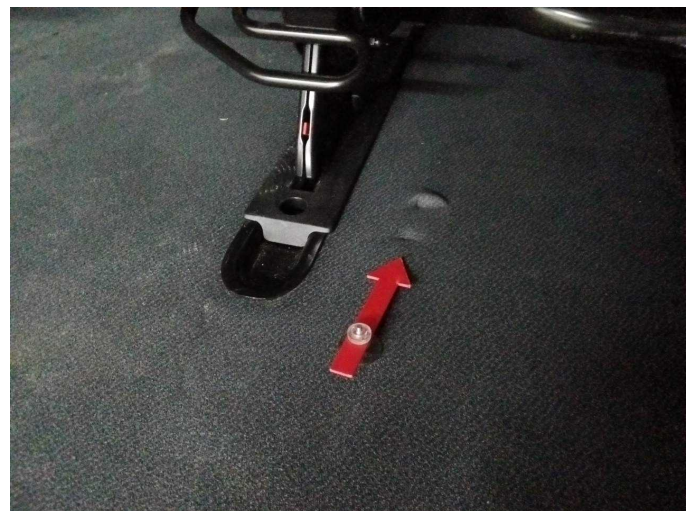
Damage 6: Rear of vehicle: Boot floor - Holes - Replace

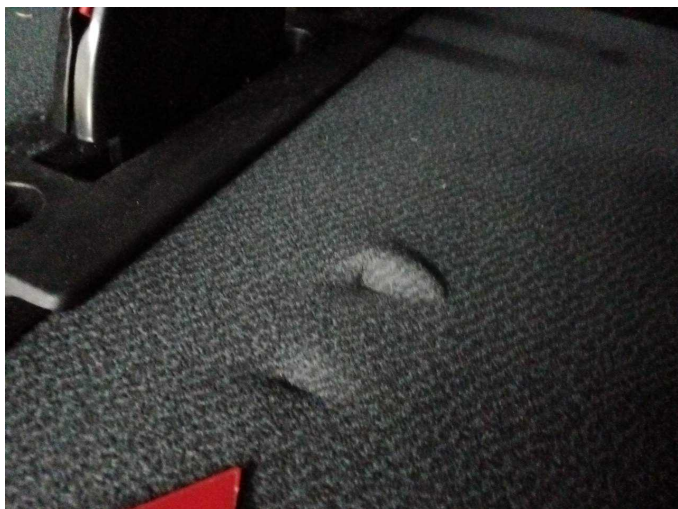
Damage 6: Rear of vehicle: Boot floor - Holes - Replace
