Expertise

Protocol number: 46635525  
Order No. / Reference: 26733581  
Inspection date: 15 Jul 2026

| Manufacturer: Opel | Model: Insignia Sports Tourer 2.0 Diesel Aut. Business |
| VIN: W0VZT8GP3N1004616 | |

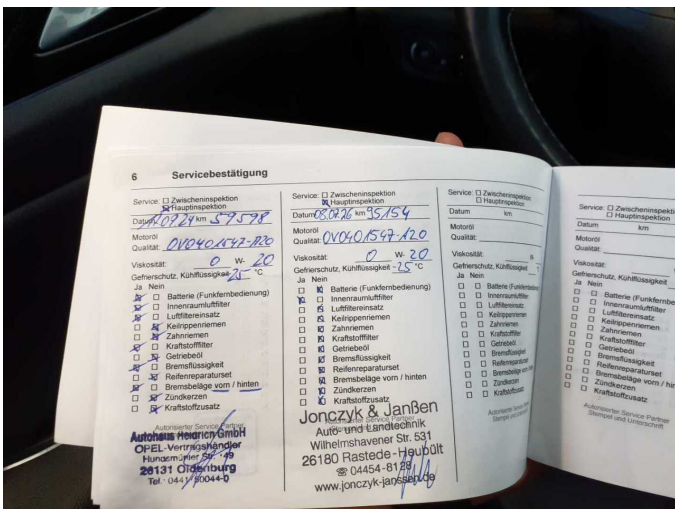
| No. | Component group | Description |
|---|---|---|
| 1 | Documents | Service book (Unvollständig - Wartung 2025 fehlt) |

**Damage 1:** Documents: Service book (Unvollständig - Wartung 2025 fehlt)

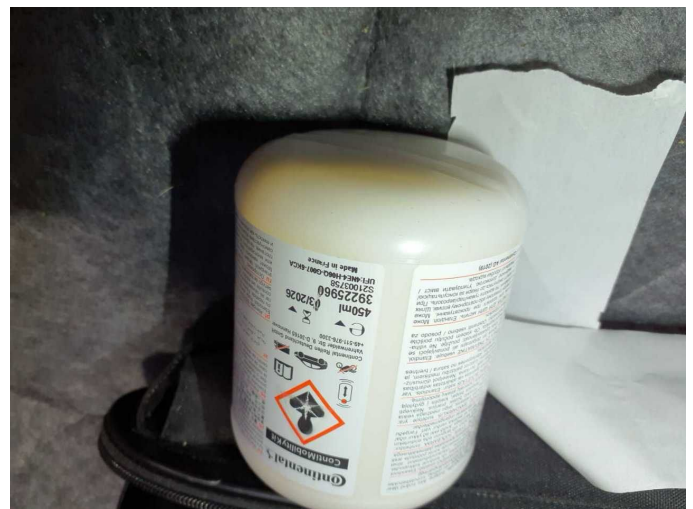
| No. | Component group | Description |
|---|---|---|
| 2 | Equipment | Tirefit filler - Expired - Replace |

**Damage 2:** Equipment: Tirefit filler - Expired - Replace

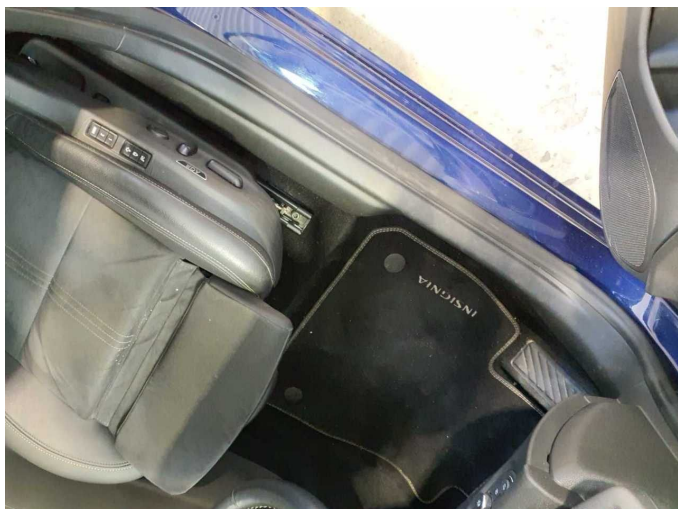
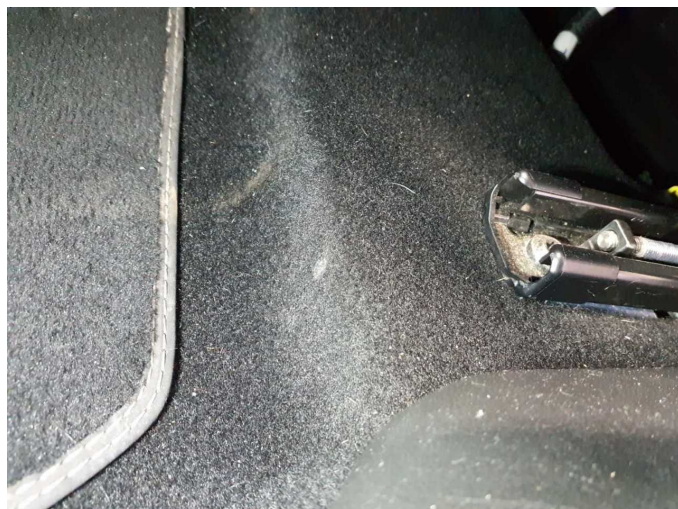
| No. | Component group | Description |
|---|---|---|
| 3 | Trim / covers | Carpet - front left side - Burn hole (cigarettes) - Smart repair |

**Damage 3:** Trim / covers: Carpet - front left side - Burn hole (cigarettes) - Smart repair

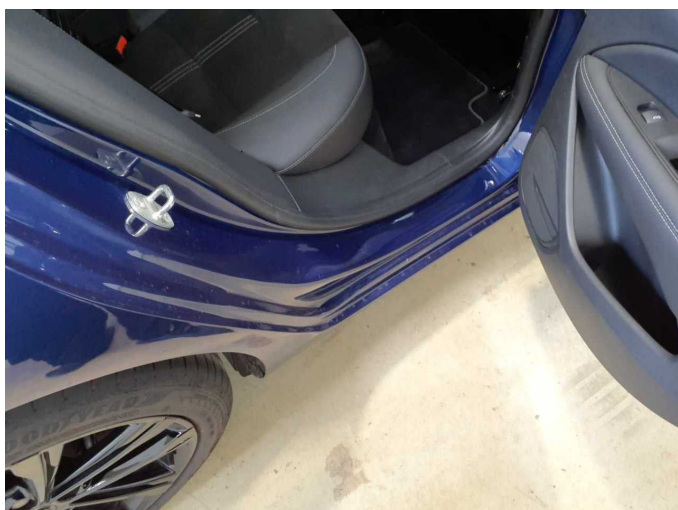
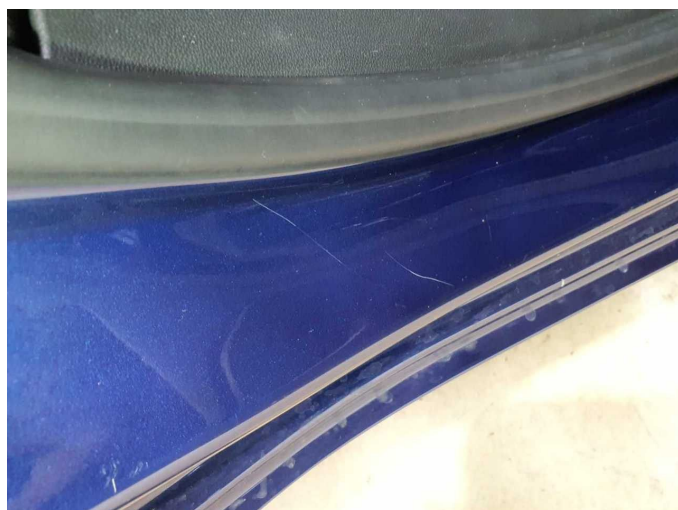
| No. | Component group | Description |
|---|---|---|
| 4 | Side panel - rear right side | Sill - Scratch(es) - Smart repair |

**Damage 4:** Side panel - rear right side: Sill - Scratch(es) - Smart repair

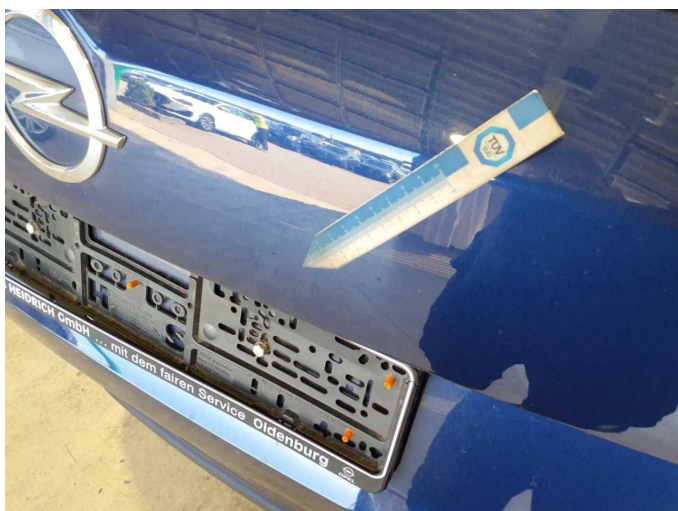
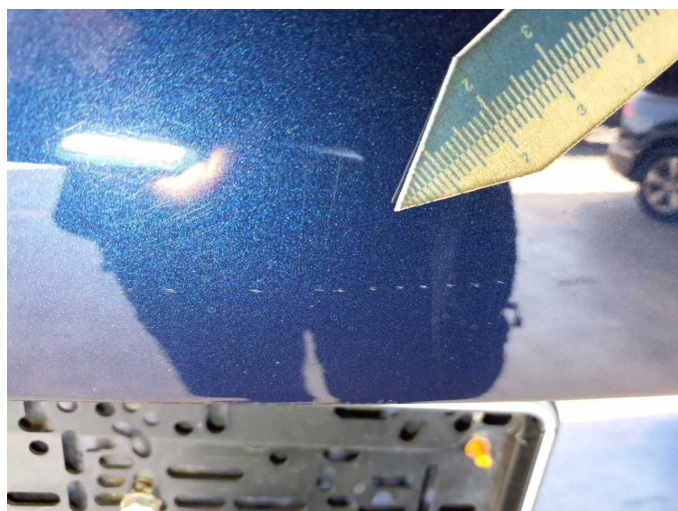
| No. | Component group | Description |
|---|---|---|
| 5 | Boot lid / rear door | Boot lid - Scratch(es) - Smart repair |

**Damage 5:** Boot lid / rear door: Boot lid - Scratch(es) - Smart repair

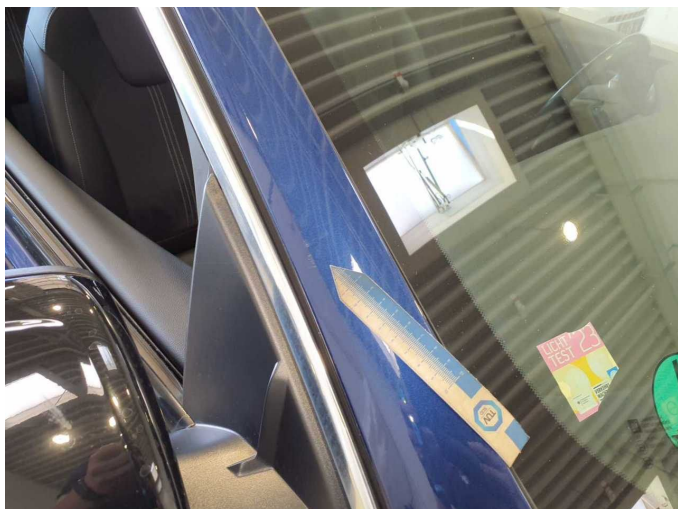
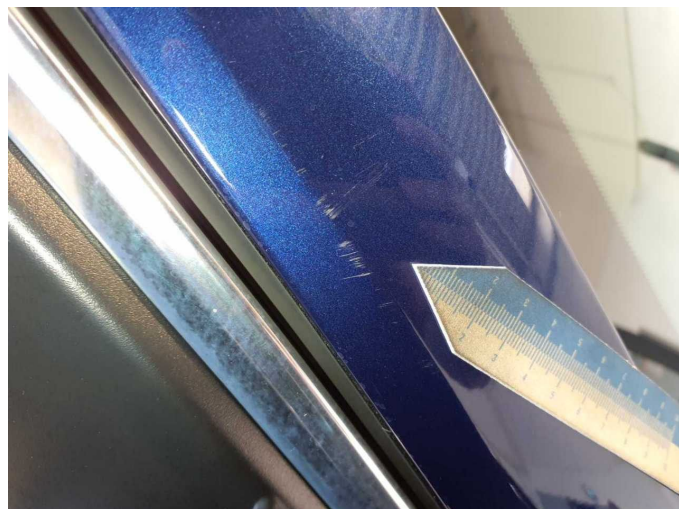
| No. | Component group | Description |
|---|---|---|
| 6 | Body | A-pillar - right side - Scratch(es) - Smart repair |

**Damage 6:** Body: A-pillar - right side - Scratch(es) - Smart repair

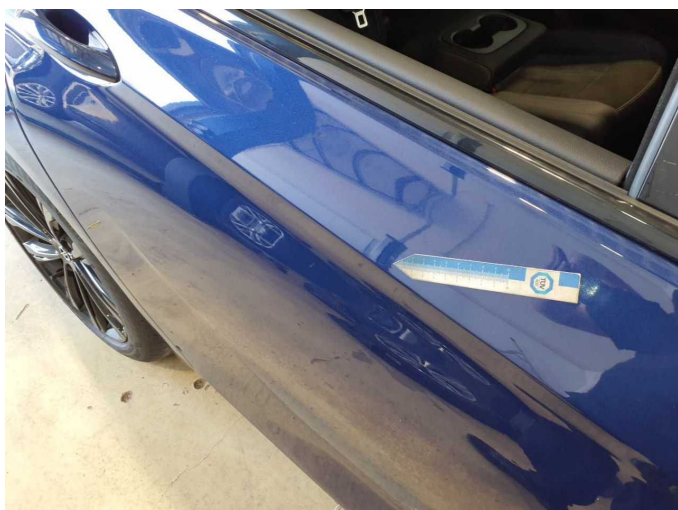
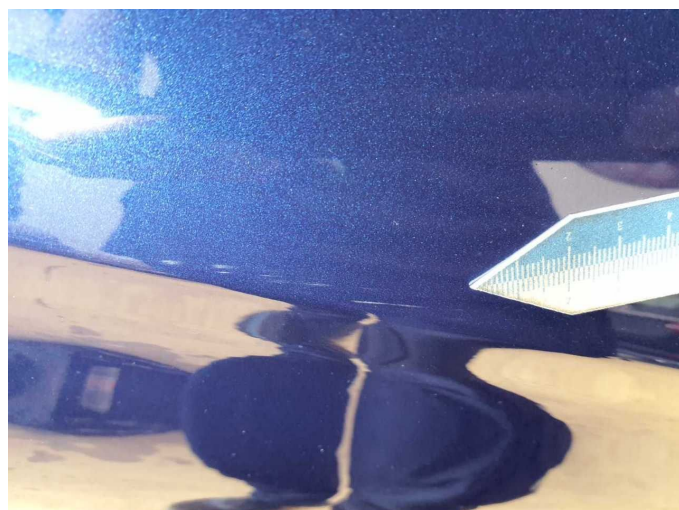
| No. | Component group | Description |
|---|---|---|
| 7 | Door - rear right side | Door - Scratch(es) - Smart repair |

**Damage 7:** Door - rear right side: Door - Scratch(es) - Smart repair

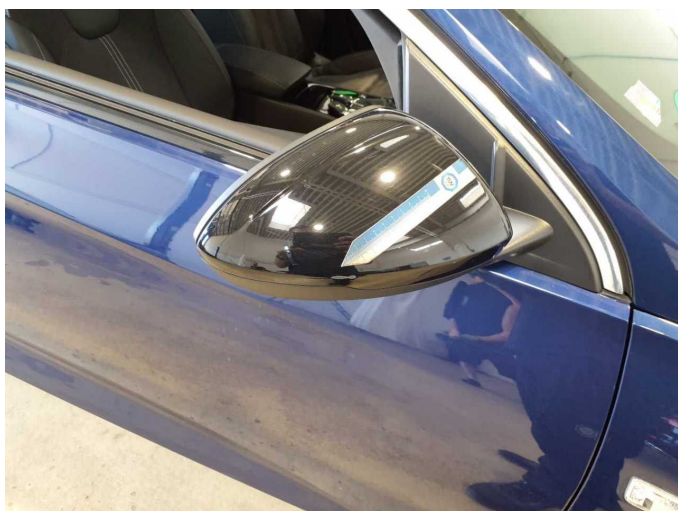
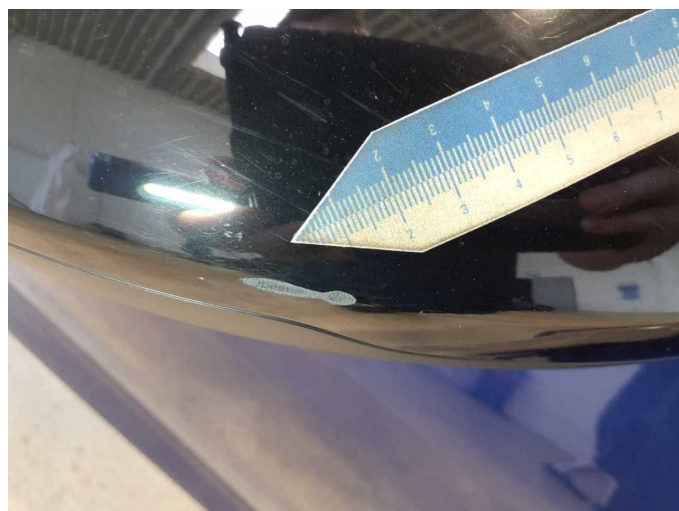
| No. | Component group | Description |
|---|---|---|
| 8 | Wing mirror - right side | Cap - Scratch(es) - Paint |

**Damage 8:** Wing mirror - right side: Cap - Scratch(es) - Paint

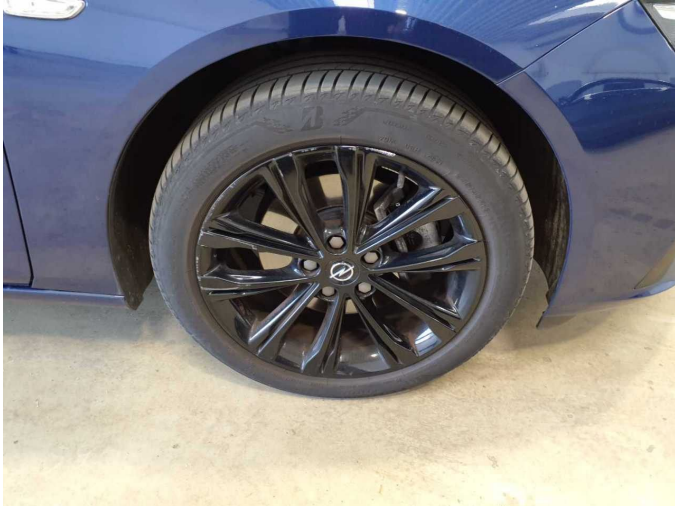
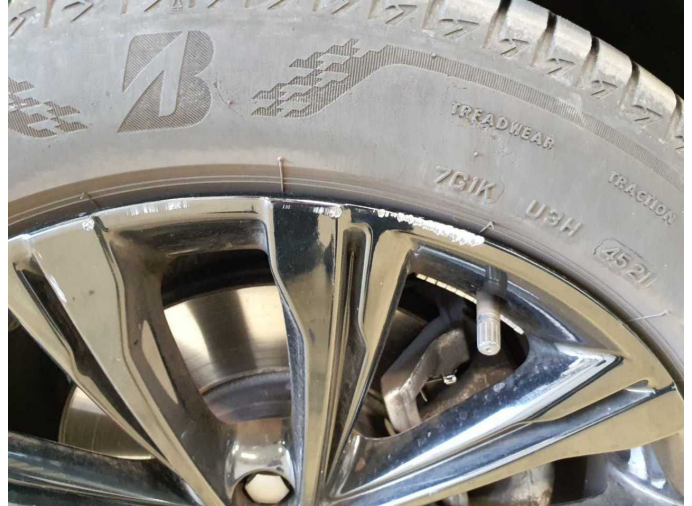
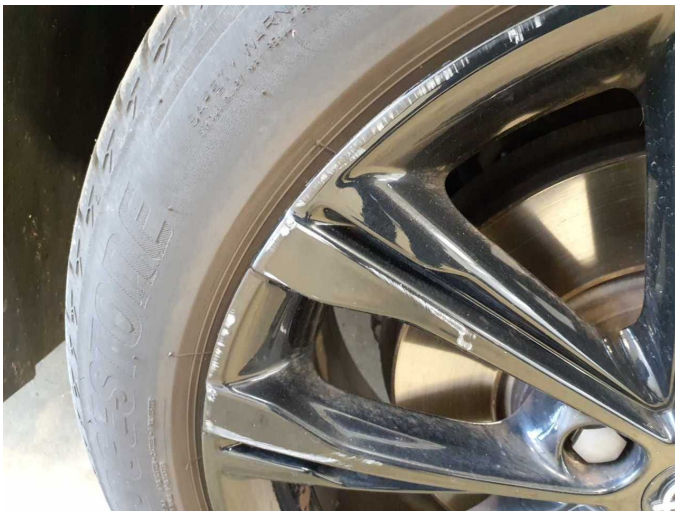
| No. | Component group | Description |
|---|---|---|
| 9 | Wheel / tyres | Alloy rim - front right side - Scratch(es) - Replace |

**Damage 9:** Wheel / tyres: Alloy rim - front right side - Scratch(es) - Replace

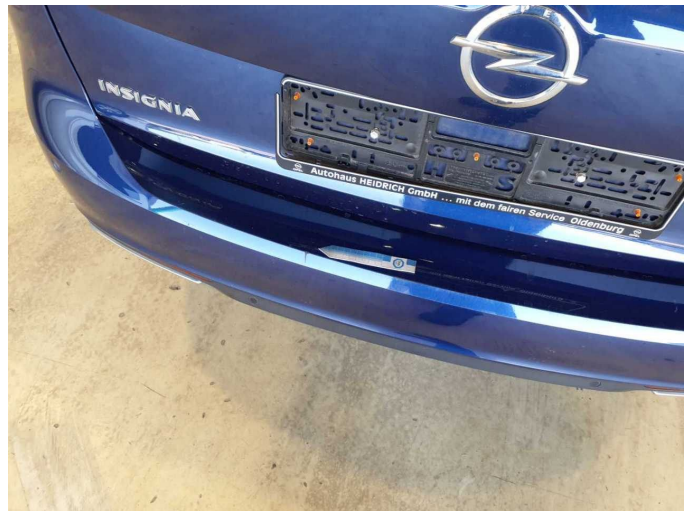
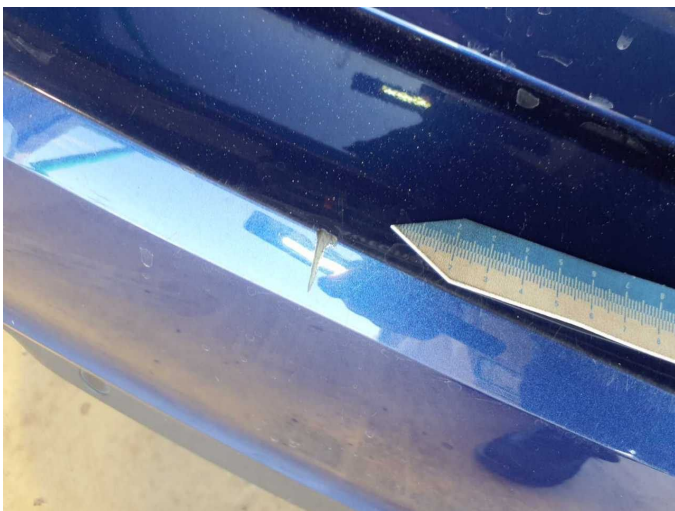
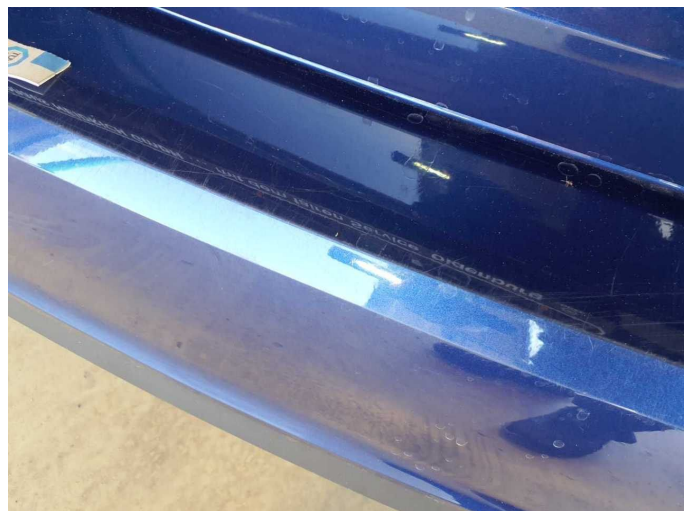
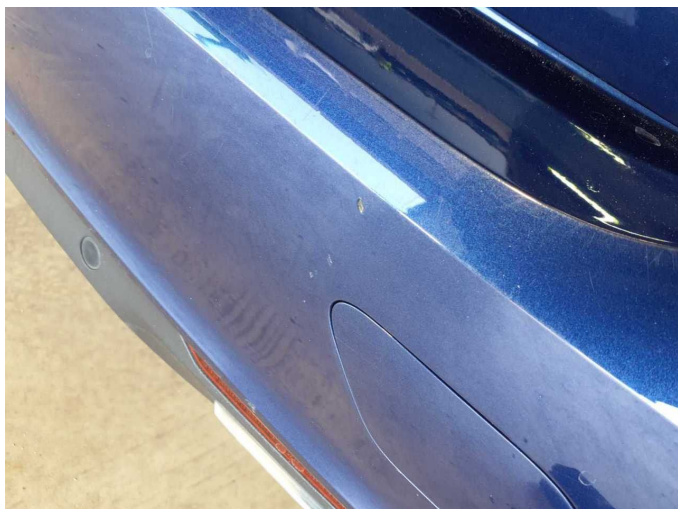
| No. | Component group | Description |
|---|---|---|
| 10 | Rear bumper | Rear bumper - Scratch(es) - Paint |

**Damage 10:** Rear bumper: Rear bumper - Scratch(es) - Paint

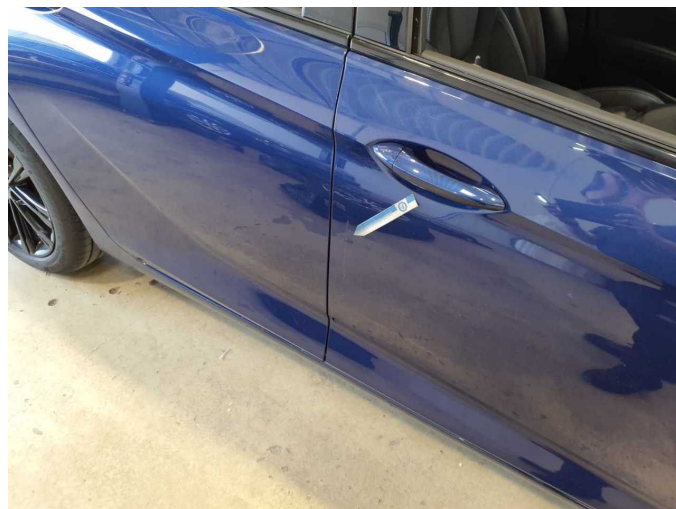
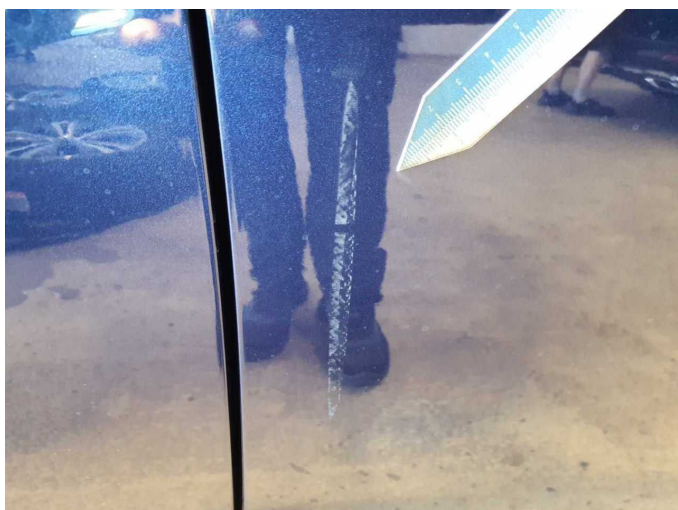
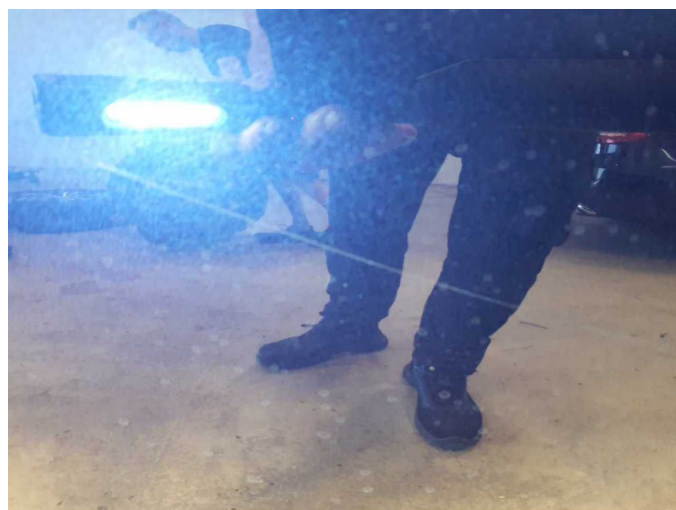
| No. | Component group | Description |
|---|---|---|
| 11 | Door - front right side | Door - Scratch(es) - Paint |

**Damage 11:** Door - front right side: Door - Scratch(es) - Paint

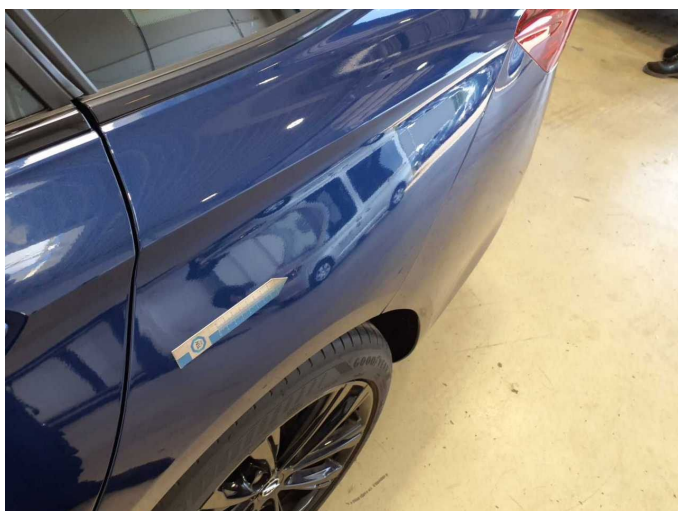
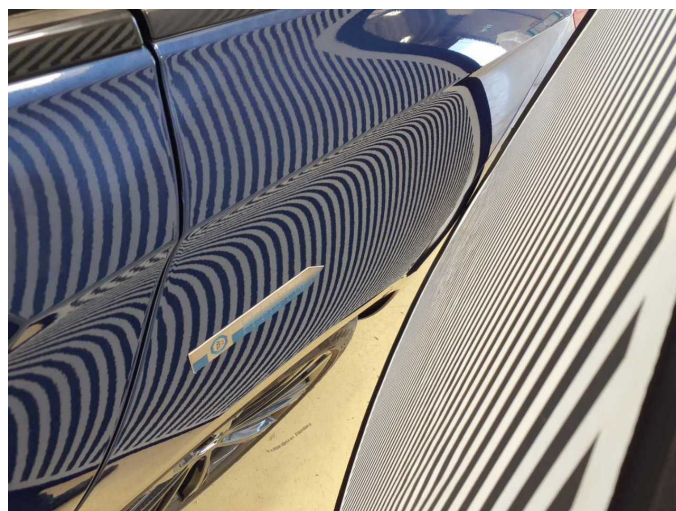
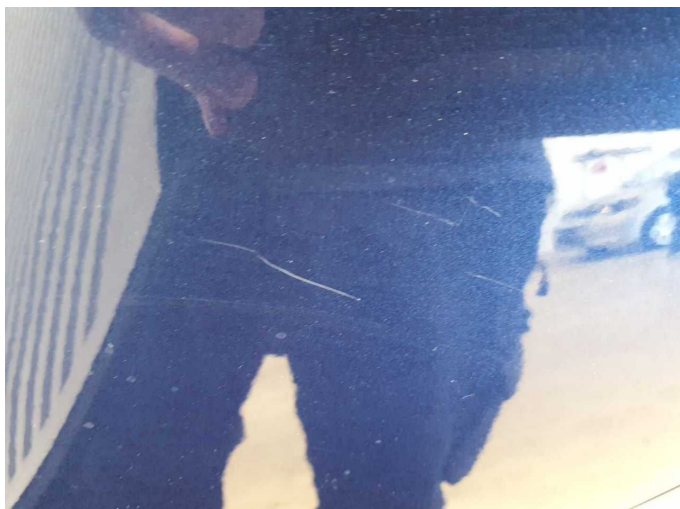
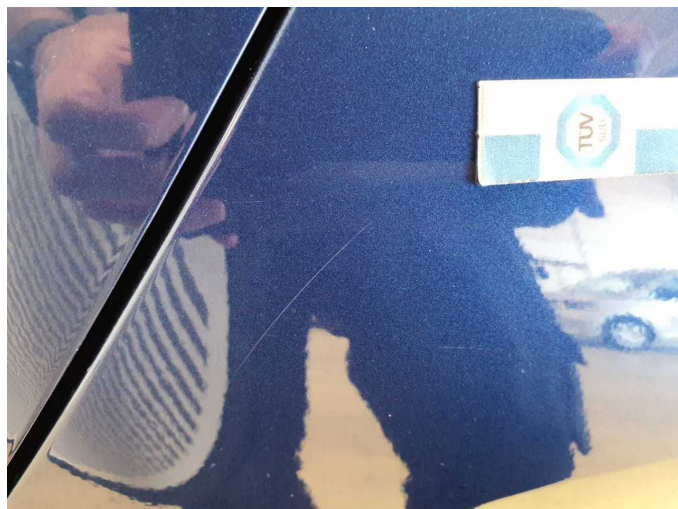
| No. | Component group | Description |
|---|---|---|
| 12 | Side panel - rear left side | Side panel - Dent / paintcoat damage - Paint |

**Damage 12:** Side panel - rear left side: Side panel - Dent / paintcoat damage - Paint

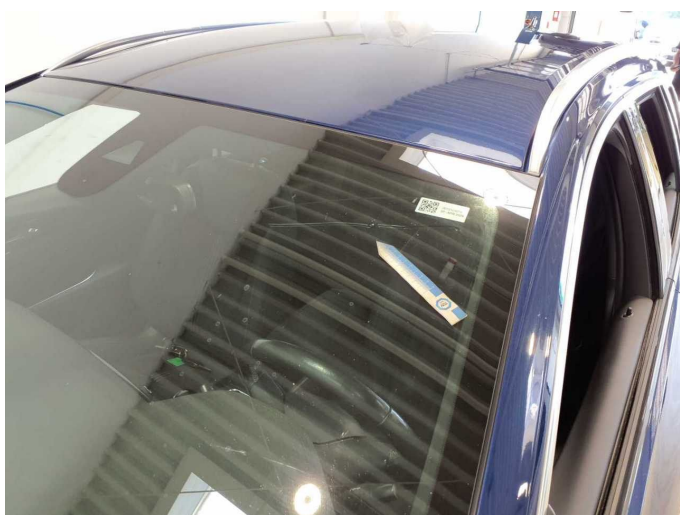
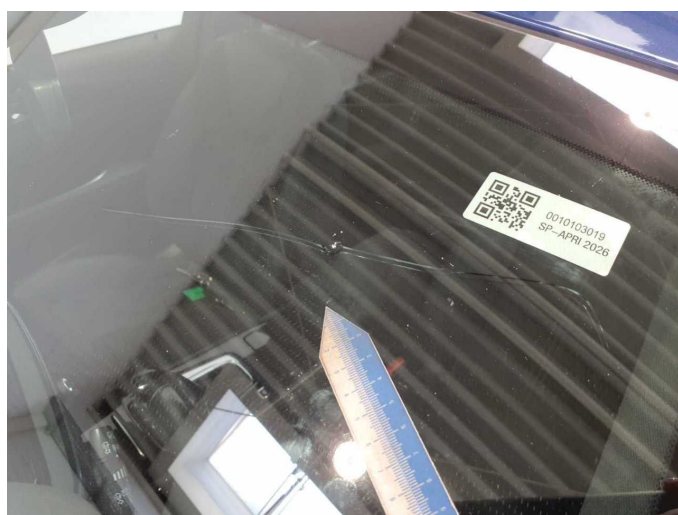
| No. | Component group | Description |
|---|---|---|
| 13 | Vehicle glazing | Windscreen - Broken / torn - Replace |

**Damage 13:** Vehicle glazing: Windscreen - Broken / torn - Replace

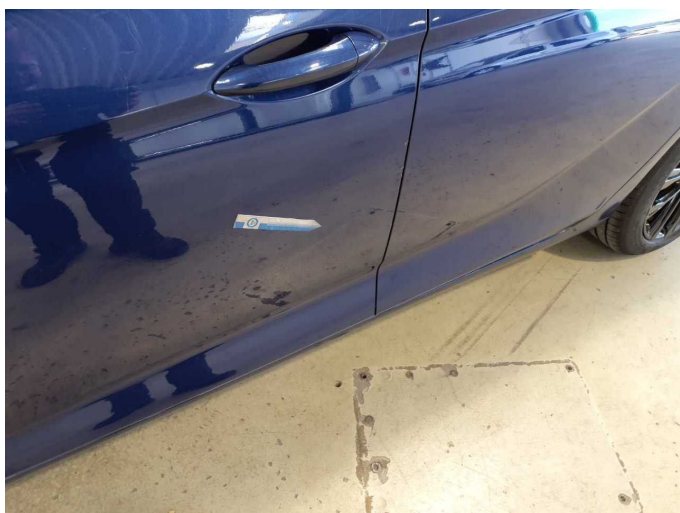
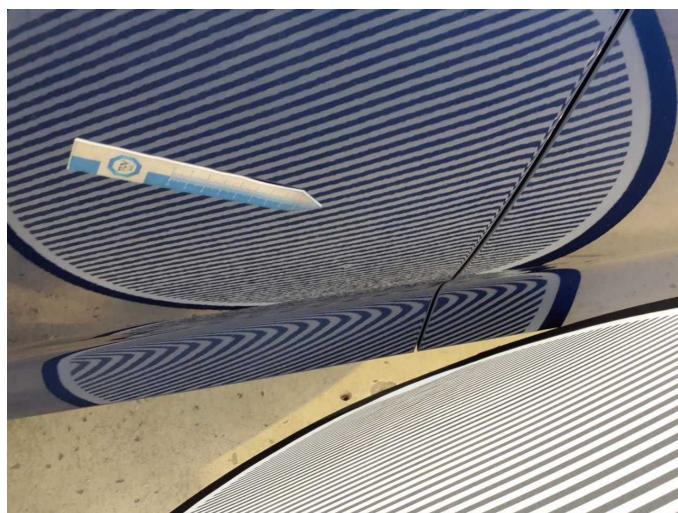
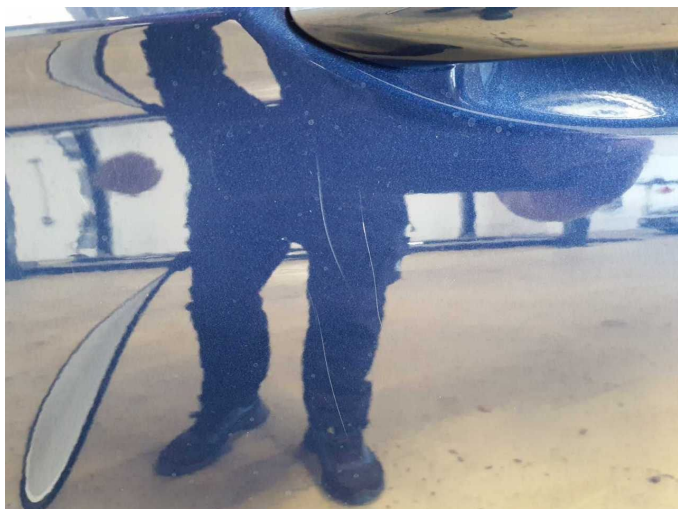
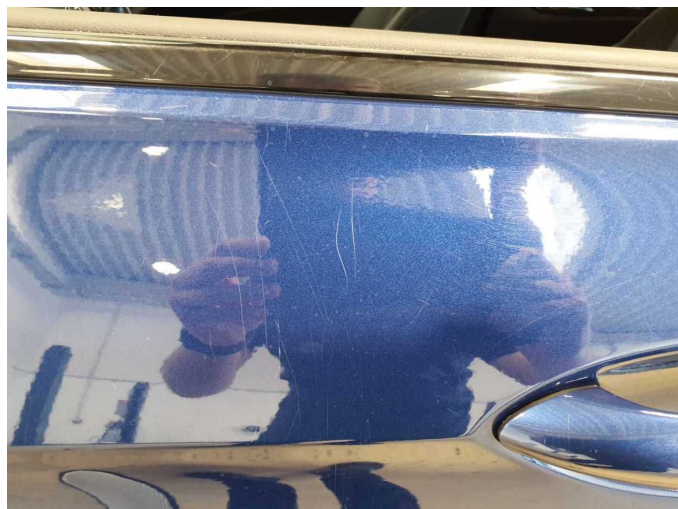
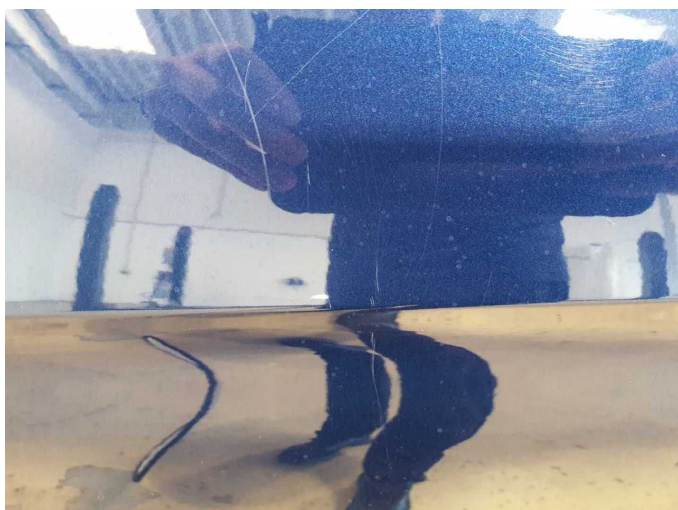
| No. | Component group | Description |
|---|---|---|
| 14 | Door - front left side | Door - Dent / paintcoat damage - Repair and paint |

**Damage 14:** Door - front left side: Door - Dent / paintcoat damage - Repair and paint

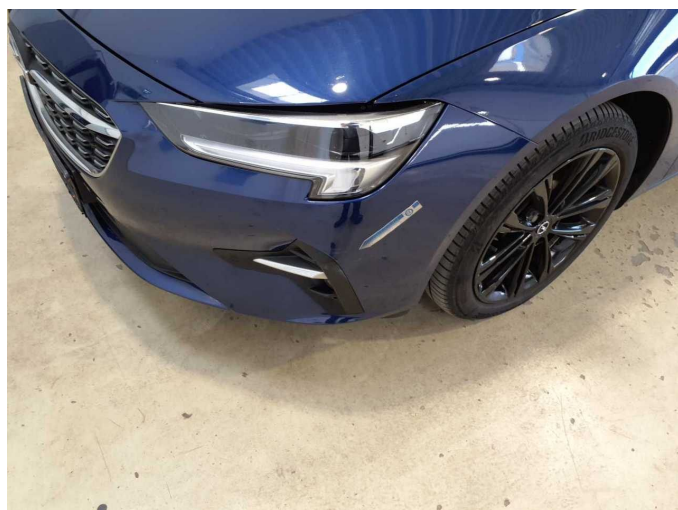
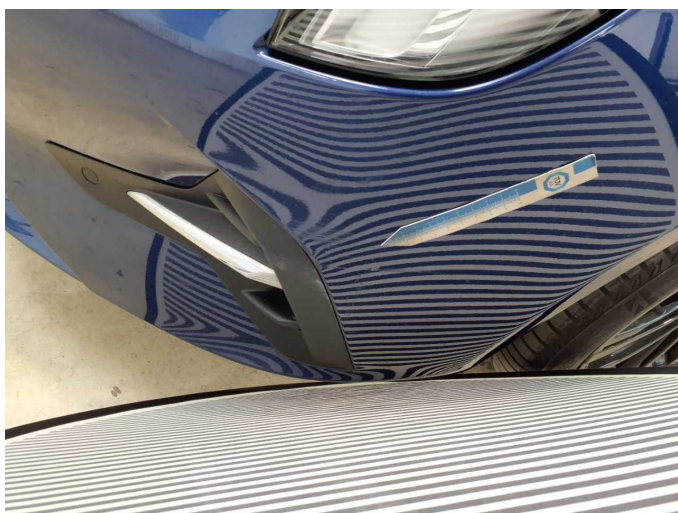
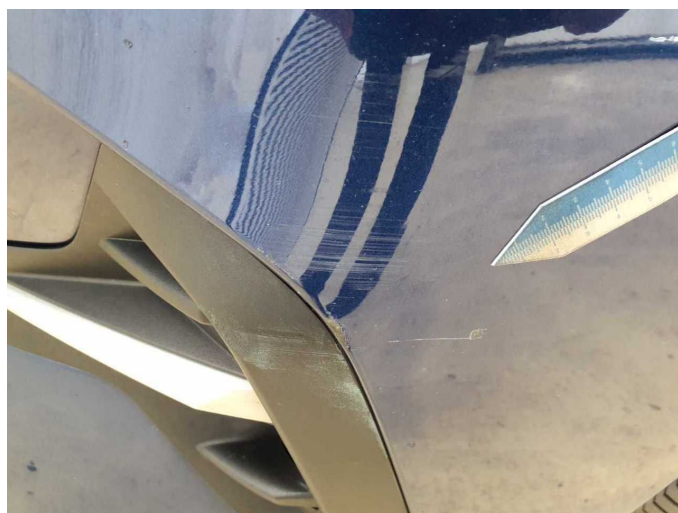
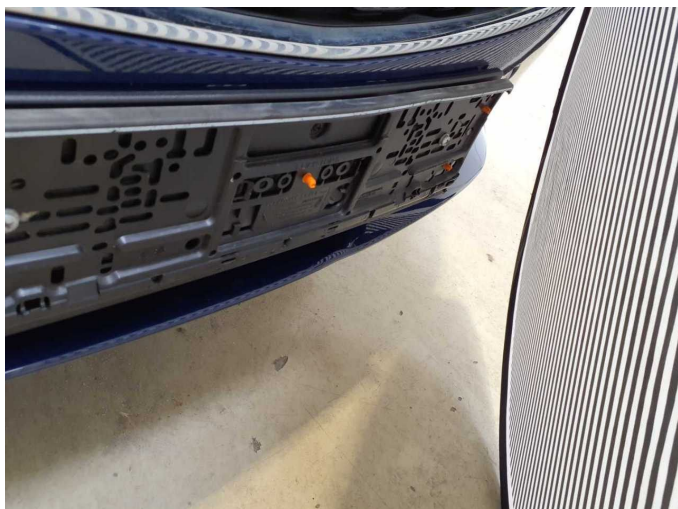
| No. | Component group | Description |
|---|---|---|
| 15 | Front bumper | Front bumper (Inklusive anbauteile) - Dent / paintcoat damage - Repair and paint |

**Damage 15:** Front bumper: Front bumper (Inklusive anbauteile) - Dent / paintcoat damage - Repair and paint

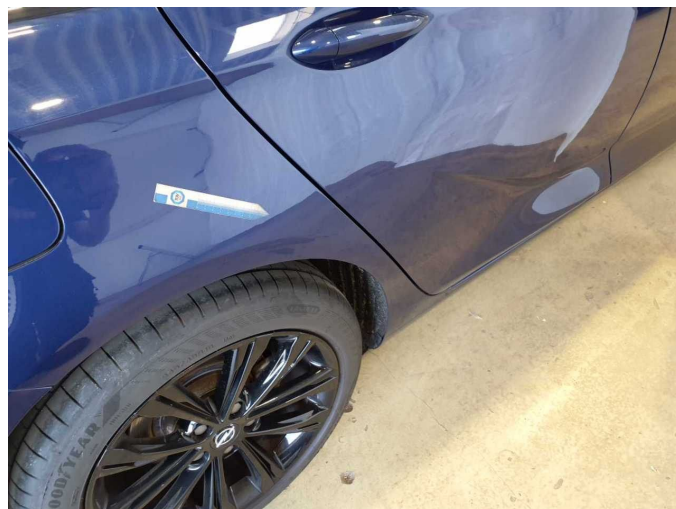
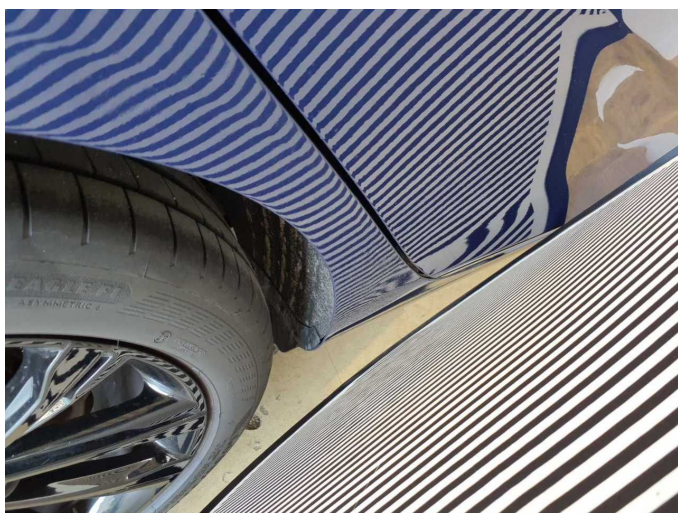
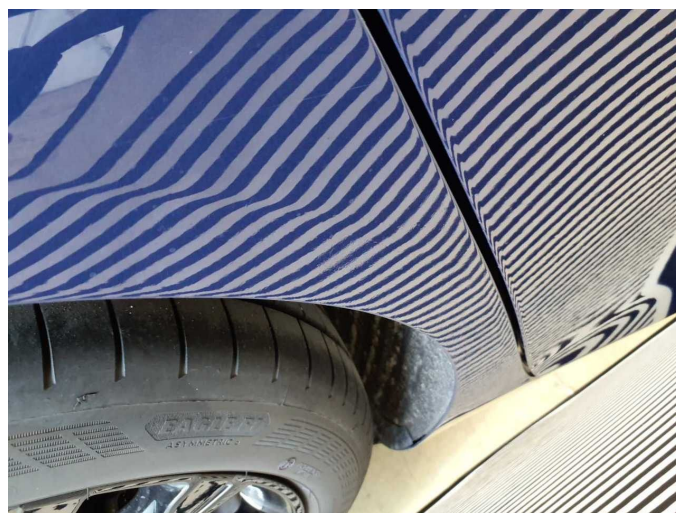
| No. | Component group | Description |
|---|---|---|
| 16 | Side panel - rear right side | Side panel (Spachtel rissig) - Unprofessionally repaired - Repair and paint |

| 1 | Side panel - rear right side, Unprofessionally carried out, Invoice of repair done Non-existent |

| Side panel - rear right side | 178 µm |

**Damage 16:** Side panel - rear right side: Side panel (Spachtel rissig) - Unprofessionally repaired - Repair and paint

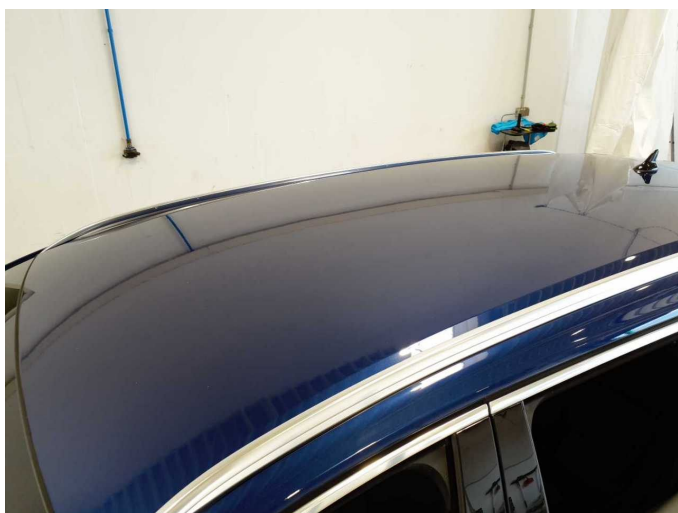
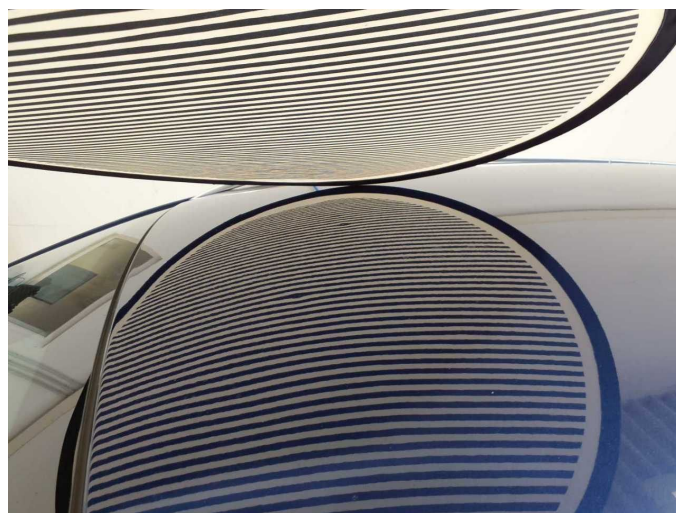
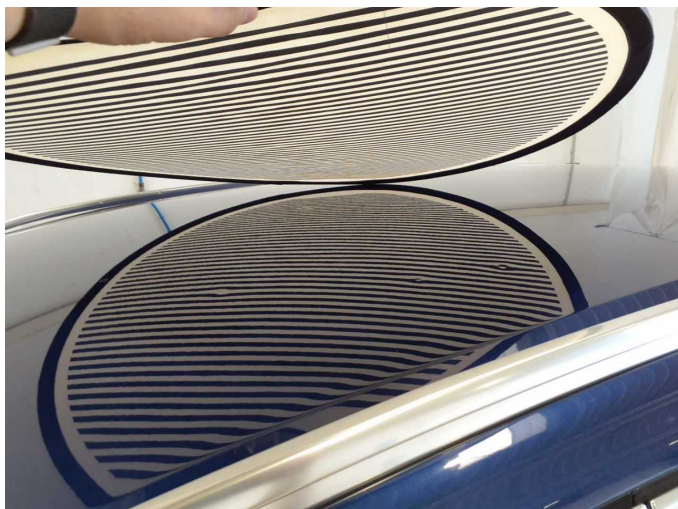
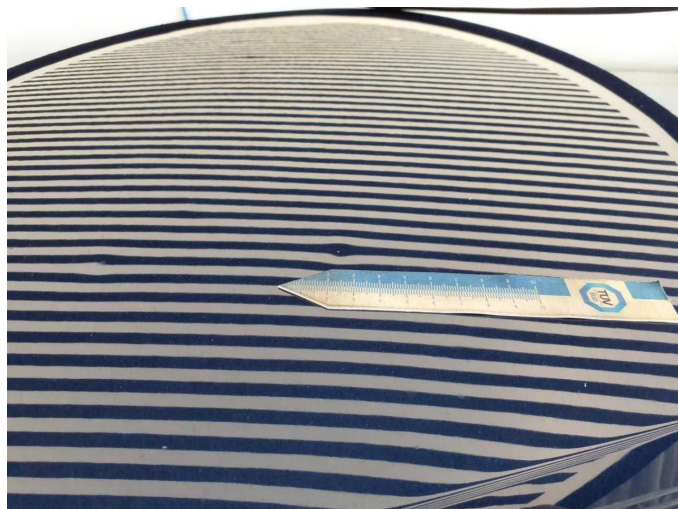
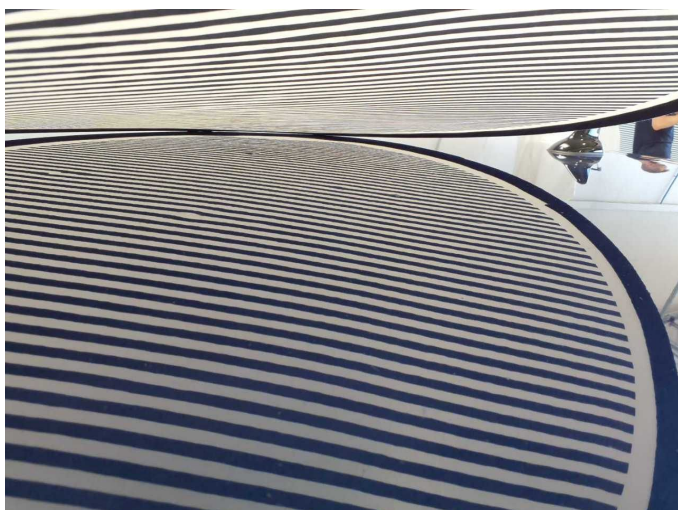
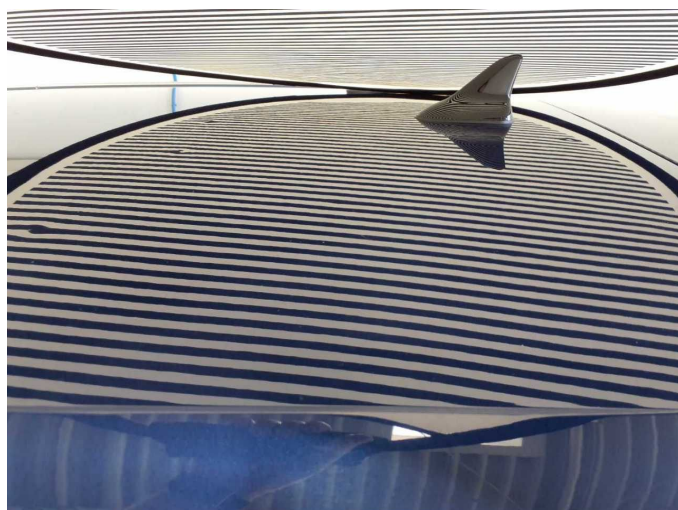
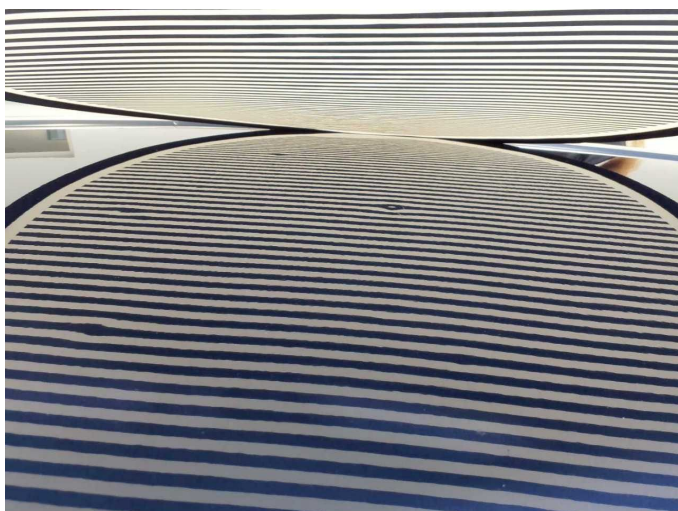
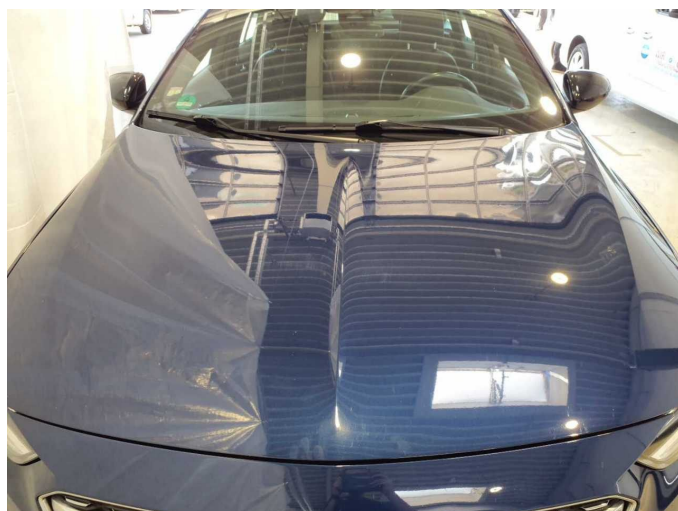
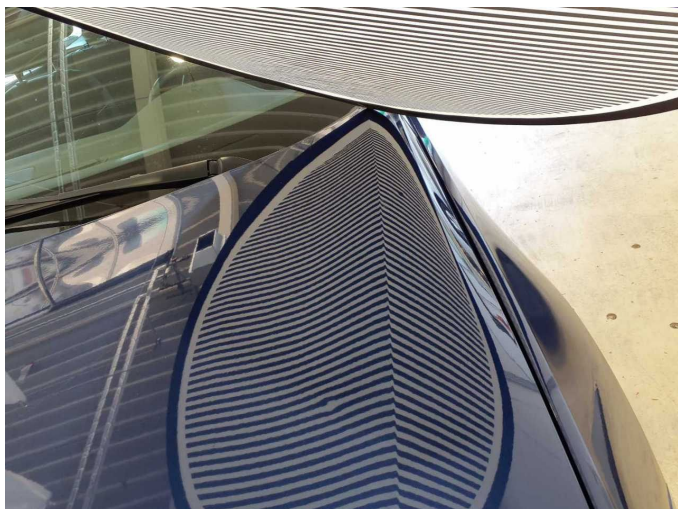
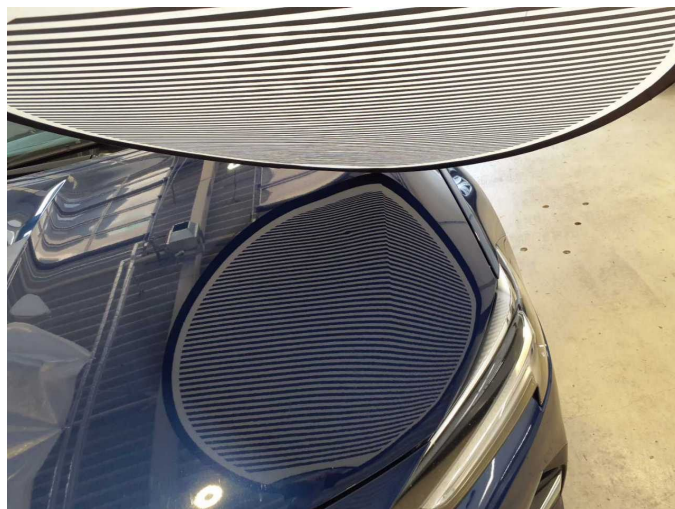
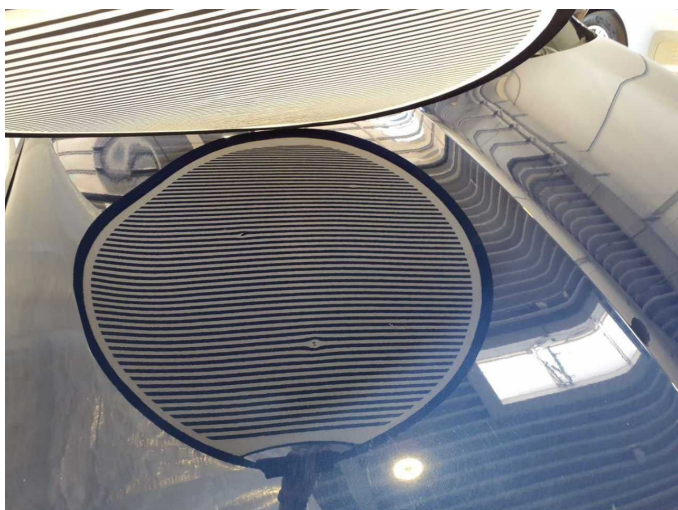
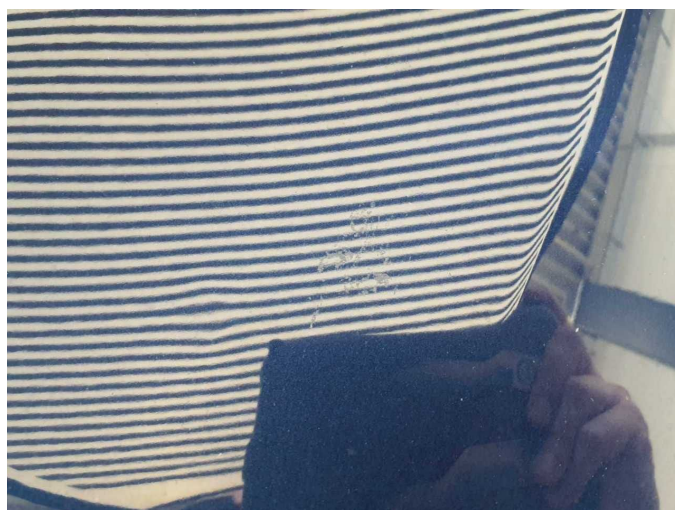
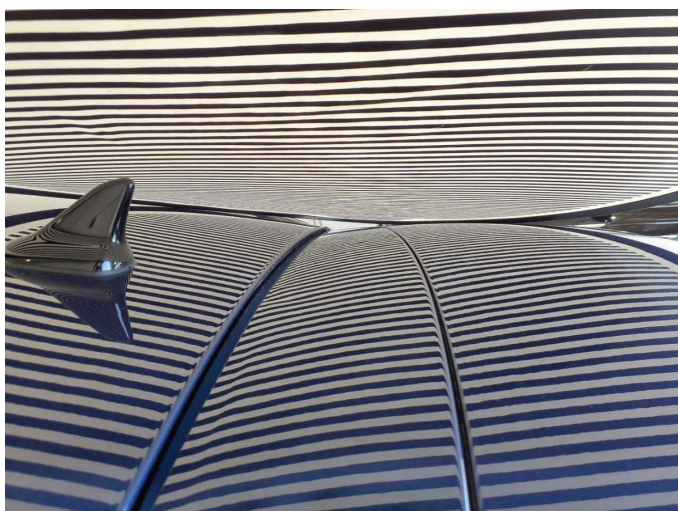
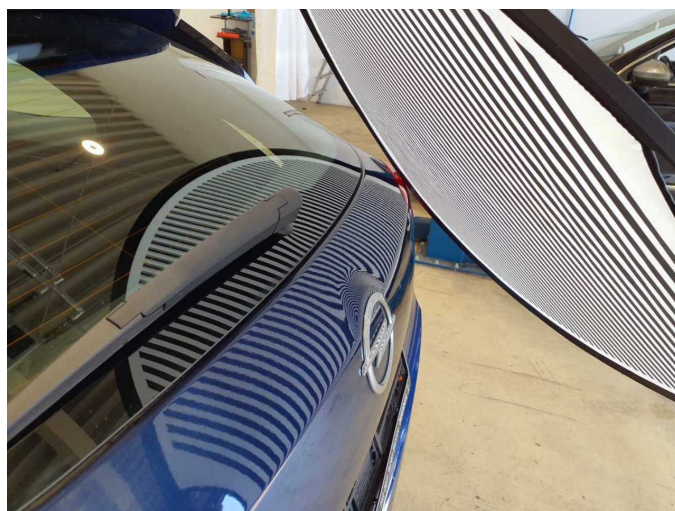
| No. | Component group | Description |
|---|---|---|
| 17 | Body | Body - Damage by hail - Repair |

**Damage 17:** Body: Body - Damage by hail - Repair

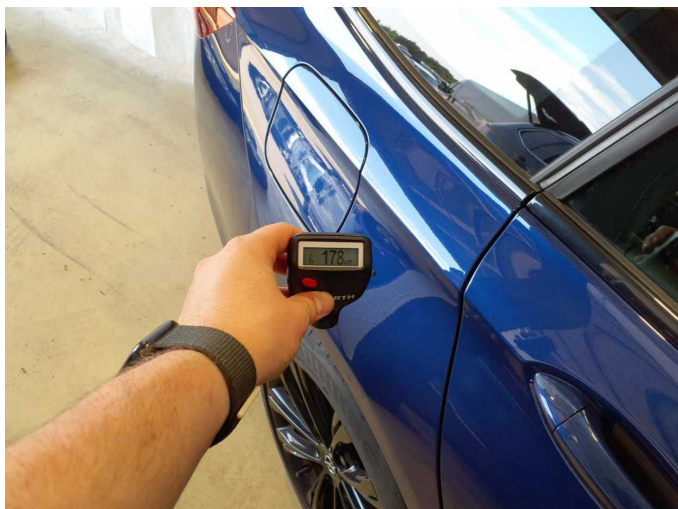
**Repainting 1:** Side panel - rear right side
