Expertise

Protocol number: 45928660
Order No. / Reference: 26489866
Inspection date: 15 Jun 2026

Model: Octavia Combi 2.0 TDI DSG Ambition

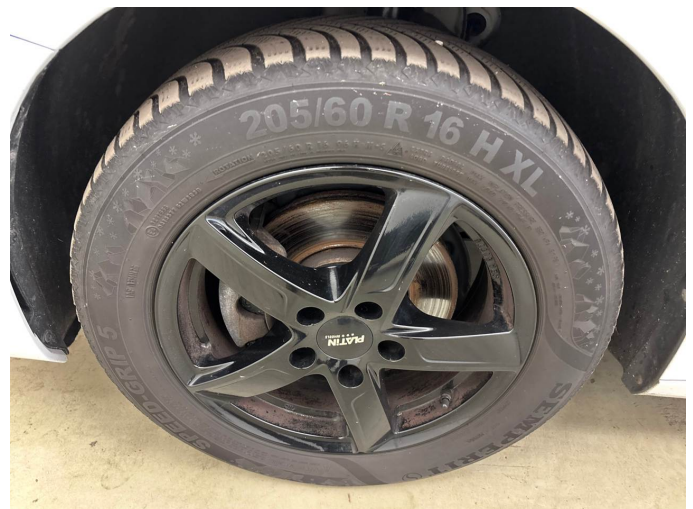
Figure 12: Mounted tyres

| No. | Component group | Description |
|---|---|--|
| 1 | Wheel / tyres | Tyre - front (2mm) - Does not meet the leasing specifications - No deduction |

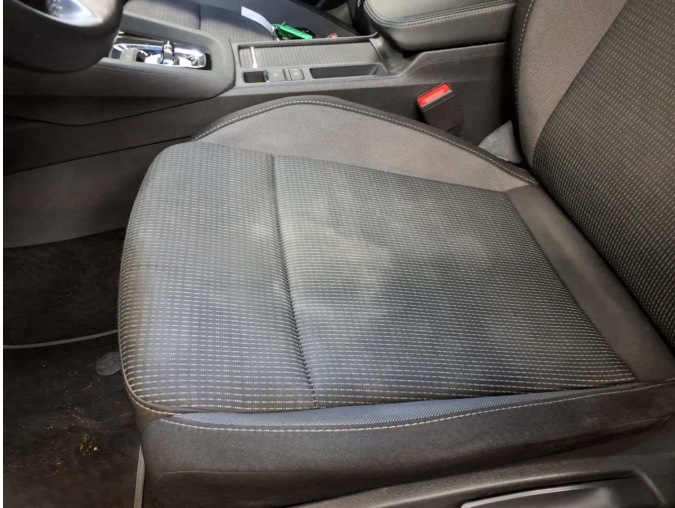
| No. | Component group | Description |
|---|---|---|
| 1 | Seat - front | Seat cover - left side - Soiled - Clean |

Damage 1: Seat - front: Seat cover - left side - Soiled - Clean

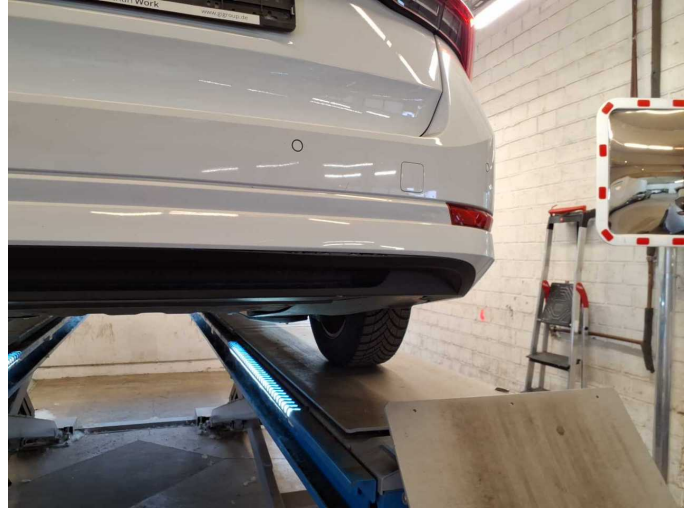
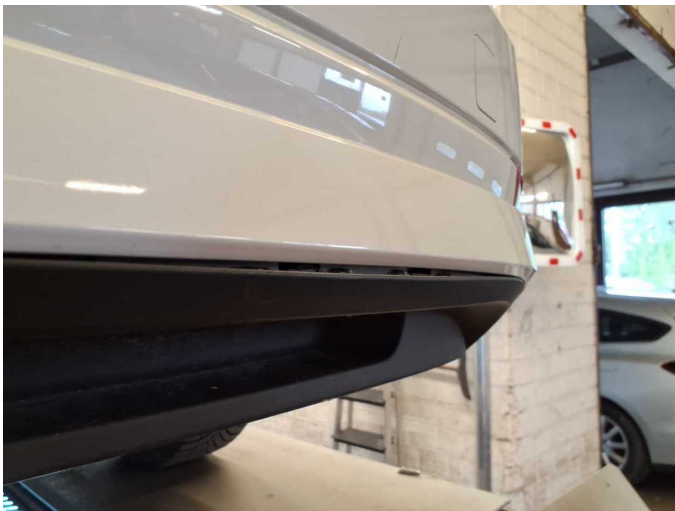
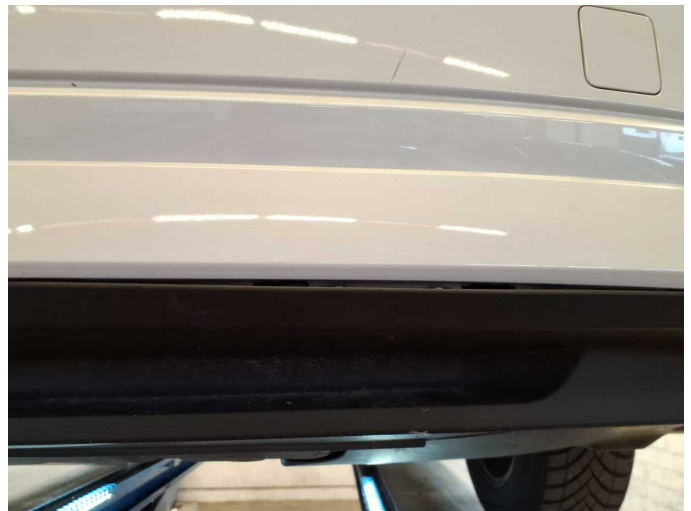
| No. | Component group | Description |
|---|---|---|
| 2 | Rear bumper | Spoiler - Malposition - Repair |

Damage 2: Rear bumper: Spoiler - Malposition - Repair

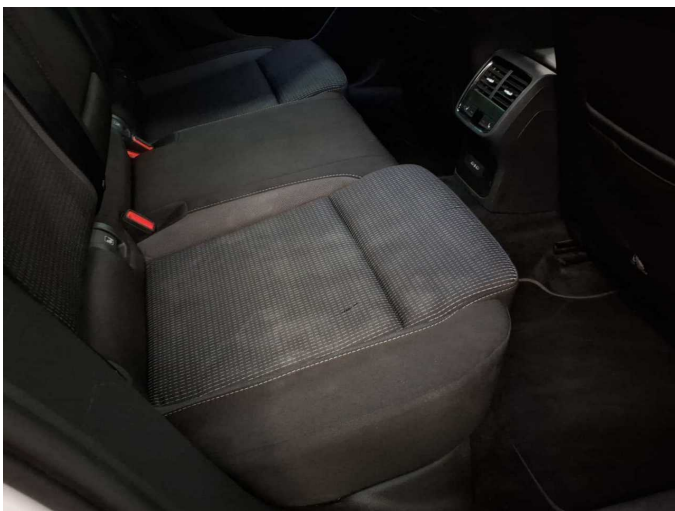
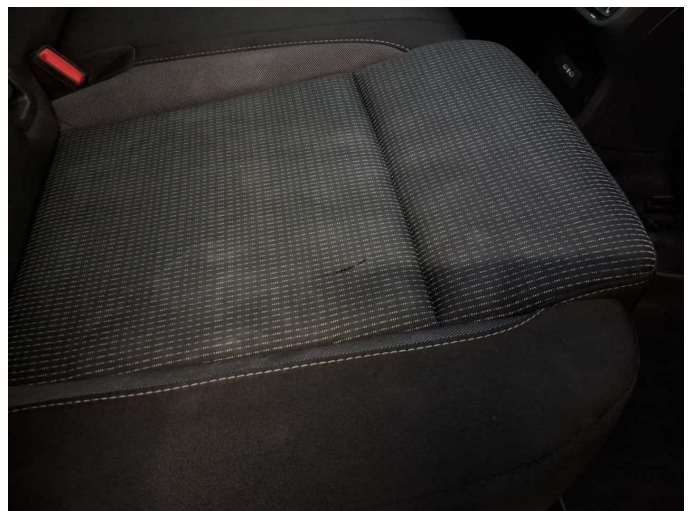
| No. | Component group | Description |
|---|---|---|
| 3 | Seat - rear | Upholstery (+ verschmutzt) - Scratch(es) - Smart repair |

Damage 3: Seat - rear: Upholstery (+ verschmutzt) - Scratch(es) - Smart repair

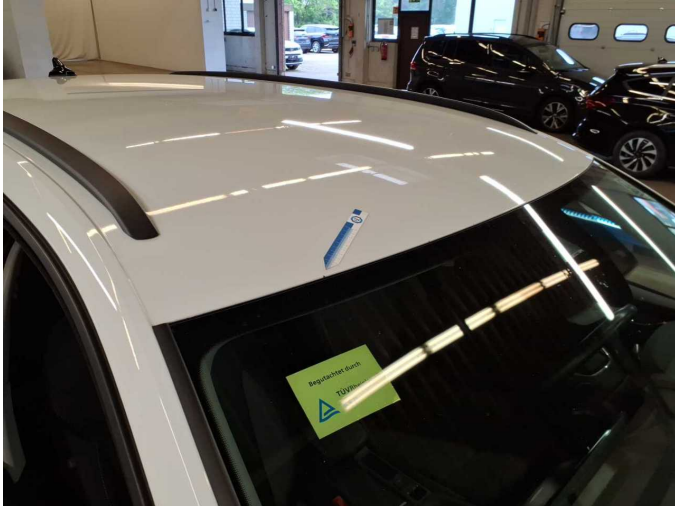
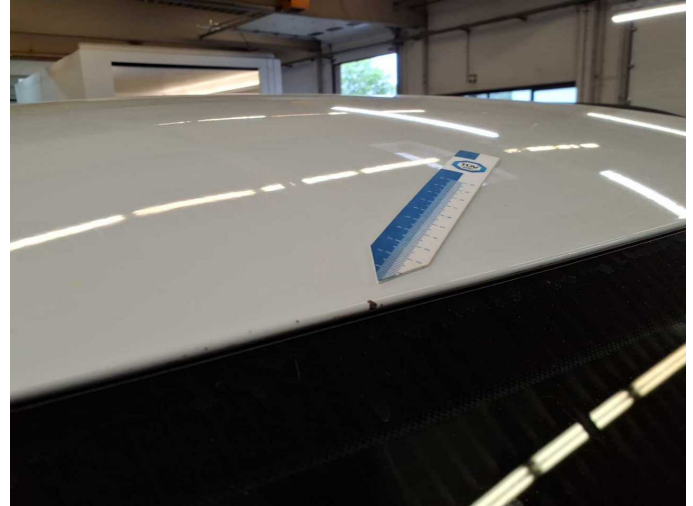
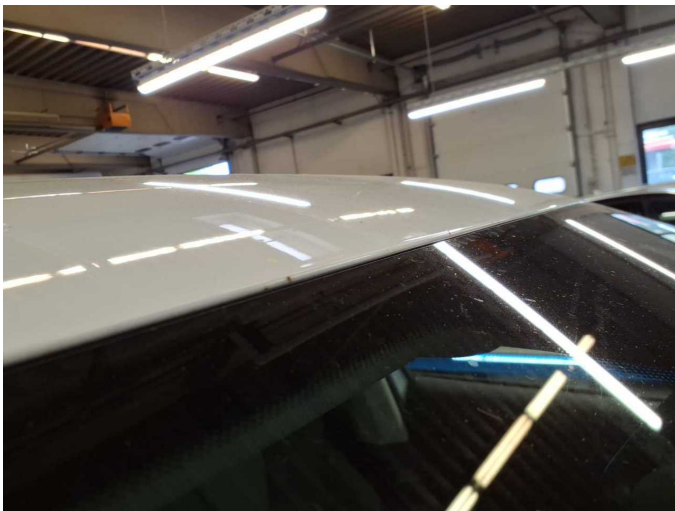
| No. | Component group | Description |
|---|---|---|
| 4 | Roof | Roof (Randbereich) - Stone chips - Smart repair |

Damage 4: Roof: Roof (Randbereich) - Stone chips - Smart repair

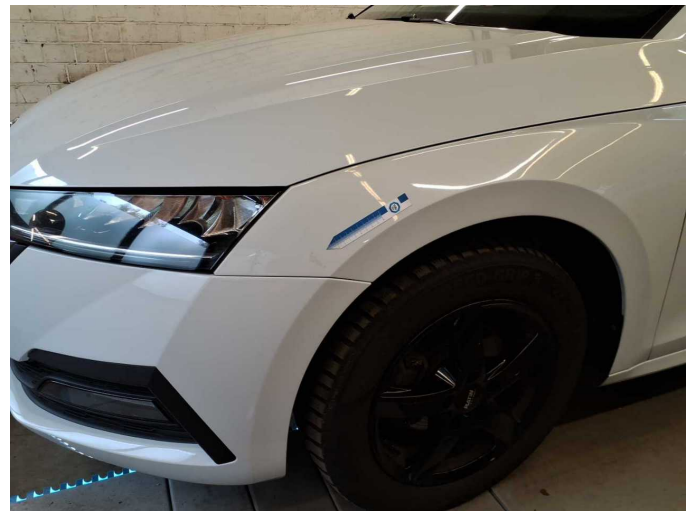
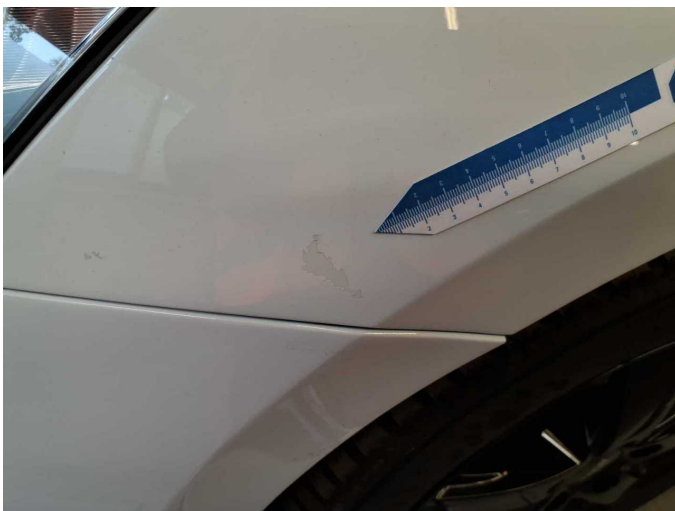
| No. | Component group | Description |
|---|---|---|
| 5 | Mudguard - left side | Mudguard - left side (Klarlackmangel) - Unprofessionally repaired - Paint |

| Mudguard - left side | 202 µm | Mudguard - right side | 163 µm |

Damage 5: Mudguard - left side: Mudguard - left side (Klarlackmangel) - Unprofessionally repaired - Paint

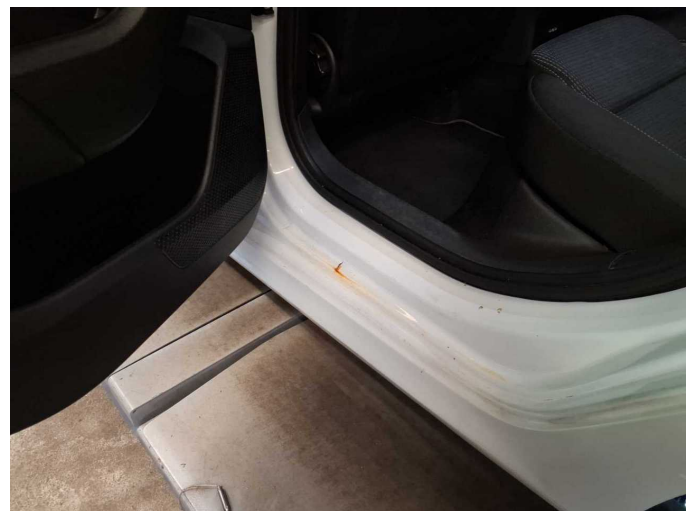
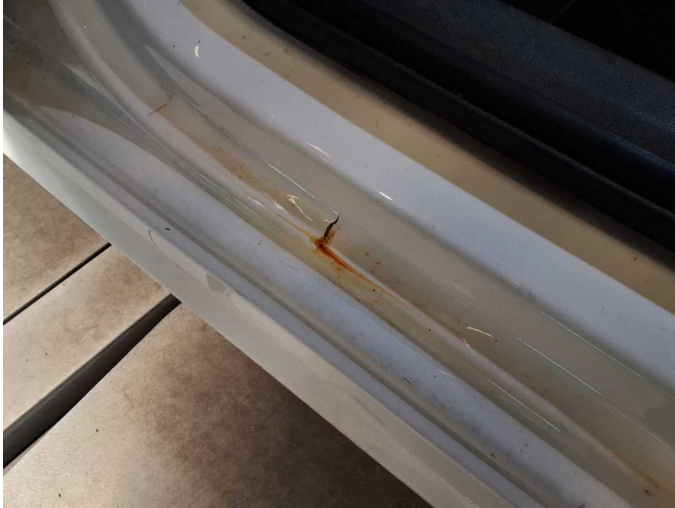
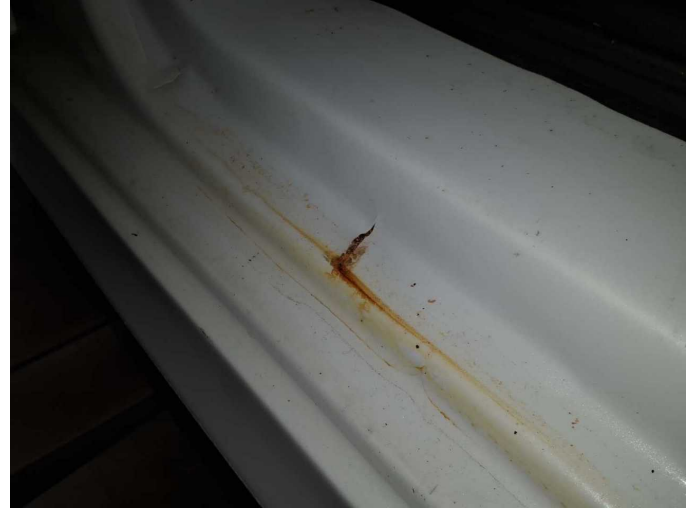
| No. | Component group | Description |
|---|---|---|
| 6 | Sill - left side | Sill (Hinten) - Broken / torn - repair according to calculation |

Damage 6: Sill - left side: Sill (Hinten) - Broken / torn - repair according to calculation

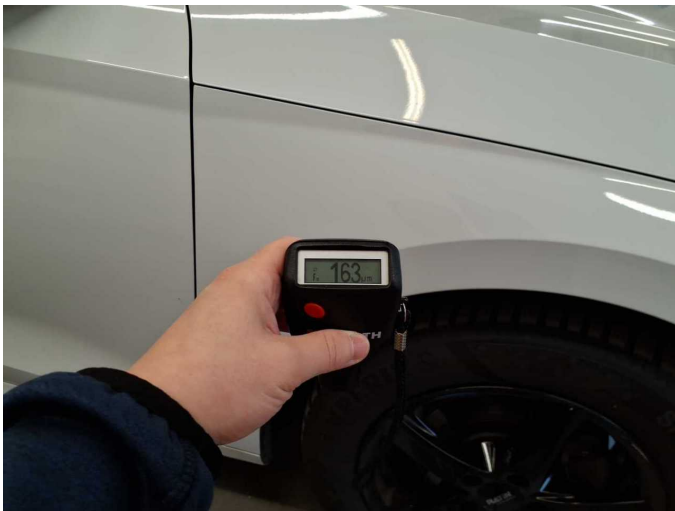
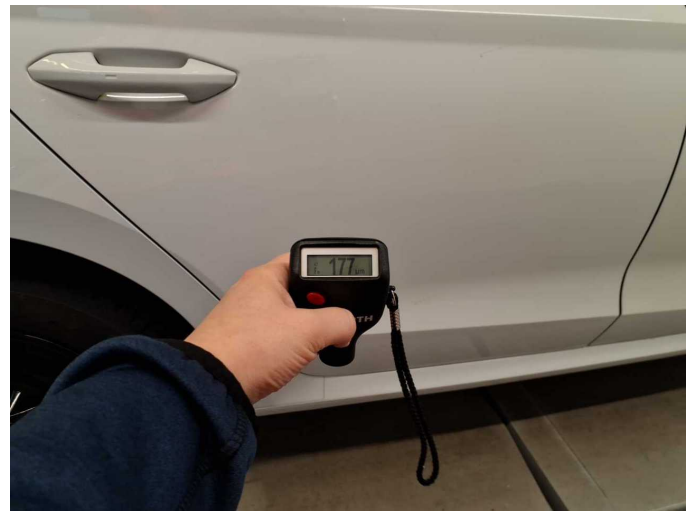
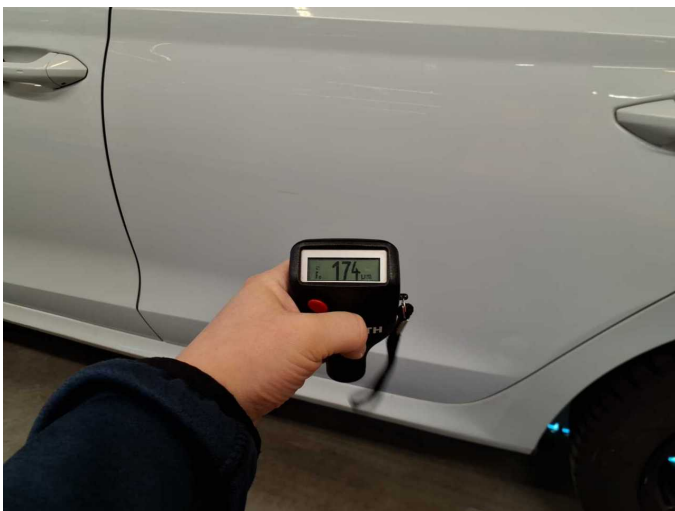
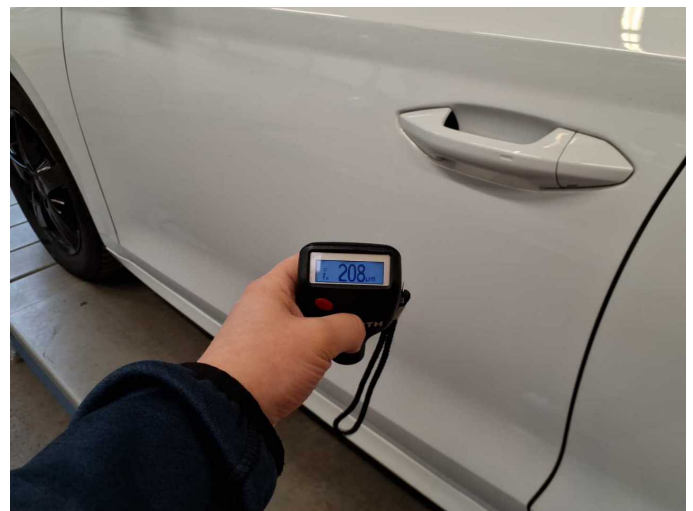
- 1 Mudguard - right side, Door - rear left side, Door - rear right side, Door - front left side, Professionally carried out, Invoice of repair done Non-existent
- 2 Mudguard - left side, Unprofessionally carried out, Invoice of repair done Non-existent

| Door - rear left side | 174 µm | Door - rear right side | 177 µm |

Repainting 1: Mudguard - right side, Door - rear left side, Door - rear right side, Door - front left side

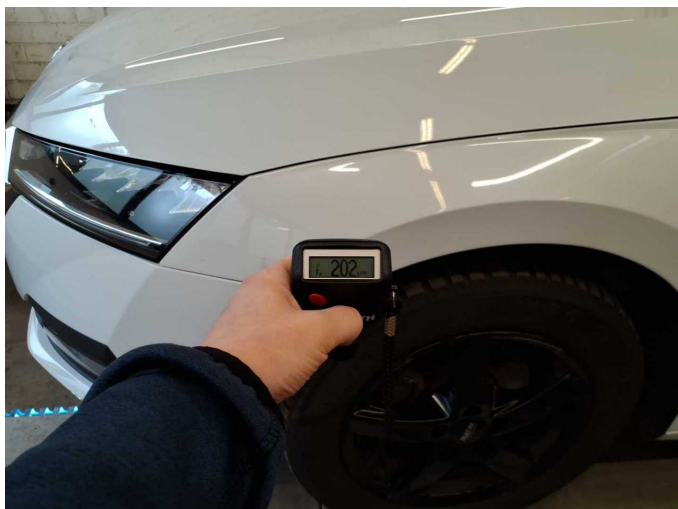
Repainting 2: Mudguard - left side
