Expertise

Protocol number: 46109419
Order No. / Reference: 26558650
Inspection date: 23 Jun 2026

Model: Twingo Electric ZEN

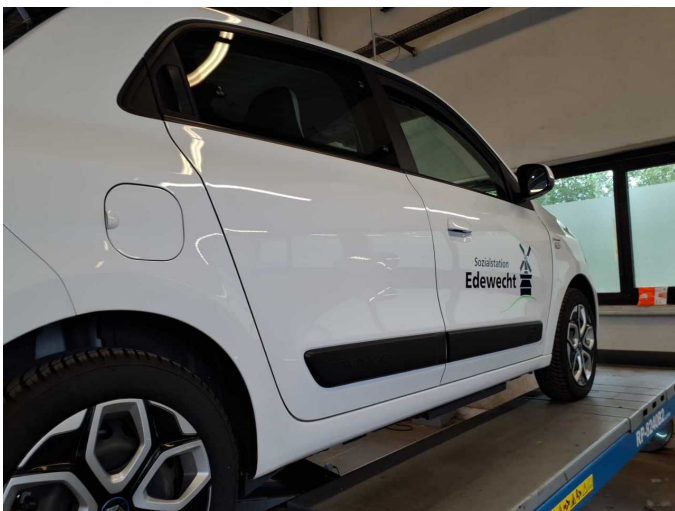
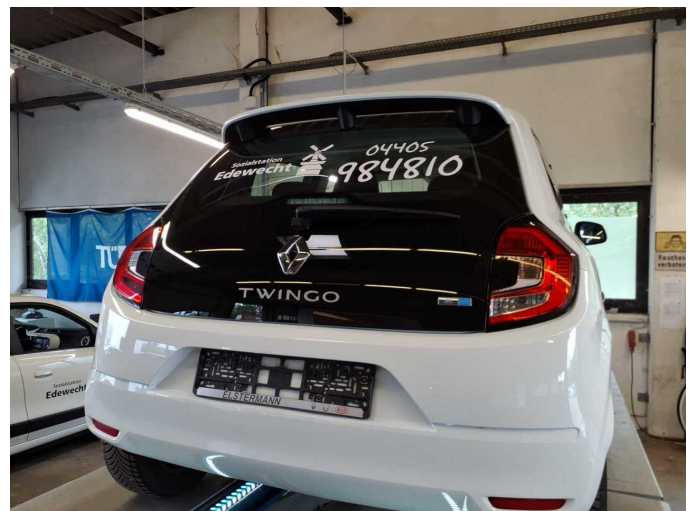
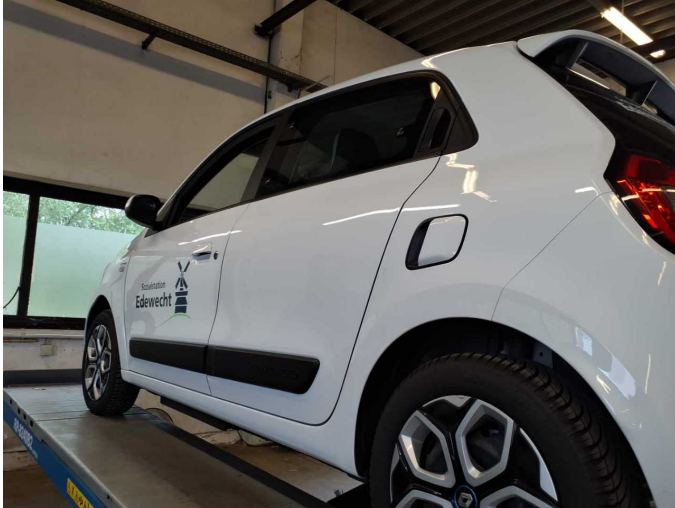
Damage 2: Body: Body - Glued / labelled - De-glue / neutralise

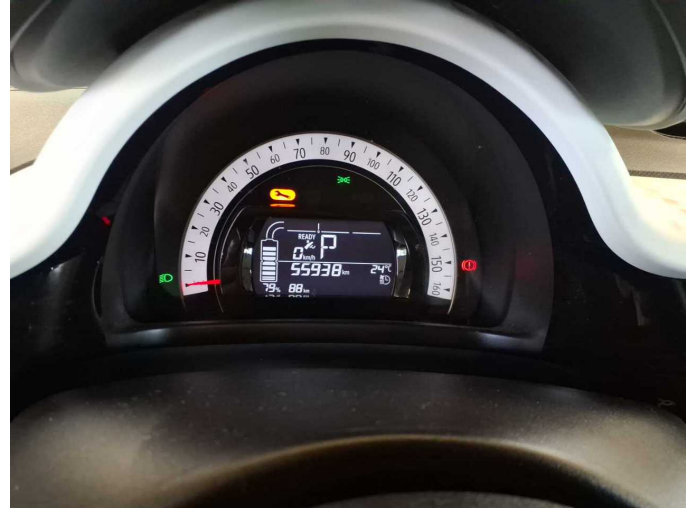
Damage 3: Misc.: Inspection / maintenance - Due - Perform

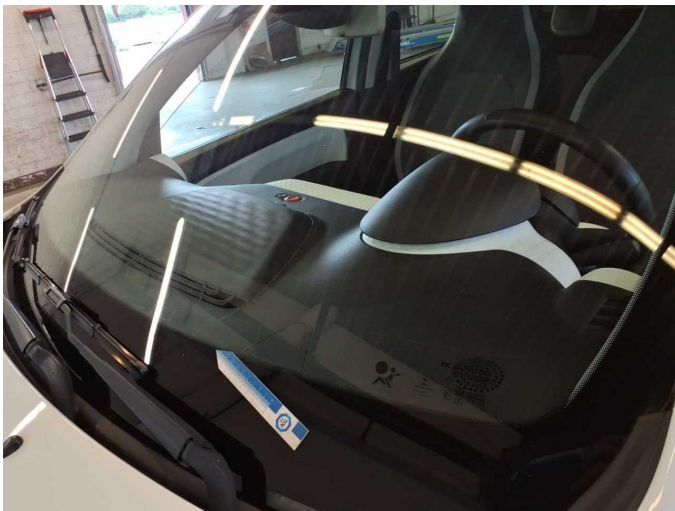
Wear and tear 2: Vehicle glazing: Windscreen - Stone chips - No deduction
