Expertise

Protocol number: 44804557
Order No. / Reference: 25619476
Inspection date: 2 Apr 2026

Model: Focus Turnier 1.5 EcoBlue Start-Stopp-System Aut.
COOL&CONNECT

VIN: WF0PXXGCHPNB00467

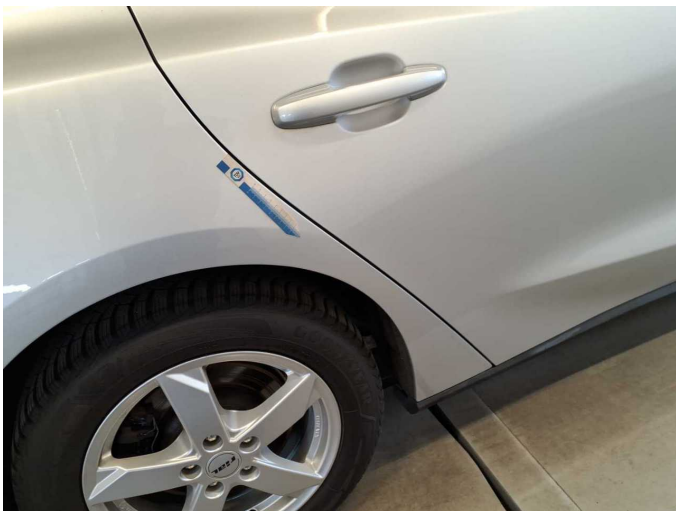
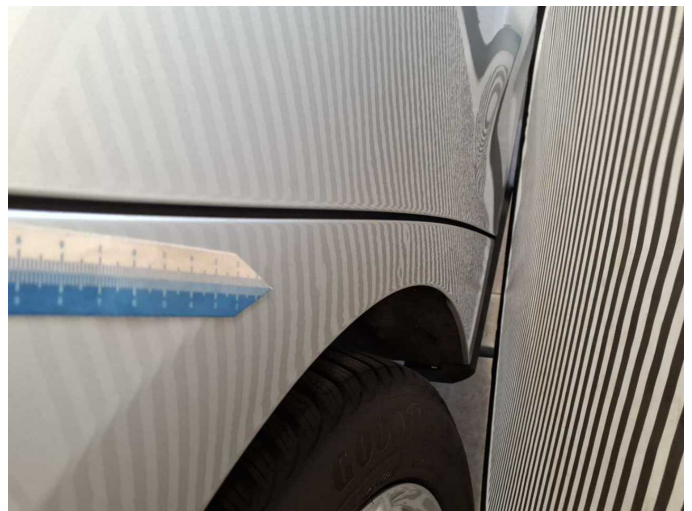
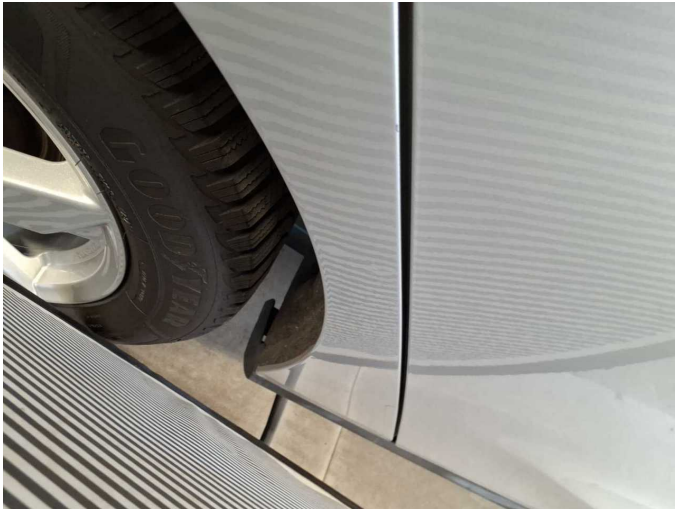
No.	Component group	Description
1	Side panel - rear right side	Elbow (3) - dent(s) - Smart repair
2	Rear bumper	Spoiler (Loch für anhängerkuppl. fehlt) - does not comply with manufacturer's specifications - Replace
3	Front bumper	Front bumper (Sandstrahleffekt) - Scratch(es) - Paint
4	2nd wheel set	2nd wheel set (Originaldesignfelgen+Reifen fehlen) - Differs from the original configuration - repair according to calculation

Damage 1: Side panel - rear right side: Elbow (3) - dent(s) - Smart repair

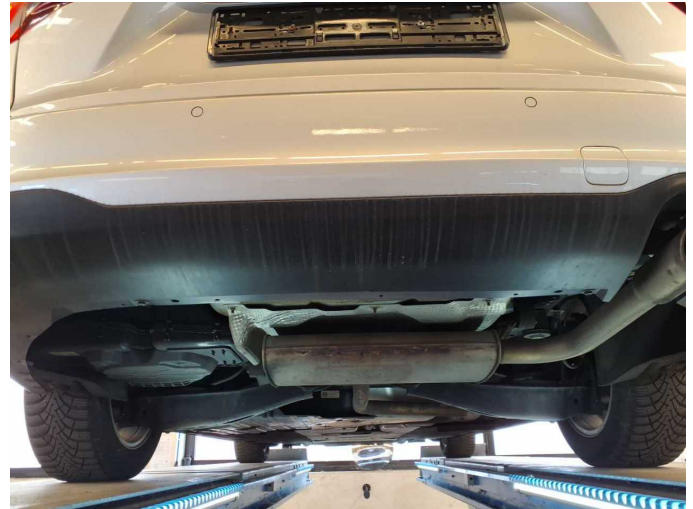
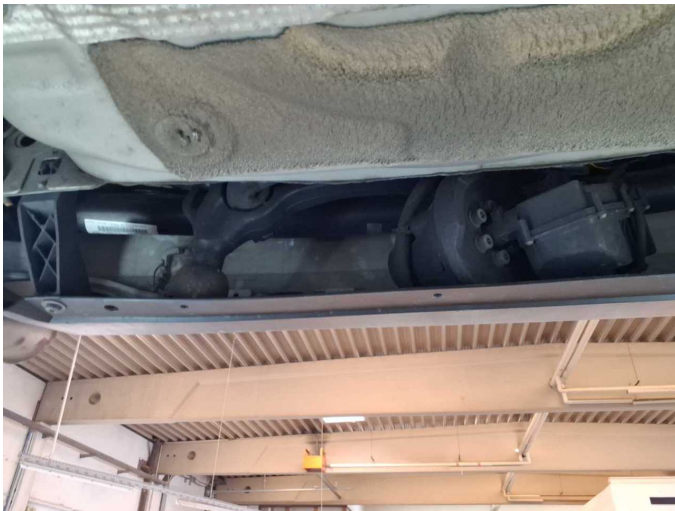
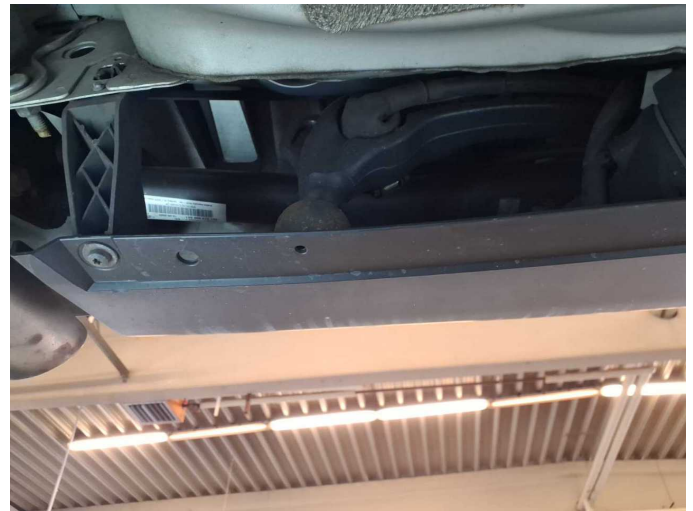
Damage 2: Rear bumper: Spoiler (Loch für anhängerkuppl. fehlt) - does not comply with manufacturer's specifications - Replace

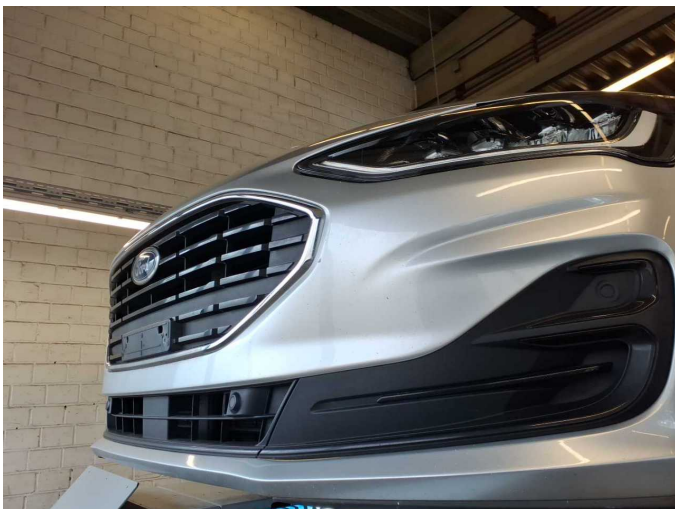
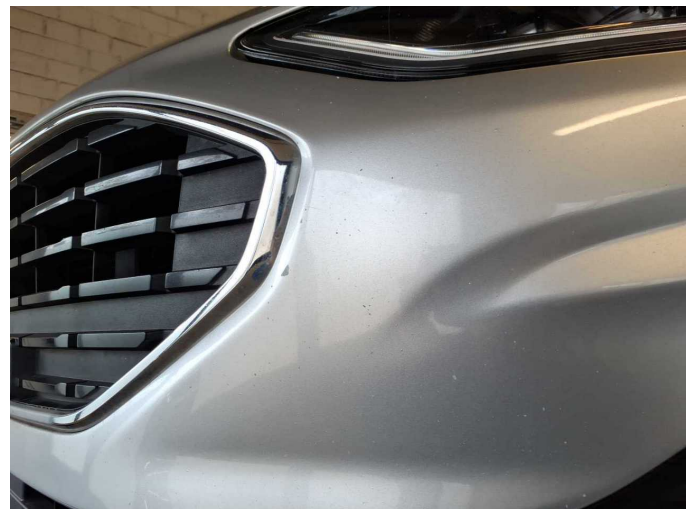
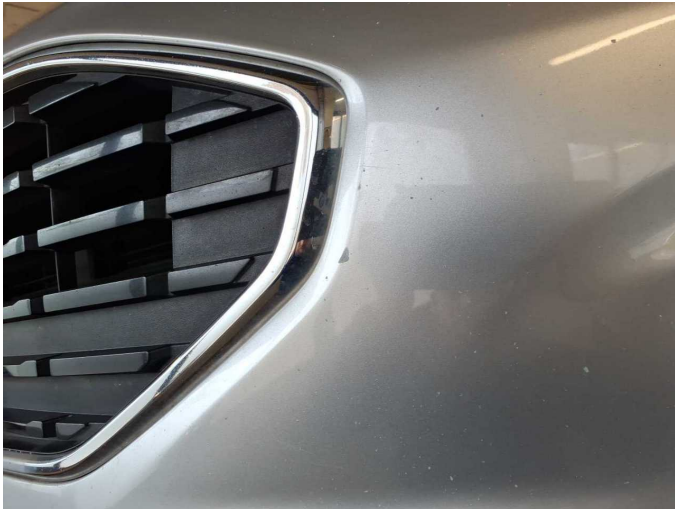
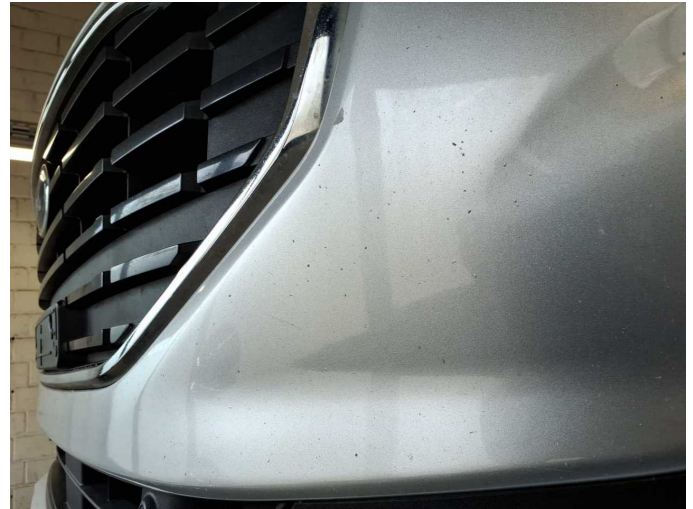
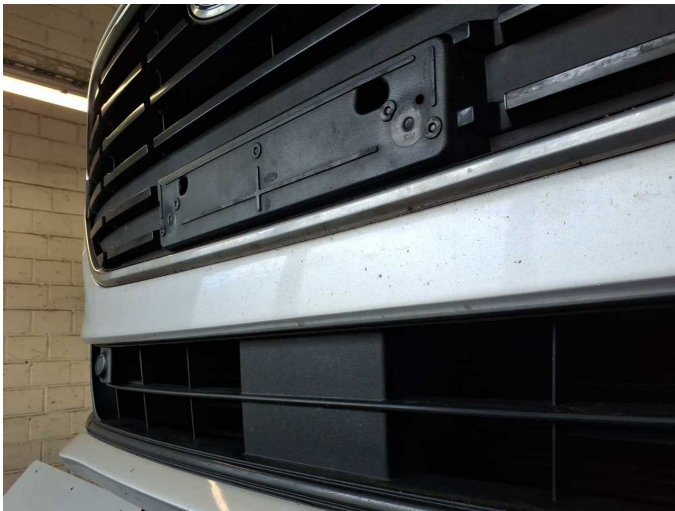
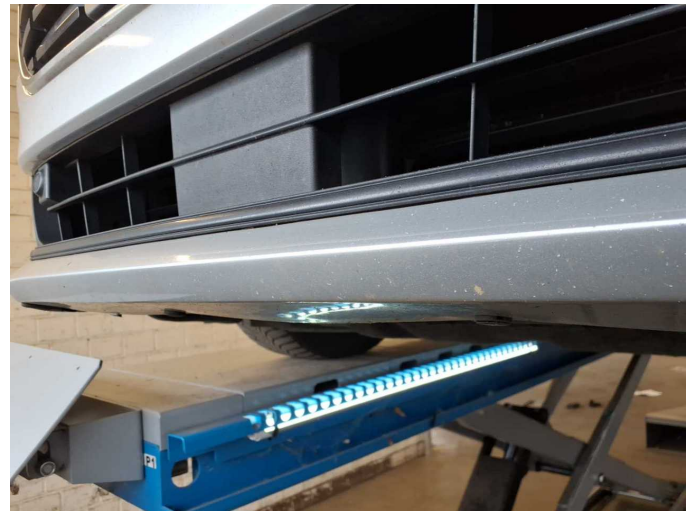
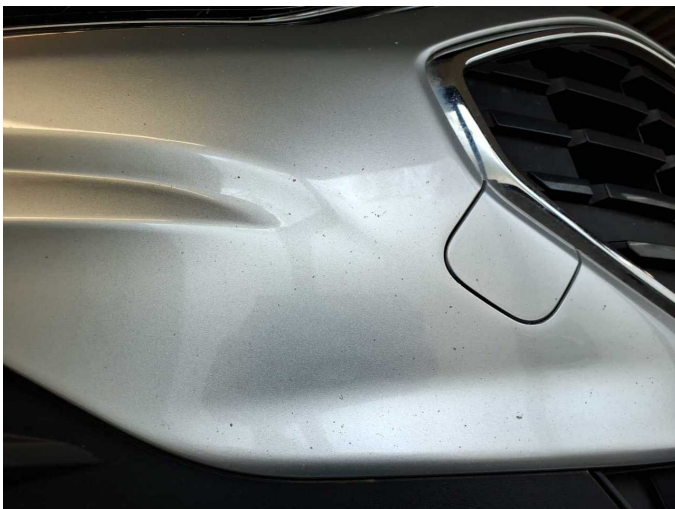
Damage 3: Front bumper: Front bumper (Sandstrahleffekt) - Scratch(es) - Paint

Damage 3: Front bumper: Front bumper (Sandstrahleffekt) - Scratch(es)
- Paint

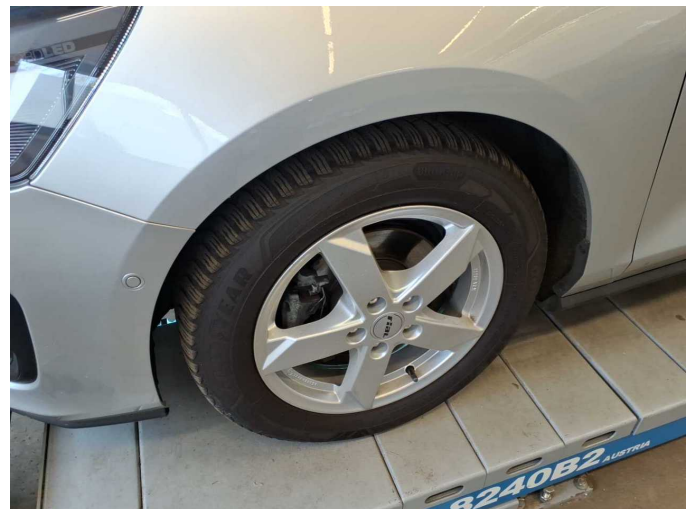
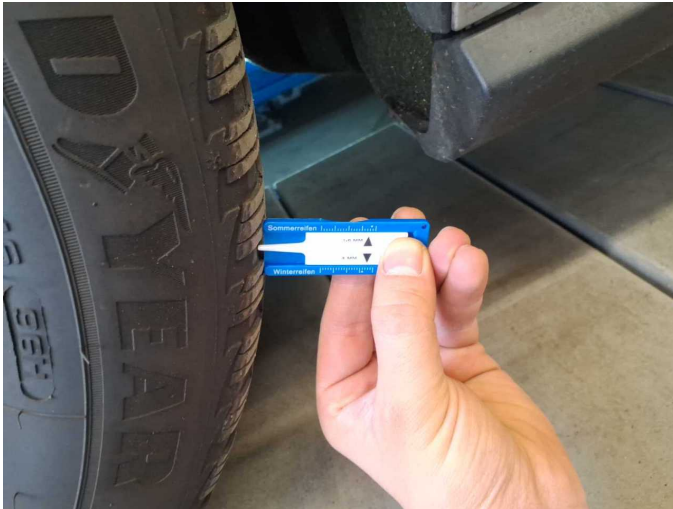
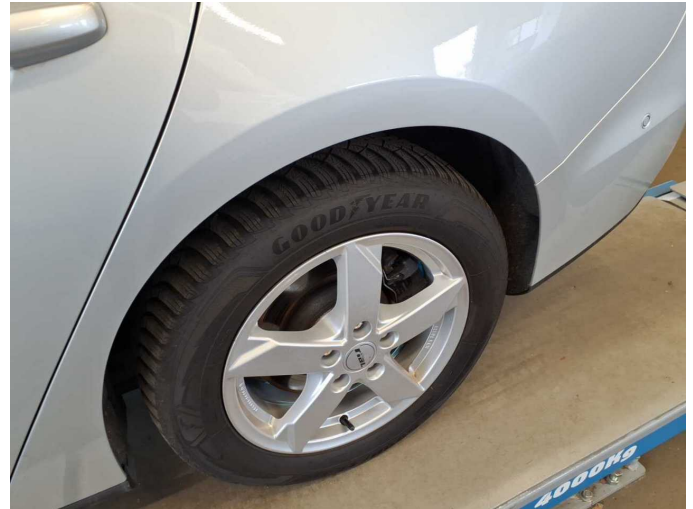
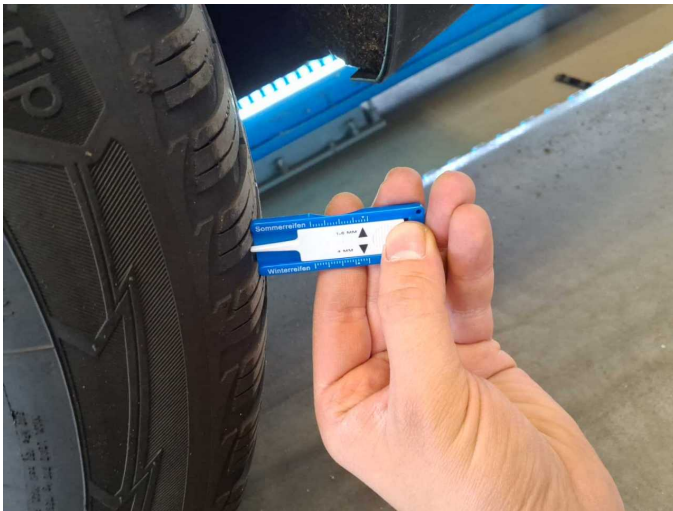
Wear and tear 1: Wheel / tyres: Tyres - complete set - Does not meet the
leasing specifications - No deduction

Wear and tear 1: Wheel / tyres: Tyres - complete set - Does not meet the leasing specifications - No deduction

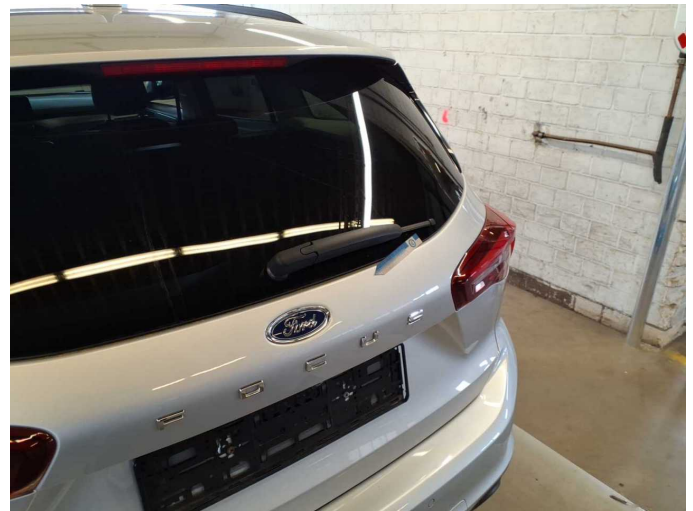
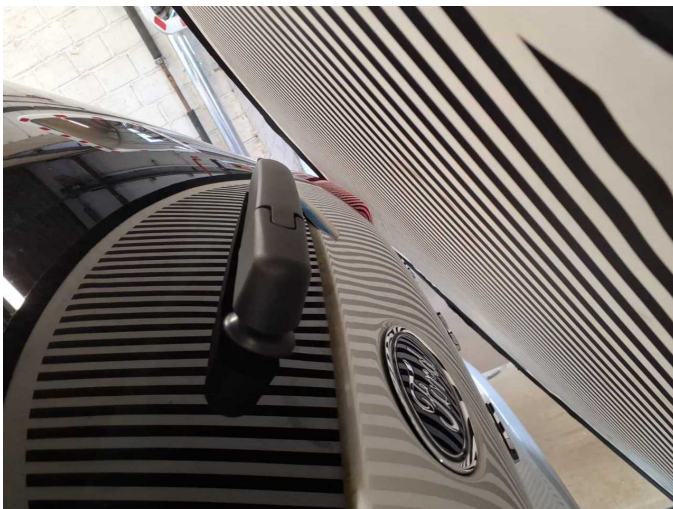
Wear and tear 2: Boot lid / rear door: Boot lid (1) - dent(s) - No deduction

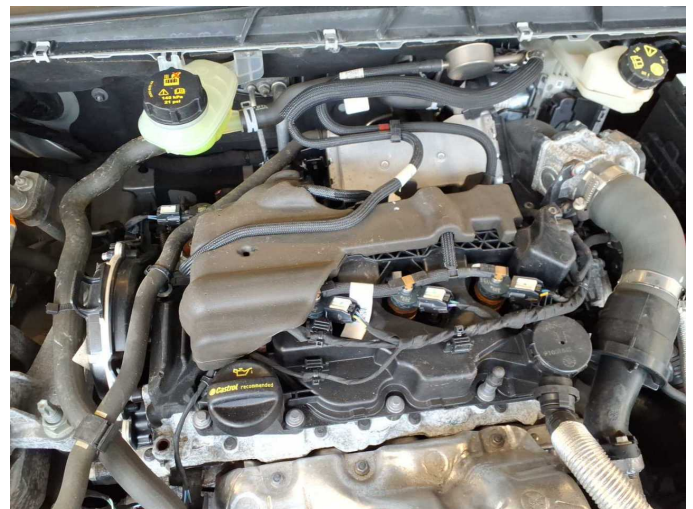
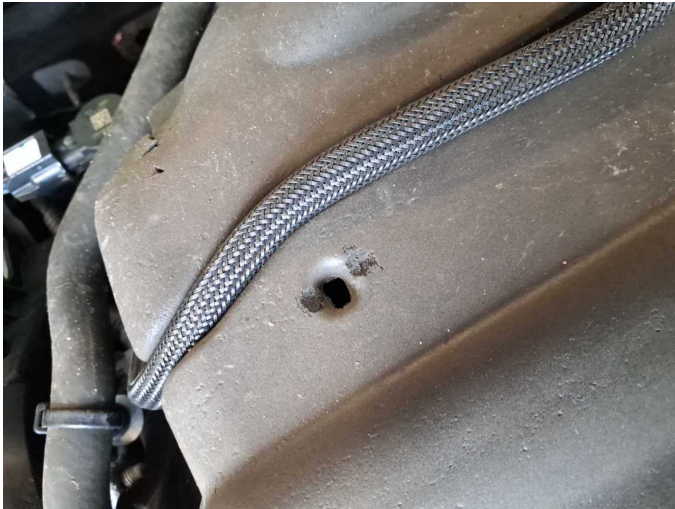
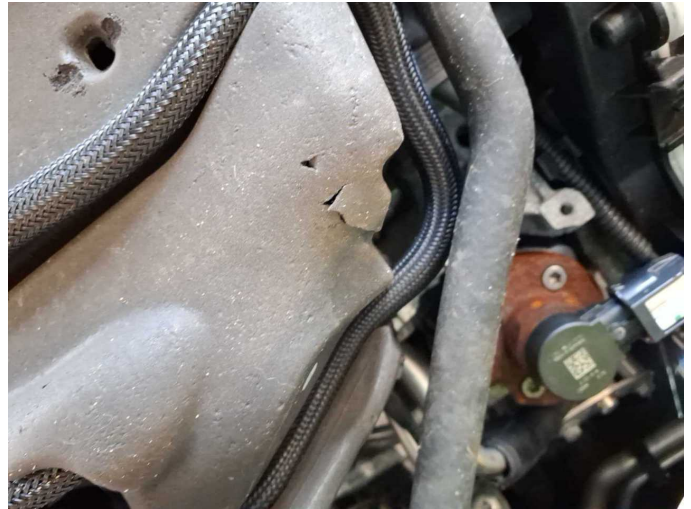
Engine - Engine cover (+Maderbiss)

Missing part 1: Engine: Engine cover (+Maderbiss) - Missing - Replace

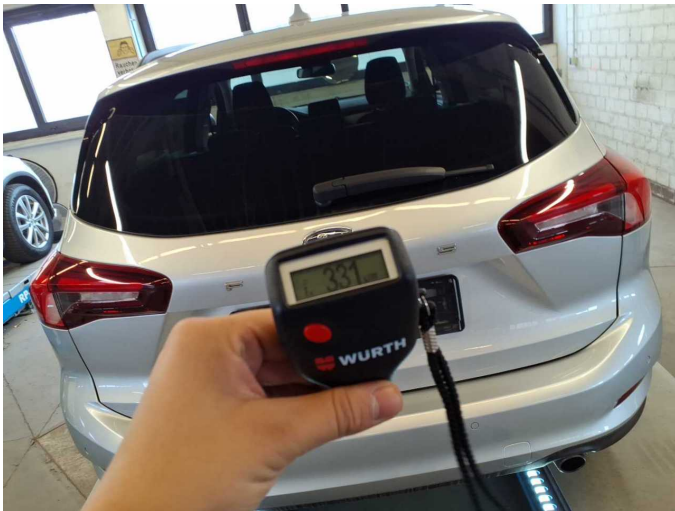
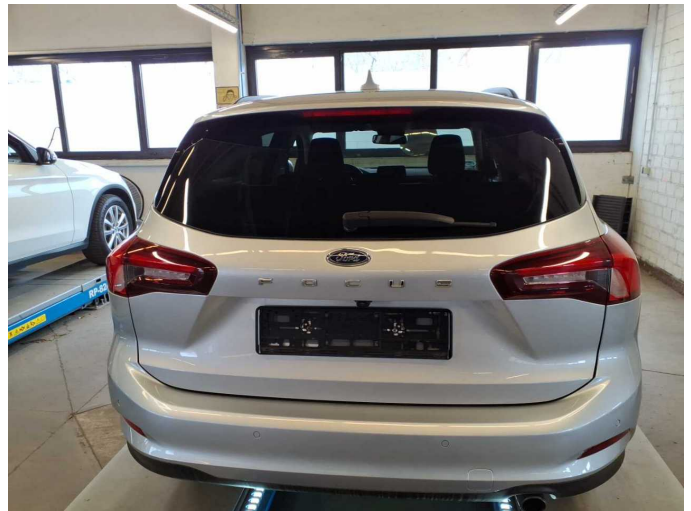
1	Boot lid / rear door, Professionally carried out, Invoice of repair done Non-existent
---	---

Repainting 1: Boot lid / rear door
