Expertise

Protocol number: 46029072  
Order No. / Reference: 26530008  
Inspection date: 18 Jun 2026

| Manufacturer: CUPRA | Model: Born 150kW/58kWh |
| VIN: VSSZZK19RP027353 | |

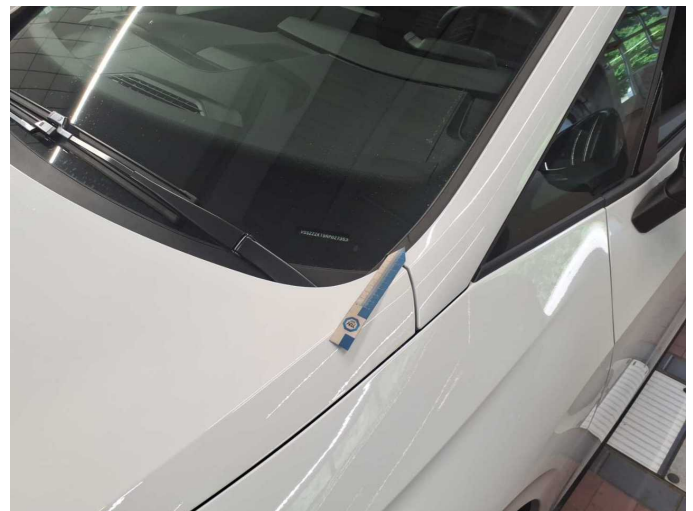
| No. | Component group | Description |
|---|---|---|
| 1 | Trim / covers | Brightware / decorative strip (Frontscheibe links) - Scratch(es) - Replace |

**Damage 1:** Trim / covers: Brightware / decorative strip (Frontscheibe links) - Scratch(es) - Replace

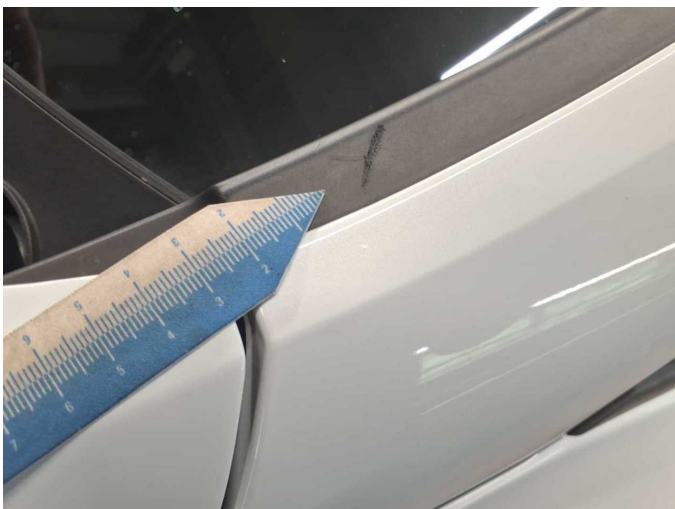
**Damage 1:** Trim / covers: Brightware / decorative strip (Frontscheibe links) - Scratch(es) - Replace

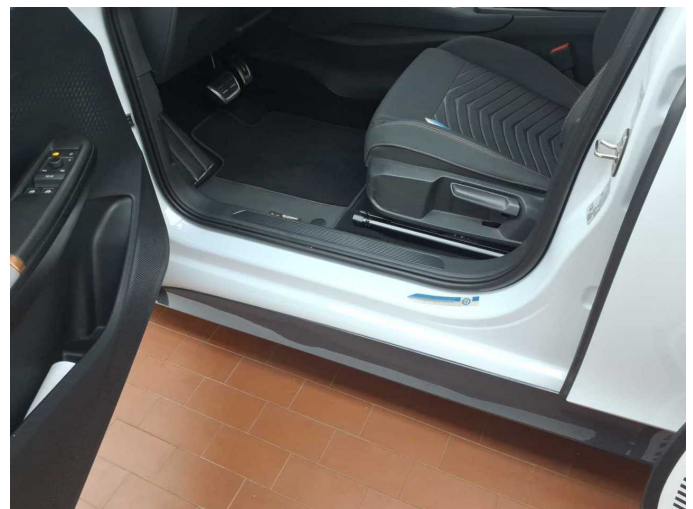
| No. | Component group | Description |
|---|---|---|
| 2 | Sill - left side | Sill (Vorne) - dent(s) - Smooth repair work |

**Damage 2:** Sill - left side: Sill (Vorne) - dent(s) - Smooth repair work

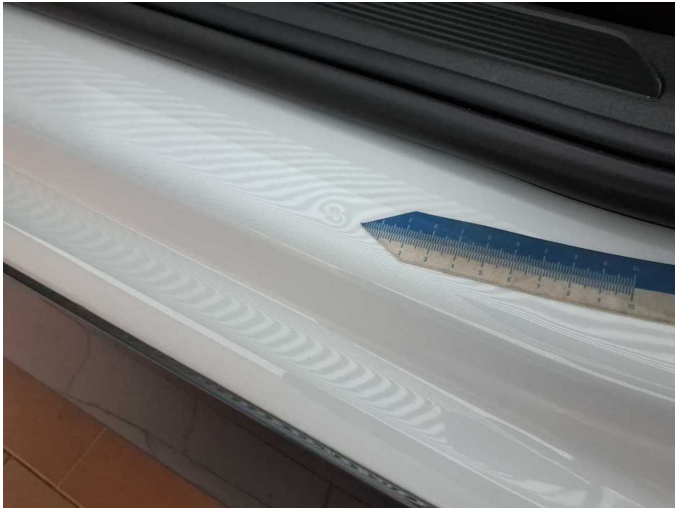
**Damage 2:** Sill - left side: Sill (Vorne) - dent(s) - Smooth repair work

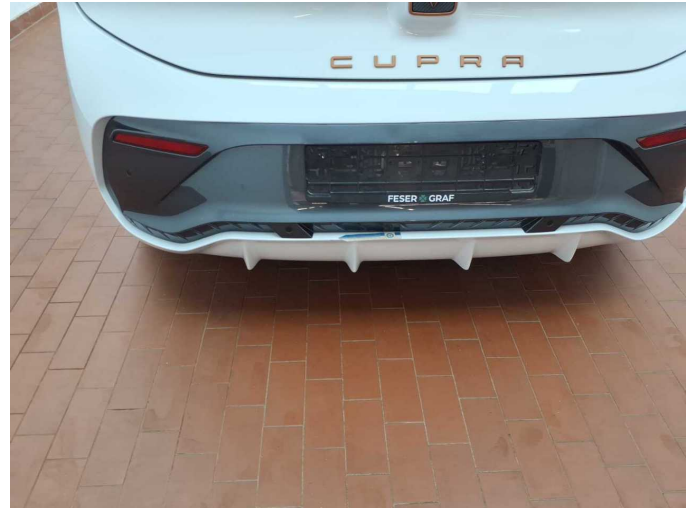
| No. | Component group | Description |
|---|---|---|
| 3 | Rear bumper | Rear bumper - Scratch(es) - Smart repair |

**Damage 3:** Rear bumper: Rear bumper - Scratch(es) - Smart repair

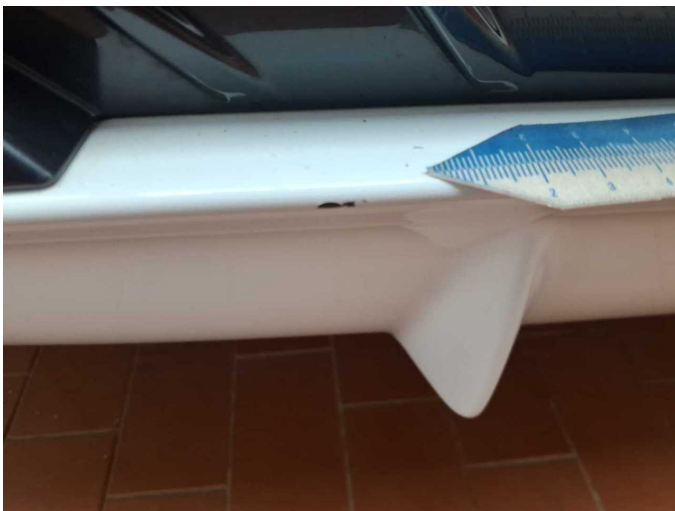
**Damage 3:** Rear bumper: Rear bumper - Scratch(es) - Smart repair

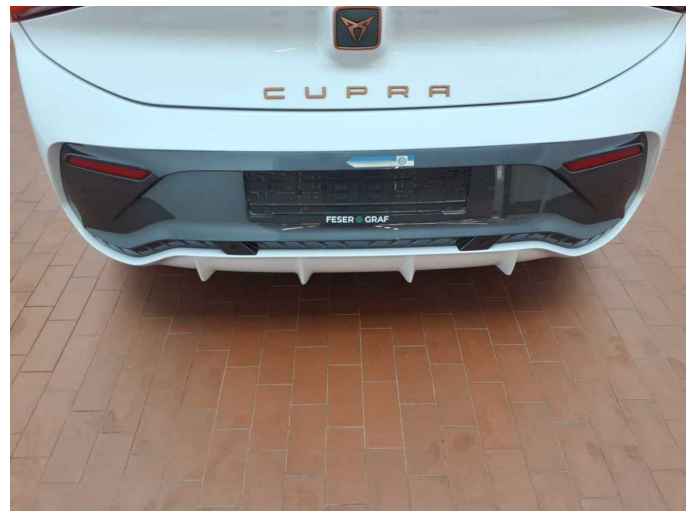
| No. | Component group | Description |
|---|---|---|
| 4 | Rear bumper | Spoiler - Scratched - Repair and paint |

**Damage 4:** Rear bumper: Spoiler - Scratched - Repair and paint

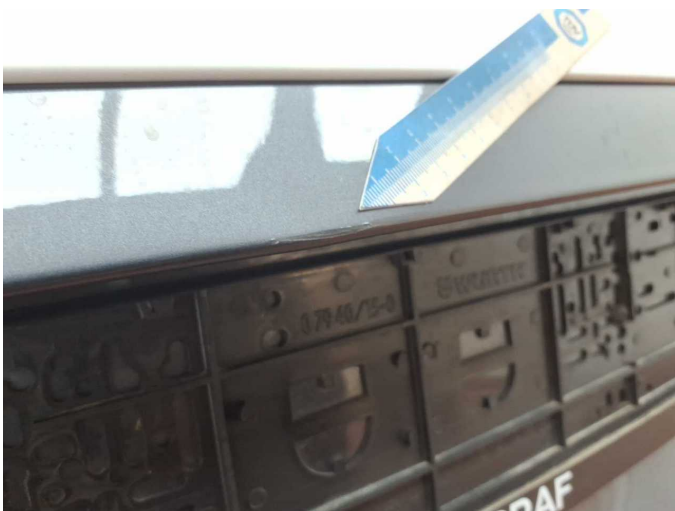
**Damage 4:** Rear bumper: Spoiler - Scratched - Repair and paint

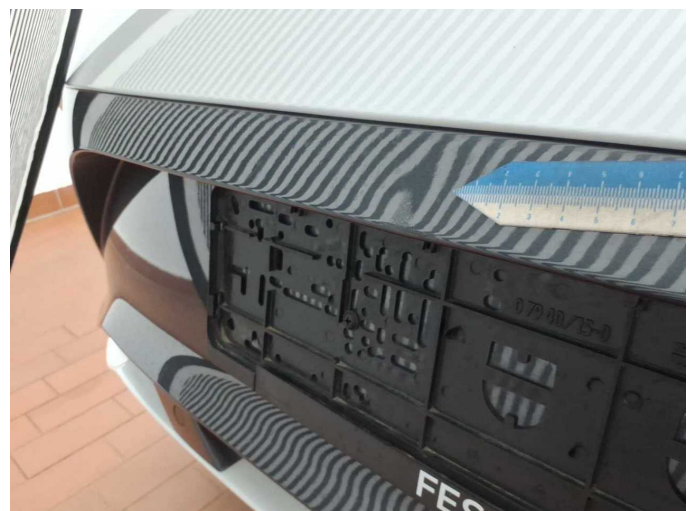
**Damage 4:** Rear bumper: Spoiler - Scratched - Repair and paint

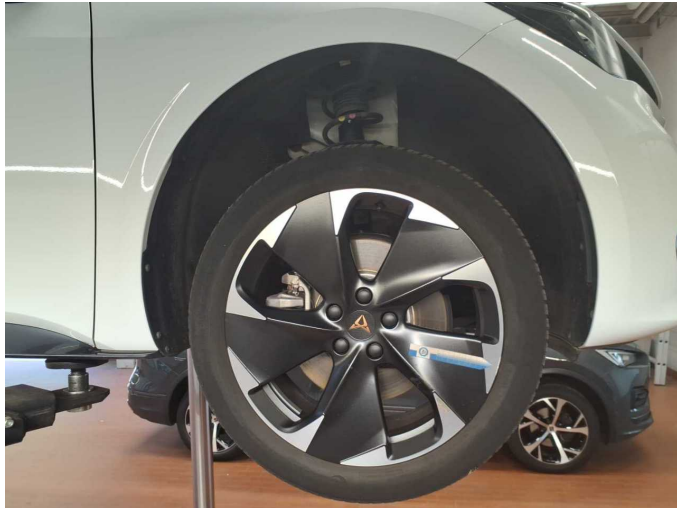
| No. | Component group | Description |
|---|---|---|
| 5 | Wheel / tyres | Alloy rim - front right side (Materialabtrag) - Scratched - Loss in value |

**Damage 5:** Wheel / tyres: Alloy rim - front right side (Materialabtrag) - Scratched - Loss in value

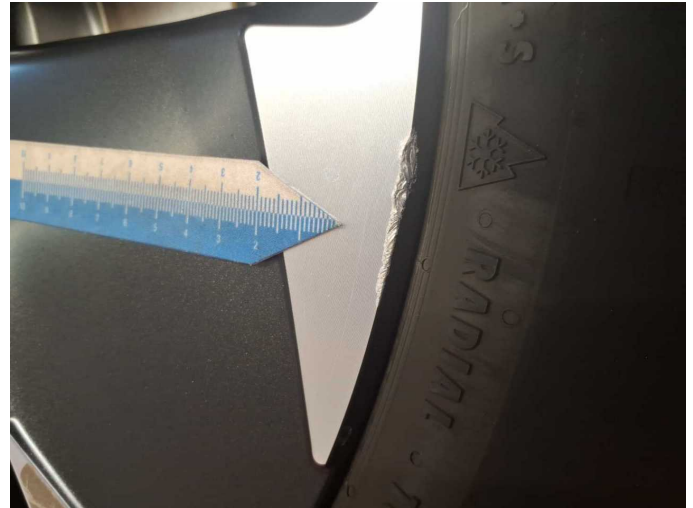
**Damage 5:** Wheel / tyres: Alloy rim - front right side (Materialabtrag) - Scratched - Loss in value

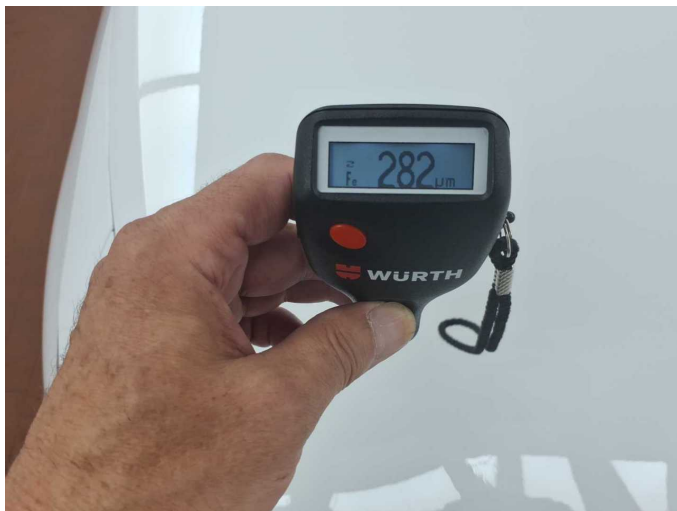
| 1 | Bonnet |

| Bonnet | 282 µm |

**Repainting 1:** Bonnet
