Expertise

Protocol number: 46210481  
Order No. / Reference: 26535079  
Inspection date: 25 Jun 2026

Manufacturer: Ford  
VIN: WF0JXXWPCJNP22584

Model: S-Max 2.0 EcoBlue Aut. Trend

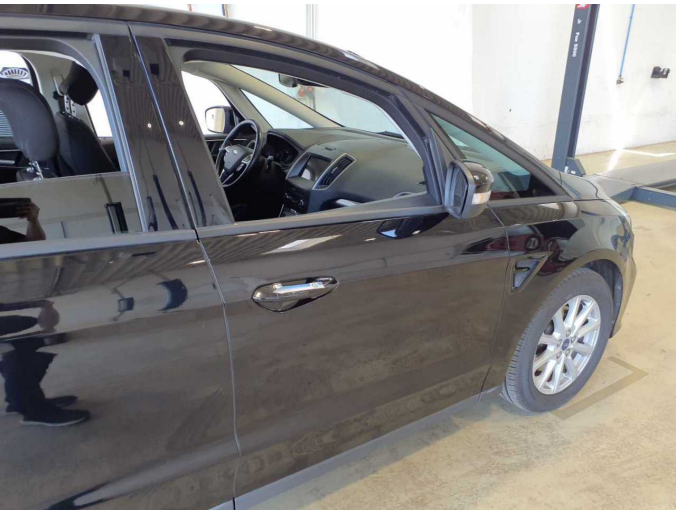
| No. | Component group | Description |
|---|---|---|
| 1 | Door - front right side | Door handle - outside - Scratch(es) - Smart repair |

Damage 1: Door - front right side: Door handle - outside - Scratch(es) - Smart repair

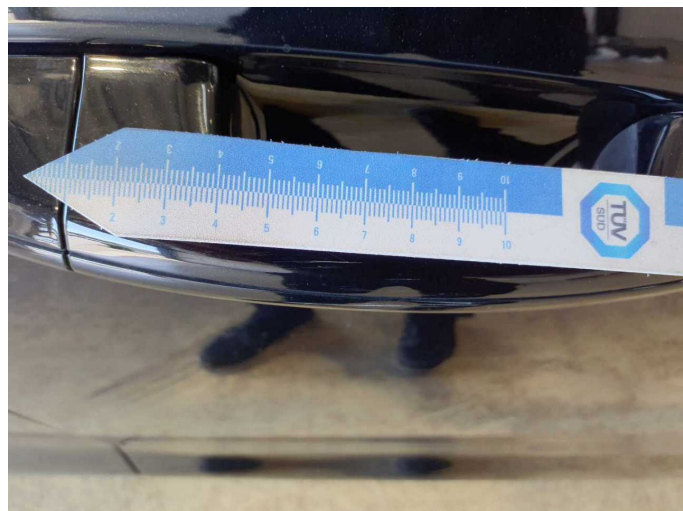
Damage 1: Door - front right side: Door handle - outside - Scratch(es) - Smart repair

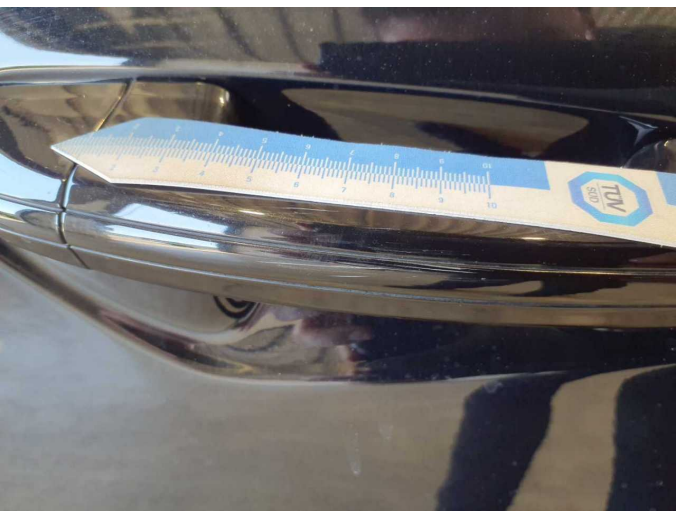
Damage 1: Door - front right side: Door handle - outside - Scratch(es) - Smart repair

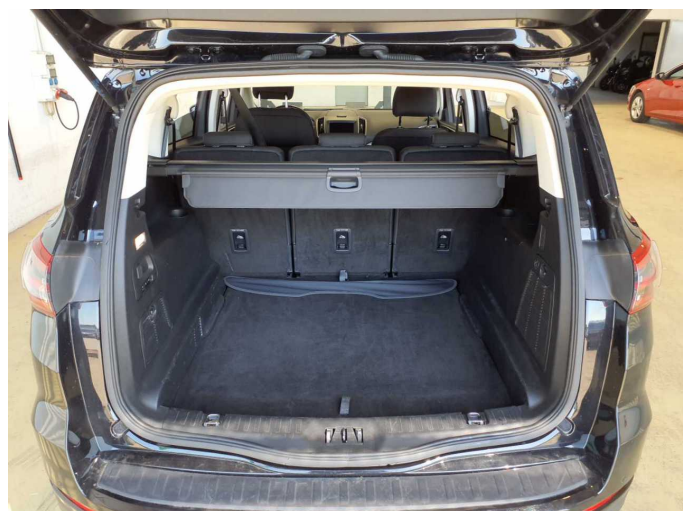
| No. | Component group | Description |
|---|---|---|
| 2 | Boot lid / rear door | Seal - Broken / torn - Replace |

Damage 2: Boot lid / rear door: Seal - Broken / torn - Replace

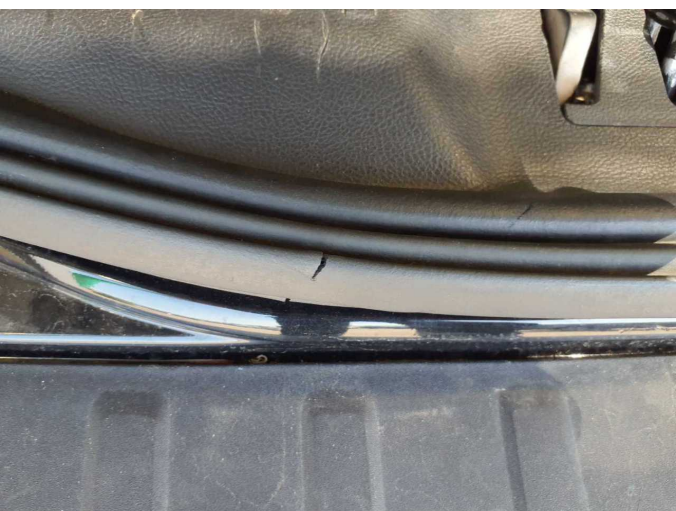
Damage 2: Boot lid / rear door: Seal - Broken / torn - Replace

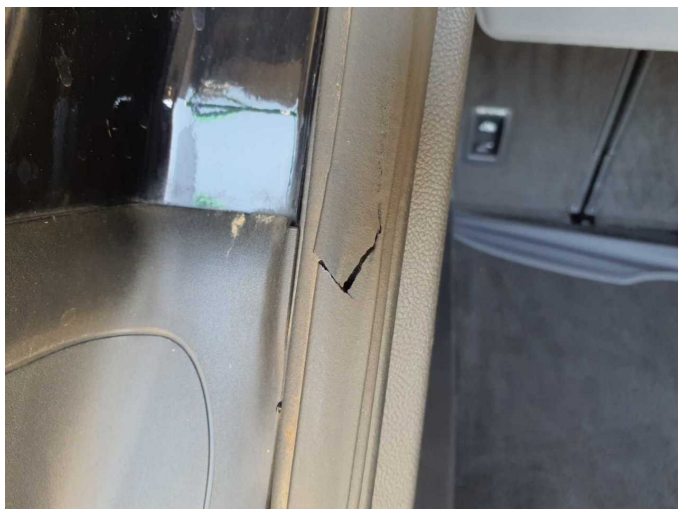
**Damage 2:** Boot lid / rear door: Seal - Broken / torn - Replace

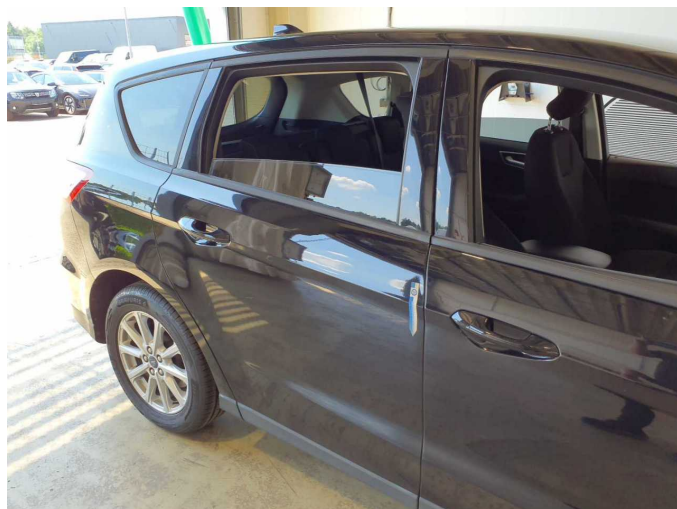
| No. | Component group | Description |
|---|---|---|
| 3 | Door - rear right side | Door - Scratch(es) - Smart repair |

**Damage 3:** Door - rear right side: Door - Scratch(es) - Smart repair

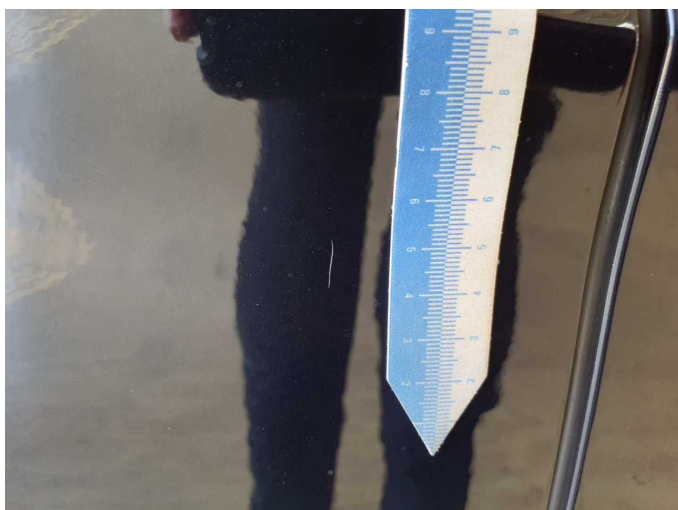
**Damage 3:** Door - rear right side: Door - Scratch(es) - Smart repair

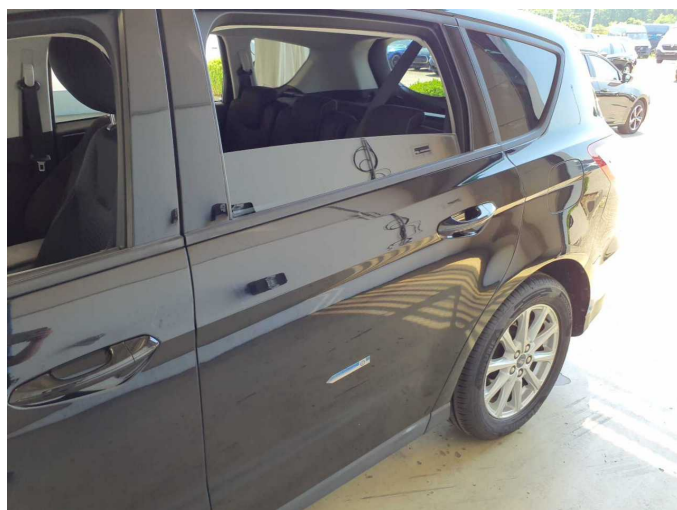
| No. | Component group | Description |
|---|---|---|
| 4 | Door - rear left side | Door (Wellig) - Unprofessionally repaired - Repair and paint |

| Side panel - rear right side | 161 µm | Door - rear left side | 167 µm |

**Damage 4:** Door - rear left side: Door (Wellig) - Unprofessionally repaired - Repair and paint

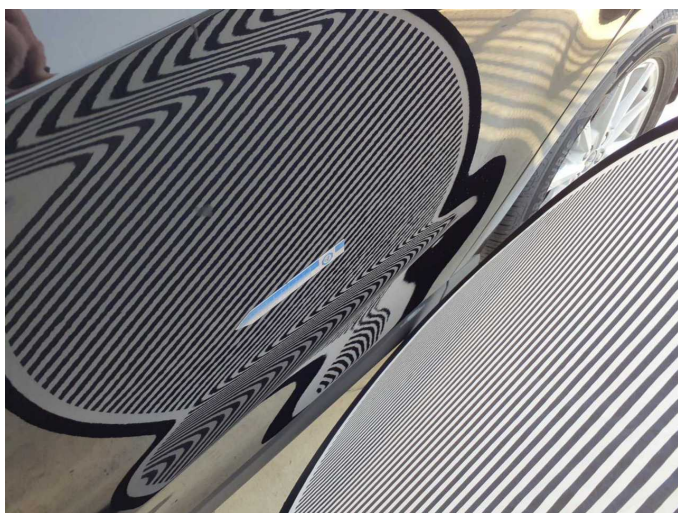
**Damage 4:** Door - rear left side: Door (Wellig) - Unprofessionally repaired - Repair and paint

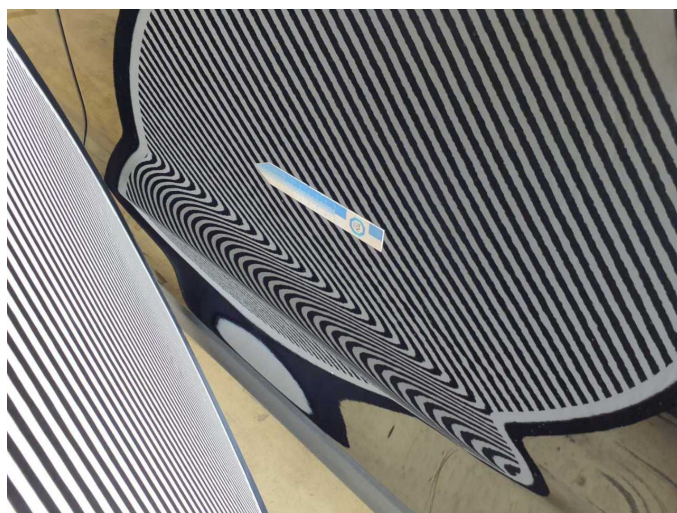
**Damage 4:** Door - rear left side: Door (Wellig) - Unprofessionally repaired - Repair and paint

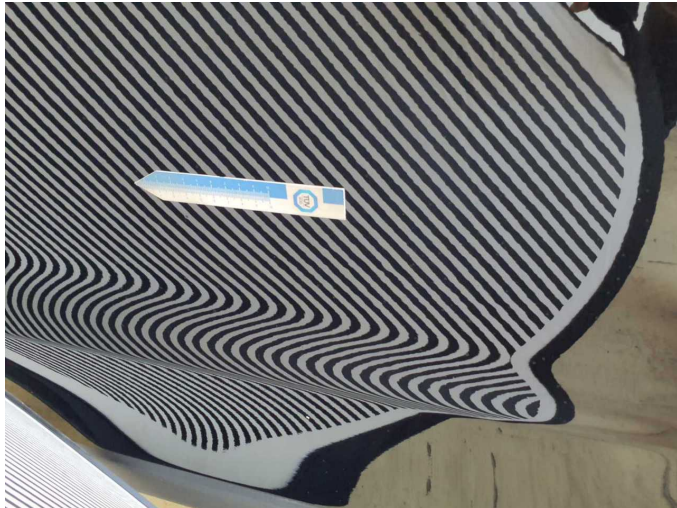
**Damage 4:** Door - rear left side: Door (Wellig) - Unprofessionally repaired - Repair and paint

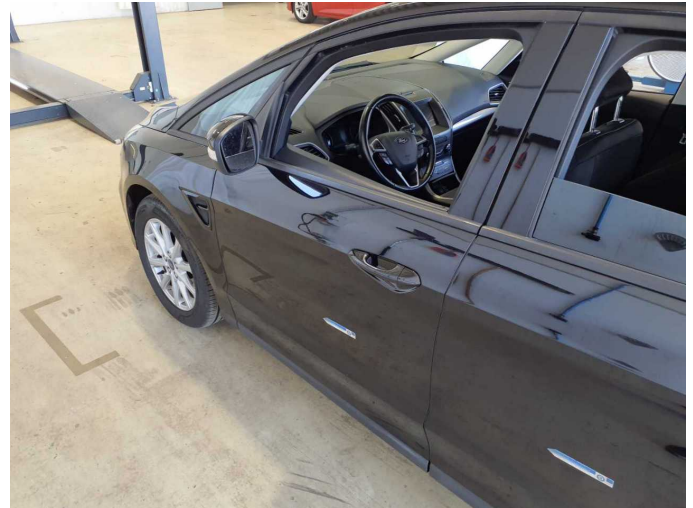
| No. | Component group | Description |
|---|---|---|
| 5 | Door - front left side | Door (Wellig) - Unprofessionally repaired - Repair and paint |

| Door - front left side | 185 µm | Door - front right side | 213 µm |

**Damage 5:** Door - front left side: Door (Wellig) - Unprofessionally repaired - Repair and paint

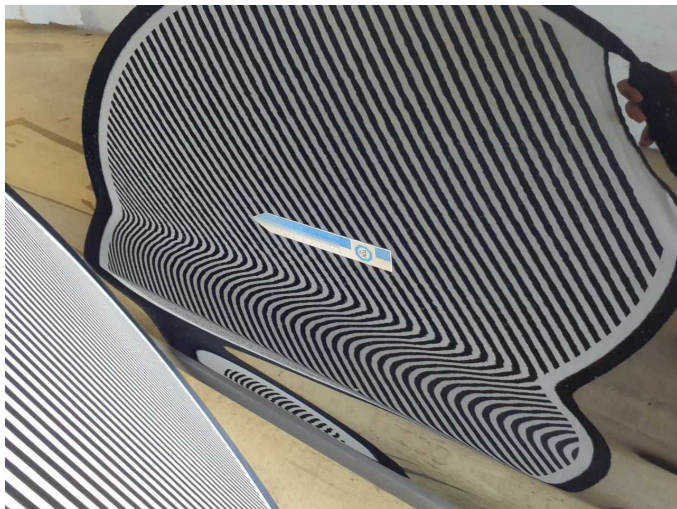
**Damage 5:** Door - front left side: Door (Wellig) - Unprofessionally repaired - Repair and paint

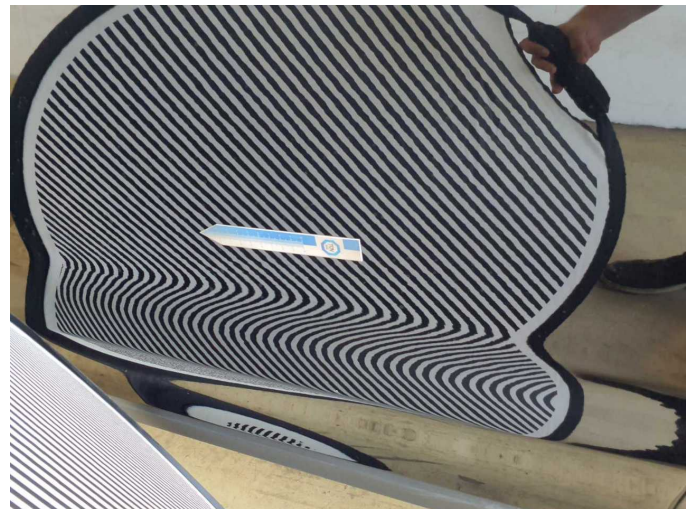
**Damage 5:** Door - front left side: Door (Wellig) - Unprofessionally repaired - Repair and paint

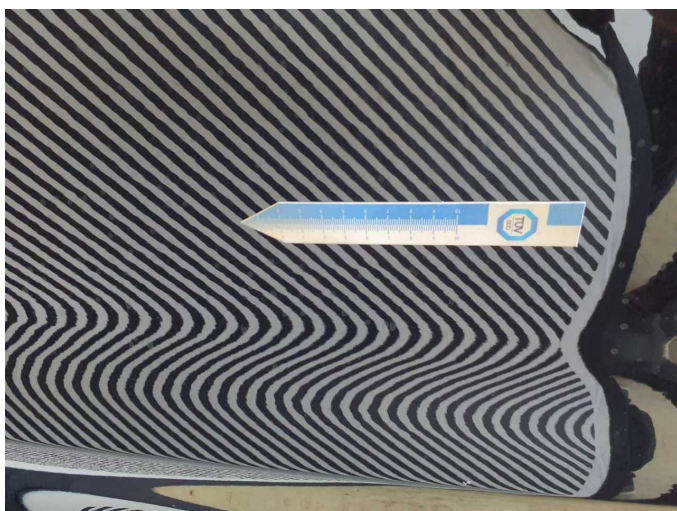
**Damage 5:** Door - front left side: Door (Wellig) - Unprofessionally repaired - Repair and paint

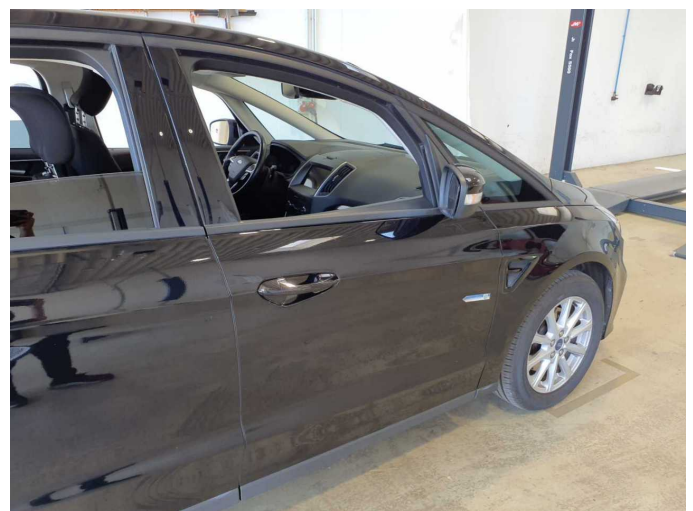
| No. | Component group | Description |
|---|---|---|
| 6 | Door - front right side | Door (Wellig) - Unprofessionally repaired - Repair and paint |

**Damage 6:** Door - front right side: Door (Wellig) - Unprofessionally repaired - Repair and paint

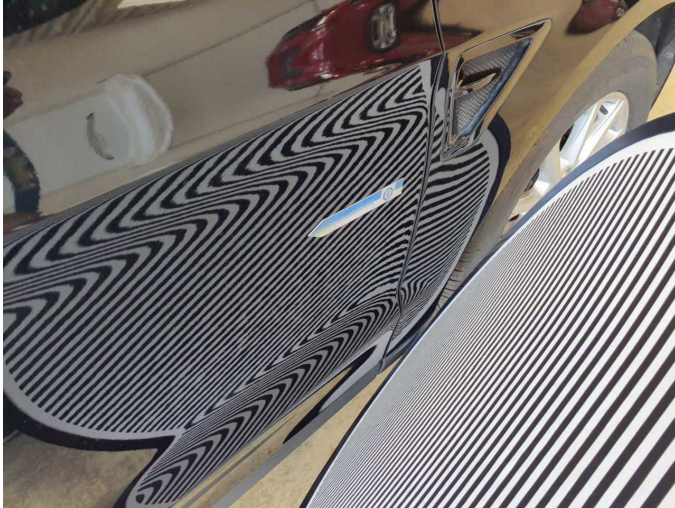
**Damage 6:** Door - front right side: Door (Wellig) - Unprofessionally repaired - Repair and paint

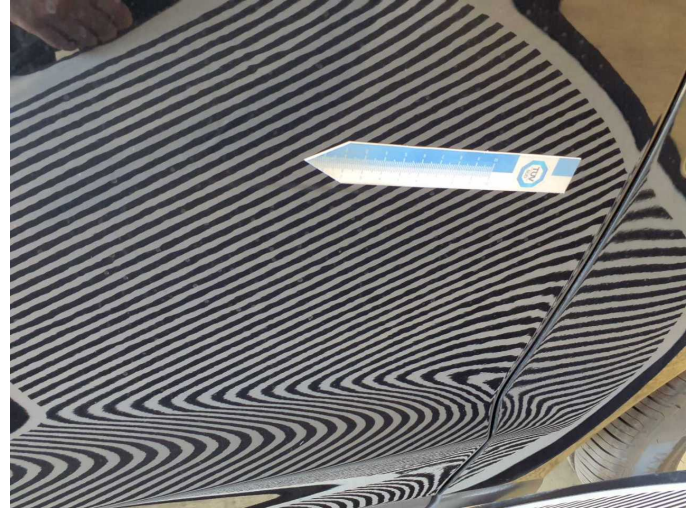
**Damage 6:** Door - front right side: Door (Wellig) - Unprofessionally repaired - Repair and paint

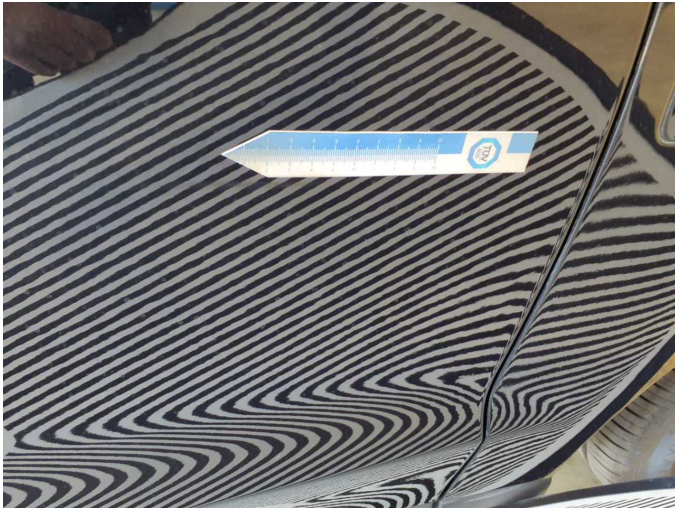
**Damage 6:** Door - front right side: Door (Wellig) - Unprofessionally repaired - Repair and paint

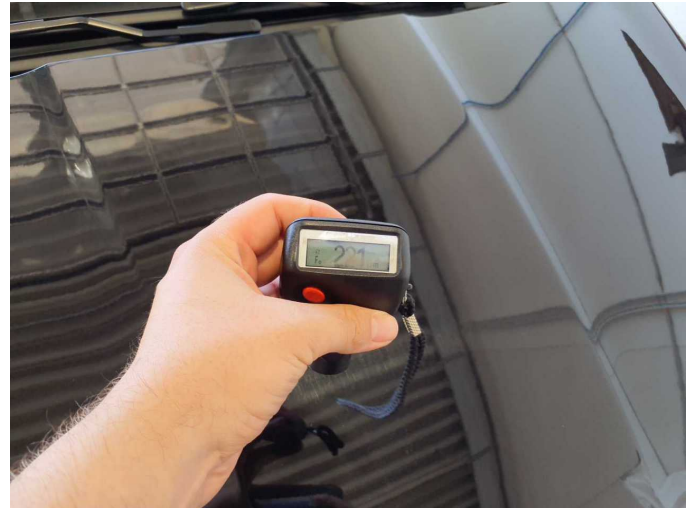
- 1 Bonnet, Side panel - rear left side, Side panel - rear right side, Professionally carried out, Invoice of repair done Non-existent
- 2 Door - rear left side, Door - front left side, Unprofessionally carried out, Invoice of repair done Non-existent
- 3 Door - front right side, Unprofessionally carried out, Invoice of repair done Non-existent

| Bonnet | 221 µm | Side panel - rear left side | 281 µm |

**Repainting 1:** Bonnet, Side panel - rear left side, Side panel - rear right side

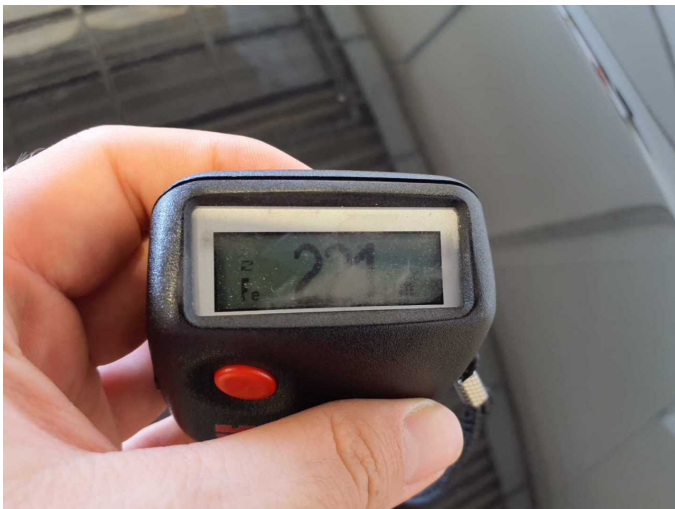
**Repainting 1:** Bonnet, Side panel - rear left side, Side panel - rear right side

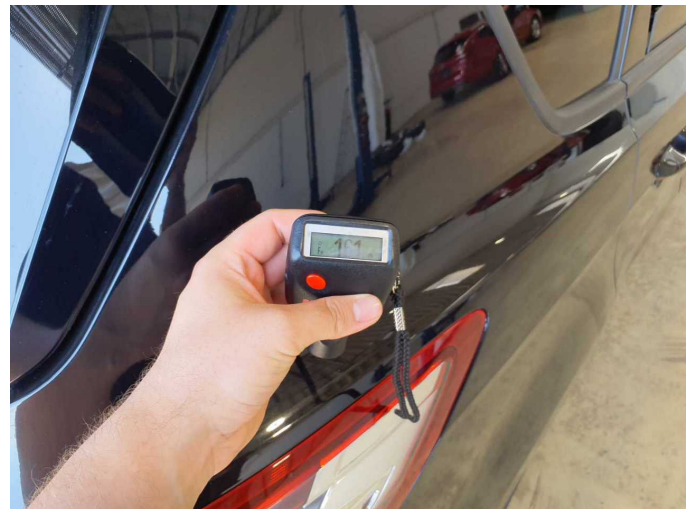
**Repainting 1:** Bonnet, Side panel - rear left side, Side panel - rear right side

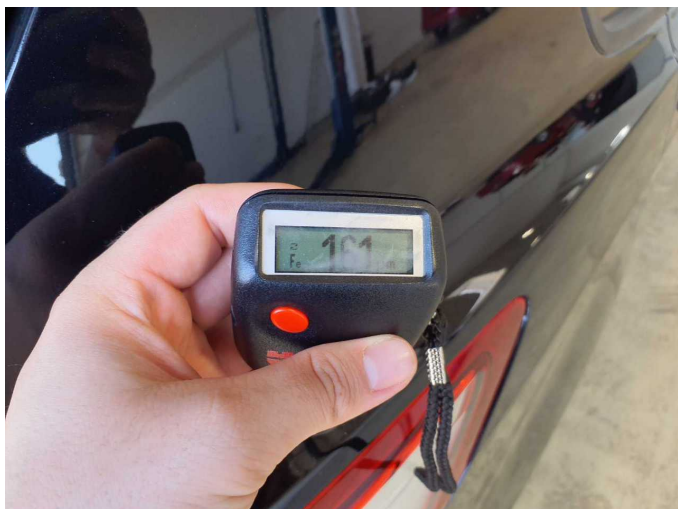
**Repainting 1:** Bonnet, Side panel - rear left side, Side panel - rear right side

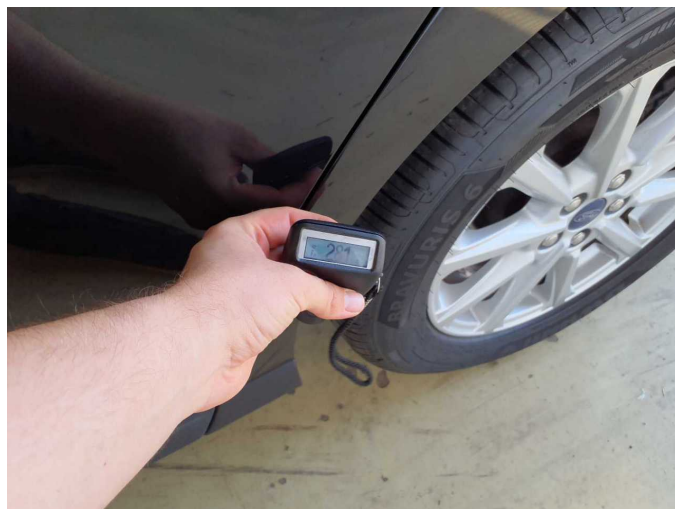
**Repainting 1:** Bonnet, Side panel - rear left side, Side panel - rear right side

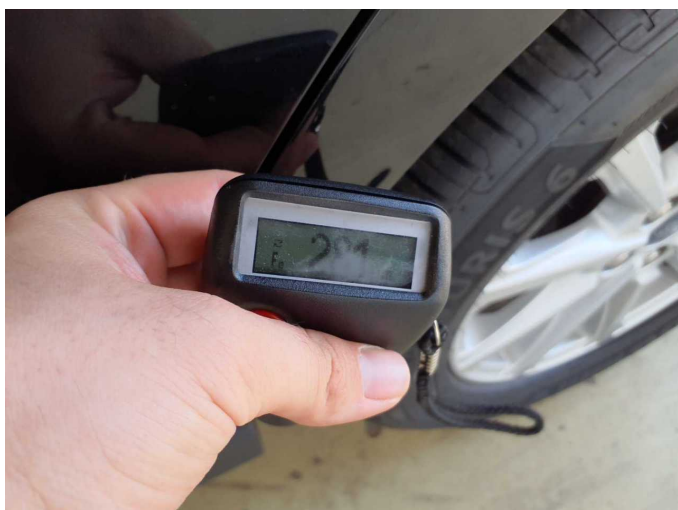
**Repainting 1:** Bonnet, Side panel - rear left side, Side panel - rear right side

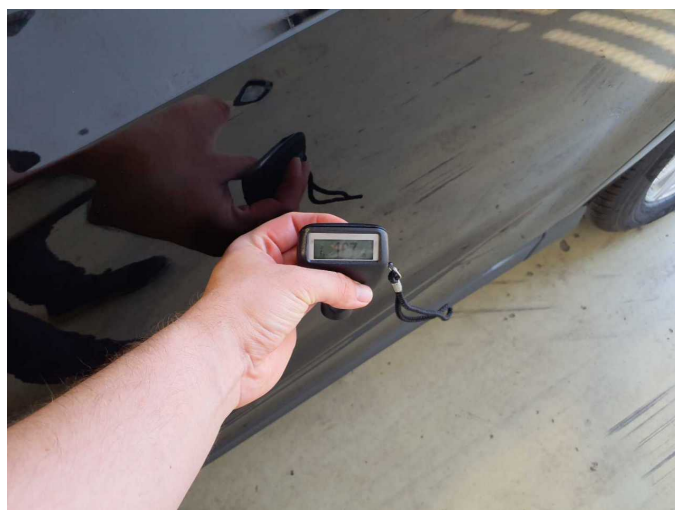
**Repainting 2:** Door - rear left side, Door - front left side

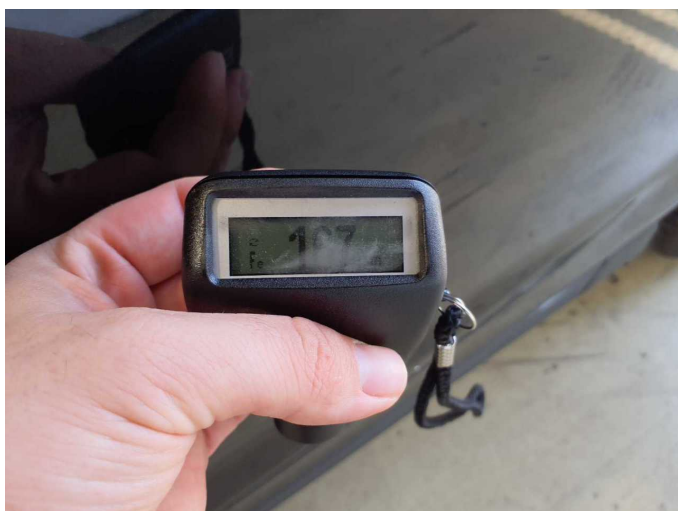
**Repainting 2:** Door - rear left side, Door - front left side

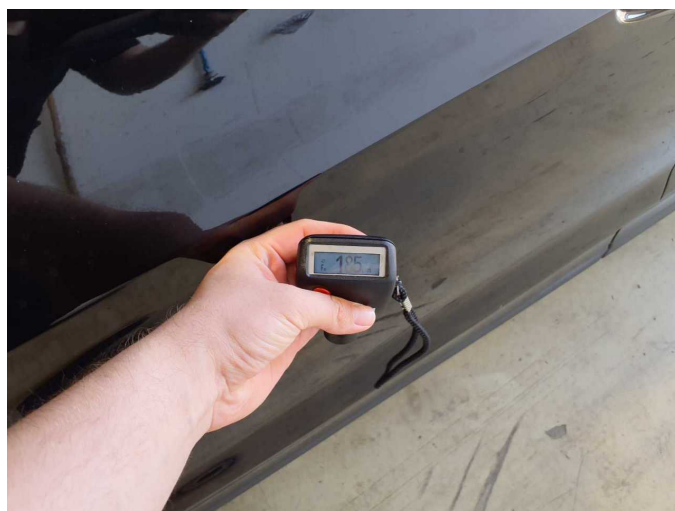
**Repainting 2:** Door - rear left side, Door - front left side

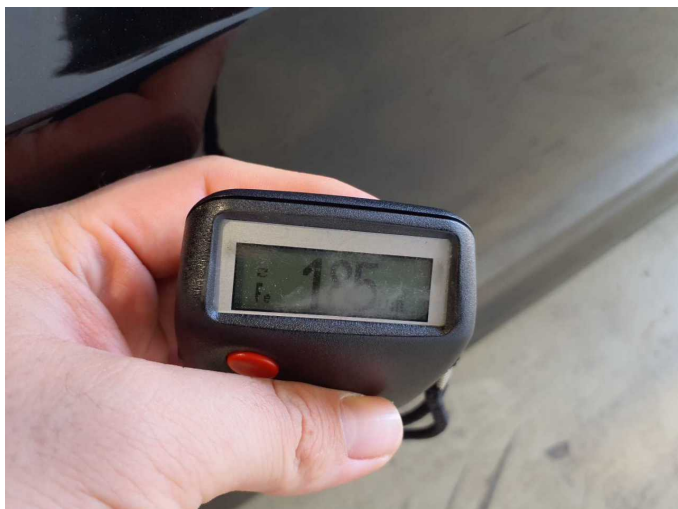
**Repainting 2:** Door - rear left side, Door - front left side

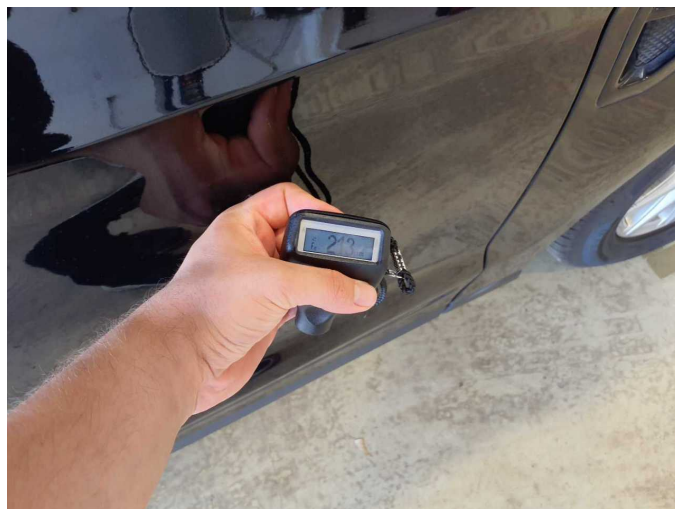
**Repainting 3:** Door - front right side

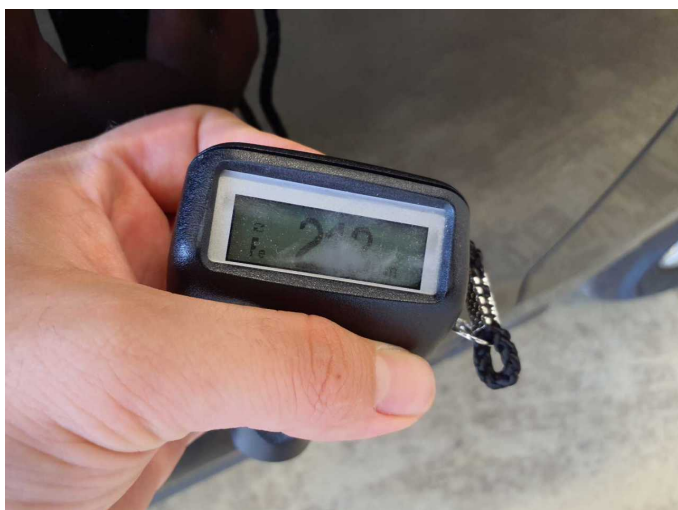
**Repainting 3:** Door - front right side
