Expertise

Protocol number: 46230273
Order No. / Reference: 26584305
Inspection date: 30 Jun 2026

Manufacturer: Toyota

Model: Aygo X S-CVT Play

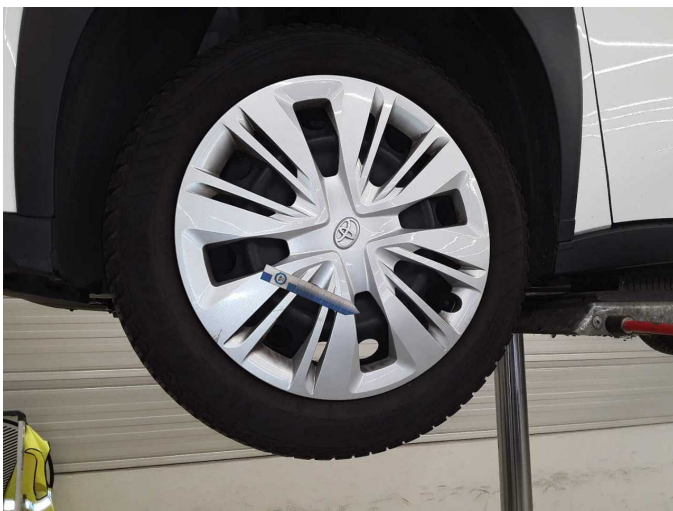
Damage 1: Wheel / tyres: Wheel cover - front left side - Scratched - Replace

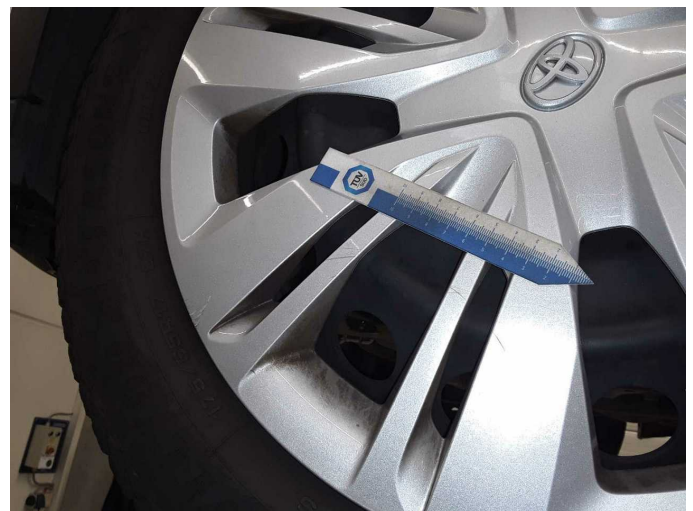
Damage 1: Wheel / tyres: Wheel cover - front left side - Scratched - Replace

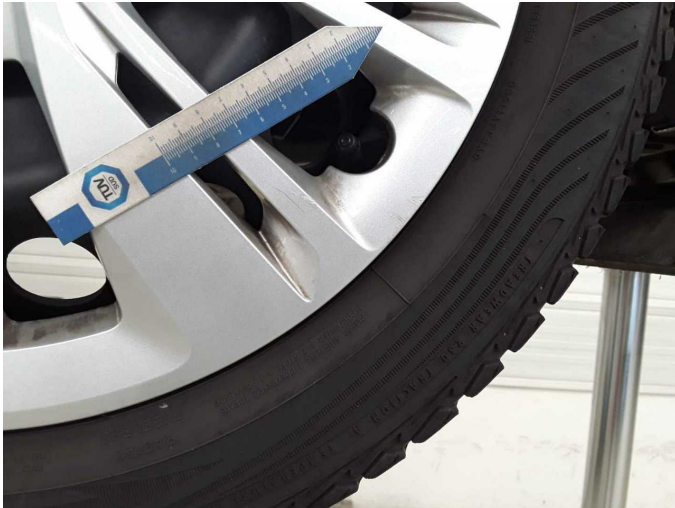
Damage 1: Wheel / tyres: Wheel cover - front left side - Scratched - Replace

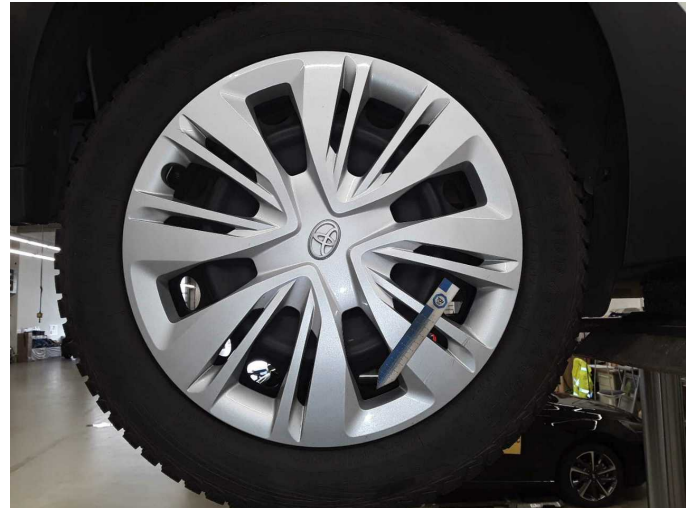
Damage 2: Wheel / tyres: Wheel cover - rear right side - Scratched - Replace

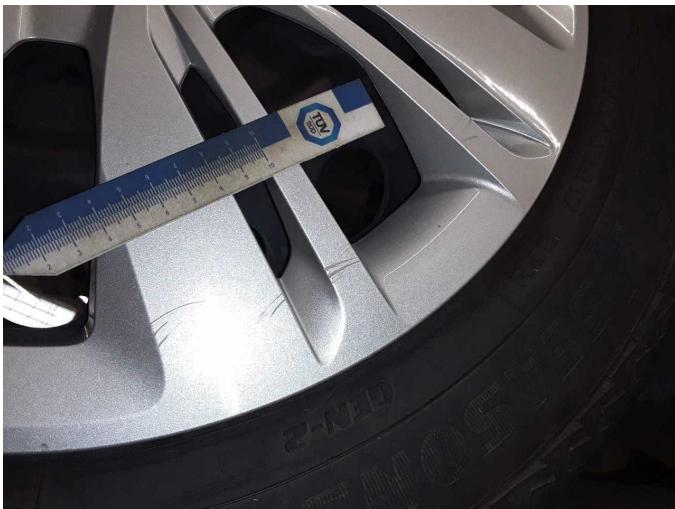
Damage 2: Wheel / tyres: Wheel cover - rear right side - Scratched - Replace

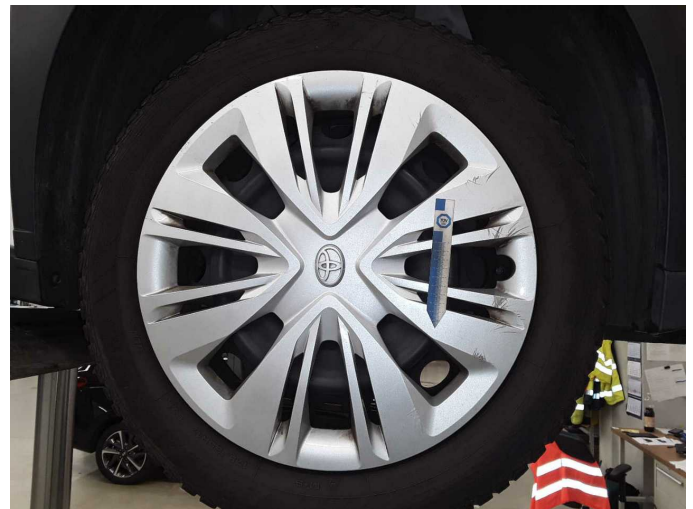
Damage 3: Wheel / tyres: Wheel cover - front right side - Scratched - Replace

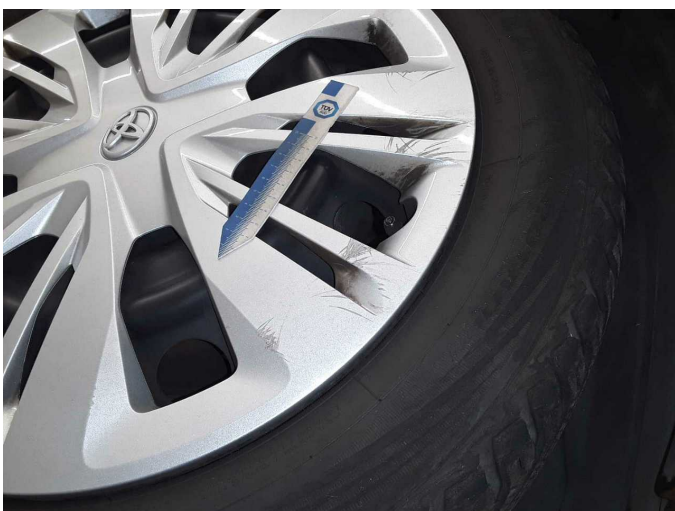
Damage 3: Wheel / tyres: Wheel cover - front right side - Scratched - Replace

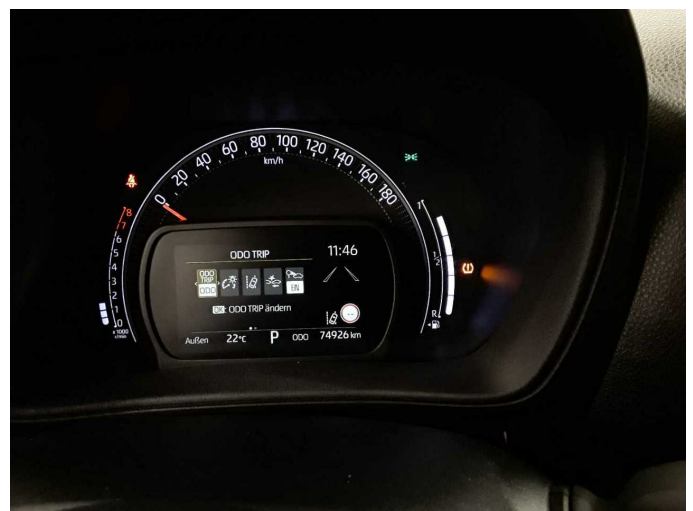
Damage 4: Instrument panel: Indicator light (Reifendruckkontrolle) - on - Diagnosed and repair if necessary

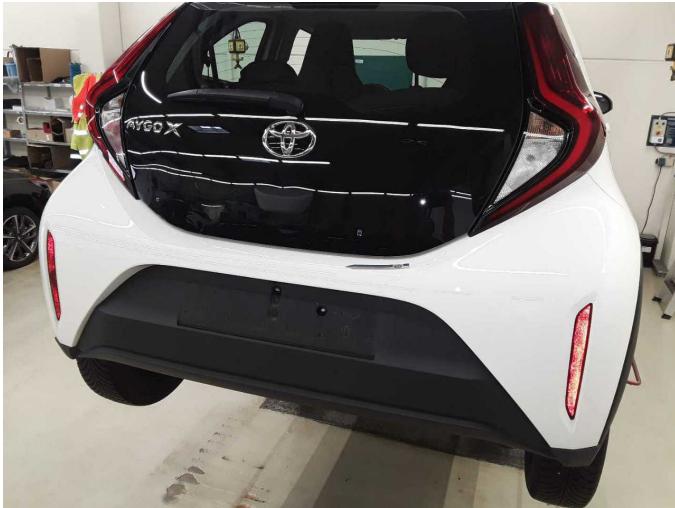
Damage 5: Rear bumper: Rear bumper - Scratch(es) - Smart repair

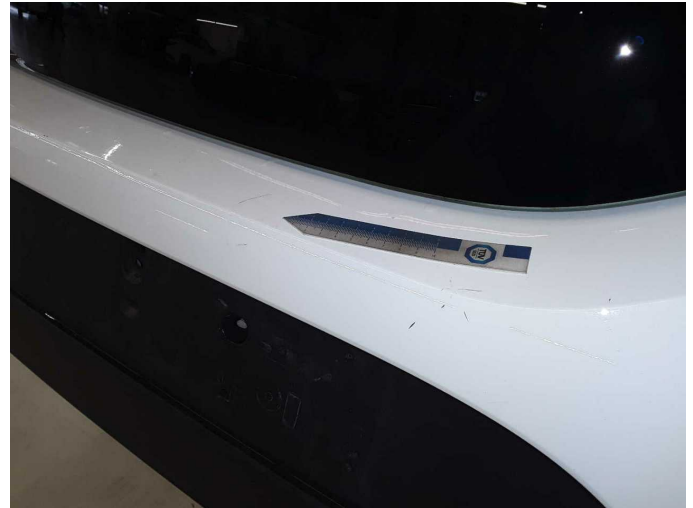
Damage 5: Rear bumper: Rear bumper - Scratch(es) - Smart repair

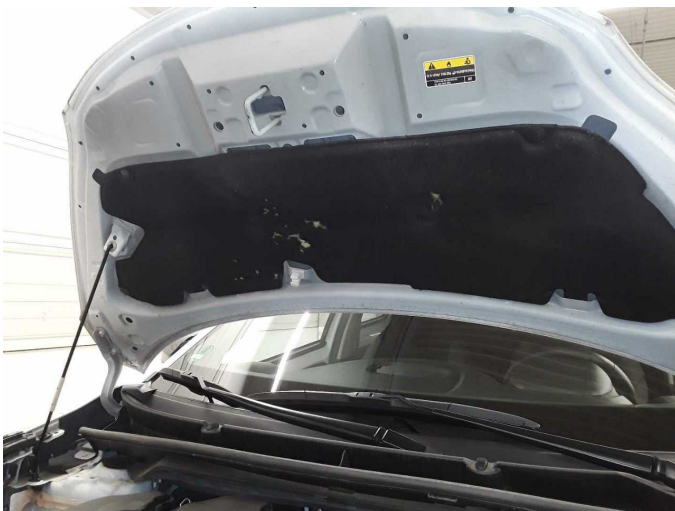
Damage 6: Bonnet: Insulation lining - Damage caused by marten / rodent - Replace

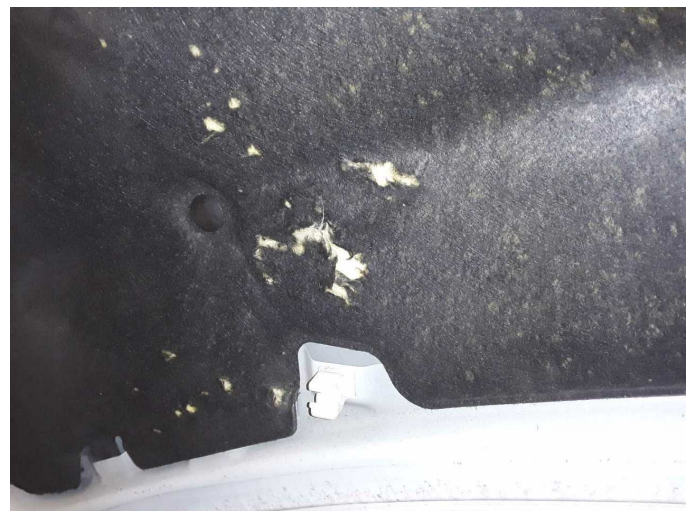
Damage 6: Bonnet: Insulation lining - Damage caused by marten / rodent - Replace

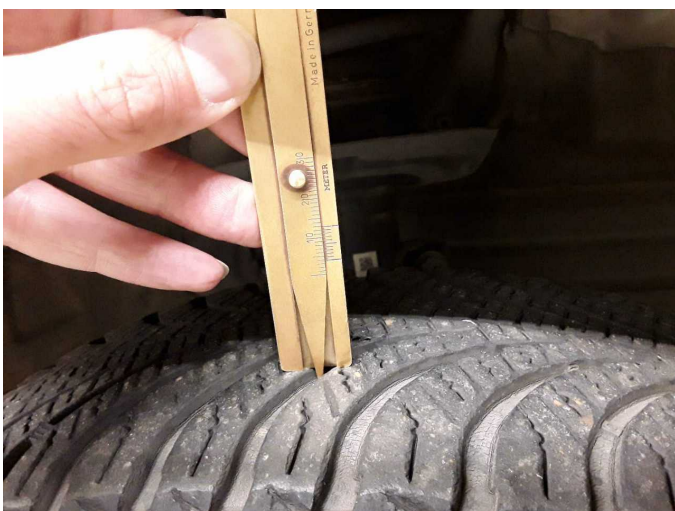
Damage 7: Wheel / tyres: Tyre - front - Does not meet the leasing specifications - Replace

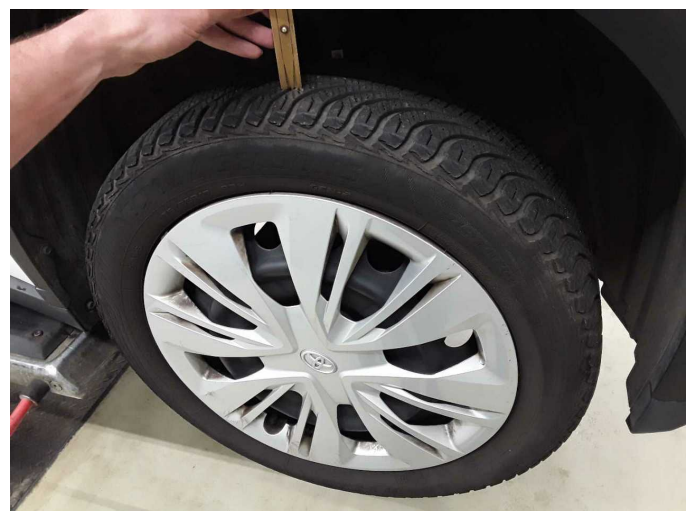
Damage 7: Wheel / tyres: Tyre - front - Does not meet the leasing specifications - Replace

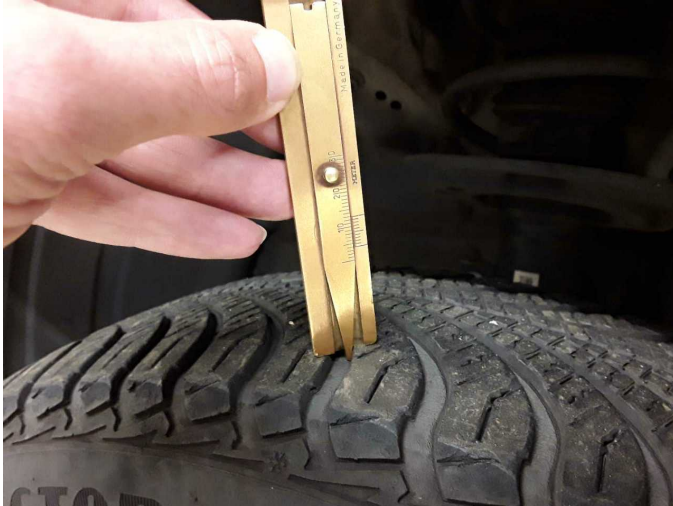
Damage 7: Wheel / tyres: Tyre - front - Does not meet the leasing specifications - Replace

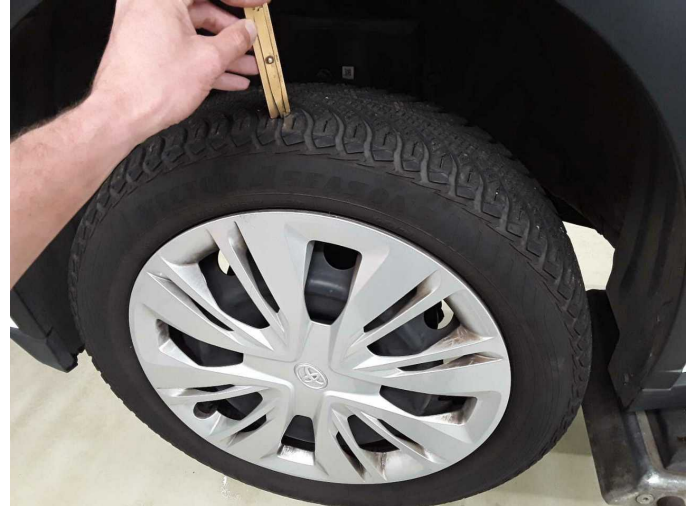
Damage 7: Wheel / tyres: Tyre - front - Does not meet the leasing specifications - Replace

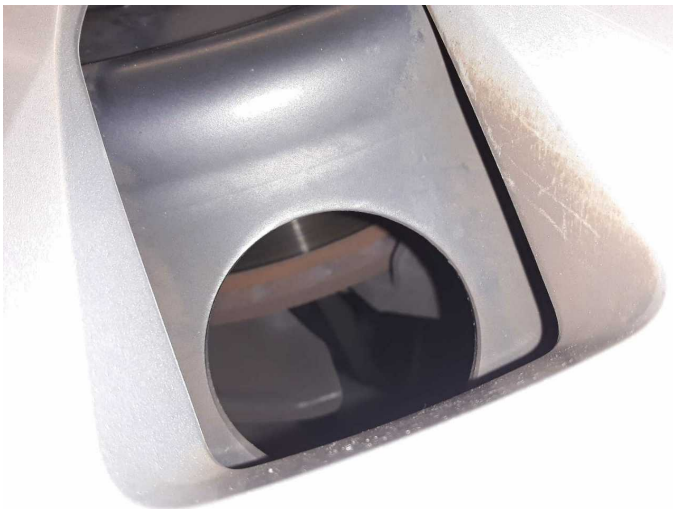
Damage 8: Braking system: Brake discs and brake pads - front (Bremsscheiben sind eingelaufen und) - Worn - Replace

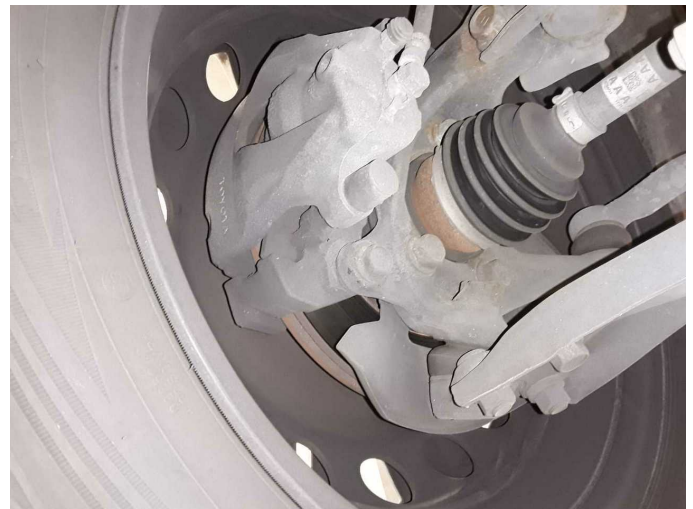
Damage 8: Braking system: Brake discs and brake pads - front (Bremsscheiben sind eingelaufen und) - Worn - Replace

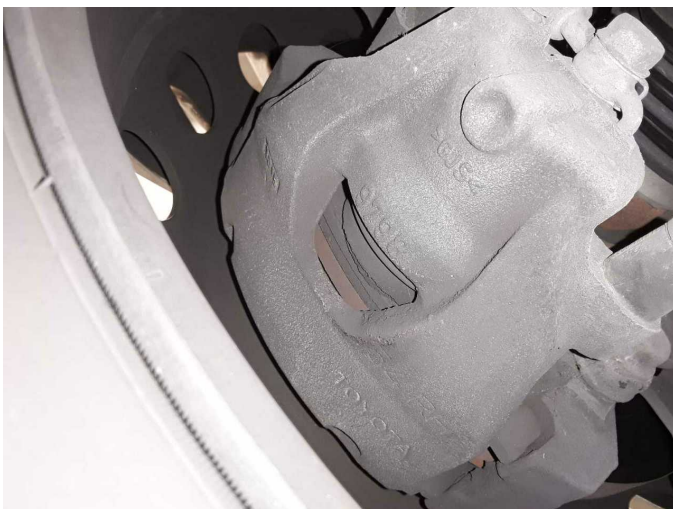
Damage 8: Braking system: Brake discs and brake pads - front (Bremsscheiben sind eingelaufen und) - Worn - Replace

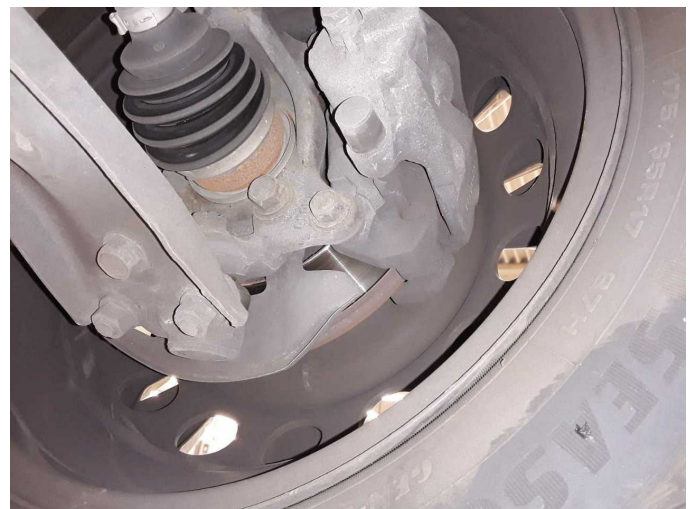
Damage 8: Braking system: Brake discs and brake pads - front (Bremsscheiben sind eingelaufen und) - Worn - Replace

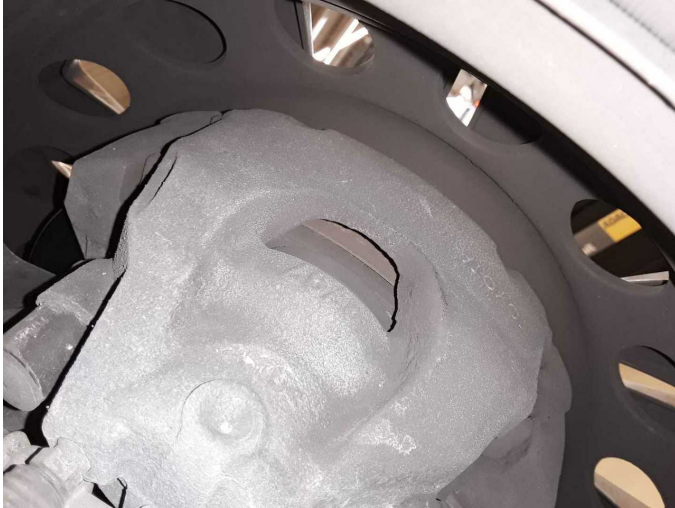
Damage 8: Braking system: Brake discs and brake pads - front (Bremscheiben sind eingelaufen und) - Worn - Replace

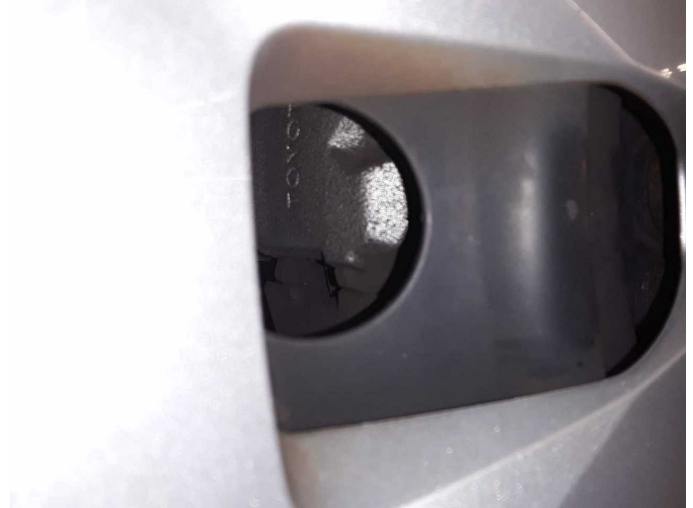
Damage 8: Braking system: Brake discs and brake pads - front (Bremscheiben sind eingelaufen und) - Worn - Replace

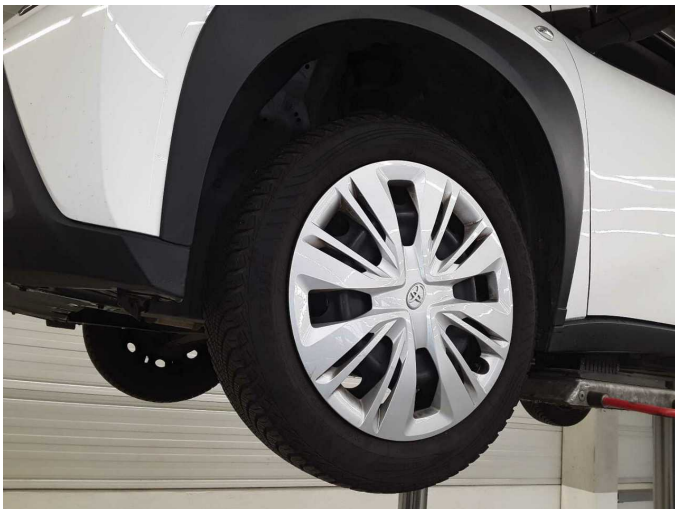
Damage 8: Braking system: Brake discs and brake pads - front (Bremscheiben sind eingelaufen und) - Worn - Replace

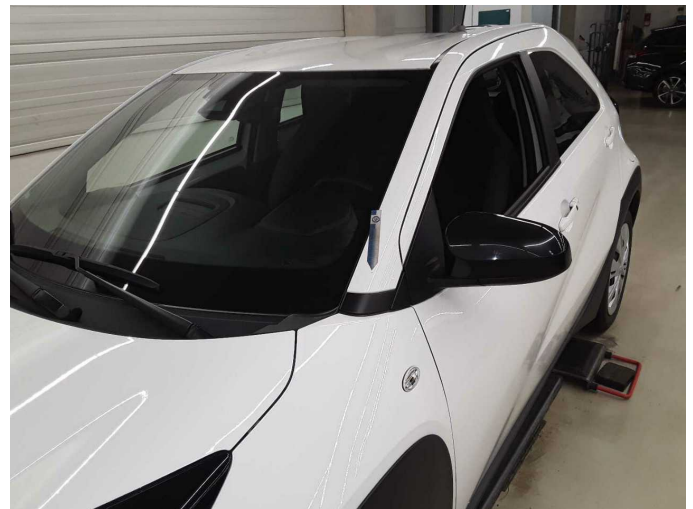
Wear and tear 1: Roof: Roof rail - left side - Stone chips - No deduction

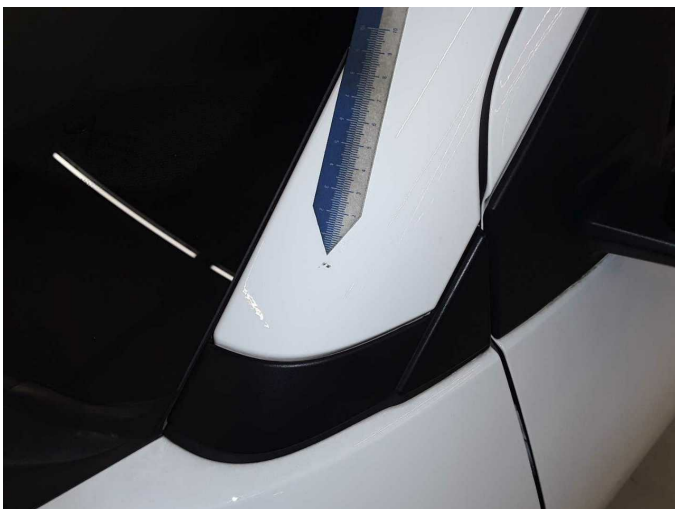
Wear and tear 1: Roof: Roof rail - left side - Stone chips - No deduction

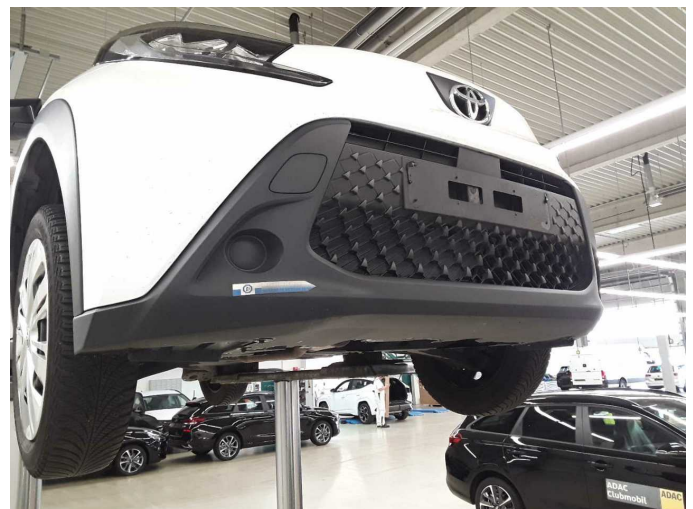
Wear and tear 2: Front bumper: Front bumper (Unlackiert) - Scratch(es) - No deduction

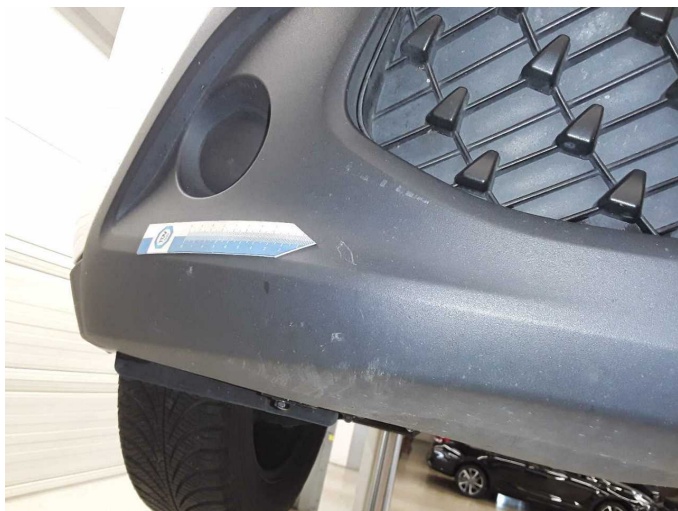
Wear and tear 2: Front bumper: Front bumper (Unlackiert) - Scratch(es) - No deduction

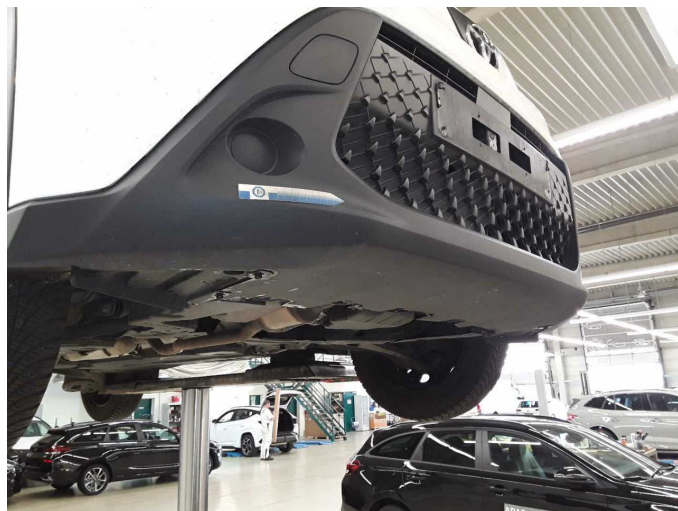
Wear and tear 2: Front bumper: Front bumper (Unlackiert) - Scratch(es) - No deduction
