Expertise

Protocol number: 46468392  
Order No. / Reference: 26546824  
Inspection date: 10 Jul 2026

Manufacturer: MAN  
VIN: WMA03VUY1P9011294

Model: TGE 3.140 4X2F SB

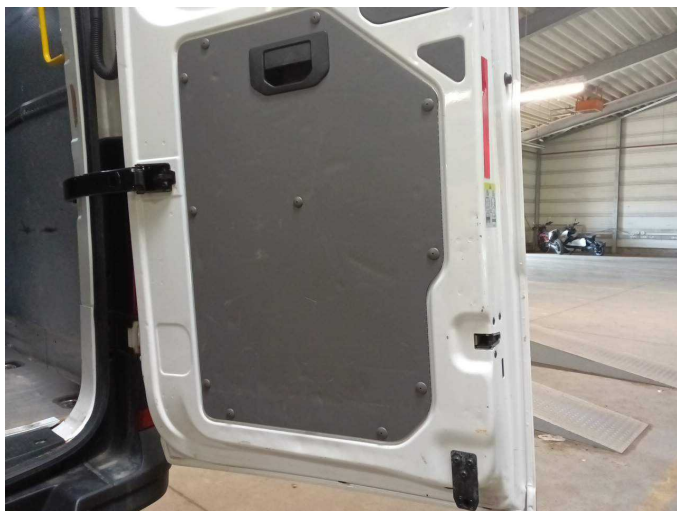
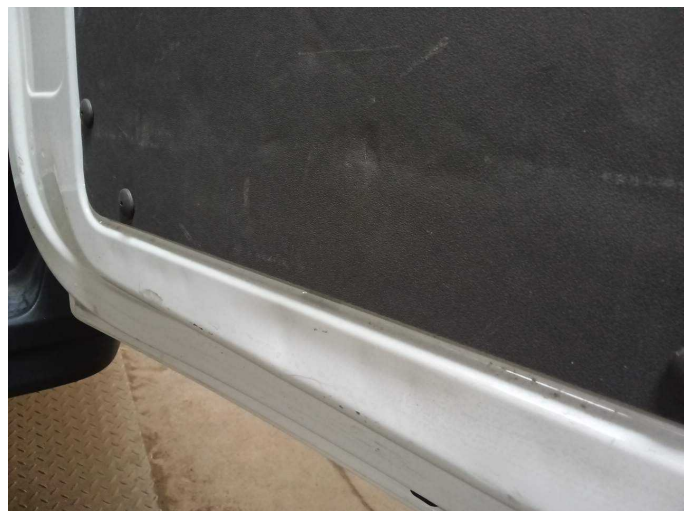
| No. | Component group | Description |
|---|---|---|
| 1 | Boot lid / rear door | Boot lid - dent(s) - Smooth repair work |

**Damage 1:** Boot lid / rear door: Boot lid - dent(s) - Smooth repair work

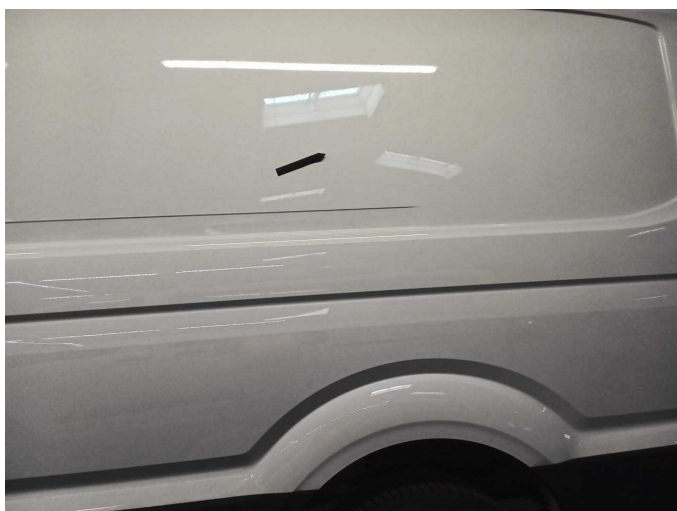
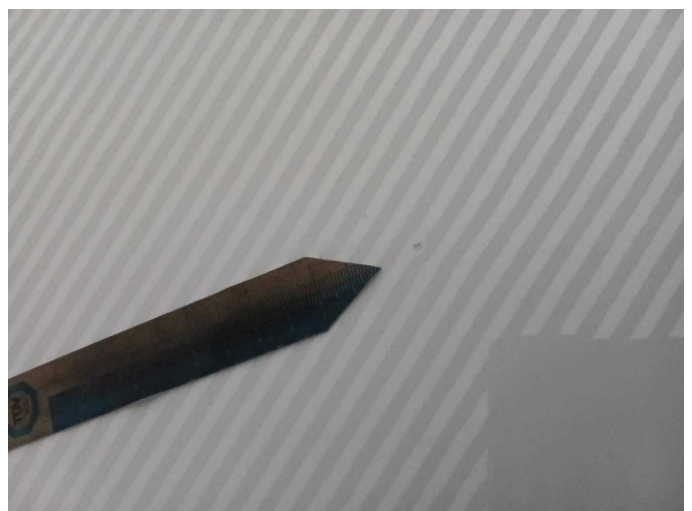
| No. | Component group | Description |
|---|---|---|
| 2 | Side panel - rear left side | Side panel - Dent / paintcoat damage - Smart repair |

**Damage 2:** Side panel - rear left side: Side panel - Dent / paintcoat damage - Smart repair

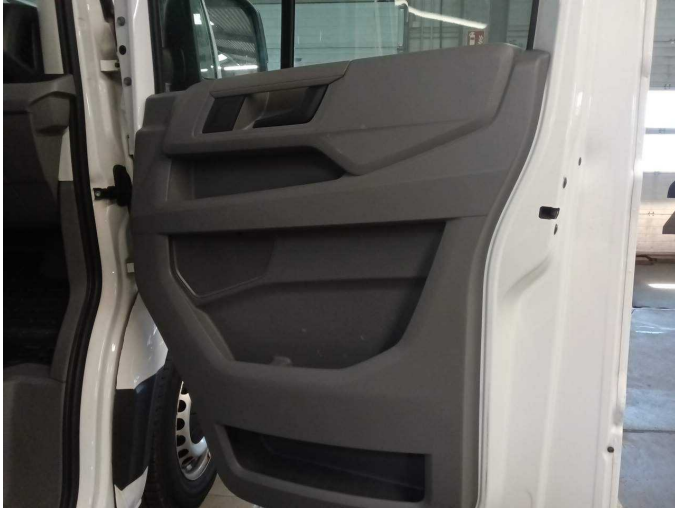
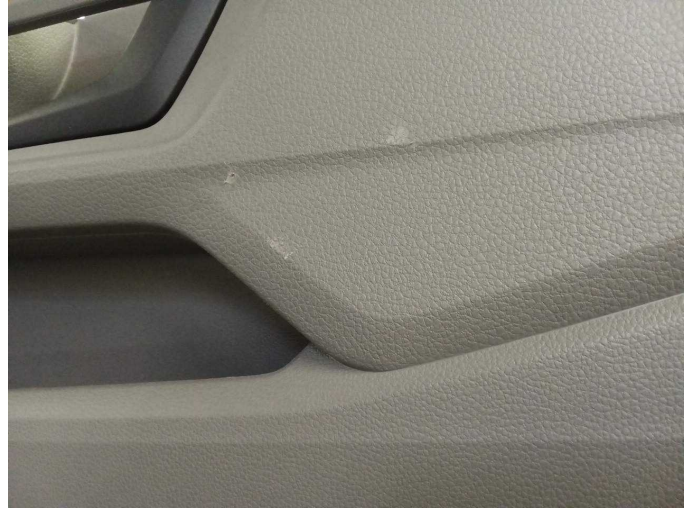
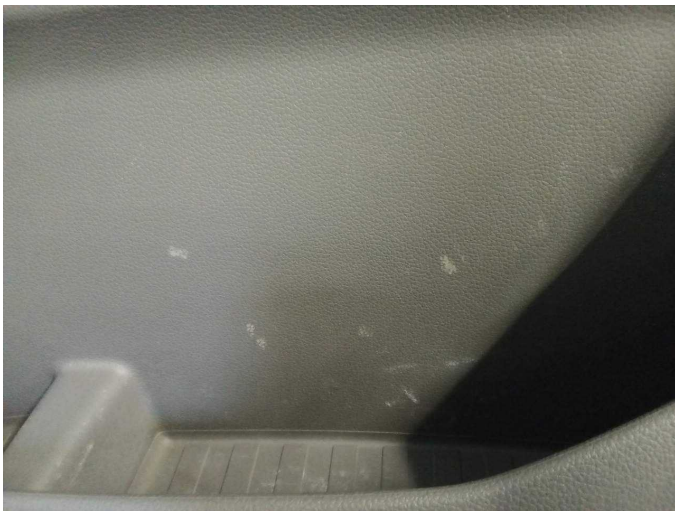
| No. | Component group | Description |
|---|---|---|
| 3 | Trim / covers | Door trim - front right side - Scratch(es) - Smart repair |

**Damage 3:** Trim / covers: Door trim - front right side - Scratch(es) - Smart repair

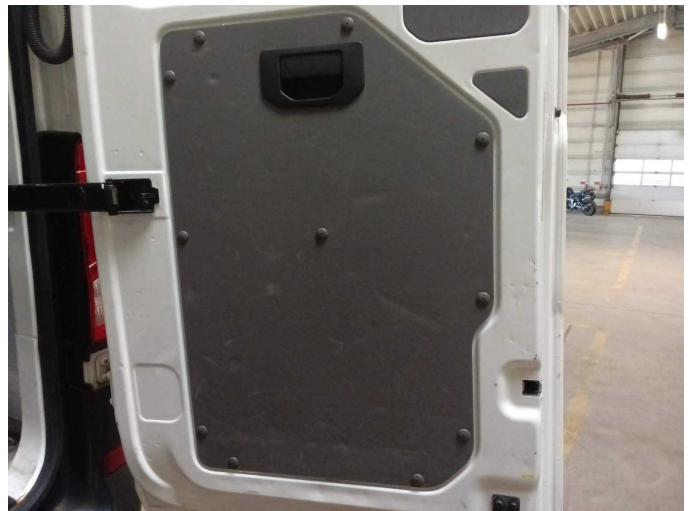
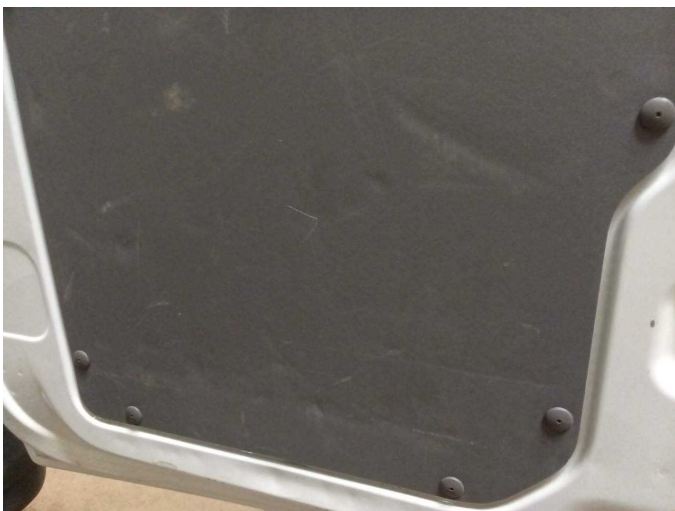
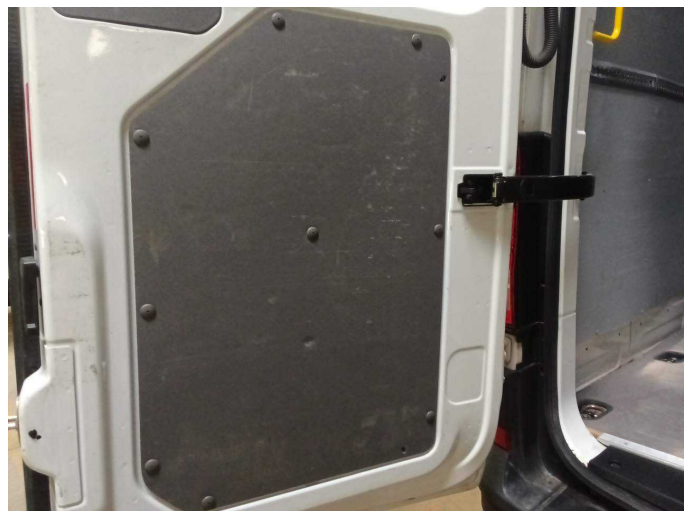
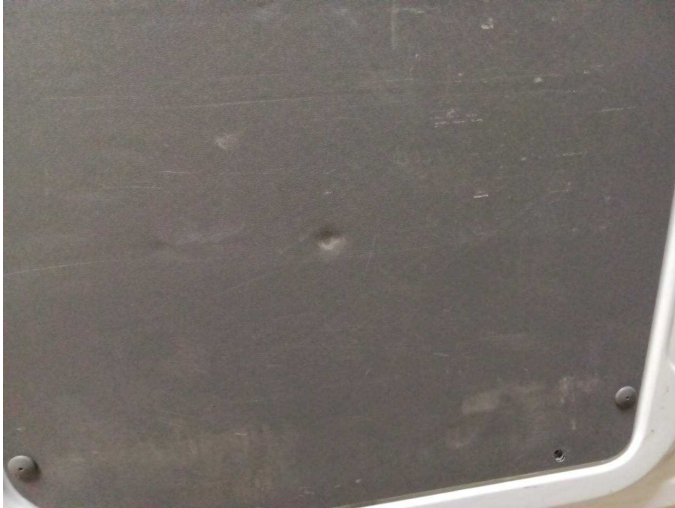
| No. | Component group | Description |
|---|---|---|
| 1 | Trim / covers | Boot lid - interior trim - dent(s) - No deduction |

**Wear and tear 1:** Trim / covers: Boot lid - interior trim - dent(s) - No deduction

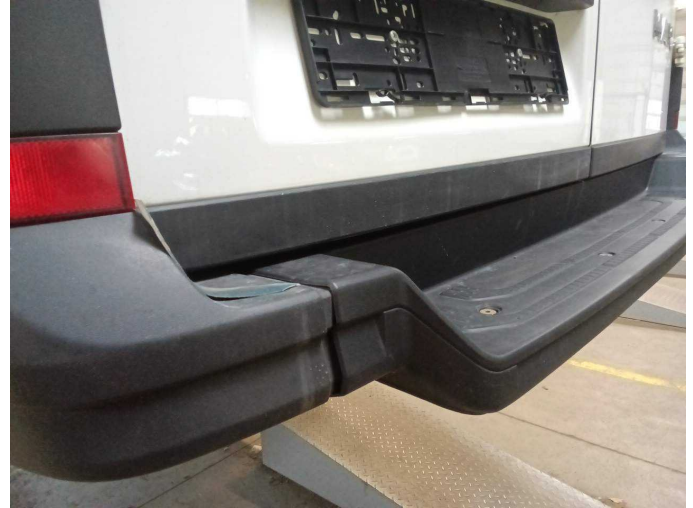
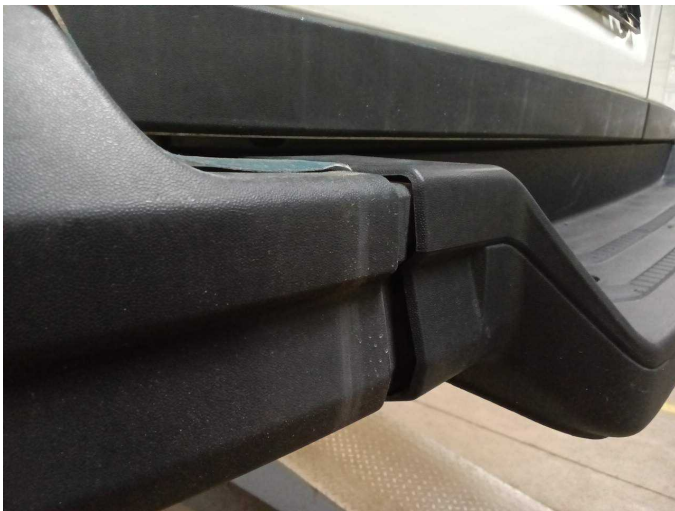
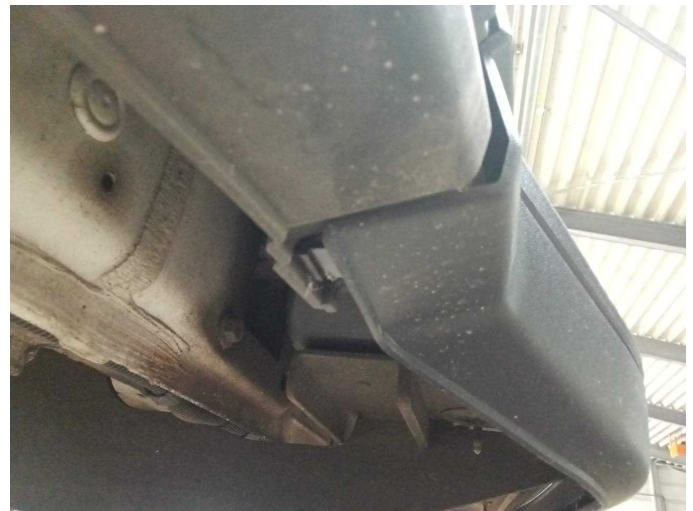
| No. | Component group | Description |
|---|---|---|
| 2 | Rear bumper | Rear bumper - Malposition - No deduction |

**Wear and tear 2:** Rear bumper: Rear bumper - Malposition - No deduction
