## Expertise

Protocol number: 45800289  
Order No. / Reference: 26332027  
Inspection date: 22 May 2026

Manufacturer: Mercedes-Benz

Model: C 300 d T 9G-TRONIC Avantgarde

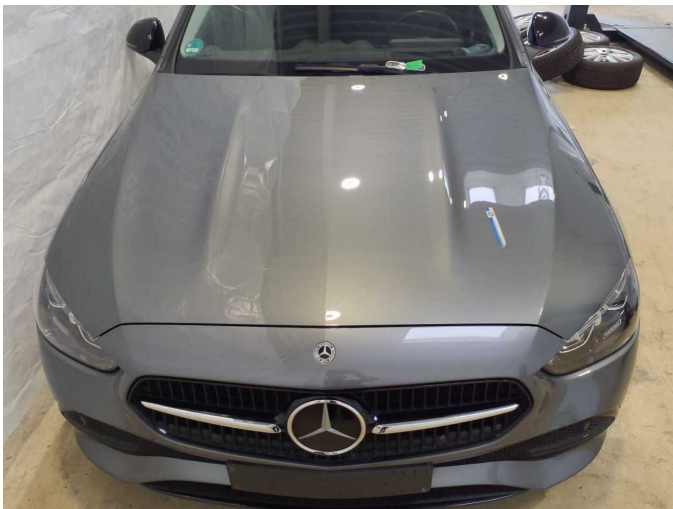
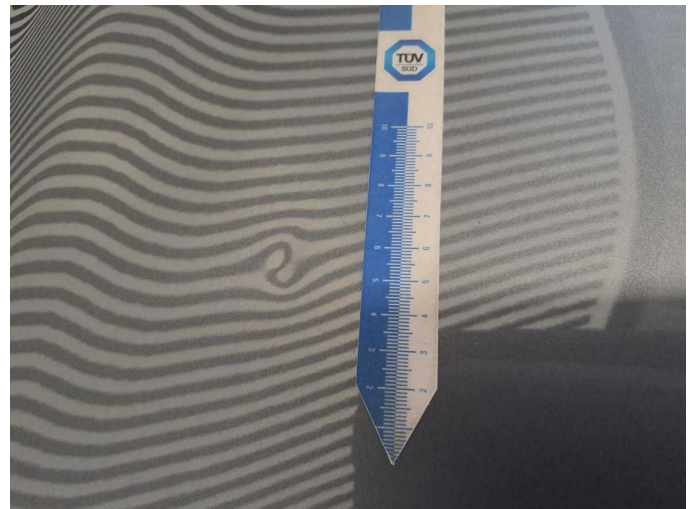
| No. | Component group | Description |
|---|---|--|
| 3 | Bonnet | Bonnet - dent(s) - Smooth repair work |

Damage 3: Bonnet: Bonnet - dent(s) - Smooth repair work

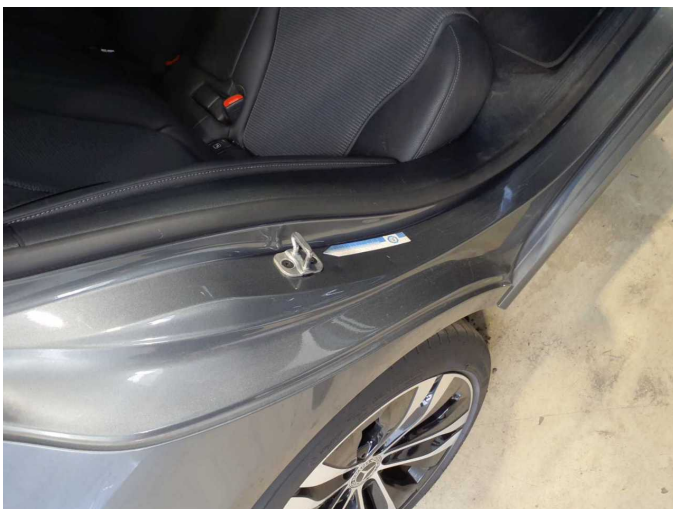
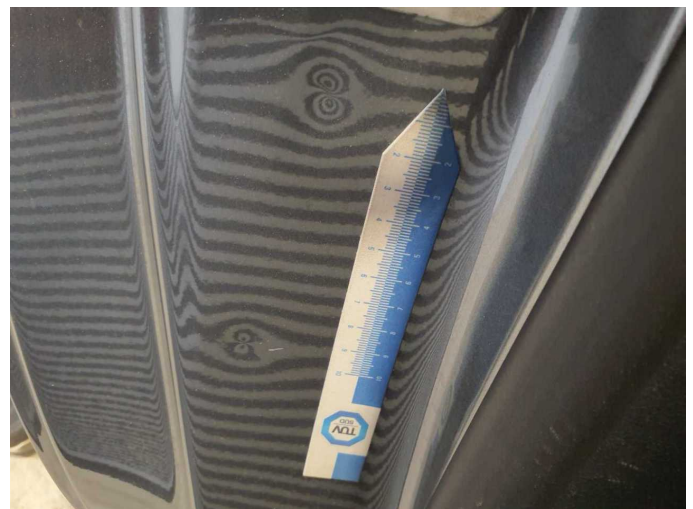
| No. | Component group | Description |
|---|---|--|
| 4 | Side panel - rear right side | Sill - Dent / paintcoat damage - Smart repair |

Damage 4: Side panel - rear right side: Sill - Dent / paintcoat damage - Smart repair

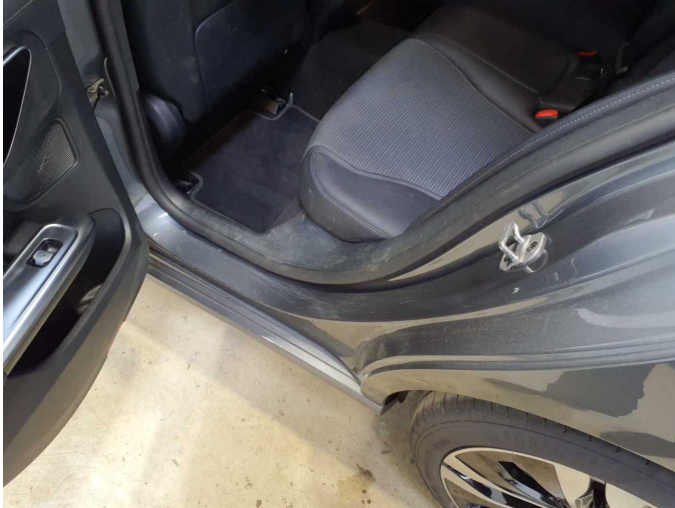
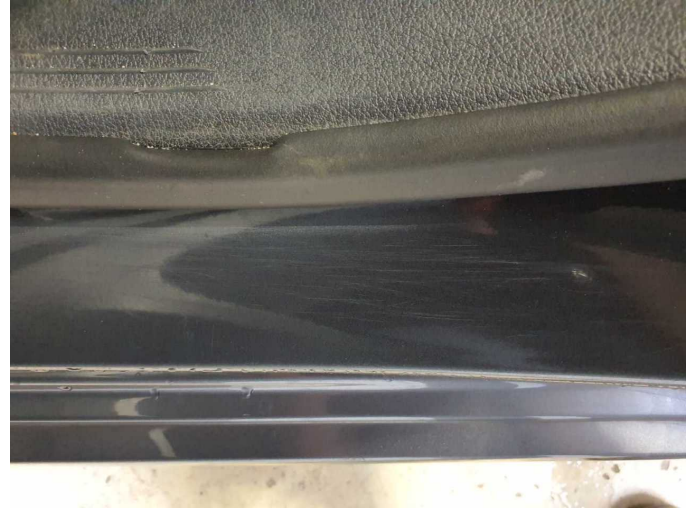
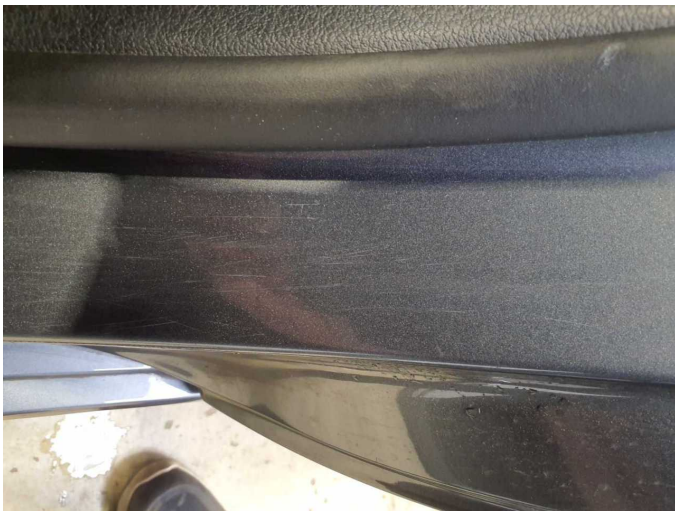
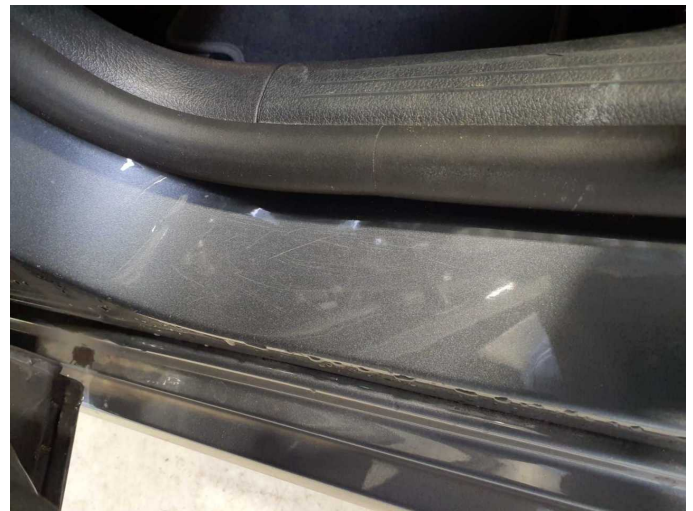
| No. | Component group | Description |
|---|---|--|
| 5 | Sill - left side | Sill - Scratch(es) - Smart repair |

**Damage 5:** Sill - left side: Sill - Scratch(es) - Smart repair

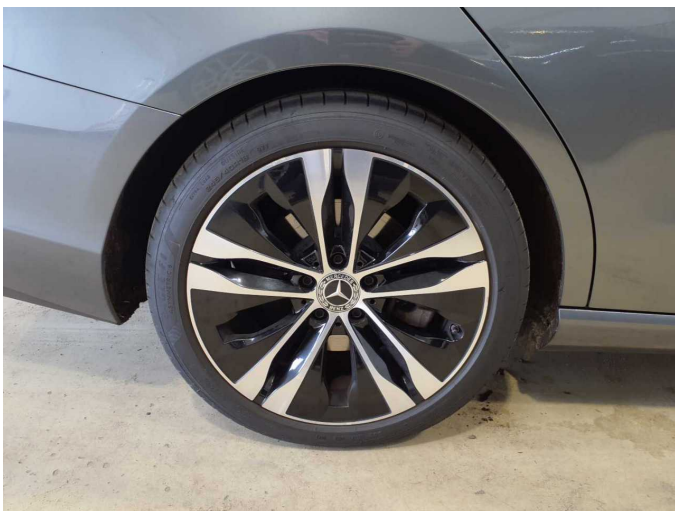
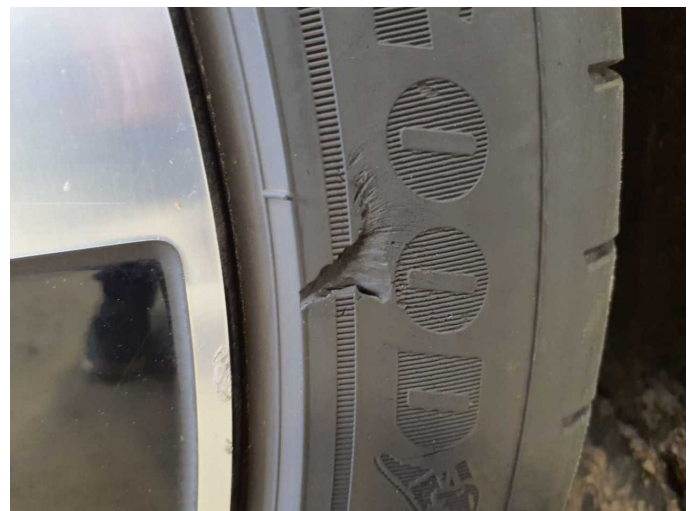
| No. | Component group | Description |
|---|---|--|
| 6 | Wheel / tyres | Tyre - rear right side (nicht fahrbereit) - Porous / cracked - Replace |

**Damage 6:** Wheel / tyres: Tyre - rear right side (nicht fahrbereit) - Porous / cracked - Replace

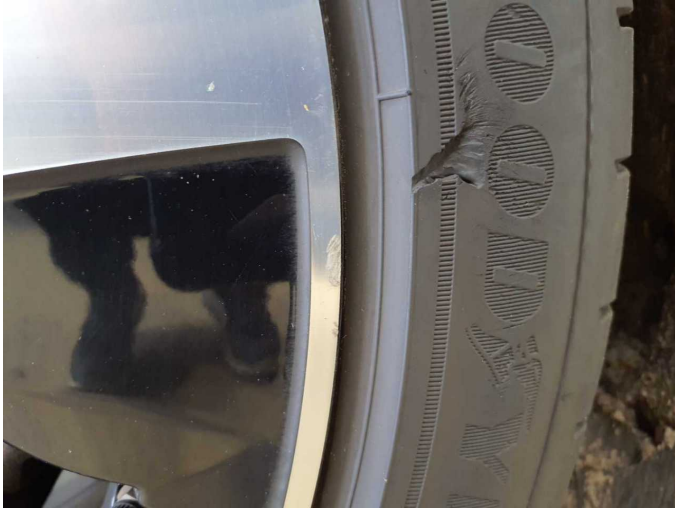
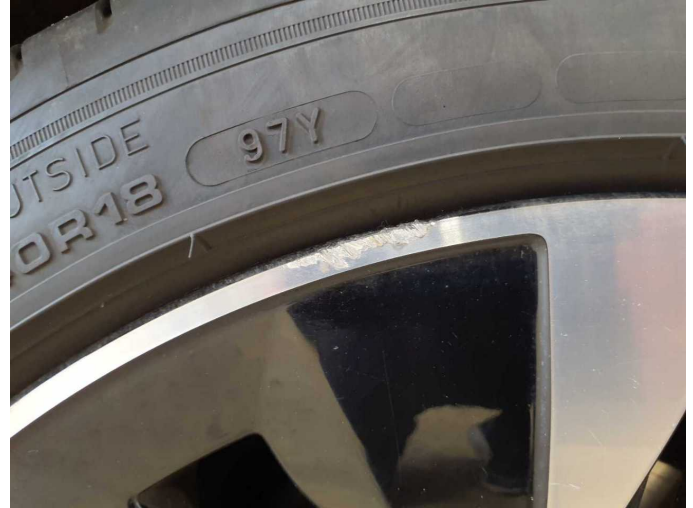
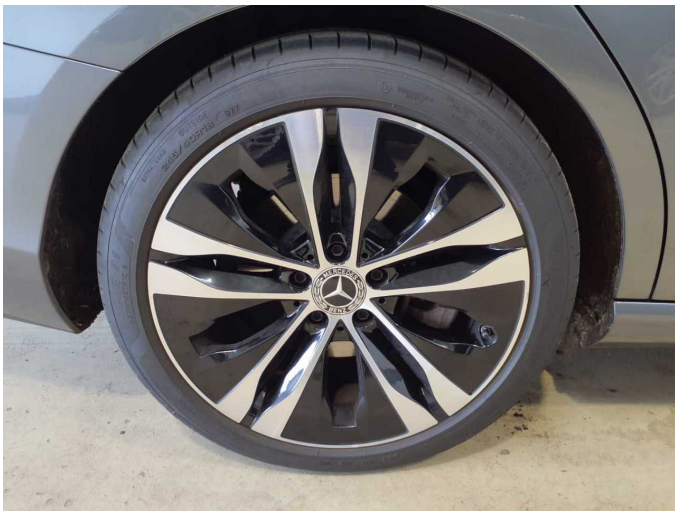
| No. | Component group | Description |
|---|---|--|
| 7 | Wheel / tyres | Alloy rim - rear right side - Scratch(es) - Loss in value |

**Damage 7:** Wheel / tyres: Alloy rim - rear right side - Scratch(es) - Loss in value

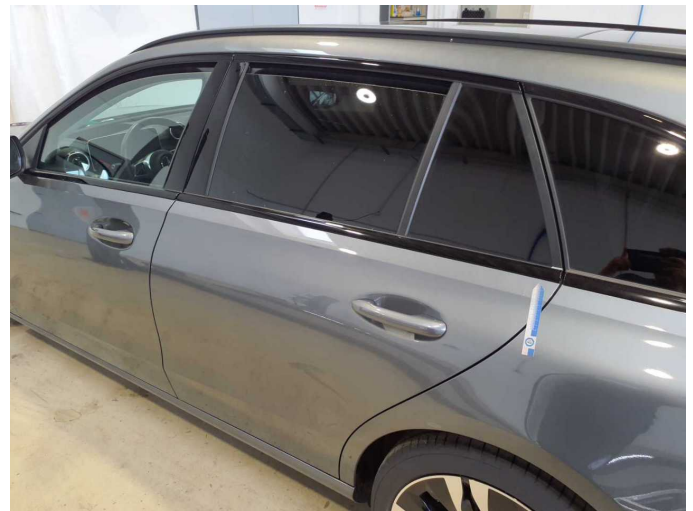
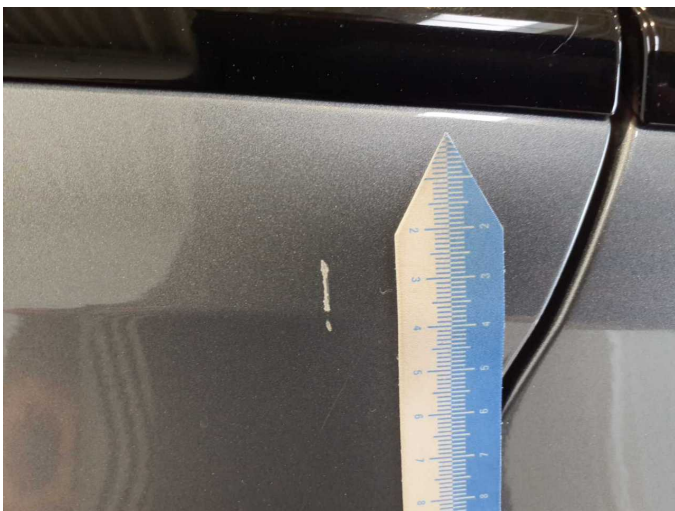
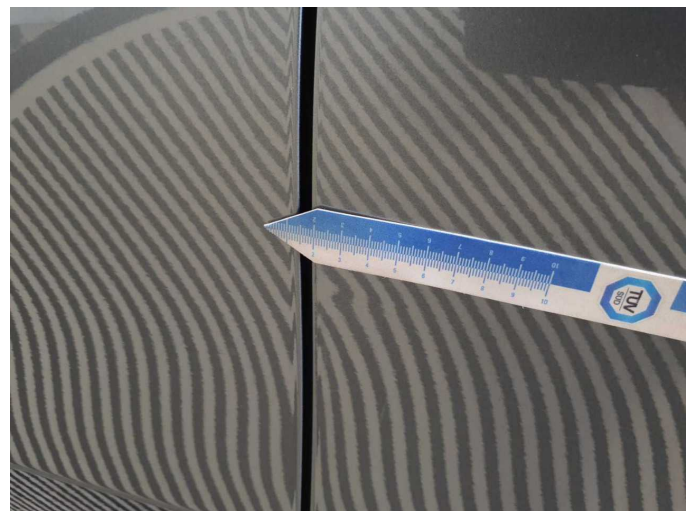
| No. | Component group | Description |
|---|---|--|
| 8 | Door - rear left side | Door - Dent / paintcoat damage - Repair and paint |

**Damage 8:** Door - rear left side: Door - Dent / paintcoat damage - Repair and paint

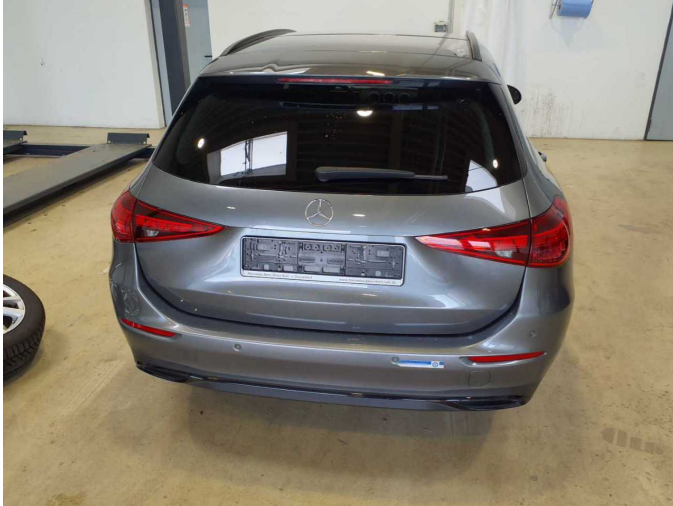
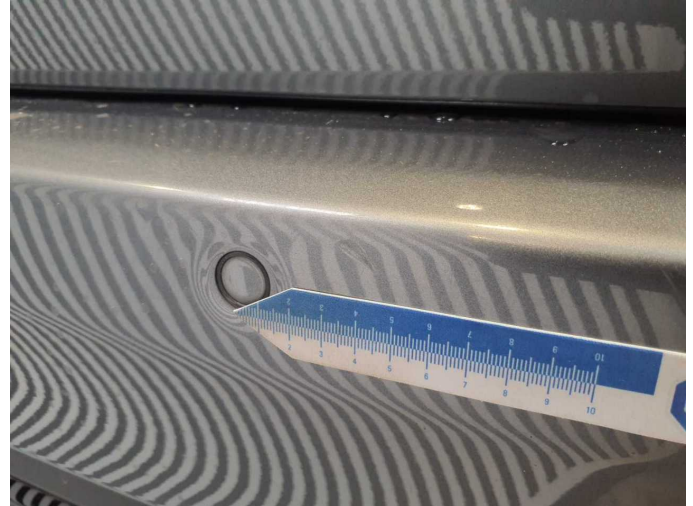
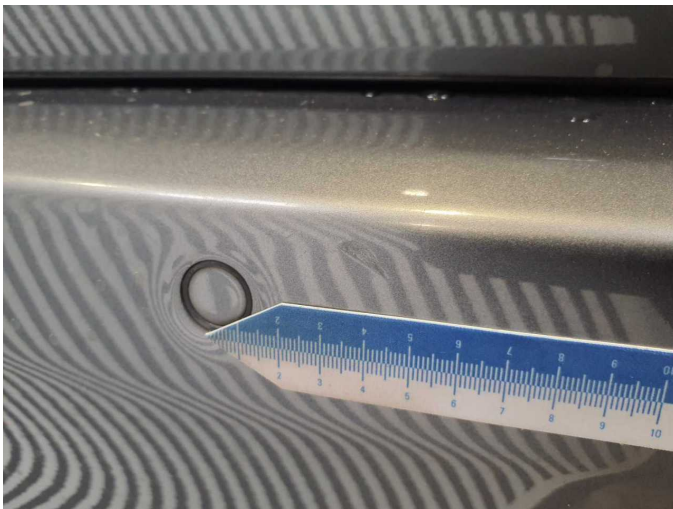
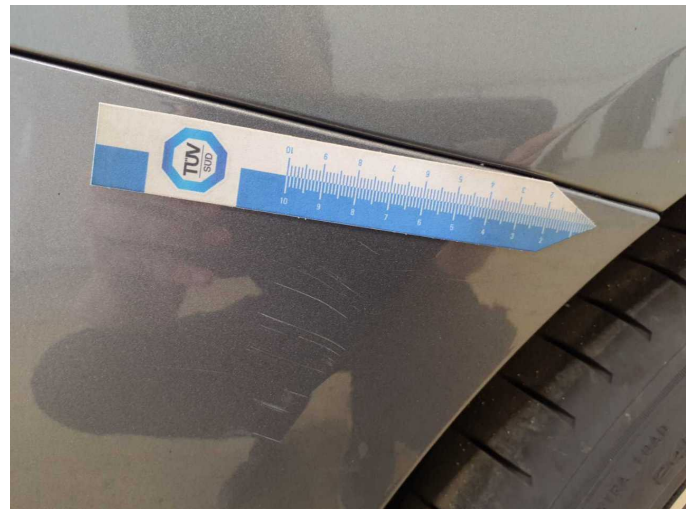
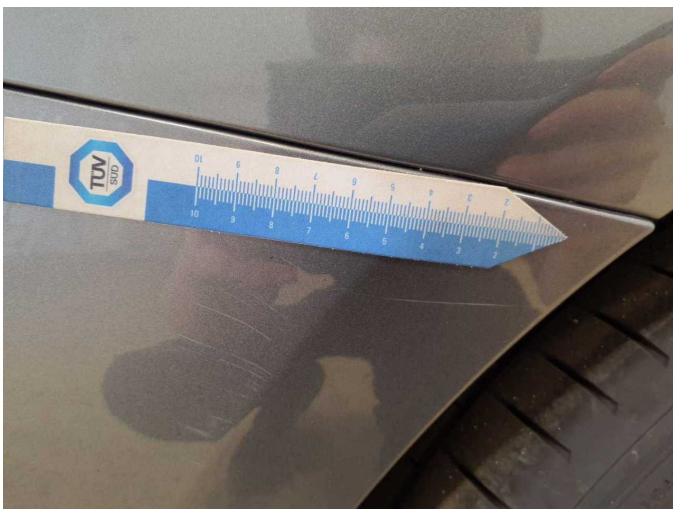
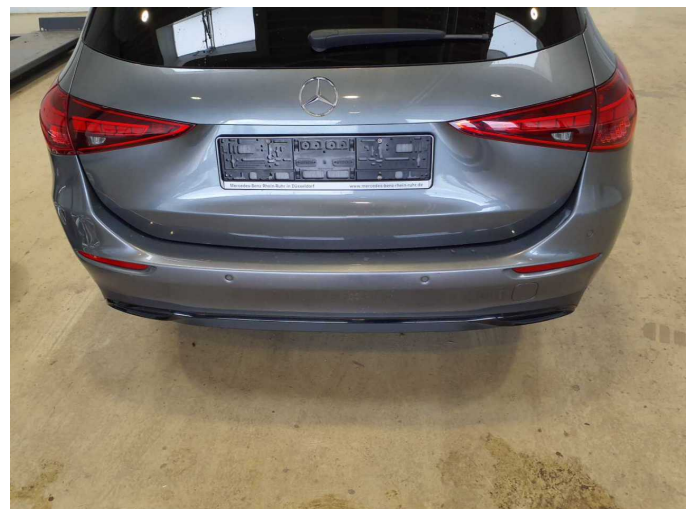
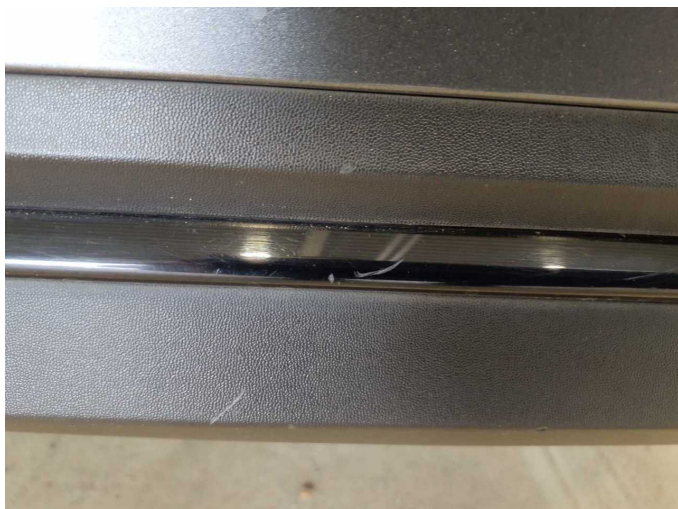
| No. | Component group | Description |
|---|---|--|
| 9 | Rear bumper | Rear bumper (Zusätzlich Kratzer Blende und Spoiler) - Dent / paintcoat damage - Repair and paint |

**Damage 9:** Rear bumper: Rear bumper (Zusätzlich Kratzer Blende und Spoiler) - Dent / paintcoat damage - Repair and paint
