Expertise

Protocol number: 46509615  
Order No. / Reference: 26028776  
Inspection date: 10 Jul 2026

Model: Vito 116 CDI Lang HA PRO Kasten

VIN: W1VVLBEZ5T4562644

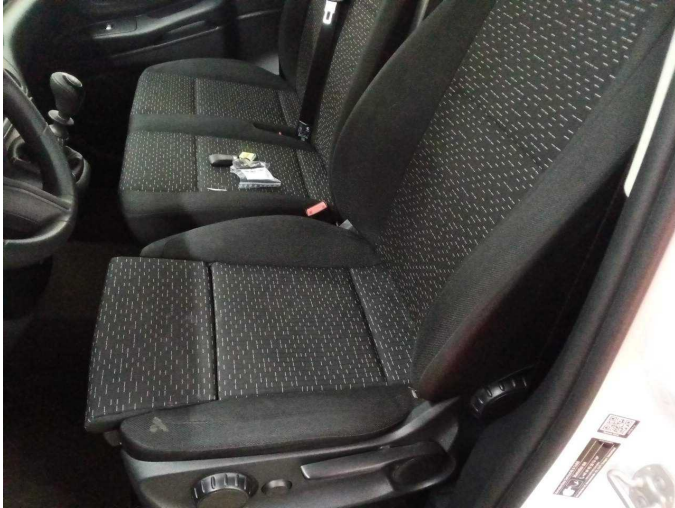
| No. | Component group | Description |
|---|---|---|
| 1 | Seat - front | Seat cover - left side (Version) - Clean |

**Damage 1:** Seat - front: Seat cover - left side (Version) - Clean

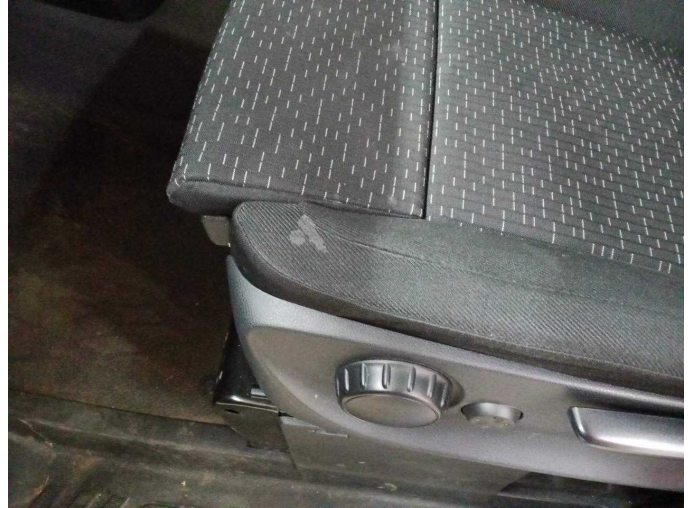
**Damage 1:** Seat - front: Seat cover - left side (Version) - Clean

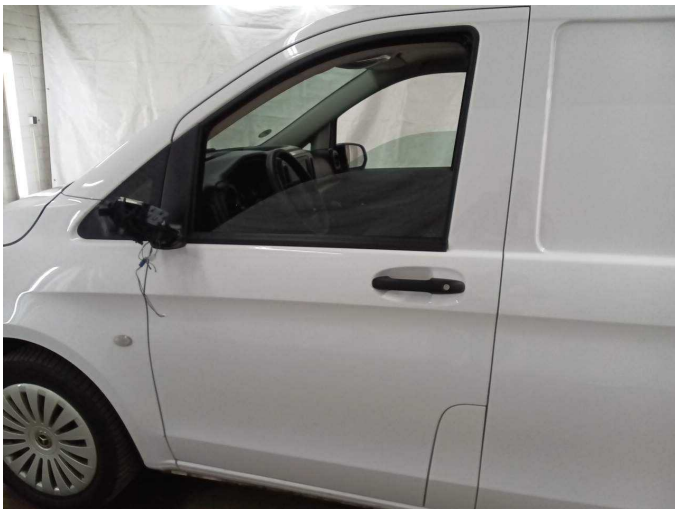
| No. | Component group | Description |
|---|---|---|
| 2 | Door - front left side | Door - Scratch(es) - Smart repair |

**Damage 2:** Door - front left side: Door - Scratch(es) - Smart repair

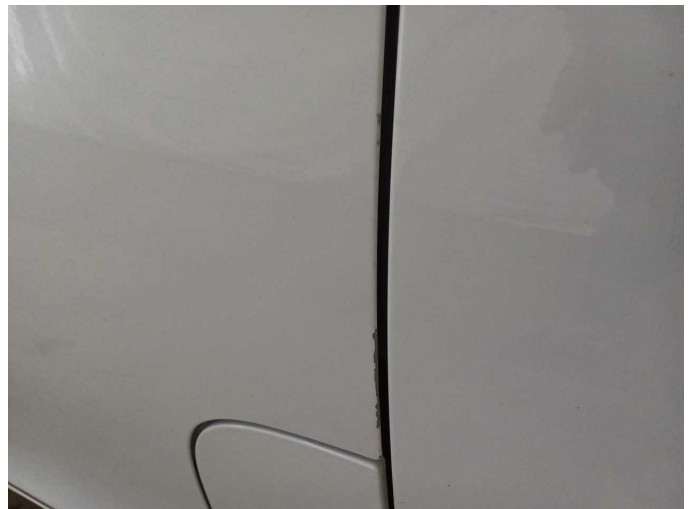
**Damage 2:** Door - front left side: Door - Scratch(es) - Smart repair

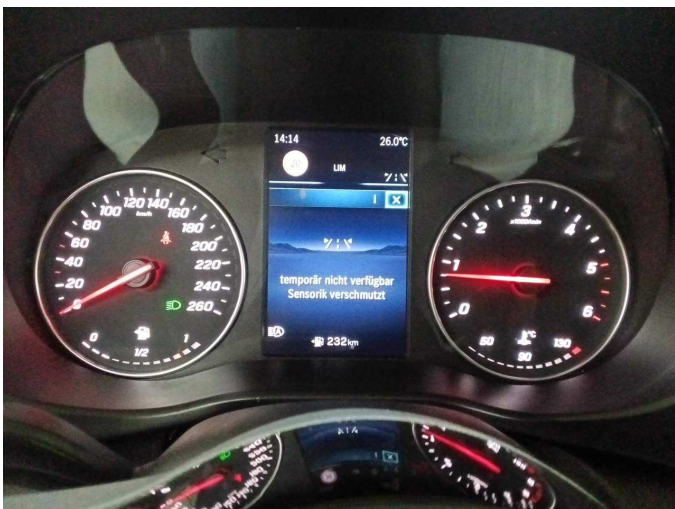
| No. | Component group | Description |
|---|---|---|
| 3 | Electronic systems | Start assist - Non-operational - Perform diagnosis |

**Damage 3:** Electronic systems: Start assist - Non-operational - Perform diagnosis

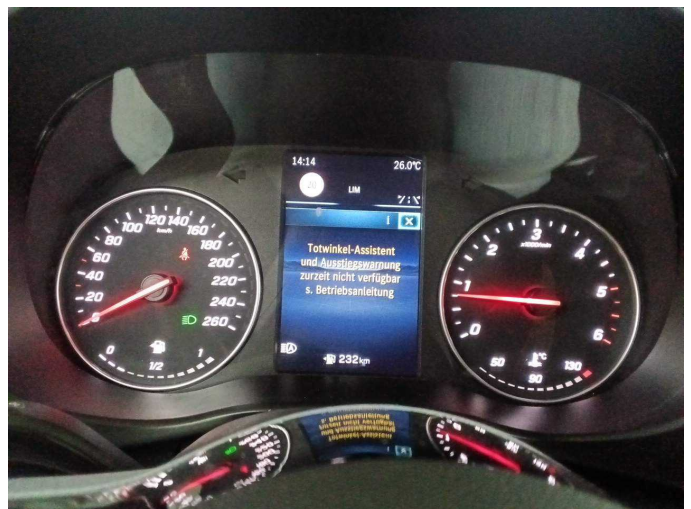
**Damage 3:** Electronic systems: Start assist - Non-operational - Perform diagnosis

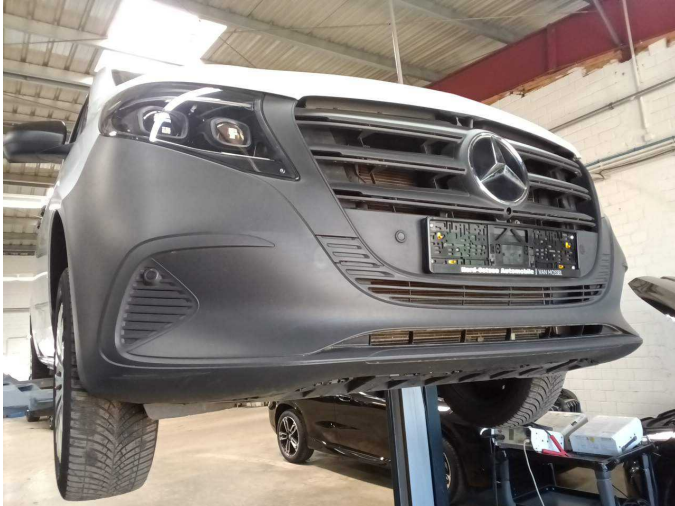
| No. | Component group | Description |
|---|---|---|
| 4 | Front bumper | Front bumper - Scratch(es) - Loss in value |

**Damage 4:** Front bumper: Front bumper - Scratch(es) - Loss in value

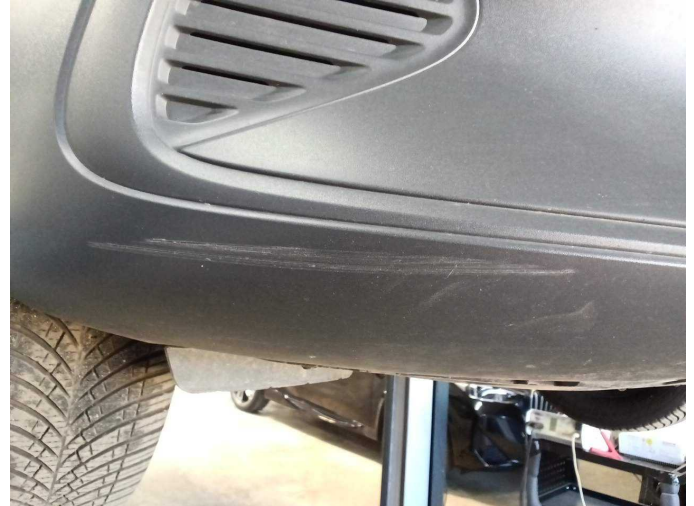
**Damage 4:** Front bumper: Front bumper - Scratch(es) - Loss in value

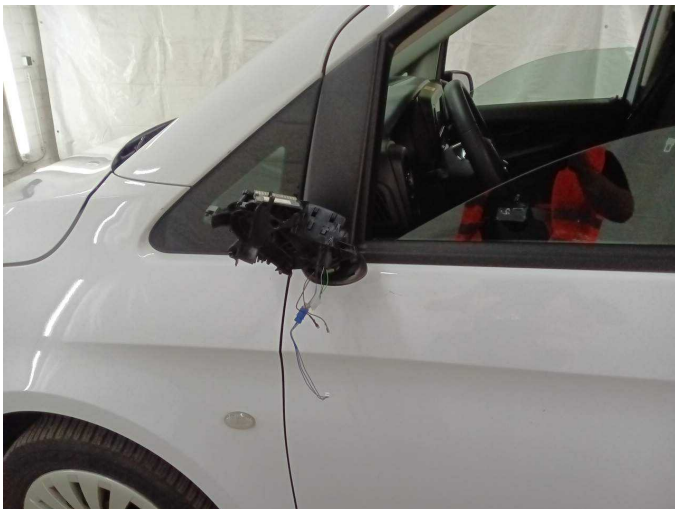
| No. | Component group | Description |
|---|---|---|
| 5 | Wing mirror - left side | Wing mirror - Broken / torn - Replace |

**Damage 5:** Wing mirror - left side: Wing mirror - Broken / torn - Replace

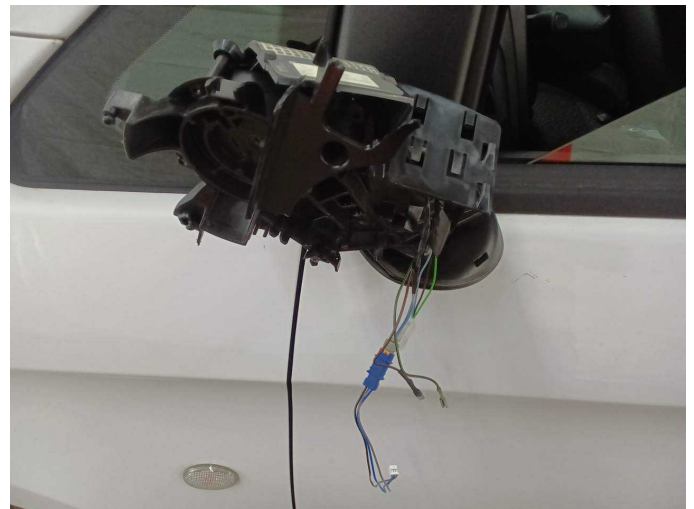
**Damage 5:** Wing mirror - left side: Wing mirror - Broken / torn - Replace
