## Expertise

Protocol number: 45872899  
Order No. / Reference: 26412481  
Inspection date: 10 Jun 2026

Model: 308 SW BlueHDi 130 EAT8 Allure Pack

VIN: VR3FCYHZTNY646022

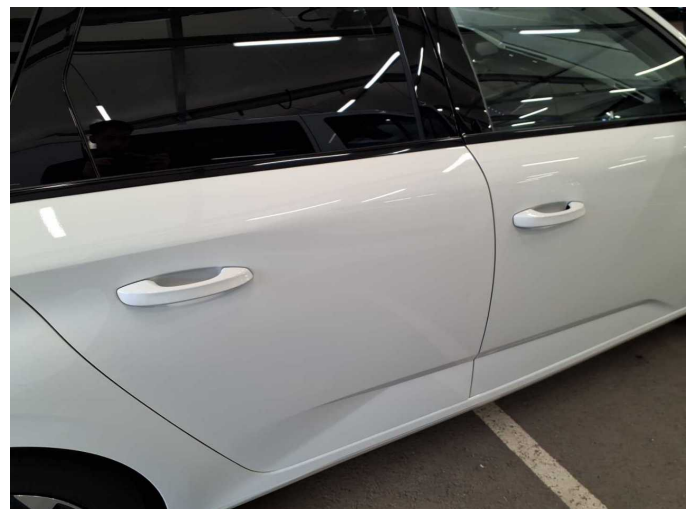
| No. | Component group | Description |
|---|---|--|
| 2 | Door - rear right side | Door - dent(s) - Smooth repair work |

Damage 2: Door - rear right side: Door - dent(s) - Smooth repair work

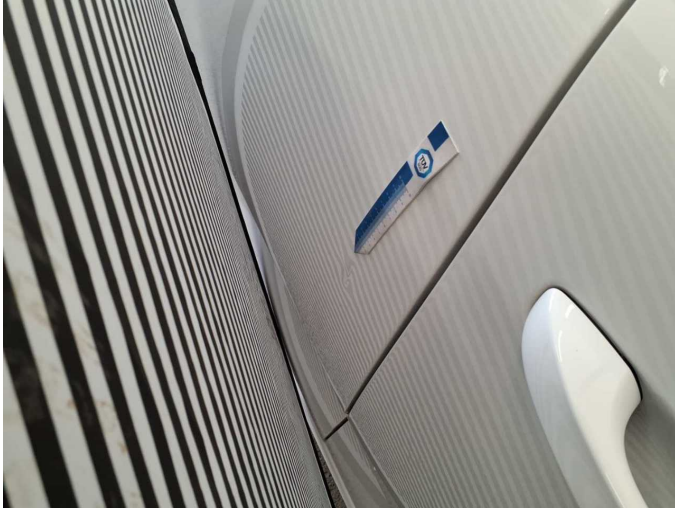
**Damage 2:** Door - rear right side: Door - dent(s) - Smooth repair work

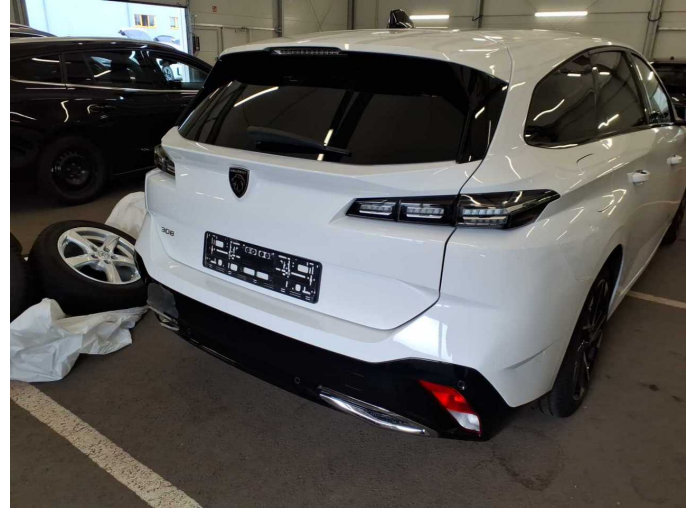
| No. | Component group | Description |
|---|---|--|
| 3 | Rear bumper | Rear bumper - Scratched - Paint |

**Damage 3:** Rear bumper: Rear bumper - Scratched - Paint

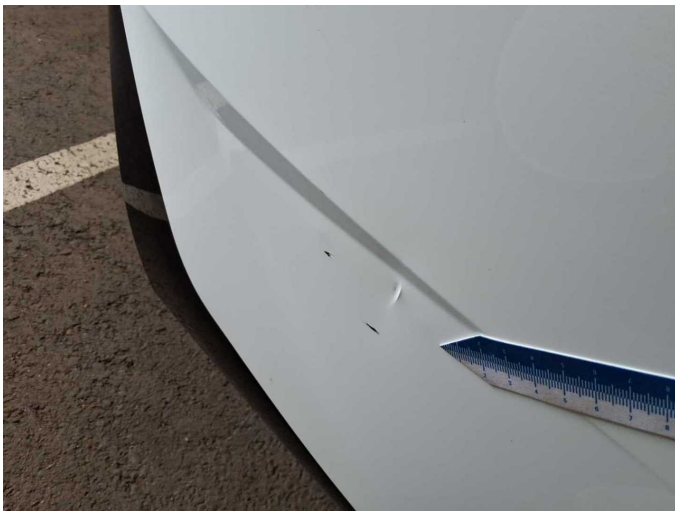
**Damage 3:** Rear bumper: Rear bumper - Scratched - Paint

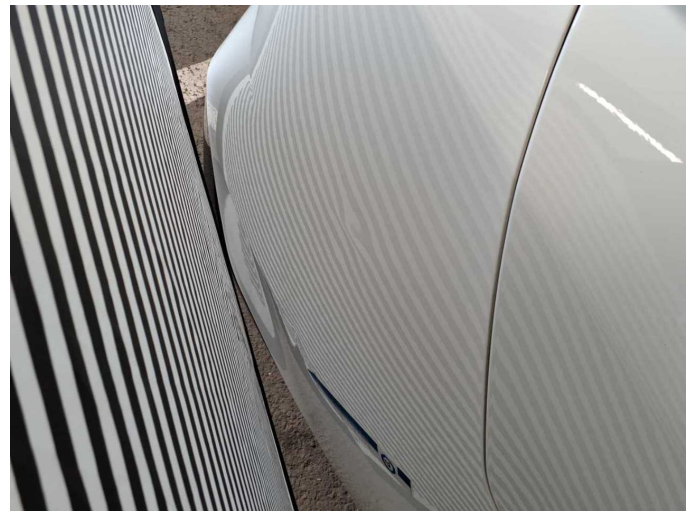
**Damage 3:** Rear bumper: Rear bumper - Scratched - Paint

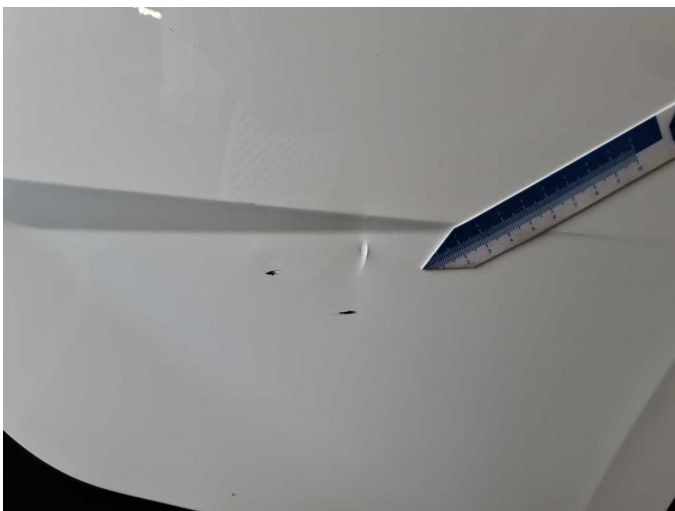
**Damage 3:** Rear bumper: Rear bumper - Scratched - Paint
