Expertise

Protocol number: 46393495
Order No. / Reference: 26642319
Inspection date: 8 Jul 2026

Manufacturer: Ford

Model: Transit Custom 280 L1H1 LKW VA Trend

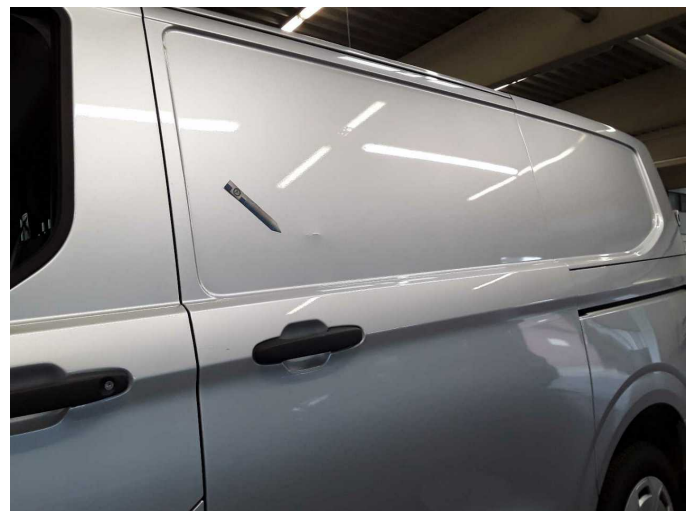
No.	Component group	Description
1	Sliding door - left side	Sliding door - Dent / paintcoat damage - Repair and paint

Damage 1: Sliding door - left side: Sliding door - Dent / paintcoat damage
- Repair and paint

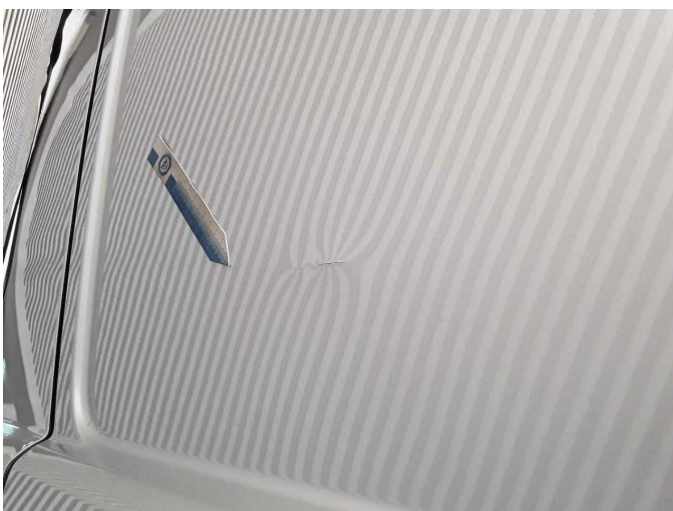
Damage 1: Sliding door - left side: Sliding door - Dent / paintcoat damage
- Repair and paint

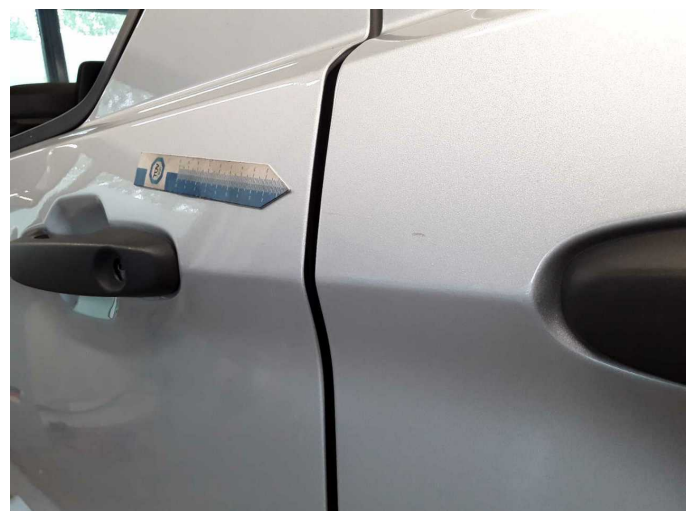
Damage 1: Sliding door - left side: Sliding door - Dent / paintcoat damage
- Repair and paint
