Expertise

Protocol number: 46318146
Order No. / Reference: 26310026
Inspection date: 3 Jul 2026

Manufacturer: Opel

Model: Astra Sports Tourer 1.2 Turbo Automatik GS

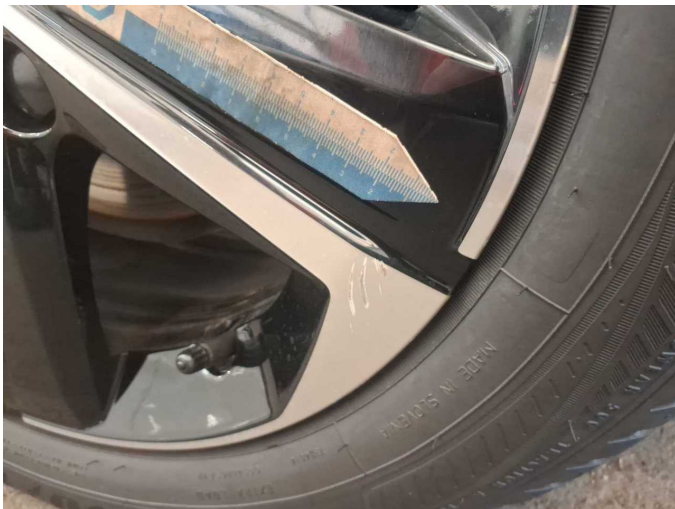
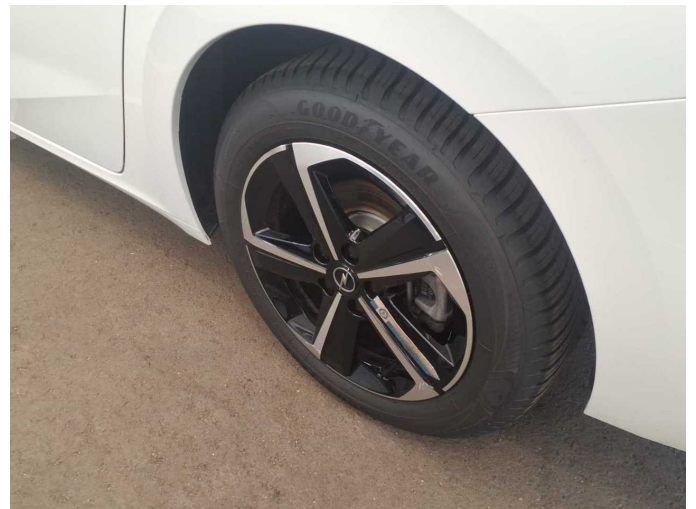
Damage 1: Wheel / tyres: Alloy rim - rear left side - Scratch(es) - Loss in value

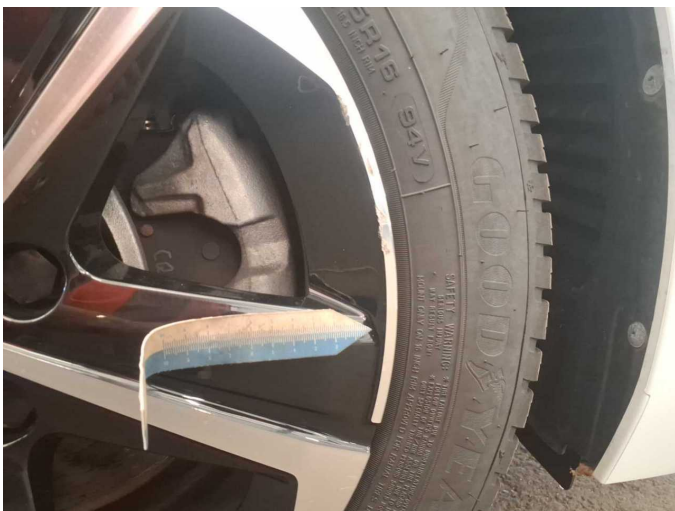
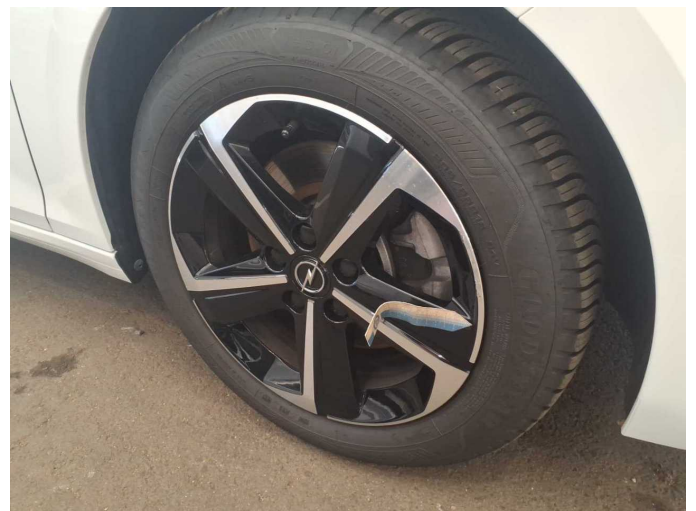
Damage 2: Wheel / tyres: Alloy rim - front right side - Scratch(es) - Loss in value

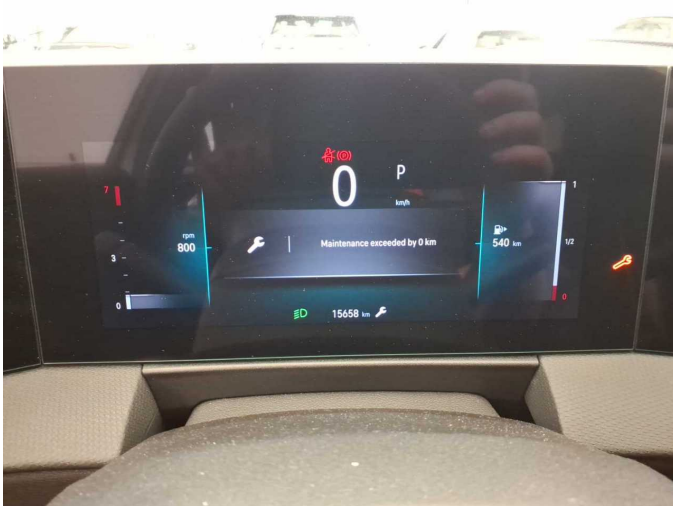
Damage 3: Misc.: Inspection / maintenance - Expired - Perform

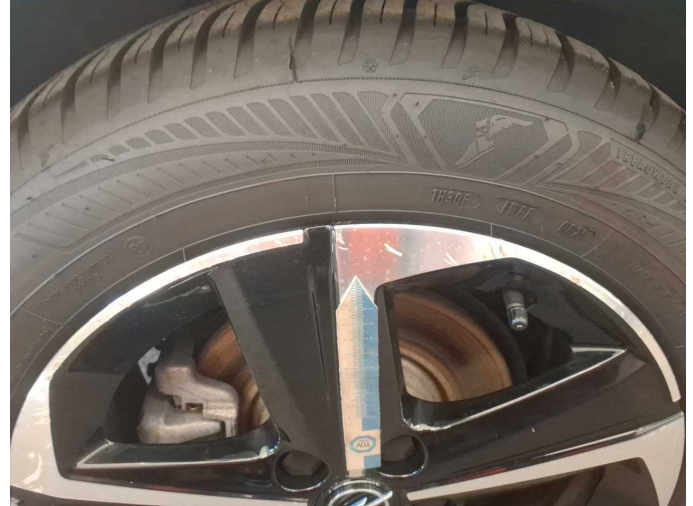
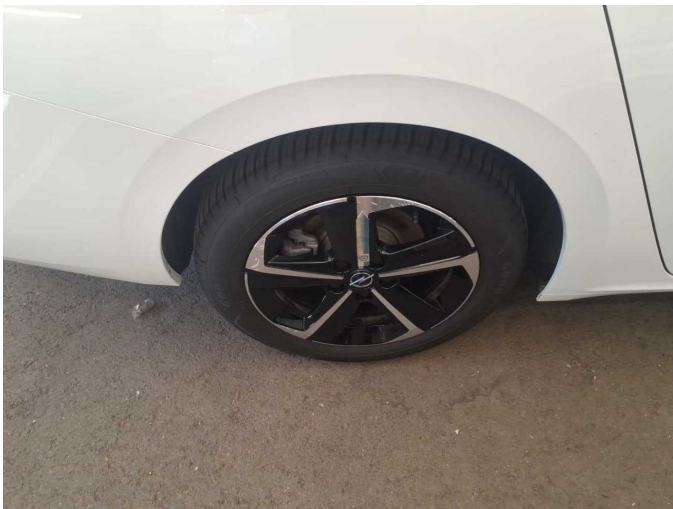
Wear and tear 1: Wheel / tyres: Alloy rim - rear right side - Scratch(es) - No deduction

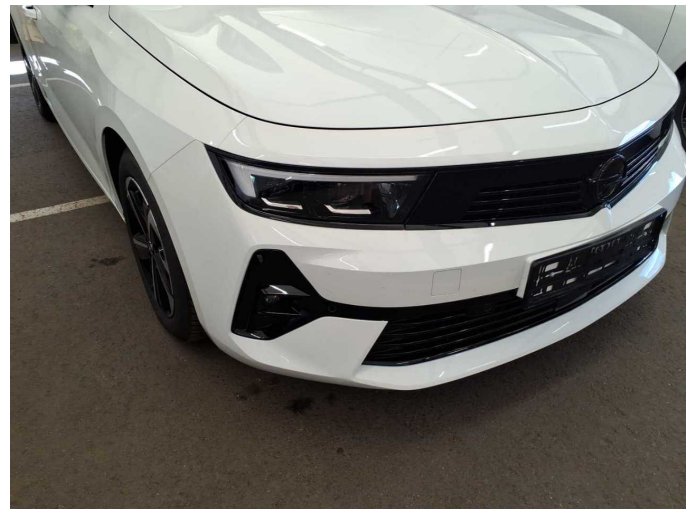
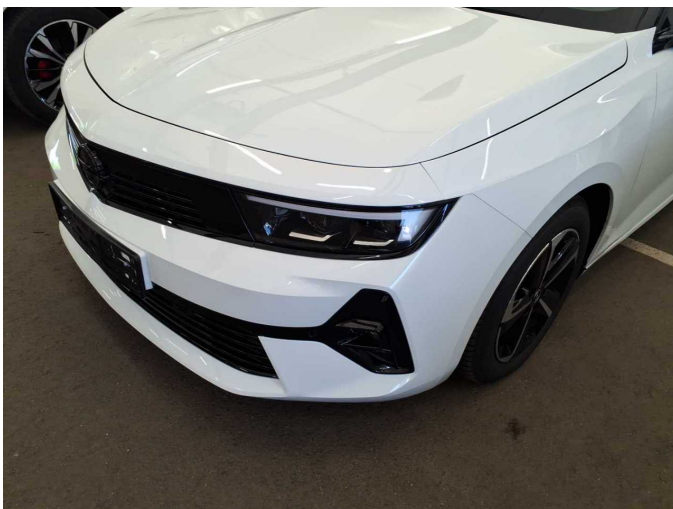
Wear and tear 2: Front bumper: Front bumper - Stone chips - No deduction

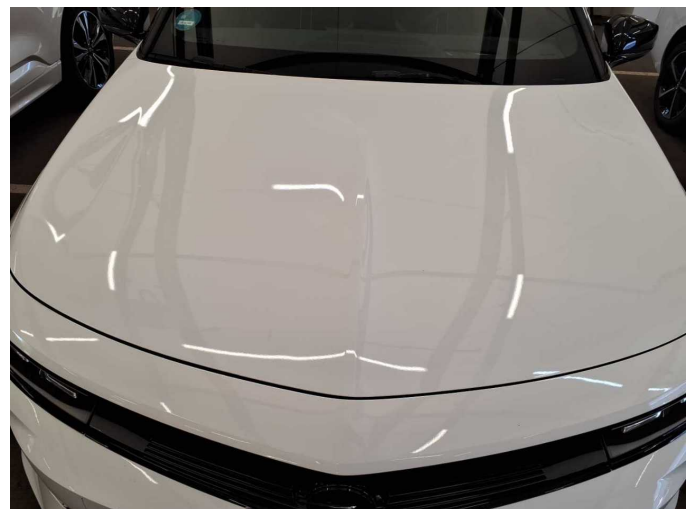
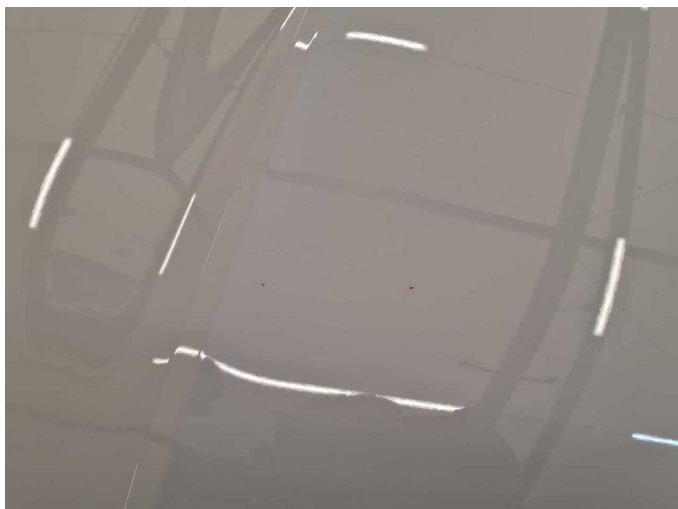
Wear and tear 3: Bonnet: Bonnet (Flugrost auf Motorhaube keine Lackbeschädigung) - Stone chips - No deduction

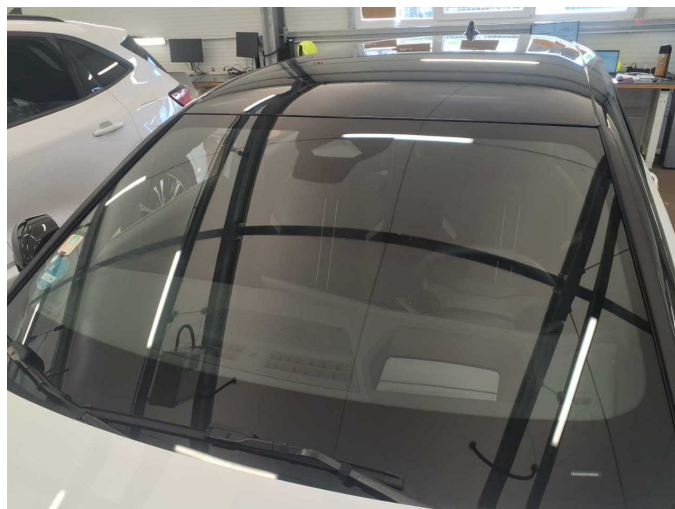
Wear and tear 4: Vehicle glazing: Windscreen - Stone chips - No deduction

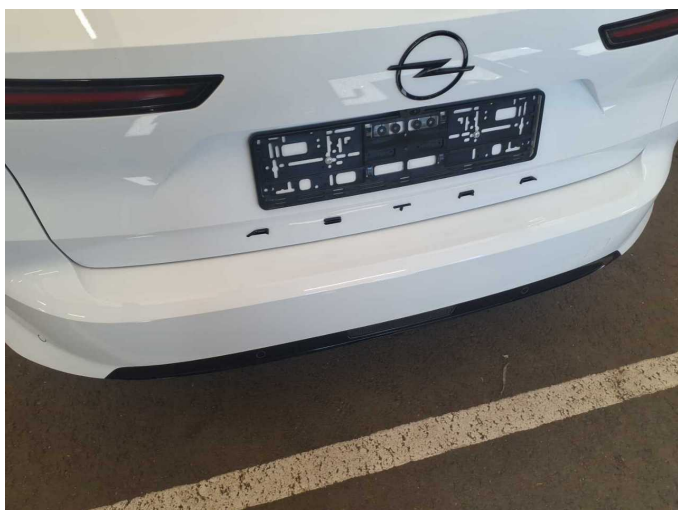
Wear and tear 6: Rear bumper: Rear bumper - Scratch(es) - No deduction
