## Expertise

Protocol number: 46264054  
Order No. / Reference: 26529671  
Inspection date: 29 Jun 2026

Manufacturer: Mercedes-Benz

Model: C 200 d T 9G-TRONIC

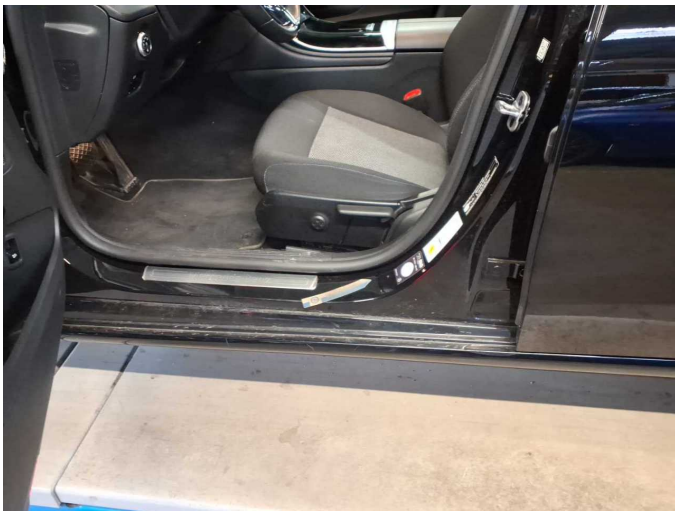
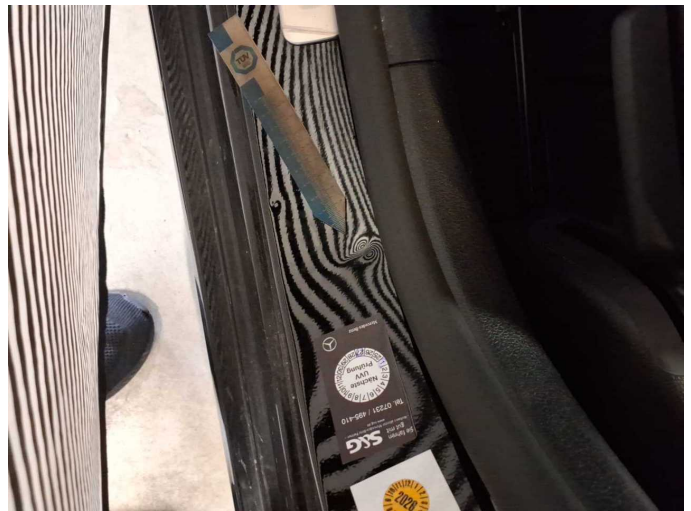
Damage 2: Sill - left side: Sill - dent(s) - Smooth repair work

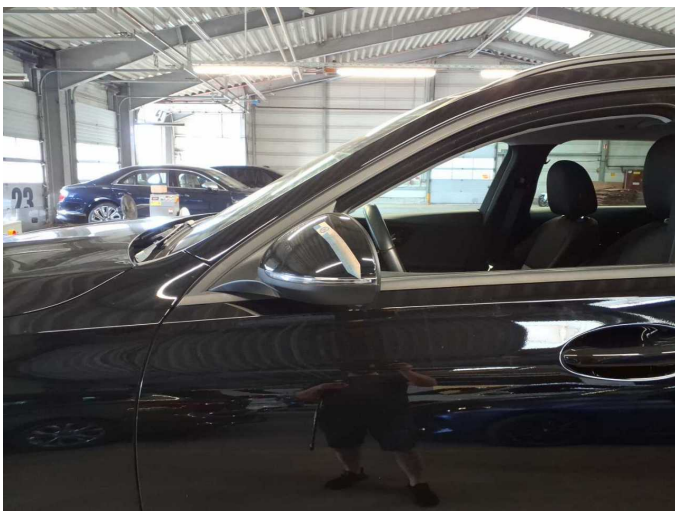
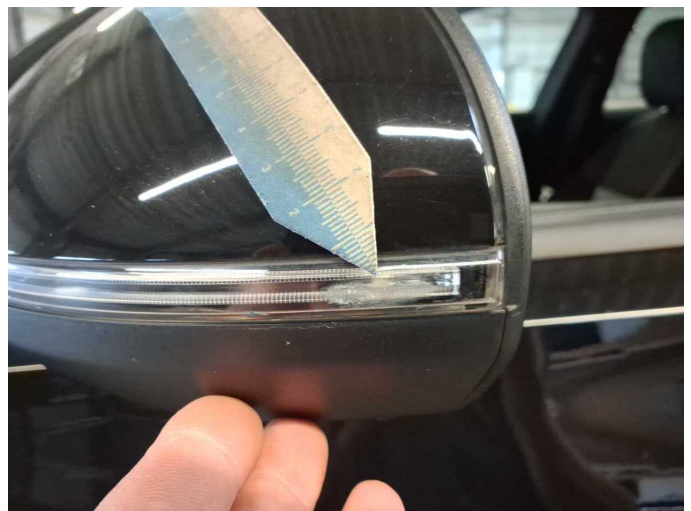
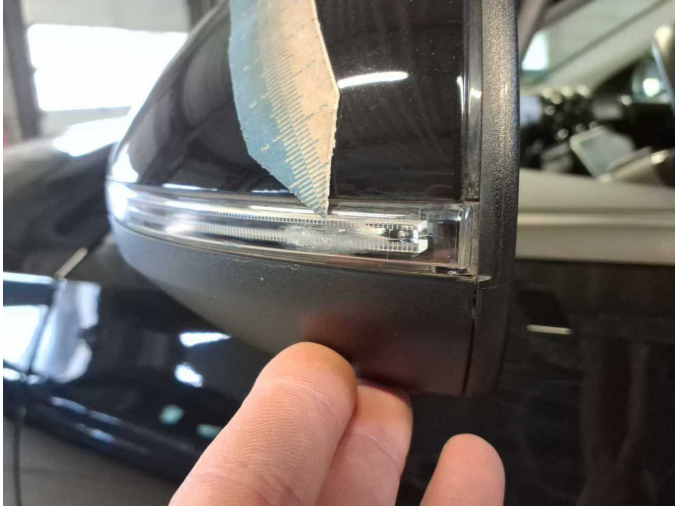
Damage 3: Indicator - front: Mirror - left side (Materialabtrag) - Scratched - Replace

**Damage 3:** Indicator - front: Mirror - left side (Materialabtrag) - Scratched - Replace

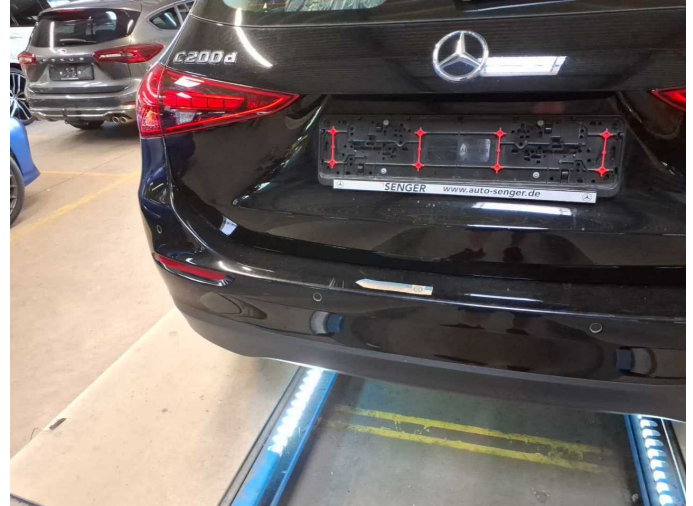
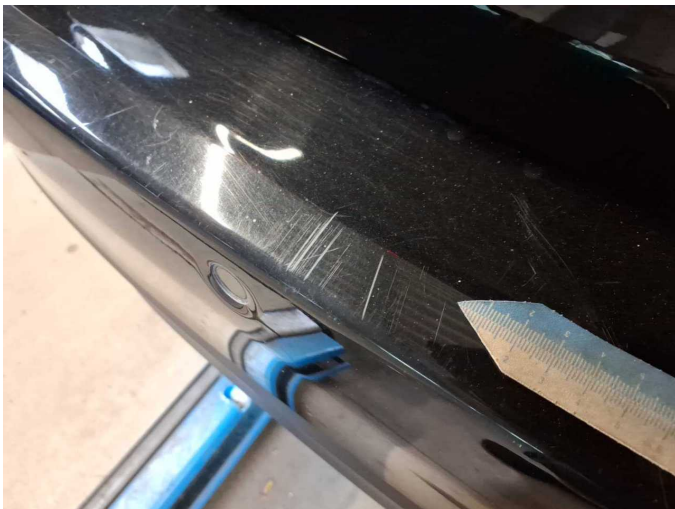
**Damage 4:** Rear bumper: Rear bumper - Scratch(es) - Smart repair

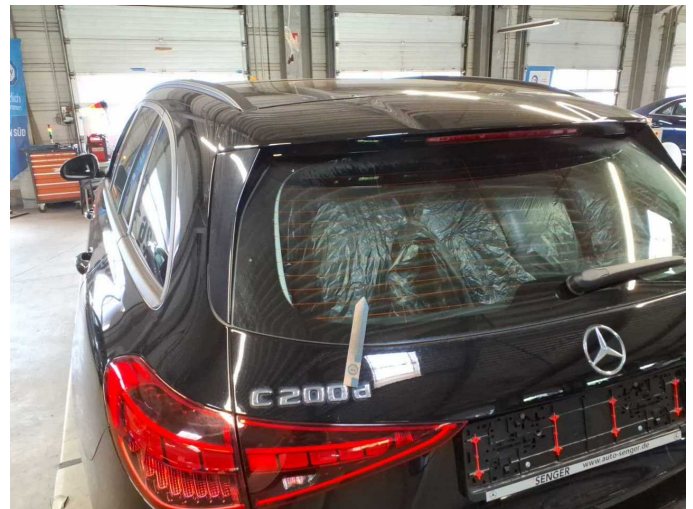
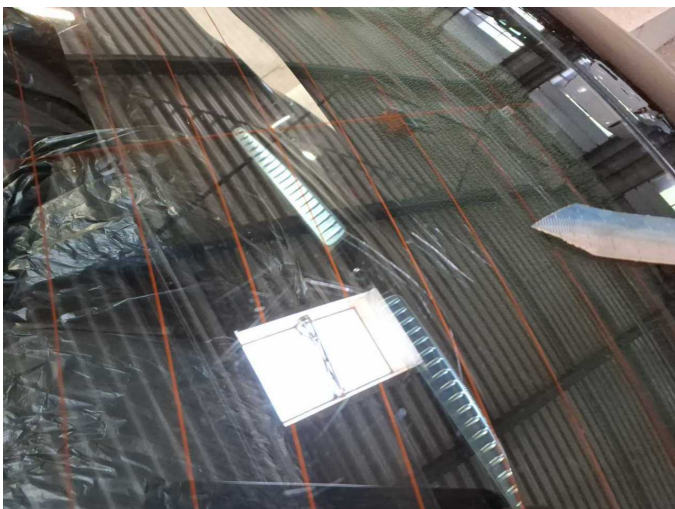
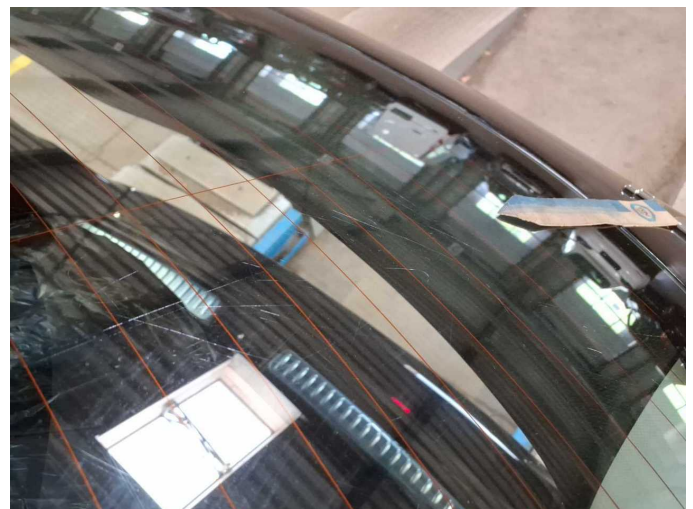
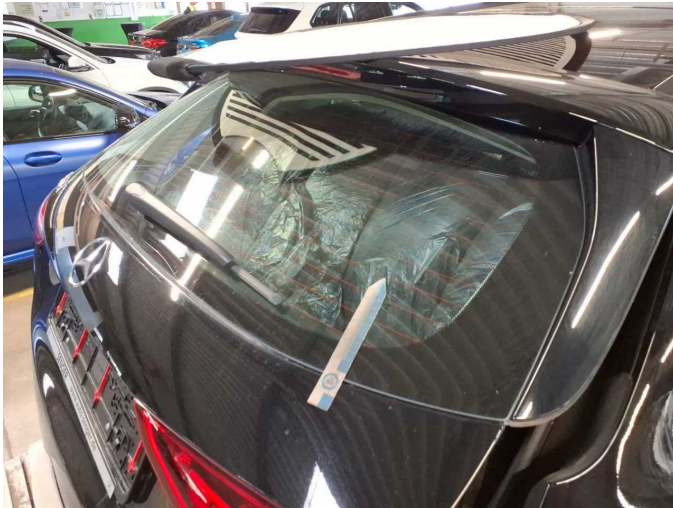
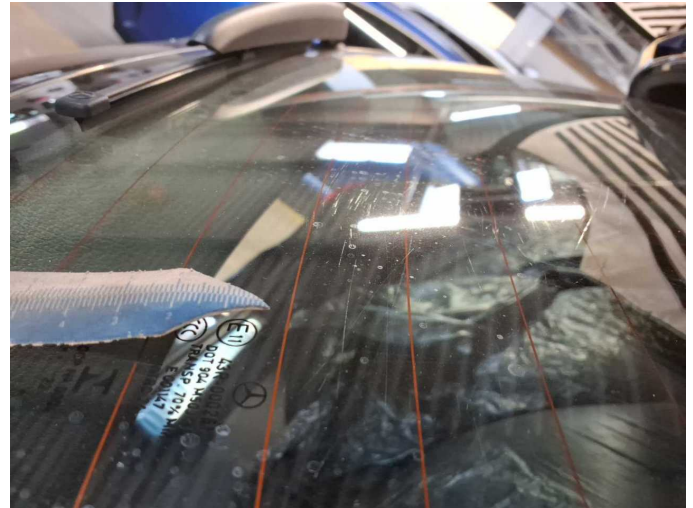
**Damage 5:** Vehicle glazing: Rear window - Scratch(es) - Loss in value

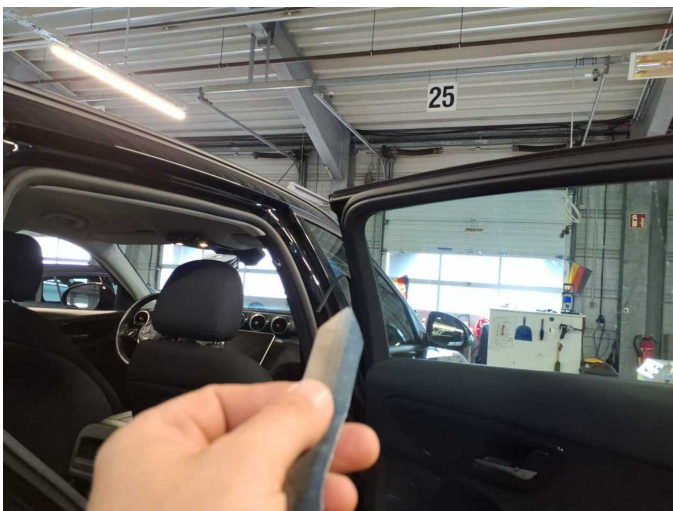
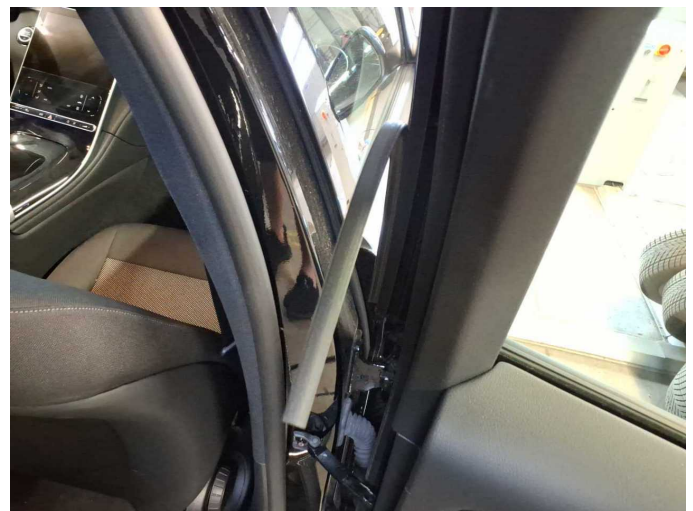
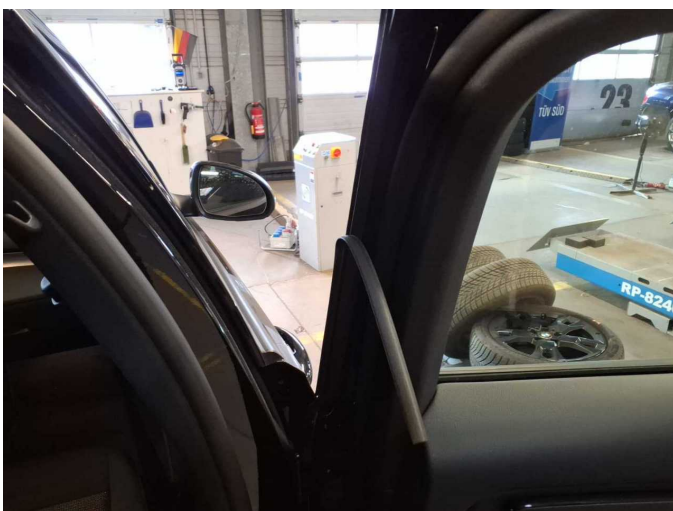
**Damage 6:** Door - rear right side: Door (Dichtung) - Broken / torn - Replace

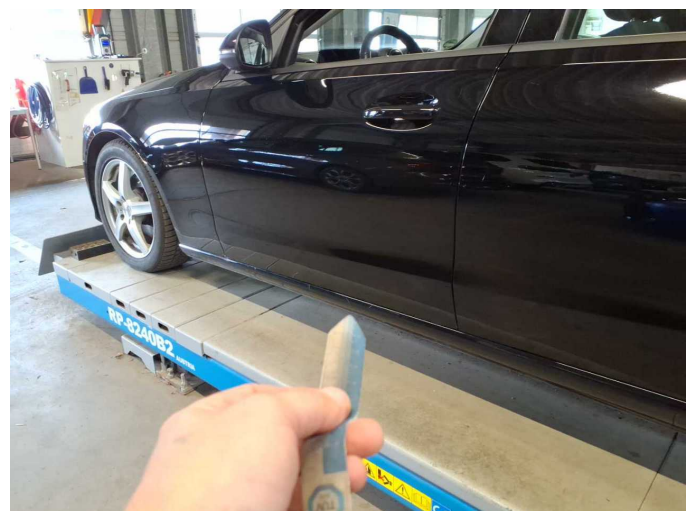
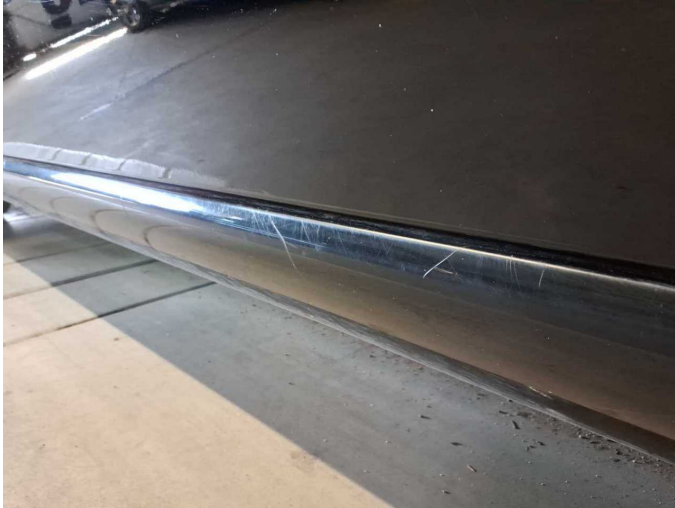
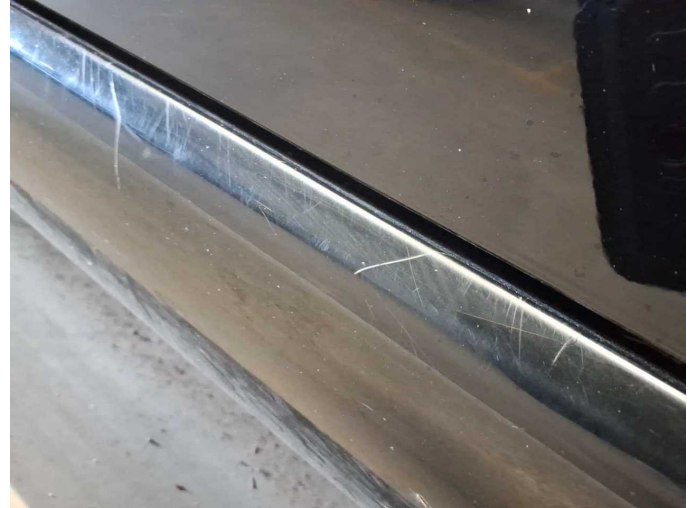
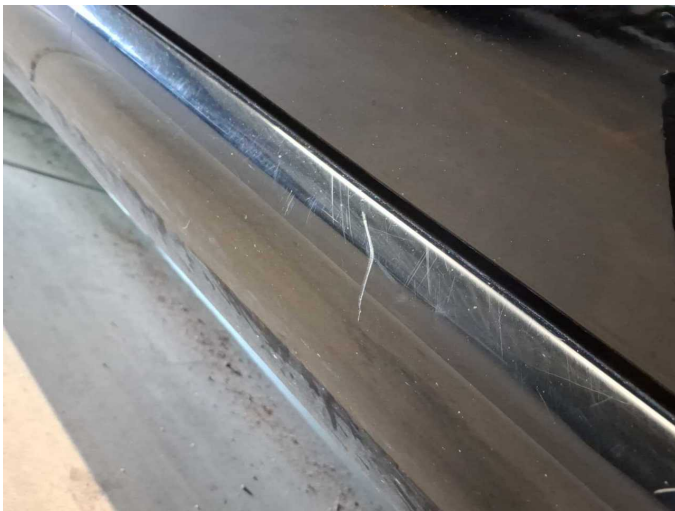
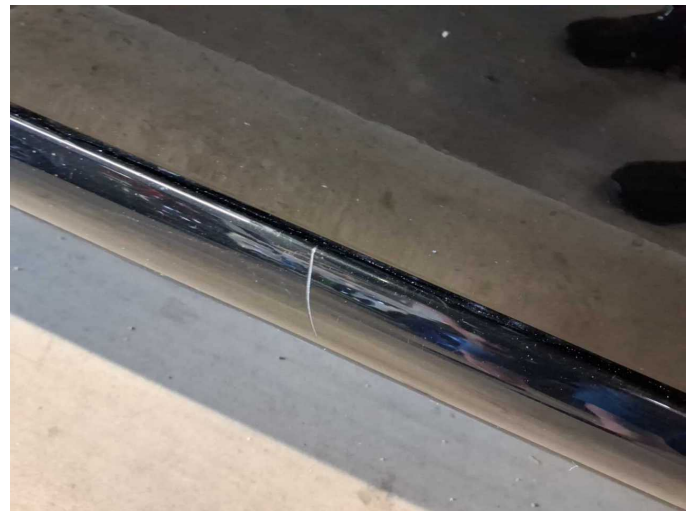
**Damage 7:** Sill - left side: Trim - Scratch(es) - Paint

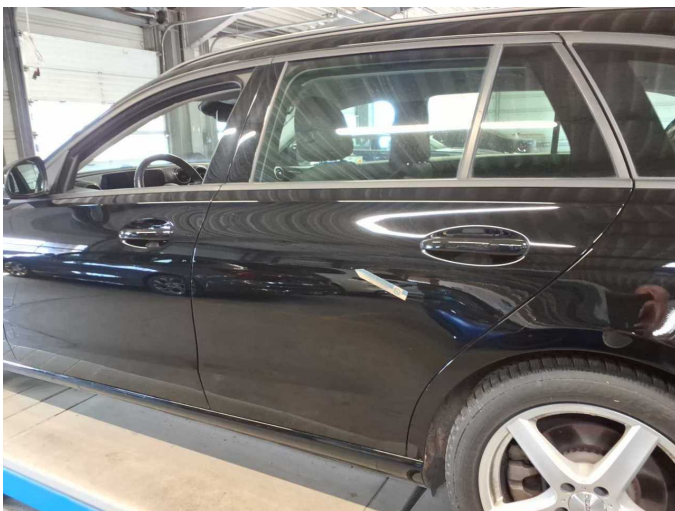
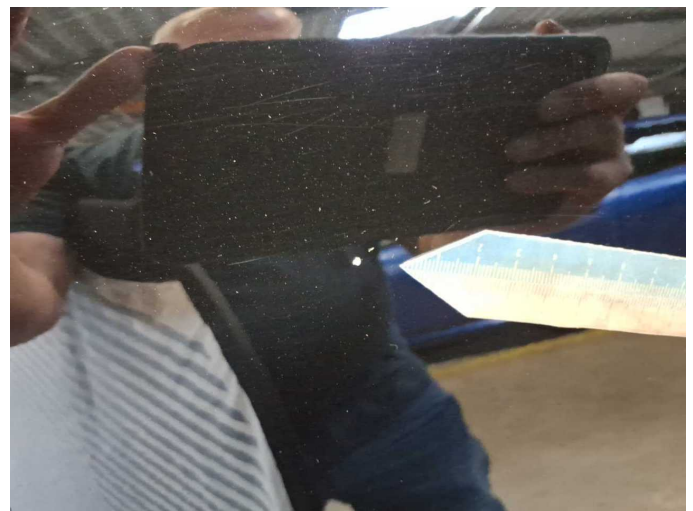
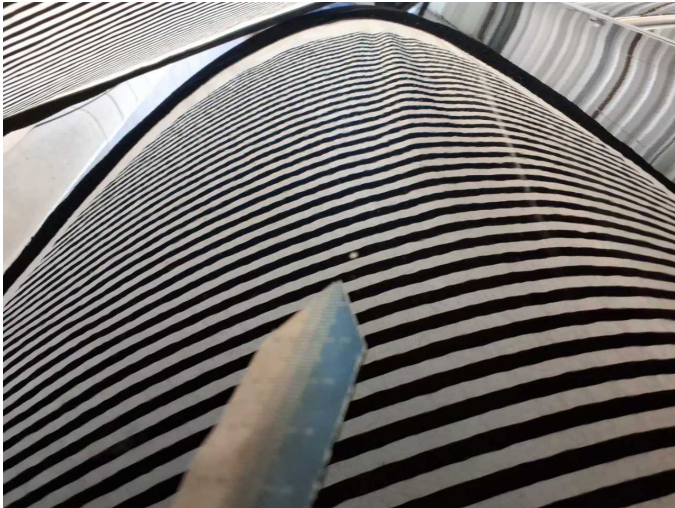
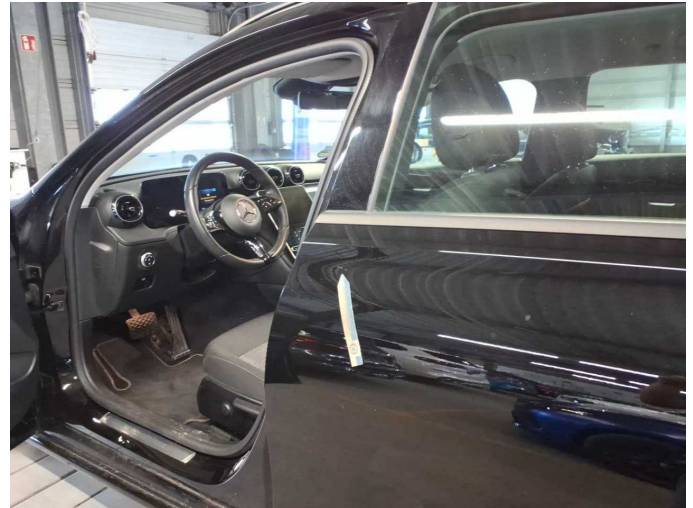
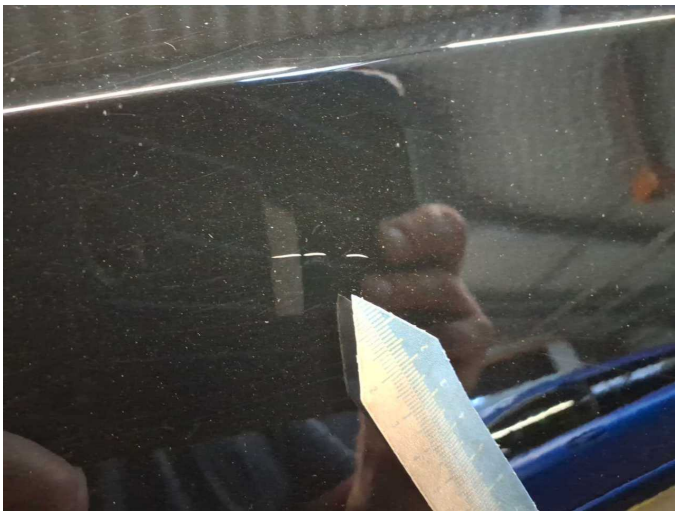
**Damage 8:** Door - rear left side: Door (Kratzern) - Stone chips - Paint

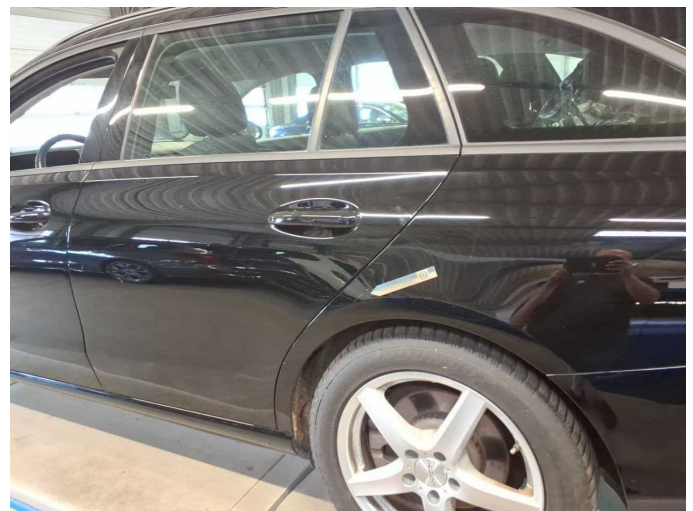
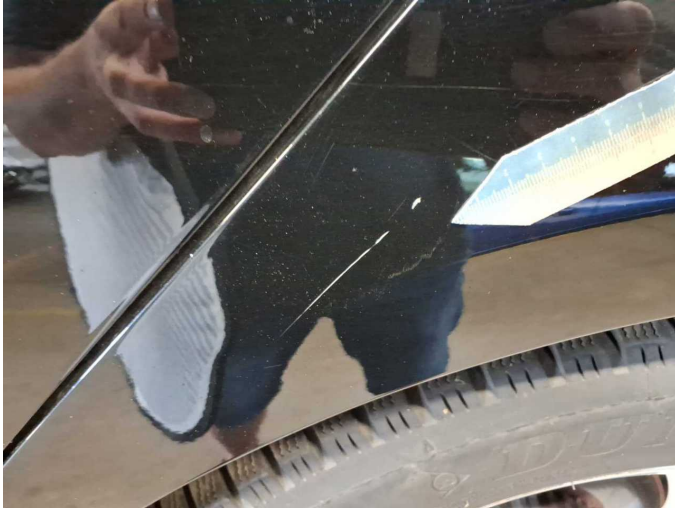
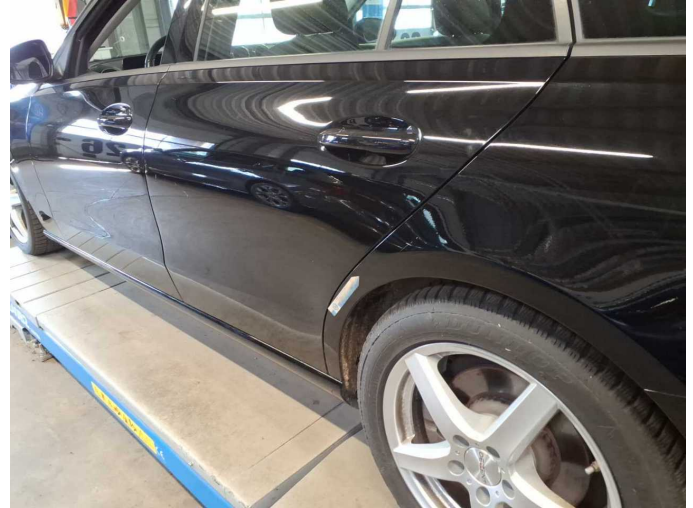
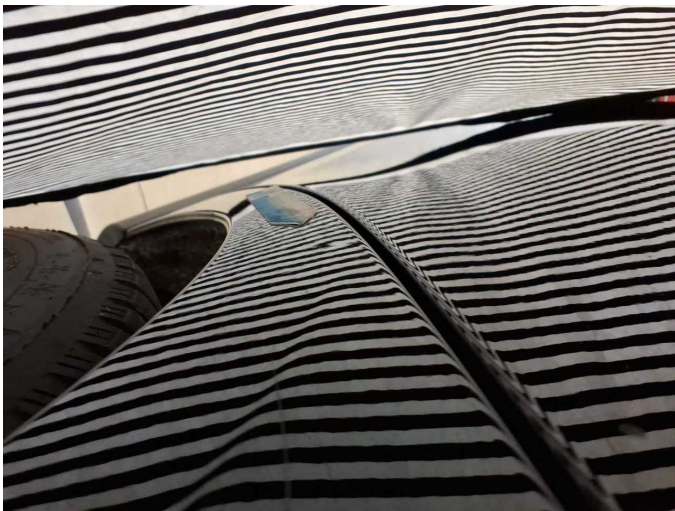
**Damage 10:** Side panel - rear left side: Side panel - Dent / paintcoat damage - Repair and paint

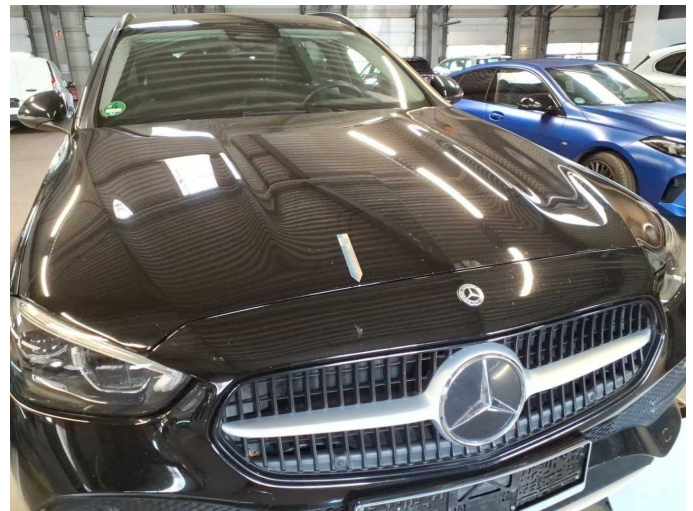
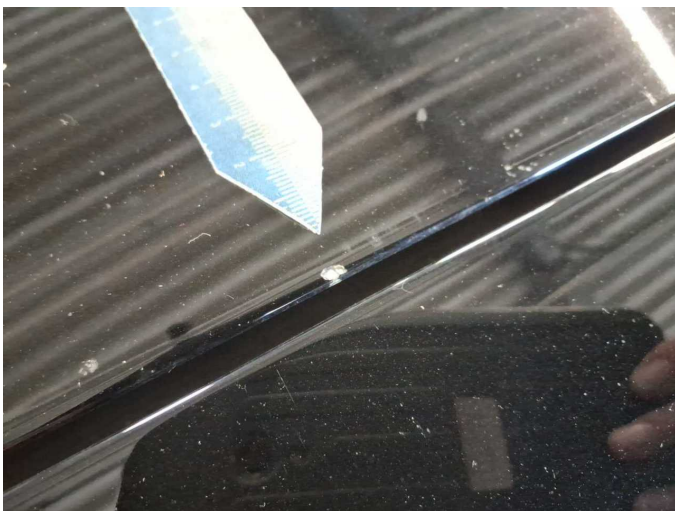
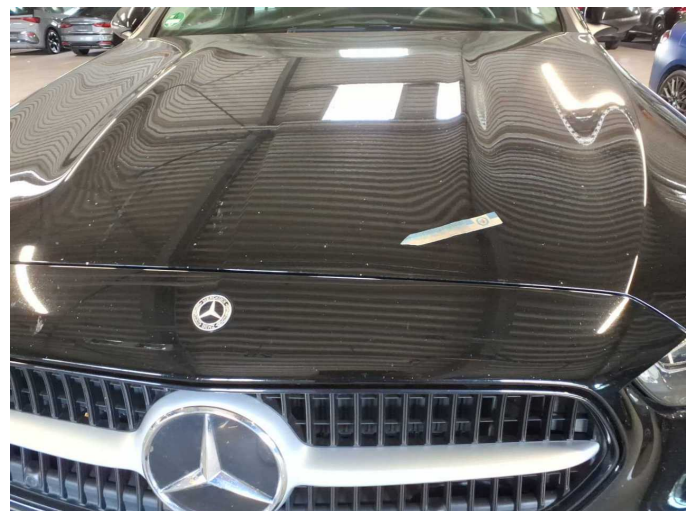
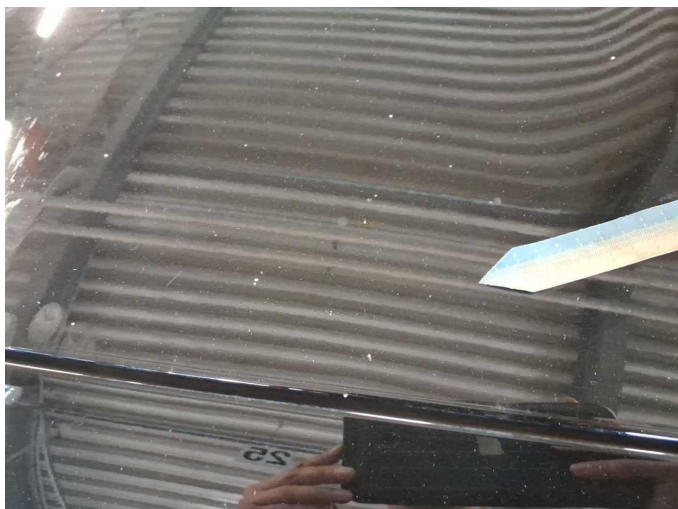
**Damage 11:** Bonnet: Bonnet - Stone chips - Paint
