Expertise

Protocol number: 46291651
Order No. / Reference: 26512259
Inspection date: 2 Jul 2026

Model: Octavia 2.0 TDI DSG Style

VIN: TMBAJ7NXXMY141195

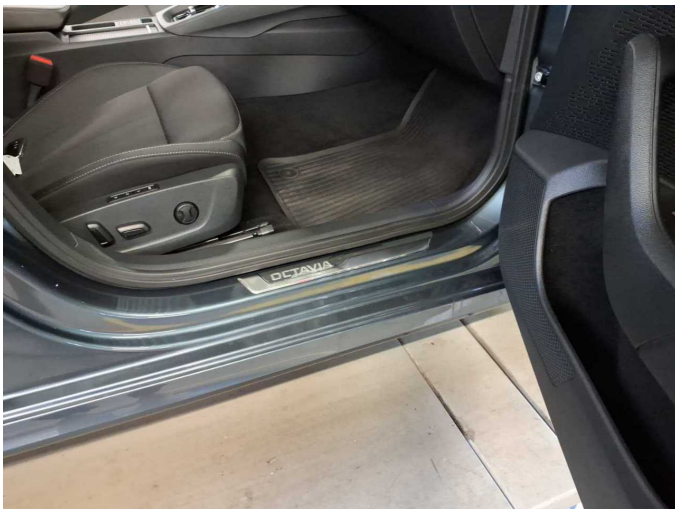
Damage 2: Sill - right side: Sill (Emblem, lack blättert ab) - Paint defect - Replace

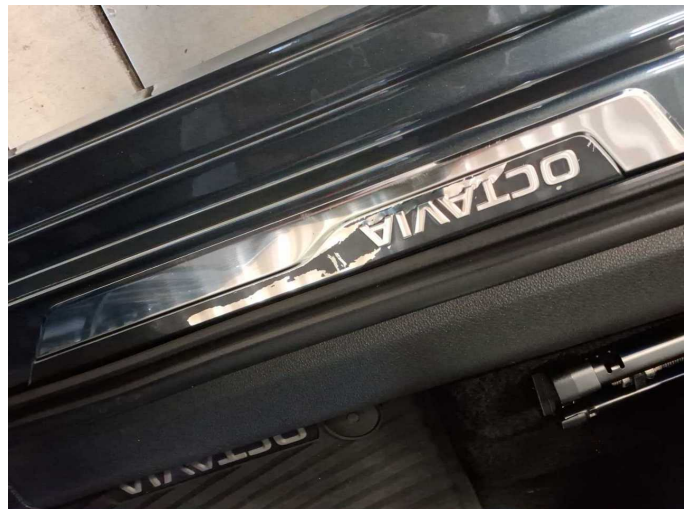
Damage 2: Sill - right side: Sill (Emblem, lack blättert ab) - Paint defect - Replace

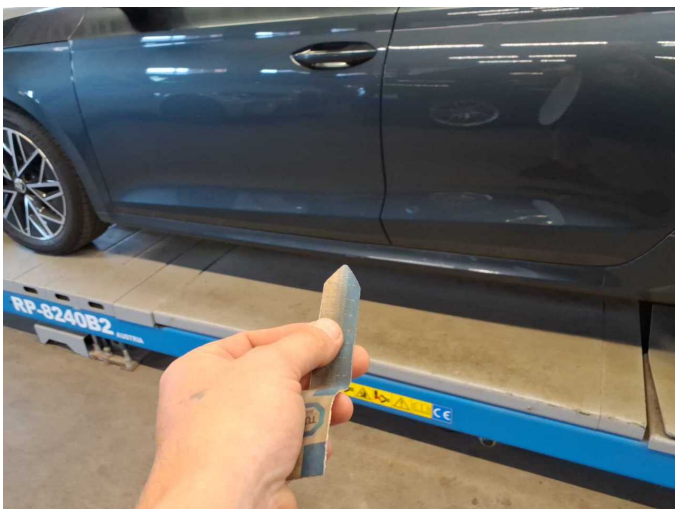
Damage 3: Sill - left side: Sill - Scratch(es) - Smart repair

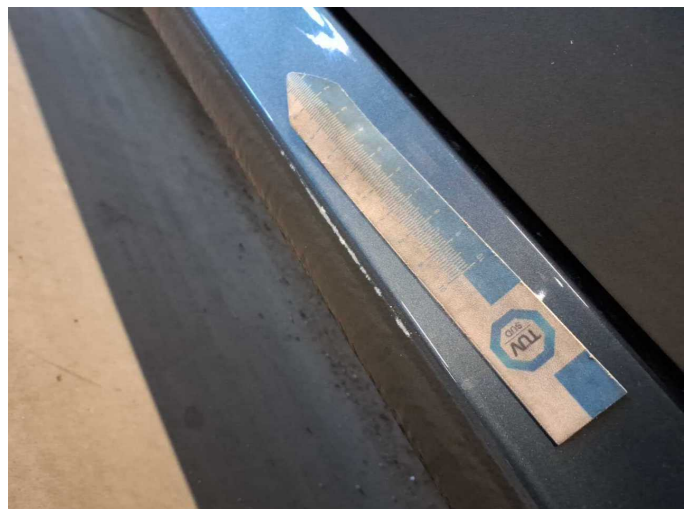
Damage 3: Sill - left side: Sill - Scratch(es) - Smart repair

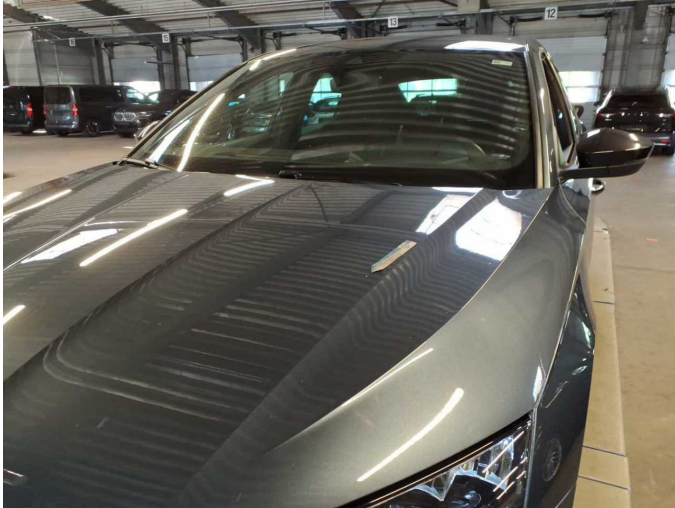
Damage 4: Bonnet: Bonnet - Stone chips - Paint

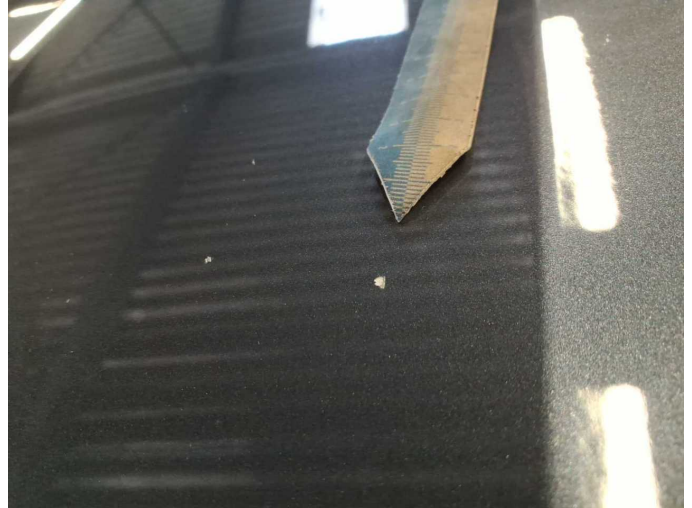
Damage 4: Bonnet: Bonnet - Stone chips - Paint

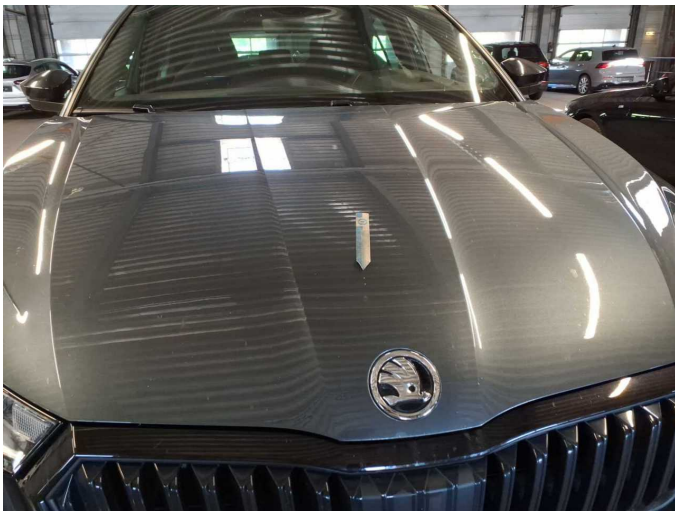
Damage 4: Bonnet: Bonnet - Stone chips - Paint

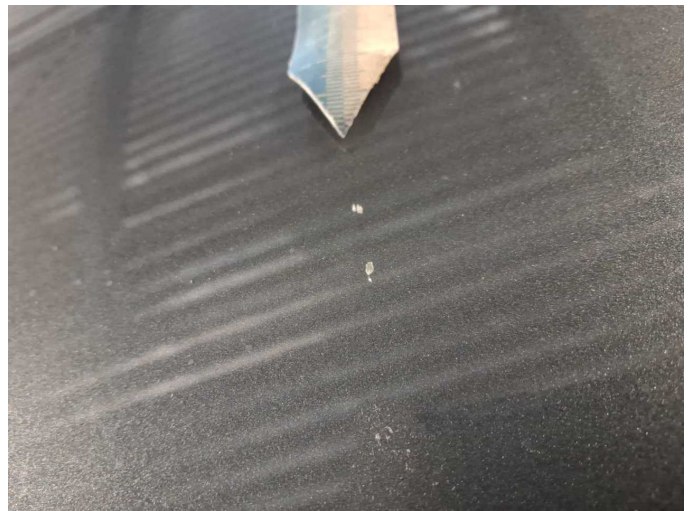
Damage 4: Bonnet: Bonnet - Stone chips - Paint

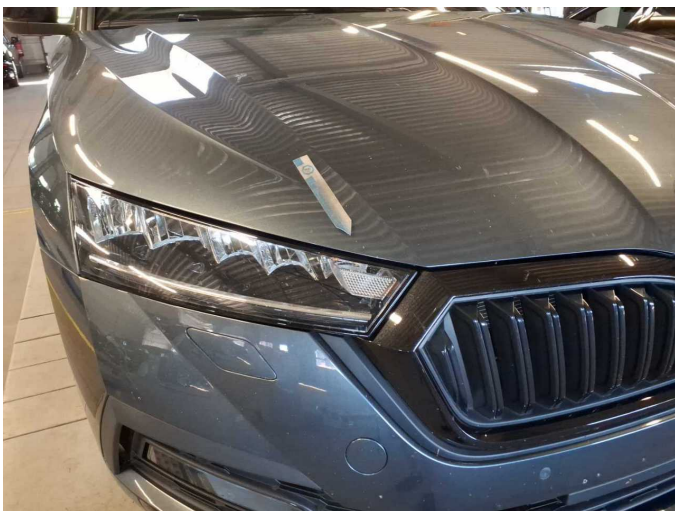
Damage 4: Bonnet: Bonnet - Stone chips - Paint

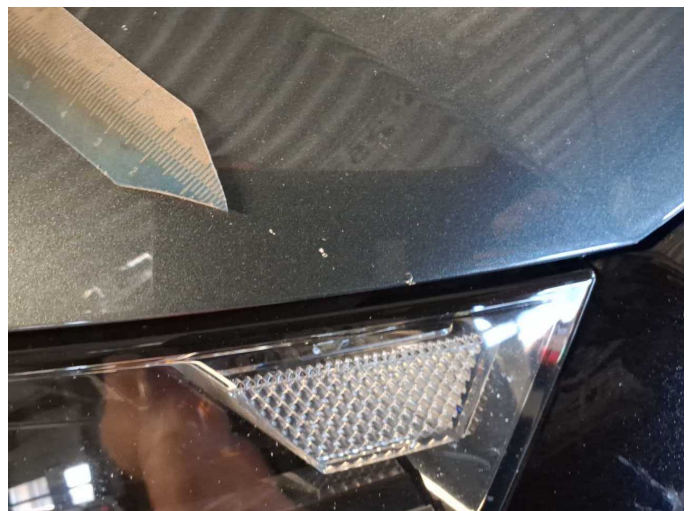
Damage 4: Bonnet: Bonnet - Stone chips - Paint

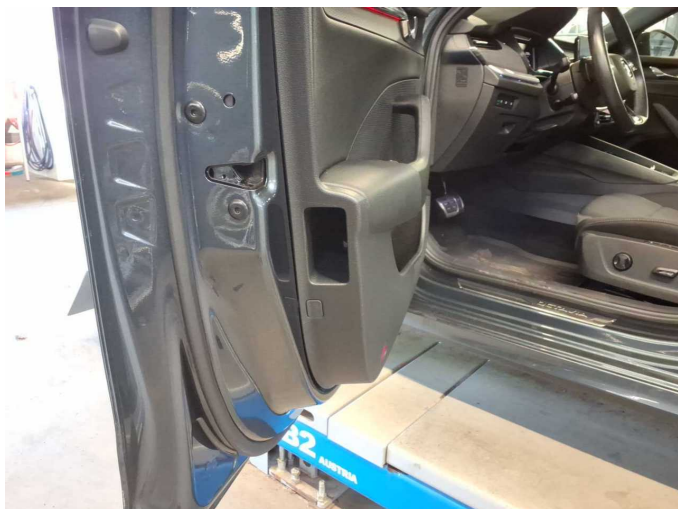
Missing part 1: Equipment: Umbrella - Missing - Replace

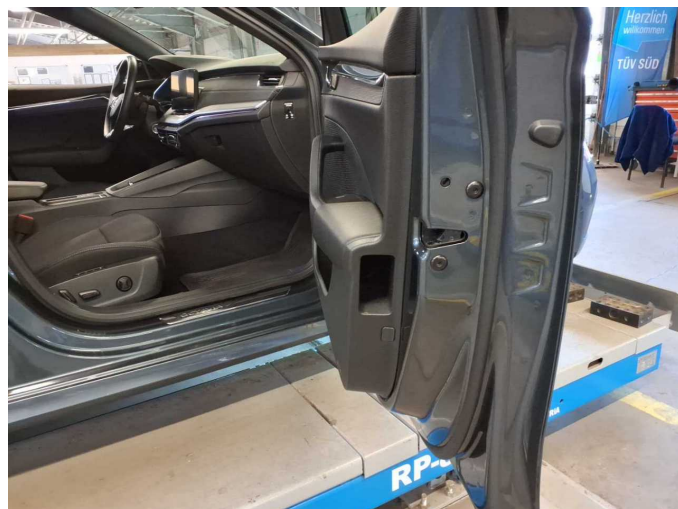
Missing part 1: Equipment: Umbrella - Missing - Replace
