Expertise

Protocol number: 46589193  
Order No. / Reference: 26154527  
Inspection date: 22 Jun 2026

Manufacturer: Mercedes-Benz  
VIN: W1VVLGFZ9T4564148

Model: Vito 116 CDI Tourer Extralang Aut. PRO

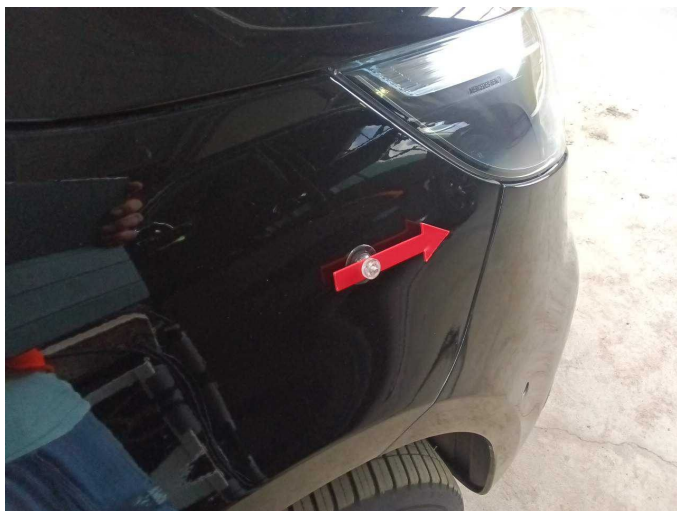
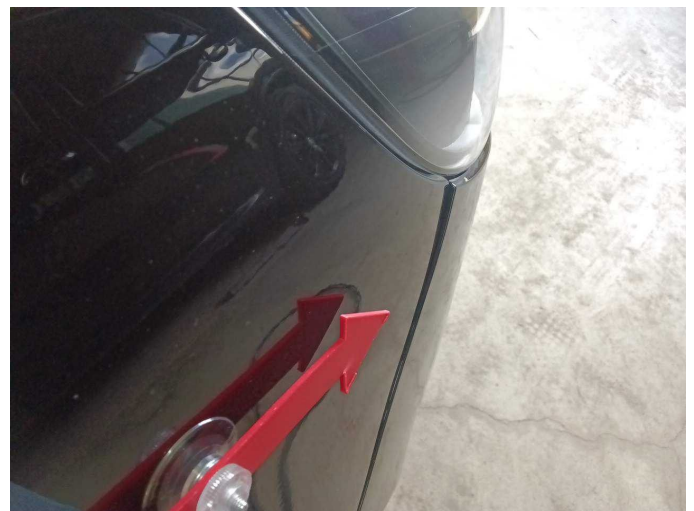
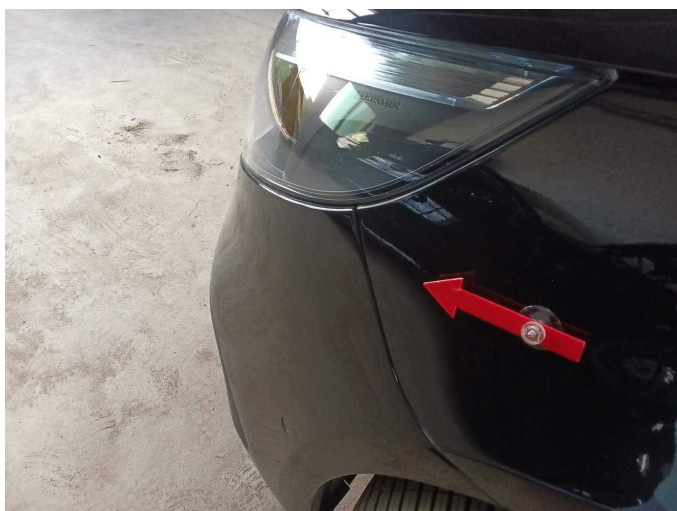
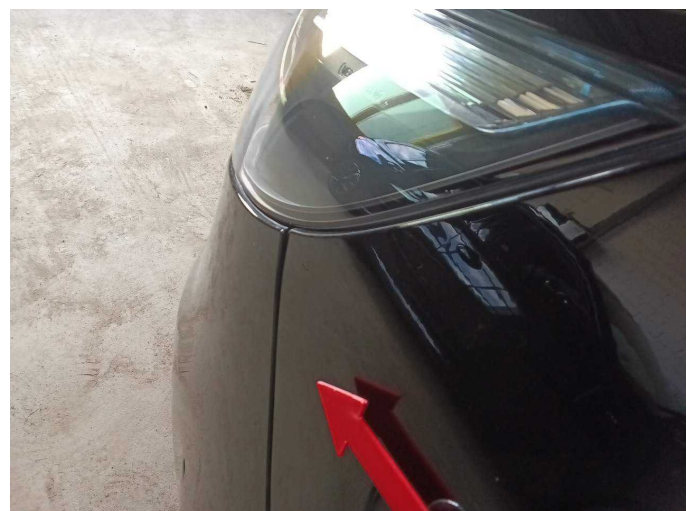
| No. | Component group | Description |
|---|---|---|
| 2 | Front bumper | Front bumper - Malposition - Un- / install |

Damage 2: Front bumper: Front bumper - Malposition - Un- / install

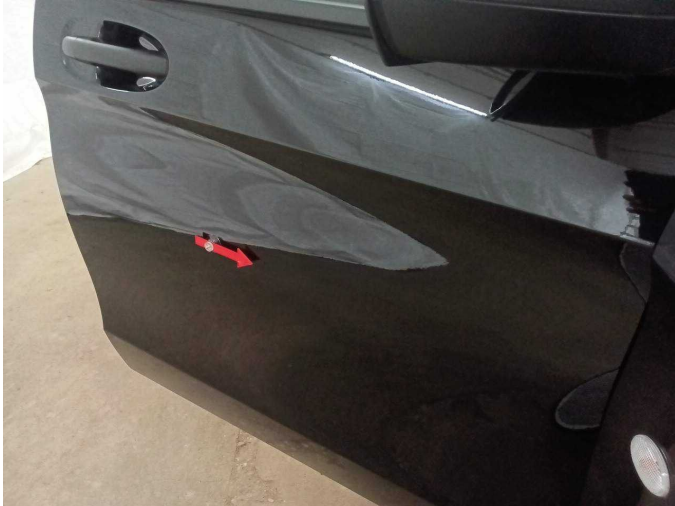
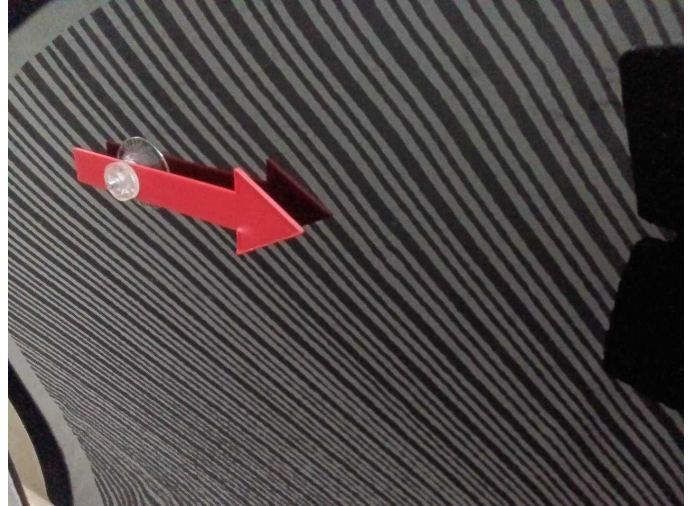
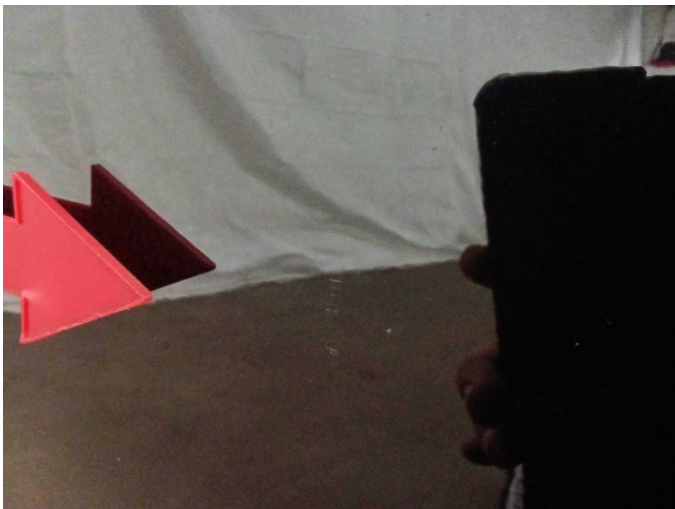
| No. | Component group | Description |
|---|---|---|
| 3 | Door - front right side | Door - Dent / paintcoat damage - Smart repair |

**Damage 3:** Door - front right side: Door - Dent / paintcoat damage - Smart repair

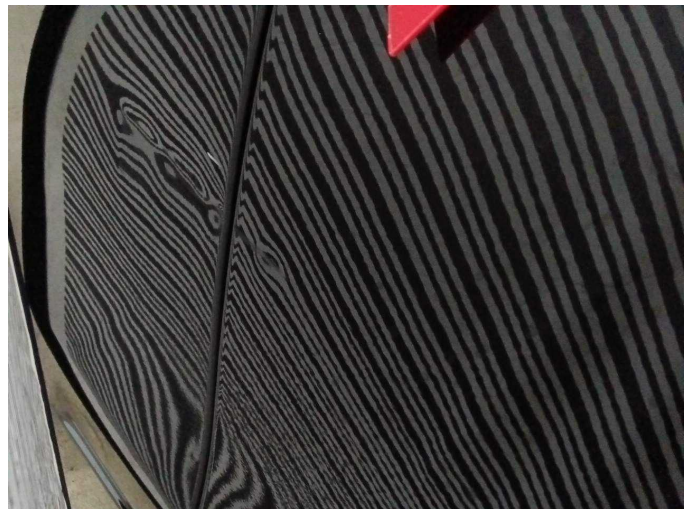
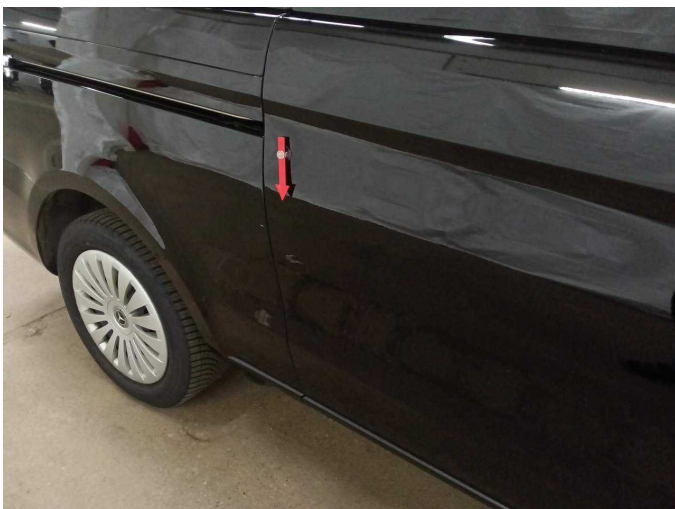
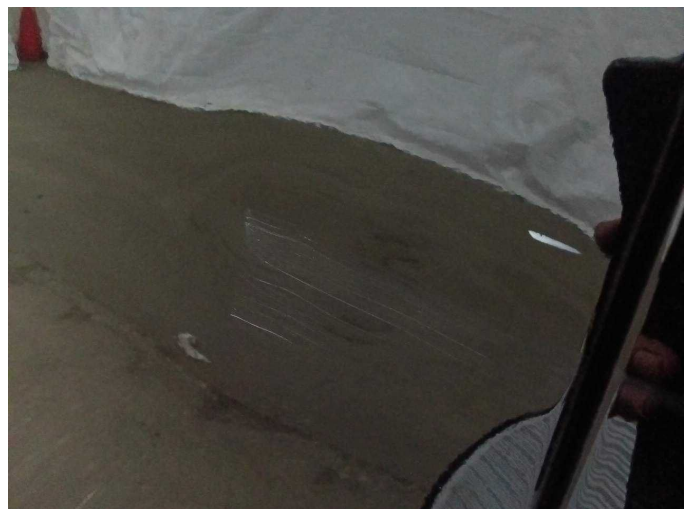
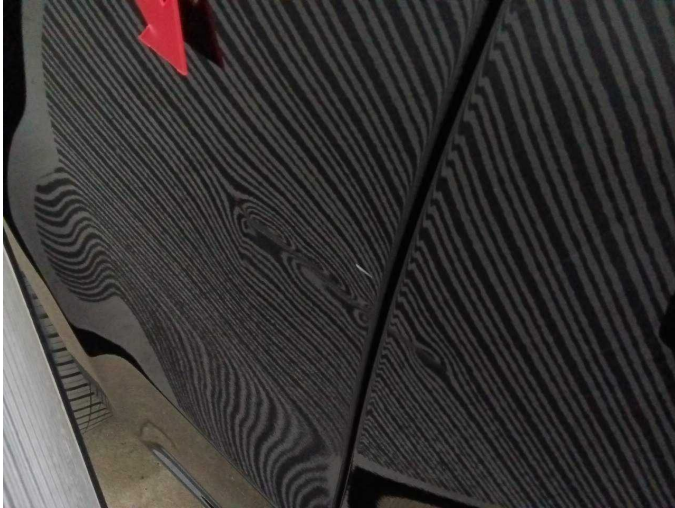
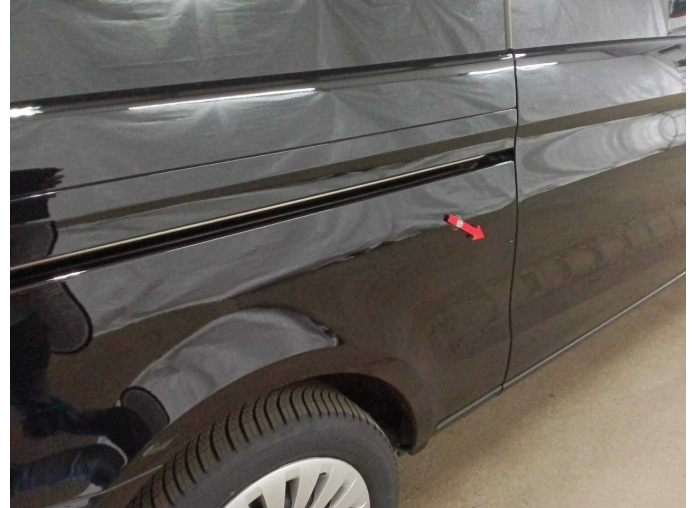
1 Side right

**Accident 1:** Side right

**Accident 1: Side right**
