Expertise

Protocol number: 45924105
Order No. / Reference: 26410548
Inspection date: 10 Jun 2026

Model: Astra 1.5 D Start/Stop Sports Tourer Automatik GS Line

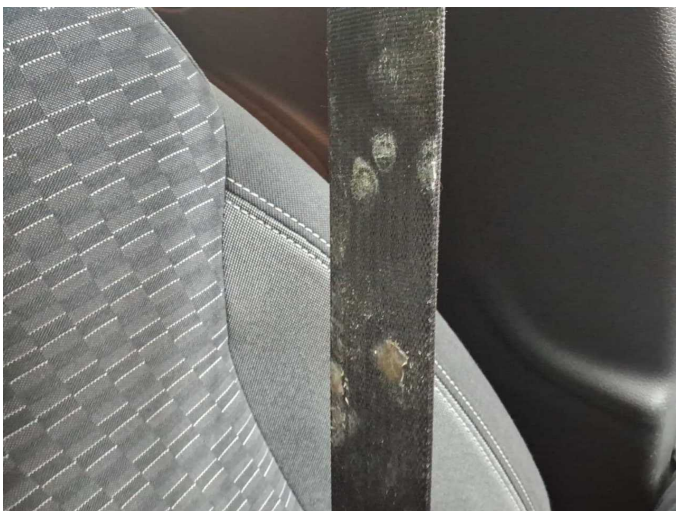
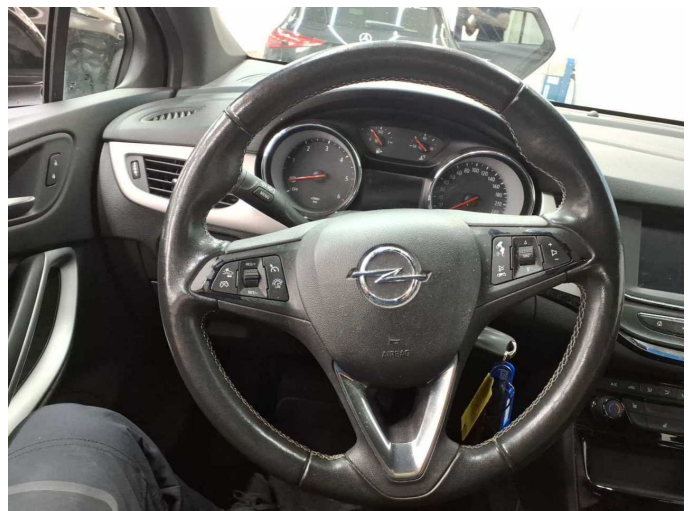
Damage 2: Seat belts - front: Seat belt - front left side - Soiled - Clean

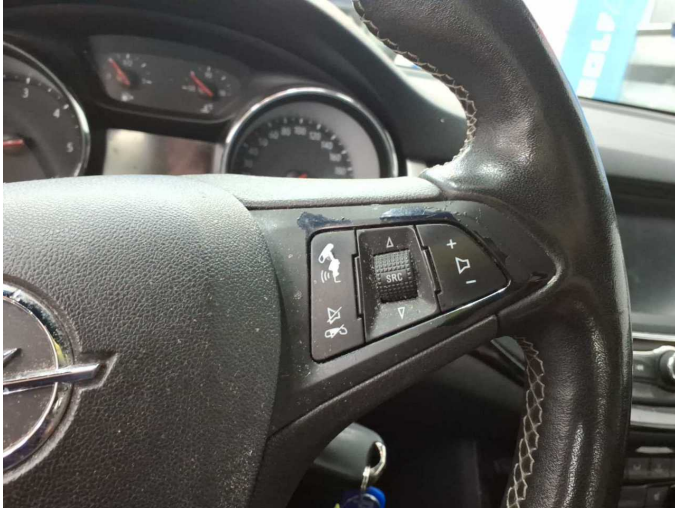
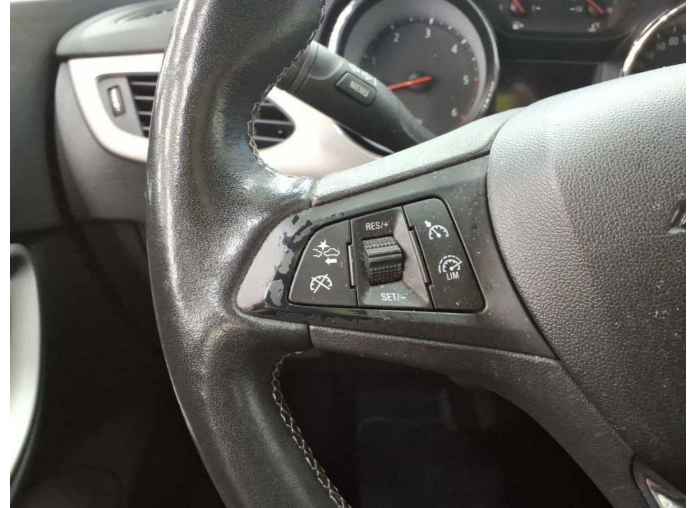
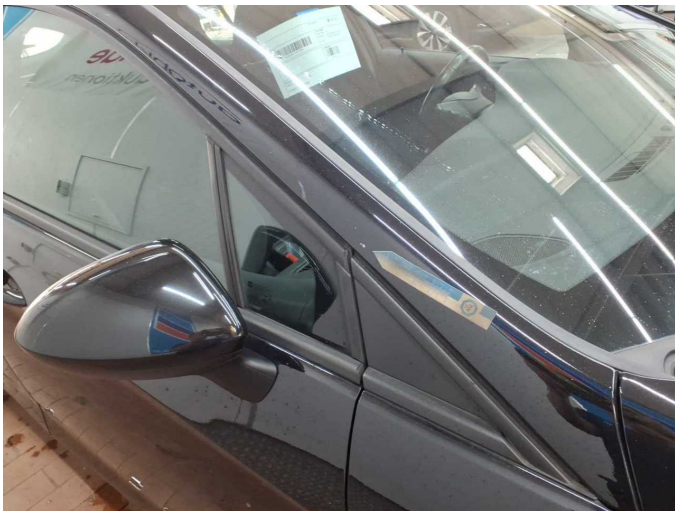
Damage 3: Steering system: Steering wheel - Abrasion - Loss in value

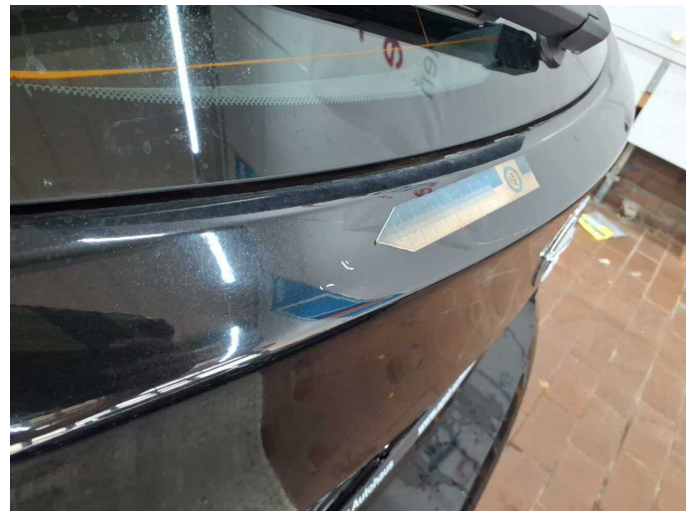
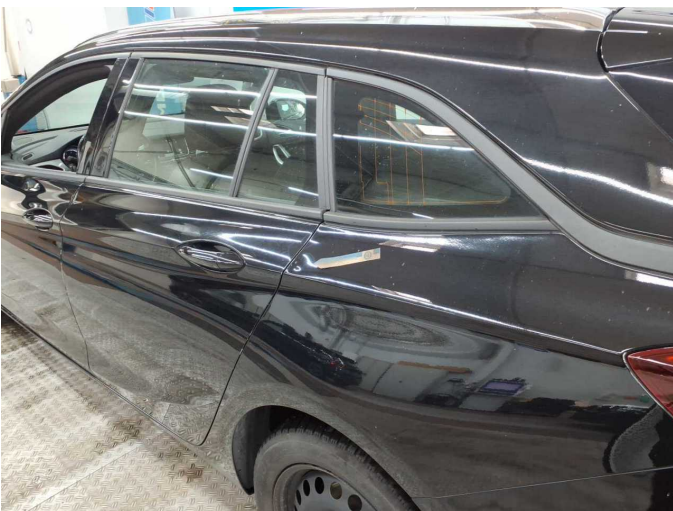
Damage 7: Boot lid / rear door: Boot lid - Scratch(es) - Smart repair

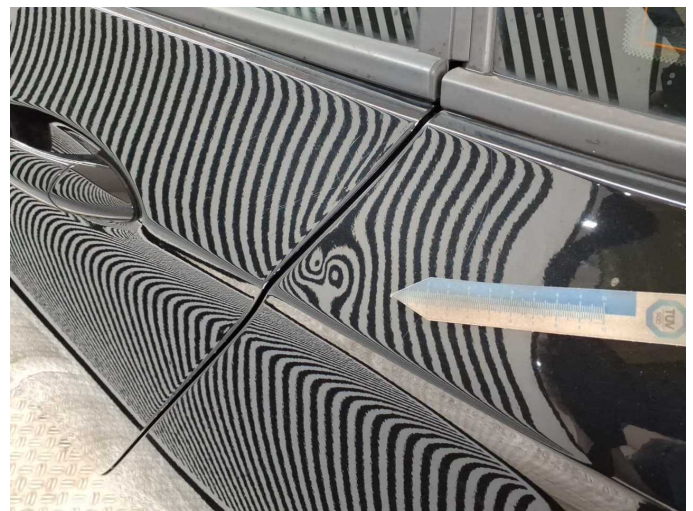
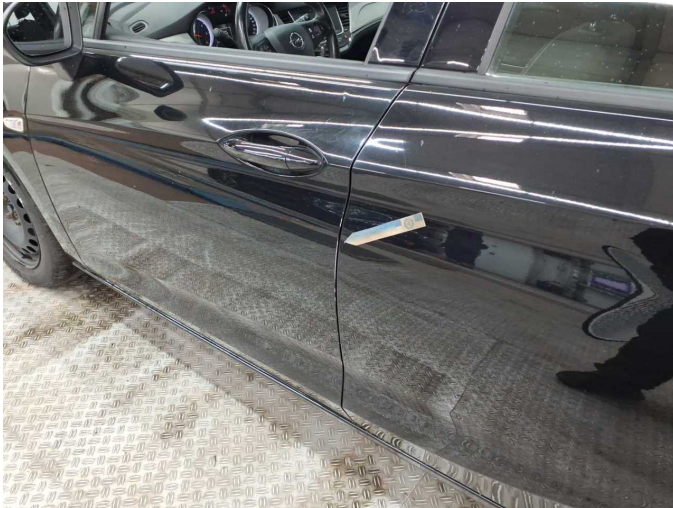
Damage 8: Side panel - rear left side: Side panel - dent(s) - Smart repair

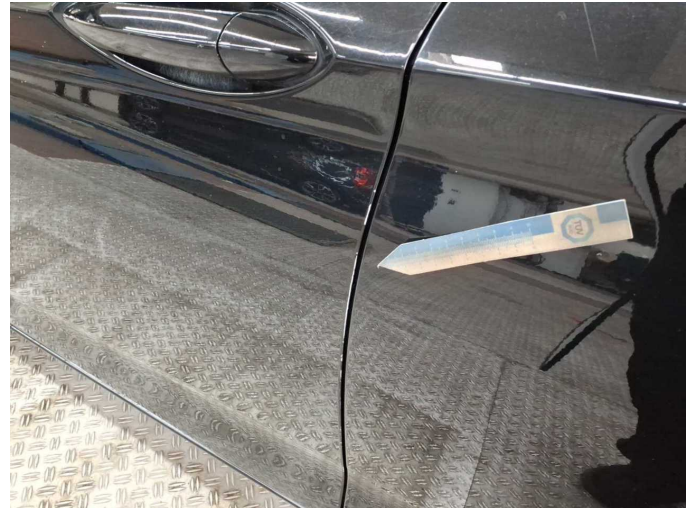
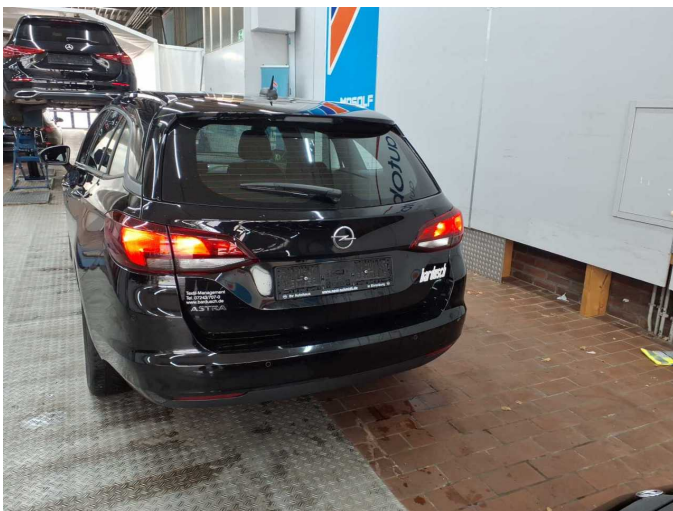
Damage 9: Door - front left side: Door edge - Scratch(es) - Smart repair

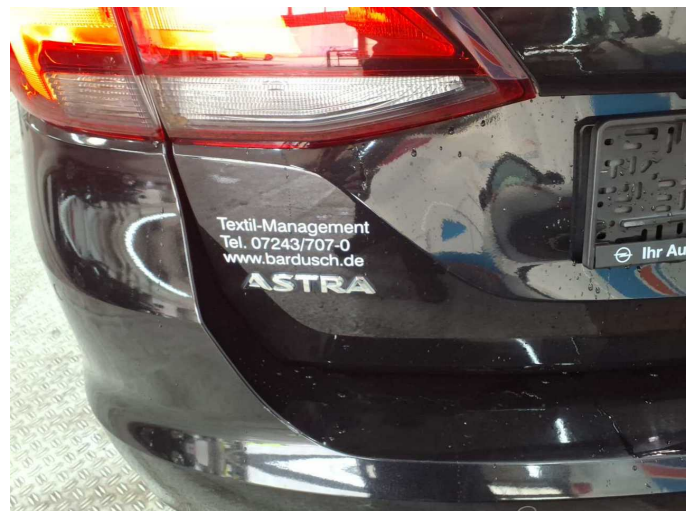
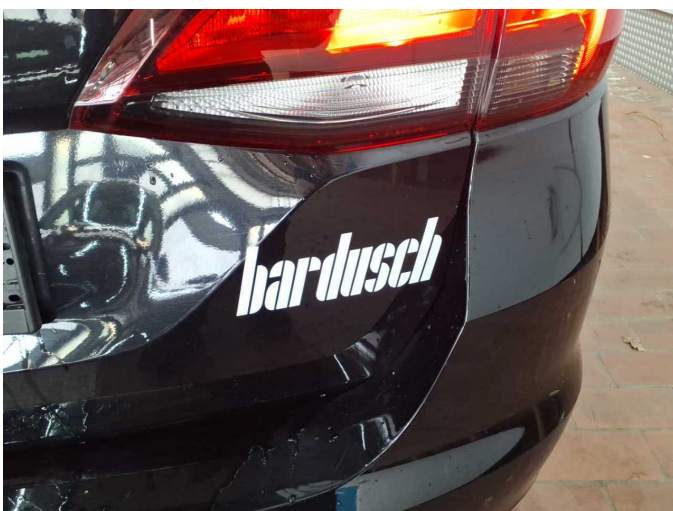
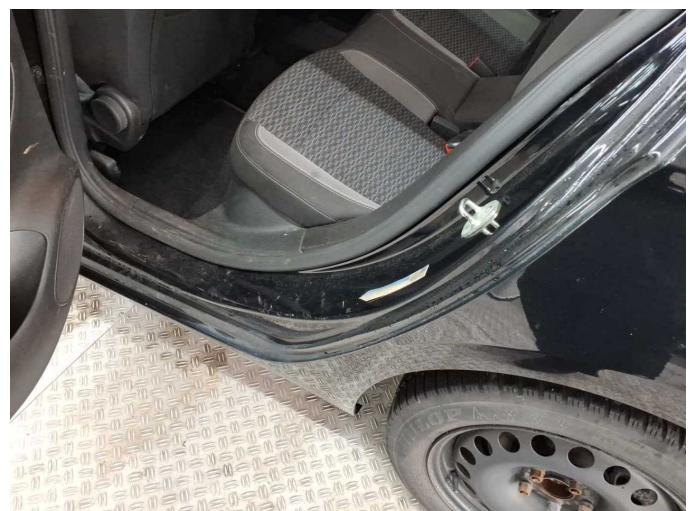
Damage 10: Boot lid / rear door: Boot lid - Glued / labelled - De-glu / neutralise

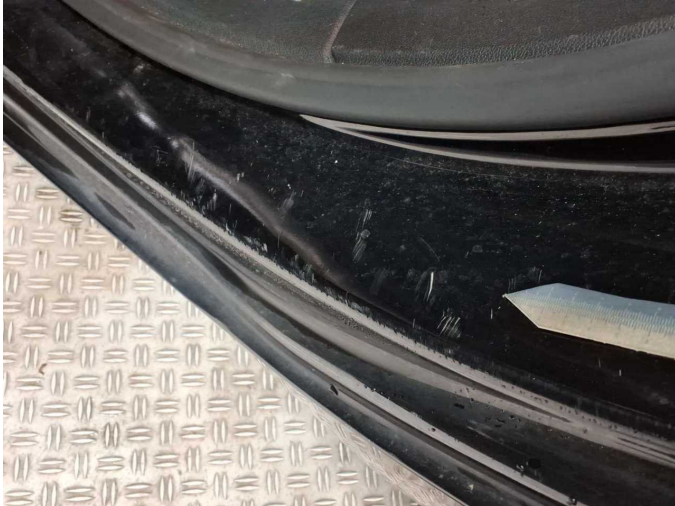
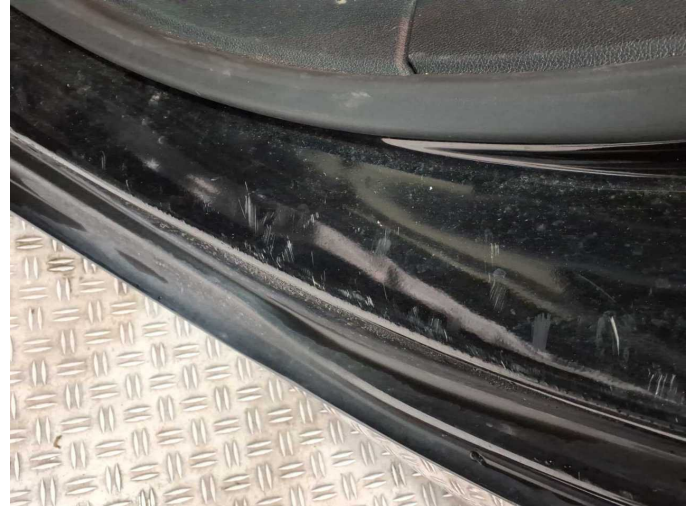
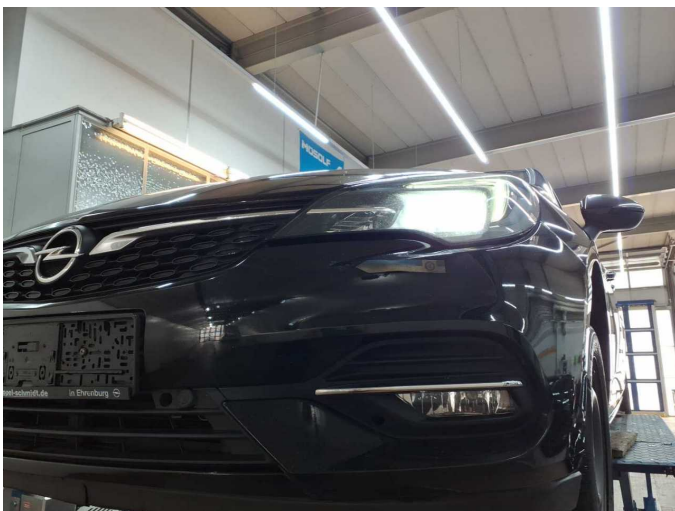
Damage 11: Side panel - rear left side: Sill - Scratch(es) - Smart repair

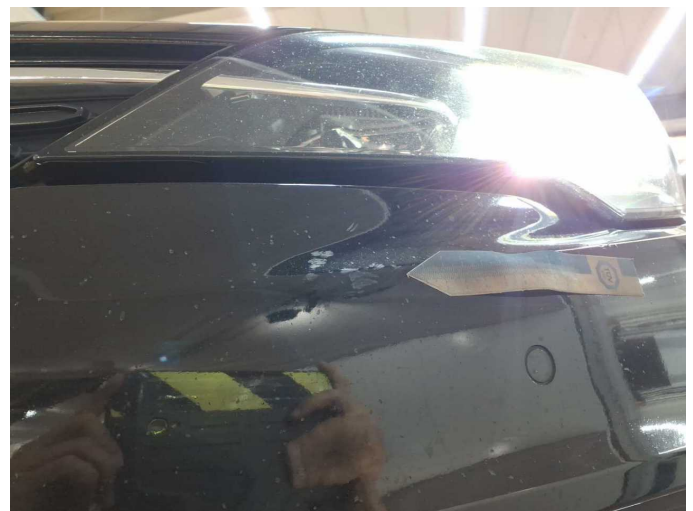
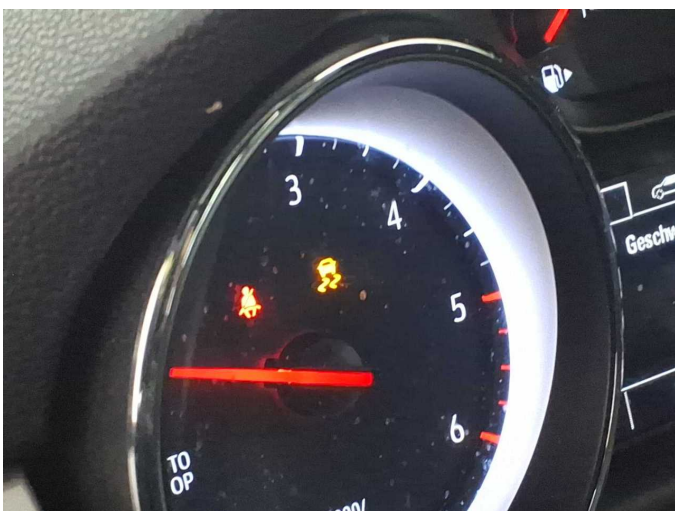
Damage 12: Front bumper: Front bumper (unpainted) - Scratch(es) - Smart repair

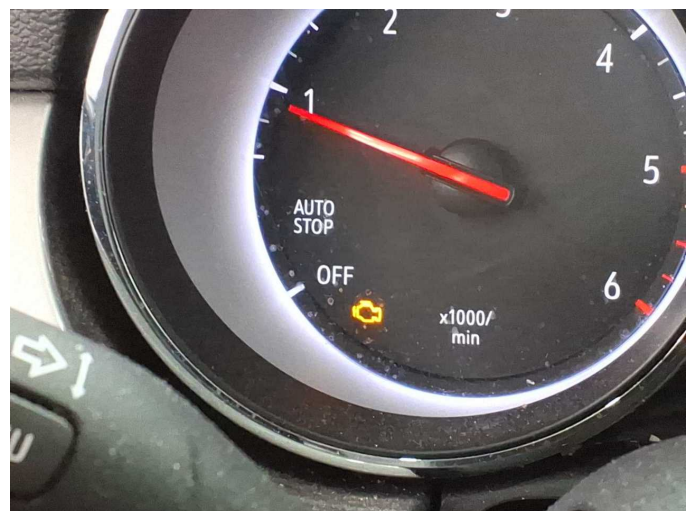
Damage 13: Instrument panel: Indicator light (Elektronisches Stabilisierungs Programm) - on - Perform diagnosis

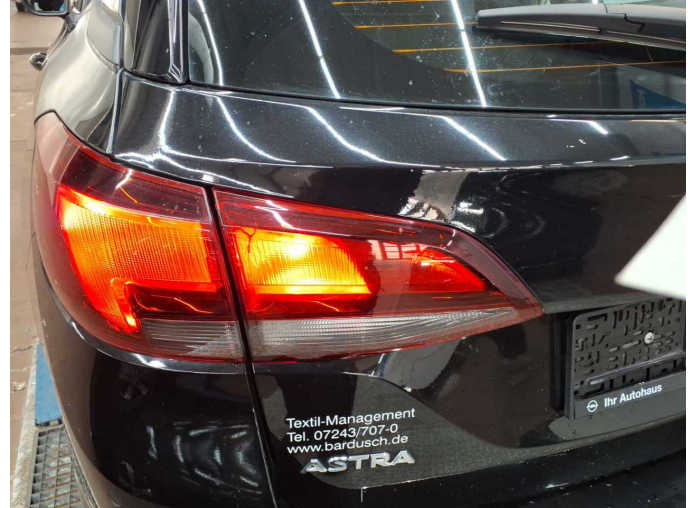
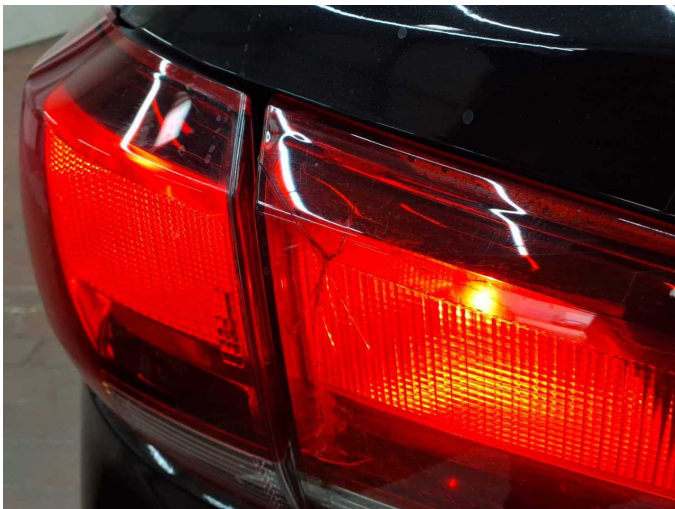
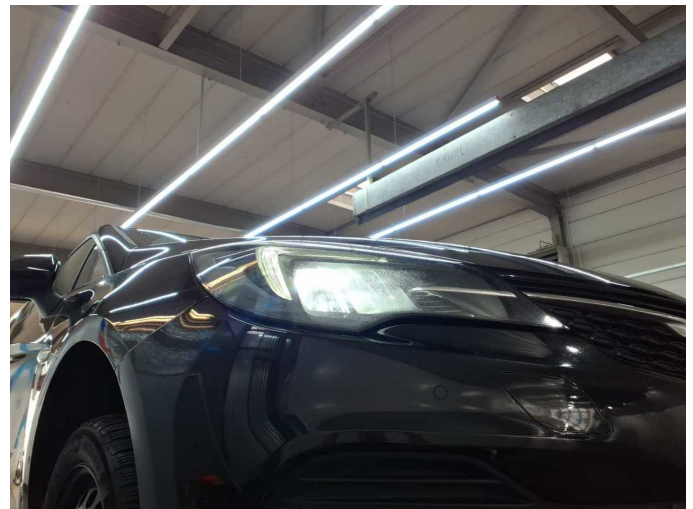
Damage 15: Tail light: Tail lamp - left side - Broken / torn - Replace

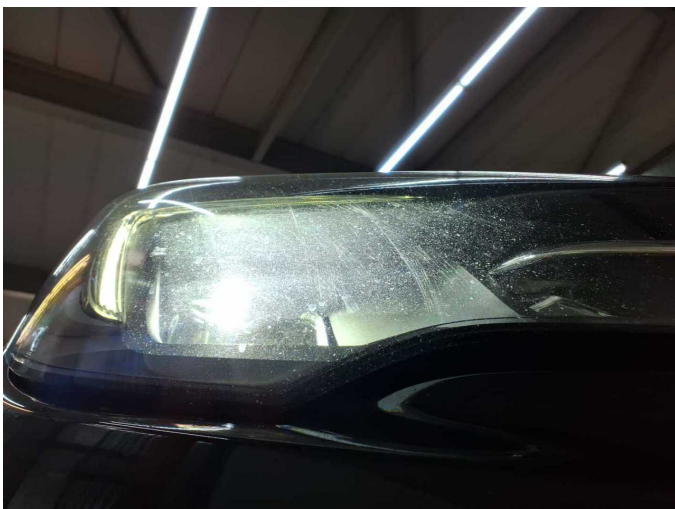
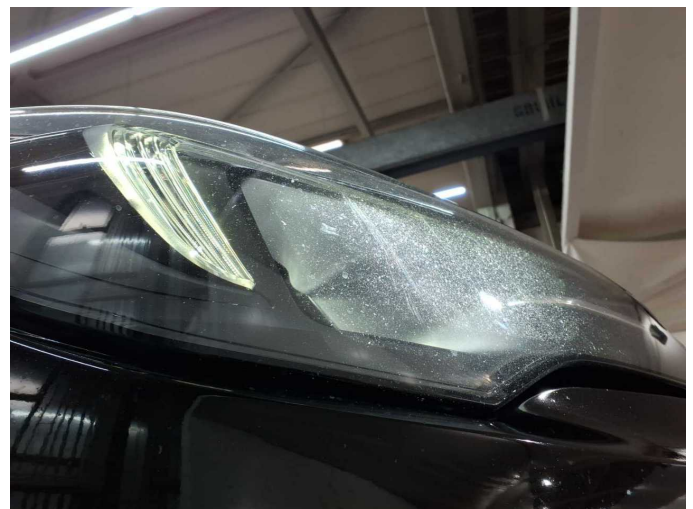
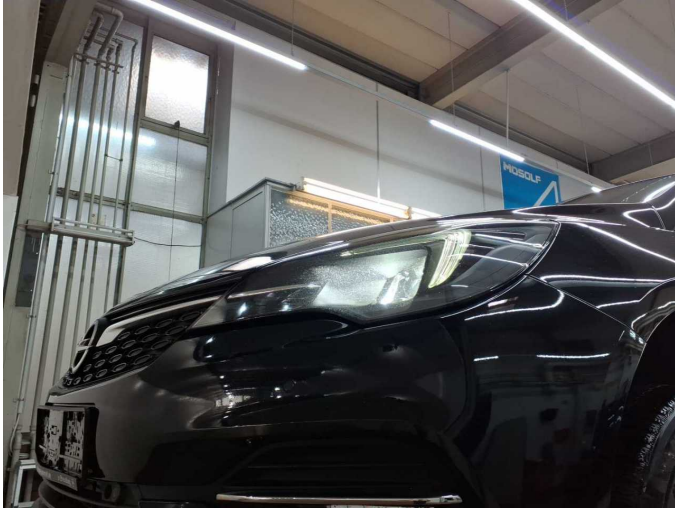
Damage 16: Headlight: Headlight - right side (Klarlack löst sich.) - Paint defect - Replace

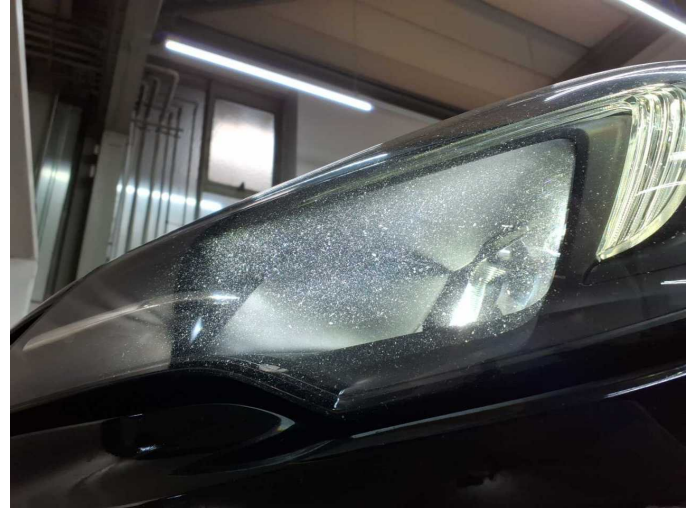
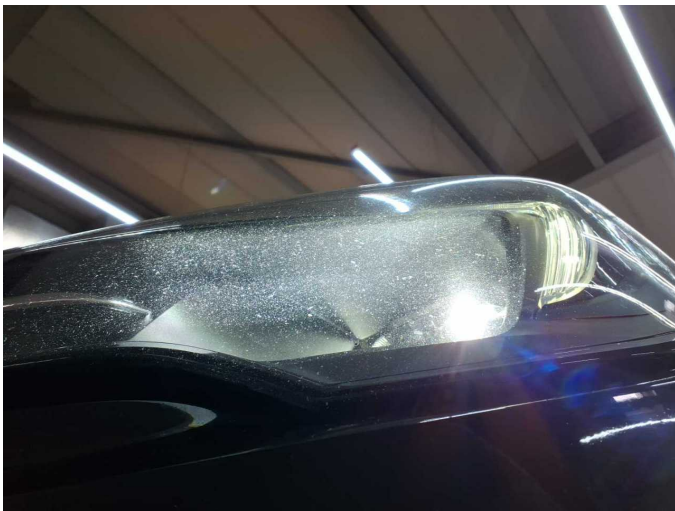
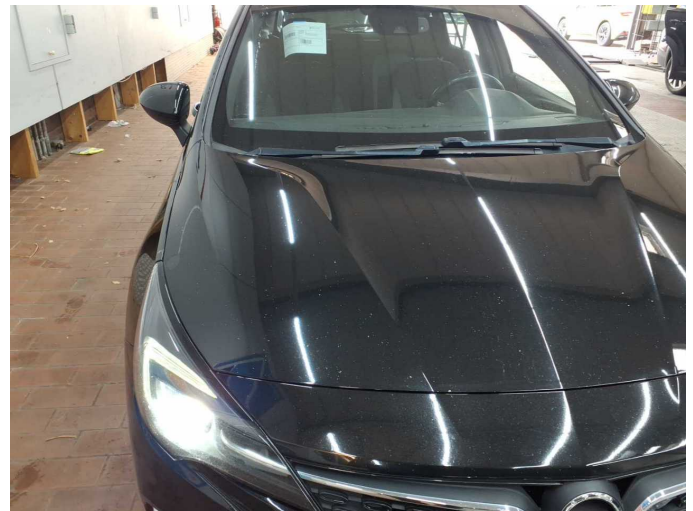
Damage 17: Headlight: Headlight - left side (Klarlack löst sich) - Paint defect - Replace

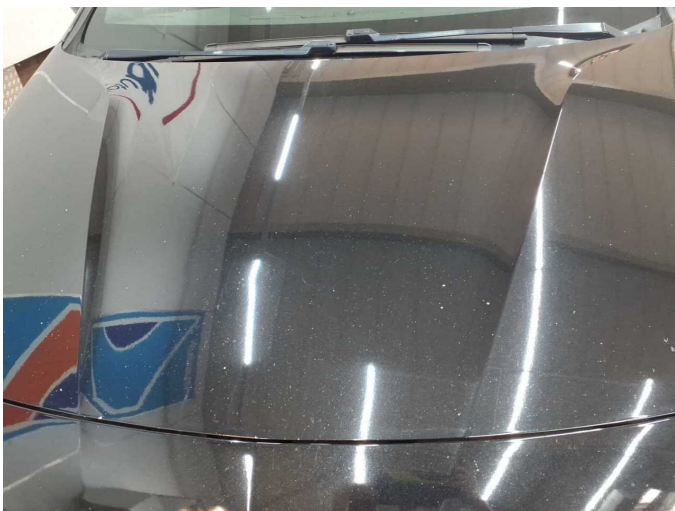
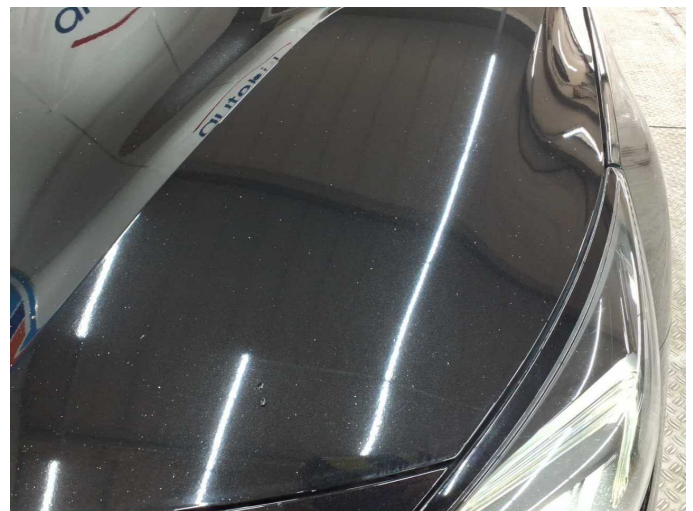
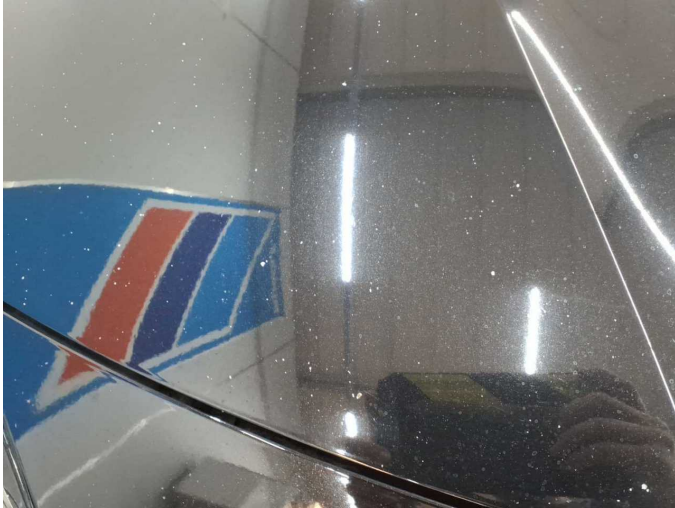
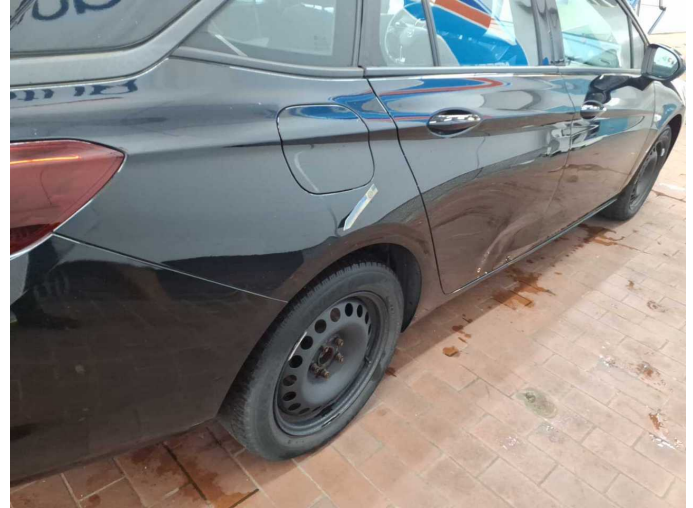
Damage 18: Bonnet: Bonnet - Stone chips - Paint

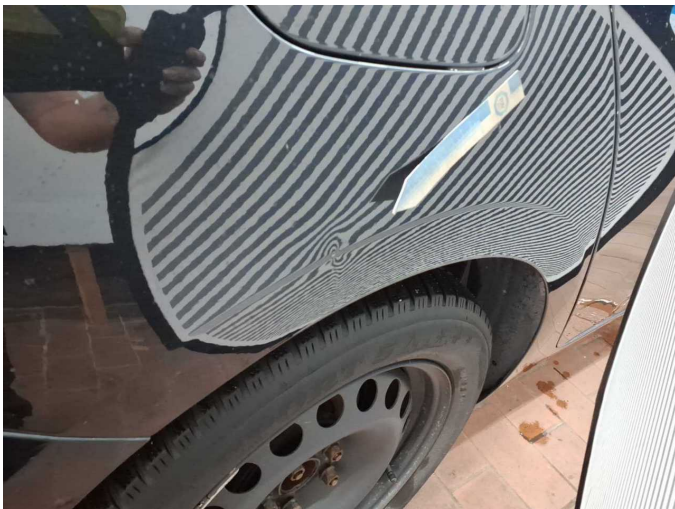
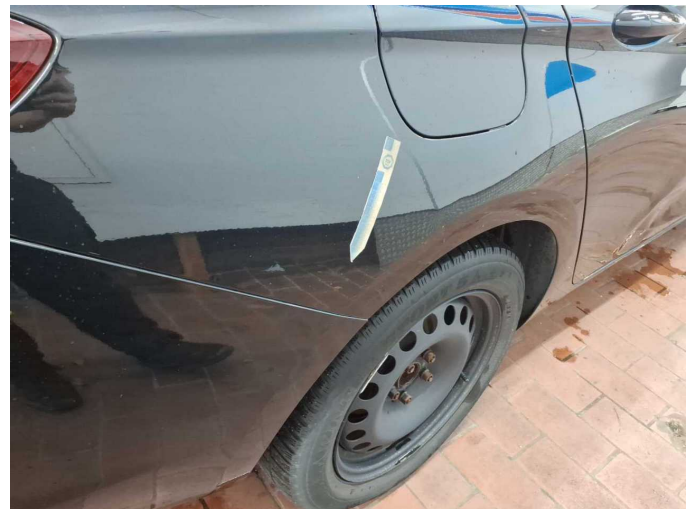
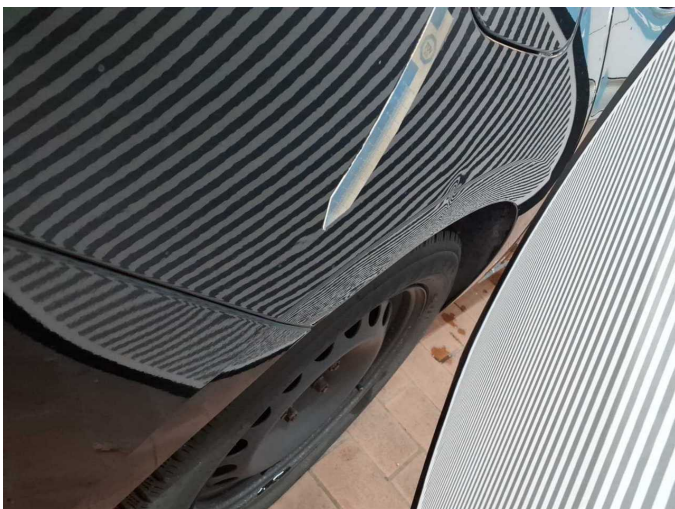
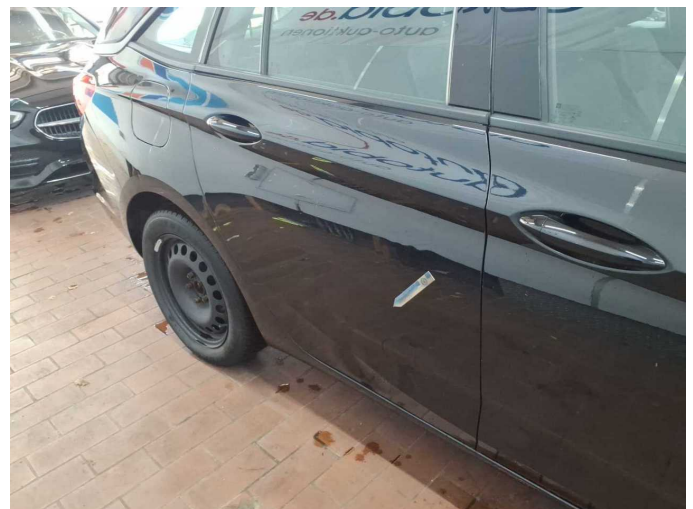
Damage 19: Side panel - rear right side: Side panel - dent(s) - Repair and paint

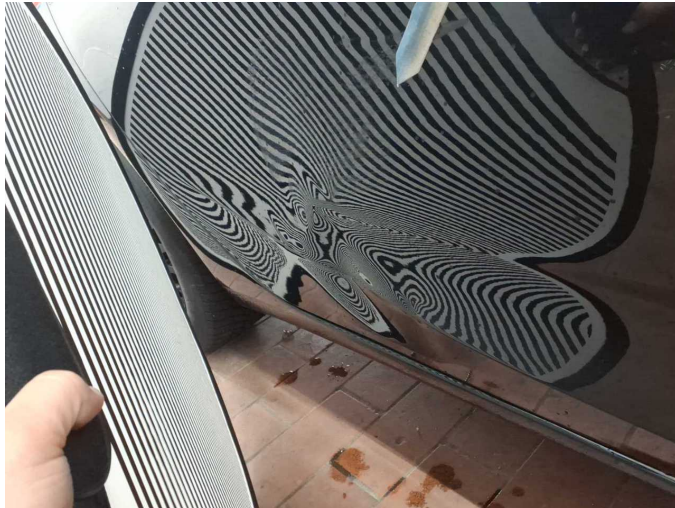
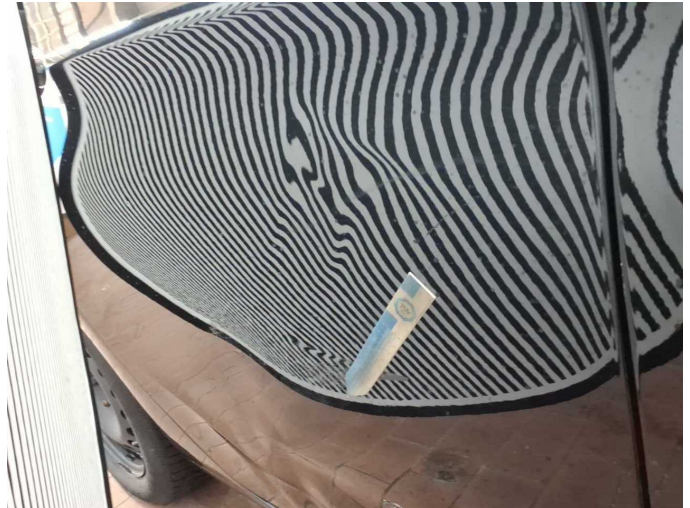
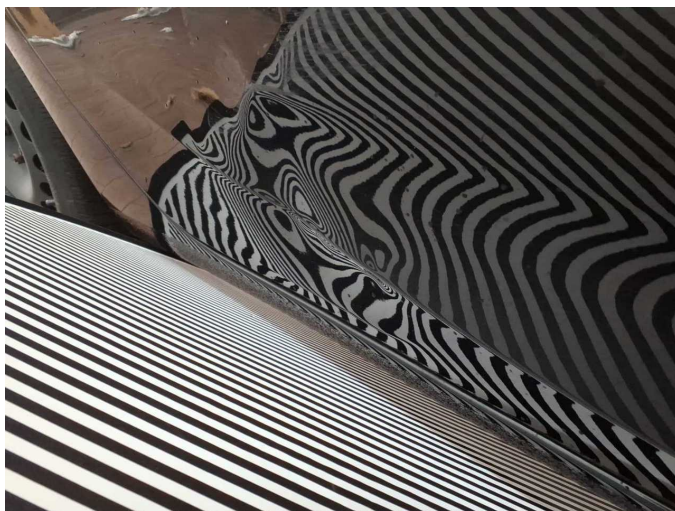
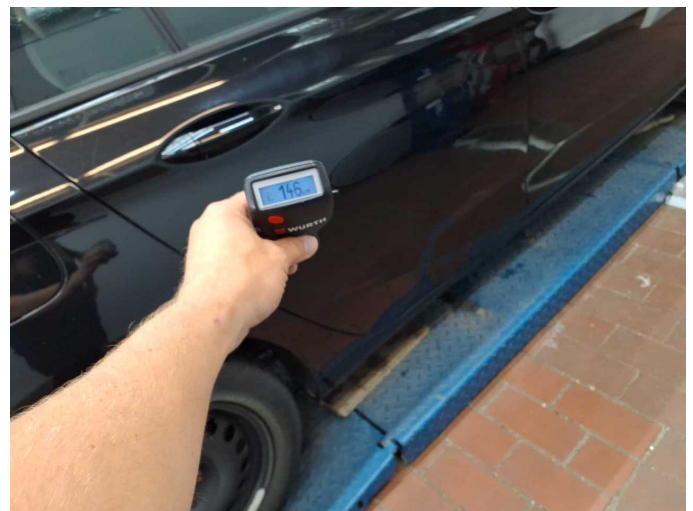
Damage 20: Door - rear right side: Door - Deformed - repair according to calculation

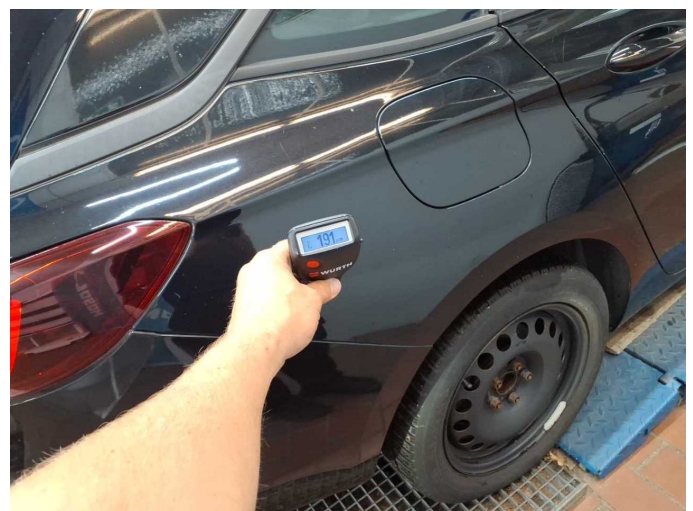
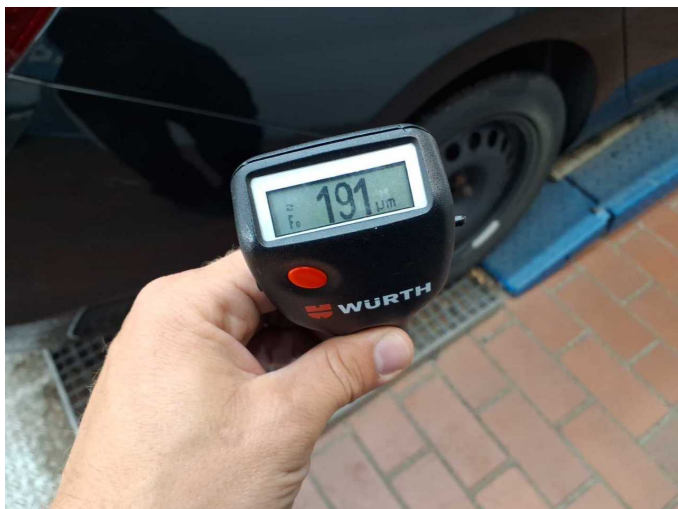
1	Side panel - rear right side, Door - rear right side, Professionally carried out, Invoice of repair done Non-existent
---	---

Side panel - rear right side	191 µm	Door - rear right side	146 µm
------------------------------	--------	------------------------	--------

Repainting 1: Side panel - rear right side, Door - rear right side
