Expertise

Protocol number: 45139377
Order No. / Reference: 25785035
Inspection date: 24 Apr 2026

Manufacturer: Mercedes-Benz

Model: eSprinter Kasten 414 Standard 56 kWh PRO

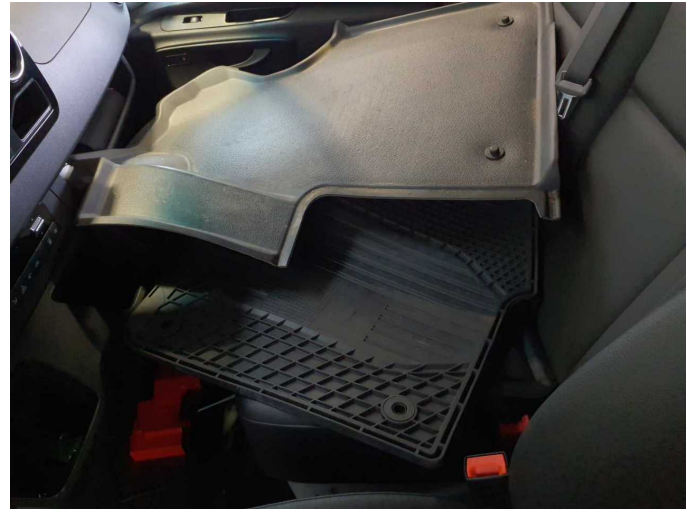
Damage 2: Electrical system: Battery (Tiefenentladen) - Functional / admissibility - Perform diagnosis

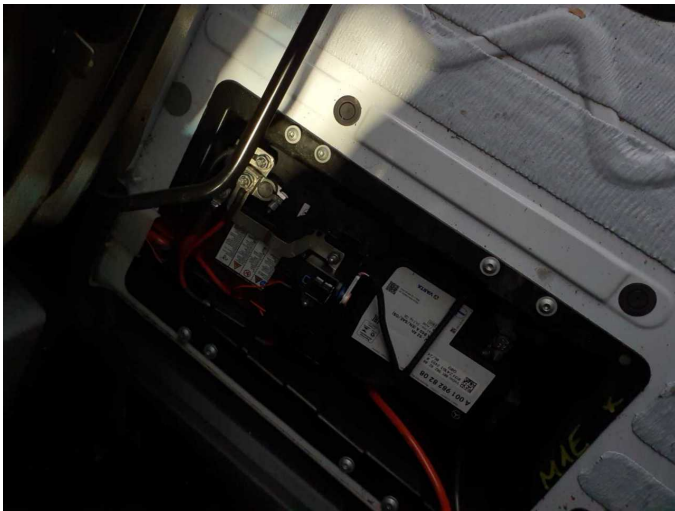
Damage 2: Electrical system: Battery (Tiefenentladen) - Functional / admissibility - Perform diagnosis

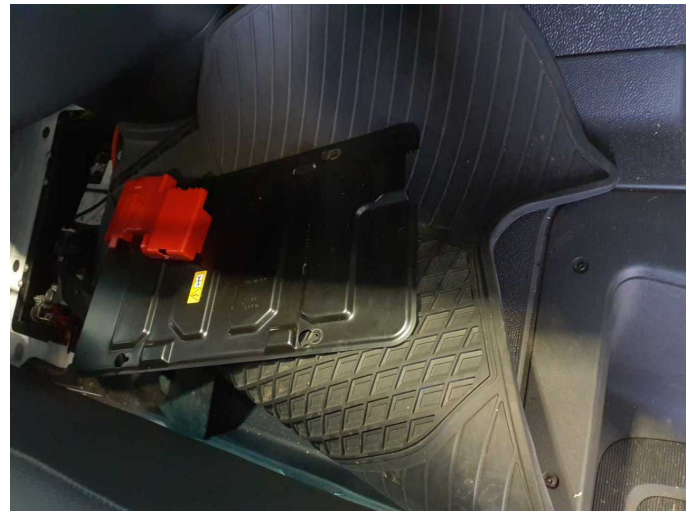
Damage 2: Electrical system: Battery (Tiefenentladen) - Functional / admissibility - Perform diagnosis

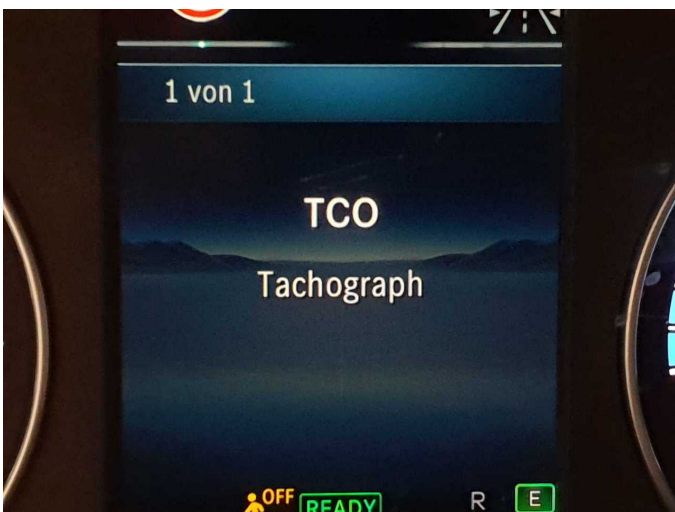
Damage 3: Instrument panel: Indicator light (Tachograf) - on - Perform diagnosis

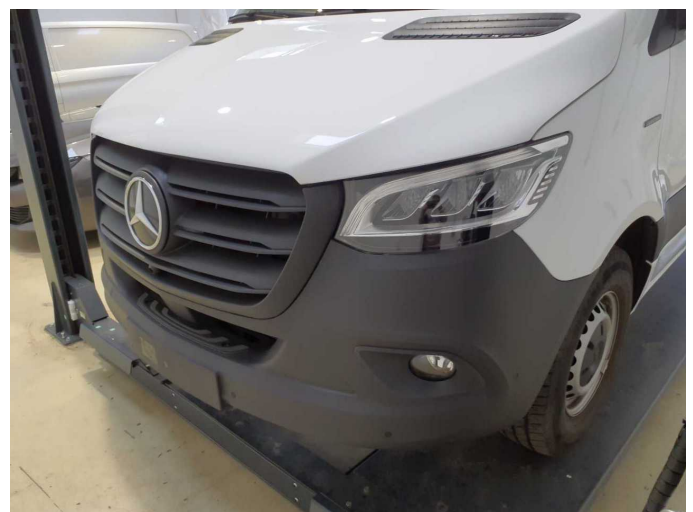
Damage 4: Front bumper: Front bumper (unpainted) - Scratch(es) - Loss in value

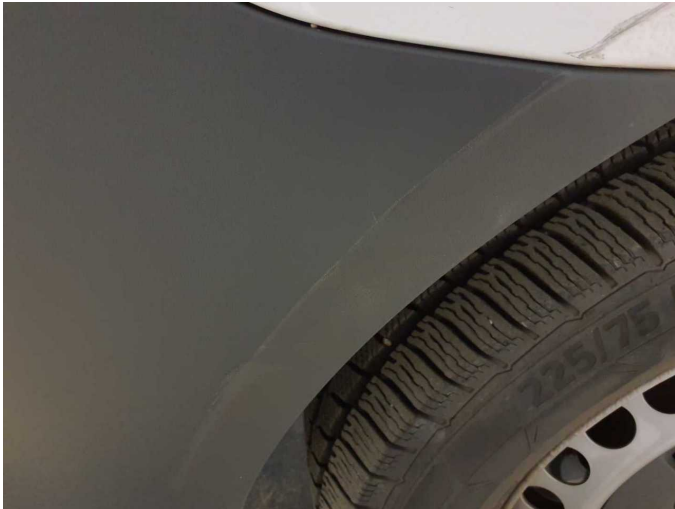
Damage 4: Front bumper: Front bumper (unpainted) - Scratch(es) - Loss in value

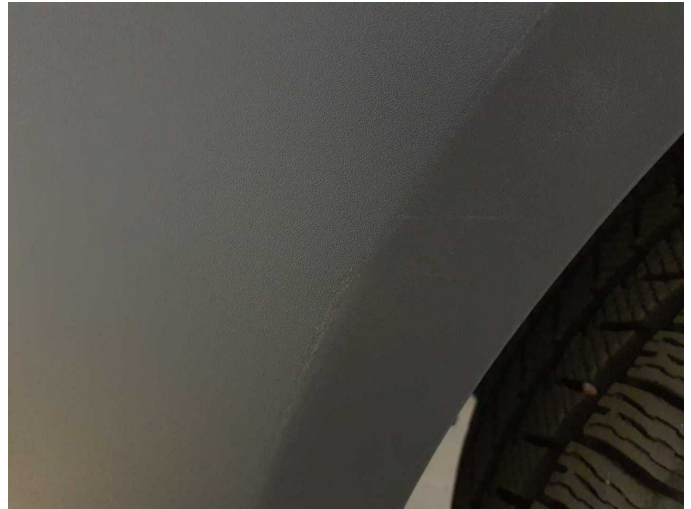
Damage 4: Front bumper: Front bumper (unpainted) - Scratch(es) - Loss in value

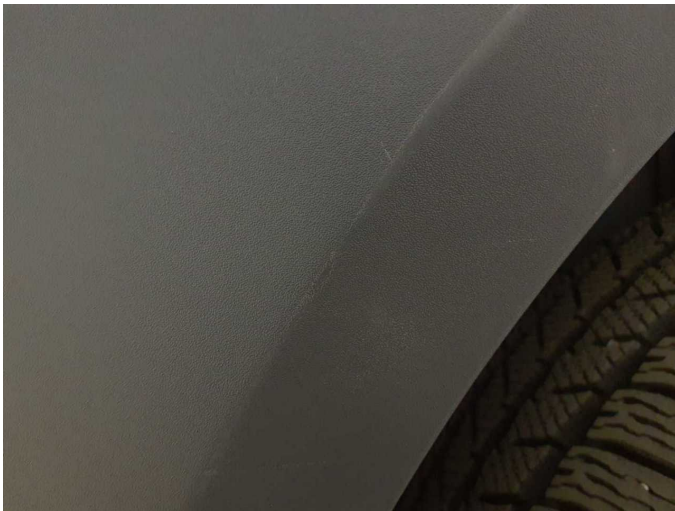
Damage 4: Front bumper: Front bumper (unpainted) - Scratch(es) - Loss in value

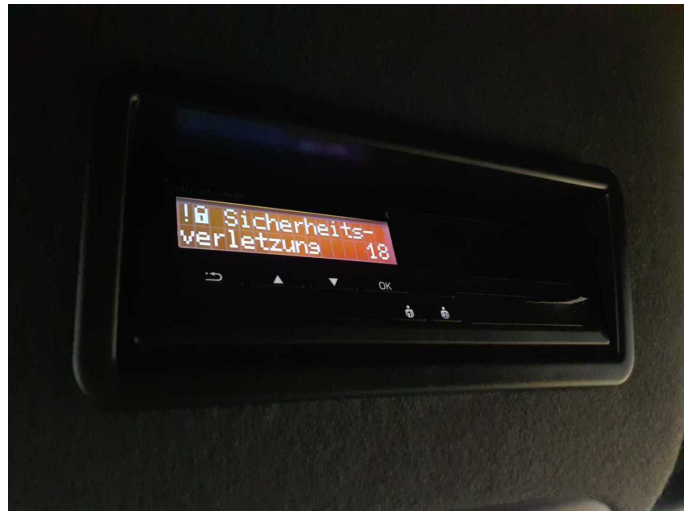
Damage 5: Misc.: Tachograph inspection (Sicherheitsverletzung) - Functional / admissibility - Perform diagnosis

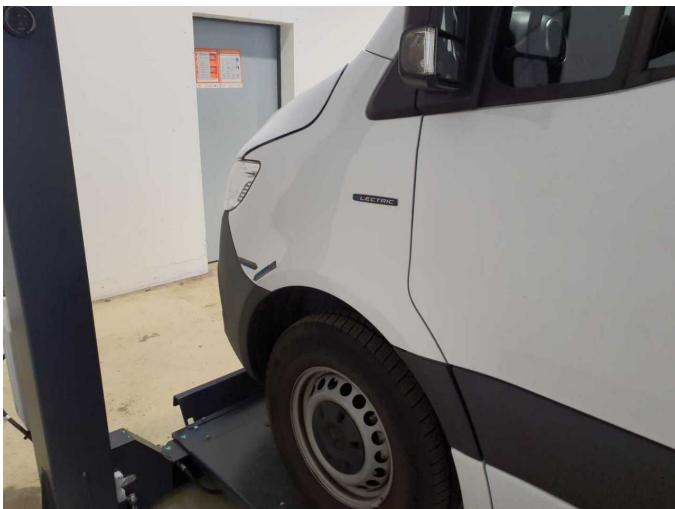
Damage 6: Mudguard - left side: Mudguard - left side - Scratch(es) - Paint

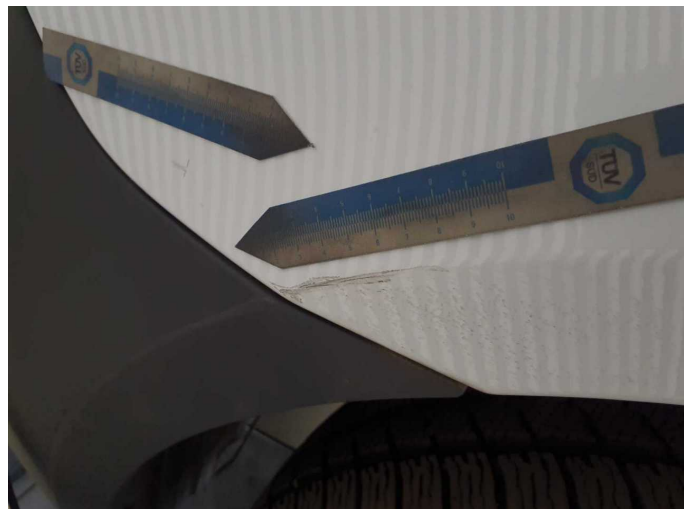
Damage 6: Mudguard - left side: Mudguard - left side - Scratch(es) - Paint

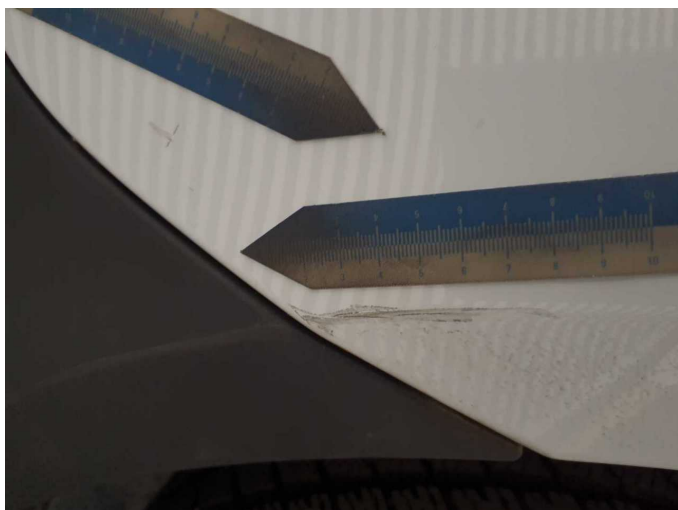
Damage 6: Mudguard - left side: Mudguard - left side - Scratch(es) - Paint

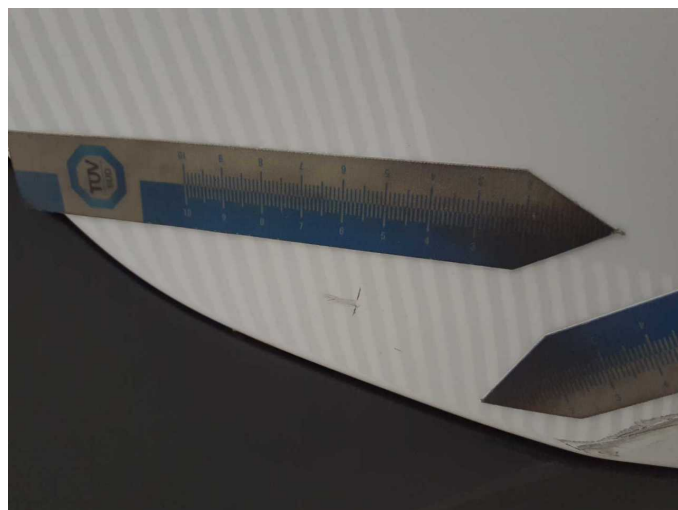
Damage 6: Mudguard - left side: Mudguard - left side - Scratch(es) - Paint
