Expertise

Protocol number: 46441555  
Order No. / Reference: 26360101  
Inspection date: 7 Jul 2026

Manufacturer: Opel

Model: Insignia Sports Tourer 2.0 Diesel Aut. Business

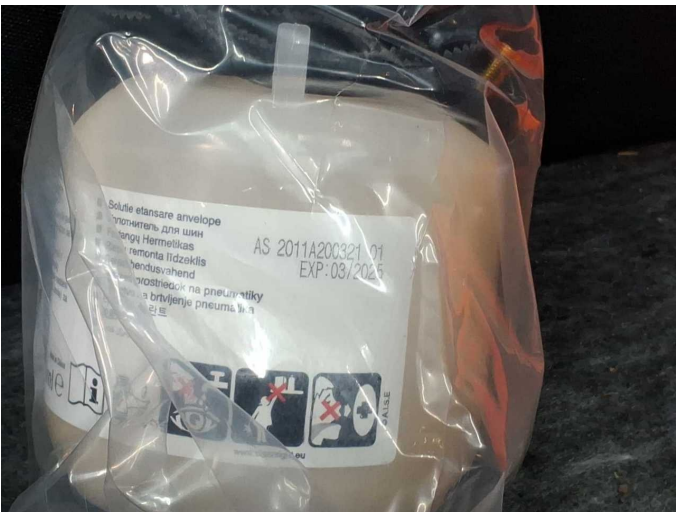
| No. | Component group | Description |
|---|---|---|
| 1 | Equipment | Tirefit filler - Expired - Replace |

Damage 1: Equipment: Tirefit filler - Expired - Replace

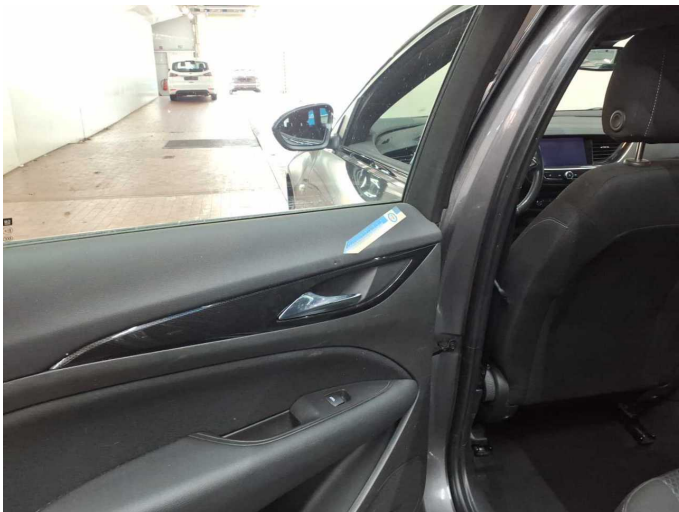
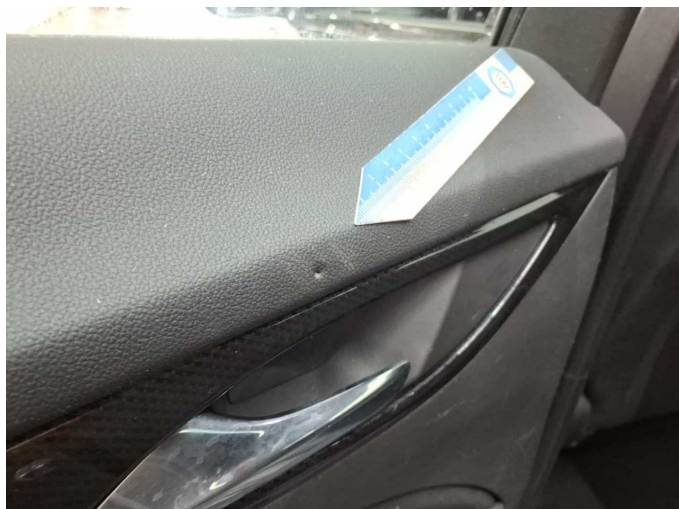
| No. | Component group | Description |
|---|---|---|
| 2 | Trim / covers | Door trim - rear left side - Deformed - Loss in value |

Damage 2: Trim / covers: Door trim - rear left side - Deformed - Loss in value

**Damage 2:** Trim / covers: Door trim - rear left side - Deformed - Loss in value

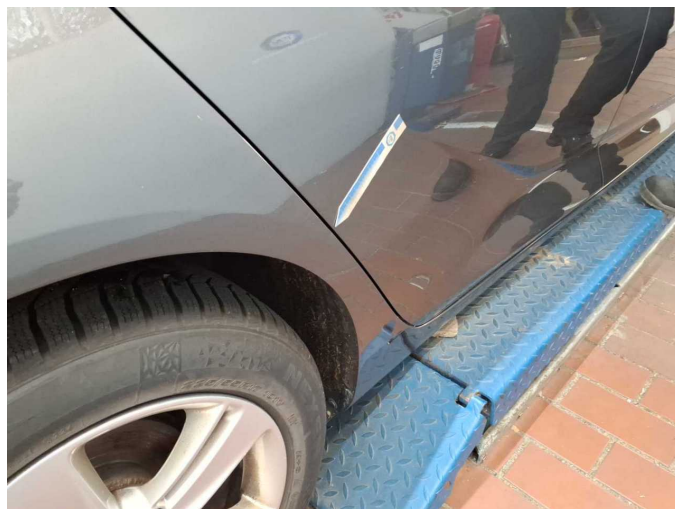
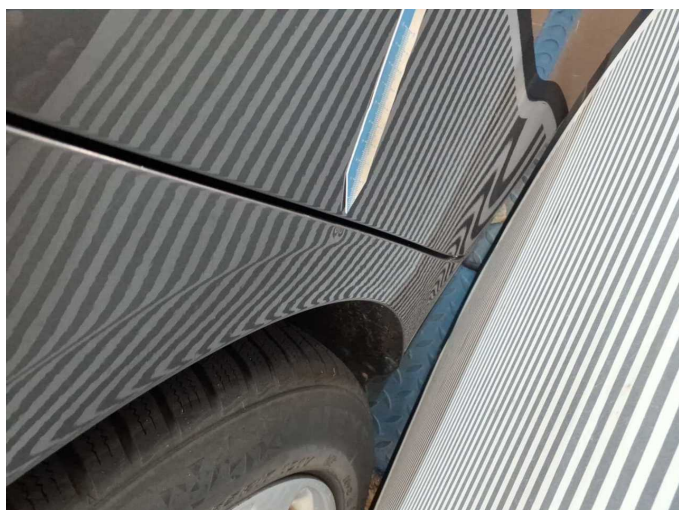
| No. | Component group | Description |
|---|---|---|
| 3 | Side panel - rear right side | Elbow - dent(s) - Smart repair |

**Damage 3:** Side panel - rear right side: Elbow - dent(s) - Smart repair

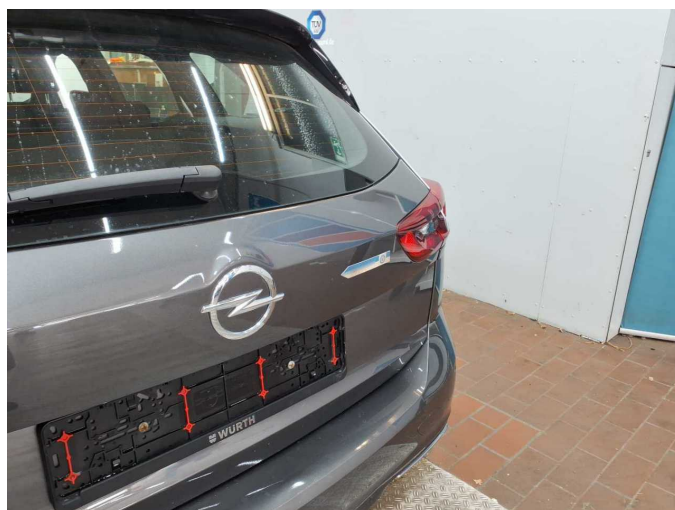
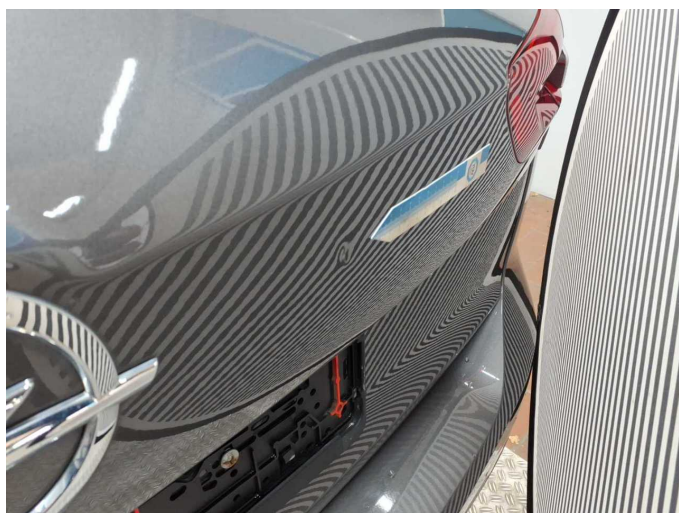
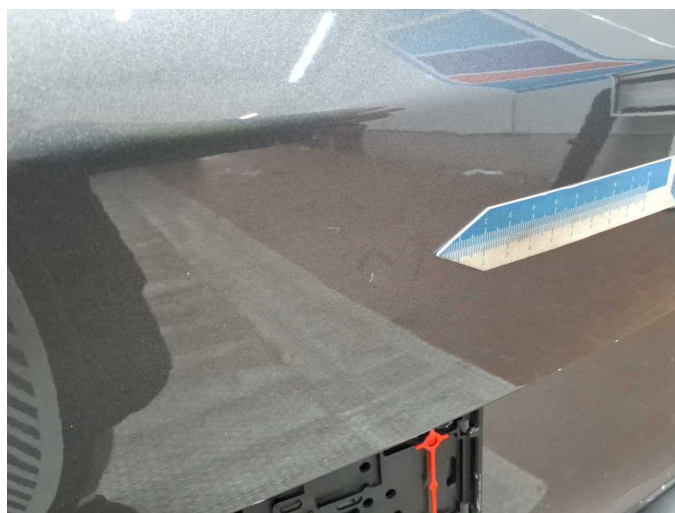
| No. | Component group | Description |
|---|---|---|
| 4 | Boot lid / rear door | Boot lid - Dent / paintcoat damage - Smart repair |

**Damage 4:** Boot lid / rear door: Boot lid - Dent / paintcoat damage - Smart repair

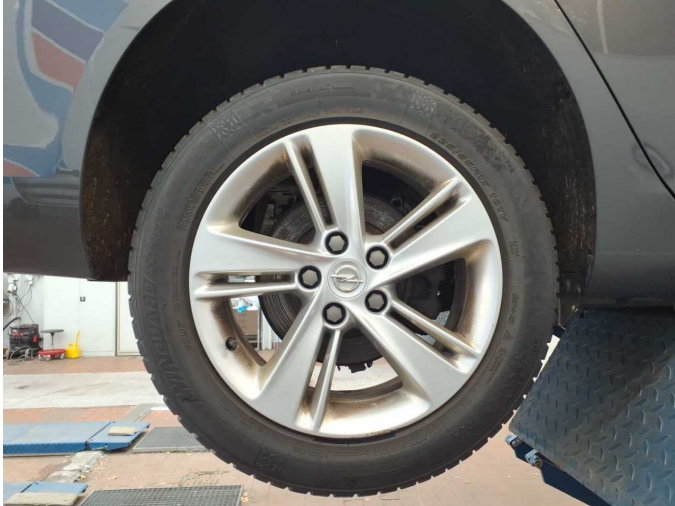
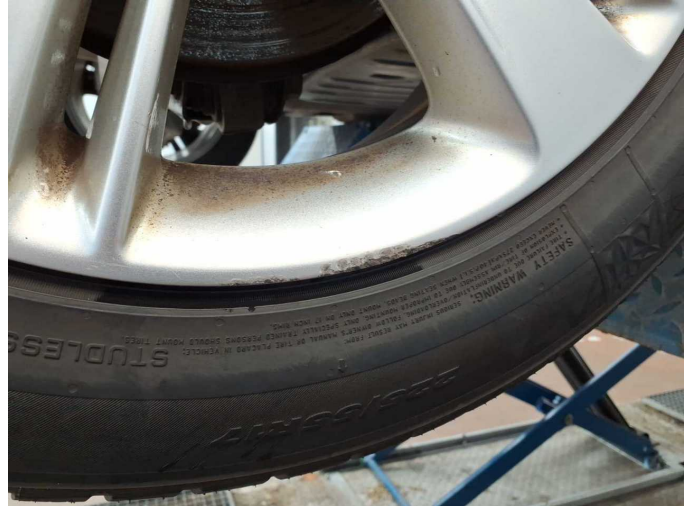
| No. | Component group | Description |
|---|---|---|
| 5 | Wheel / tyres | Alloy rim - rear right side - Scratch(es) - Loss in value |

**Damage 5:** Wheel / tyres: Alloy rim - rear right side - Scratch(es) - Loss in value

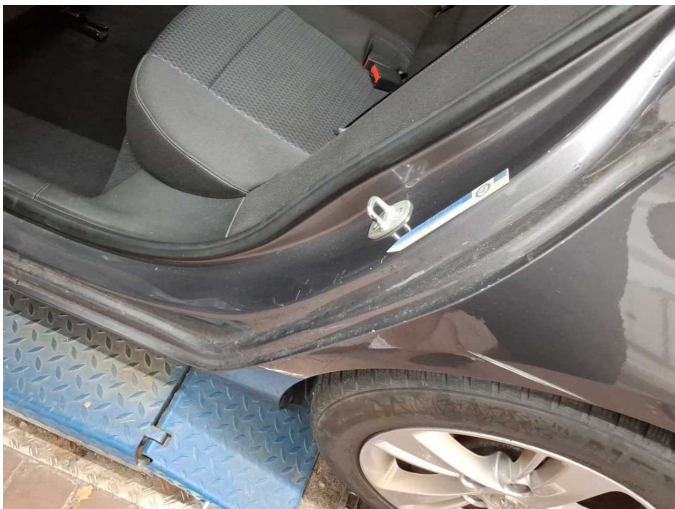
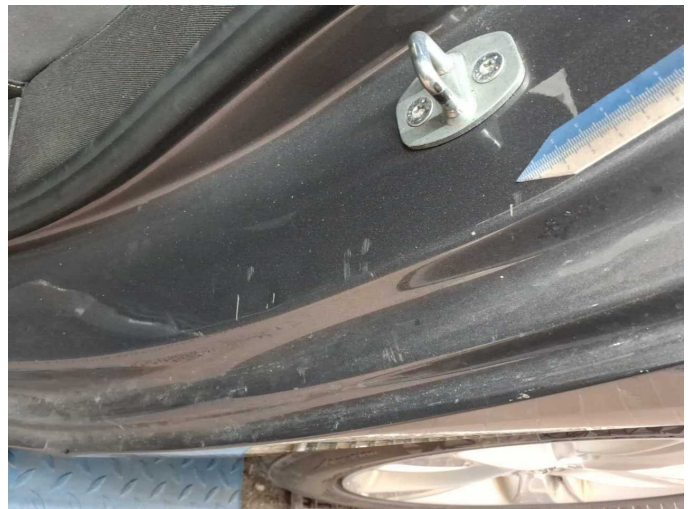
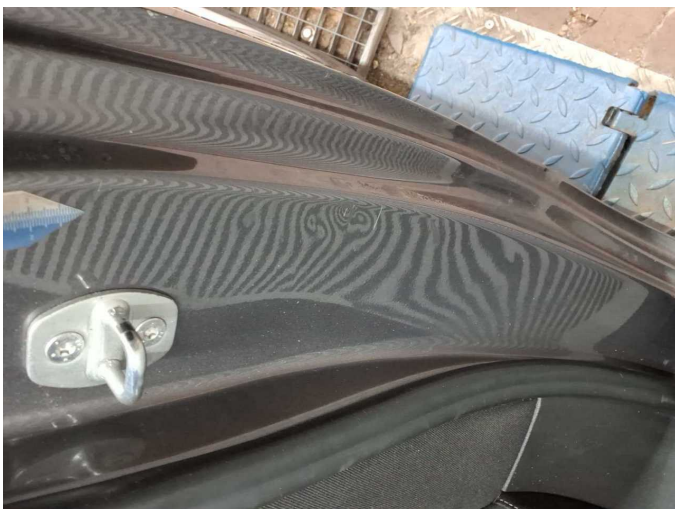
| No. | Component group | Description |
|---|---|---|
| 6 | Side panel - rear left side | Sill - Dent / paintcoat damage - Smart repair |

**Damage 6:** Side panel - rear left side: Sill - Dent / paintcoat damage - Smart repair

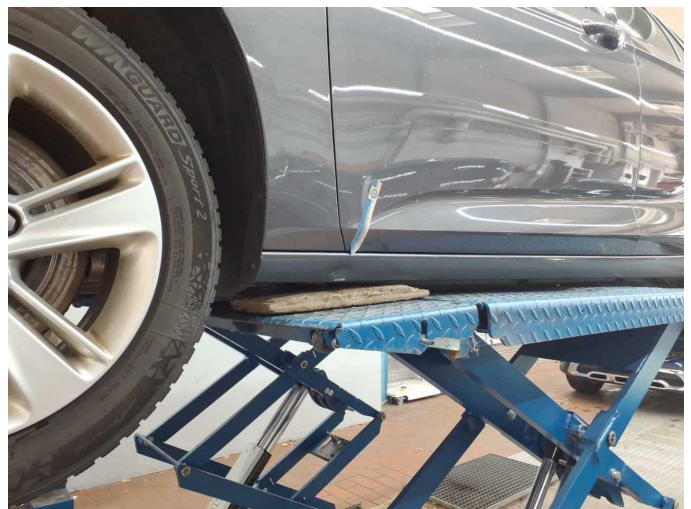
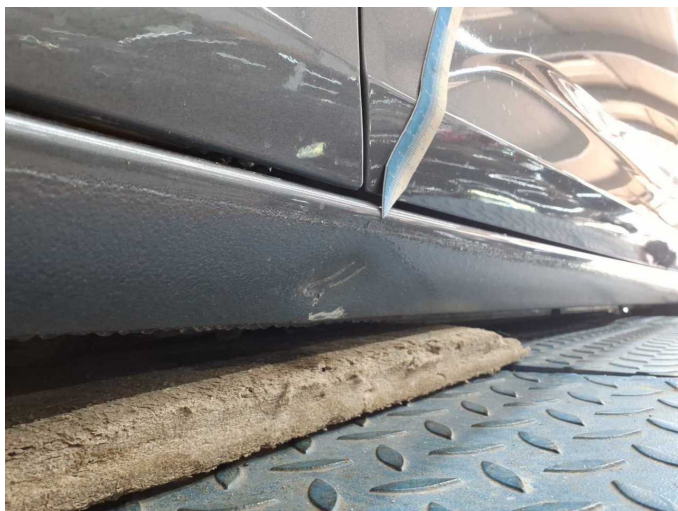
| No. | Component group | Description |
|---|---|---|
| 7 | Sill - left side | Sill - Dent / paintcoat damage - Smart repair |

**Damage 7:** Sill - left side: Sill - Dent / paintcoat damage - Smart repair

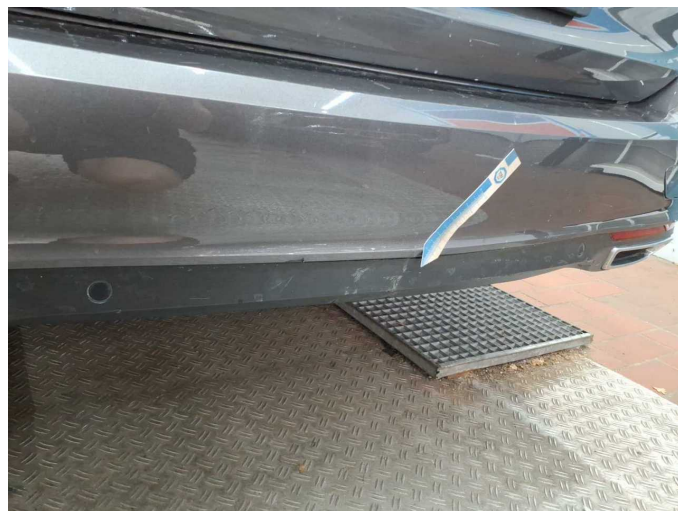
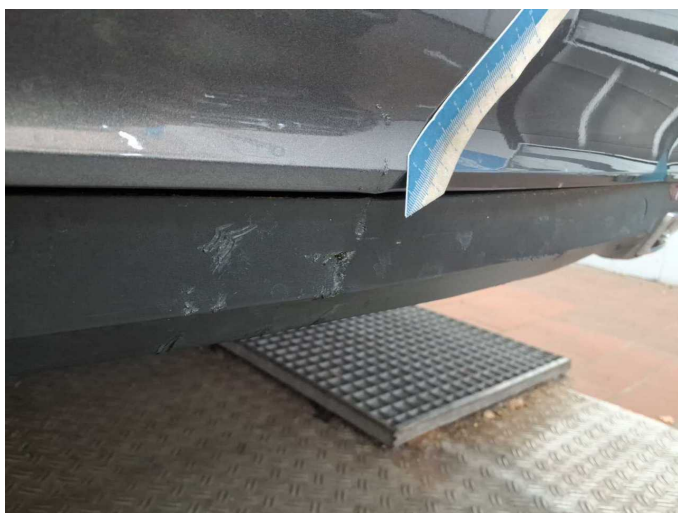
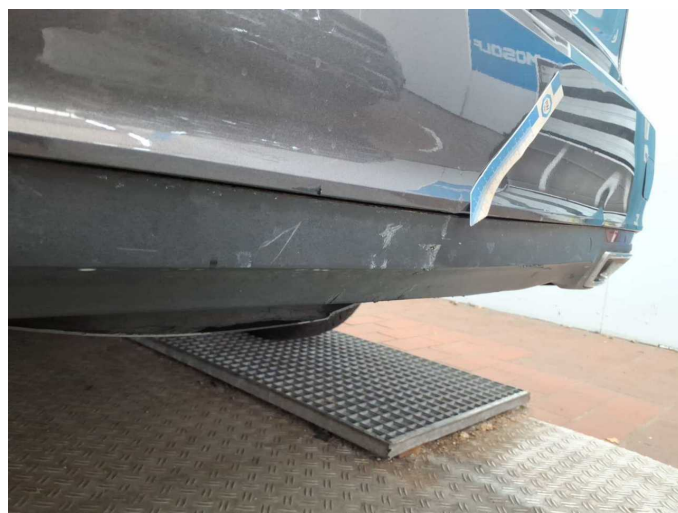
| No. | Component group | Description |
|---|---|---|
| 8 | Rear bumper | Spoiler - Deformed - Replace |

**Damage 8:** Rear bumper: Spoiler - Deformed - Replace

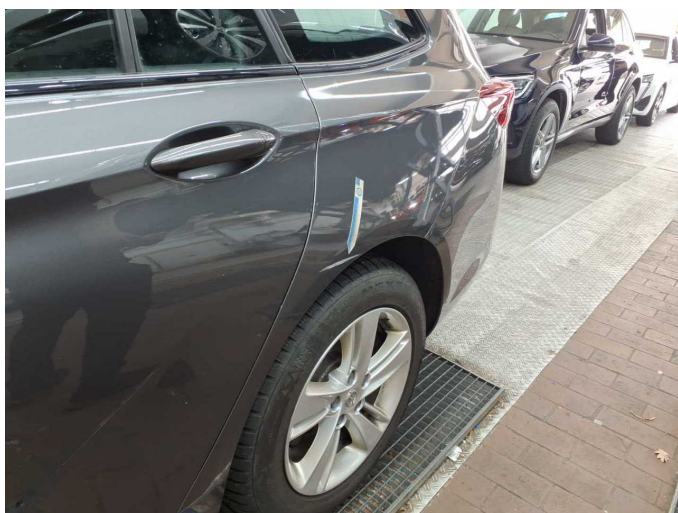
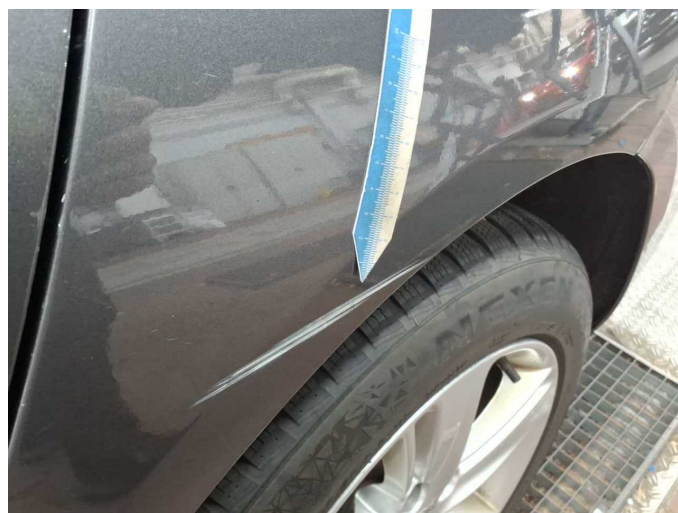
| No. | Component group | Description |
|---|---|---|
| 9 | Side panel - rear left side | Side panel - Scratch(es) - Paint |

**Damage 9:** Side panel - rear left side: Side panel - Scratch(es) - Paint

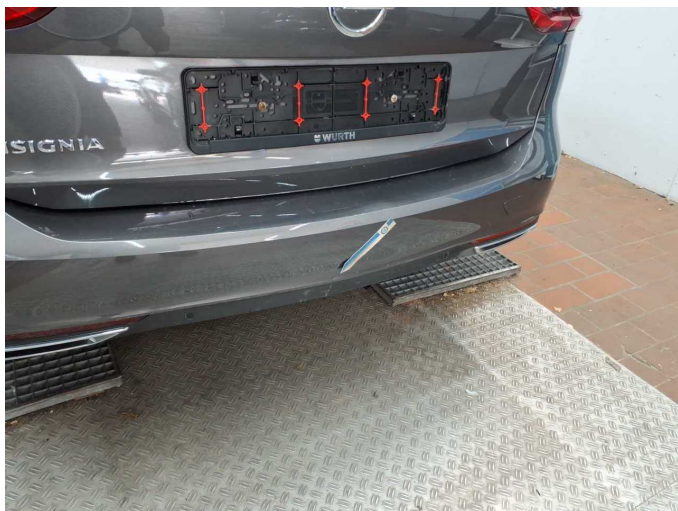
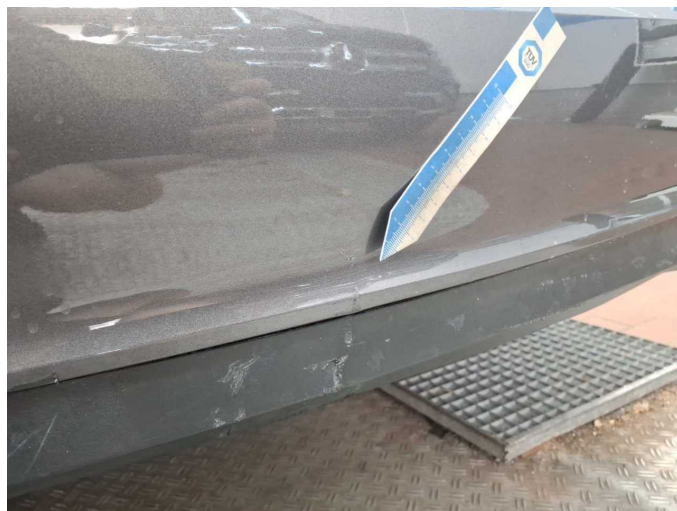
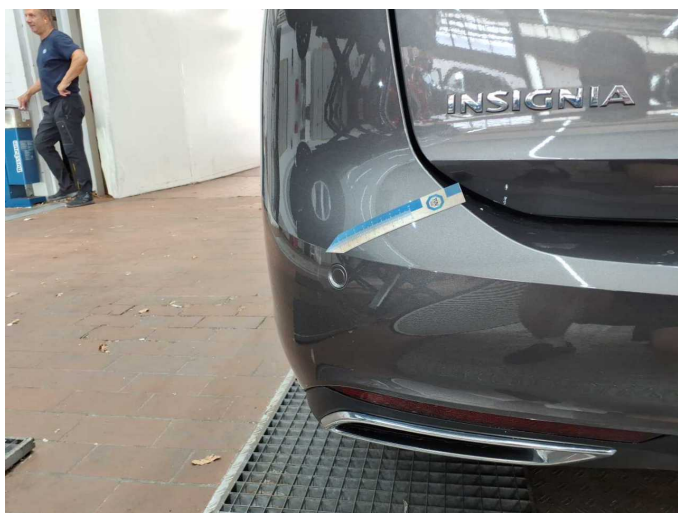
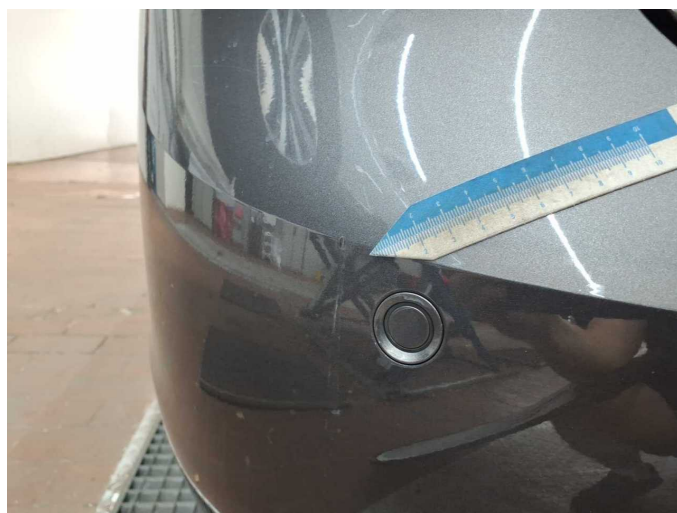
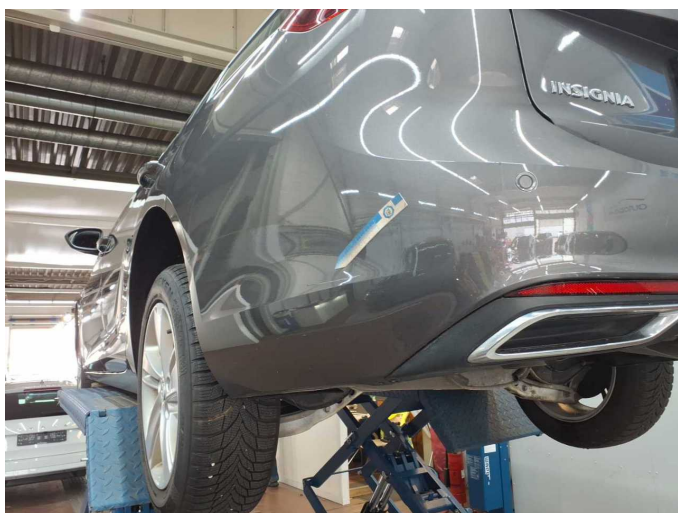
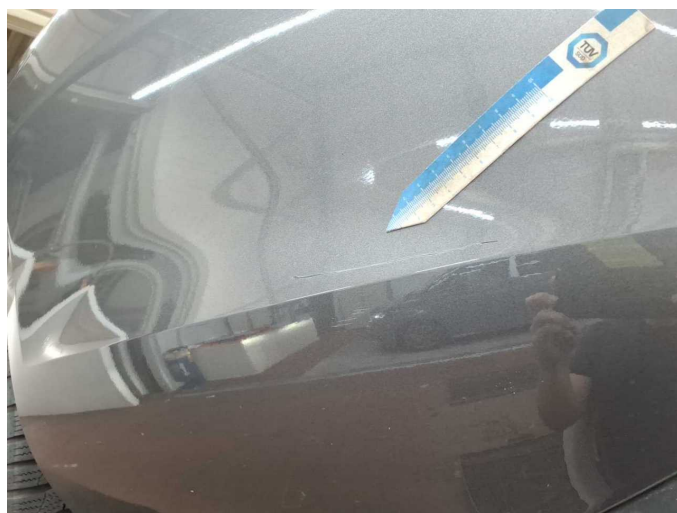
| No. | Component group | Description |
|---|---|---|
| 10 | Rear bumper | Rear bumper - Scratch(es) - Paint |

**Damage 10:** Rear bumper: Rear bumper - Scratch(es) - Paint

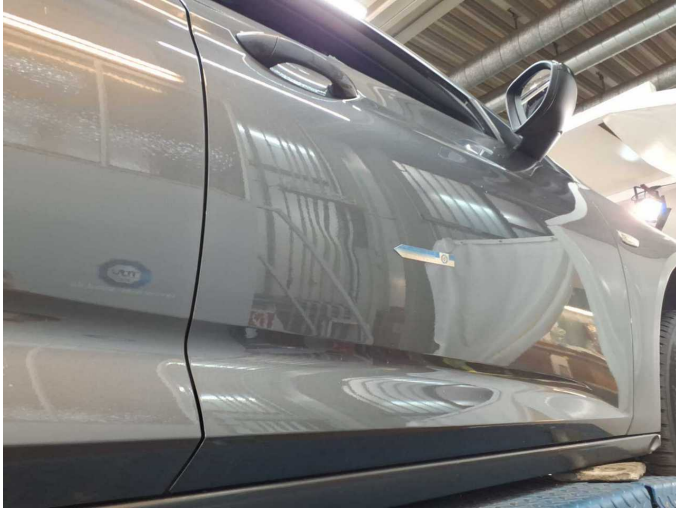
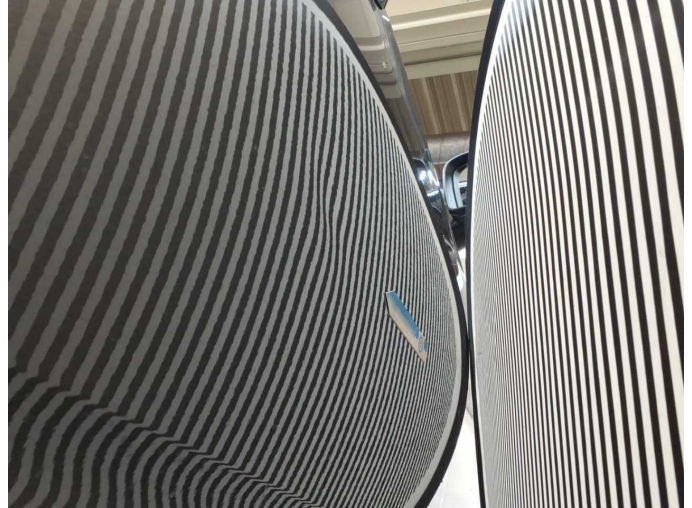
| No. | Component group | Description |
|---|---|---|
| 11 | Door - front right side | Door - Deformed - Repair and paint |

**Damage 11:** Door - front right side: Door - Deformed - Repair and paint

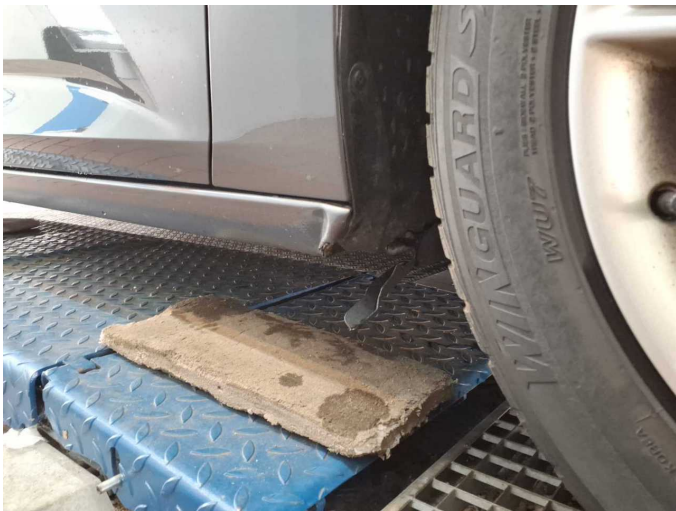
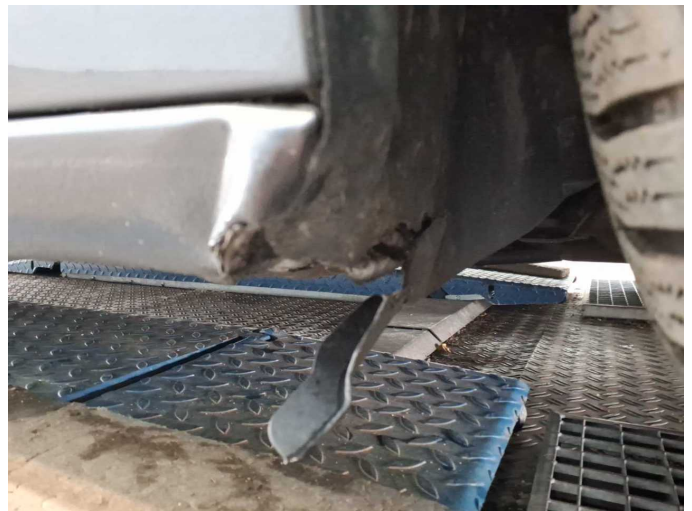
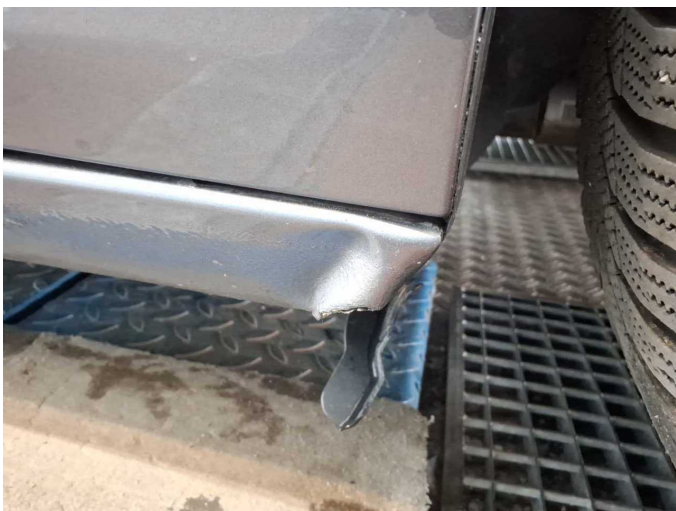
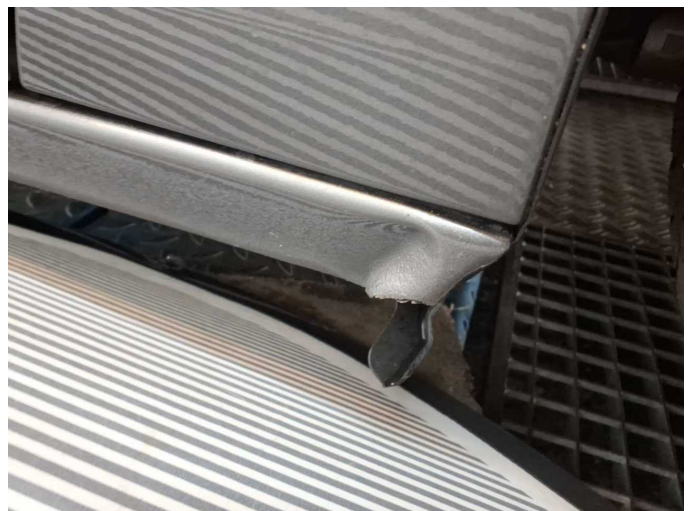
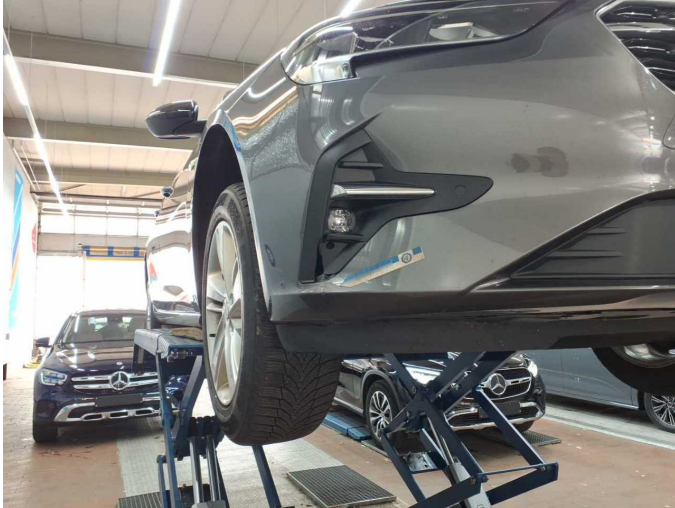
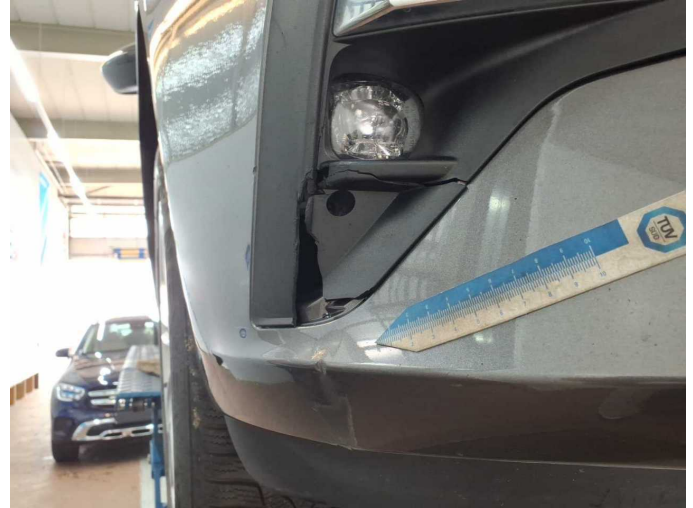
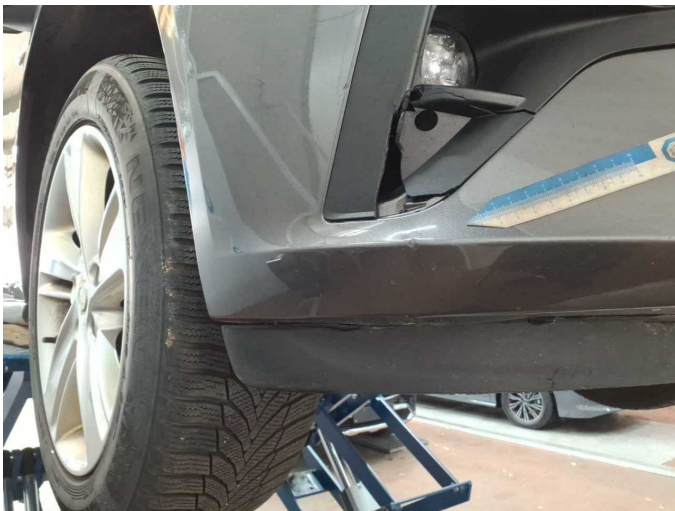
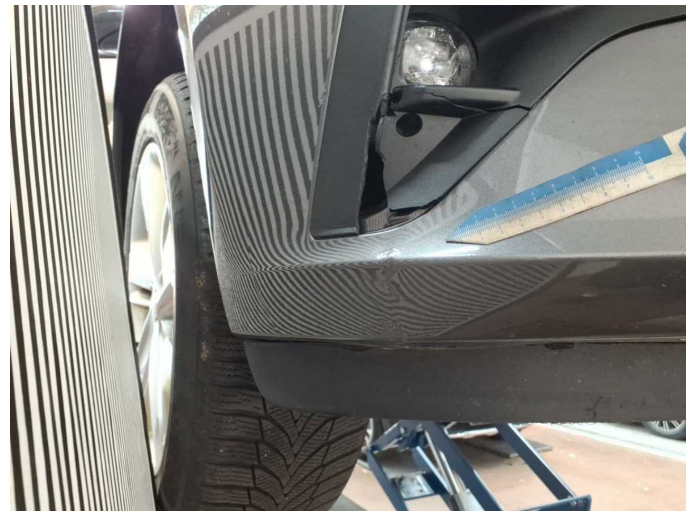
| No. | Accident |
|---|---|
| 1 | Front, Side right, Underbody |

**Accident 1:** Front, Side right, Underbody
